# Case 452 : Narrative

Case Vehicle (A): 2002 Jeep
Type: Liberty, 4x4, 4-door SUV
Driver: 30-year-old male
CDC: 99-0000-0, 12-FLEE-3

# Case 452: Vehicle Report

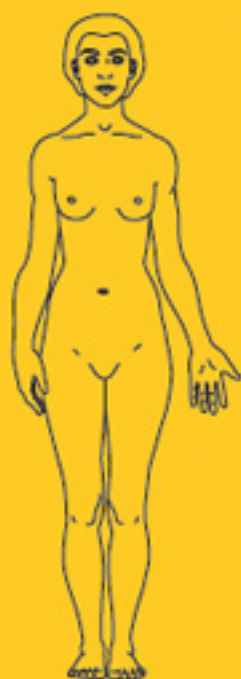
Fracture, transverse  
process L5 (2)

Fracture, pubic  
symphysis (3)

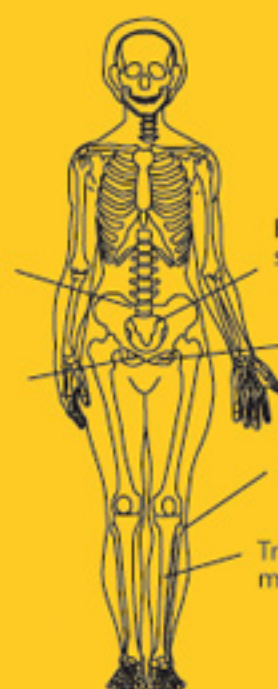
Fracture, left  
sacrum (2)

Fracture, inferior  
left pubic ramus (2)

Displaced fracture, proximal  
aspect of left fibular neck (2)

Transverse fracture,  
mid shaft left tibia (2)
