Case 453 : Narrative

Case Vehicle (A): 1998 Ford	Vehicle (B): 1999 Pontiac
Type: Escort SE, 4-door sedan	Type: Grand Am SE, 2-door coupe
Driver: 19-year-old female	Driver: 21-year-old female
CDC: 12-FDEW-2, 03-RPEW-1	CDC: 09-LYEW-3, 09-LBEW-1

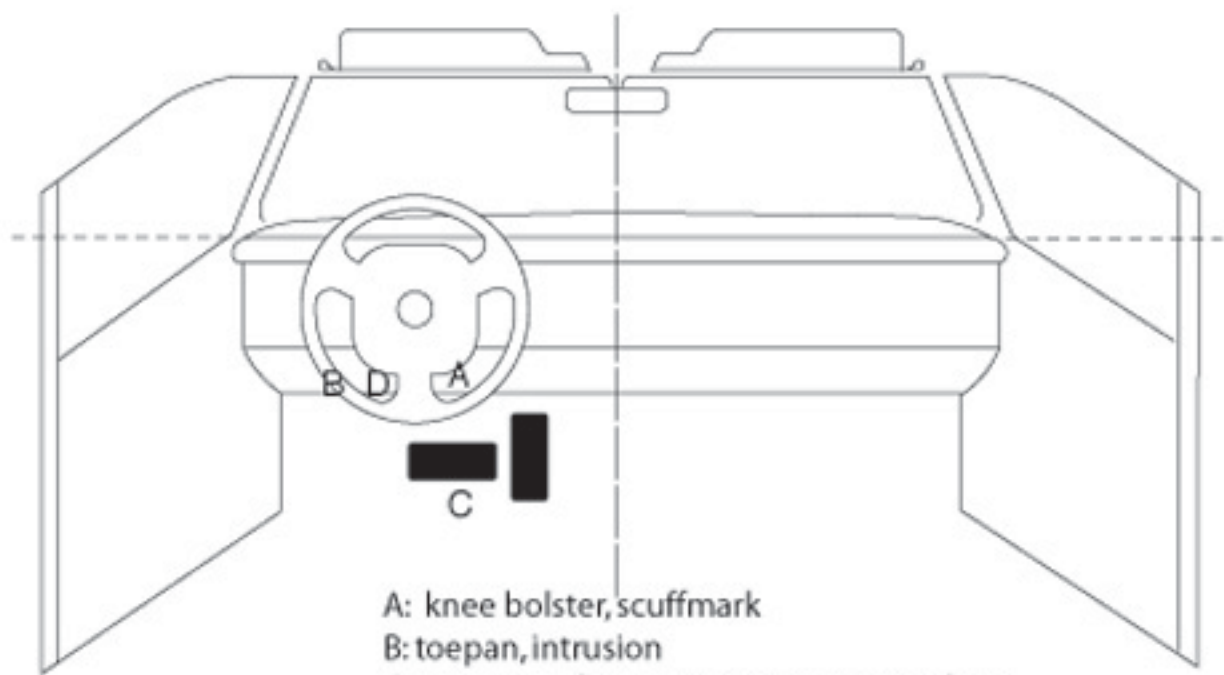
- A: knee bolster, scuffmark
B: toepan, intrusion
C: steering column cover near ignition key,
plastic is cracked
D = steering column, scuffmark on left side

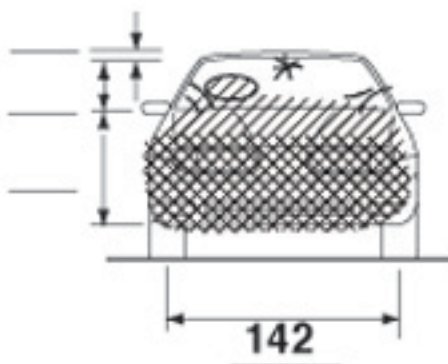
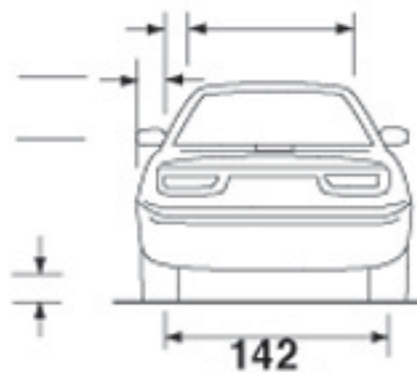
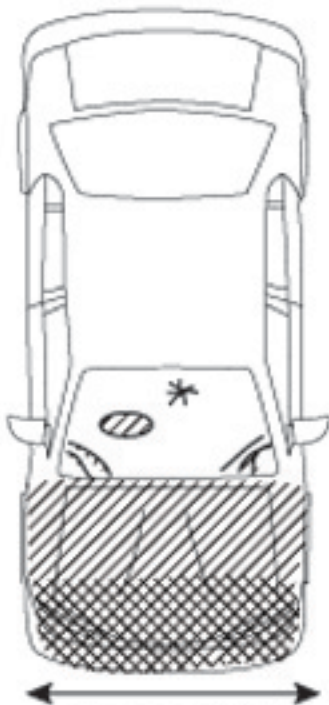
impact #1
144-cm direct damage
31-cm max crush

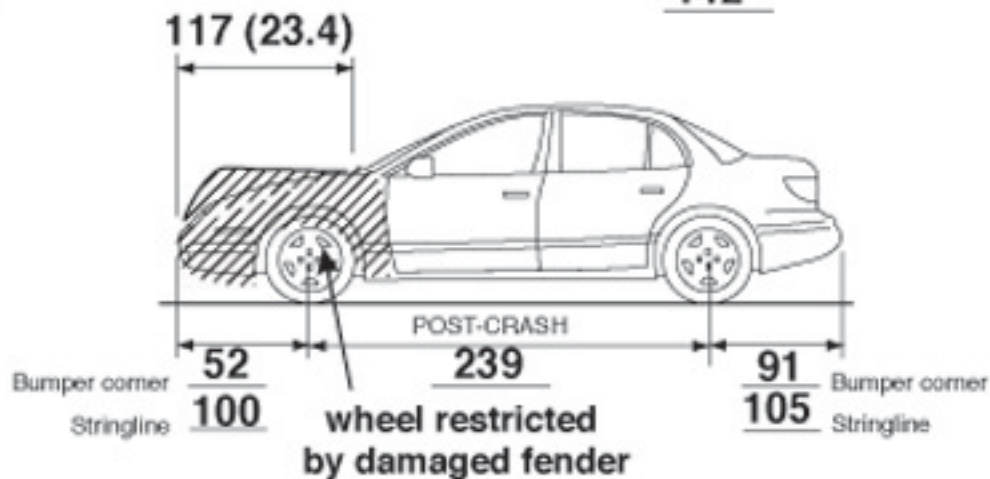
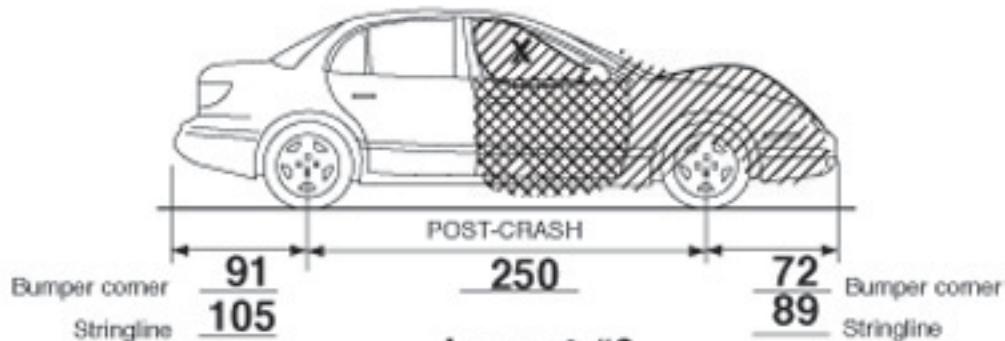
impact #2
100-cm direct damage
7-cm max crush

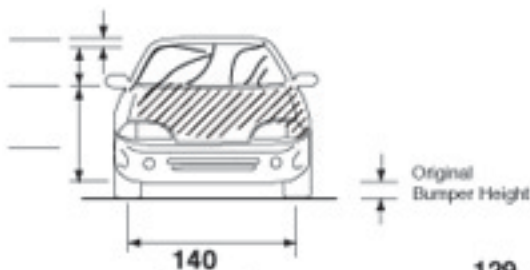
trunk would not close after opening

impact #2
77-cm direct damage
1-cm max crush

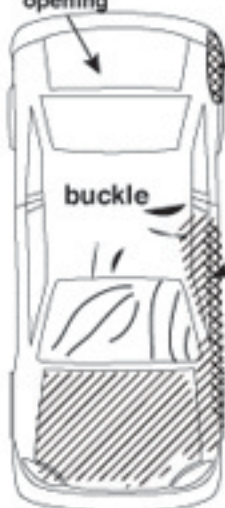
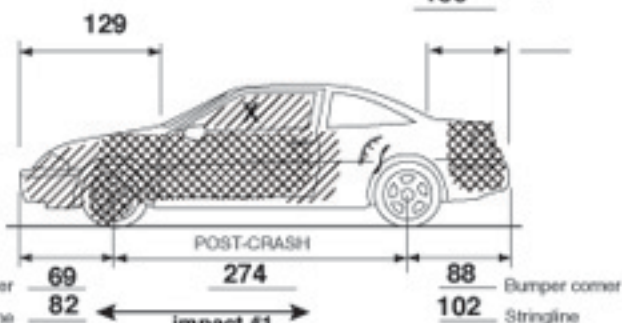
151-cm direct damage
28-cm max crush
