# Case 456 : Narrative

Case Vehicle (A): 2003 Toyota
Type: Camry XLE, 4-door sedan
Driver: 47-year-old male
CDC: 12-FZEW-3

# Case 456: Vehicle Report

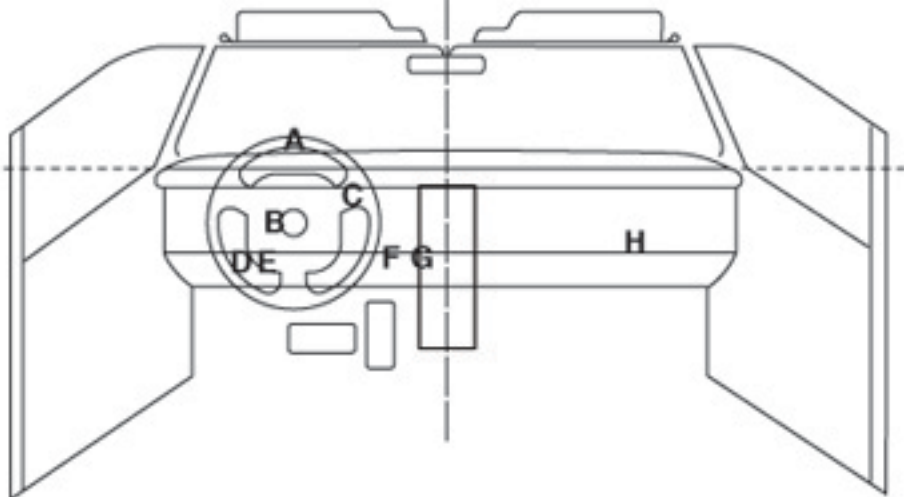
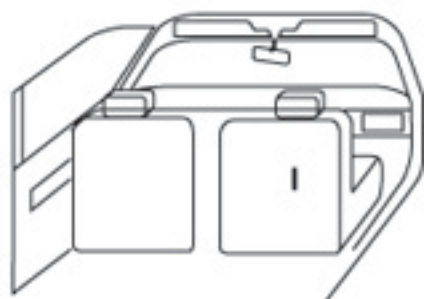
Driver Airbag Doors

- A** = upper half of steering-wheel rim, displaced forward
- B** = steering-wheel hub, cracked
- C** = steering-wheel spokes, broken
- D** = knee bolster left of steering column, scuffmark
- E** = steering column, scuffmark
- F** = knee bolster right of steering column, scuffmark
- G** = vertical console, deflected forward and scuffmark
- H** = glove box door, scuffmark
- I** = right-front seatback, dented

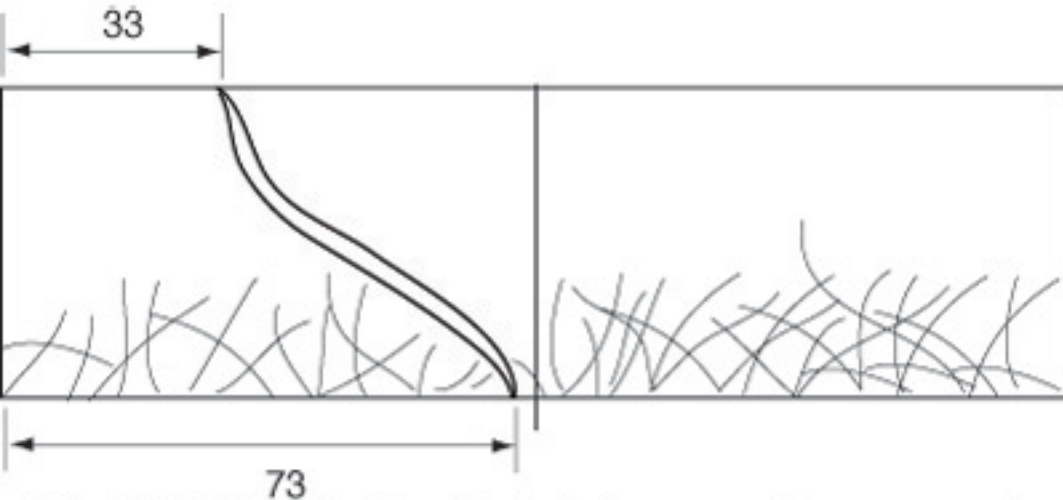
**Windshield cracked and holed due to cowl contact and impact forces**

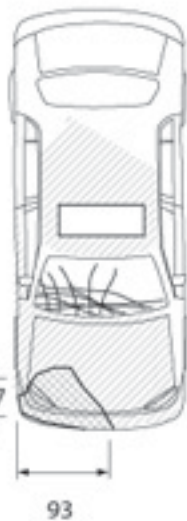
Max. crush is  
inboard from  
right-front  
bumper corner

Width of direct damage to front
