## Case 459 : Narrative

Case Vehicle (A): 2002 Ford	Vehicle (B): 1990 Ford
Type: F150 XLT, Supercab, 4-door pickup	Type: Taurus LX, 4-door sedan
Driver: 44-year-old male	Driver: 43-year-old female
CDC: 01-FZEW-3	CDC: 99-0000-0

# Case 459: Vehicle Report

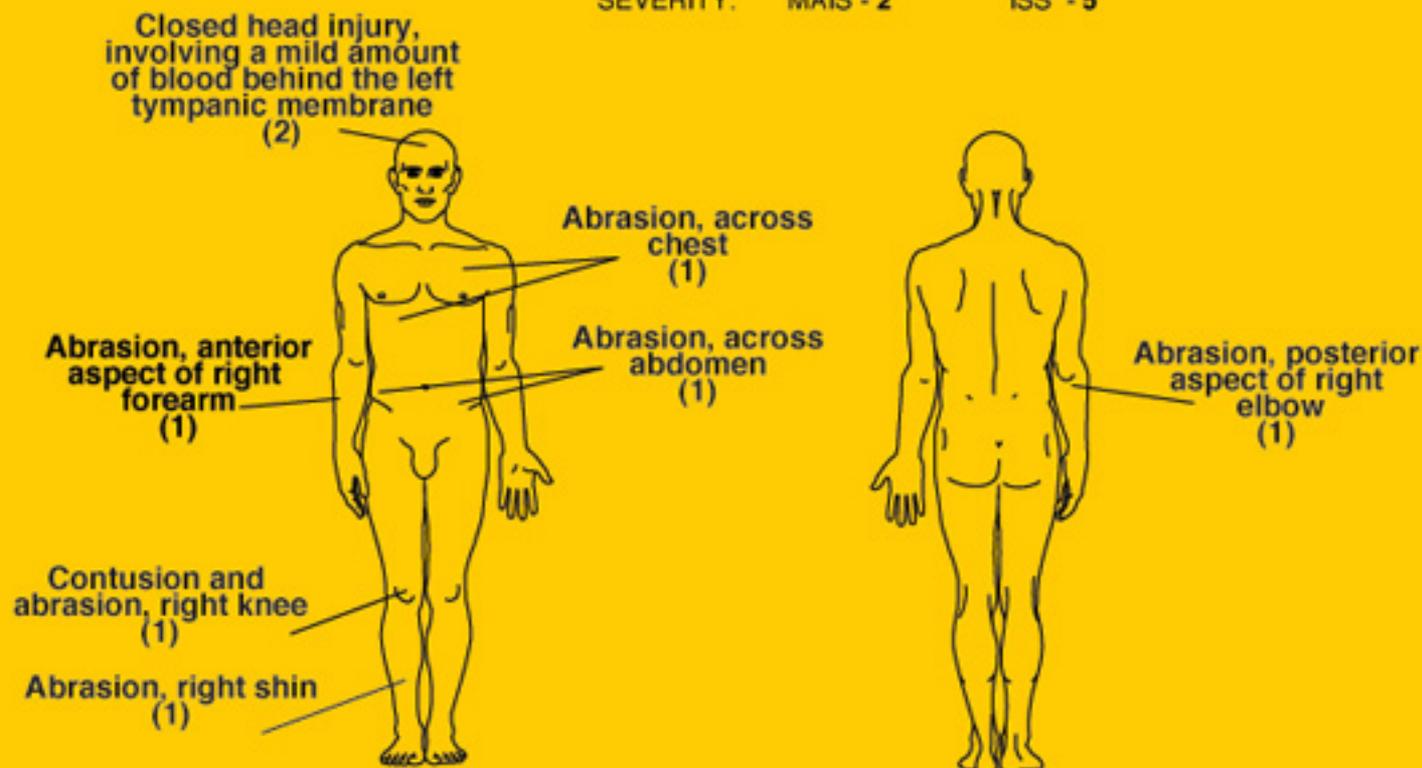
The following table and [65](#) attached drawing summarize the injuries sustained by the restrained driver of case vehicle (A).

Occupant: Driver		Age: 44 years	Gender: Male		
Restraints: Seat-integrated 3-point belt with pretensioner;steering-wheel airbag		Stature: 191 cm (6 ft, 3 in)	Mass: 109 kg (240 lb)		
Injury Description	A.I.S.	Injury Source			
		Definite	Probable	Possible	
—	—	Definite	Probable	Possible	
Closed head injury involving a small amount of blood behind the left tympanic membrane	2	Unknown	—	—	
Abrasion, across the chest	1	Shoulder belt	—	—	
Abrasion, posterior aspect of right elbow	1	Unknown	—	—	
Abrasion, across abdomen	1	Lap belt	—	—	
Abrasion, anterior aspect of right forearm	1	—	—	Airbag	
Abrasion, right knee	1	Knee bolster	—	—	
Contusion, right knee	1	Knee bolster	—	—	
Abrasion, right shin	1	Unknown	—	—	
Maximum A.I.S. Level	2	—	—	—	
Injury Severity Score	5	—	—	—

SEVERITY:    MAIS - 2    ISS - 5

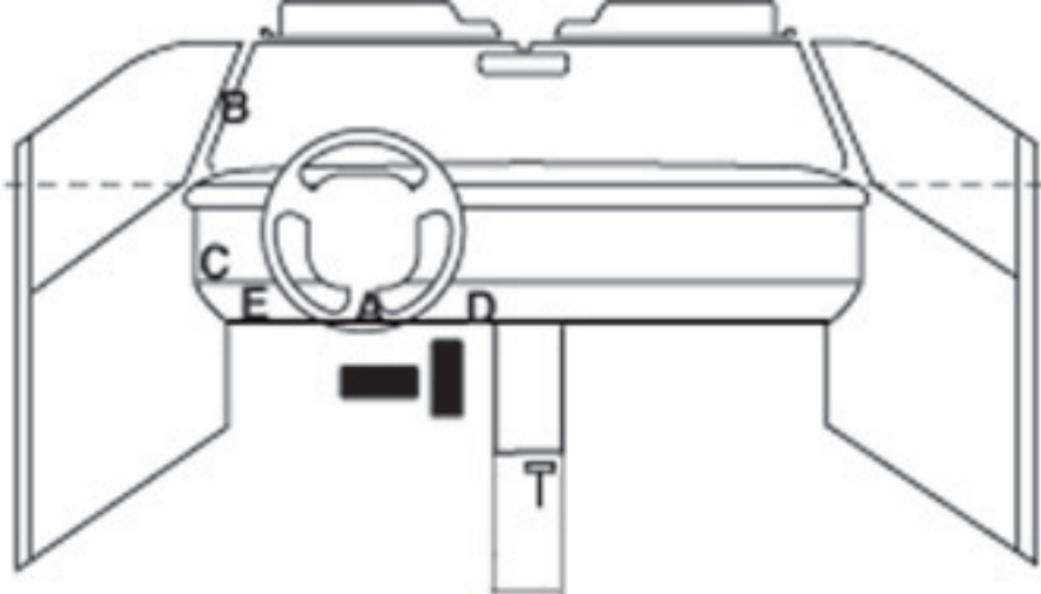
Driver Airbag

Vents:  Y  Nif yes, how many: 2

Vents @ 11 and 1 o'clock

Tethers:  Y  Nif yes, how many: 1

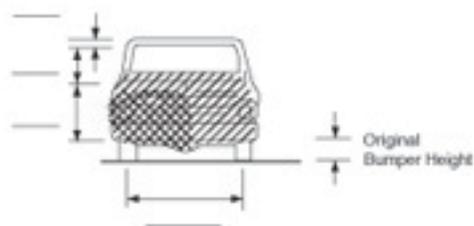
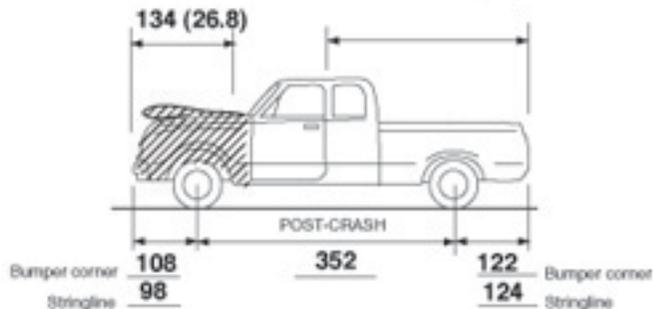
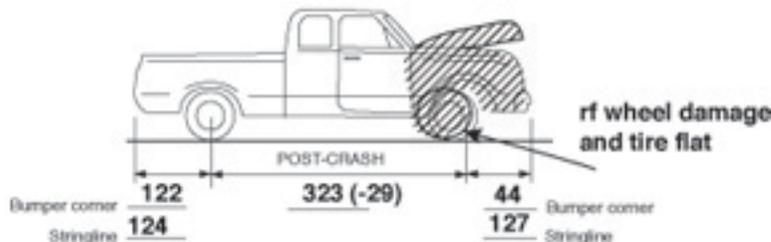
94 cm direct damage  
55 cm max crush at C6
