Case 461 : Narrative

Case Vehicle (A): 1999 Ford
Type: Contour SE sport, 4-door sedan
Driver: 46-year-old female
CDC: 12-FCEN-3

GENERAL VEHICLE DAMAGE AND ESTIMATED CRASH SEVERITIES

DESCRIPTION OF DAMAGE TO CASE VEHICLE (A)

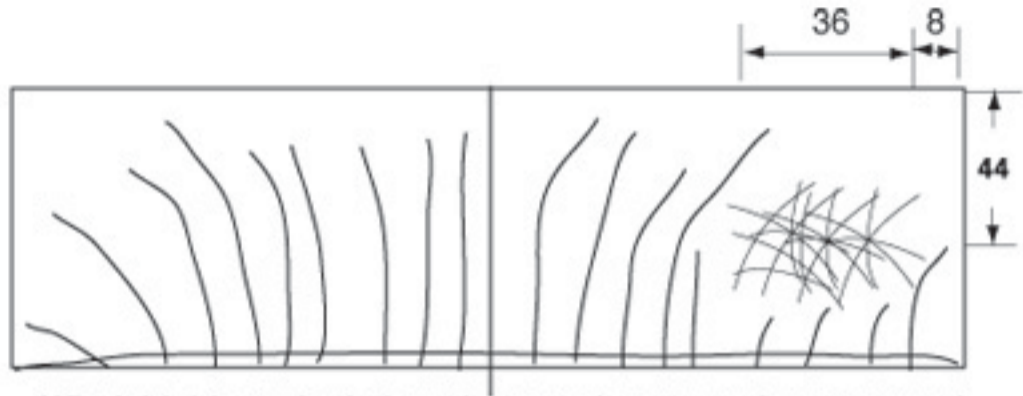
WINDSHIELD MARK ON CASE VEHICLE:

Windshield cracked along bottom due to cowl contact and right due to contact by dash-mounted passenger side airbag cover

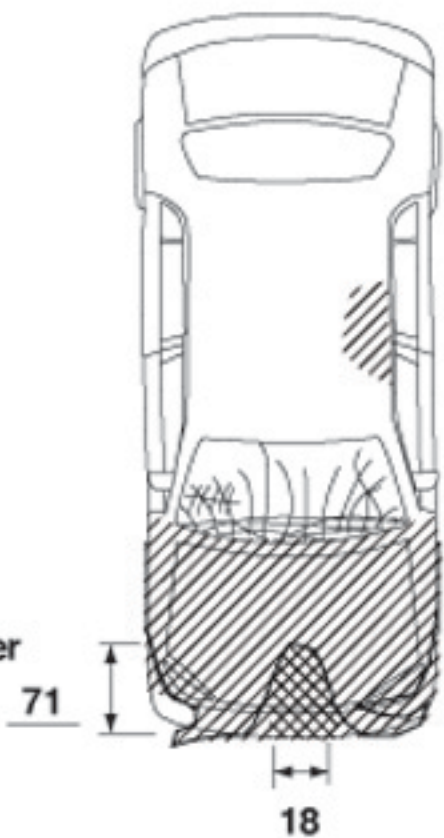
Max. crush to center of front bumper

Width of direct damage to front
