Case 468 : Narrative

| Case Vehicle (A): 1999 Mitsubishi |
| Type: Galant, 4-door sedan |

This is a fatal crash. The 4-year-old left-rear male passenger of case vehicle (A) died from head/neck injuries sustained during this pole-type frontal crash.

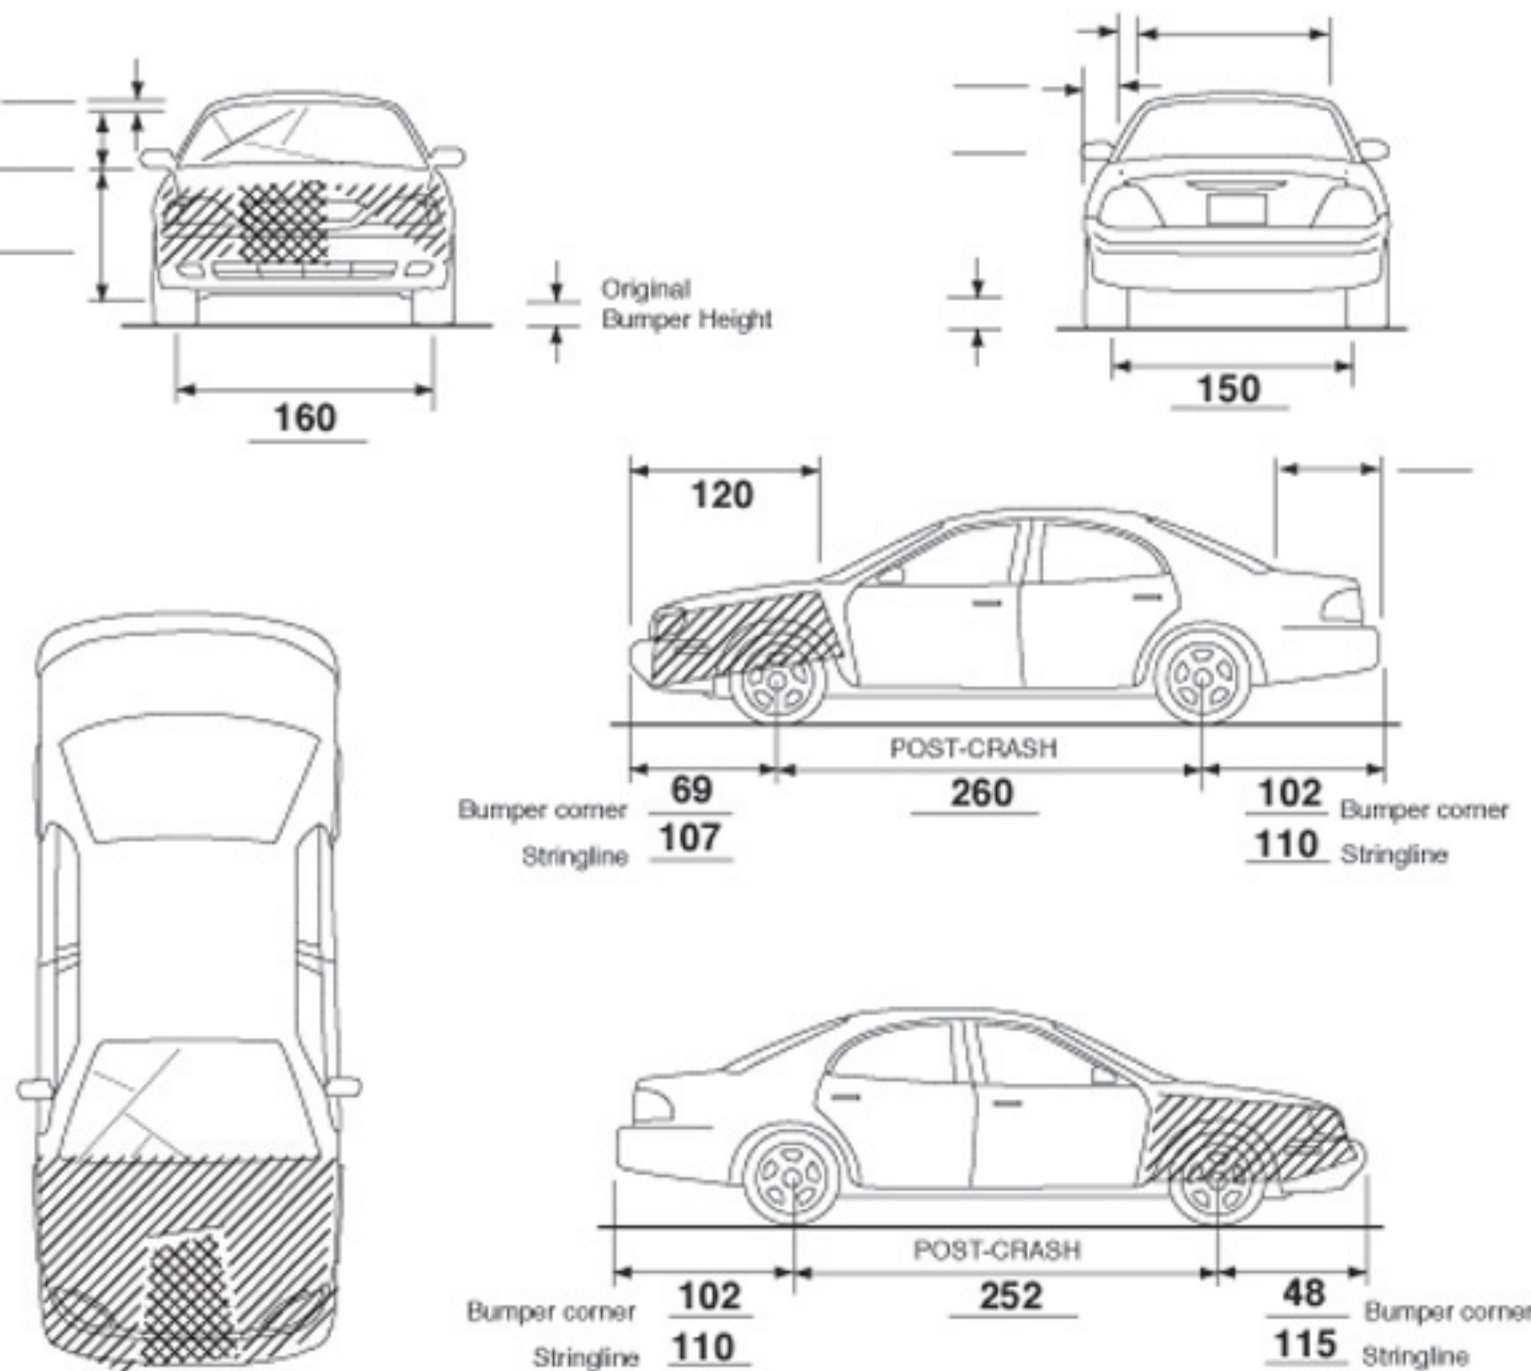
[11](#) In the front, the centers of the bumper and hood were crushed rearward past the plane of the radiator supports, and the middle of the hood was buckled up. The hood latch was damaged and jammed closed, the left hood hinge was bent to the right, and the right hood hinge was bent rearward. The rear edge of the hood was elevated but it did not contact the windshield, which was cracked from cowl and upper-right A-pillar distortion as well as from contact by the deploying dash-mounted airbag.

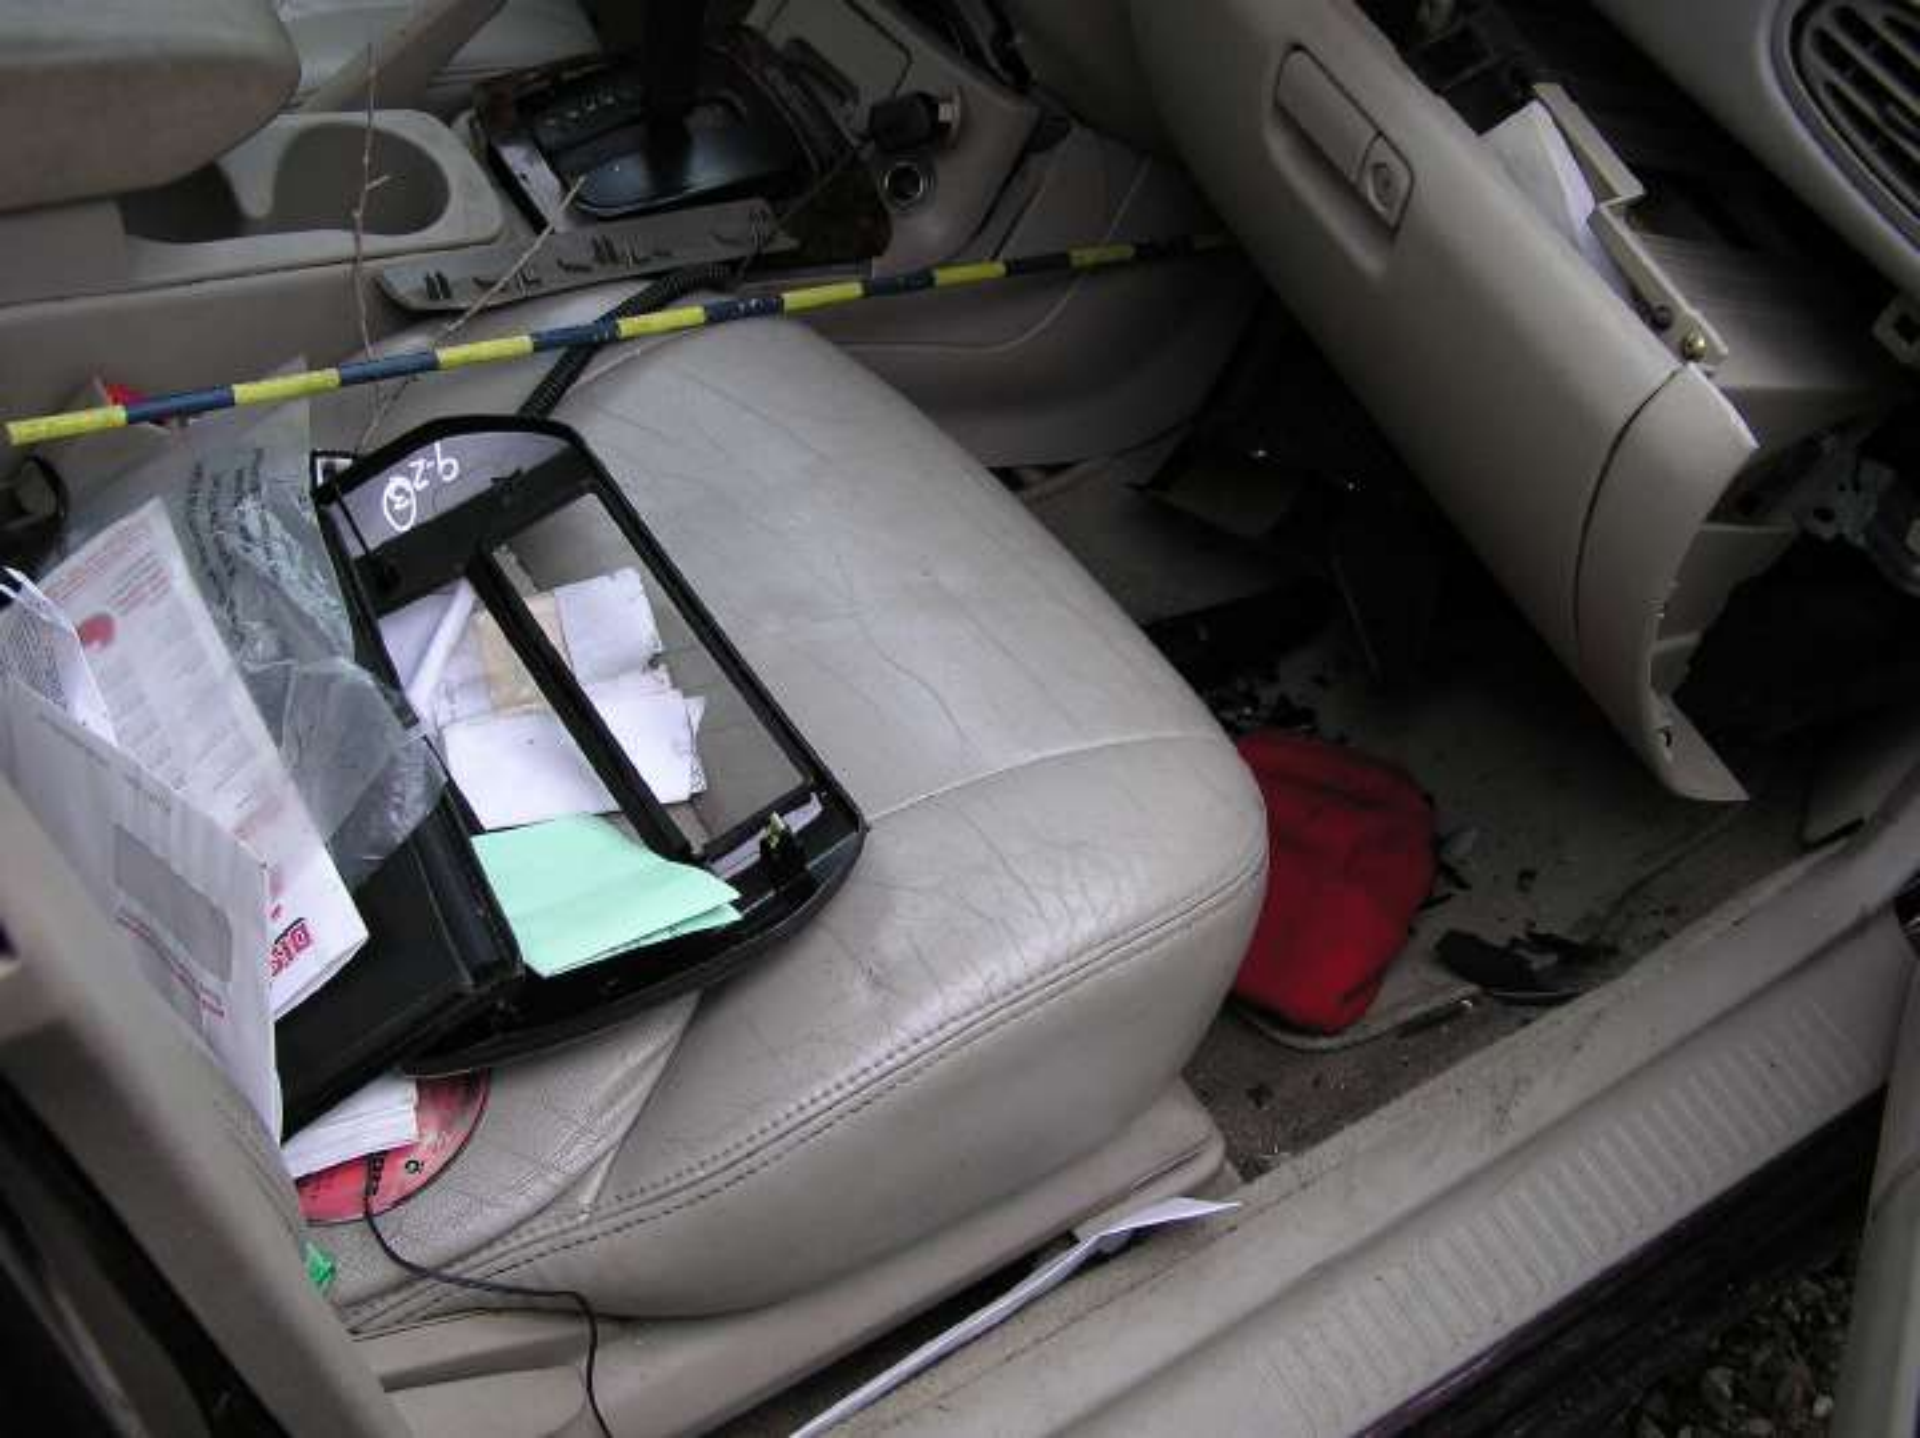
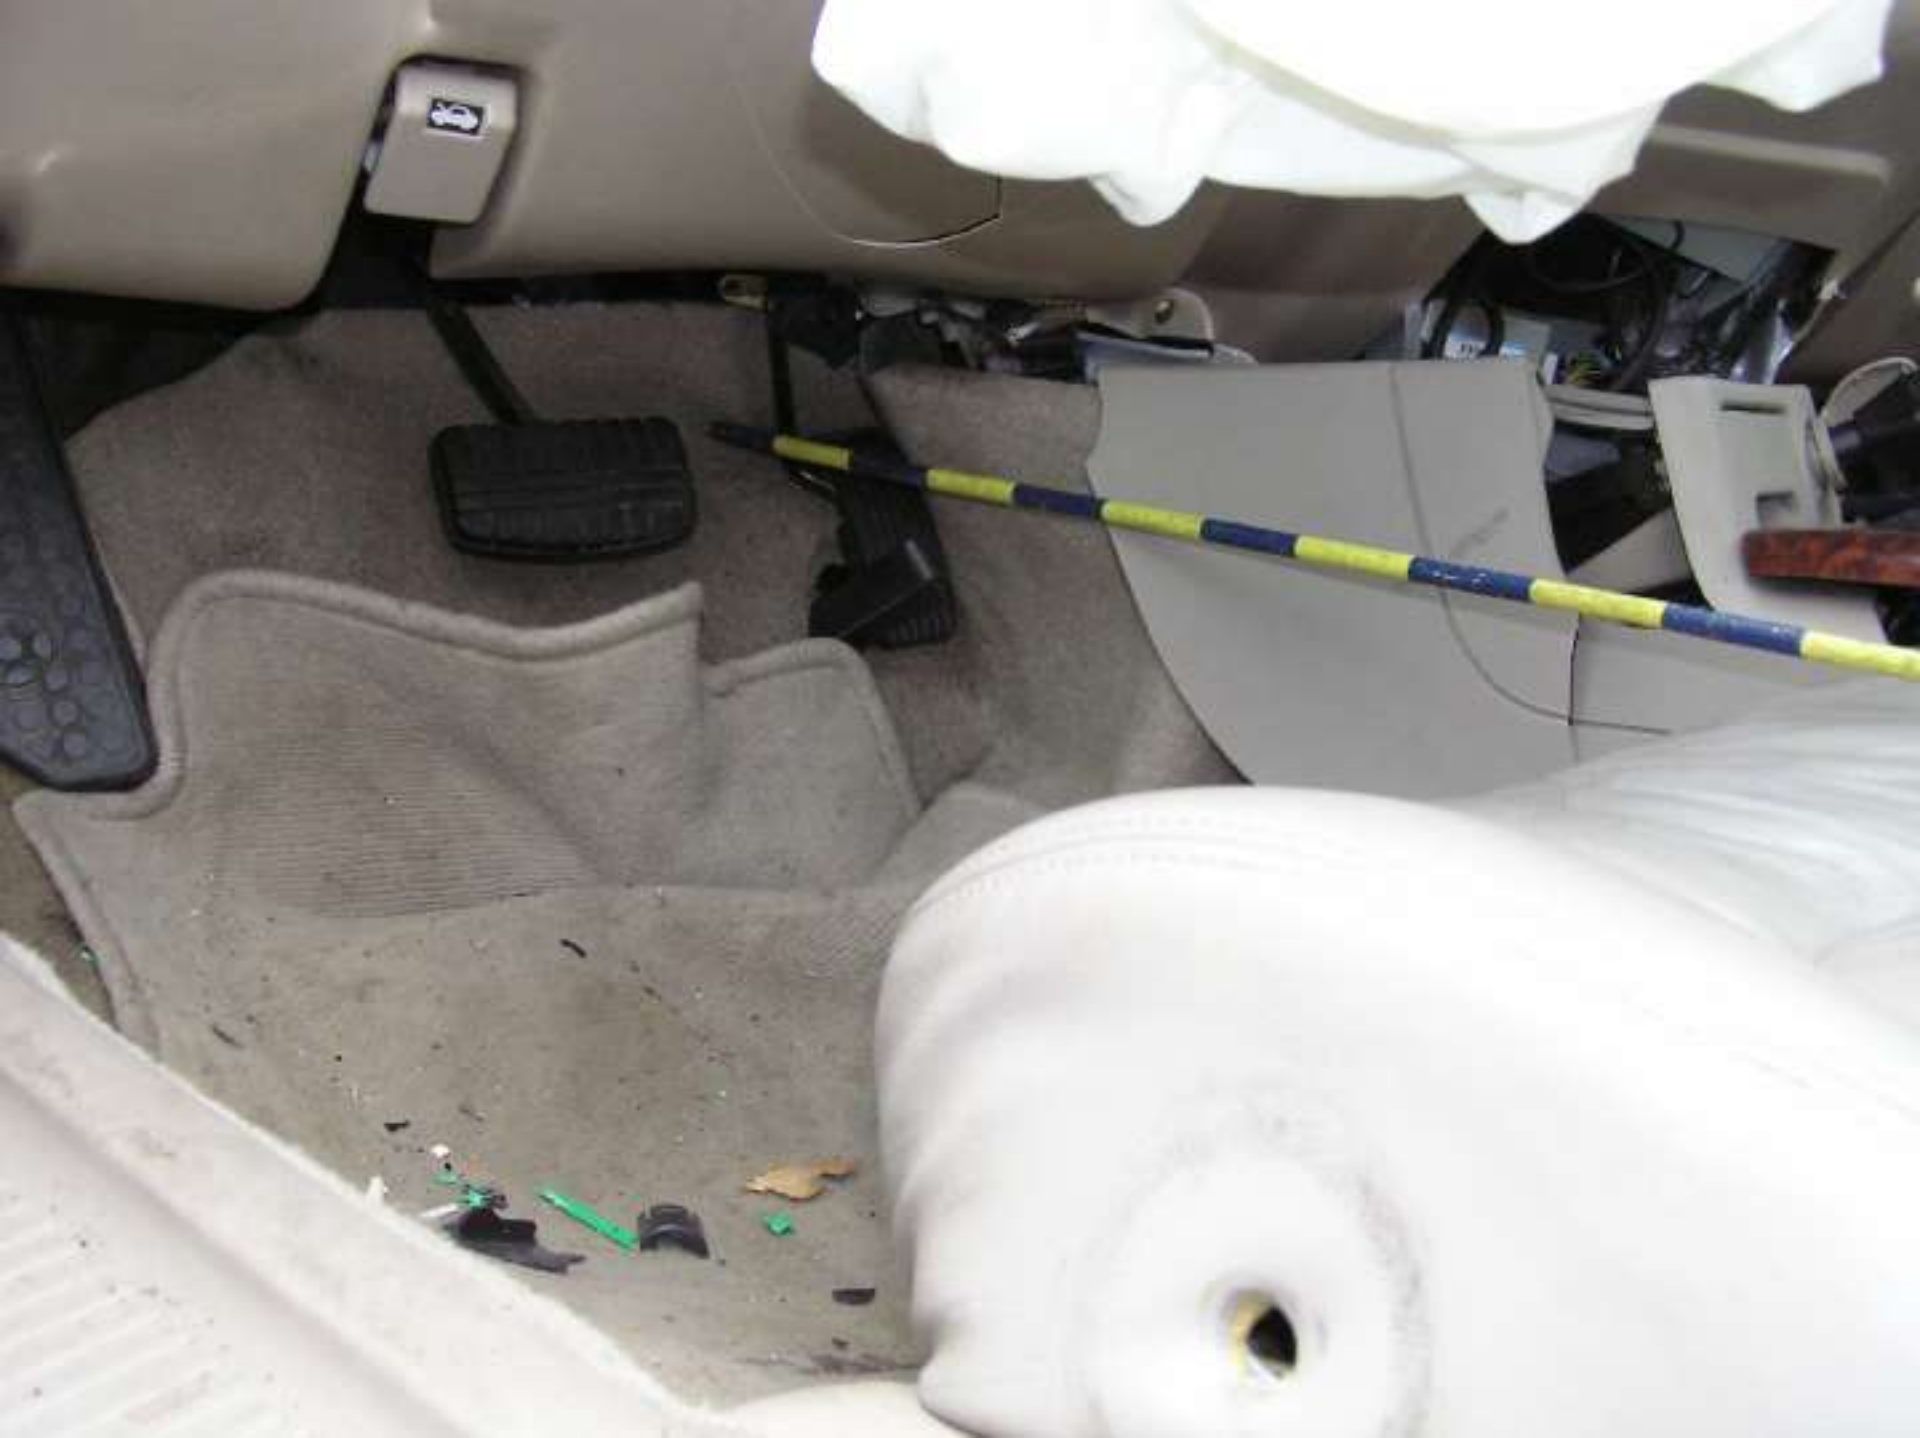
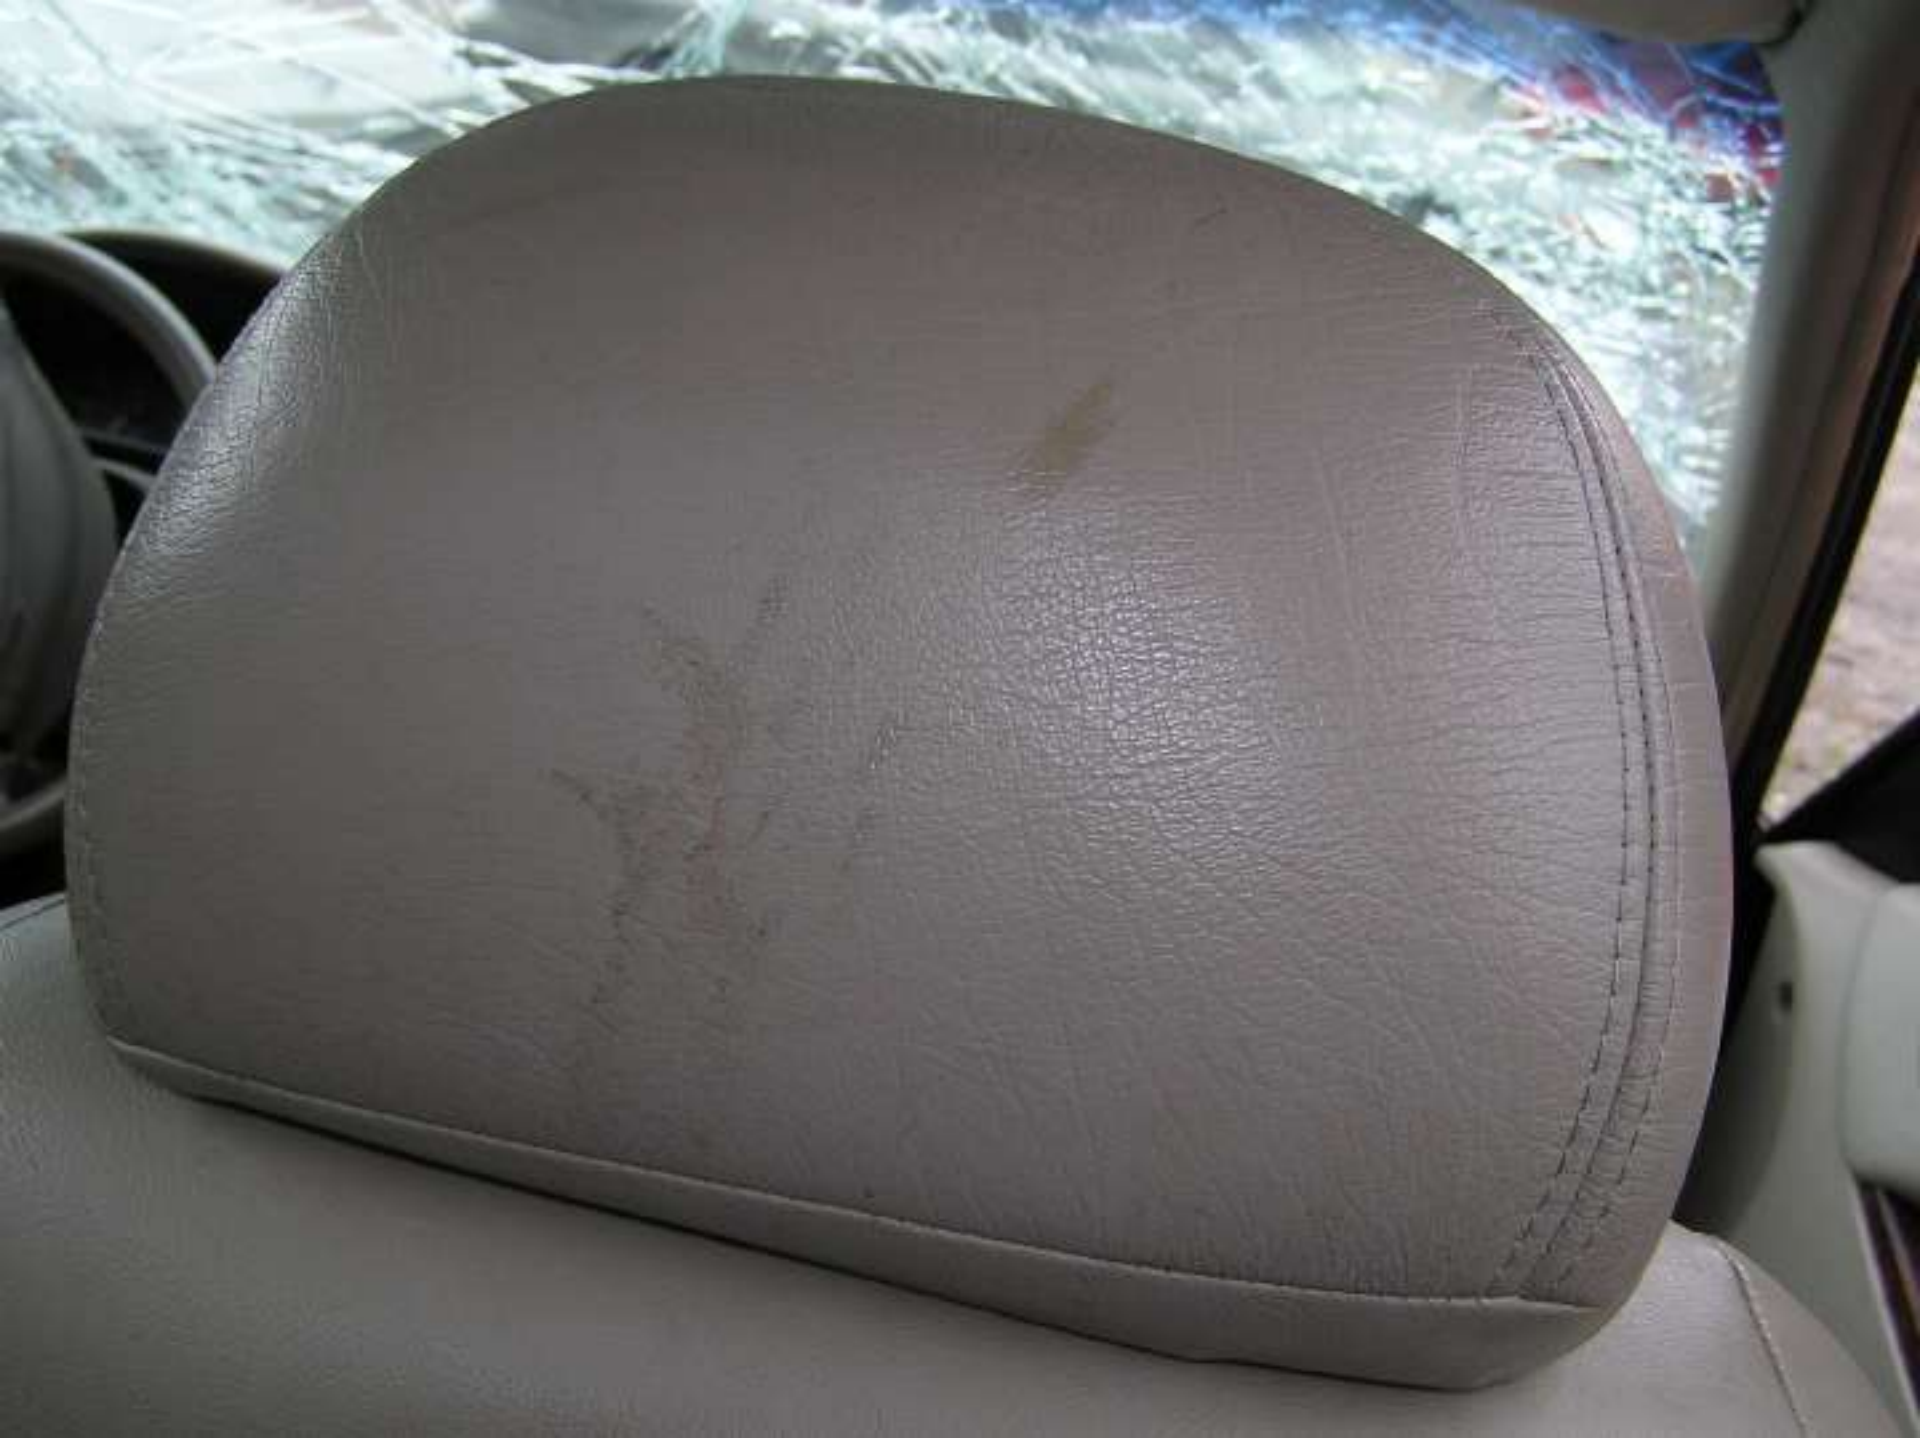
This vehicle was equipped with steering-wheel and dash-mounted frontal-impact airbags, and both deployed during the frontal impact with the bridge abutment. [18](#) [19](#) [20](#) In the driver area, there was no damage to the deployed steering-wheel airbag and there were no occupant contact marks. [21](#) All four of the steering-wheel spokes were slightly deformed and the upper-left portion of the steering-wheel rim was deflected forward approximately 3 cm. [22](#) [23](#) The right portion of the driver instrument panel was displaced rearward, resulting in contact with the control stalks mounted on the right side of the steering column, and the right side of the column shroud was deformed. [24](#) [25](#) There was no rearward intrusion or rotation of the steering column. [26](#) The left side of the driver knee bolster was cracked from contact by the driver's left knee and [27](#) the right side was scuffed, deformed, and displaced rearward. [25](#) The upper instrument panel was not damaged but the left air vent was displaced slightly from its fitting. [28](#) The toe pan was displaced rearward and the floor pan forward of the accelerator pedal was buckled and displaced up. [29](#) The accelerator pedal was deformed and dislodged from the linkage. [41](#) The windshield was cracked throughout from body distortion, [30](#) [31](#) [32](#) there were six distinct blood spots on the front surface of the driver sunvisor, and [33](#) [34](#) there was also a scuffmark on the left side of the visor. [35](#) [36](#) [37](#) There was a cloth transfer on, and a dent in, the forward portion of the driver-door interior. [38](#) [39](#) [40](#) The driver seat was in a mid-track position and the seat was not damaged.
