Case 468 : Narrative

| Case Vehicle (A): 1999 Mitsubishi |
| Type: Galant, 4-door sedan |

This is a fatal crash. The 4-year-old left-rear male passenger of case vehicle (A) died from head/neck injuries sustained during this pole-type frontal crash.

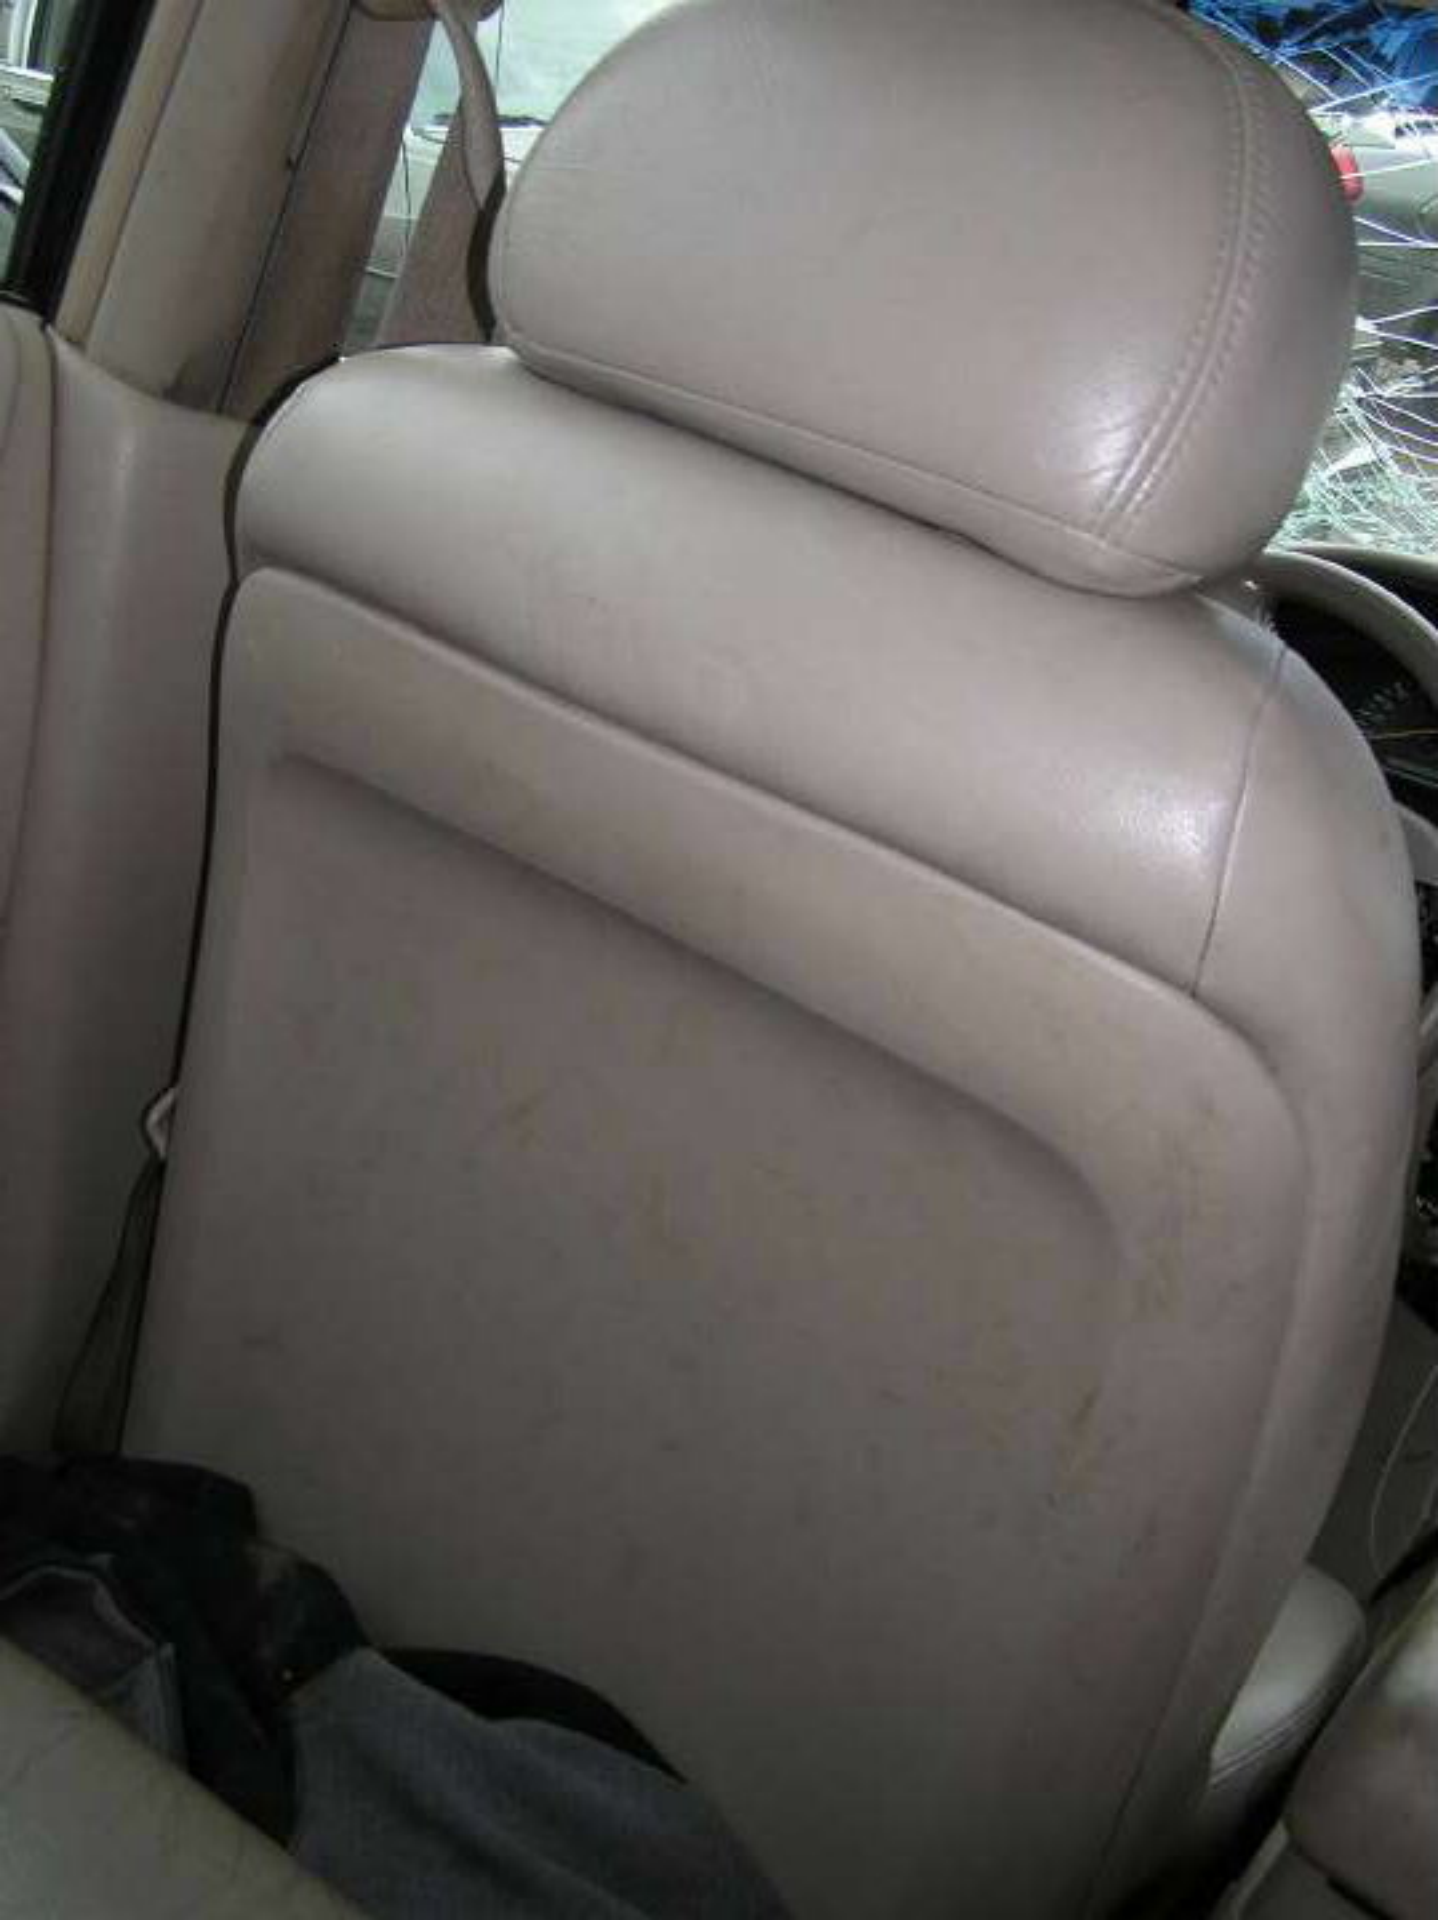
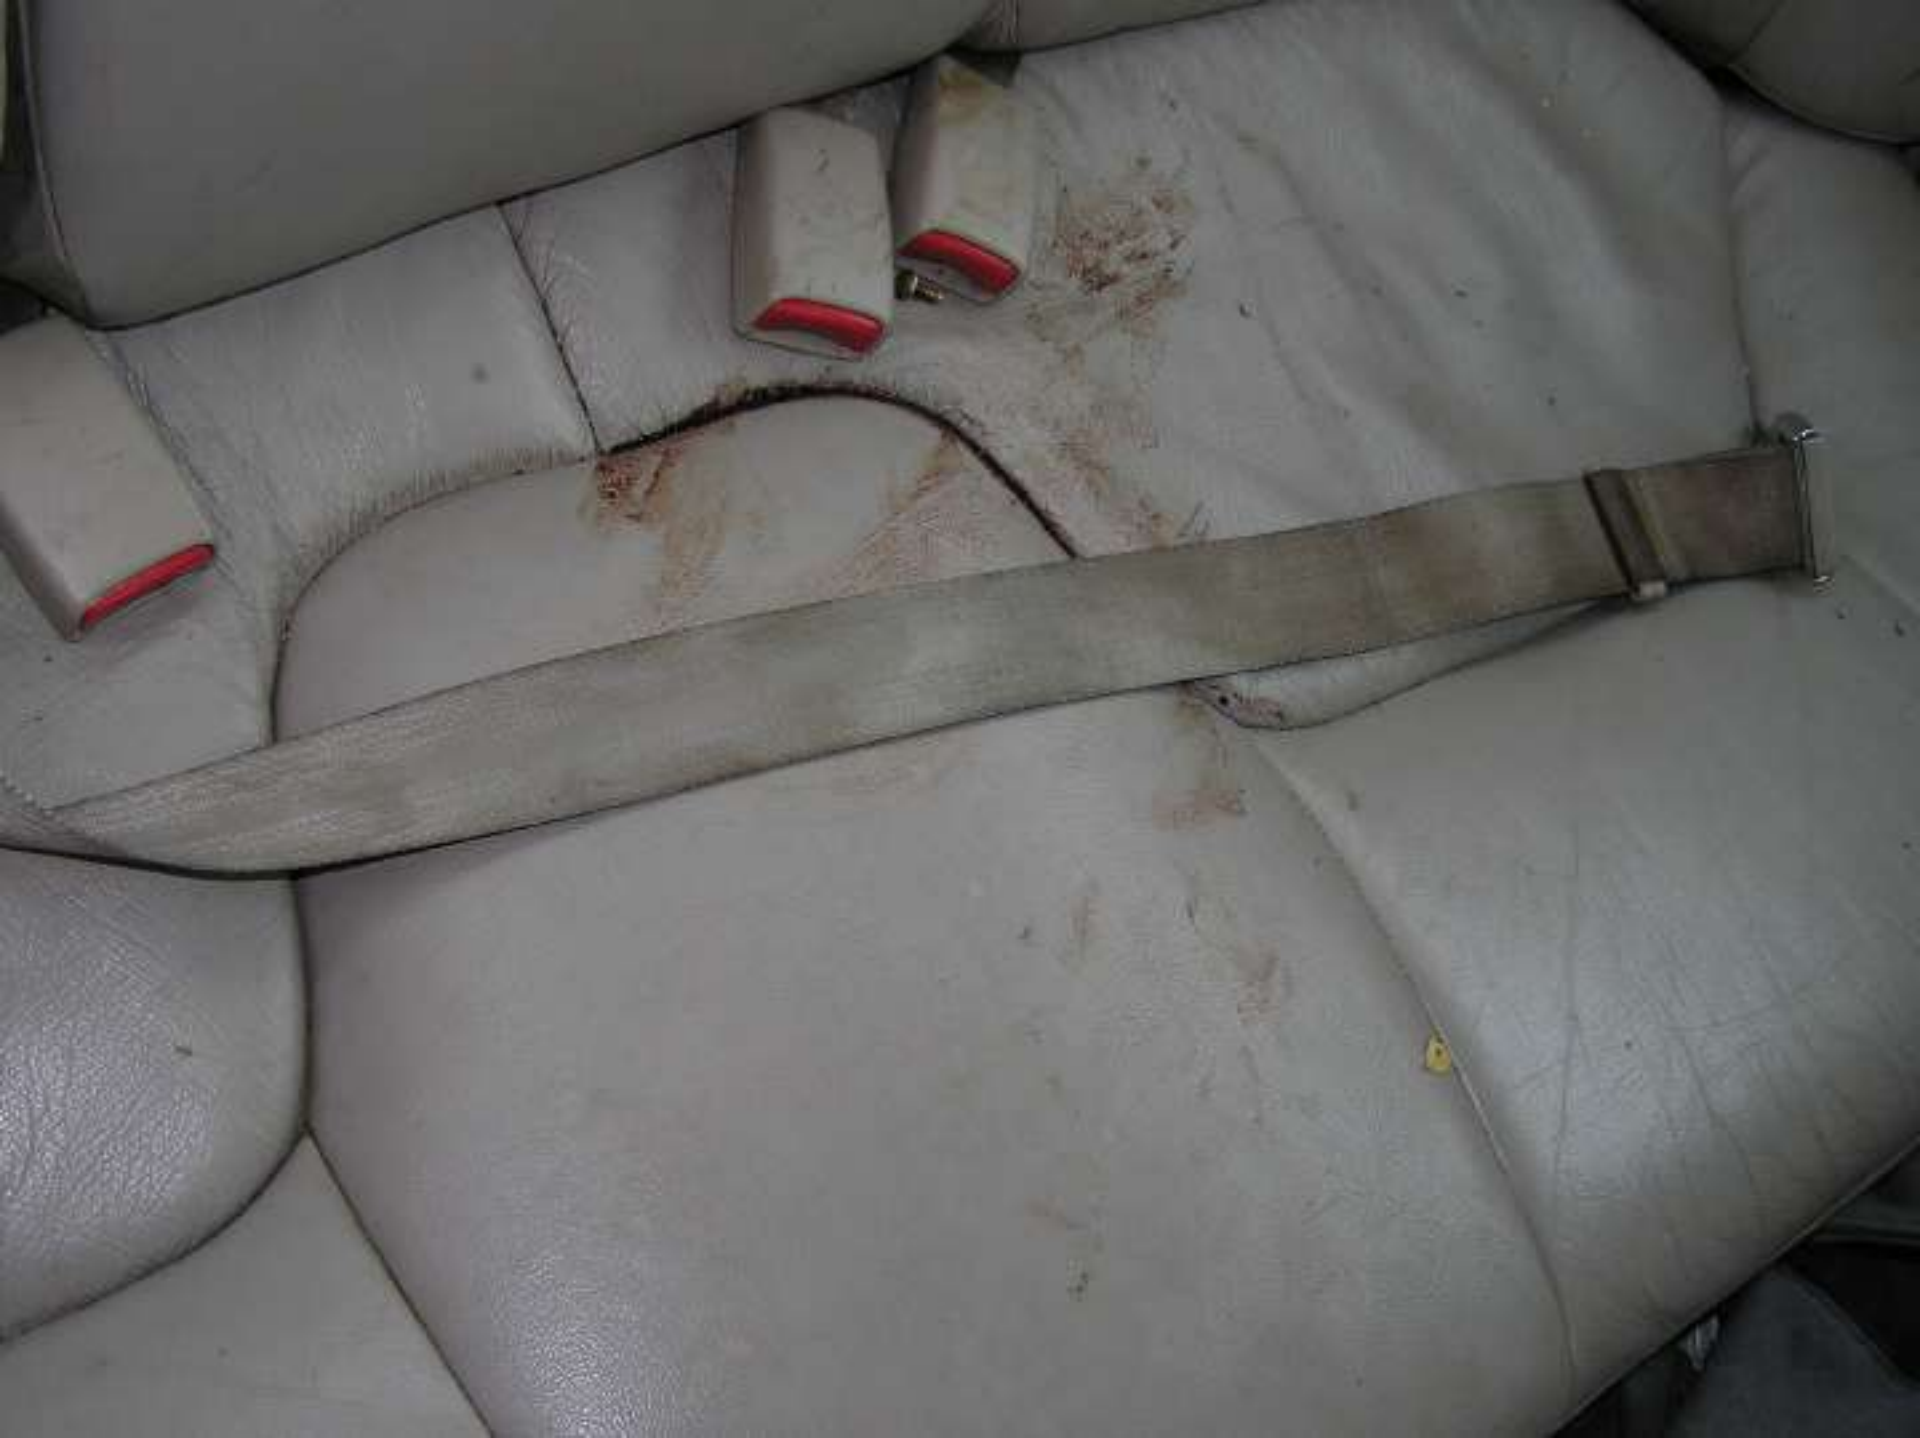
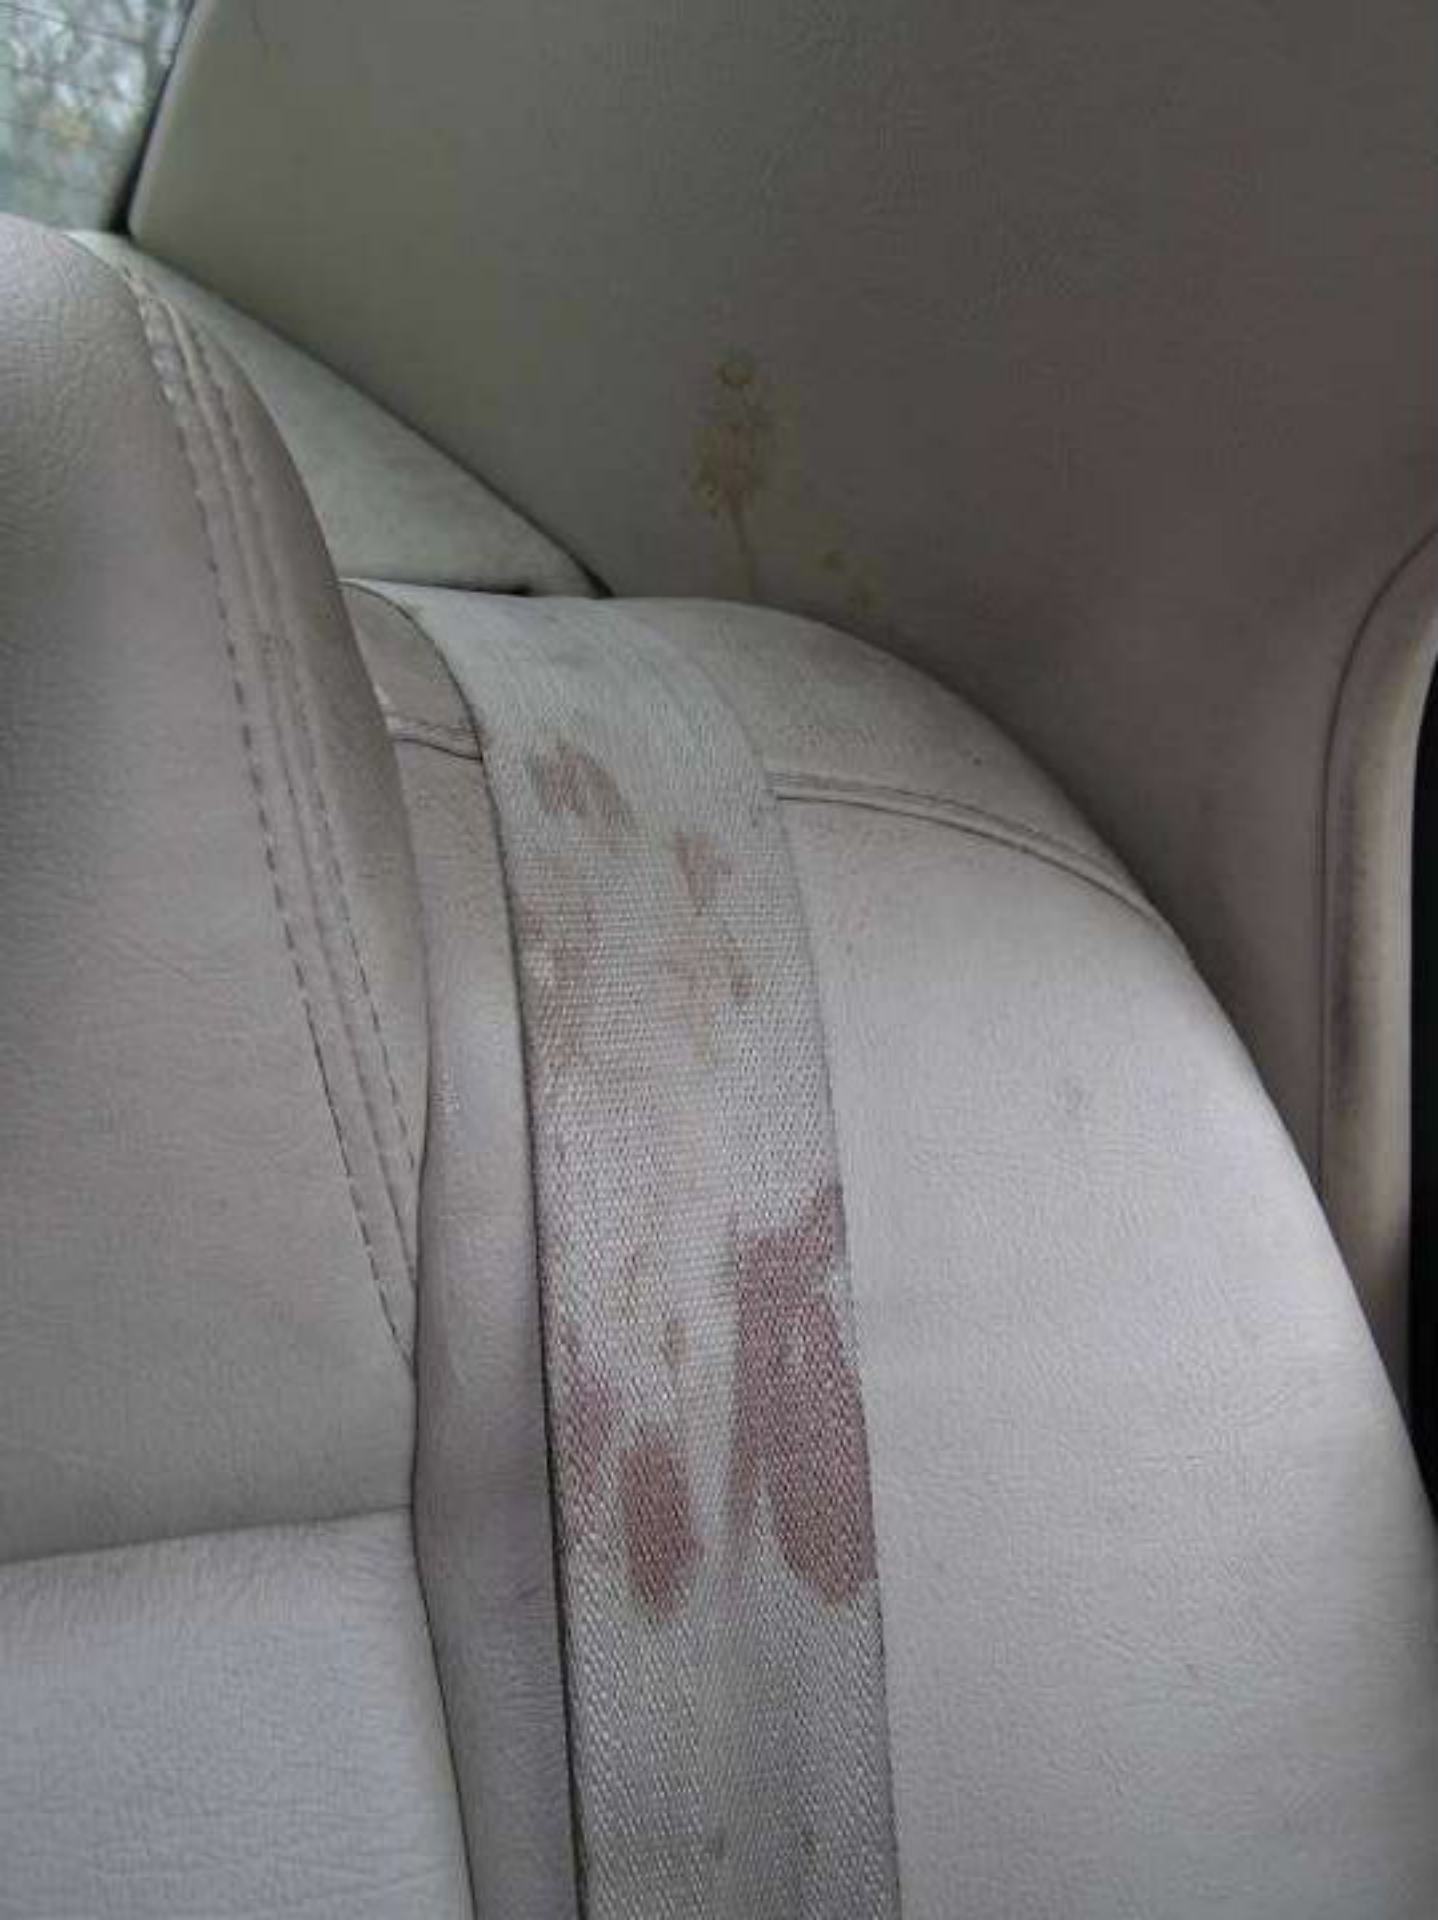
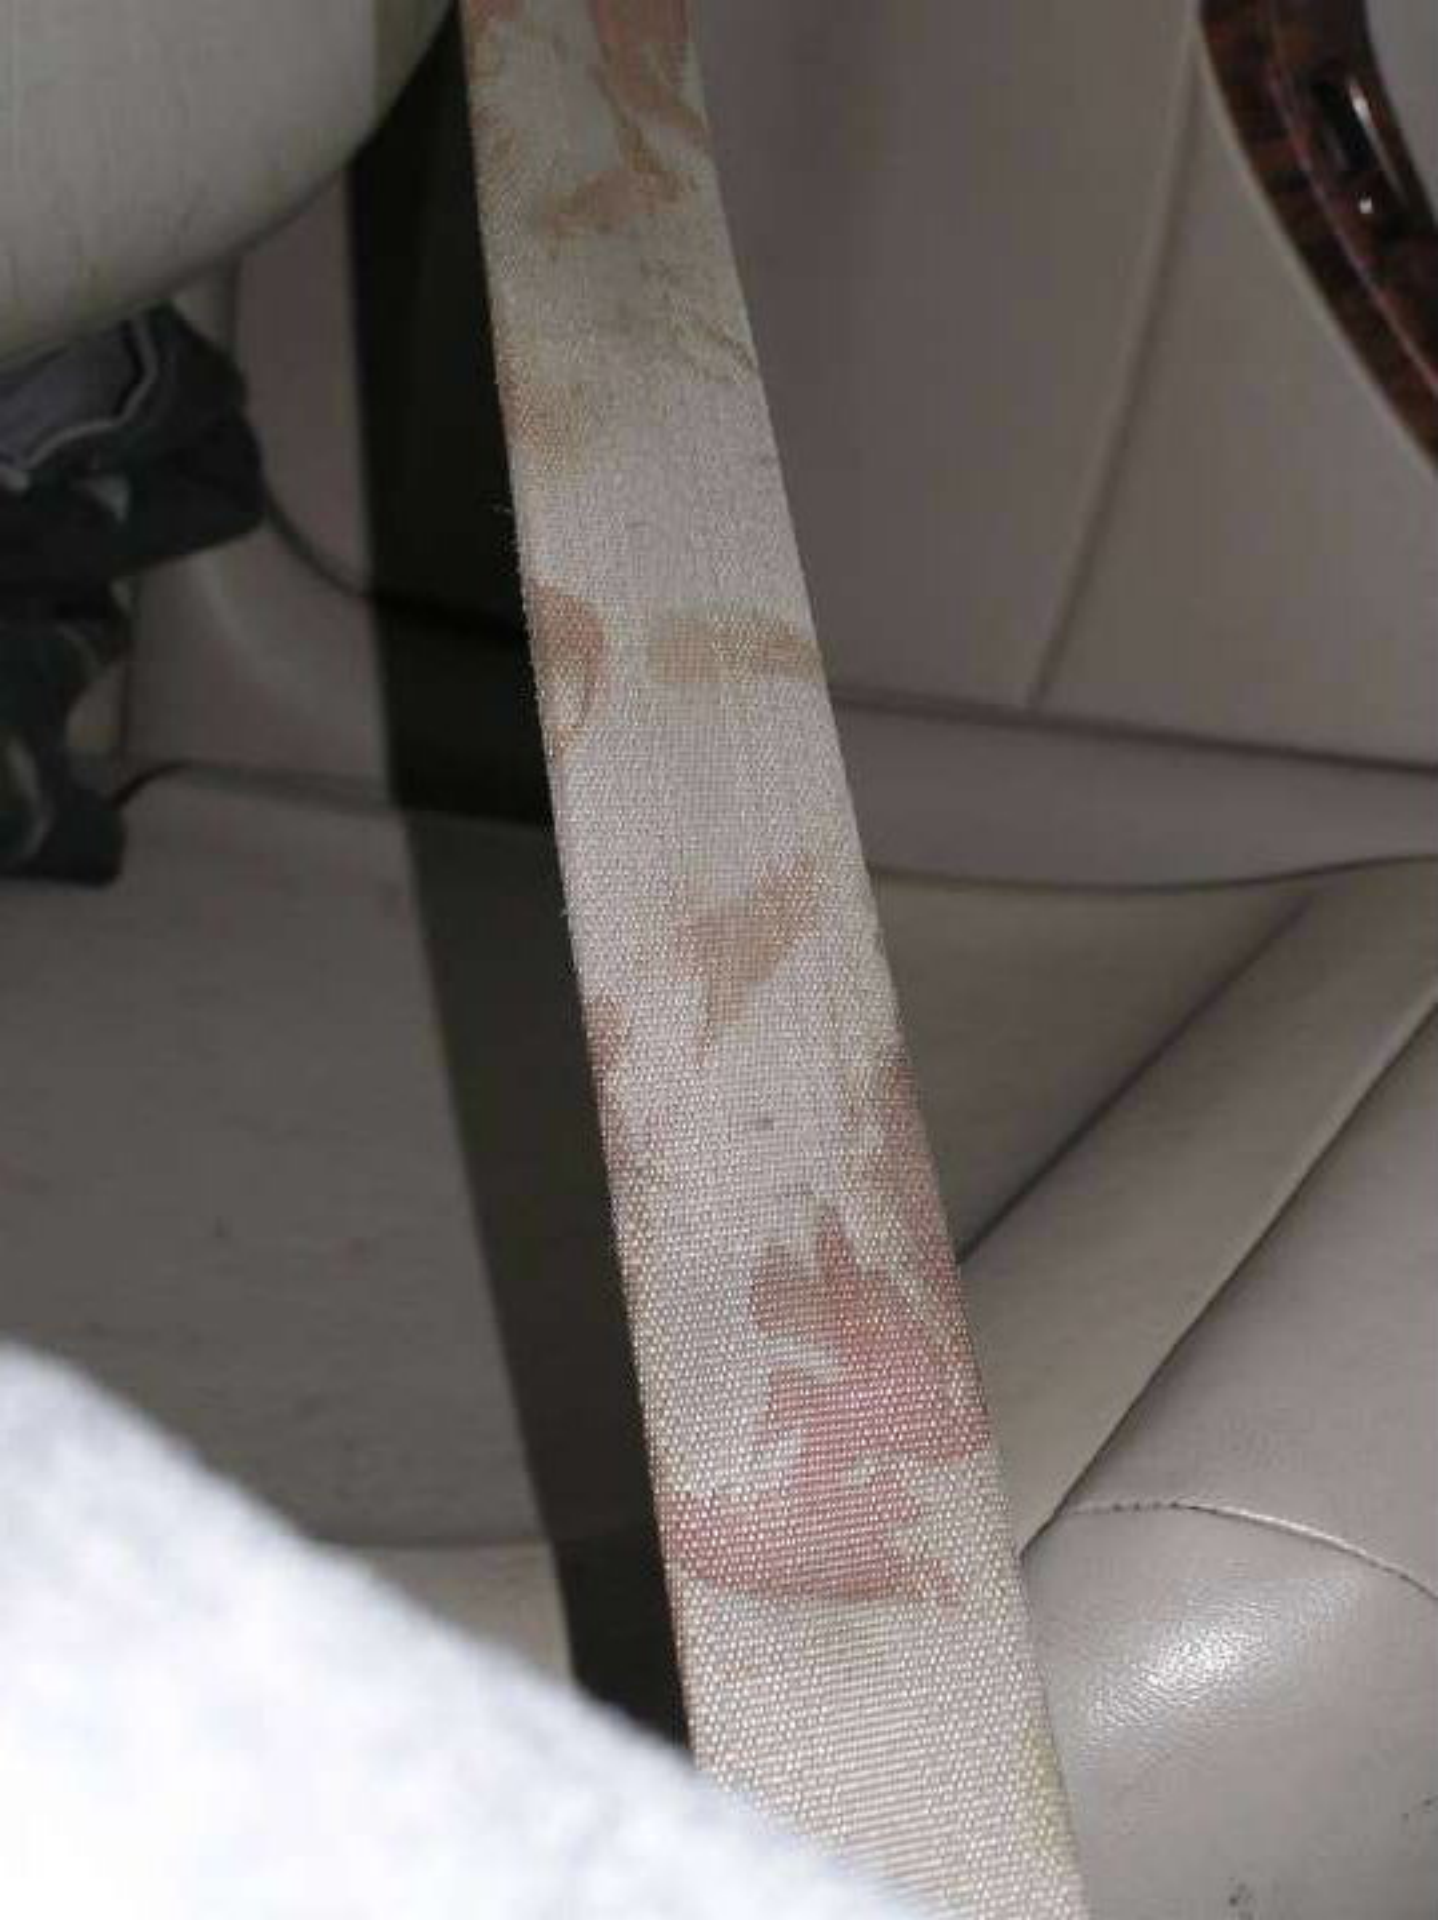
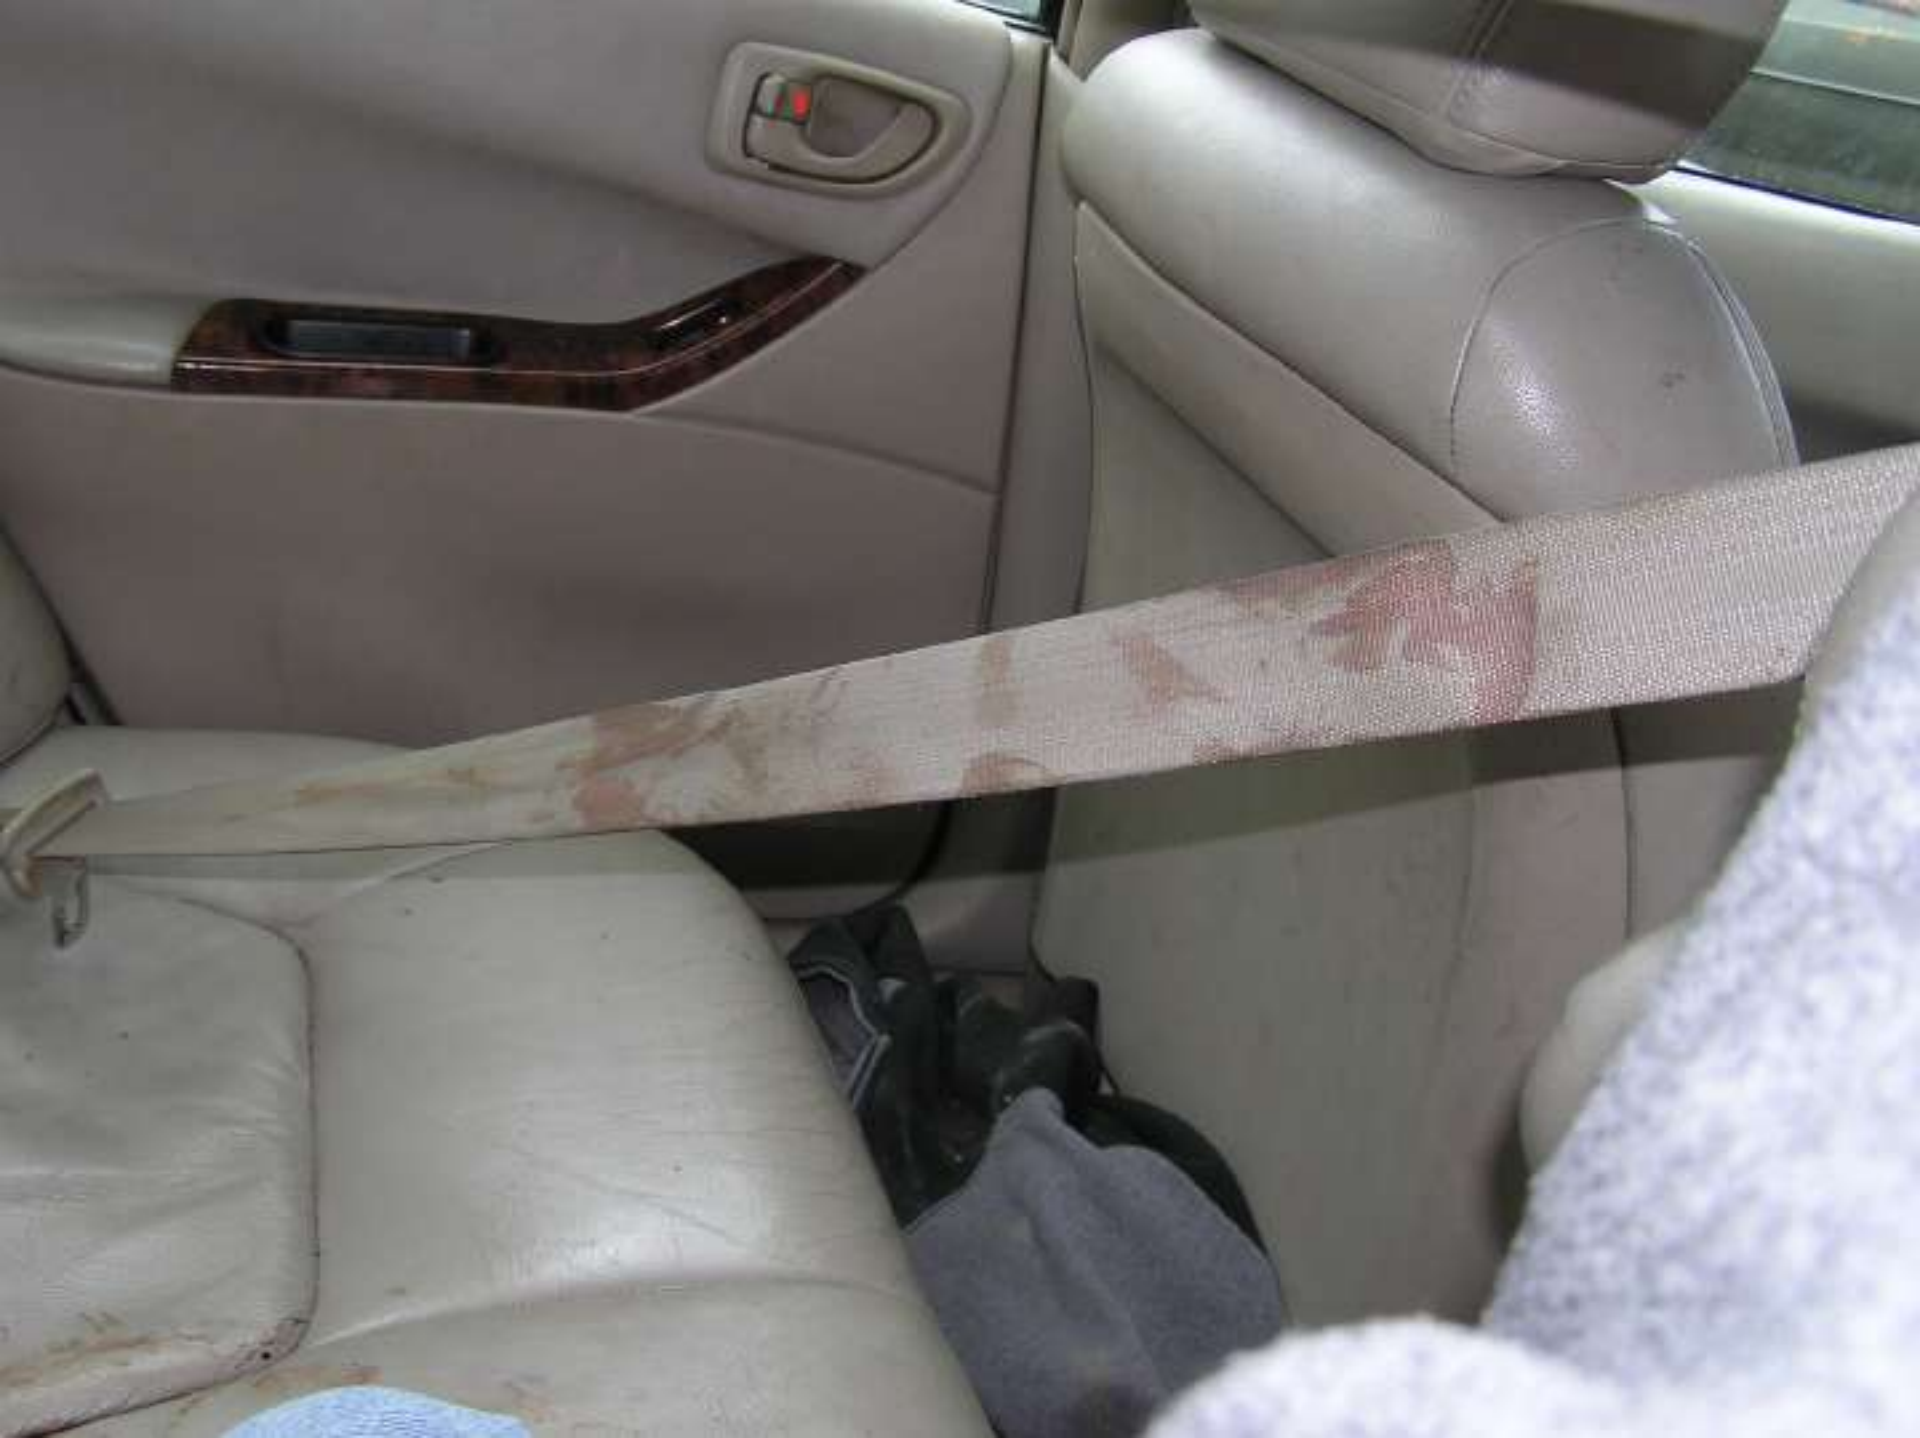
[43](#) In the right-front seating area, the instrument panel, the knee bolster, and the toe pan were displaced rearward. [48](#) The glove-box door was open and would not close and [49](#) there was a crack in the windshield from contact by the deploying dash-mounted airbag. [50](#) There was a black scuffmark on the front of the dash-mounted airbag. [51](#) [52](#) The right-front seat was in a mid-track position and [53](#) [54](#) there

was blood on the center of the backrest, but the seat was not damaged.
