Case 468 : Narrative

| Case Vehicle (A): 1999 Mitsubishi |
| Type: Galant, 4-door sedan |

This is a fatal crash. The 4-year-old left-rear male passenger of case vehicle (A) died from head/neck injuries sustained during this pole-type frontal crash.

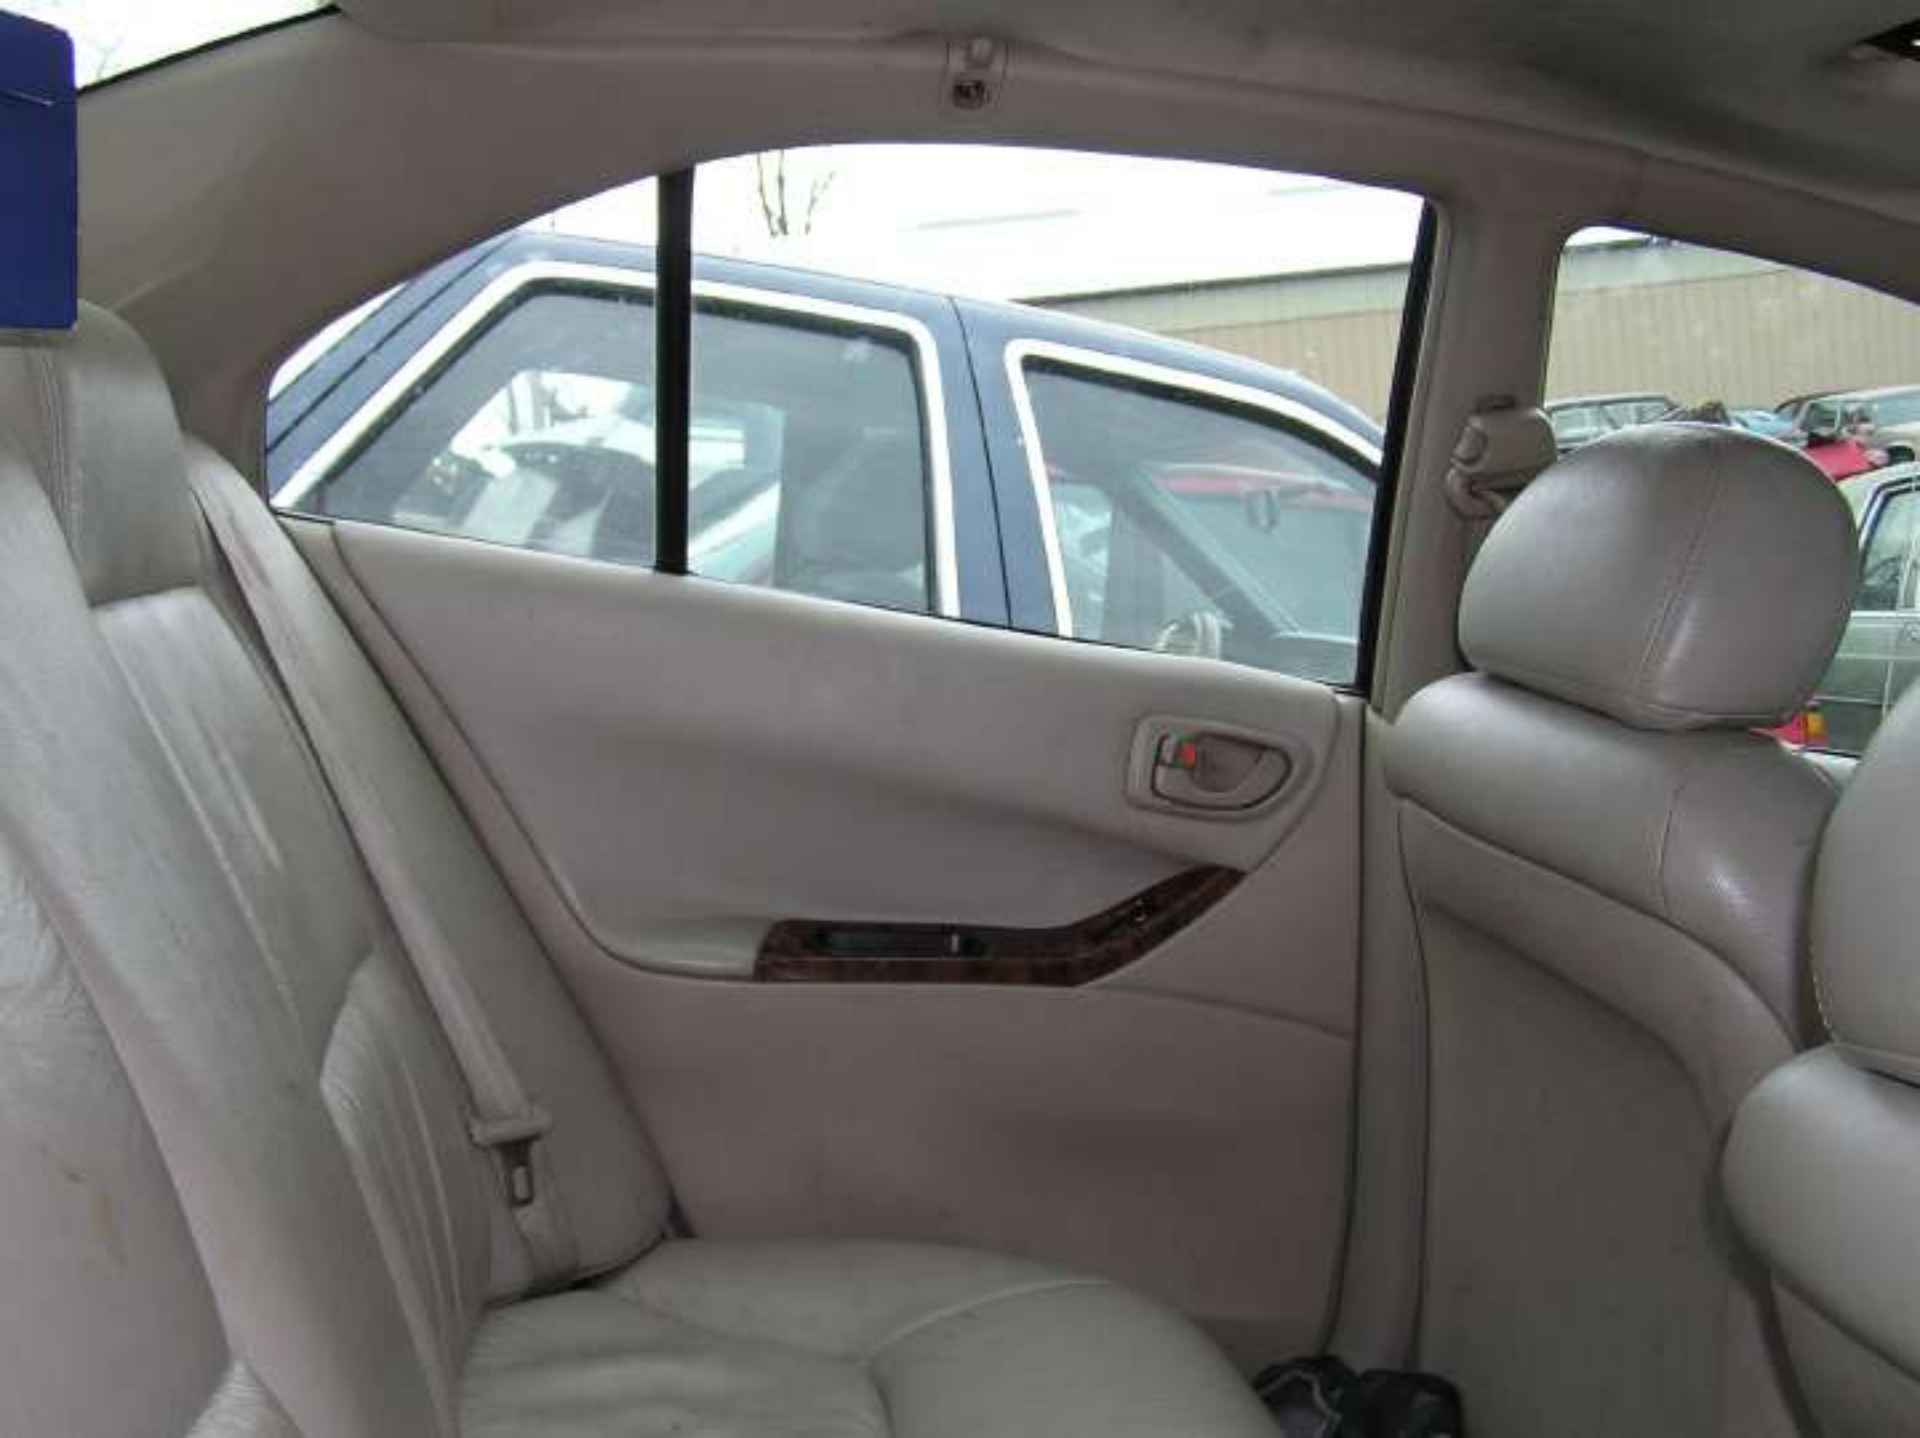
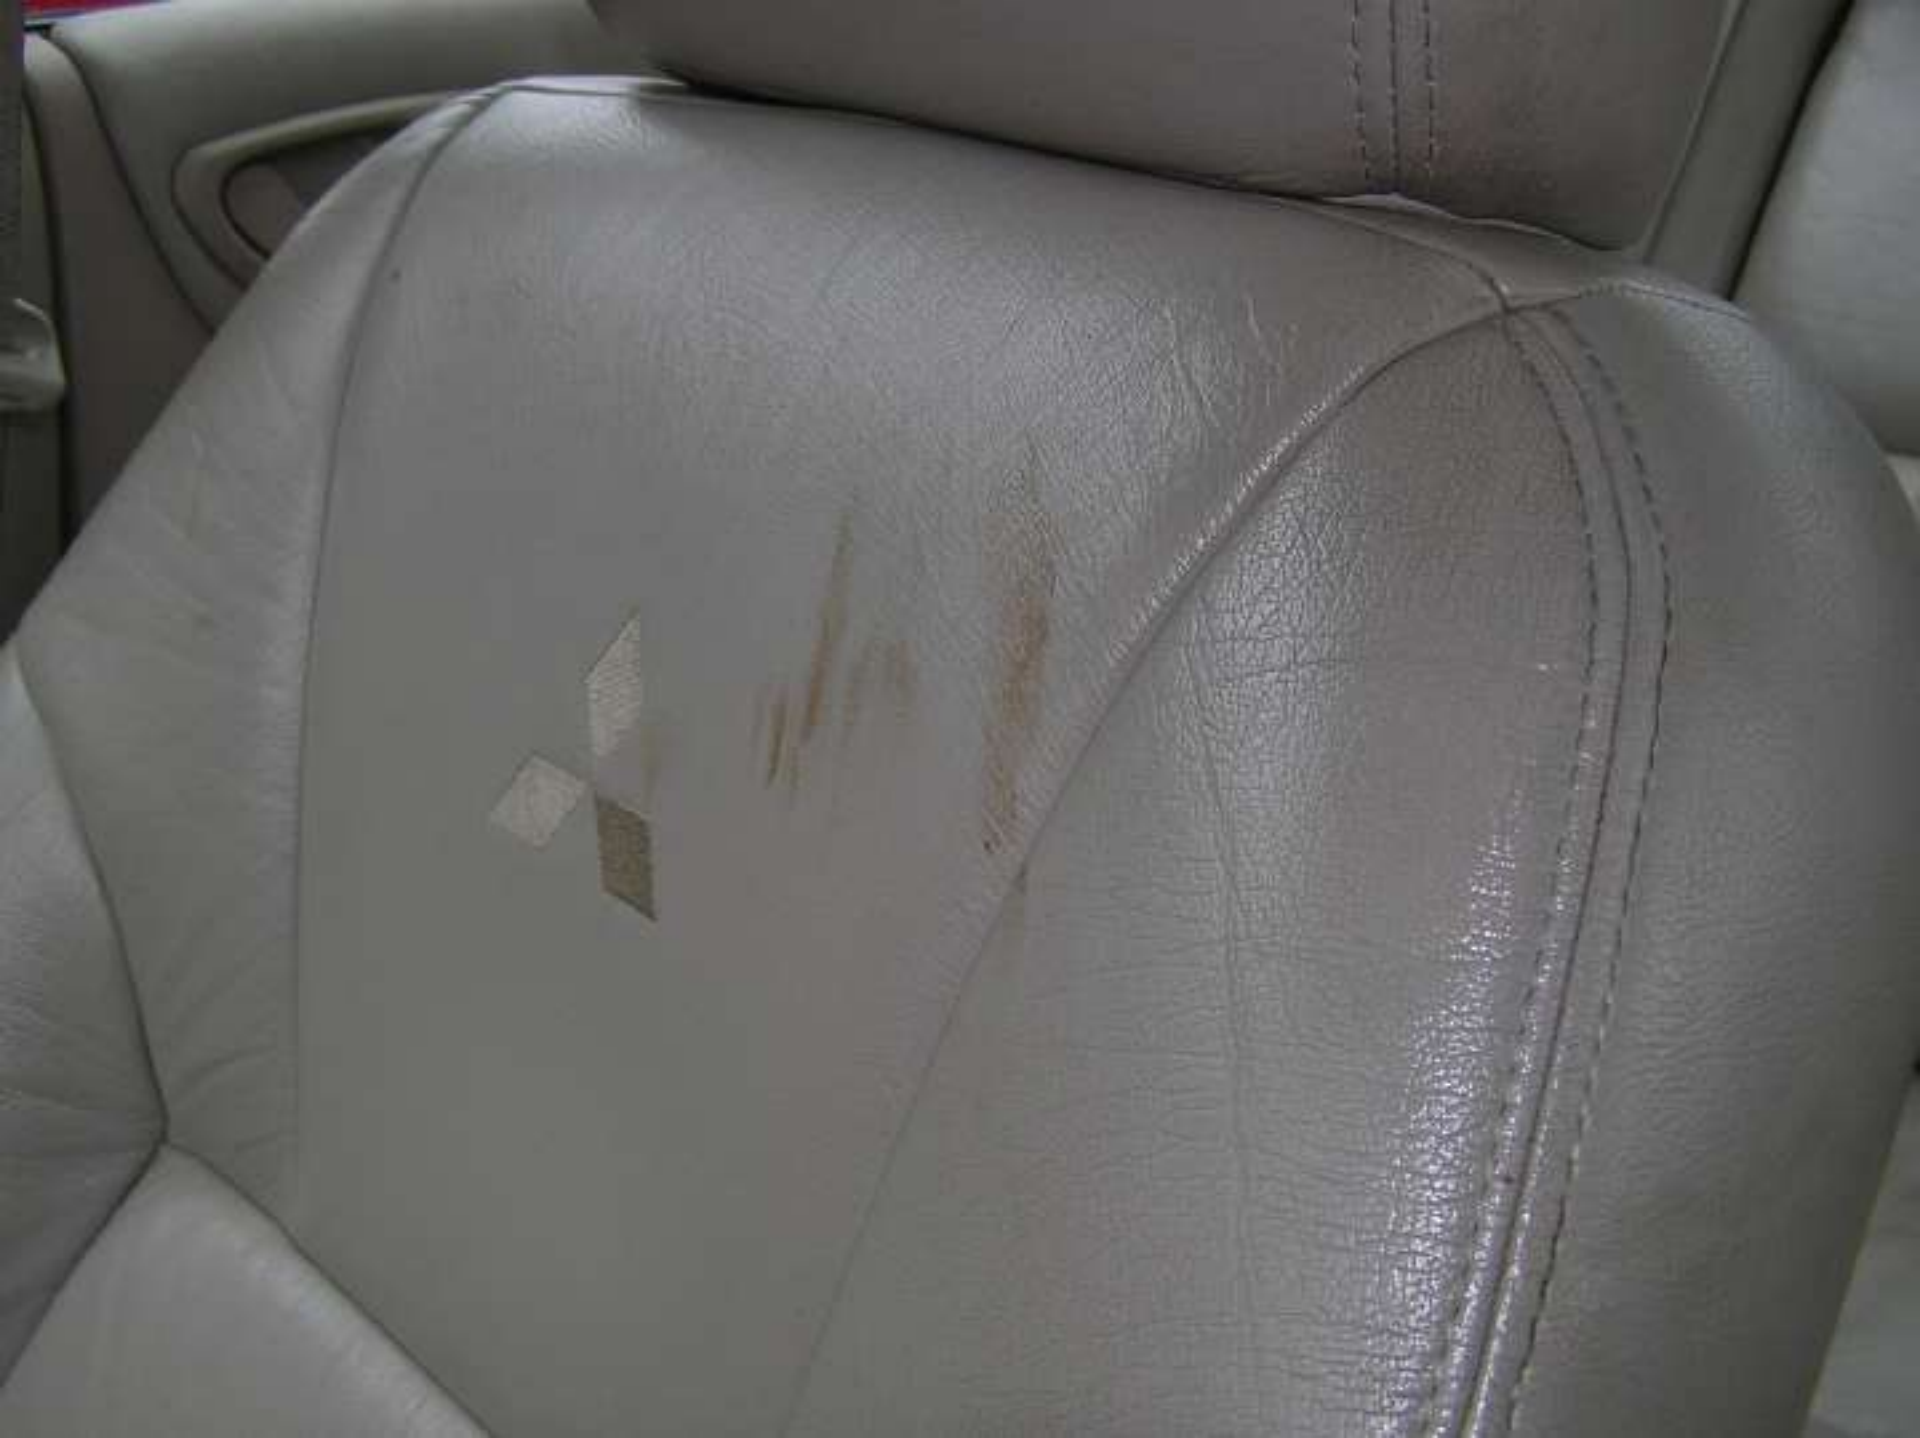
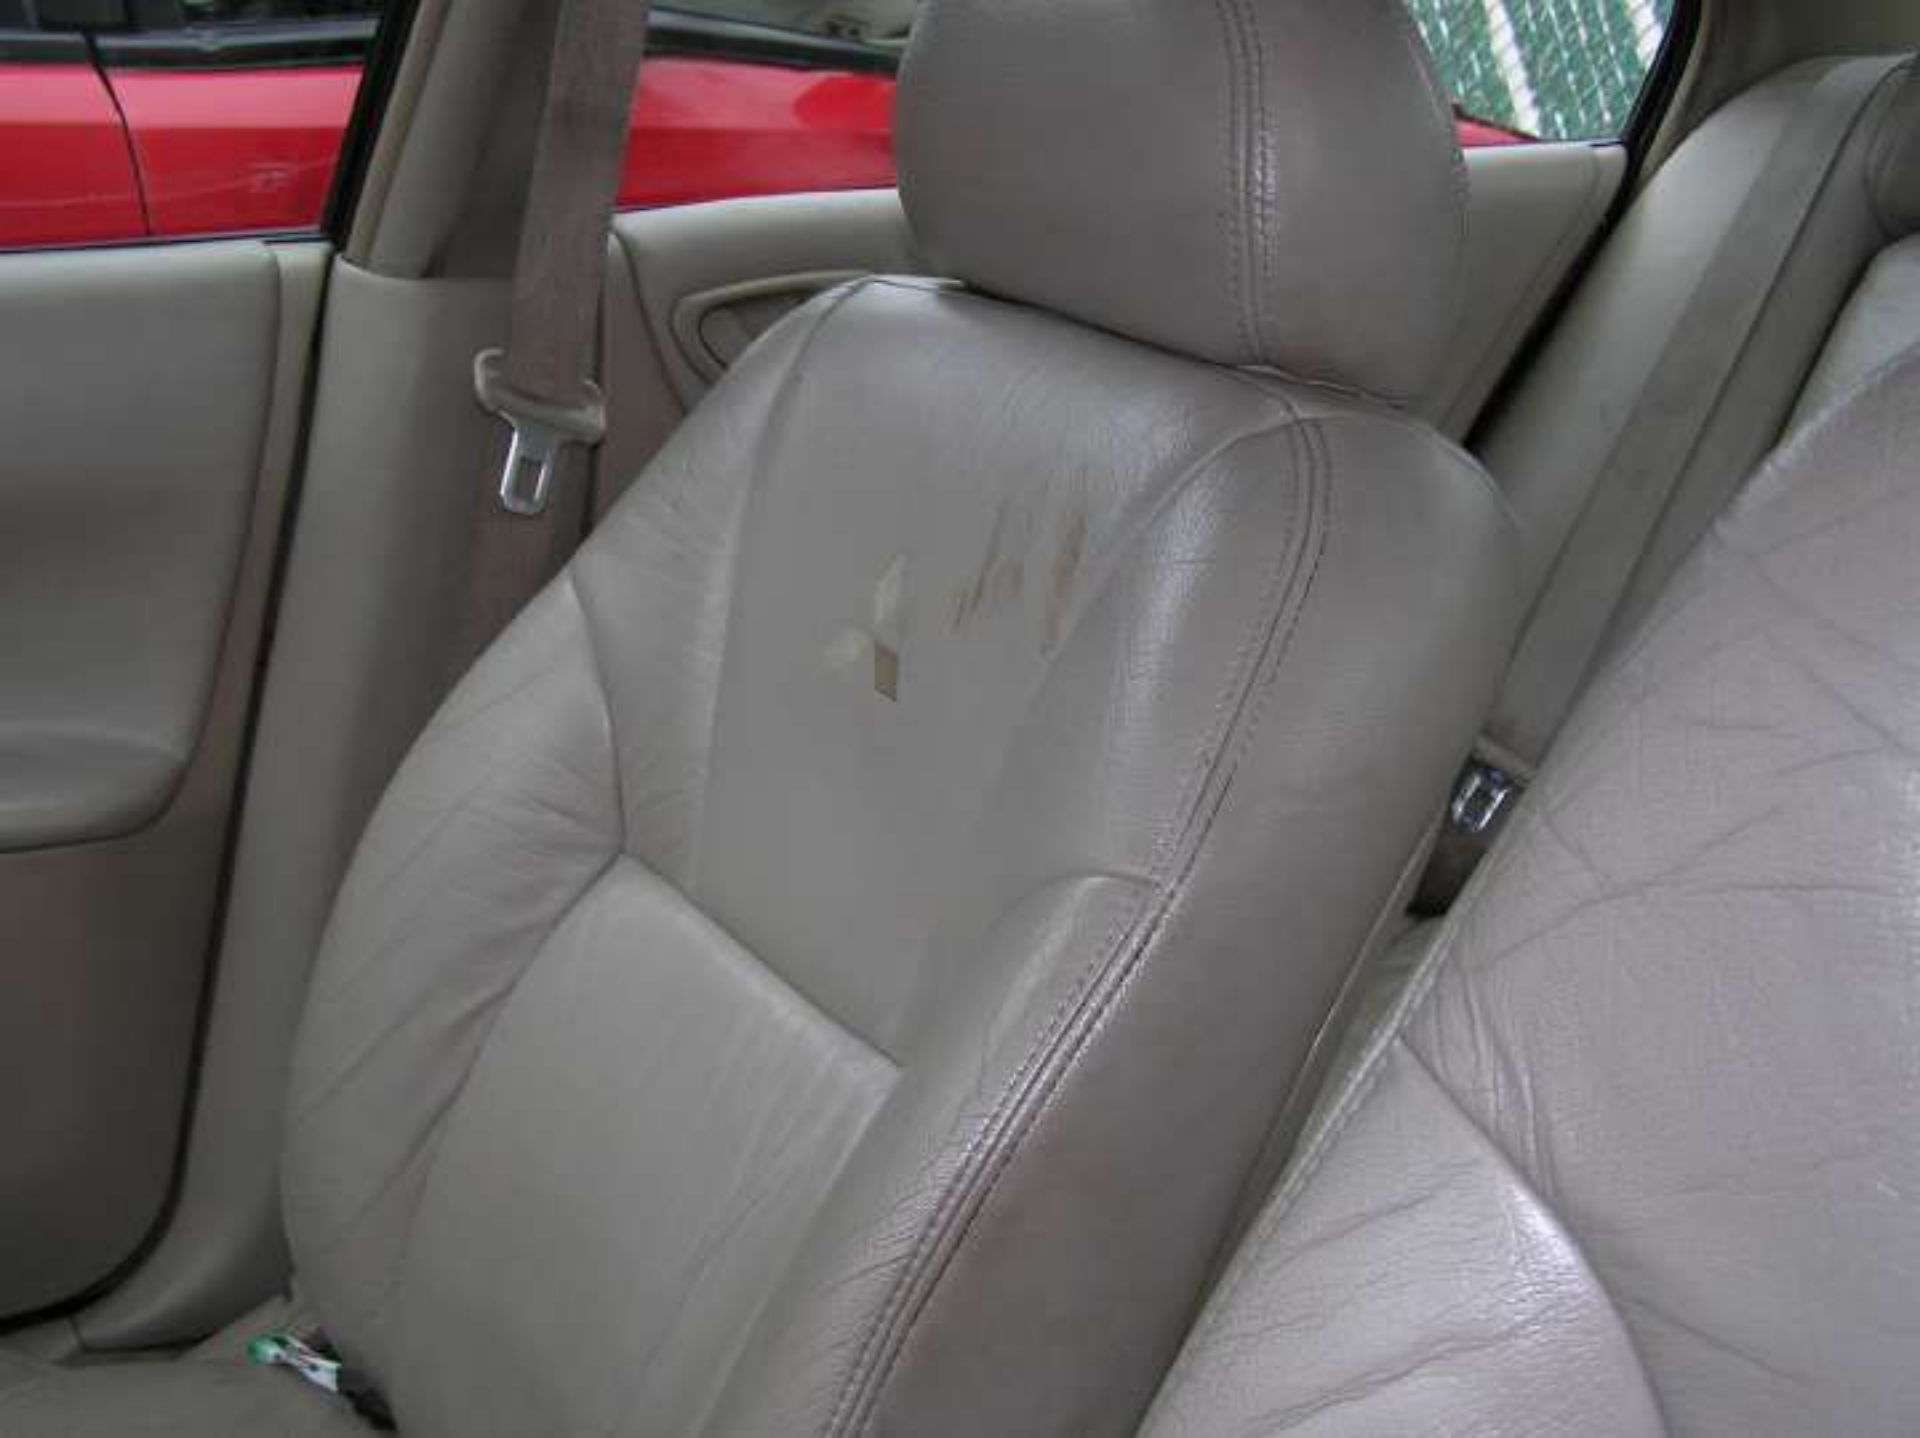
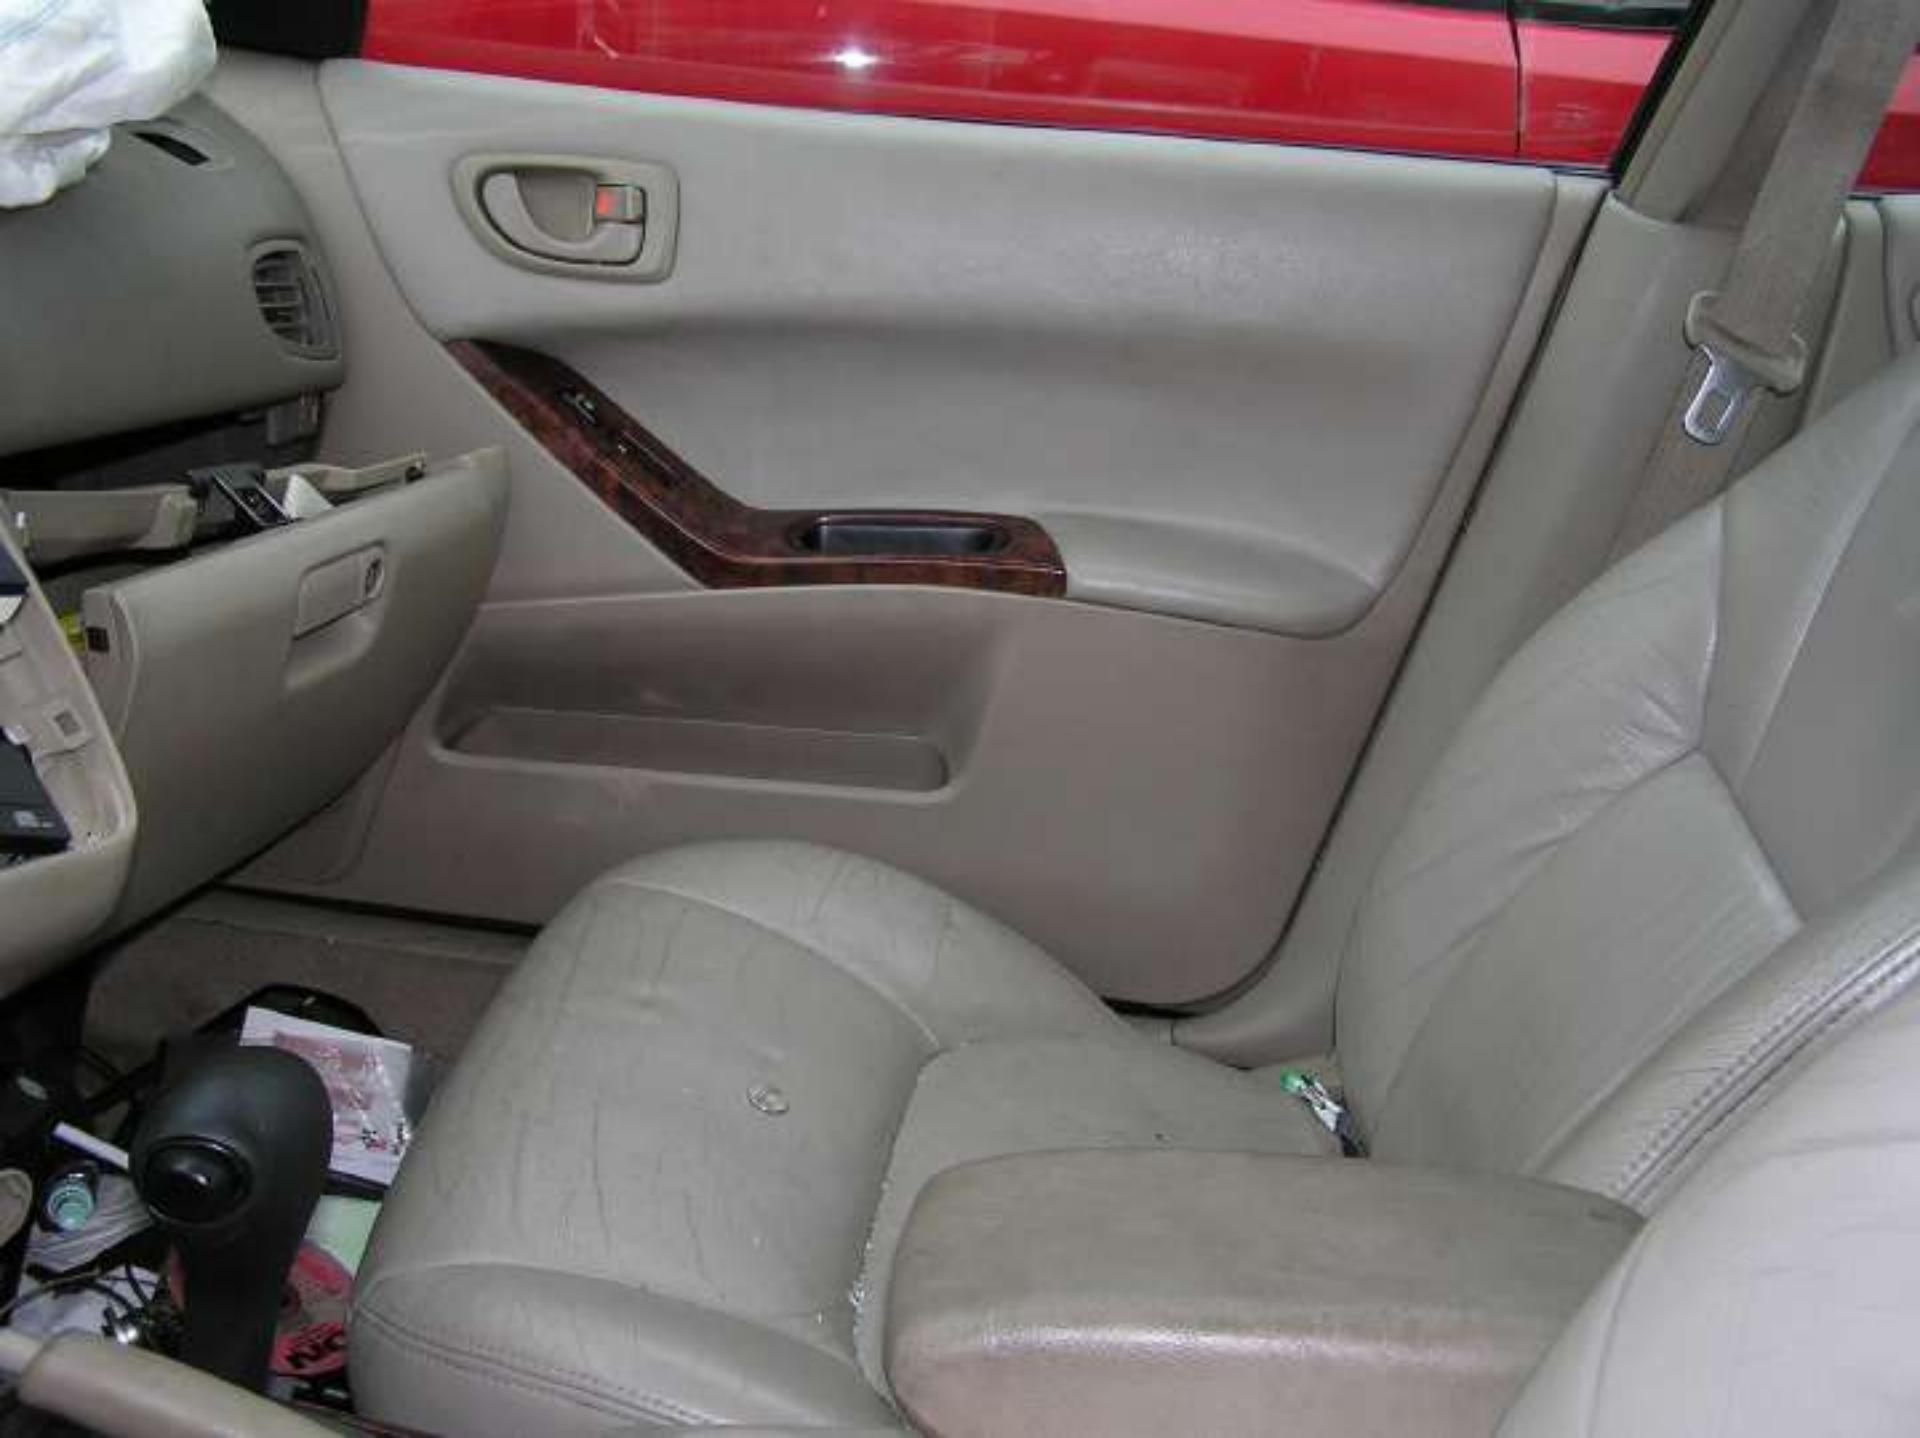
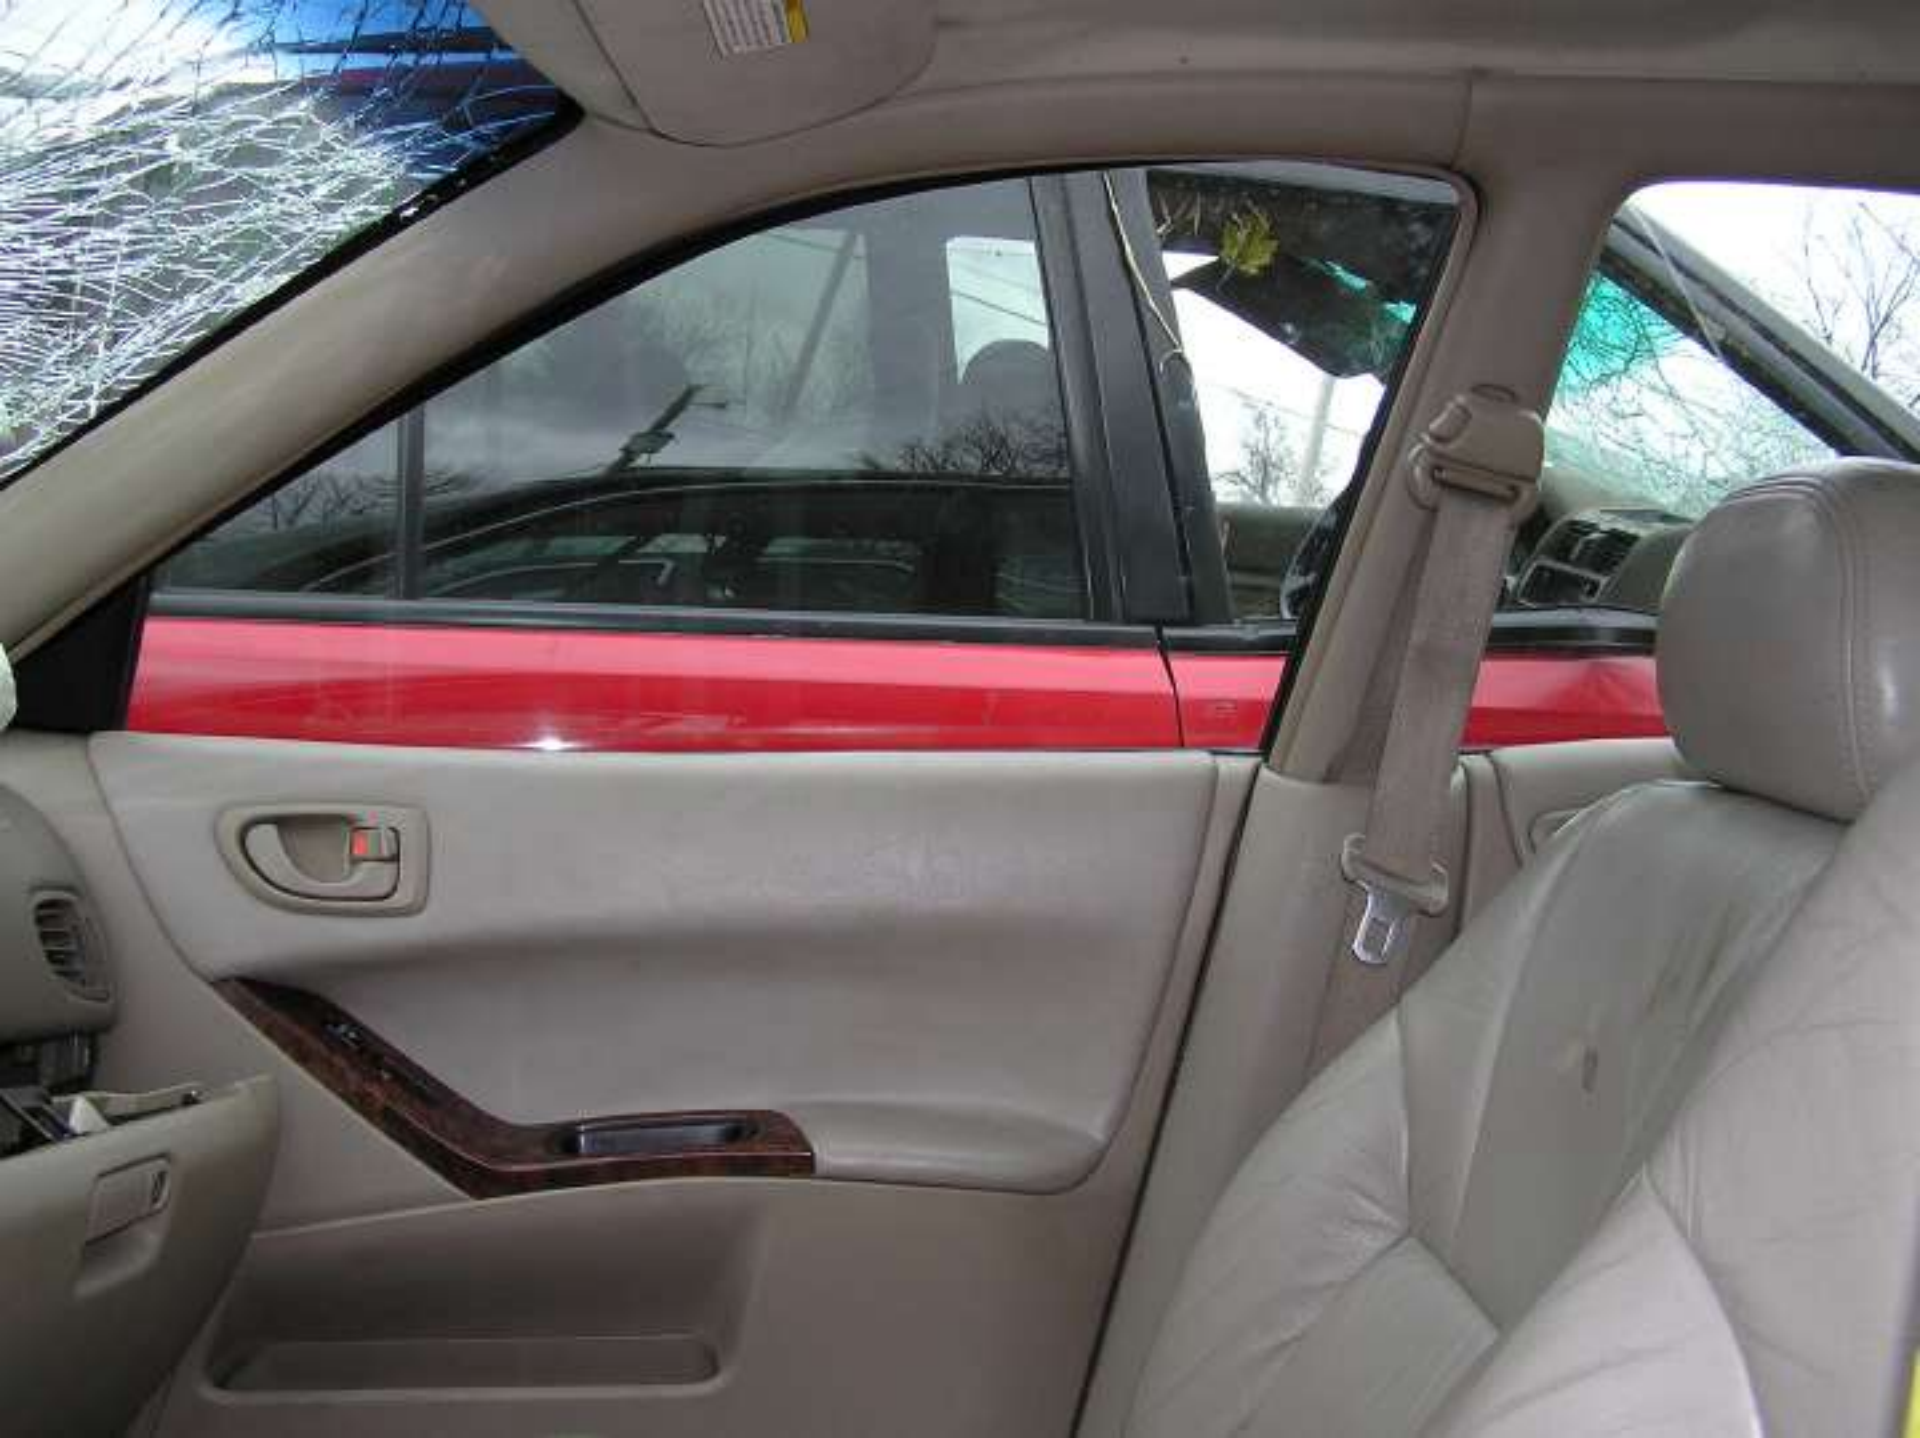
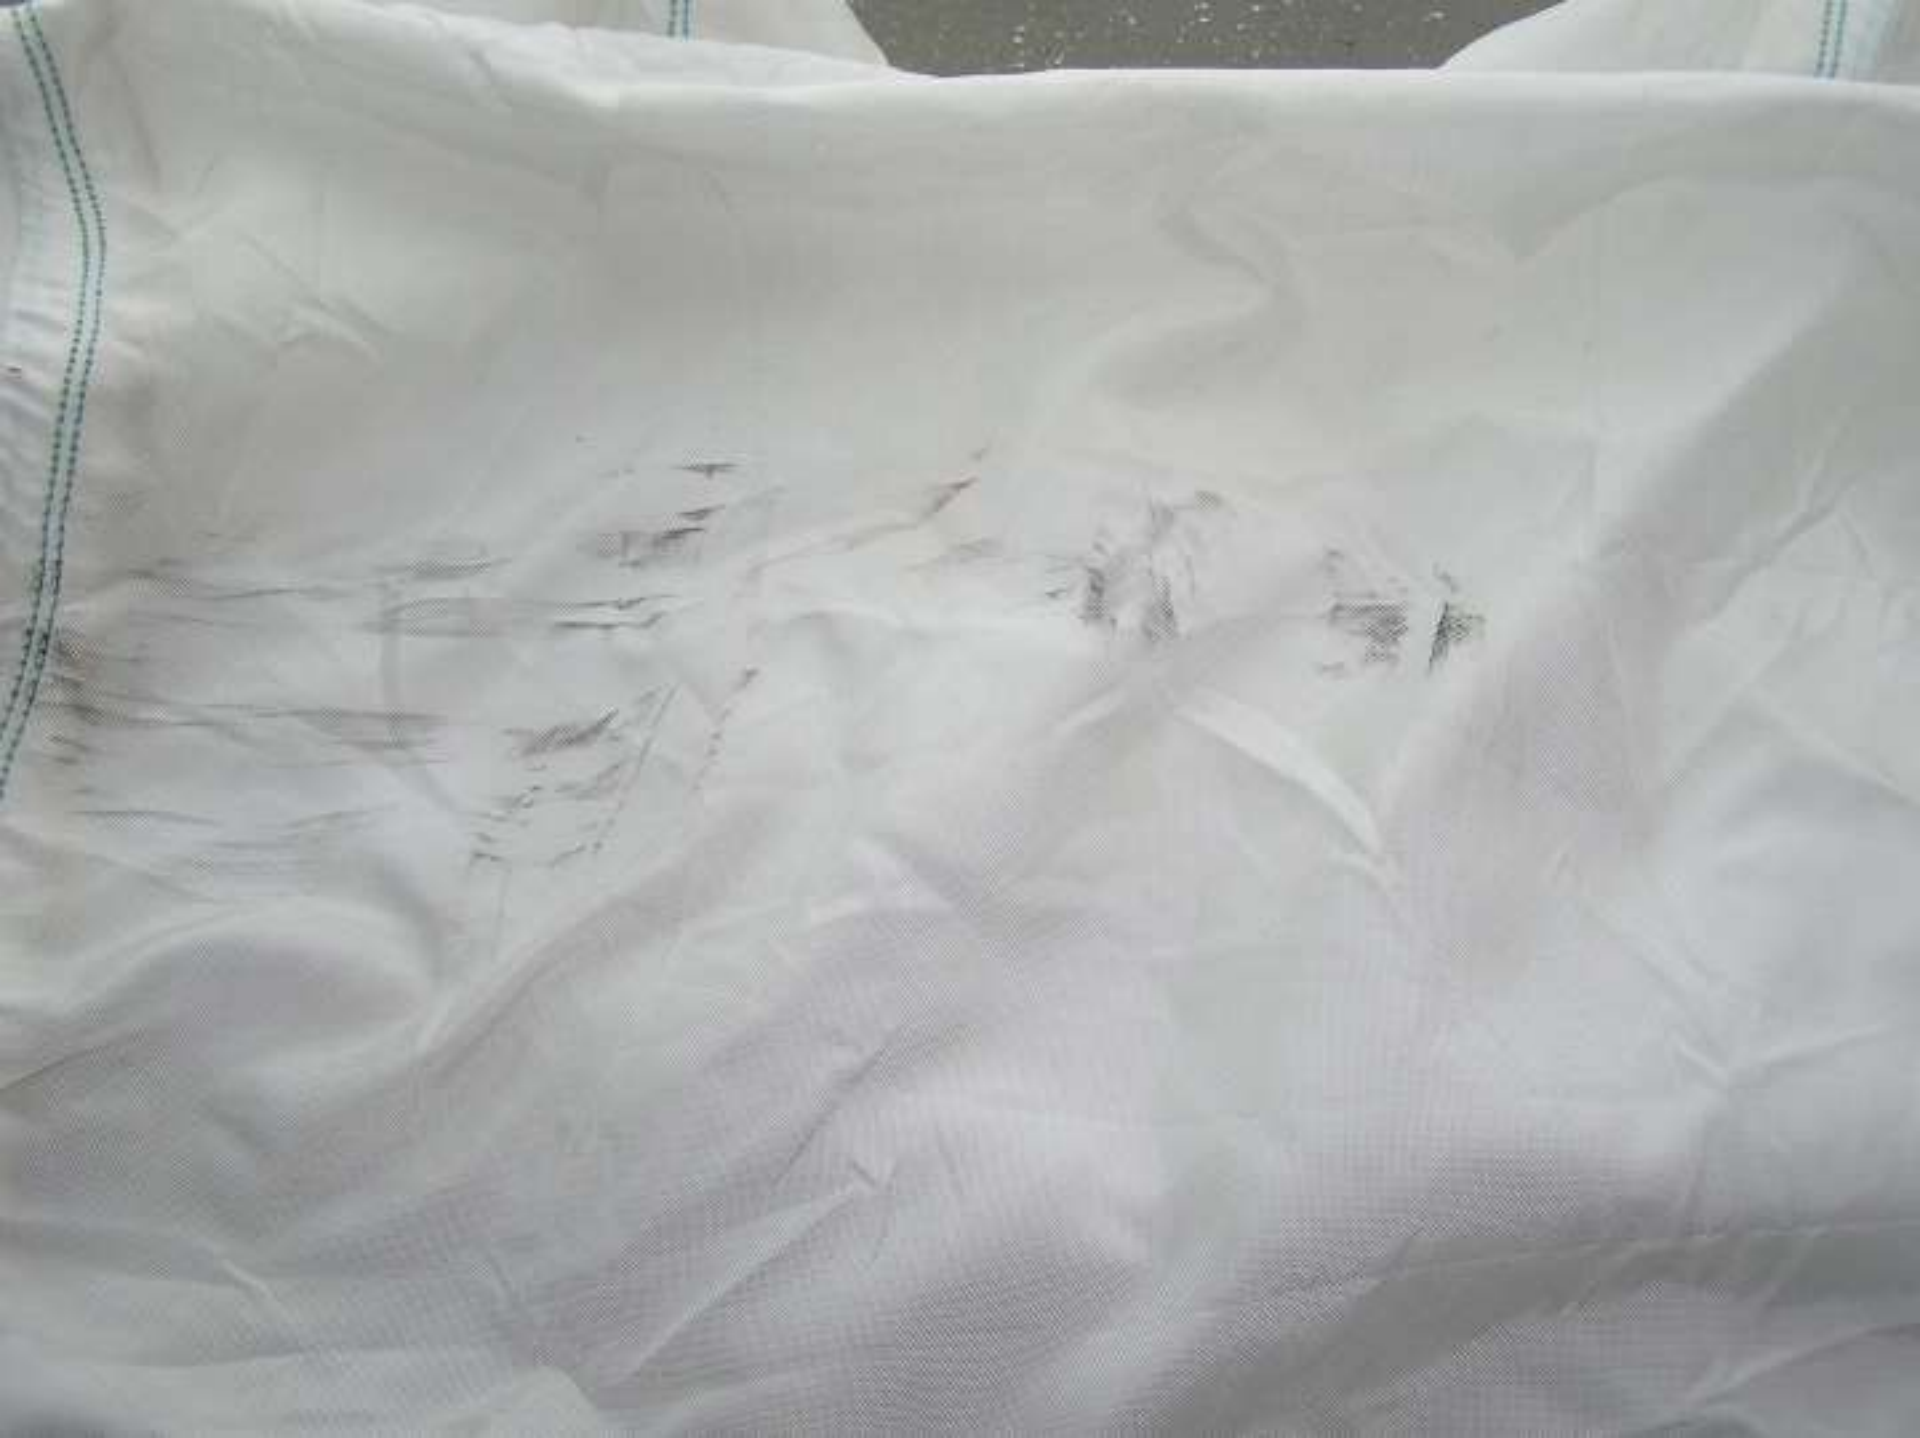
[55](#) [56](#) [57](#) [58](#) [59](#) [60](#) [61](#) [62](#) In the left-rear seating position, there were bloodstains over approximately 60 cm of the seatbelt webbing, on the plastic loop of the sliding latch plate, and on the buckle receptacle. [61](#) There was also blood on the left C-pillar near the seatbelt retractor. [63](#) There was no damage to the seat but there was a round indentation in the seatback about 42 cm above the seat cushion. [64](#) There were bloodstains on the seat cushion, primarily on left side and continuing into the center area. [65](#) There was also blood on the left-rear roof siderail and on the garment hook. [66](#) The garment hook was not damaged but a small panel covering the mounting screw was missing. [71](#) [72](#) There was also blood smeared on the roof over the left-rear seat.

[96](#) The 112 cm, 23 kg (3 ft 8 in, 50-lb), 4-year-old male left-rear passenger was using the available 3-point belt without a child booster seat. [56](#) [57](#) [58](#) [59](#) [60](#) Belt use is indicated by bloodstains on portions of the belt webbing that would not have been accessible if the belt was in a retracted mode.

During the frontal impact, the child moved forward relative to the vehicle interior, into the belt restraints. He sustained abrasions to the right eyebrow, left cheek, left ear lobe, and inner aspect of the upper lip, probably from contact with the back of the driver seatback. He sustained abrasions to the dorsum of the left hand and fingers probably from contact with the driver seatback [67](#) [68](#) [69](#) [70](#) . He
