Case 482 : Narrative

Case Vehicle (A): 2002 Ford	Vehicle (B): 1994 Ford
Type: Escape XLT, 4-door SUV, 4x4	Type: Aerostar XL, Minivan, 4x2
Driver: 26-year-old male	Driver: 35-year-old male
CDC: 12-FDEW-3	CDC: 12-FYEW-5

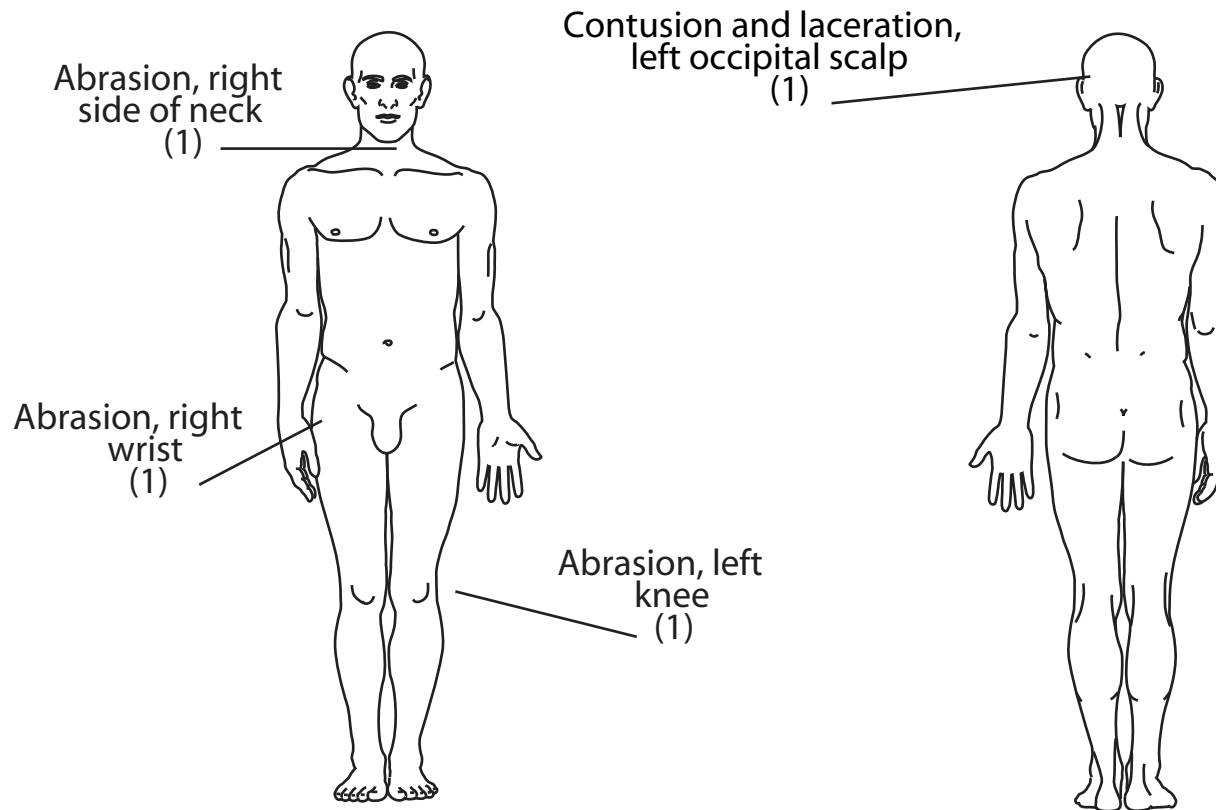
During the frontal impact, the driver moved forward relative to the vehicle interior, into the belt restraints, the airbag, and the knee bolster. He sustained an abrasion to the right side of the neck, possibly from contact by the deploying airbag. He sustained an abrasion to the right wrist, possibly from contact with the steering-wheel rim, [41](#) as evidenced by a scuffmark on the rim, or from contact by the deploying airbag. He sustained an abrasion to the left knee from contact with the knee bolster, [46](#) as evidenced by scuffmarks on the left side of the knee-bolster cover. [56](#) He sustained a contusion and a laceration to the left side of the occipital area of the scalp, possibly from head contact with the D-ring or the B-pillar during rebound.

Occupant: Driver	Age: 26 years	Gender: Male		
Restraints: 3-point belt with pretensioner;	Stature: 168 cm (5 ft, 6 in)	Mass: 66 kg (145 lb)		
Injury Description	A.I.S.	Injury Source		
		Definite	Probable	Possible
—	—	—	—	—
Contusion, left occipital scalp	1	—	—	D-ring, B-pillar
Laceration, left occipital scalp	1	—	—	D-ring, B-pillar
Abrasion, right side of neck	1	—	—	Airbag
Abrasion, right wrist	1	—	—	Steering-wheel rim; airbag
Abrasion, left knee	1	Knee bolster	—	—

Maximum A.I.S. Level	1	—	—	—
Injury Severity Score	1	—	—	—

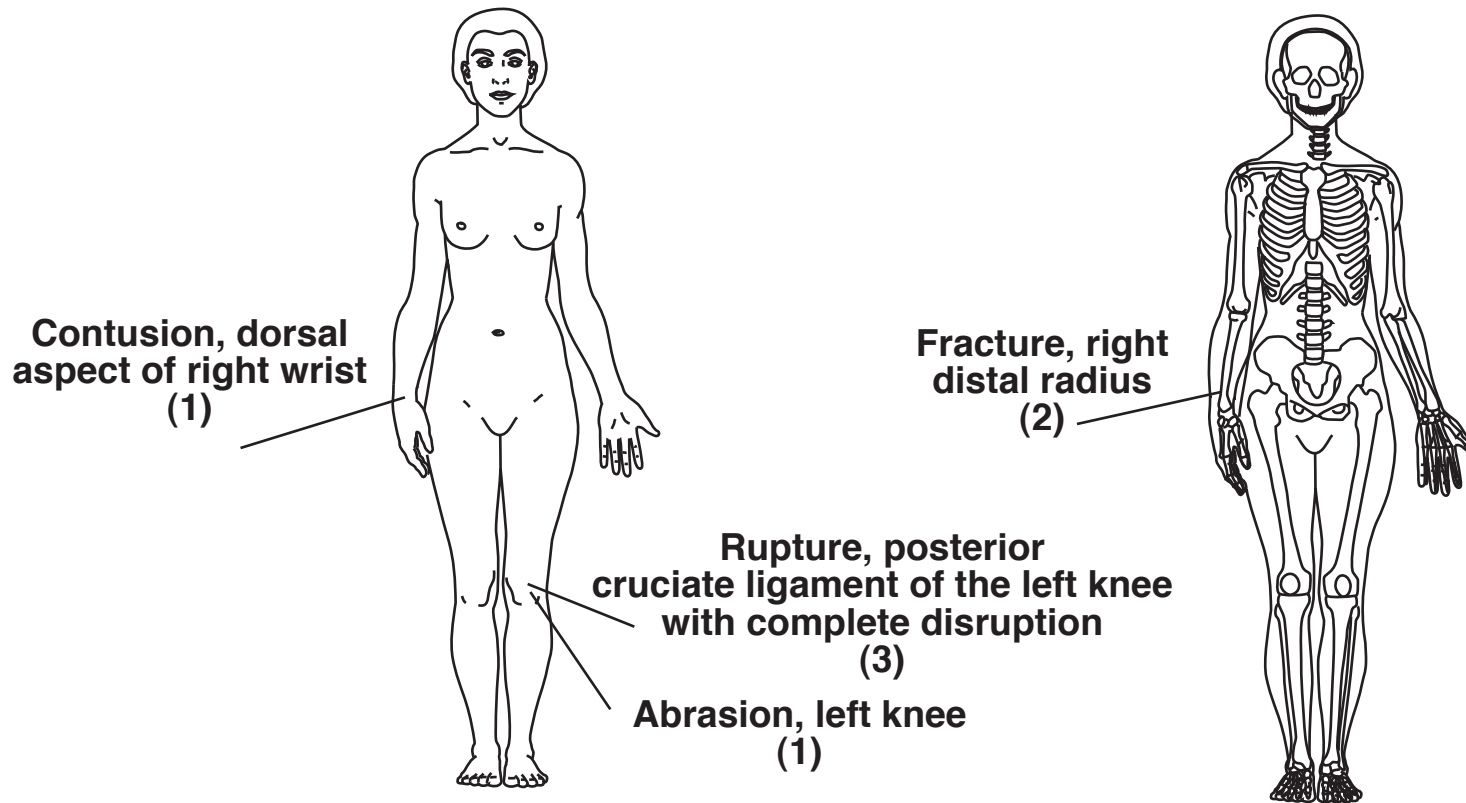
During the frontal impact, the female passenger moved forward relative to the vehicle interior, into the airbag and the dashboard/knee bolster. She sustained a fracture to the right distal radius and a contusion to the dorsal aspect of the right wrist, [52](#) [53](#) possibly from hand contact with the right side of the dashboard. She sustained an abrasion to the left knee and a rupture to the posterior cruciate ligament of the left knee with complete disruption, from knee and leg contact with knee-bolster/dashboard, [52](#) [53](#) as evidenced by a large circular crack above the glove box.

Occupant: Right front		Age: 26 years		Gender: Female	
Restraints: 3-point belt with pretensioner;		Stature: 168 cm (5 ft, 6 in)		Mass: 59 kg (130 lb)	
Injury Description	A.I.S.	Injury Source			
		Definite	Probable	Possible	
—	—	—	—	—	
Fracture, right distal radius	2	—	—	Right side of dashboard	
Contusion, dorsal aspect of right wrist	1	—	—	Right side of dashboard	
Abrasion, left knee	1	Knee bolster/dashboard	—	—	
Rupture, posterior cruciate ligament of the left knee with complete disruption	3	Knee bolster/dashboard	—	—	
Maximum A.I.S. Level	3	—	—	—	
Injury Severity Score	10	—	—	—

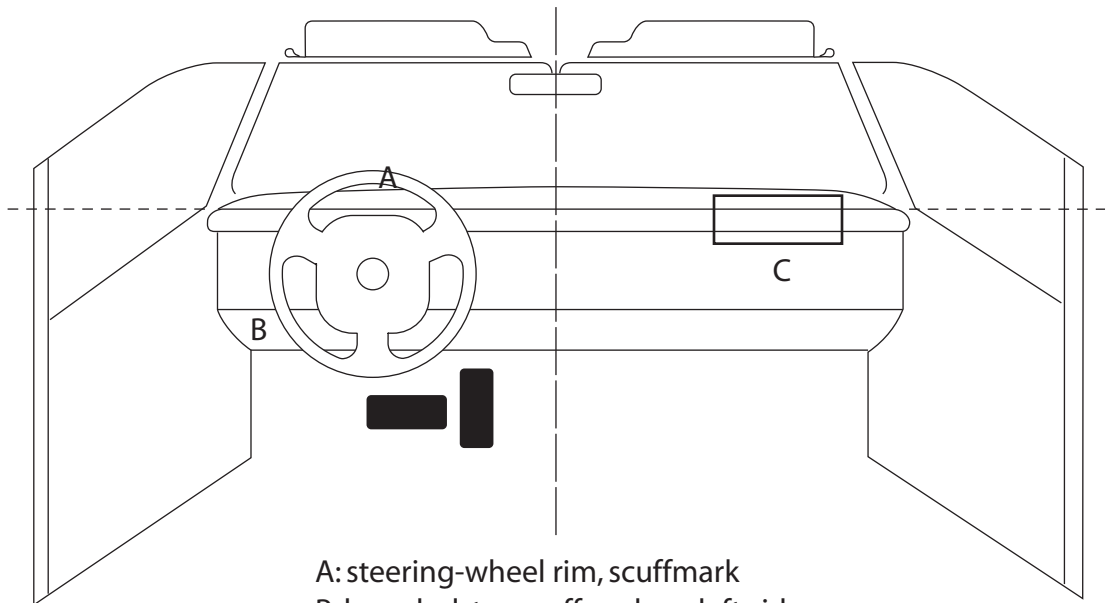
A: steering-wheel rim, scuffmark
B: knee bolster, scuffmark on left side
C: mid panel surrounding glove box, dent
