## Case 486 : Narrative

Case Vehicle (A): 2004 GMC	Vehicle (B): 2000 Chevrolet
Type: Yukon, 4x4, 4-door SUV	Type: Prizm, 4-door sedan
Driver: 36-year-old female	Driver: 65-year-old male
CDC: 12-FDEW-1	CDC: 09-LYAW-4

This is a double fatal crash. The belt-restrained driver and right-front passenger of vehicle (B) died of thoracic injuries sustained in a left-side T-type impact.

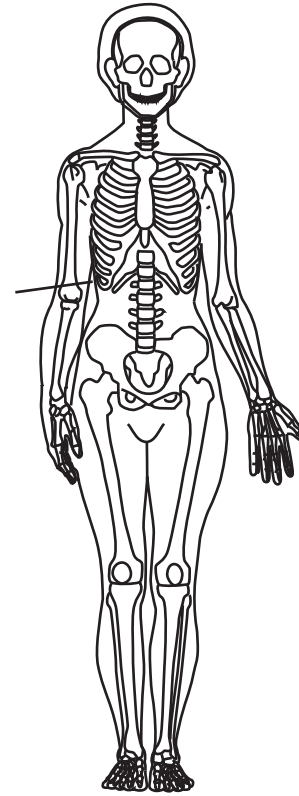
Fractures, right ribs  
11 and 12 (2)

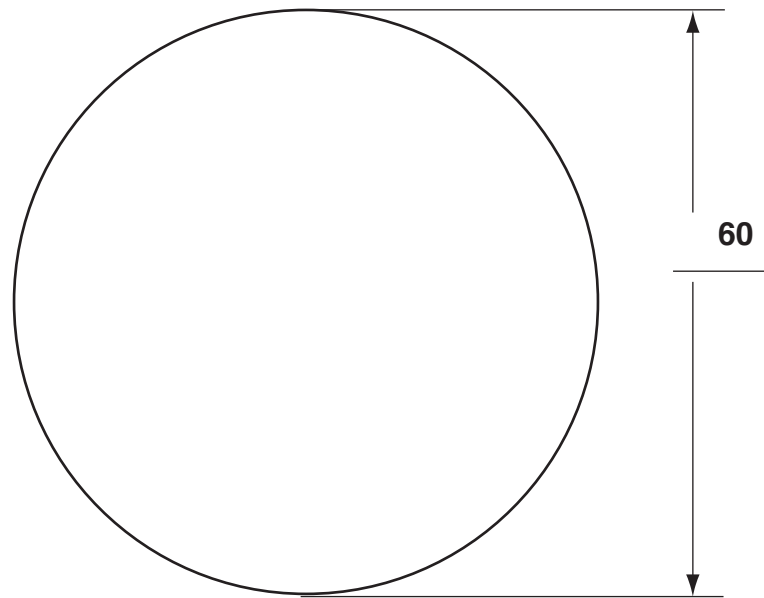
**Driver Airbag**

Vents:  Y  N  
if yes, how many: 2  
vents at 11 and 1 o'clock

Tethers:  Y  N  
if yes, how many: 2

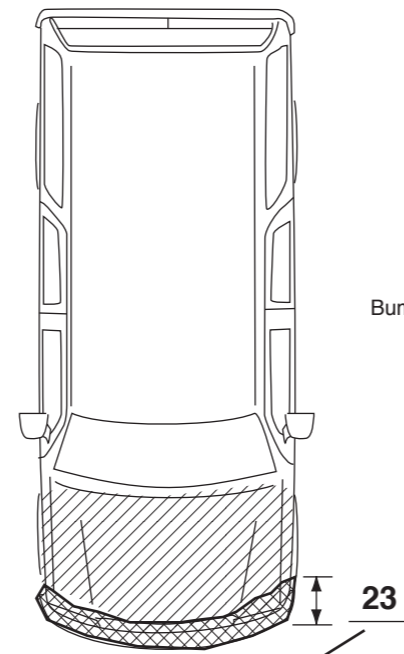
Max. crush to front at left bumper corner
