Case 501 : Narrative

Case Vehicle (A): 2001 Chevrolet	Vehicle (B): 1993 Ford
Type: Cavalier LS, 4-door sedan	Type: Aerostar XL, minivan, 4x2
Driver: 63-year-old female	Driver: 41-year-old male
CDC: 12-FDEW-2	CDC: 12-FDEW-3

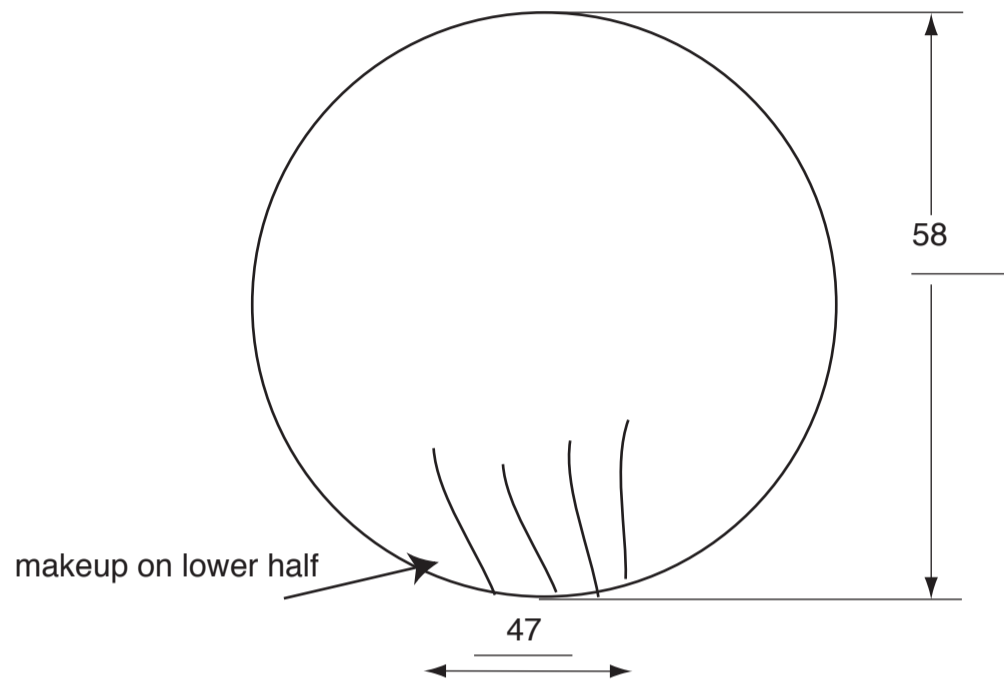
Driver Airbag

Vents: Y N
if yes, how many: 2
vents at 10 and 2 o'clock

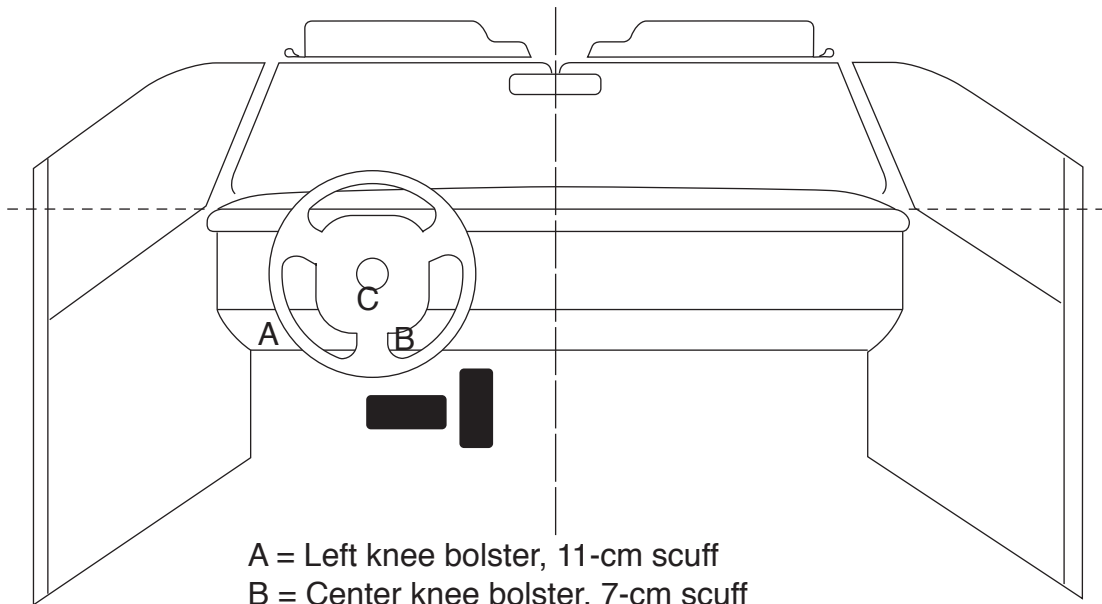
A = Left knee bolster, 11-cm scuff
B = Center knee bolster, 7-cm scuff
C = Airbag, facial makeup on bottom

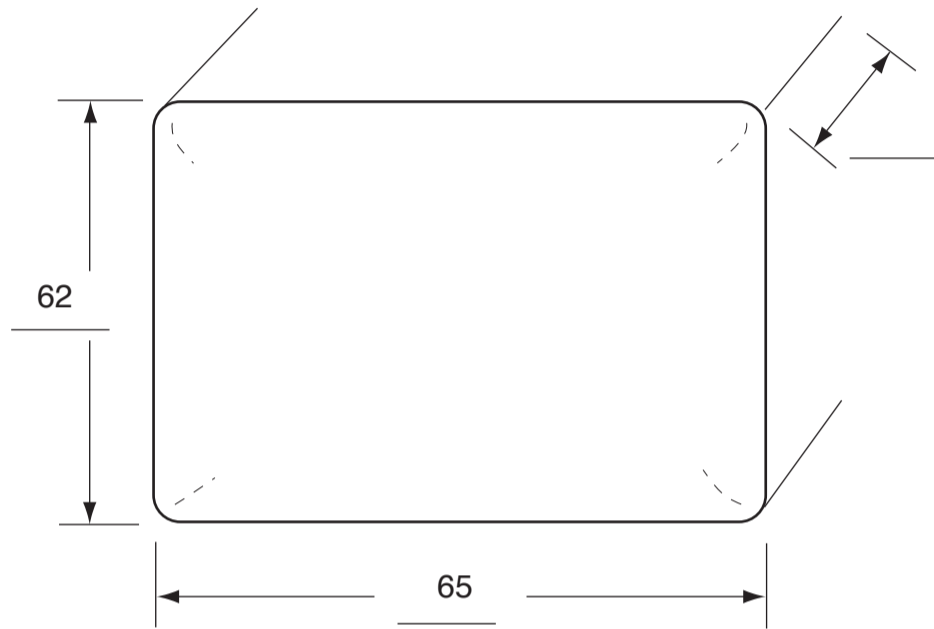
Passenger Airbag

airbag cover hit windshield glass
