# Case 503 : Narrative

Case Vehicle (A): 2003 Pontiac
Type: Sunfire, 2-door coupe
Driver: 20-year-old male
CDC: 12-FLWN-3, 12-FLWN-9, 12-LYLS-1, 12-FCEN-3, OO-TZZN-6

# 503: Vehicle Report

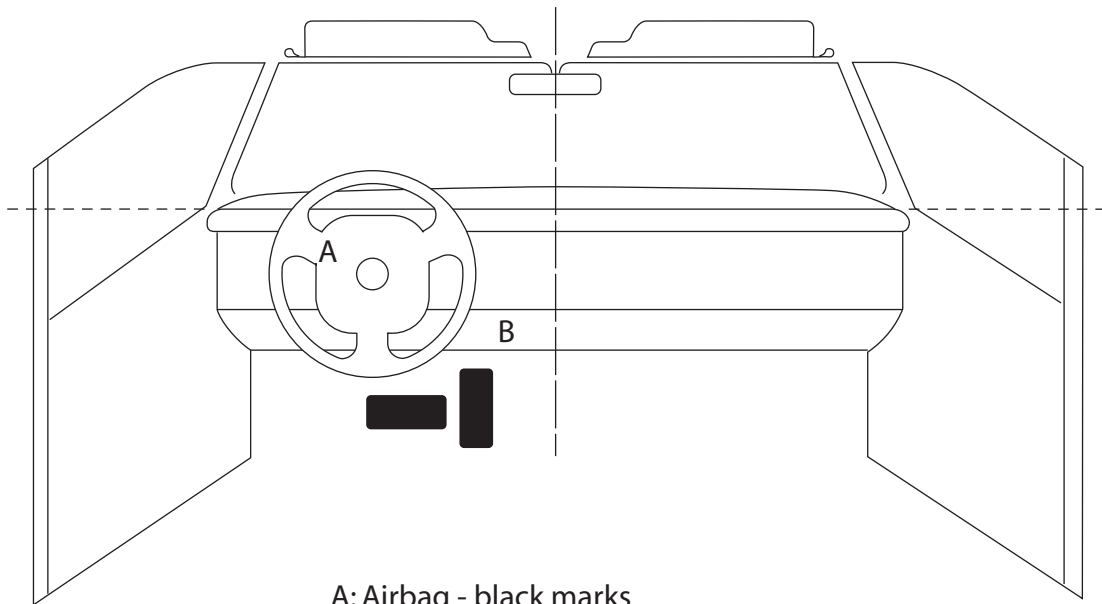
OCCUPANT CONTACT WORKSHEET

A: Airbag - black marks  
B: knee bolster - scuff on right side

Contact	Interior Component Contacted	Occupant No. if Known	Body Region if Known	Supporting Physical Evidence	Confidence Level of Contact Point
A	Airbag	1	Face	Black marks	2
B	Knee bolster	1	Right knee	Scuff	1
C					
D					
E					
F

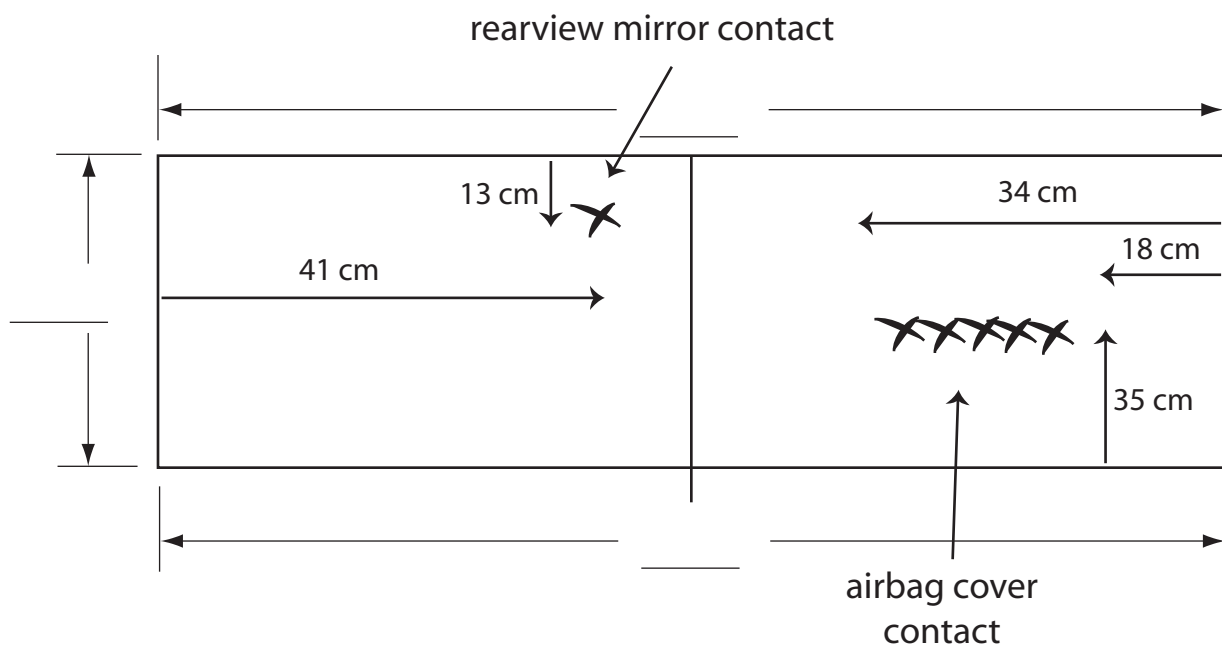
WINDSHIELD MARK ON CASE VEHICLE:

[54](#) In the center-front area, there was a star-patterned crack in the windshield from contact by the rearview mirror, but the mirror was not damaged. [55](#) There was no damage to the center console or to the floor-mounted console between the seats.
