REMOTE AIR BAG REPORT

FLEET - PRIVATE VEHICLE LOCATION - HONOR OHIO CASE NO. - 91-01

Transportation Research Center Indiana University Bloomington, Indiana

1991

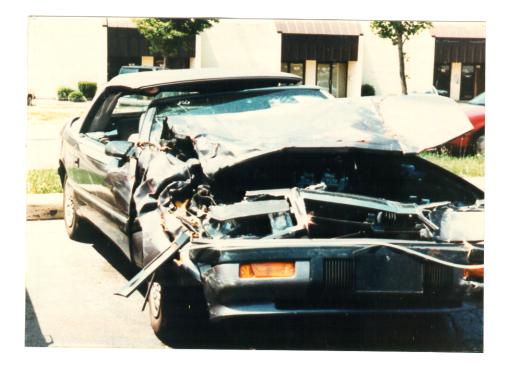
Damage components:	Front bumper, LF turn signal assembly, front grille, hood, RF fender, windshield, right A-pil- lar, right outside rear- view mirror, right door panel	Truck-mounted attenuator
Repair Estimate:	Totalled	
Interior damage:	Right instrument panel, right A-pillar, radio

# 01 1		1990	
	Ohio		
TRC/IU:	91-01,	Task:	0071
Lebaron	frontal	right	view

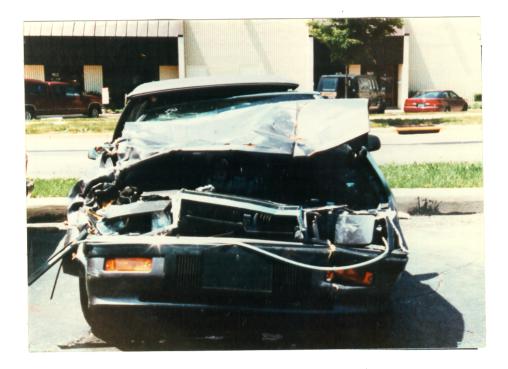
The front of the Lebaron impacted the rear of the truck-mounted attenuator, which was attached to the rear of the straight truck. The CDC is estimated as: 12-FDEW-3 for the Lebaron. CDC is not applicable for the straight truck. No reconstruction program was used on this collision.

02 -- 1990 Ohio TRC/IU: 91-01, Task: 0071 Full view of frontal plane

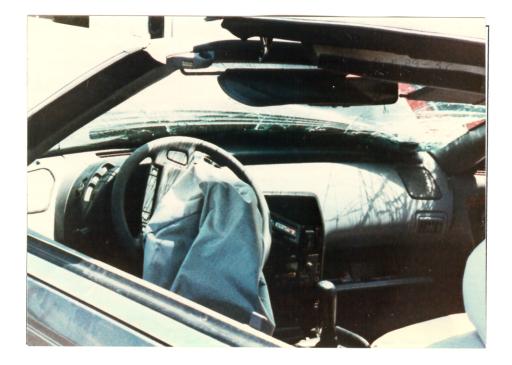
The 1990 Chrysler Lebaron was equipped with a driver supplemental restraint system (air bag) which deployed as a result of the frontal impact. The driver of the vehicle (40 year-old female) was also restrained by the active three-point lap and shoulder belt. She sustained minor (AIS-1) facial lacerations and other minor injuries. The driver of the Chrysler was listed on the Police Accident Report as sustaining a "B" (nonincapacitating-evident, possible) injury as a result of this accident. The driver (47 year-old male) of the Ford was listed on the Police Accident Report as sustaining a "C" (possible) injury.

03 -- Ohio TRC/IU: 91-01, Task: 0071 Air bag & instrument panel

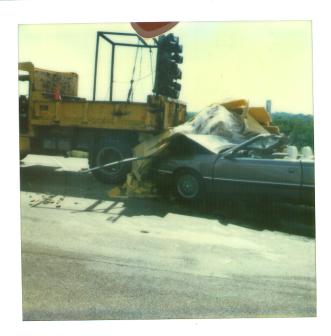
05 - Ohio TRC/IU: 91-01, Task: 0071 Final rest from left side
