AIRBAG INVESTIGATION

CASE NO. 92-07

TECHNICAL REPORT

The accident occurred on [REDACTED], 1992 on a residential street in [REDACTED], Montana. The vehicles involved were a 1992 Plymouth Sundance equipped with a driver's side airbag supplemental restraint system and a 1989 Subaru GL station wagon. The accident was investigated on-site by the [REDACTED] County Sheriff's Department.

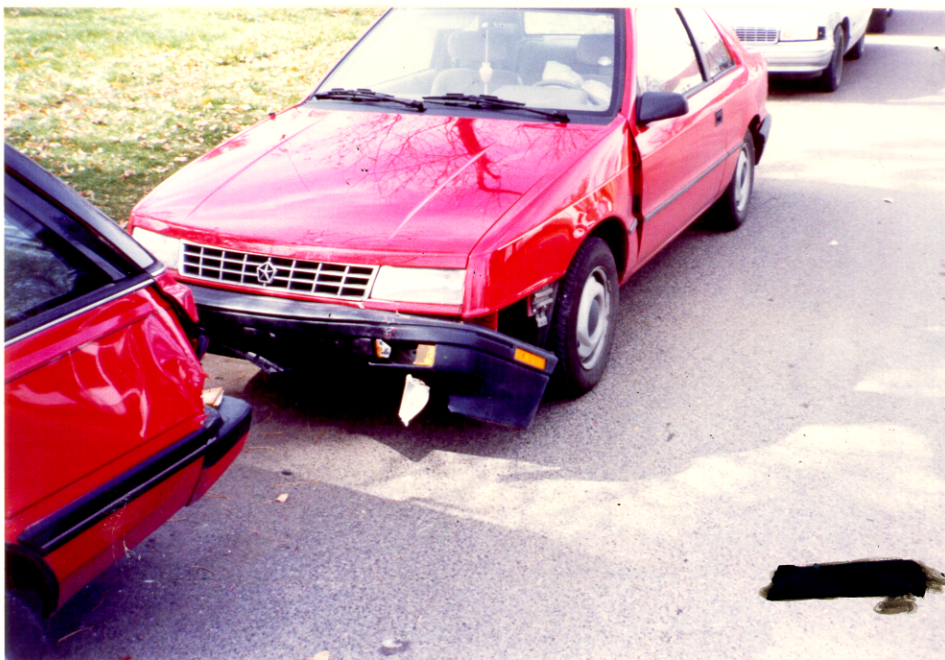
1. Front-left overall view of the Plymouth Sundance and left-rear view of the Subaru GL station wagon.

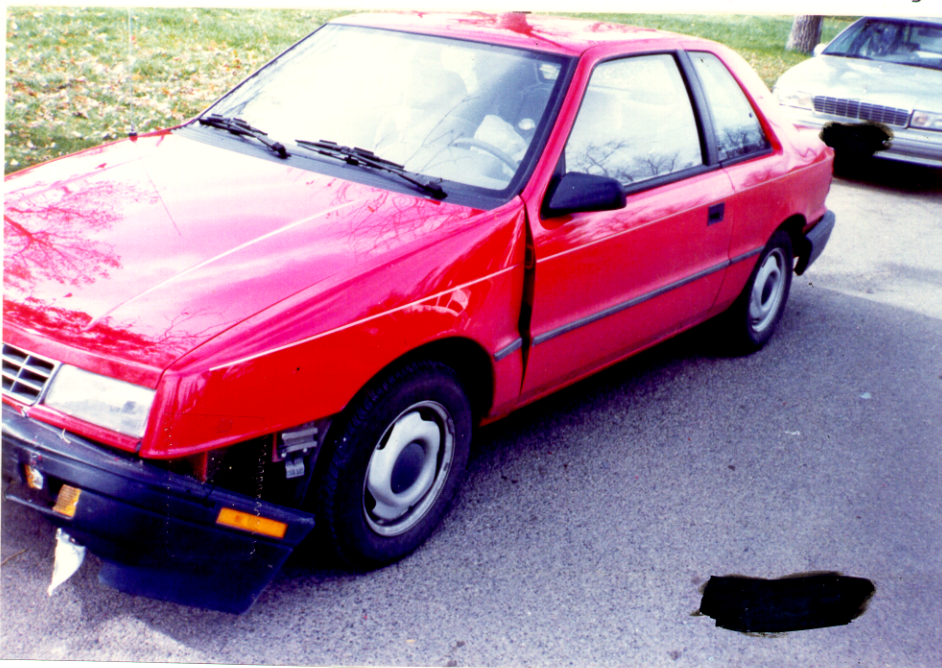
Damaged components included the front bumper, grille, left front fender, and parking lamp. See photos.

2. Left side view of the Sundance.

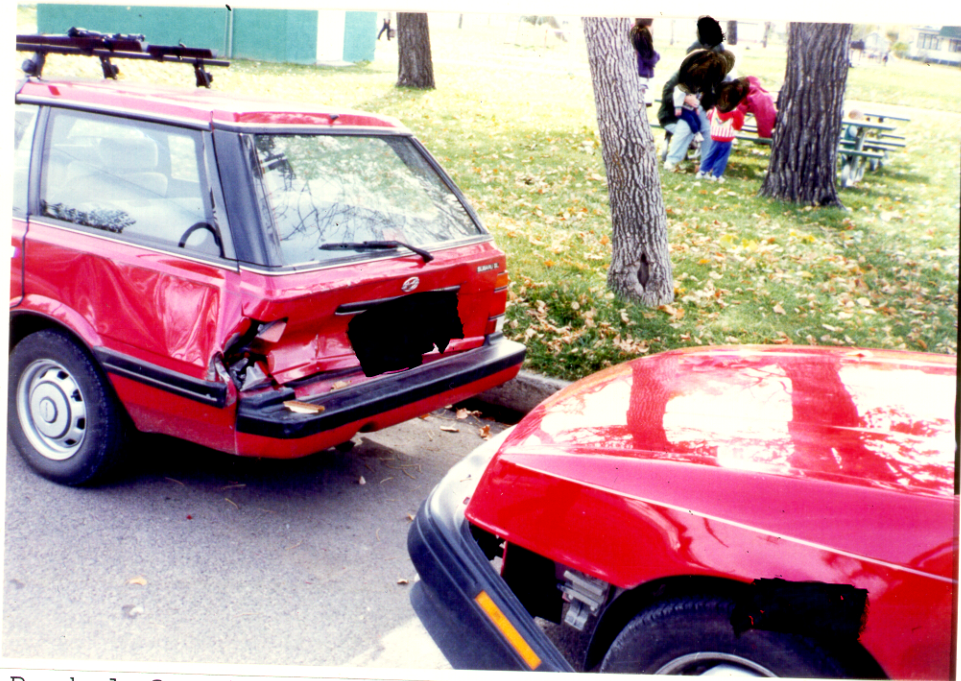
Damaged components included the rear hatch, left rear fender, and rear left tail light assembly. See photos.

The Subaru was not inspected, but from police photographs, the only component which appeared to be intruded was the rear hatch door. The intrusion appeared to be less than 3 inches.

3. Back-left view of the Subaru showing impact damage and left-front corner of the Sundance.
