CALSPAN REMOTE NON-DEPLOYMENT AIR BAG INVESTIGATION

CALSPAN CASE NO. 92-14

VEHICLE - 1991 ALFA ROMEO 164

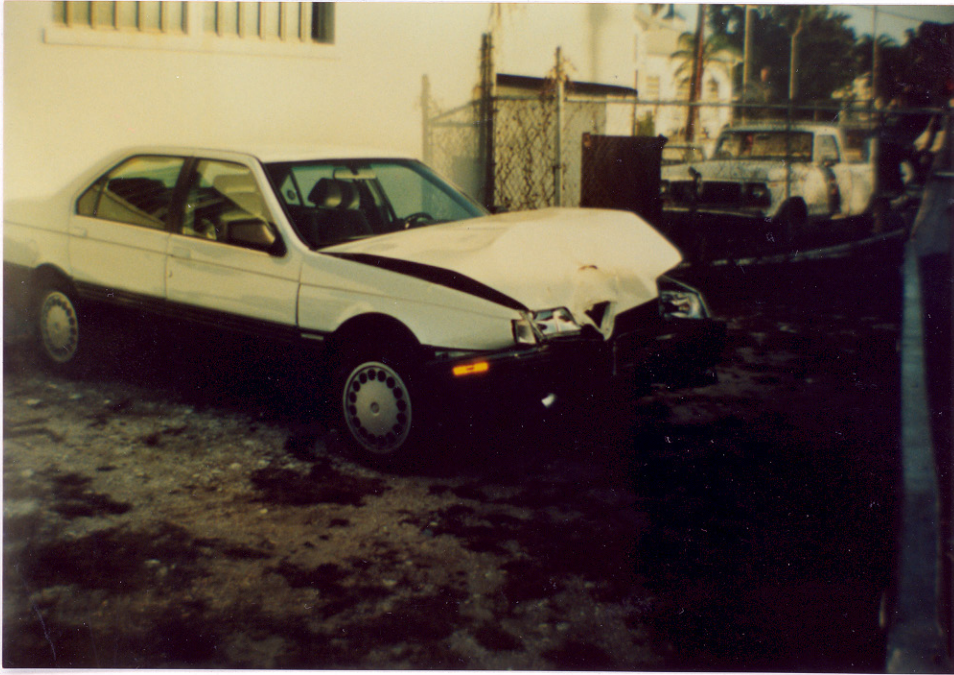
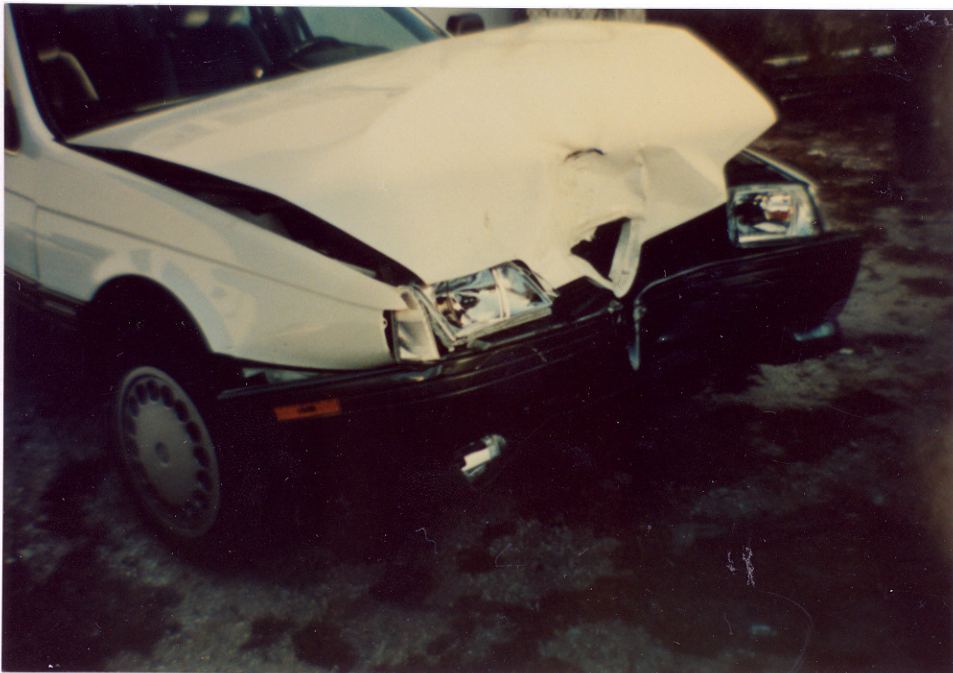
The Alfa Romeo was involved in a front to side impact sequence with a 1986 Chevrolet Cavalier that resulted in moderate frontal damage to the air bag equipped vehicle. Frontal crush was estimated at 20-25.4 cm (8-10") located at the center portion of the front bumper. The Alfa Romeo sustained a 12 o'clock impact force that resulted in an estimated longitudinal velocity change of 16-19 KPH (10-12 mph). The supplemental driver's air bag system did not deploy as a result of the crash which produced over \$10,000 of frontal damage to the Alfa Romeo 164.

Overall Views Of The Frontal Damage To The Alfa Romeo.

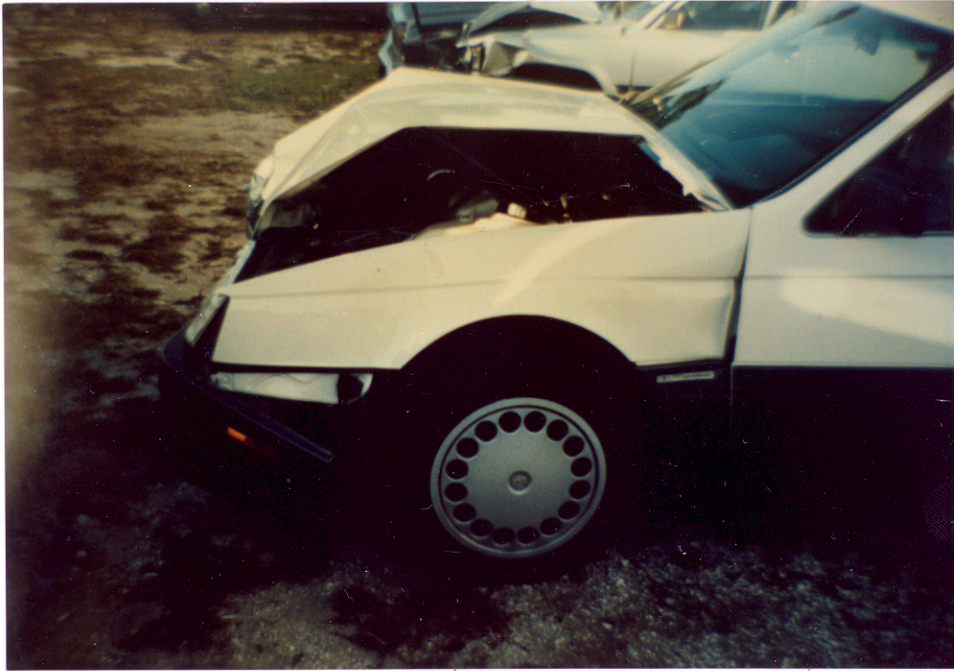
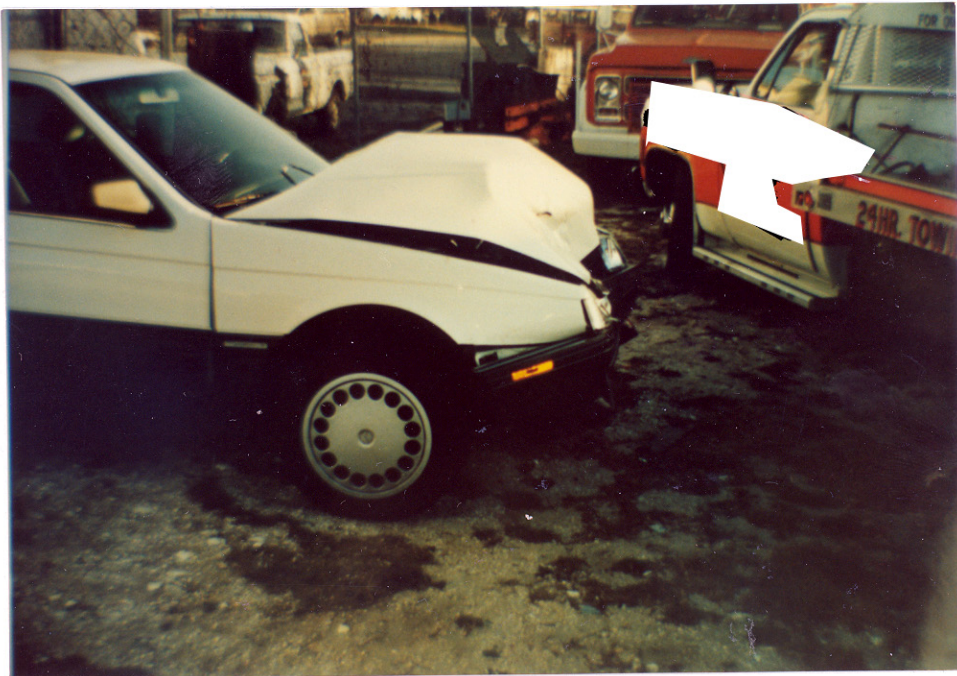
Perpendicular Views Showing The Extent Of Crush.
