**CALSPAN REMOTE AIR BAG DEPLOYMENT INVESTIGATION
CALSPAN CASE NO. 94-13
VEHICLE: 1994 JAGUAR XJ6
LOCATION: [REDACTED], FL
CRASH DATE: [REDACTED] 1994**

SUMMARY

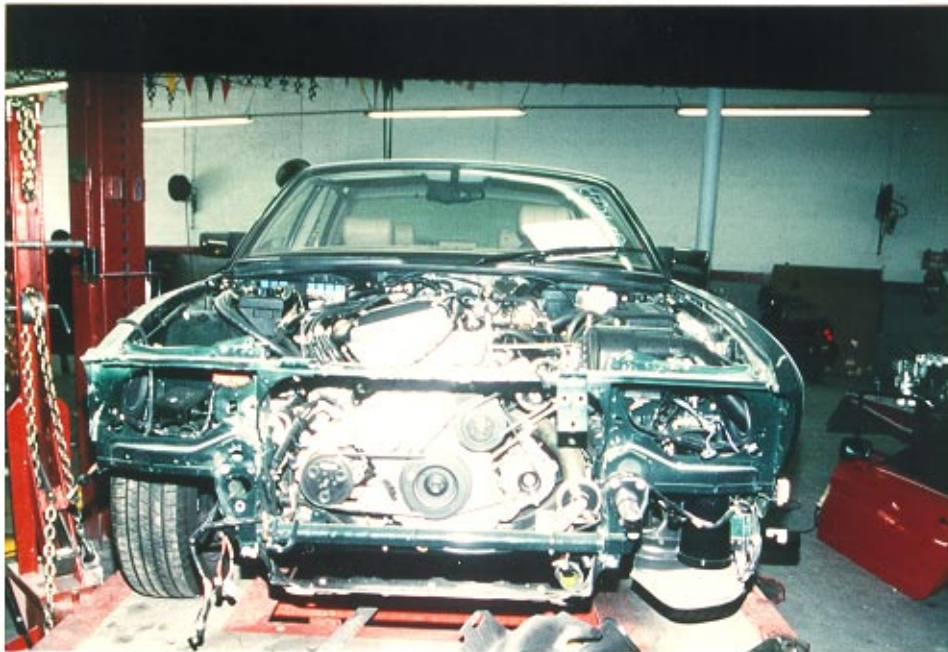
2. Frontal view of the disassembled Jaguar XJ6.

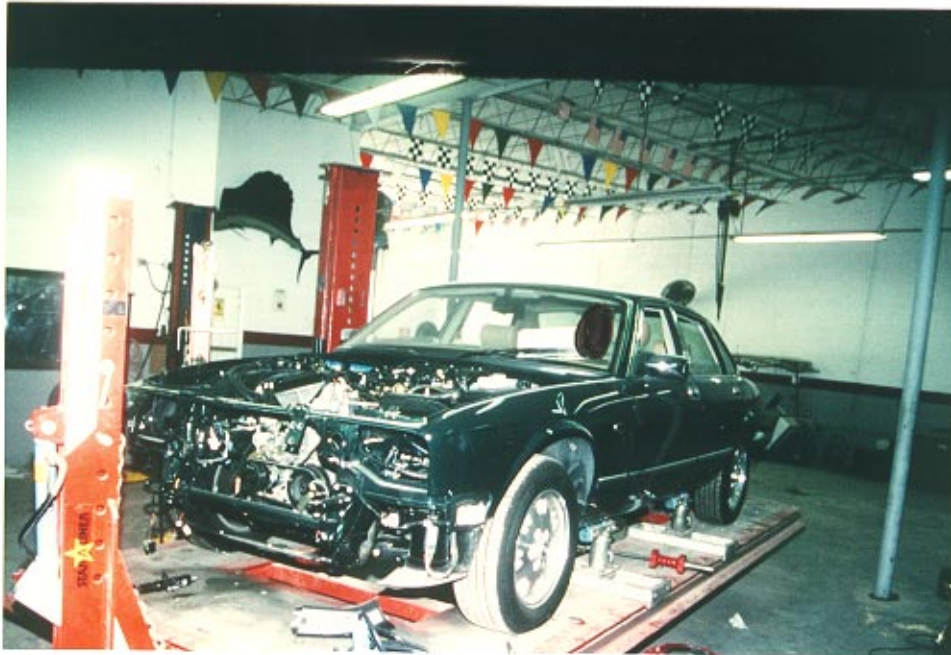
3. Left front three-quarter view.

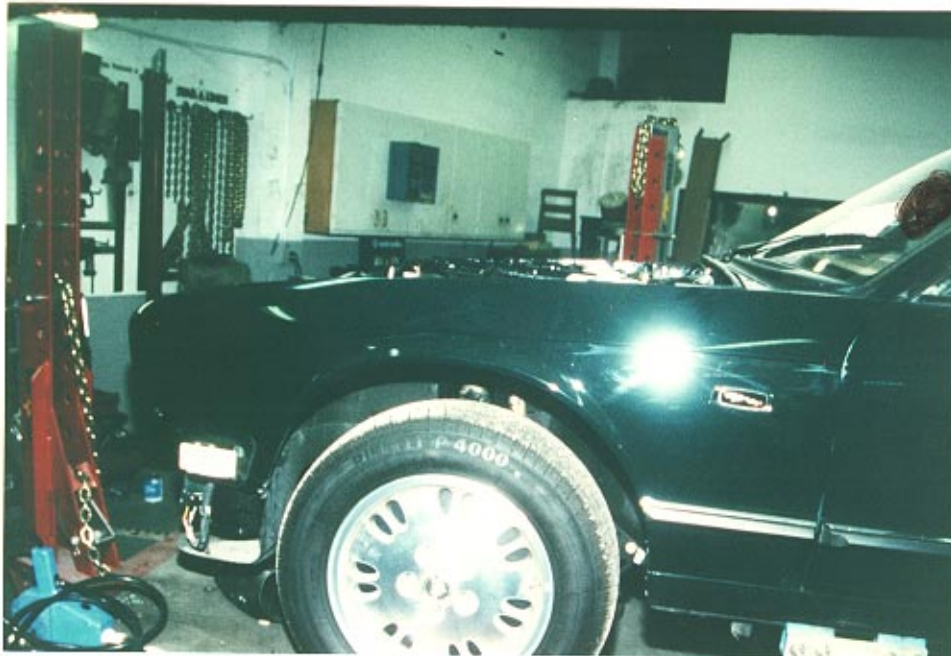
4. Close-up view of the undamaged left front fender.

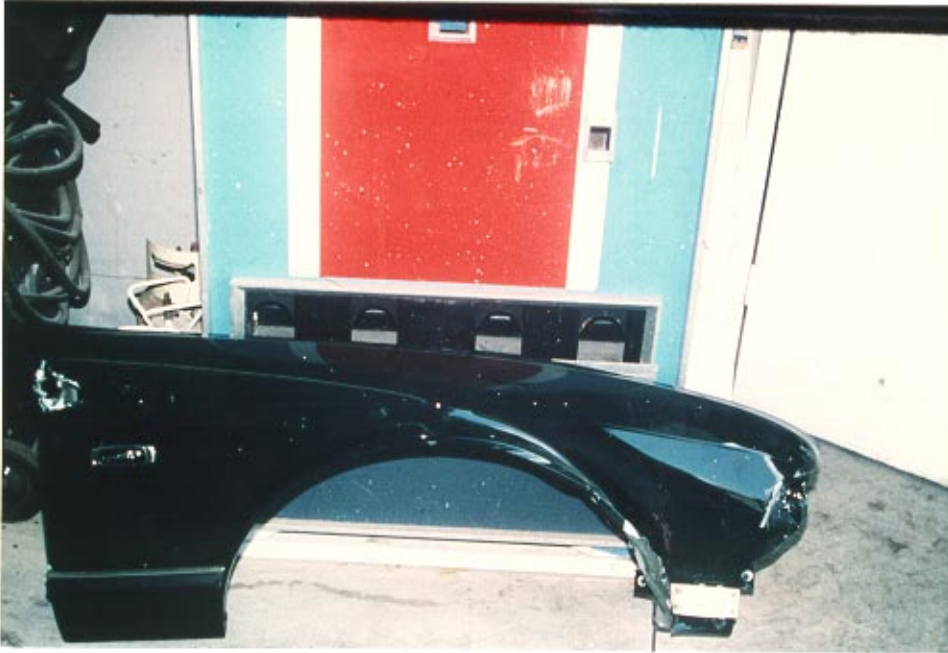
7. Removed and damaged right front fender.

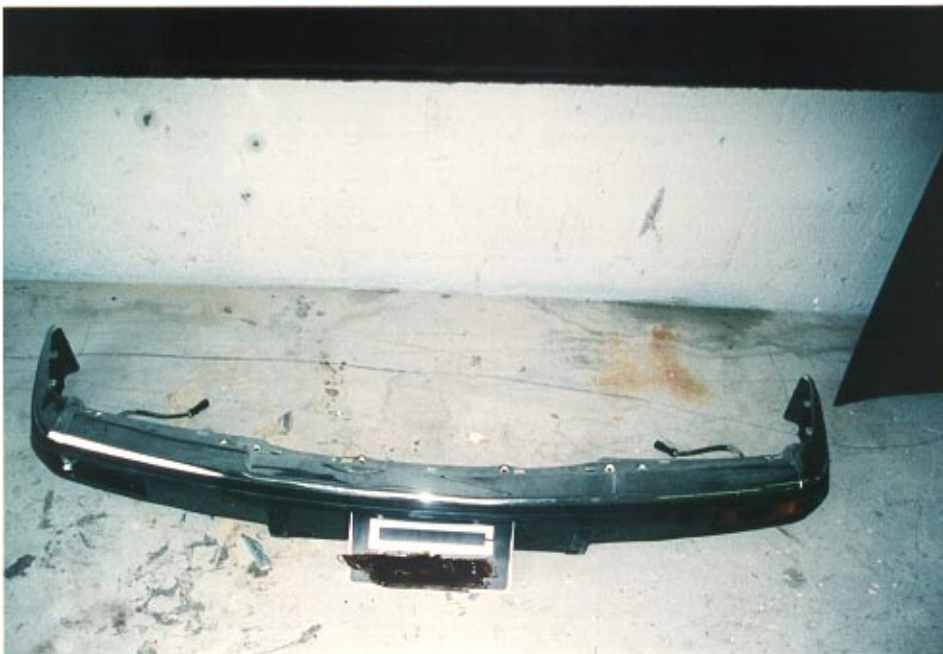
8. Removed front bumper with minimal direct contact evidence.

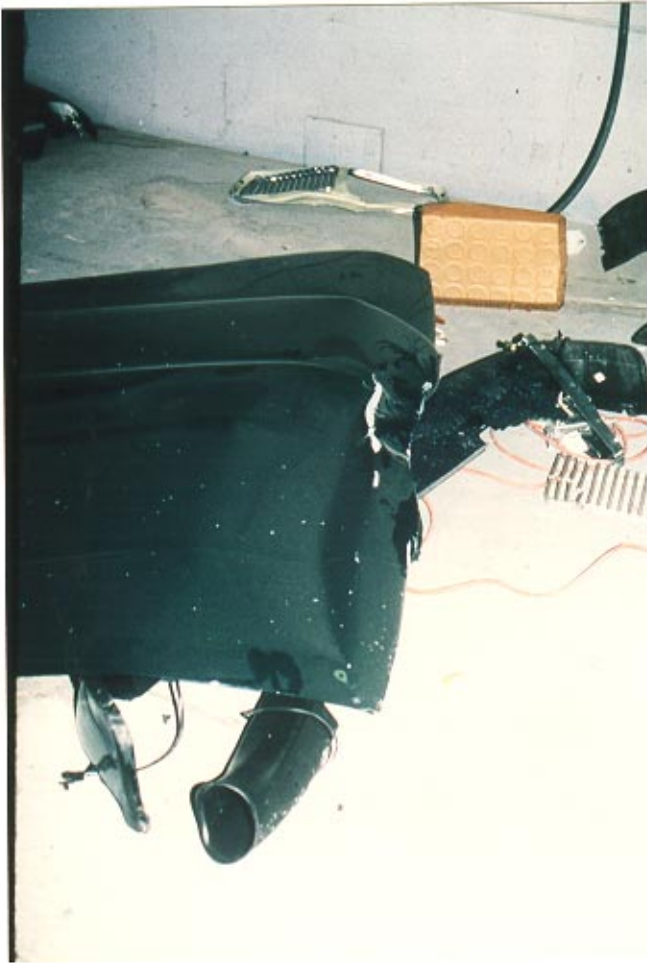
9. Damaged hood face.

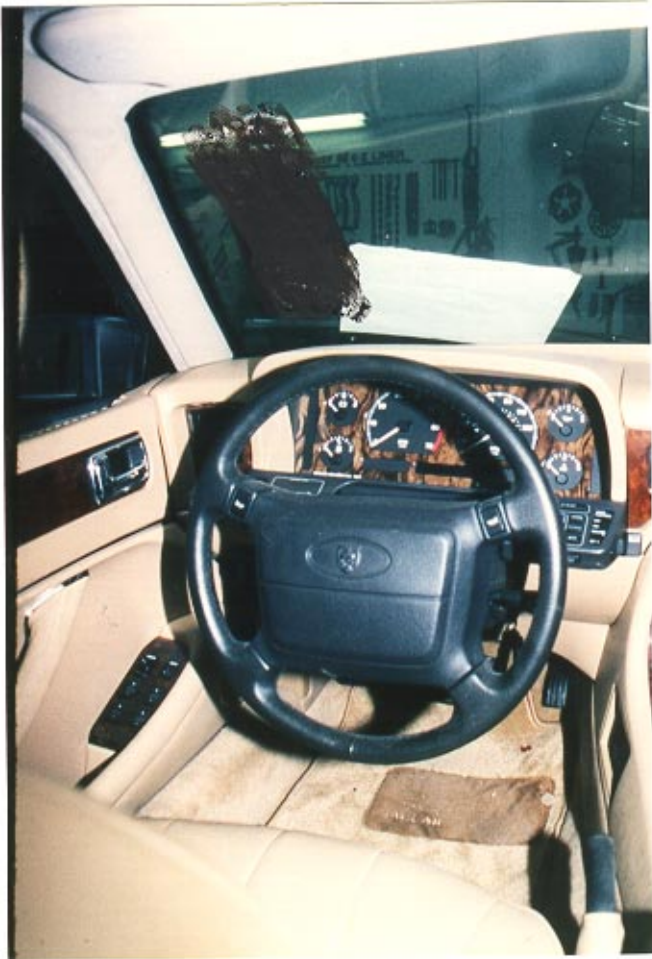
The driver's side supplemental air bag was contained in a typical module assembly within a four-spoke steering wheel. Although nondeployed, the module cover appeared to have a center horizontal parting seam which allowed for symmetrical flaps hinged at the top and bottom of the module when the wheel is in the 12/6 o'clock position. The perpendicular view of the steering assembly (photograph no.12) shows that the driver's side module protrudes approximately 2.5 cm (1.0") beyond the steering wheel rim, toward the driver.

11. Nondeployed driver's side air bag.

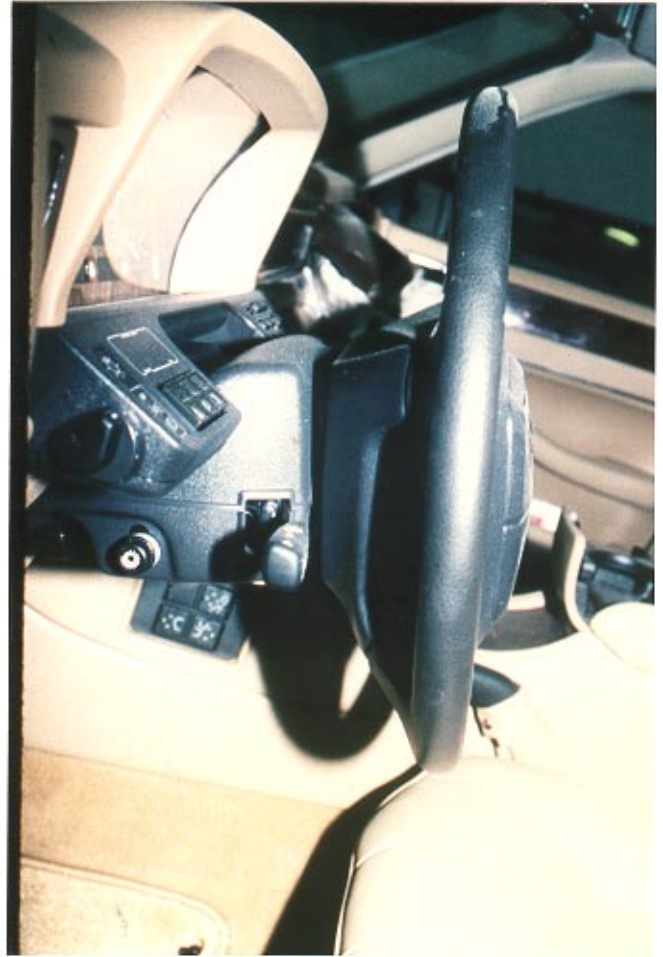
12. Perpendicular view of the wheel and air bag module assembly.

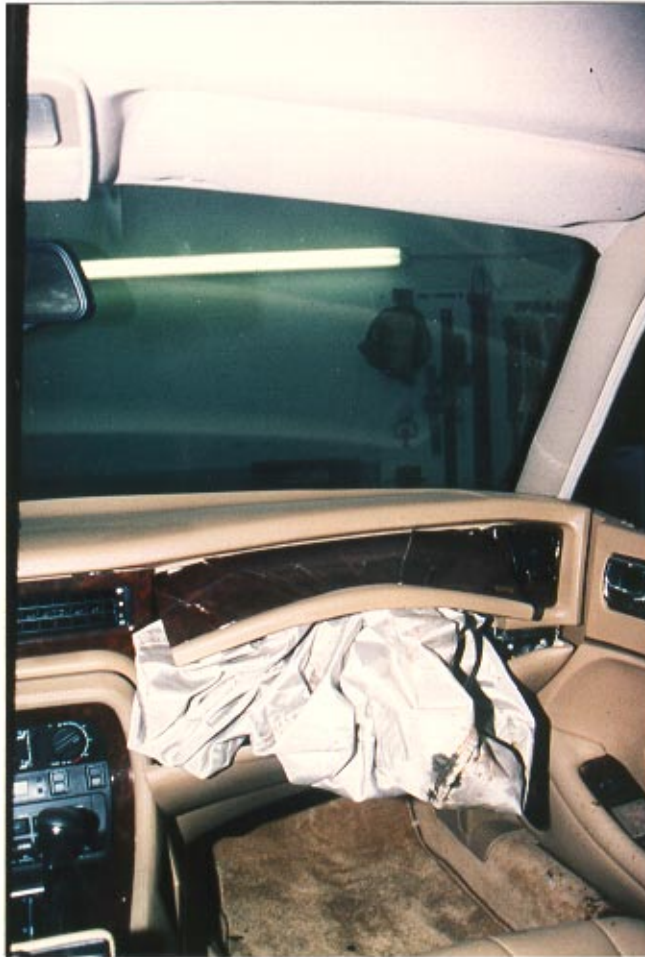
The deployed passenger side supplemental air bag system was contained within the right mid instrument panel. The large module cover door was mounted in a vertical position and extended from the right edge of the center console to the air vent adjacent to the right A -pillar. The door appeared to be rigid and was hinged at the top surface which allowed it to open in an upward direction. The face of the door was covered with a wood grain trim panel that blended into the remainder of the instrument panel. The bottom edge of the door was covered with a vinyl material that extended along the top of the glove box door. The deployment of the passenger bag bowed the

mid section of the door in an outward direction which cracked the wood grain trim panel. The horizontal surface of the upper instrument panel extended over the module cover door which prevented the door from rotating upward into the windshield.

15. Deployed passenger side air bag and module cover door.

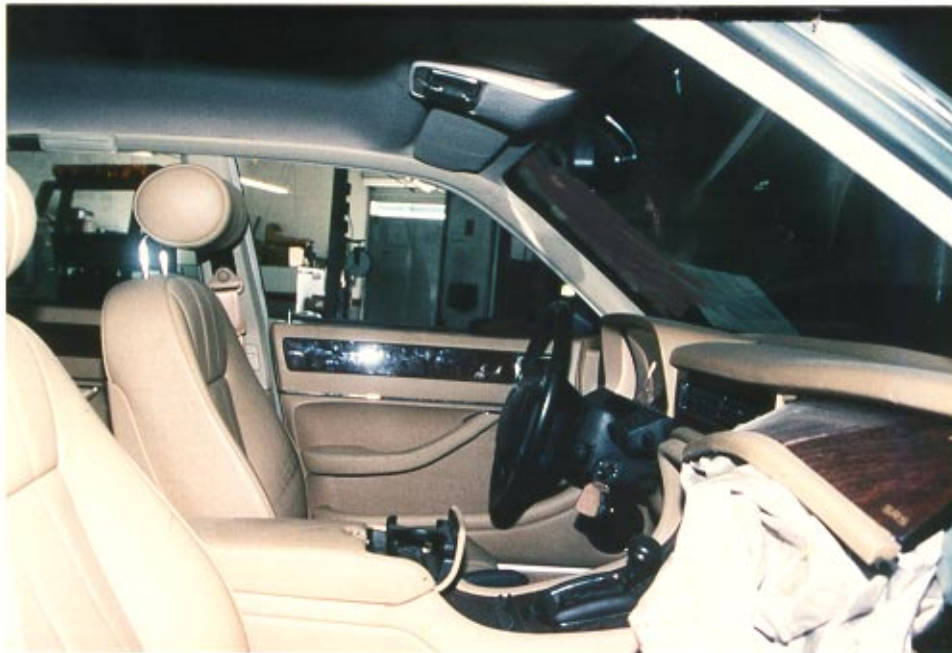
16. Perpendicular view of the passenger side module cover door.

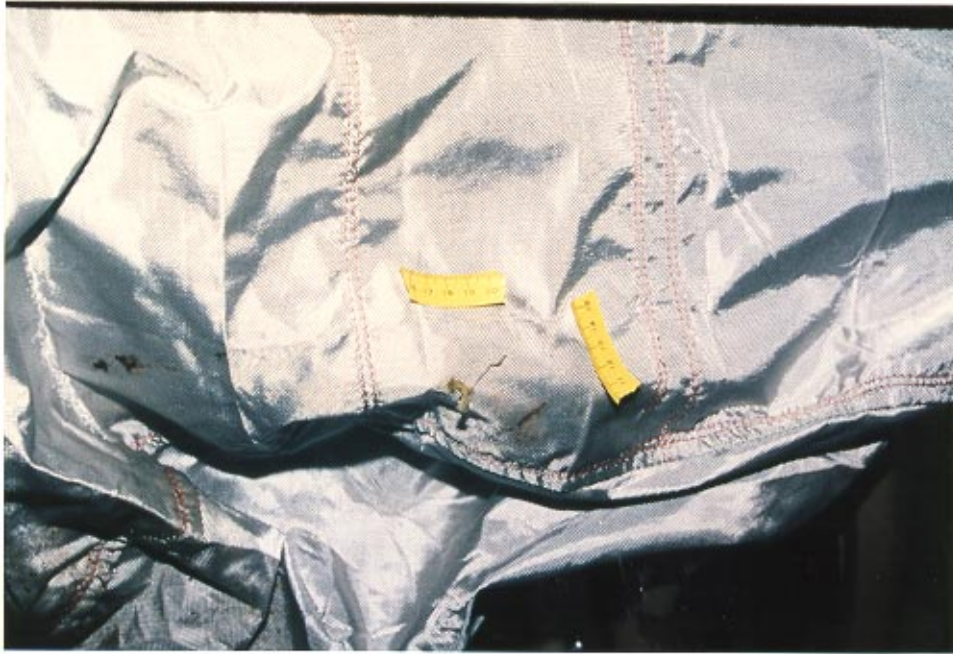
17. Possible occupant contact evidence on the passenger side air bag.

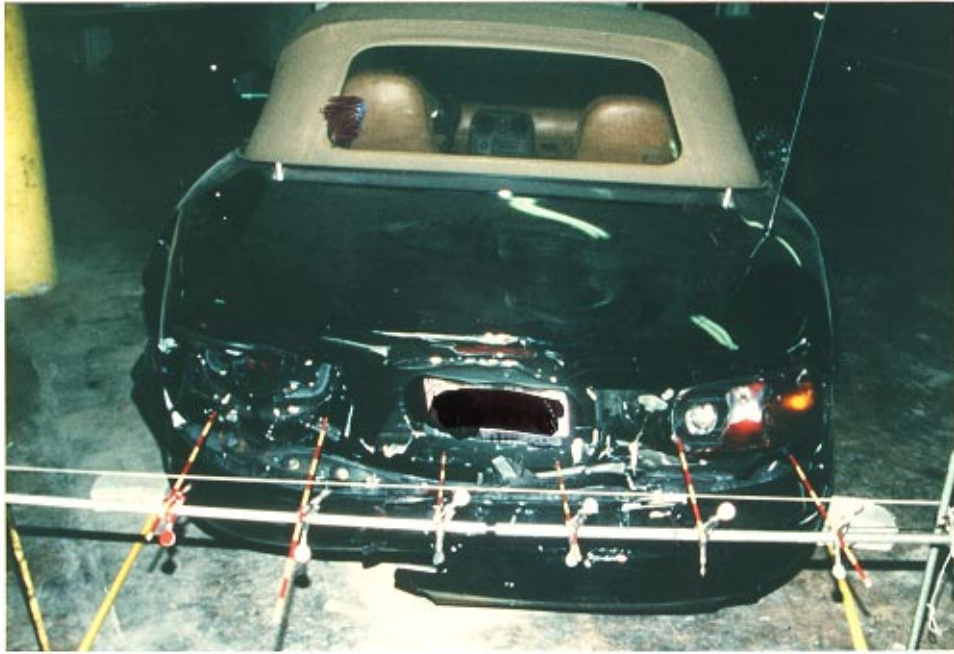
The struck Mazda sustained moderate damage that was distributed across the rear of the vehicle. Direct contact damage began at the left rear corner of the bumper and extended approximately 128 cm (50") to the right taillamp assembly. The NASS researcher documented the maximum crush as 7.0 cm (2.7") located at the left rear corner of the bumper.

19. Rear view of the struck Mazda Miata.

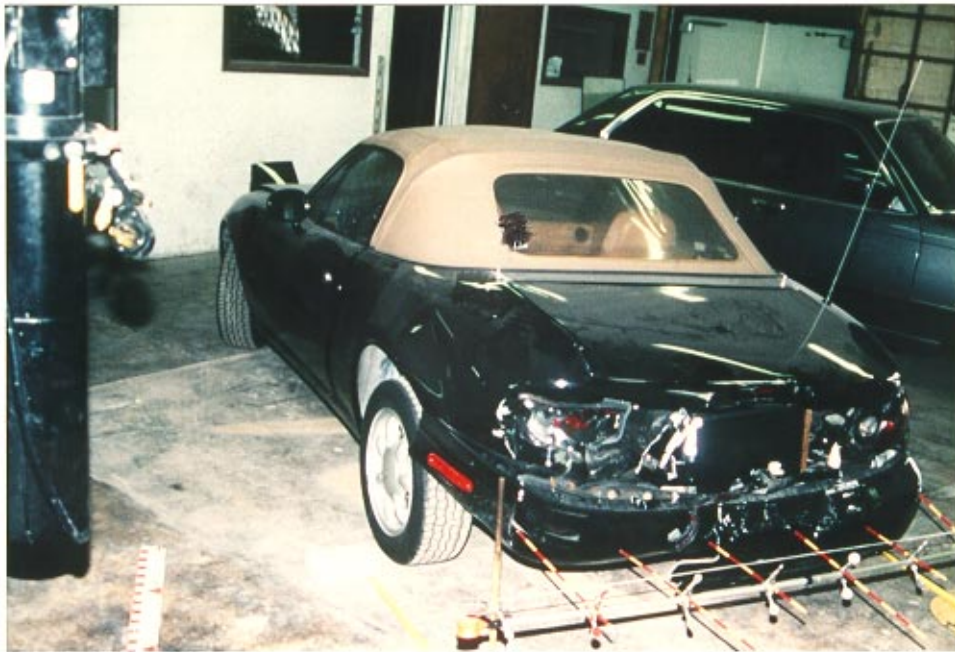
20. Left rear three-quarter view of the struck Mazda.

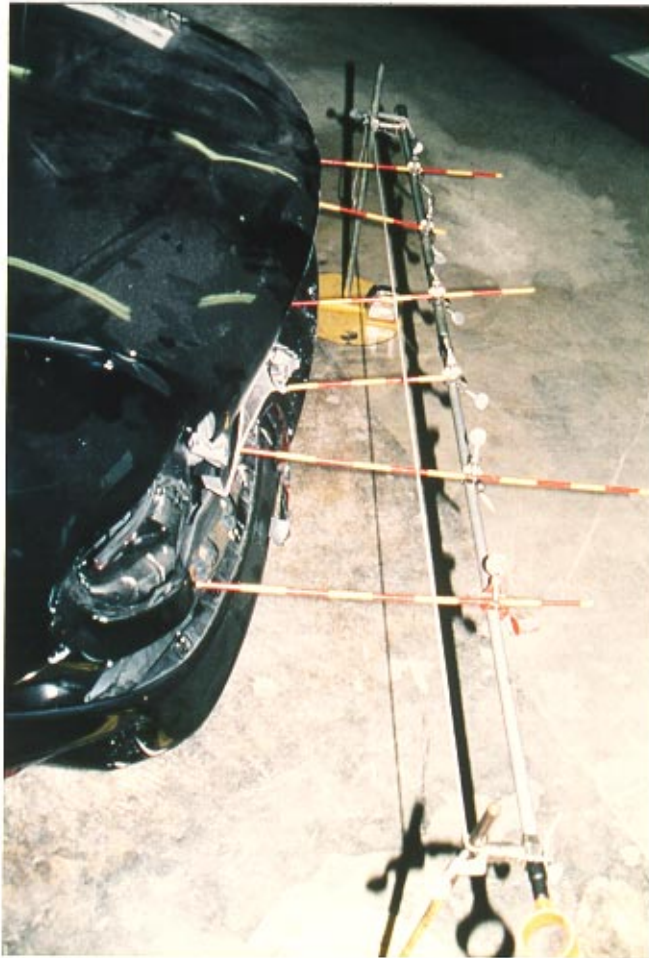
21. Perpendicular view showing the extent of crush.

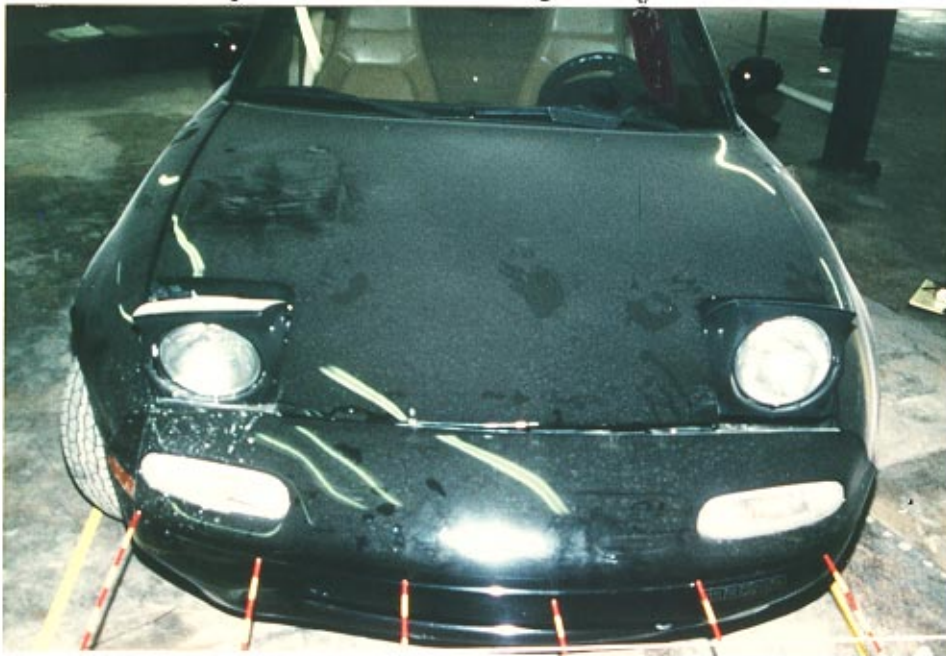
The front-to-rear impact sequence displaced the Mazda forward into the rear of the stopped Geo Prizm. This secondary impact resulted in minor damage to the involved vehicles. The Mazda sustained approximately 13 cm (5") of front bumper crush located at the right corner. The struck Geo sustained 10 cm (4") of bumper crush located at the left rear corner. Both vehicles came to rest near the point of impact.

22. Secondary impact damage to the right frontal area.
