TRANSPORTATION SCIENCES CENTER ACCIDENT RESEARCH GROUP

CALSPAN REMOTE AIR BAG DEPLOYMENT INVESTIGATION CALSPAN CASE NO. 94-34 VEHICLE: 1991 FORD CROWN VICTORIA LOCATION 1994

TECHNICAL SUMMARY

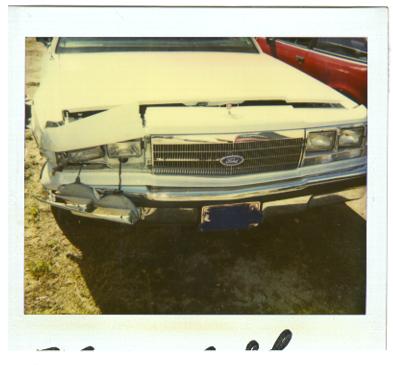
The 1991 Ford Crown Victoria sustained moderate right frontal damage from its impact sequence with vehicle #2. Direct contact damage appeared to have involved the right corner area of the front bumper. Maximum crush was estimated at 10-15 cm (4-6") located at the right corner of the bumper.

Damaged components included the front bumper, header panel, right headlamp assembly, and the right front fender.

Frontal damage to the Ford Crown Victoria.

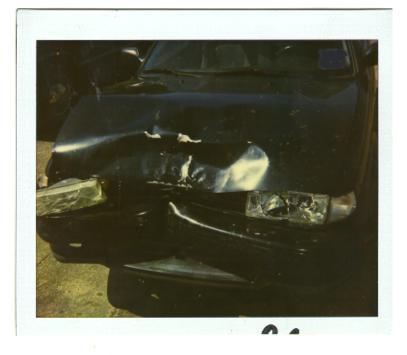
Vehicle #2, the 1991 Nissan Sentra, sustained moderate center frontal damage from its offset, head-on impact with the air bag equipped Crown Victoria. Maximum crush was estimated at 20-25 cm (8-10") located at the mid point of the front bumper.

Components damaged by the impact included the front bumper facia and reinforcement bar, grille, both headlamp assemblies,

2. Center frontal damage to vehicle #2.
