**CALSPAN ON-SITE SEAT BELT FAILURE INVESTIGATION
CALSPAN CASE NO. 94-35
VEHICLE: 1991 CHEVROLET CAPRICE (POLICE FLEET)
LOCATION: [REDACTED]**

<p>14. <i>Sponsoring Agency Code</i></p>	
<p>15. <i>Supplementary Notes</i> On-site investigation of a seat belt failure that resulted from driver loading in a 1991 Chevrolet Caprice police vehicle.</p>			
<p>16. <i>Abstract</i> This on-site investigation focused on a seat belt failure in a 1991 Chevrolet Caprice marked police vehicle. The driver was responding to an emergency police call and initiated a left turn at a four-leg intersection. A transmission tunnel mounted police radio speaker separated from its mount and fell onto the driver's right foot and under the brake pedal. As a result, the vehicle drifted wide in the turn and departed the intersection in a tracking mode. The center frontal area of the vehicle impacted a 22.9 cm (9.0") tree which resulted in a 35 km/h (22 mph) velocity change which deployed the vehicle's supplemental driver's side air bag system.</p> <p>The driver responded to the 12 o'clock direction of force impact and initiated a forward trajectory. He loaded the manual 3-point lap and shoulder belt system. His loa

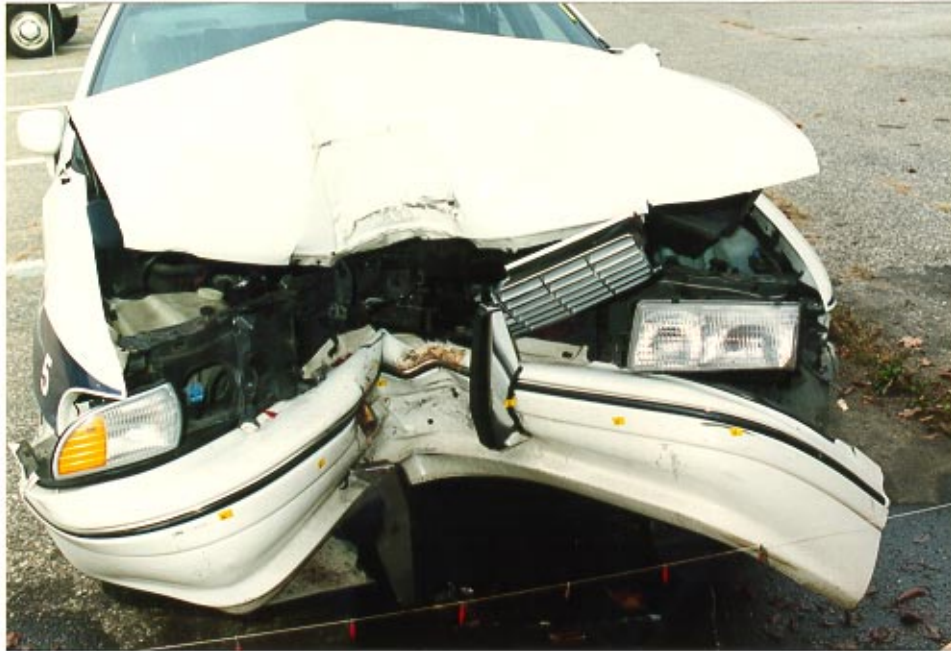
5. Frontal view of the tree impact damage to the Chevrolet Caprice.

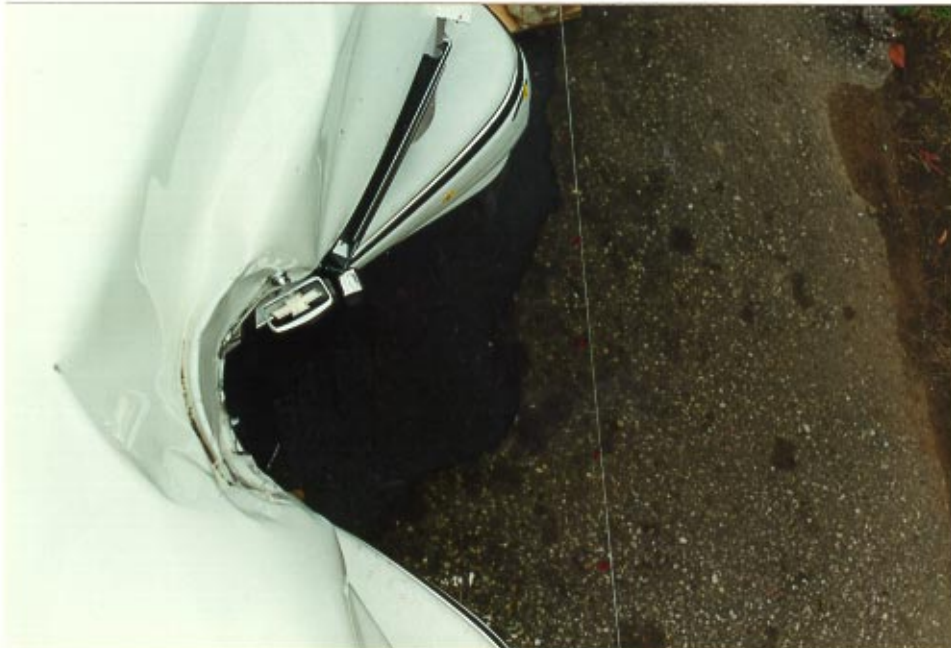
Exterior: The 1991 Chevrolet Caprice sustained moderately severe frontal damage from its impact sequence with a wooden utility pole. Maximum crush was 76.5 cm (30.1") located on the bumper fascia 8.9 cm (3.5") right of the vehicle's centerline. Direct contact damage began at the centerline and extended 24.1 cm (9.5") to the right. The narrow impact to the vehicle resulted in a combined induced and direct damage width of 94.6 cm (37.3") which extended from bumper corner-to-bumper corner. Crush values were documented at bumper level and were as follows: C₁= -2.5 cm (-1.0"), C₂= 24.1 cm (9.5"), C₃= 48.3 cm (19.0"), C₄= 76.5 cm (30.1"), C₅= 33.0 cm (13.0"), C₆= 2.5 cm (1.0").

6. Overhead view showing the extent of frontal crush.

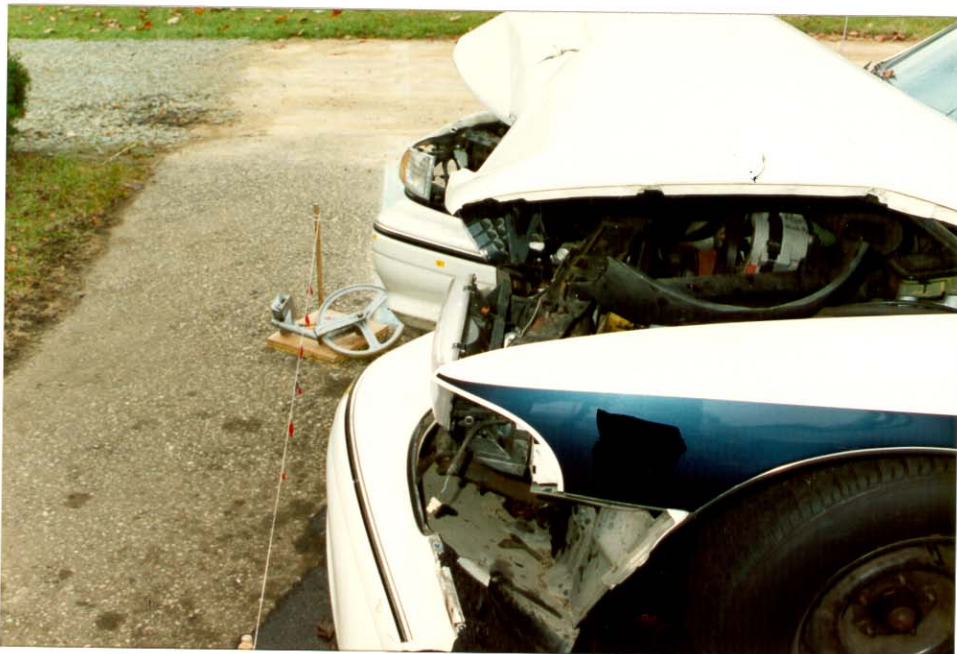
8. Perpendicular view of the frontal deformation from the left side of the vehicle.

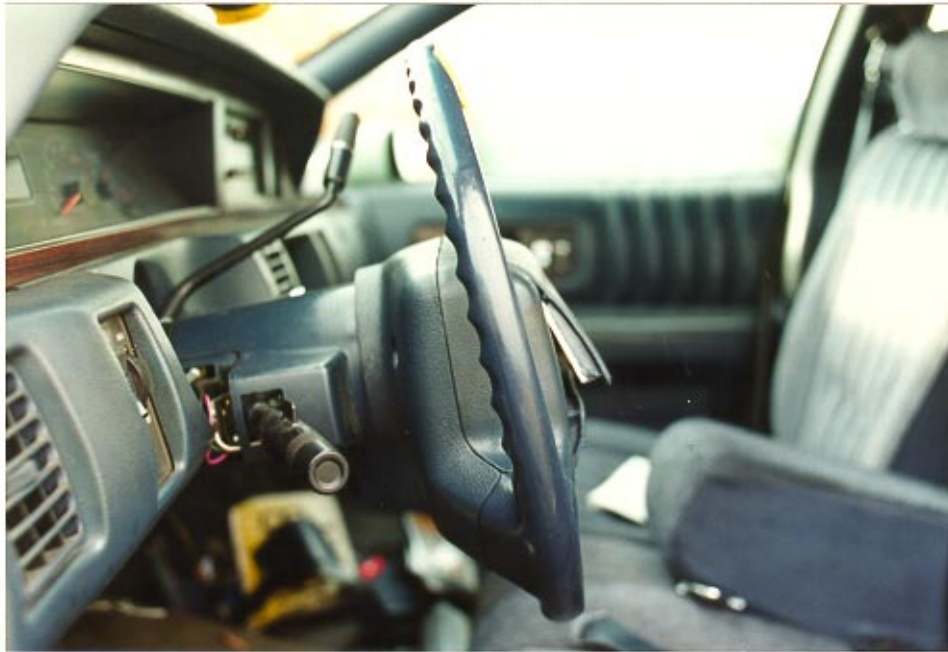
15. Forward deflection of the upper steering wheel rim.

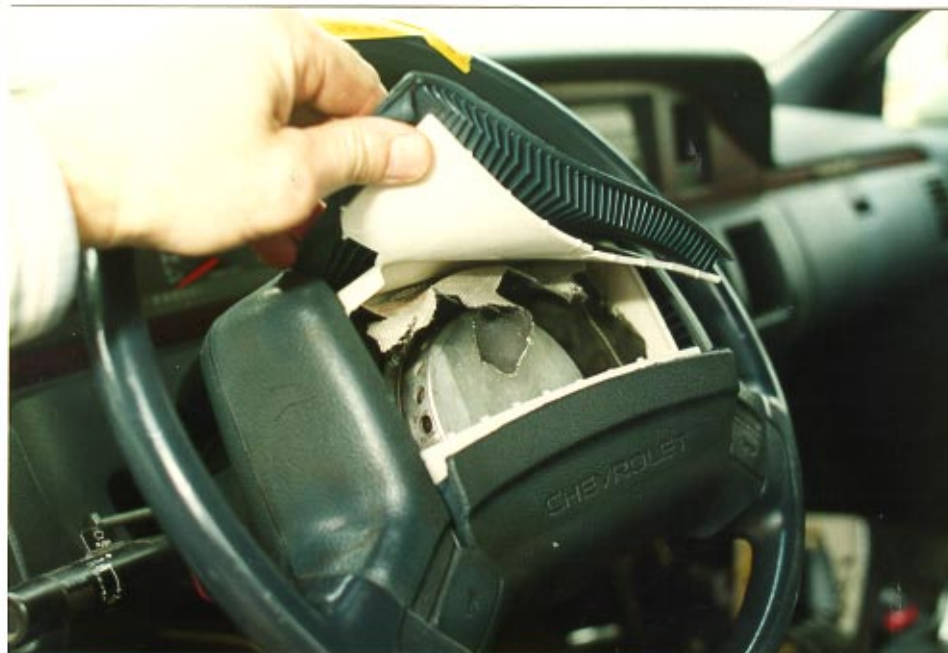
The air bag was cut from the gas generator and removed from the vehicle prior to [REDACTED] inspection of the Chevrolet Caprice, therefore contact evidence and/or damage to the air bag was unknown. The vehicle's battery lacked sufficient power to test the instrument panel indicator lamp for the post-crash status of the SIR system.

16. Air bag module cover flaps and gas generator with air bag cut from module assembly.

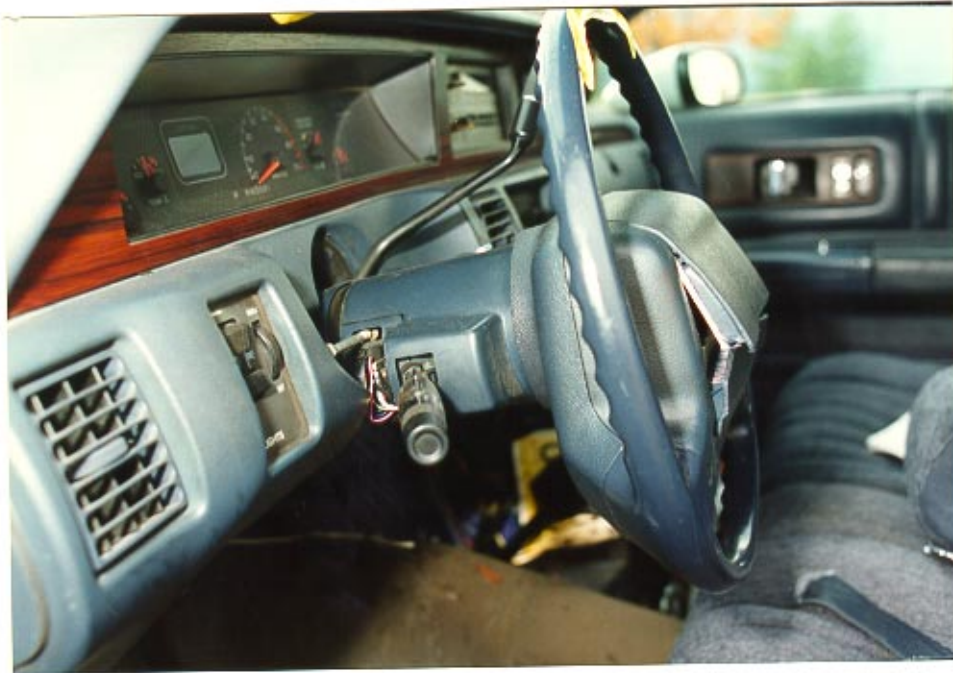
17. Compression of the energy absorbing steering column.

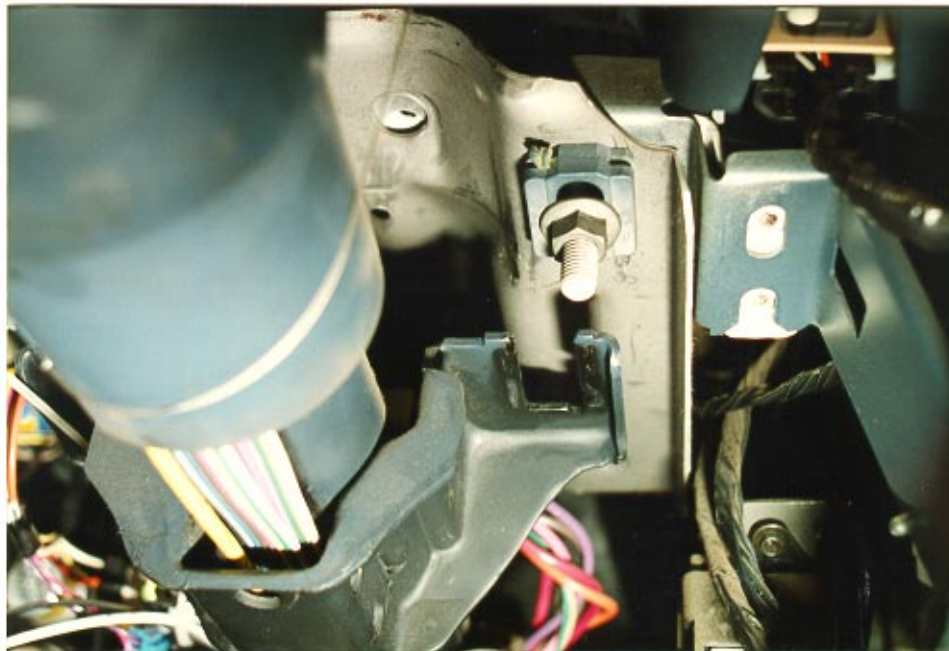
18. 4.4 cm (1.75") of displacement of the right shear capsule bracket.

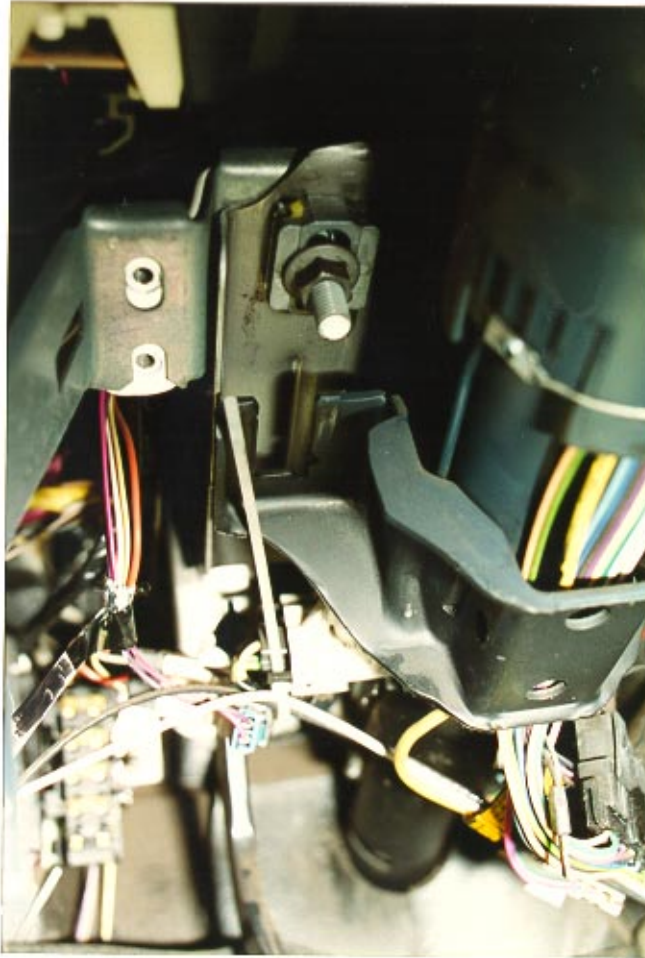
19. 1.0 cm (2.0") of left shear capsule bracket separation.

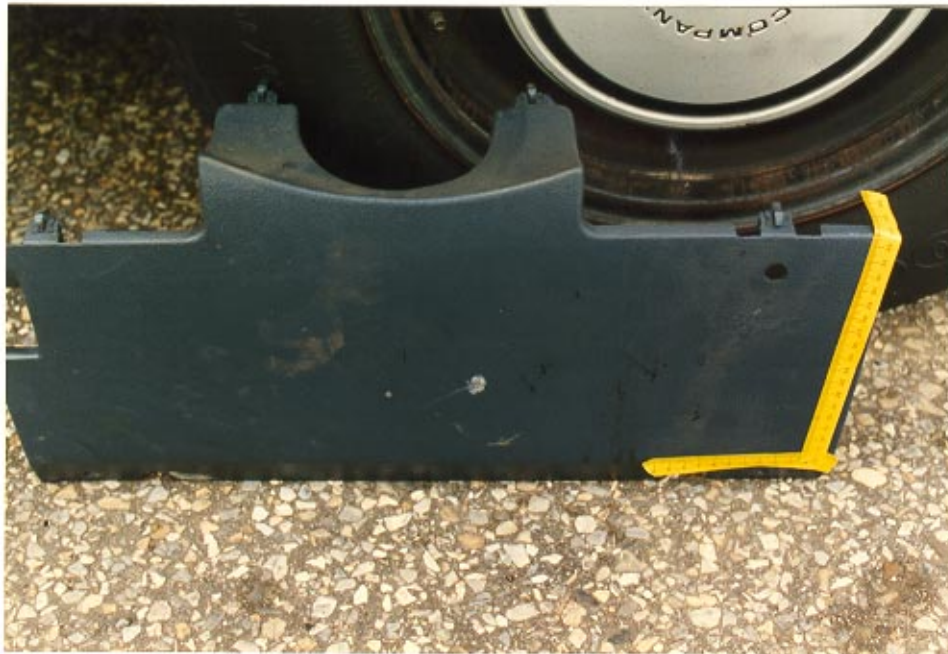
20. Right knee contact (scuff) to the removed knee bolster outer panel.

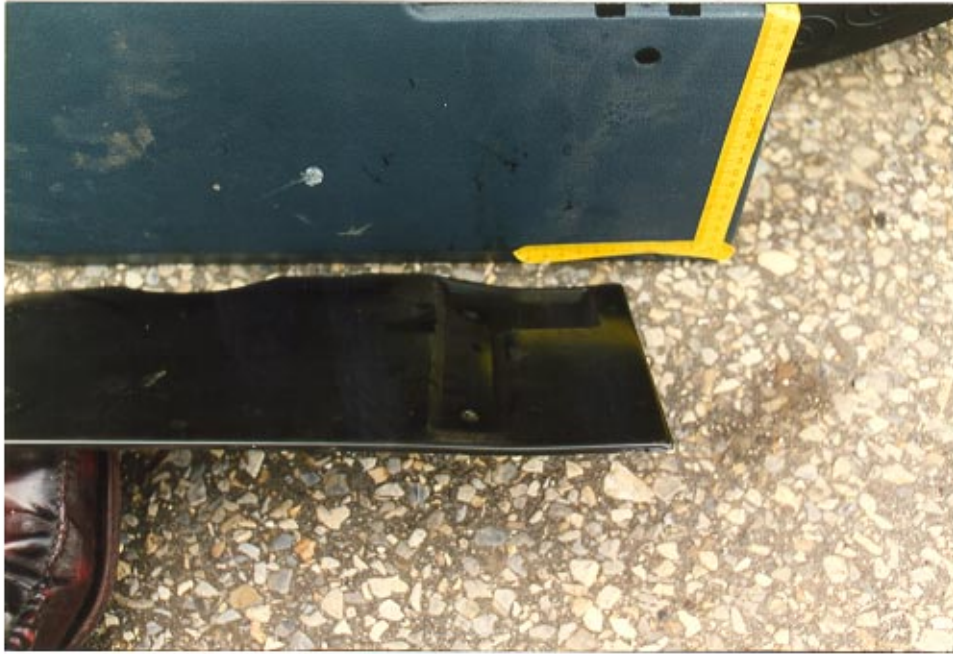
21. Deformation (0.25 cm) from right knee contact to the bolster backer panel.

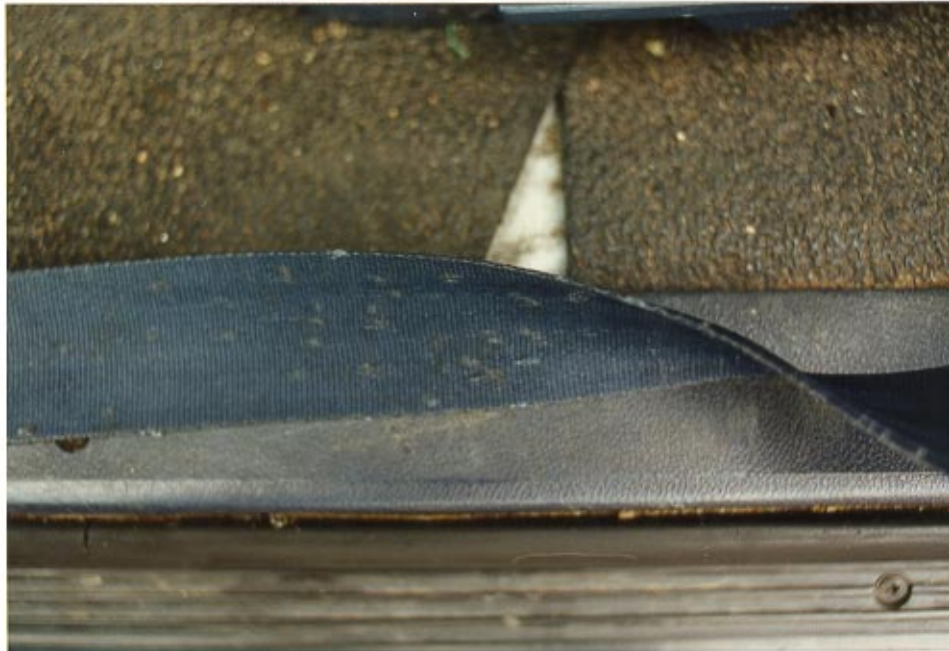
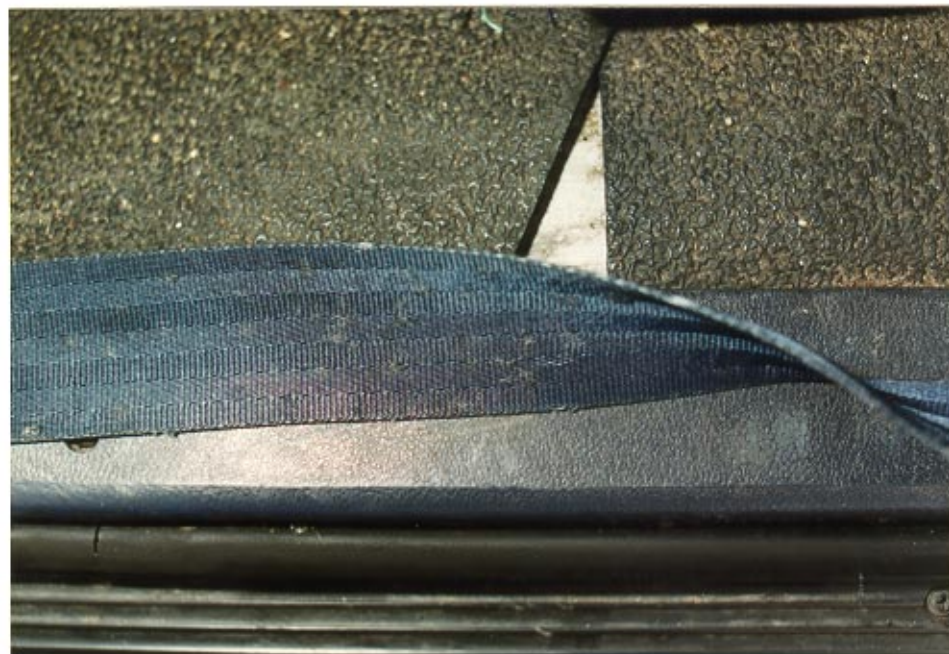
Inspection of the belt webbing revealed numerous wear patterns that resulted from extensive usage and misuse of the system. The lap belt portion of the continuous loop webbing contained numerous gouges and indentations in the fabric from the belt becoming caught between the door latch and strike plate. These marks on the webbing were located 34.3-52.1cm (13.5-20.5") above the floor

The lower segment of the belt webbing contained numerous gouges and snags on both edges of the nylon lap belt material. These were located 38.1-80.7 cm (15-31.75") above the floor anchorage. In addition, there was numerous gouges in the webbing at 34.3-52.1 cm (13.5-20.5") above the floor anchorage point that resulted from the belt webbing becoming caught between the door latch and the B-pillar mounted striker post. This pre-existing damage to the belt webbing is documented in Photograph No. [REDACTED]

23. & 24. Gouges and scrapes in lap belt webbing from belt becoming caught in door latch/striker.

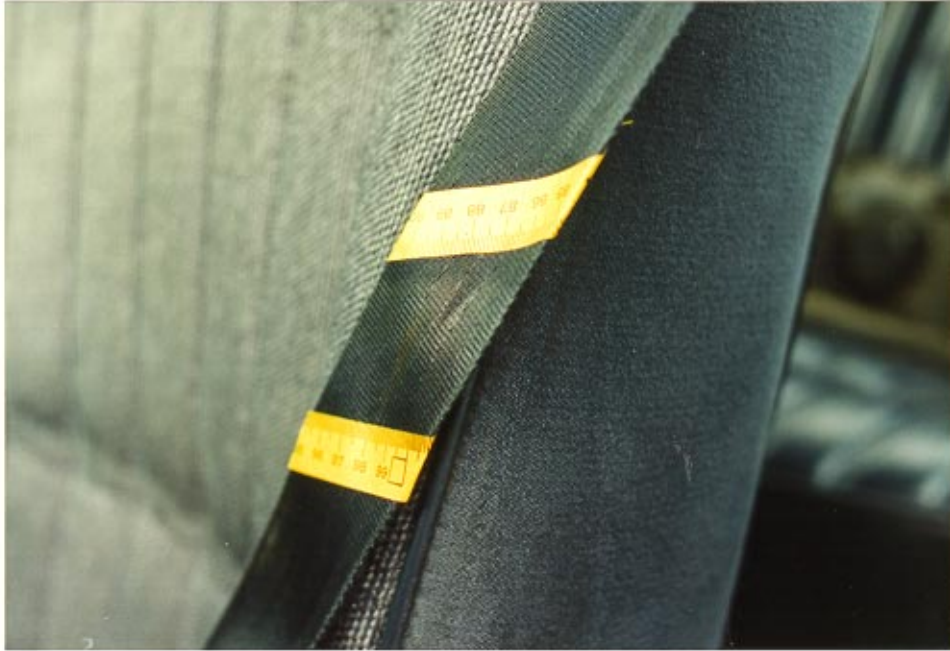
25. D-ring loading transfer on the shoulder belt webbing.

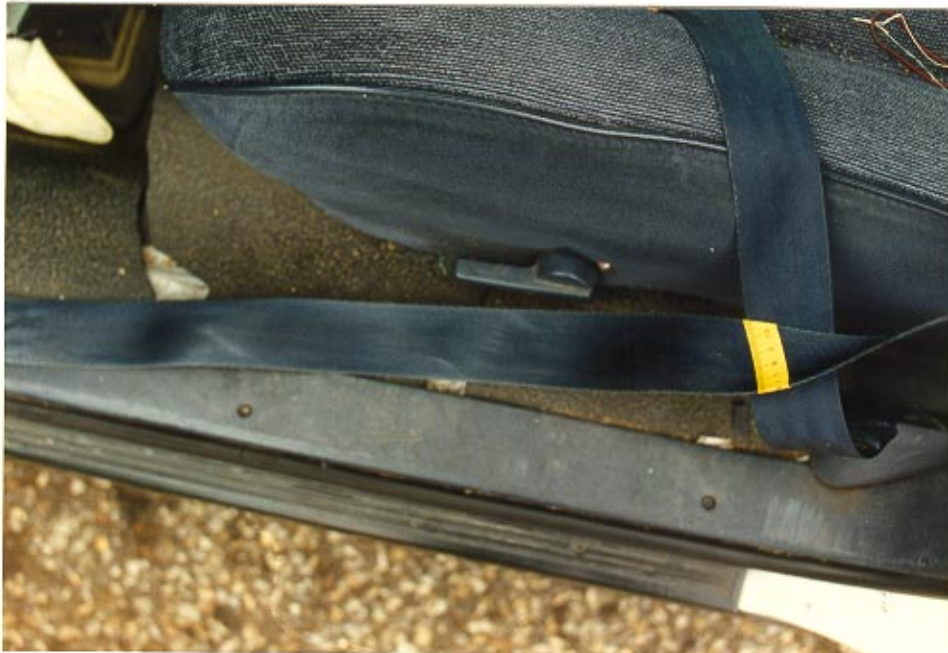
26. Driver loading fabric transfers on the shoulder belt webbing.

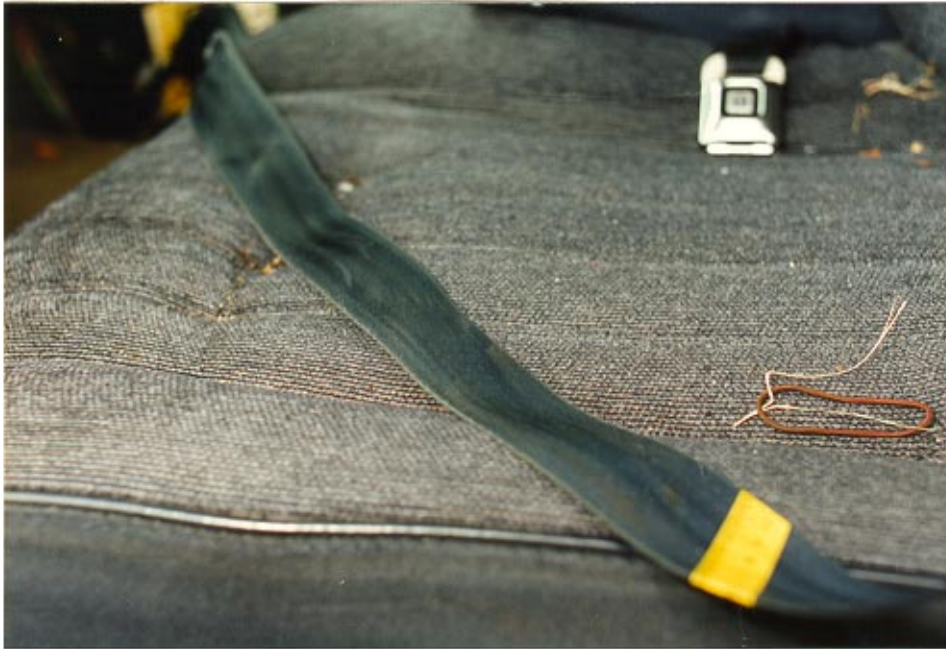
27. Additional view of the loading transfers on the shoulder belt webbing.

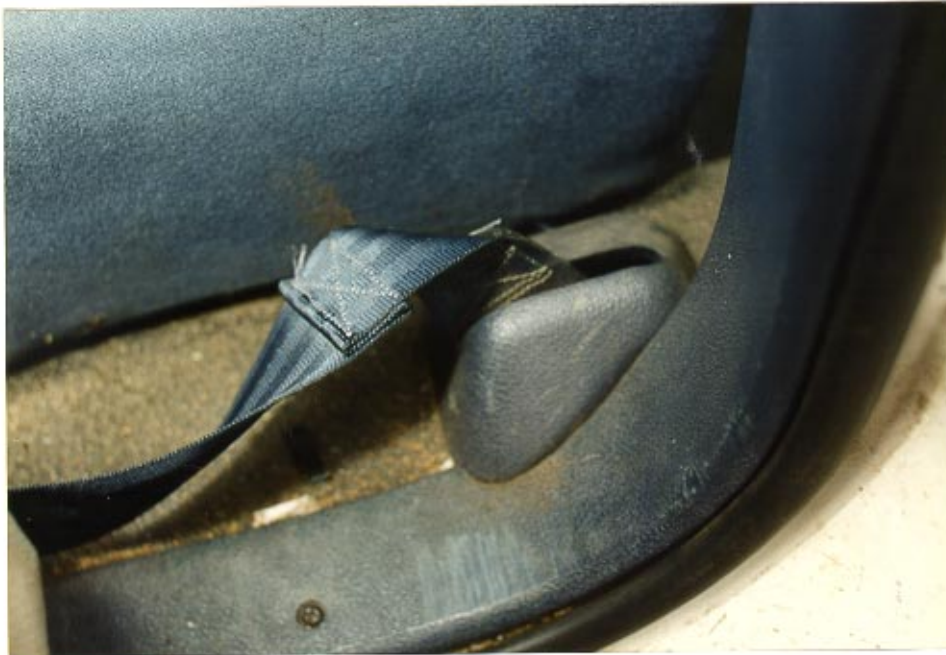
The energy management loop did not separate from occupant loading prior to the failure of the belt webbing. This would indicate that the strength of the belt webbing probably had diminished over the three year period that the vehicle was in service. The condition of the belt webbing was considered worn from frequent usage and from becoming snagged in the door latch/strike assembly. This, however, did not weaken the belt in the area of the tear. There was no evidence on the latchplate cinch bar that would indicate the webbing had been cut by this component. The driver was, however, fortunate that the Chevrolet Caprice had a supplemental driver's side air bag system which deployed and probably reduced the severity of his injuries.

28. Energy management loop and the lower anchorage point of the driver's side belt webbing.

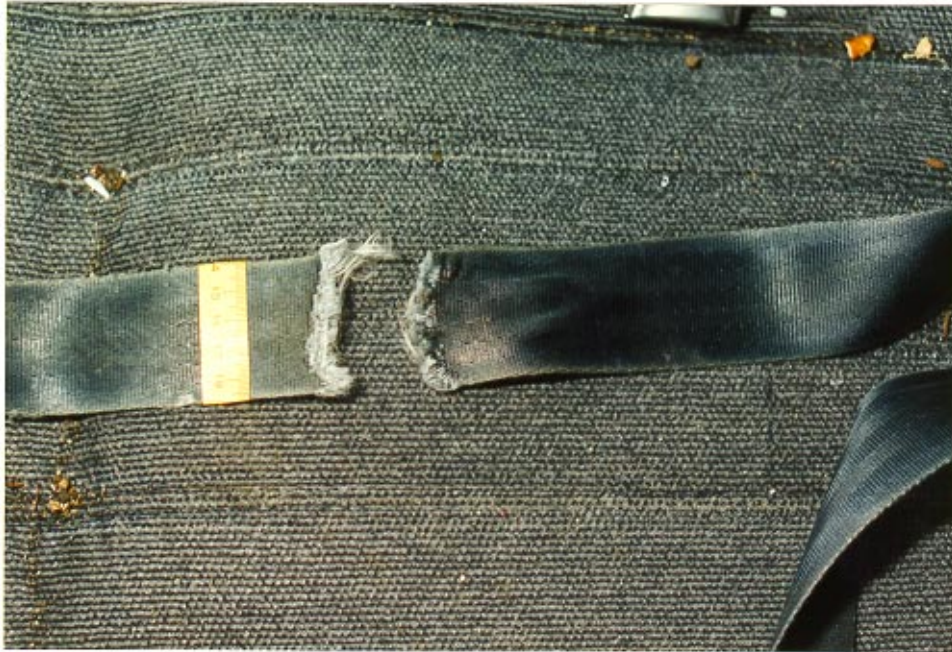
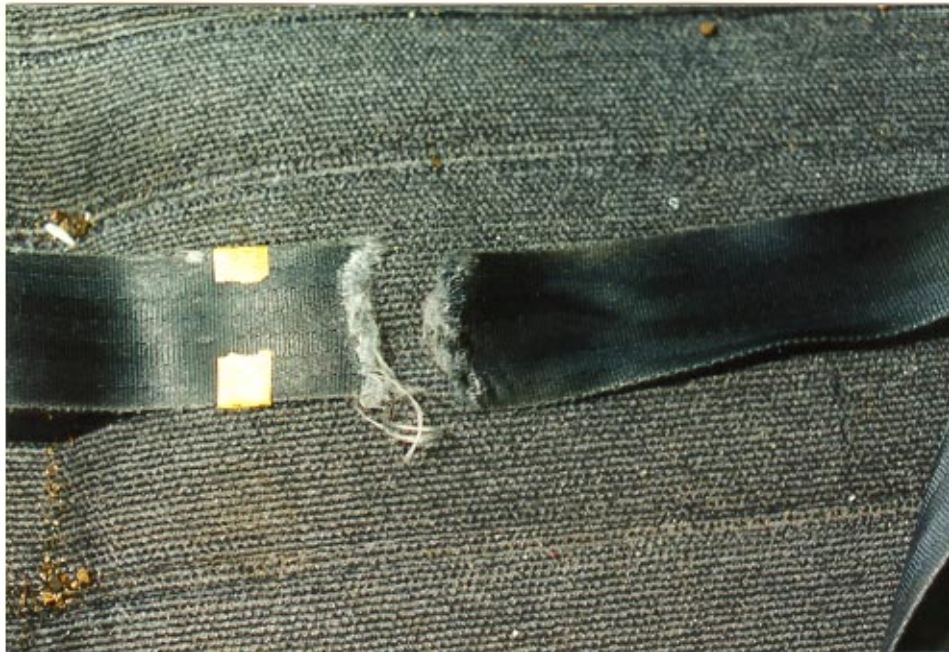
response to the 12 o'clock impact force and loaded the manual 3-point lap and shoulder belt webbing. His loading force against the belt system resulted in a complete failure of the webbing at the latchplate cinch bar. The driver's loading force against the belt resulted in a band-like contusion across the left upper quadrant of the chest and left anterior shoulder and a contused rib cage. Compression of the shock plate against his chest from belt loading probably contributed to the rib contusions. He also sustained bilateral contusions of the knees and upper shins from contact with the knee bolster. There was no contact evidence from the left knee; however, the right knee contact scuffed the plastic outer panel of the bolster and deformed the steel inner panel to a depth of approximately 2.5 mm (0.1").

The failure point on the belt webbing was located 80.6 cm (31.75") above the floor anchorage point. With the belt fully extended from the retractor, the tear point was 177.8 cm (70.0") above the B-pillar panel that surrounds the retractor mechanism. The tear was perpendicular to the webbing with both edges of the belt frayed 6.4-9.5 mm (0.25-0.375"). On the inboard side of the lap belt portion of the webbing, the full width of the belt contained a loading transfer from the latchplate cinch bar. This loading transfer extended 2.5 cm (1.0") below the failure point.

29. & 30. Separation of the belt webbing at the cinch bar location.

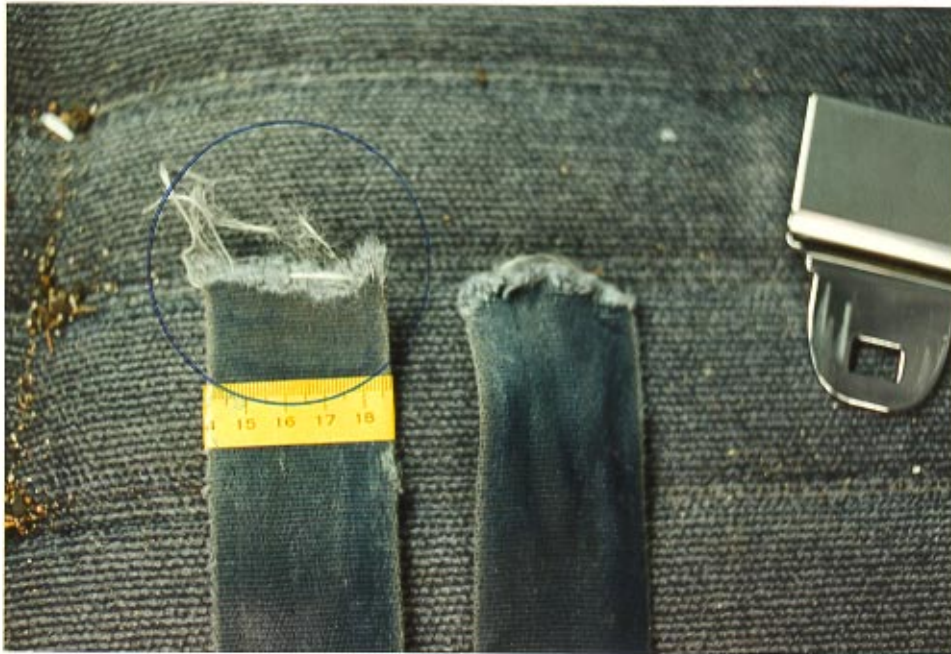
31. Cinch bar loading transfer on the inner aspect of the belt webbing (circled).

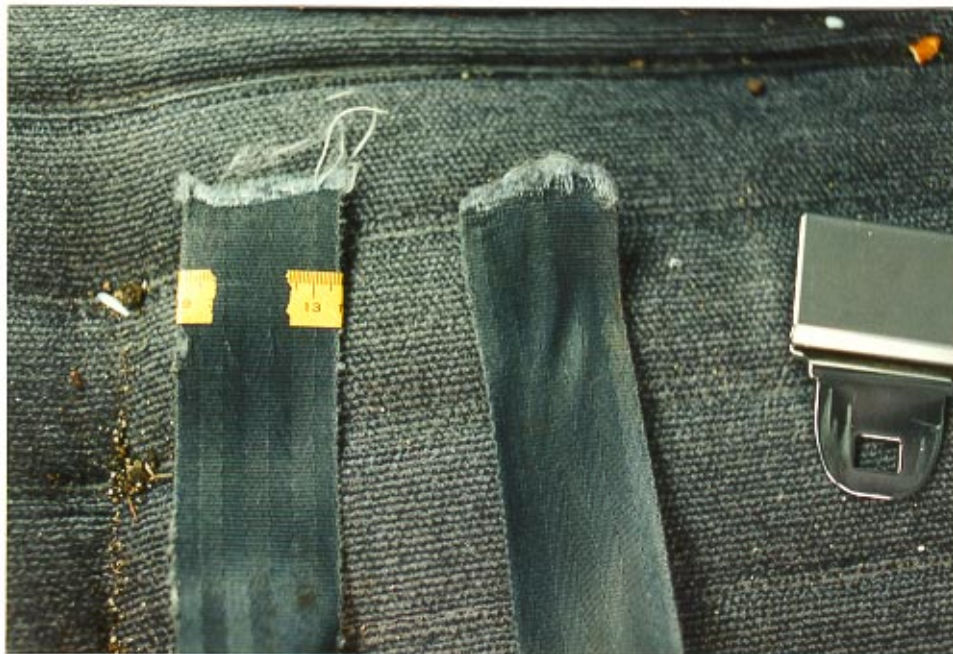
32. Additional view of the separation.

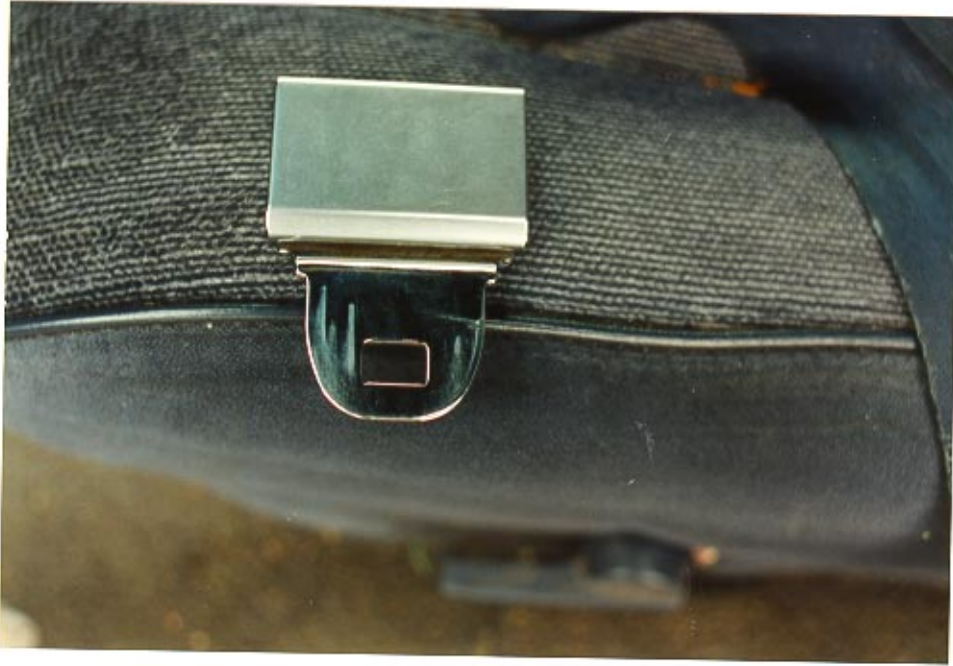
33. Routine usage wear marks on the male tab of the latchplate.

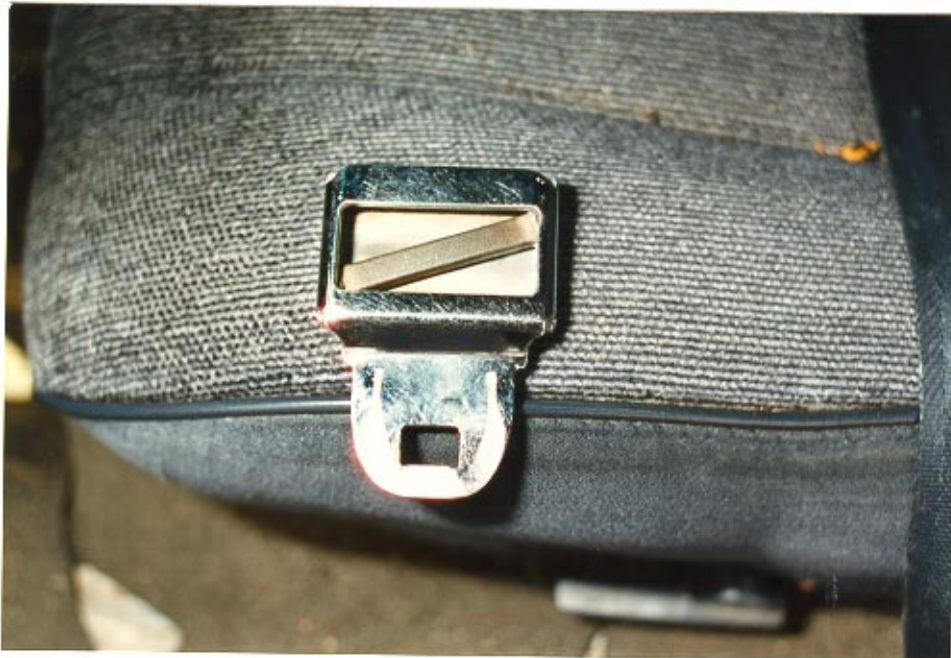
The latchplate was designed with an internal sliding cinch bar. The edges of the cinch bar which were in contact with the belt webbing appeared smooth with no evidence of sharp edges or burrs. There was no evidence of damage to the latchplate or the cinch bar mechanism. The male tab of the latchplate did contain heavy longitudinal wear marks which were attributed to routine (frequent) usage of the belt system. The latchplate was stamped with a Part No. of [REDACTED]

34. Sliding cinch bar in the latchplate.

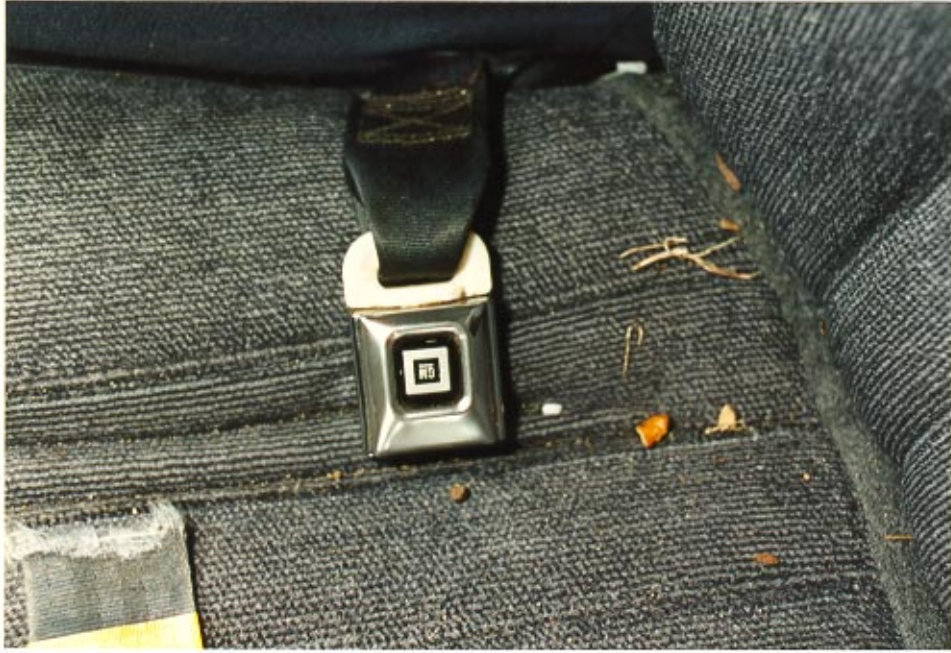
35. Undamaged buckle assembly from the driver's side belt system.

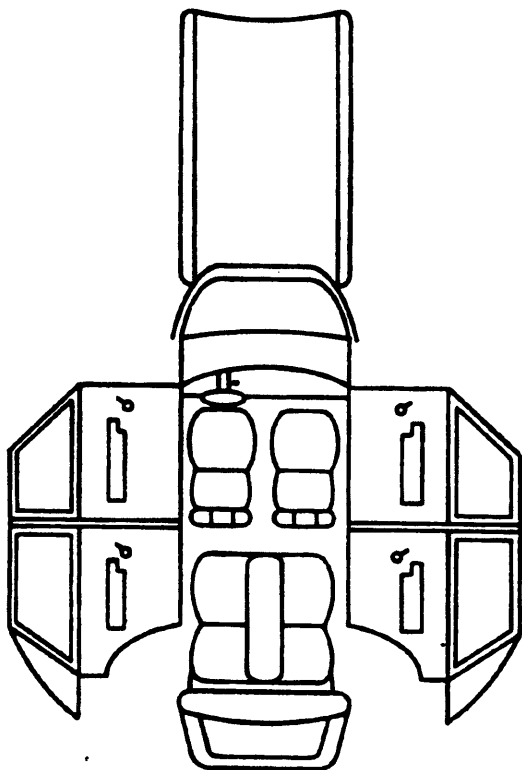
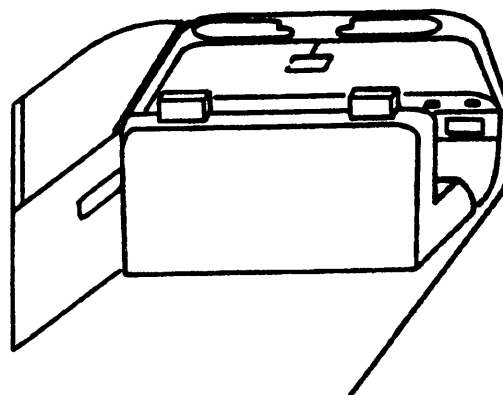
(E) BELT WEBBING TORN AT CINCH BAR OF LATCHPLATE

(A) THORACIC LOADING OF STEERING ASSEMBLY, UPPER RIM DEFORMATION, COLUMN COMPRESSION

(D) SPOT LIGHT HANDLE CRACKED AND DEFORMED

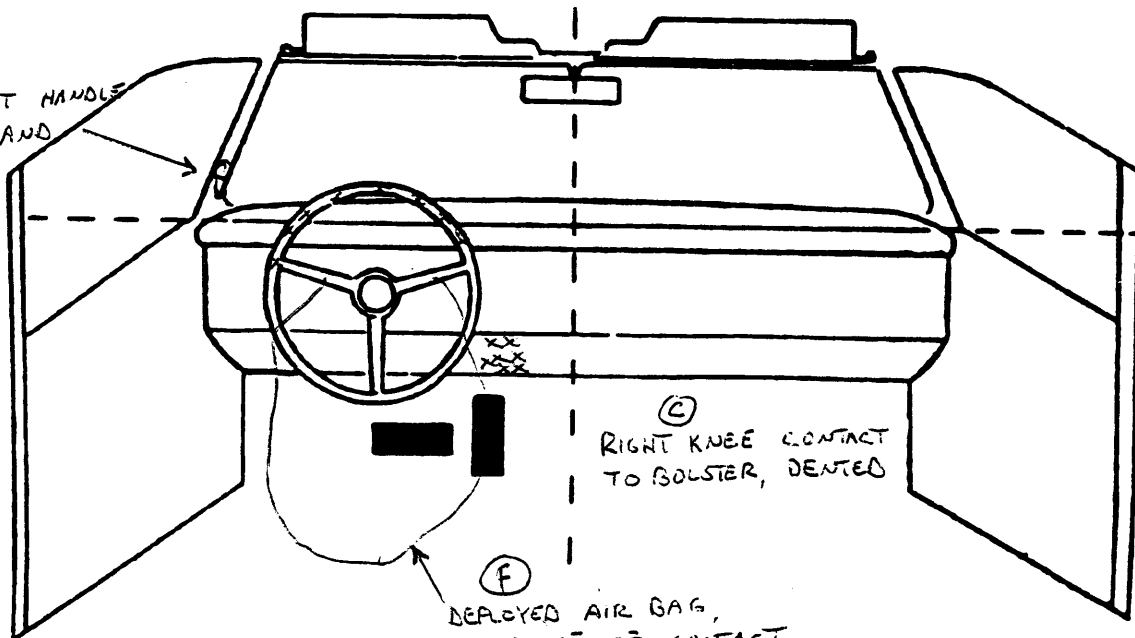
(C) RIGHT KNEE CONTACT TO BOLSTER, DENTED

(F) DEPLOYED AIR BAG, NO EVIDENCE OF CONTACT
