DYNAMIC SCIENCE, INC.
In-Depth Accident Investigation

Case Number: DSI-95-AB-011

TECHNICAL SUMMARY

This case was selected for investigation based on a report of a possible defect that caused the non-deployment of the supplemental restraint system (passenger's side air bag). The driver's side air bag did deploy from a front end impact with a deer.

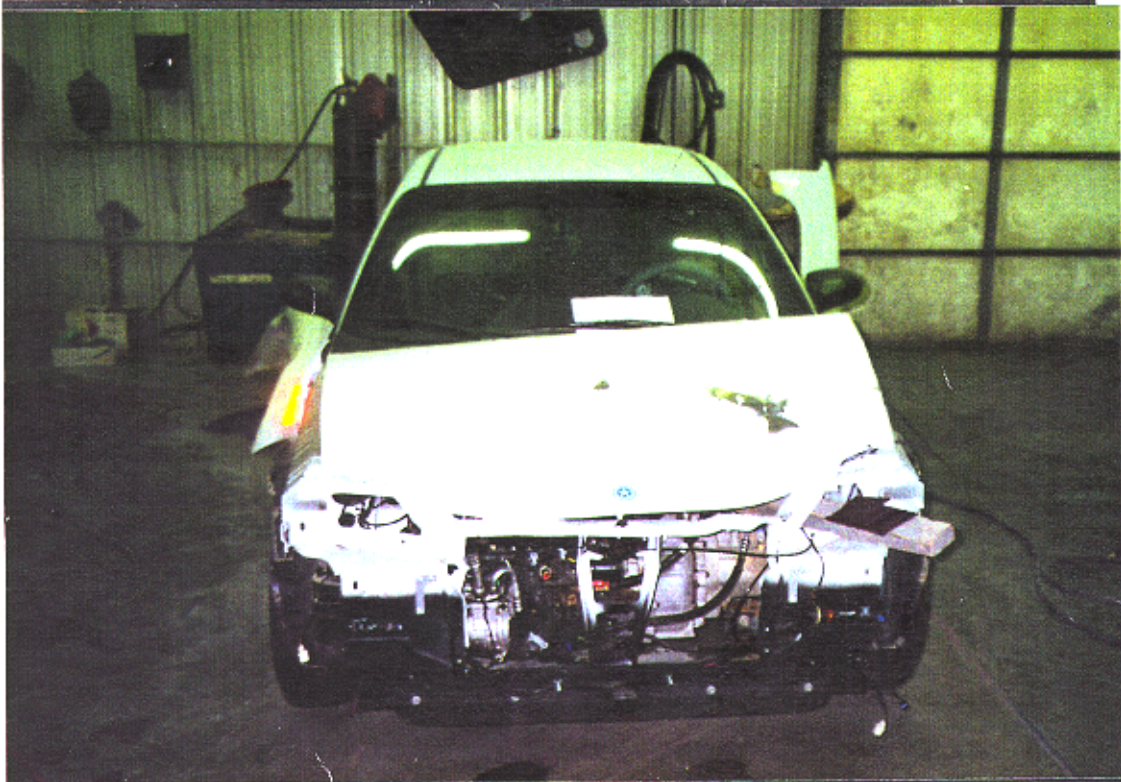
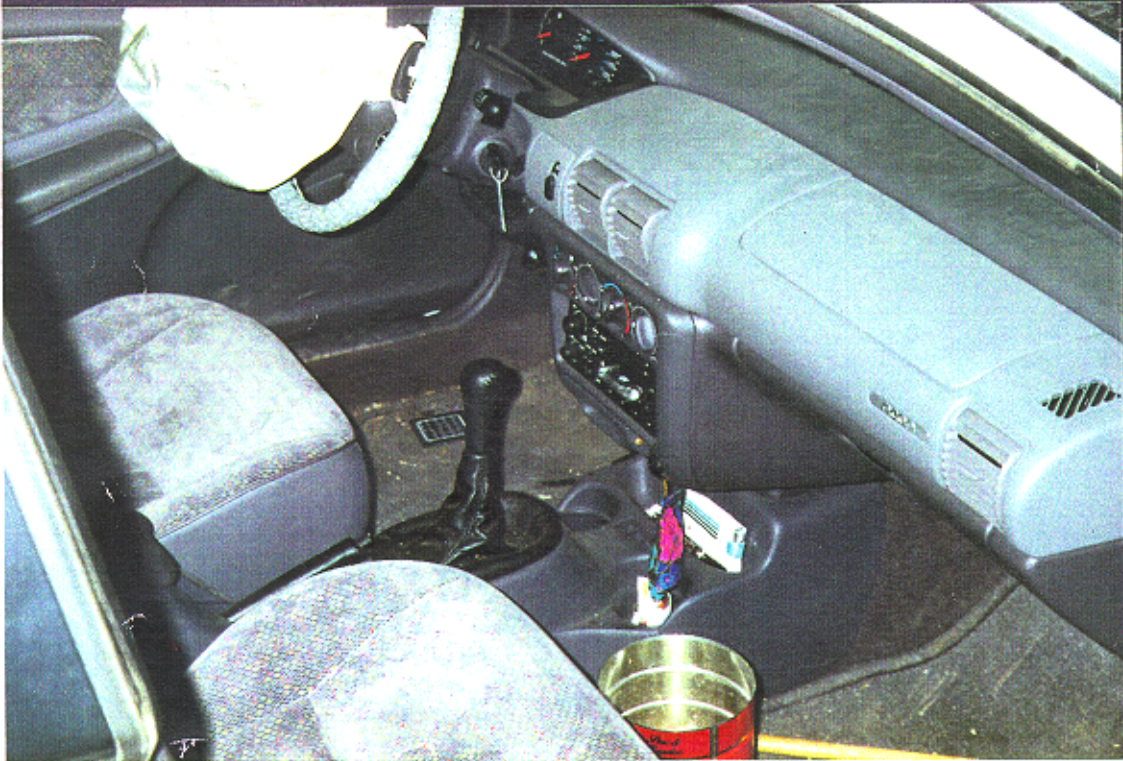
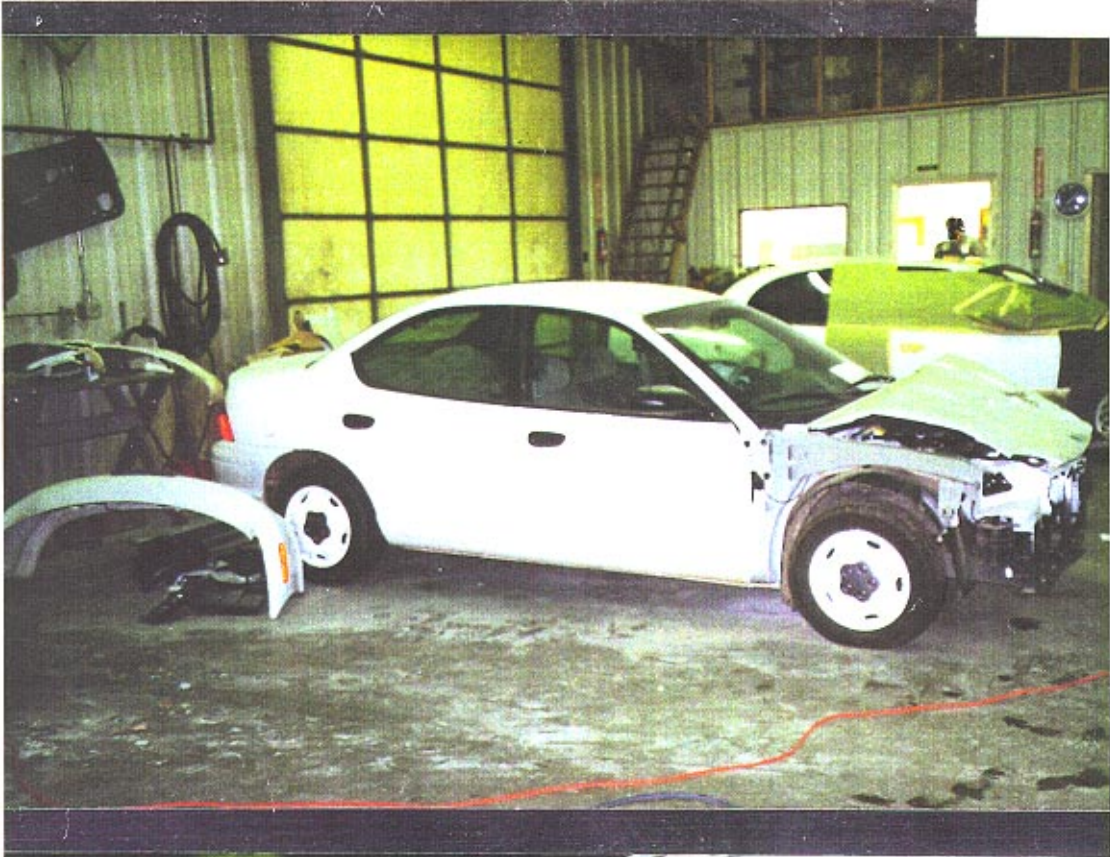
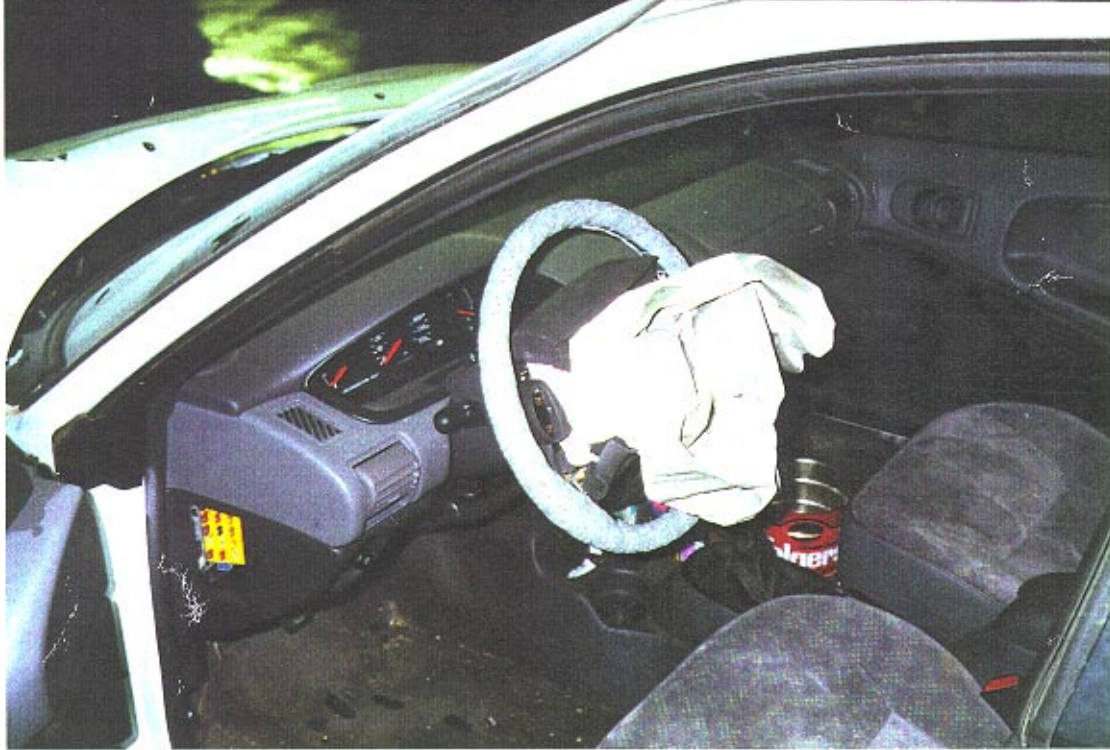
Vehicle 1's damage consisted of moderate frontal damage based on the photographs.

- 1) D.M. INSPECTED VEHICLE AT DEALERSHIP AND FOUND THAT VEHICLE HAD _____
SUSTAINED CONSIDERABLE FRONT END DAMAGE BY HITTING DEER.D.M. RETRIEVED
DRB CODES OF ACTIVE: DRIVER SQUIB CIRCUIT OPEN 1 OF 1 _____
- 2) _____ STORED: DRIVER SQUIB CIRCUIT OPEN _____
_____ 20 MINUTES _____
- 3) _____ IGN COUNTS 1 _____

P.M. INSPECTED VEHICLE ON [REDACTED] 95 FOR CUSTOMERS PRIMARY COMPLAINT OF DRIVER SIDE AIRBAG DEPLOYING AND PASSENGER SIDE NOT DEPLOYING. INSPECTION REVEALED THAT ONLY THE DRIVER SIDE AIRBAG HAD DEPLOYED. P.M. REPORTED FINDINGS VIA QUALITY REPORT TO [REDACTED]. THE [REDACTED] REQUESTED THAT 2 CRASH SENSORS, DIAGNOSTIC MODULE AND AIRBAG MODULE BE REMOVED AND SENT TO [REDACTED] FOR FURTHER TESTING TO DETERMINE CAUSE FOR PASSENGER AIRBAG NOT DEPLOYING.
