DYNAMIC SCIENCE, INC.
In-Depth Accident Investigation

Contract DTNH22-94-D-27058
Case DSI-95-AB-031

**DYNAMIC SCIENCE, INC.
ACCIDENT INVESTIGATION
CASE NUMBER: DSI-95-AB-031**

TECHNICAL SUMMARY

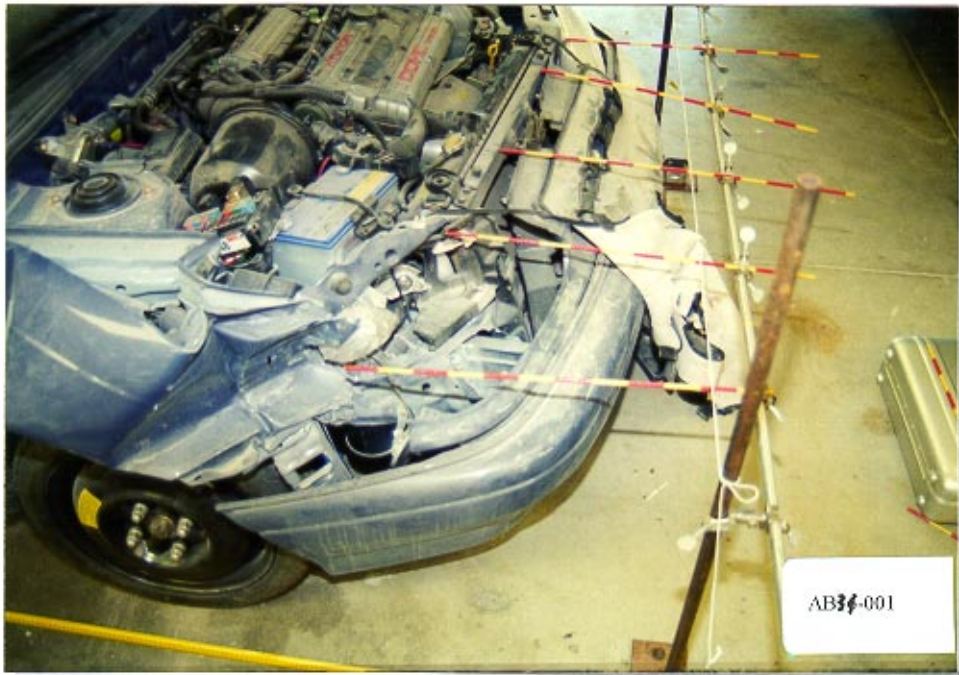
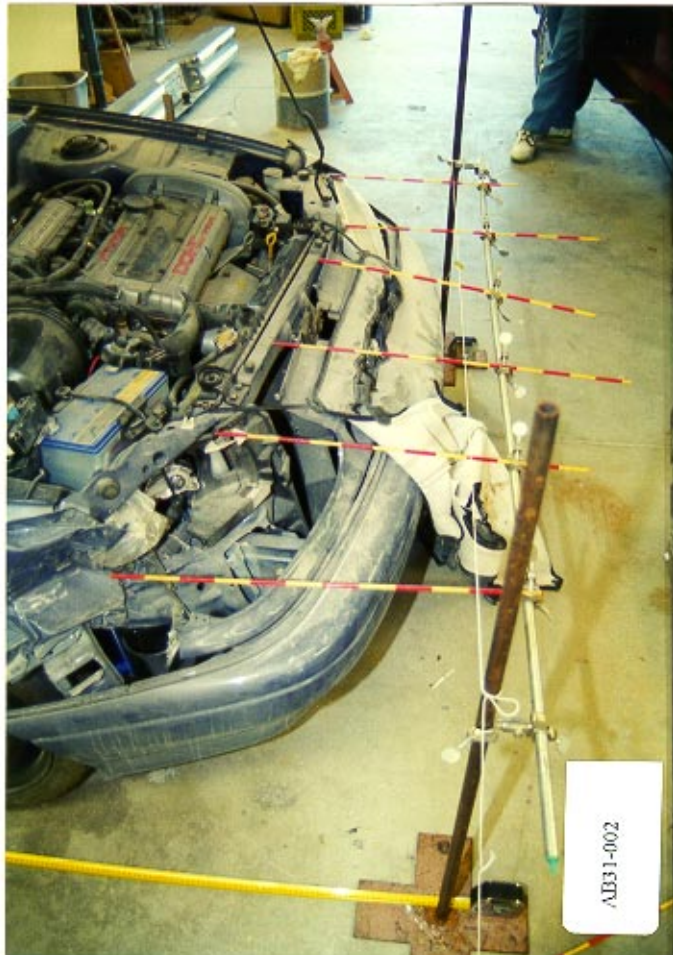
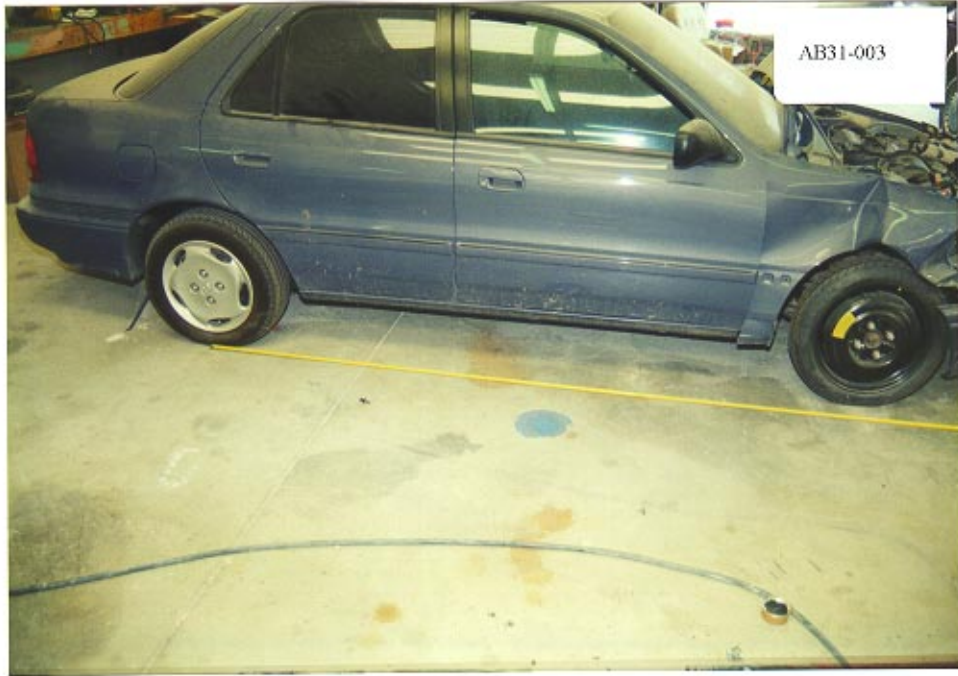
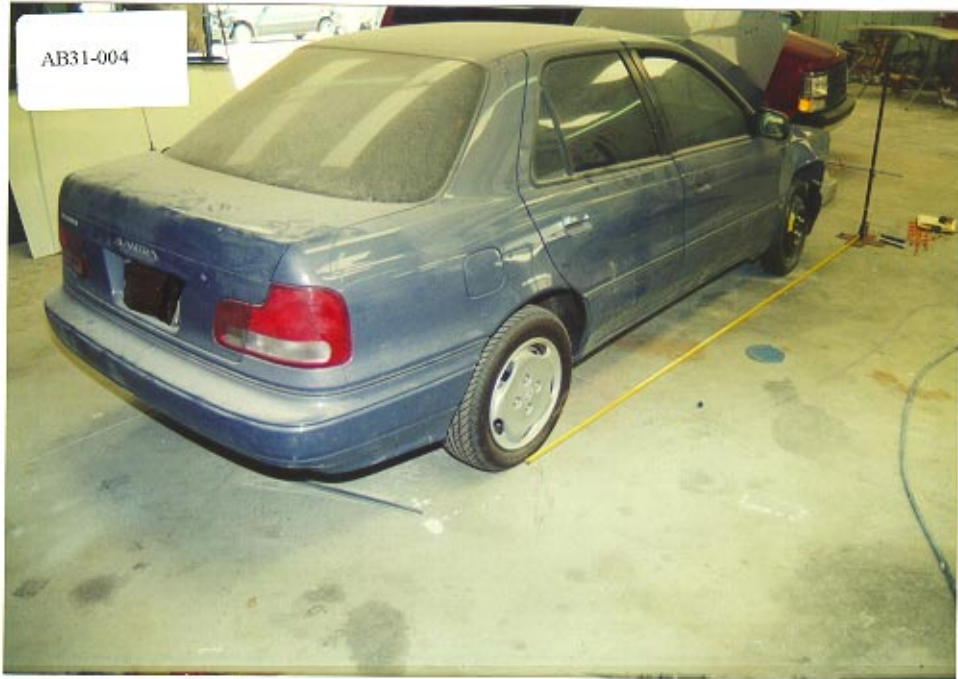
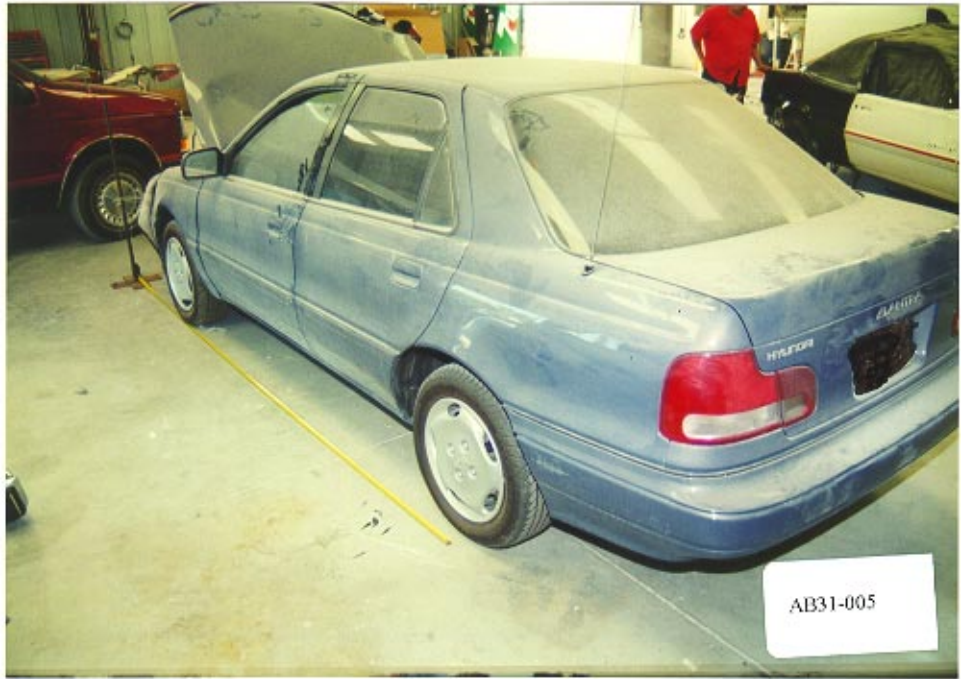
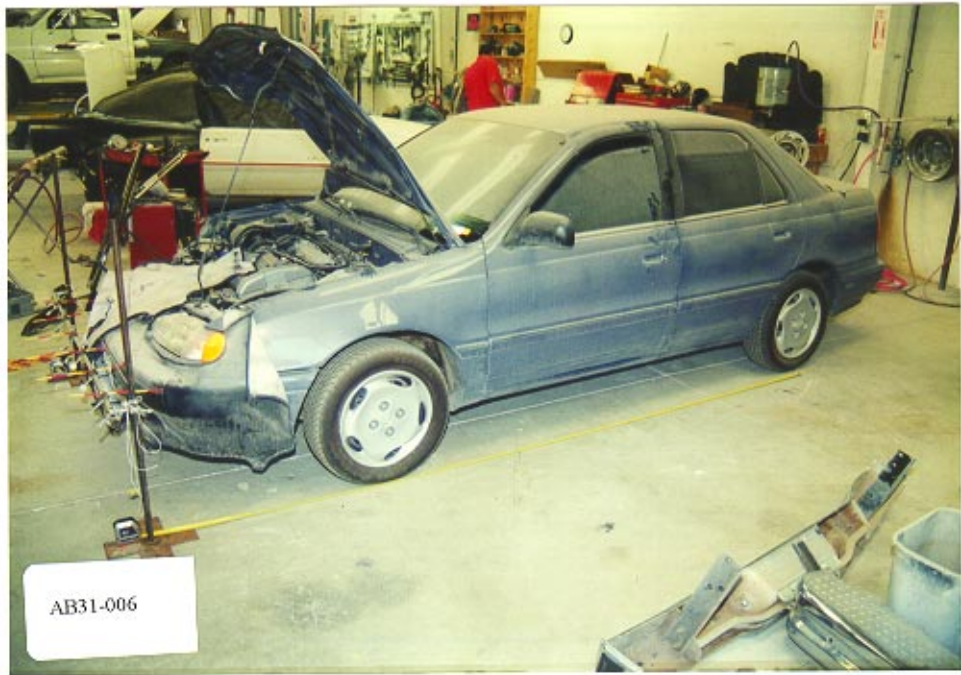
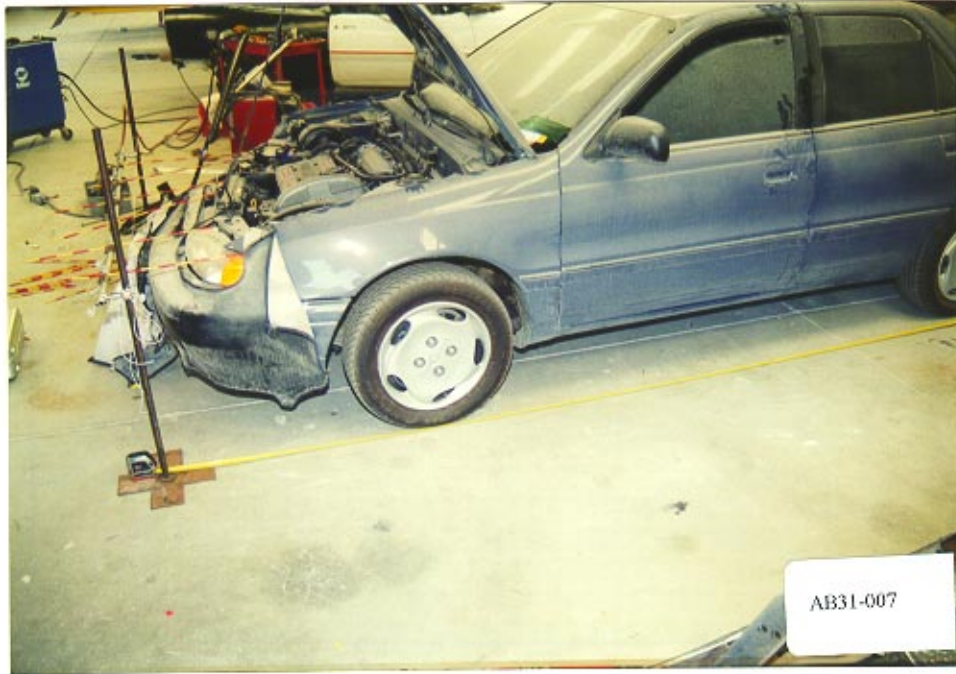
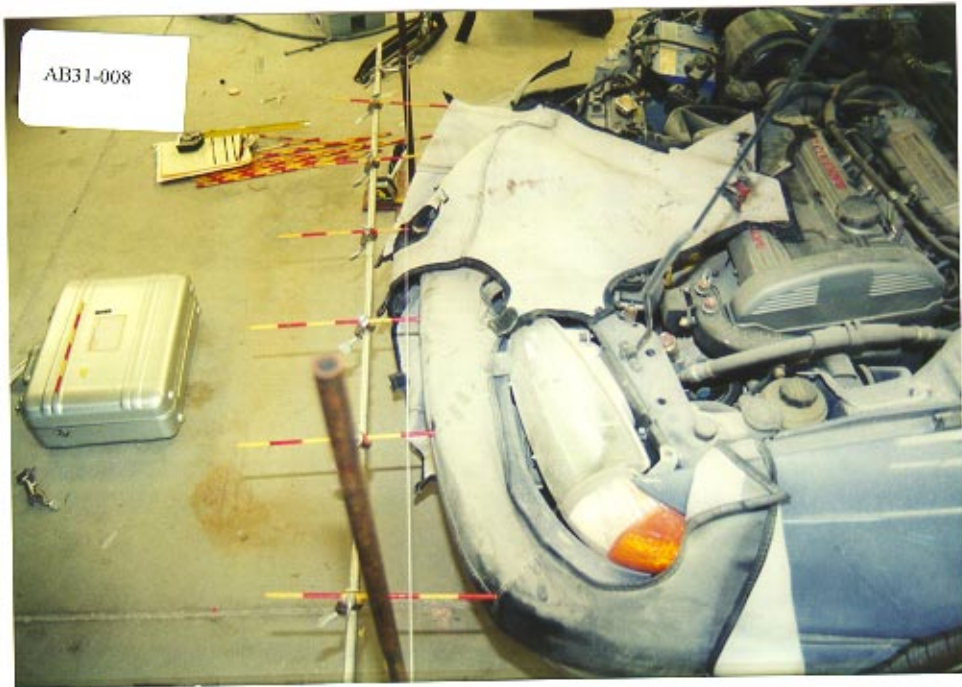
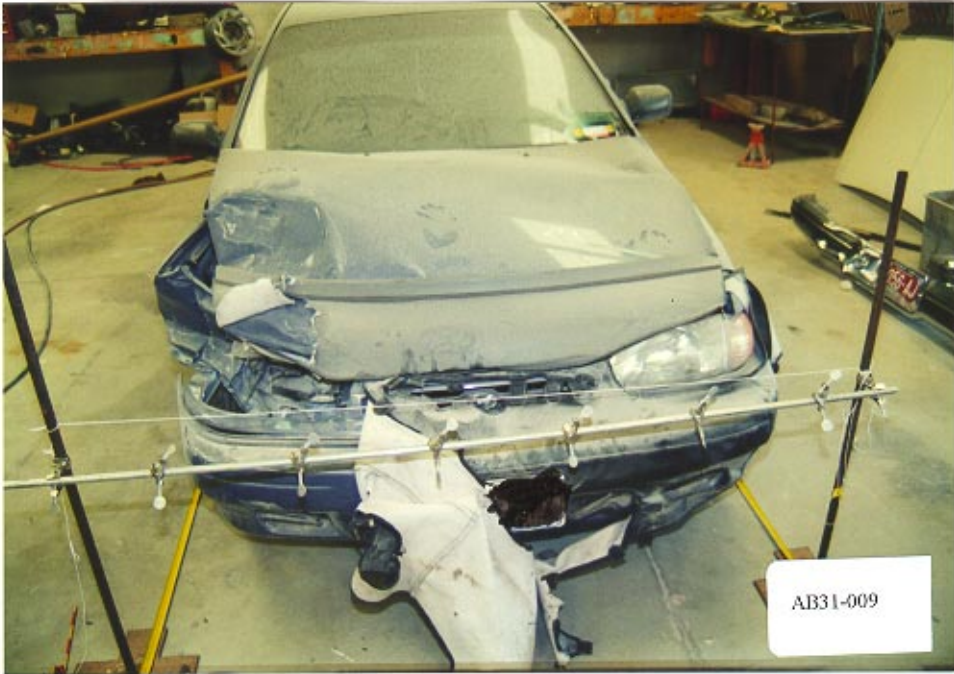
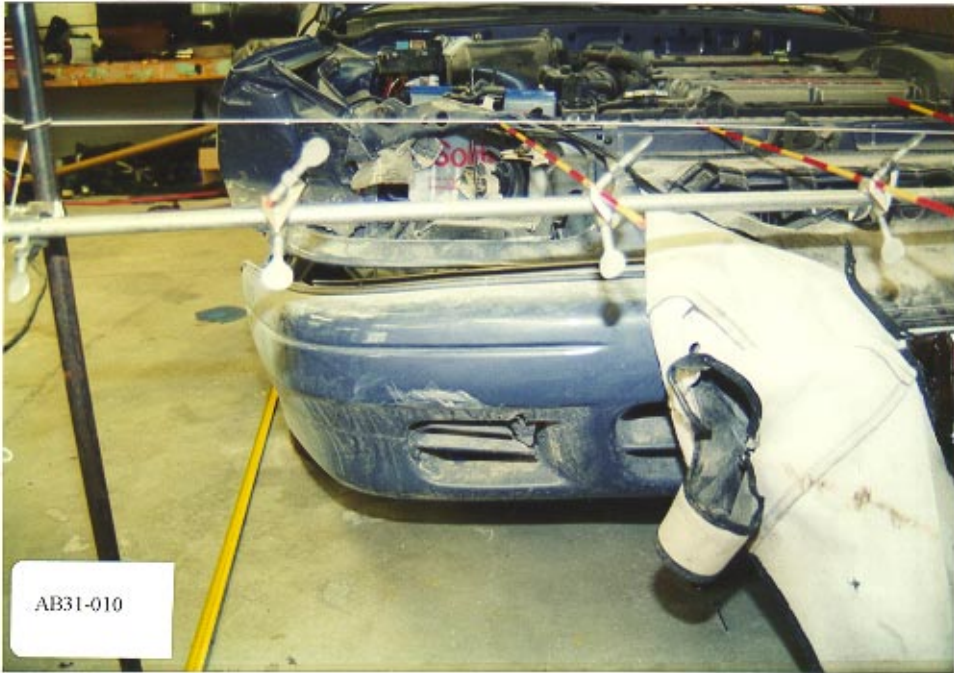
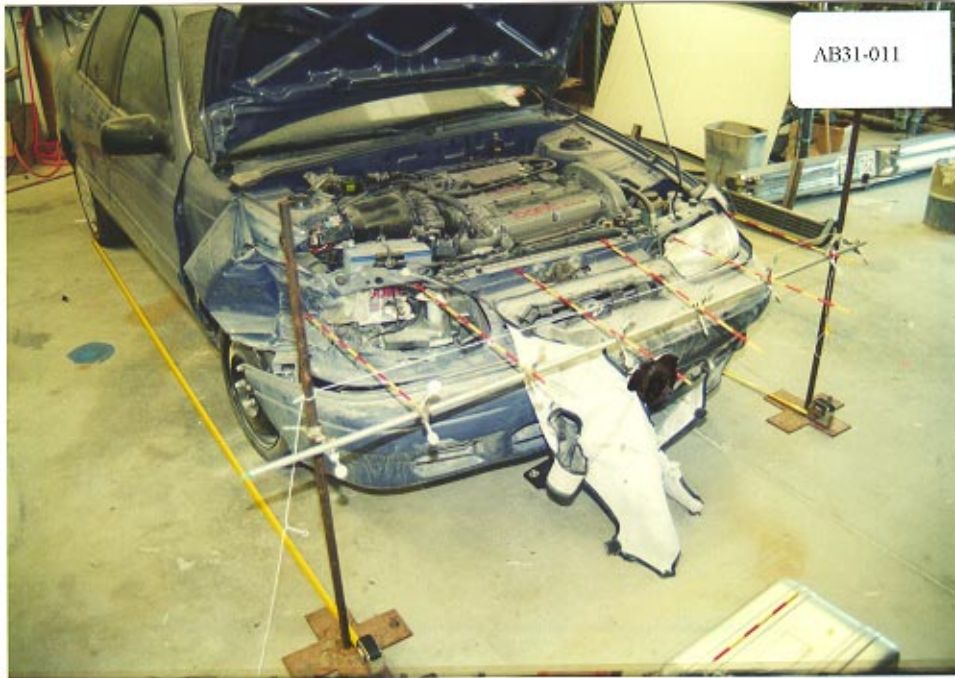
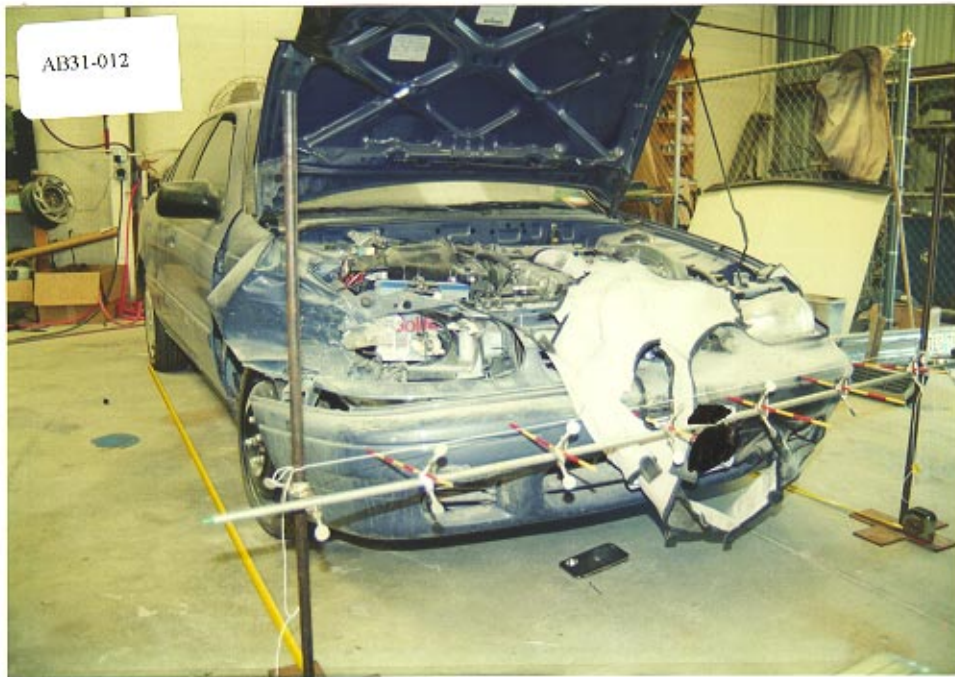
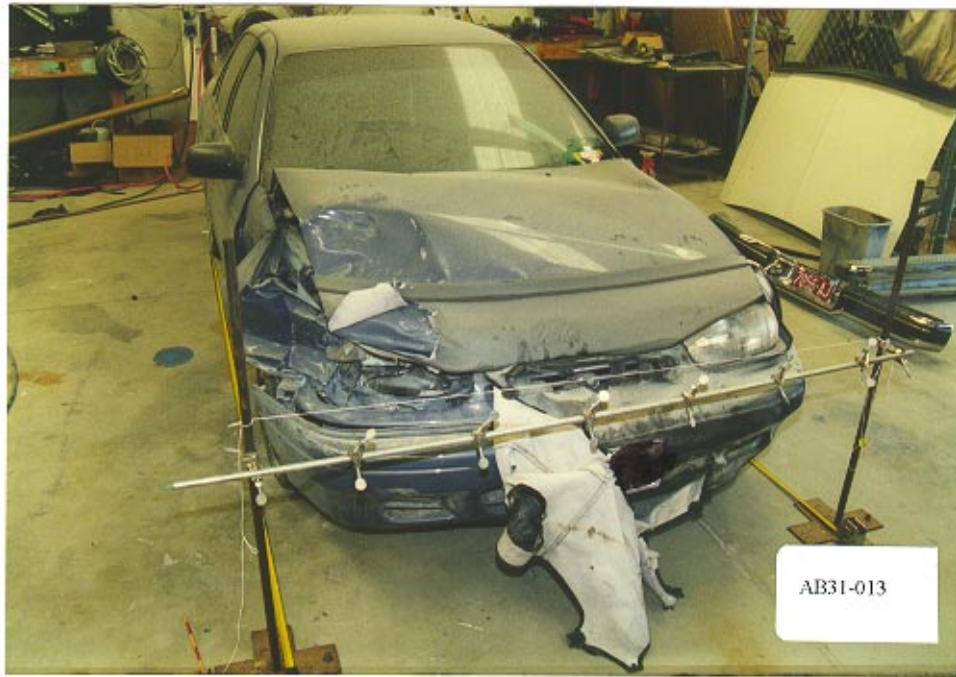
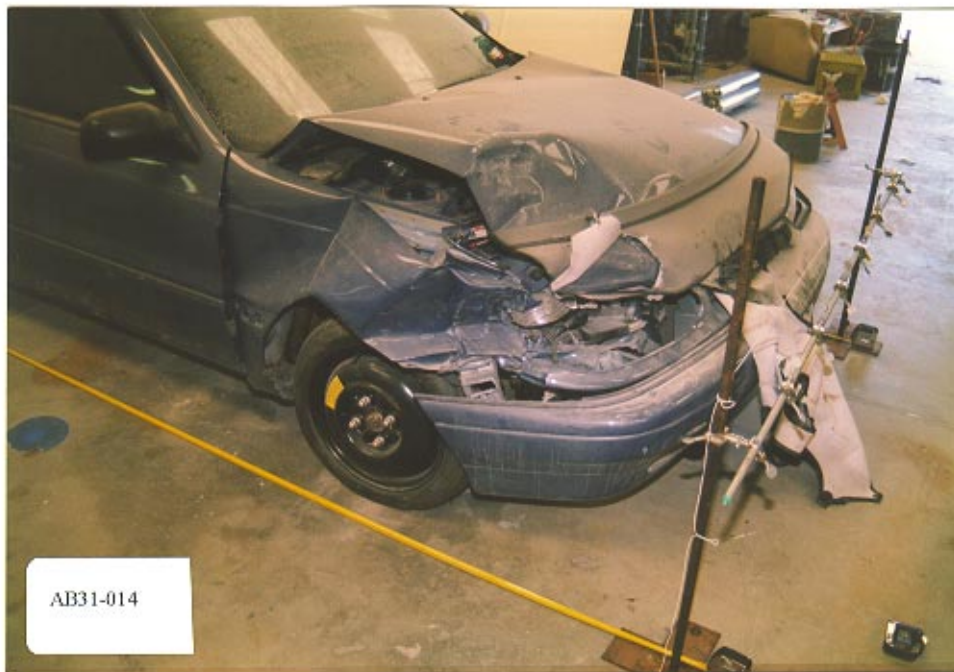
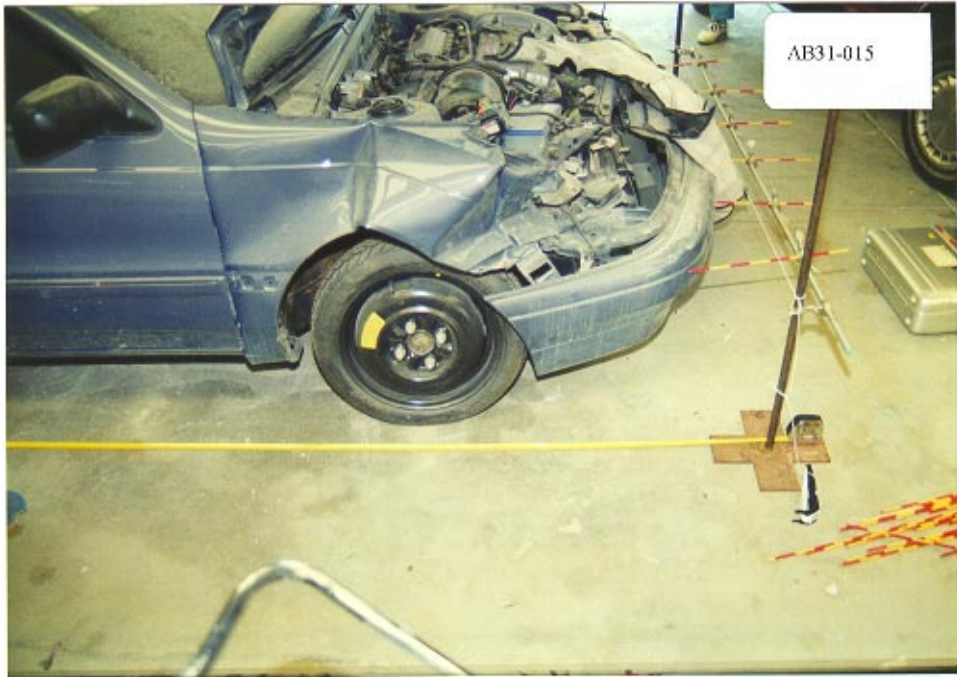
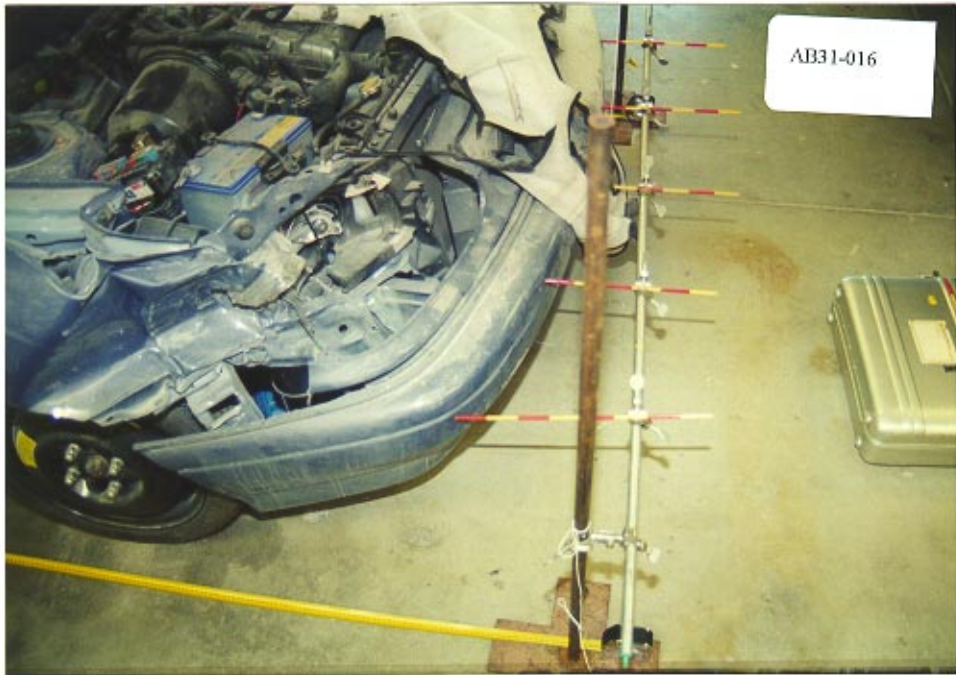
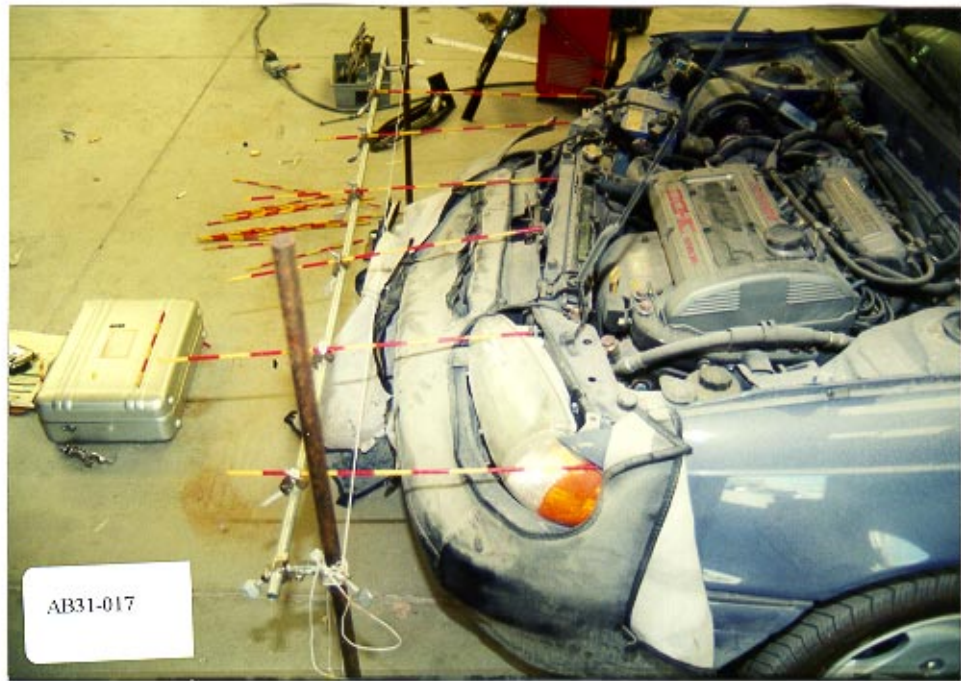
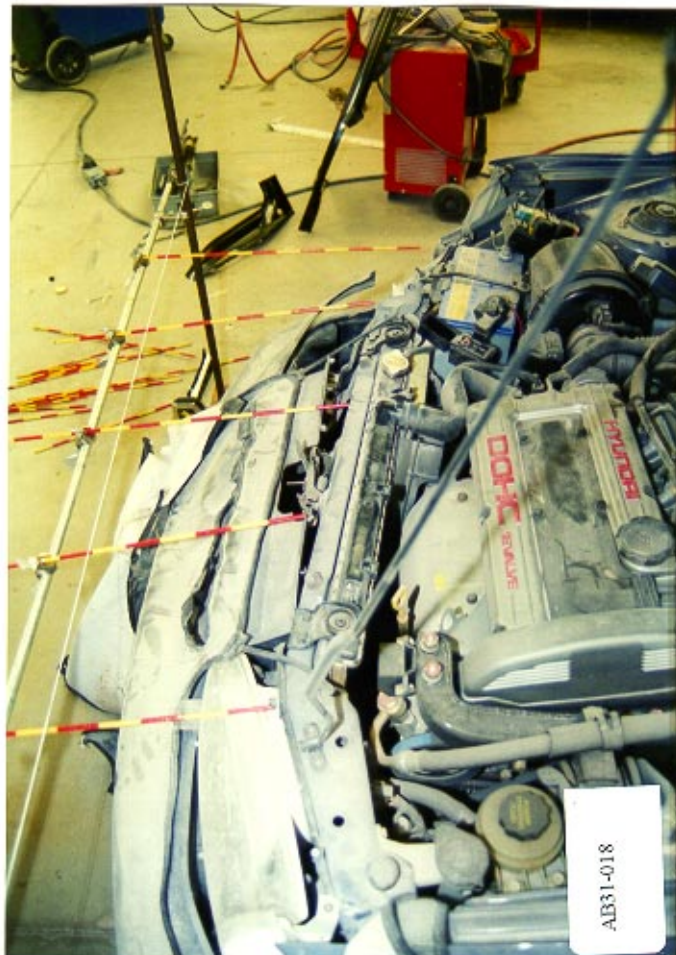
PHOTO NO.	VEHICLE NO.	DIRECTION OF PICTURE	SUBJECT MATTER
1-18	1	CW	Exterior views of Vehicle 1.
19-26	1	NA	Interior views of Vehicle 1.

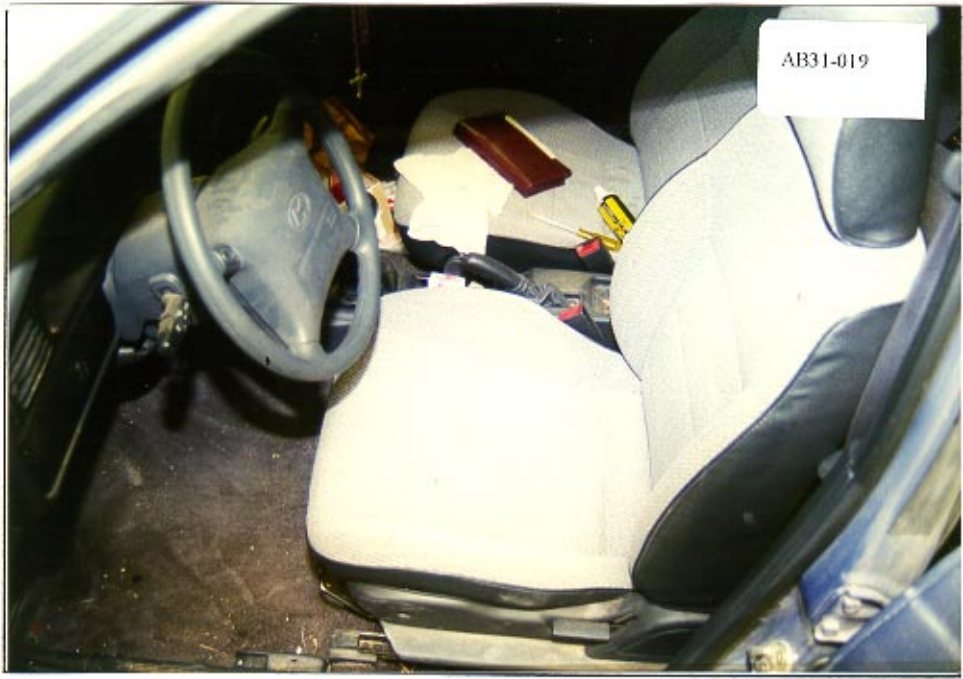
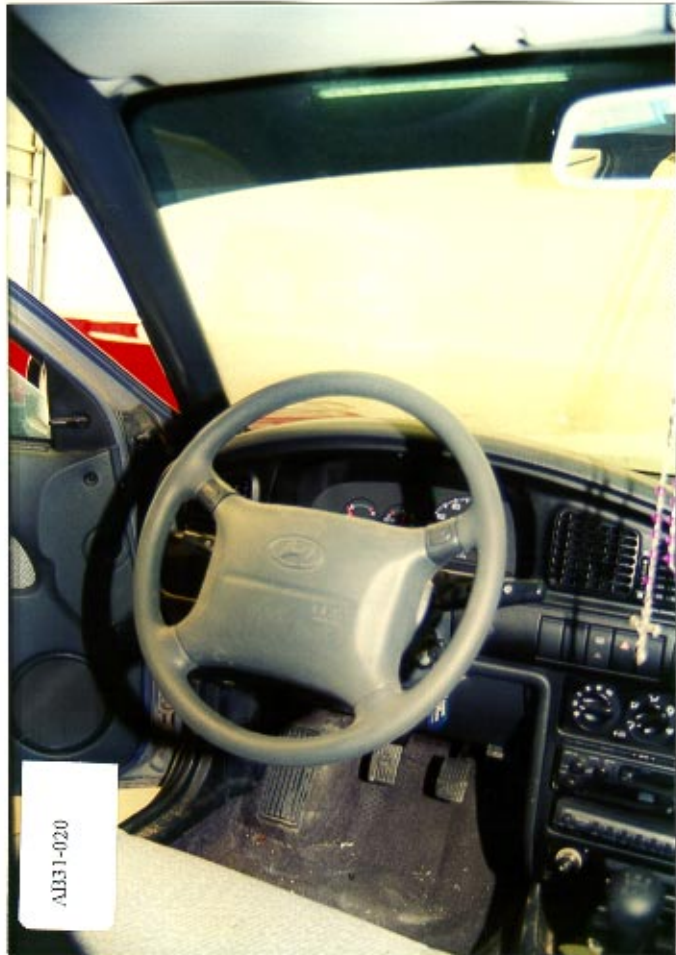
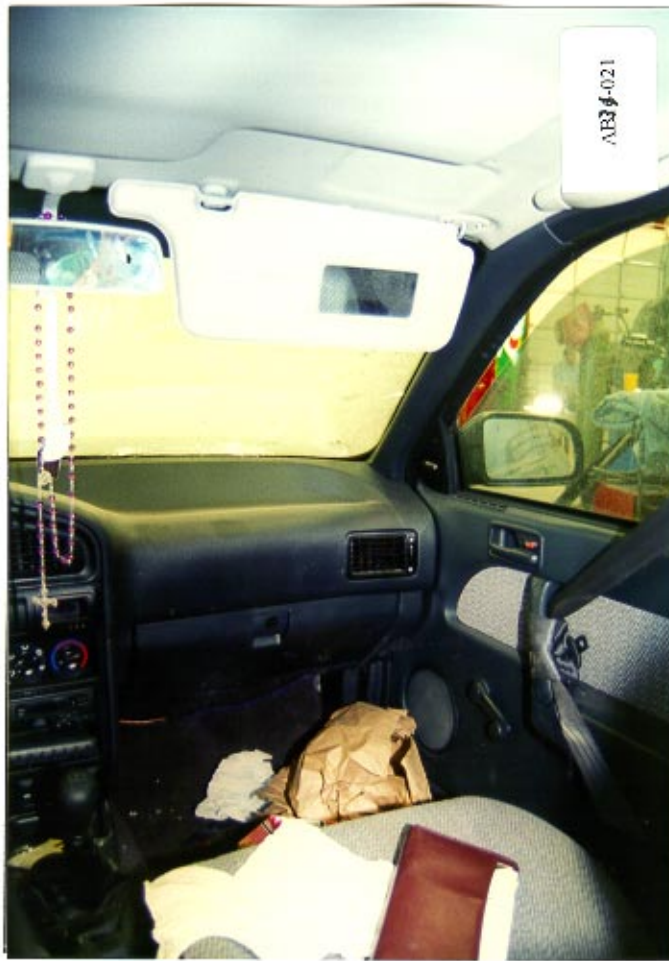
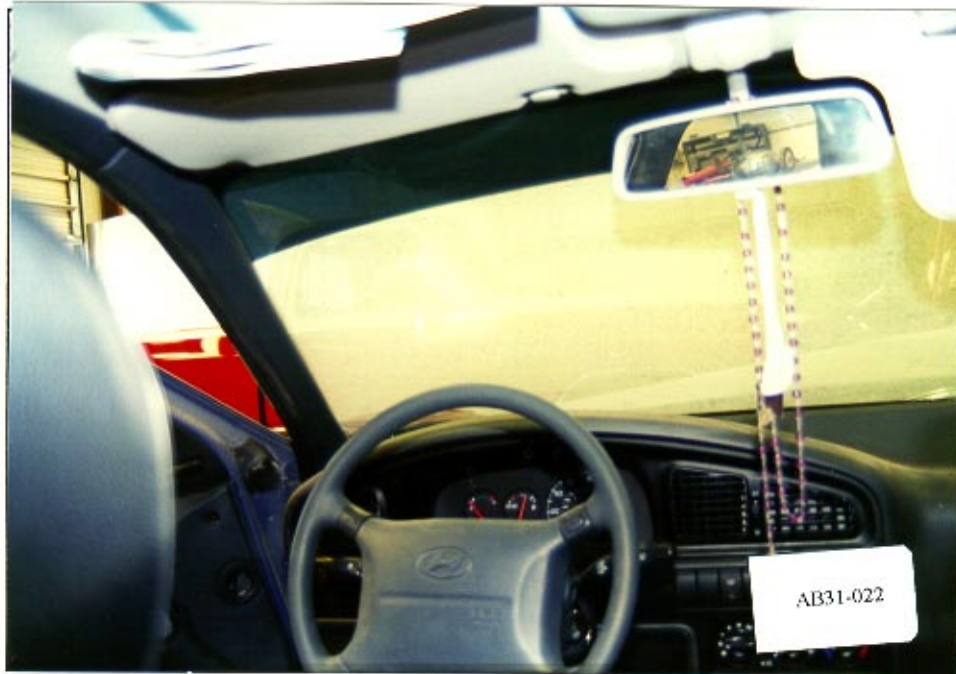
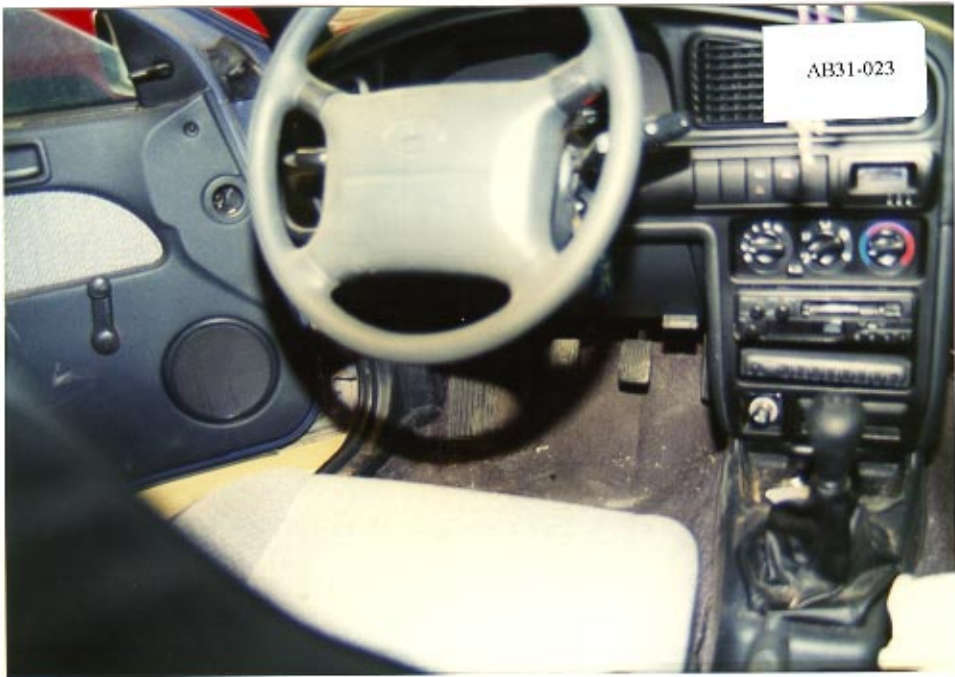
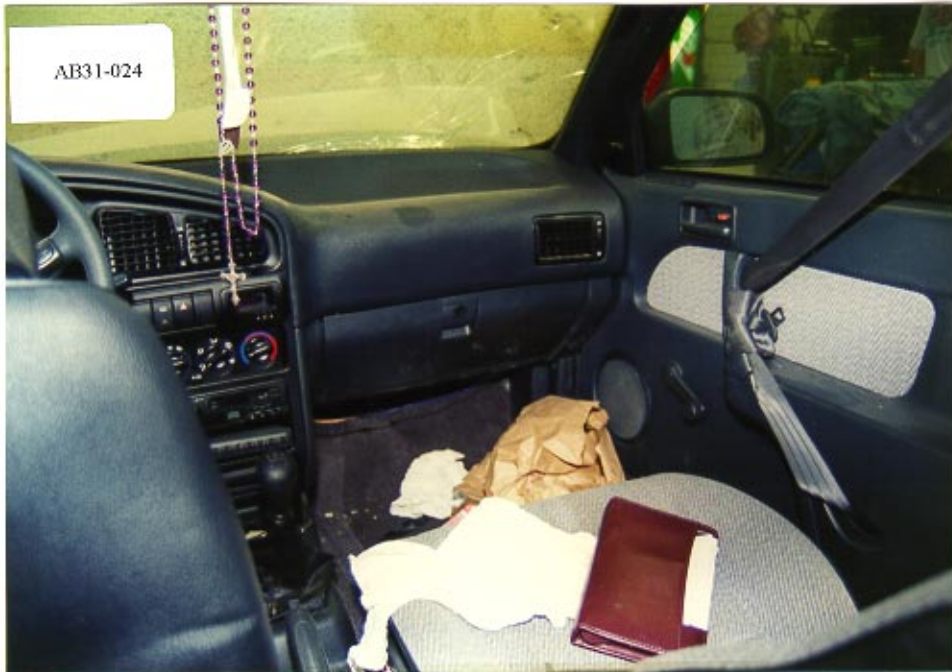
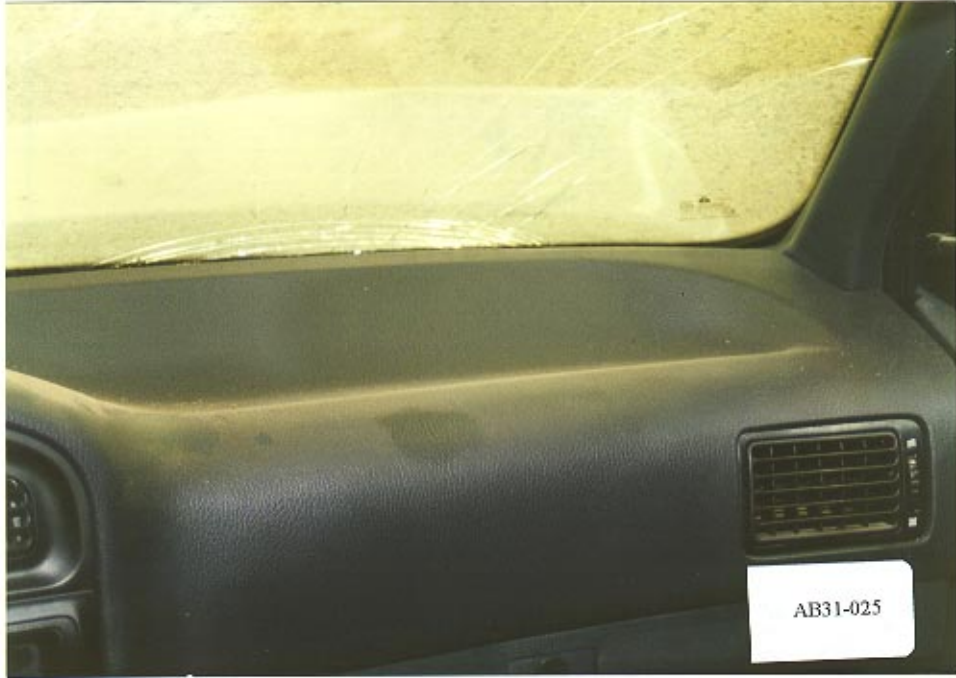
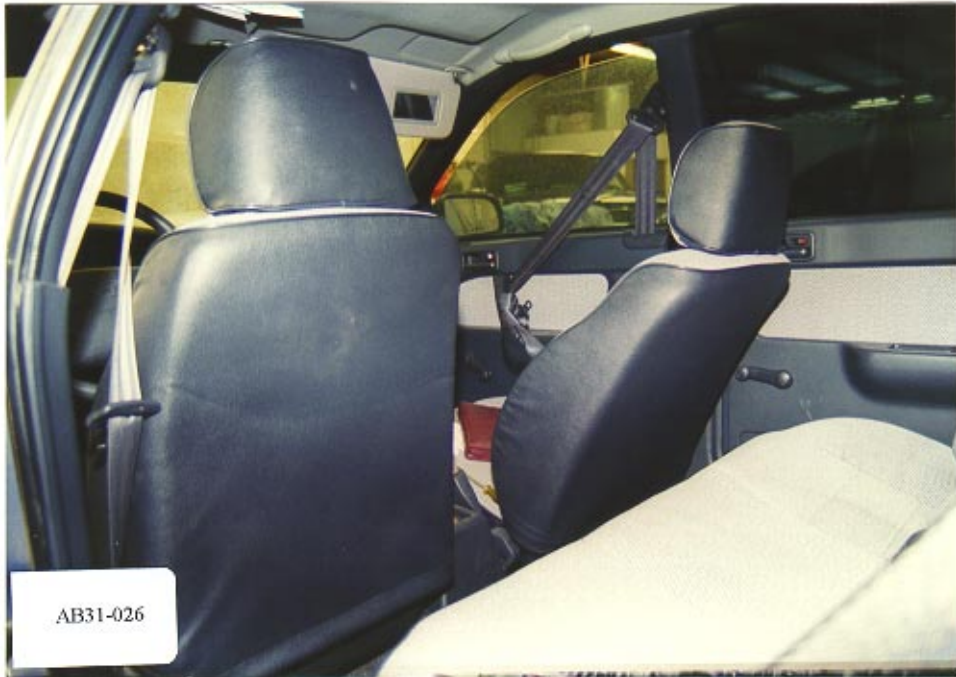
Vehicle 1 was equipped with a supplemental restraint system (driver's air bag) that did not deploy during this collision. The restraint system self test was initiated by engaging the ignition. A total of four flashes were counted prior to the light going off. According to Hyundai service personnel, this is the normal operating mode.

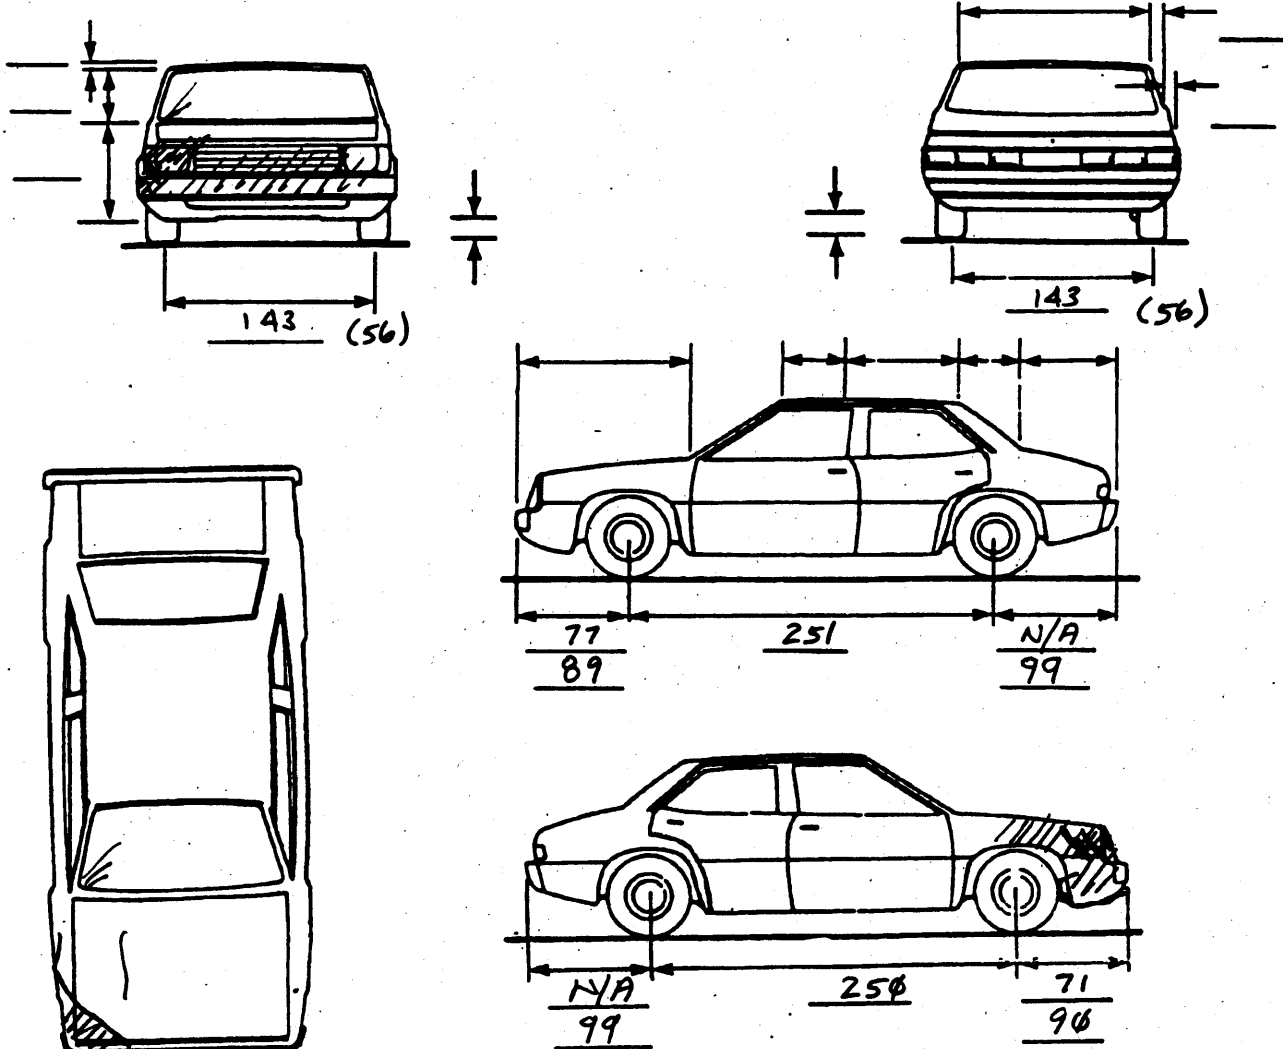
VEHICLE DAMAGE SKETCH

Specific Impact No.	Location of Direct Damage	Location of Field L	Location of Max Crush
1	@ RF BUMPER CORNER →		C-6

Specific Impact Number	Plane of Impact C-Measurements	Direct Damage		Field L	C ₁	C ₂	C ₃	C ₄	C ₅	C ₆	±D
		Width (CDC)	Max Crush								
1	BUMPER	11.φ	8.46	54.3	4.12	1.77	.98	1.97	3.9	8.46	+23.φ
			-4.9		-4.9	-.78	0	0	-.78	-4.9	
			3.56		φ	.99	.98	1.97	3.12	3.56	AVERAGE
1	ABOVE BUMPER (UPPER RADIATOR SUPPORT)		21.6		13.77	10.6	12.2	13.9	16.5	21.6	
			-13.77		-13.77	-10.6	-12.2	-12.2	-10.6	-13.77	
			7.83		φ	φ	φ	1.7	5.9	7.83	
1	FINAL	11.φ		54.3	φ	.99	.98	1.97	3.12	5.69	+23.φ
1	FINAL	28		138	φ	3	2	5	8	14	+5B
