Report No. 217-NVS-04-05

FMVSS No. 217
"BUS EMERGENCY EXITS AND WINDOW RETENTION AND RELEASE"

Compliance Test Report for a 2004 NABI, 61 Passenger Transit Bus NHTSA No. C40804

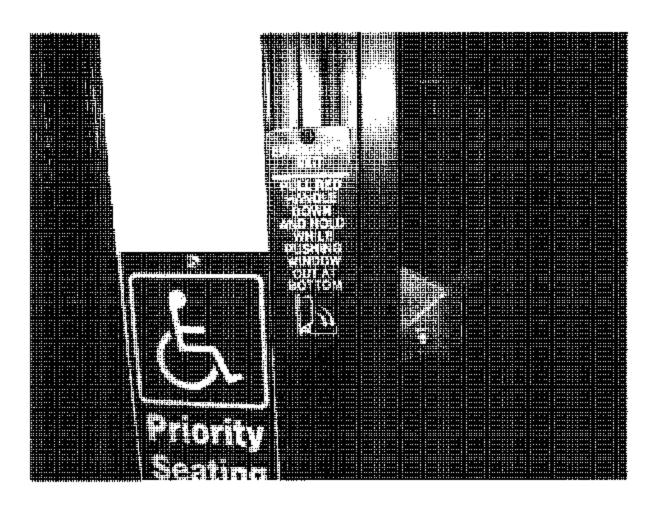
- Each emergency exit has a permanently affixed, legible label or placard with the designation "Emergency Door" or "Emergency Exit."

PASS
- Each emergency exit has a permanently affixed, legible label or placard describing the motion necessary to release (unlatch) and open the exit.

PASS
- 3. The label is within 16 cm of the nearest release mechanism. PASS

Photo 3 - Emergency Exit Label and Release Mechanism

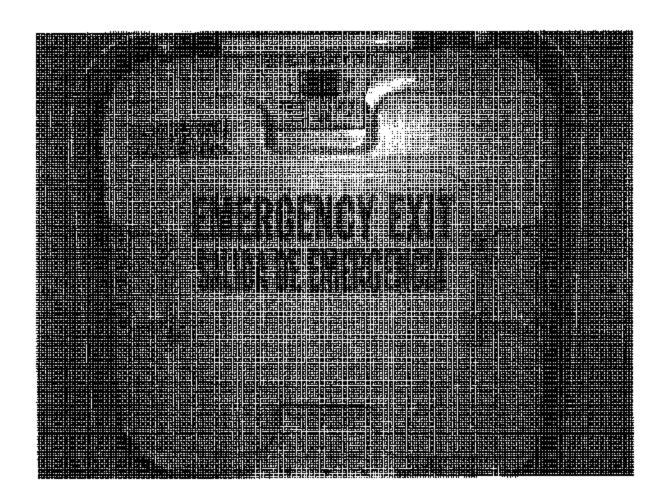
The bus has a rear roof exit and the configuration of the bus appears to preclude the installation of an accessible rear exit.

Photo 4 - Roof Emergency Exit

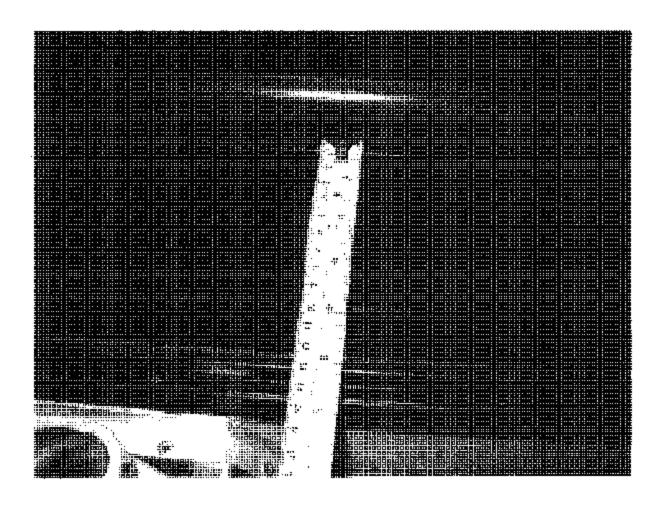
| Section | Description | Pass/Fall | Reason |
|---|---|---|---|
| S5.4 | Emergency Exit Opening | Fail | Ellipsoid cannot pass through Emergency Exit Window 1. |

Exit 1 cannot be extended to permit passage of the ellipsold. Interference from the passenger information sign at the top of the window prevents the window from extending.

Photo 6 - Emergency Exit 1, Pully Extended (Bottom of Window)

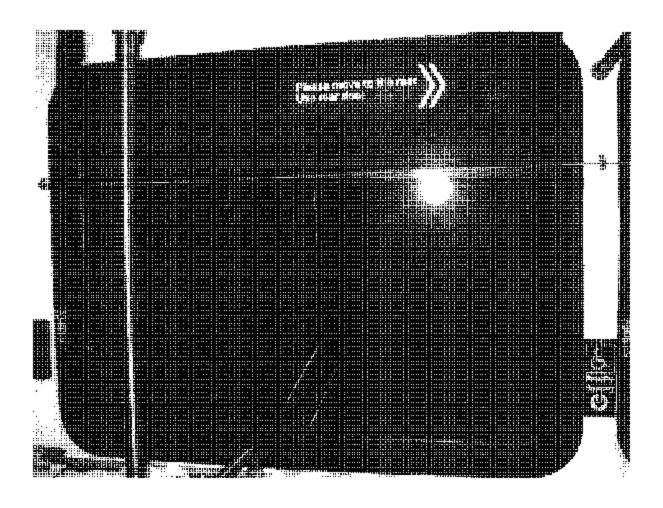
Photo 7 - Emergency Exit 1, Showing Passenger Information Sign Location
