REPORT NUMBER: 301-CAL-08-07

**SAFETY COMPLIANCE TESTING FOR FMVSS 301
FUEL SYSTEM INTEGRITY – REAR IMPACT**

HONDA OF AMERICA MFG.
2008 ACURA RDX
4-DOOR SUV

NHTSA NUMBER: C85300

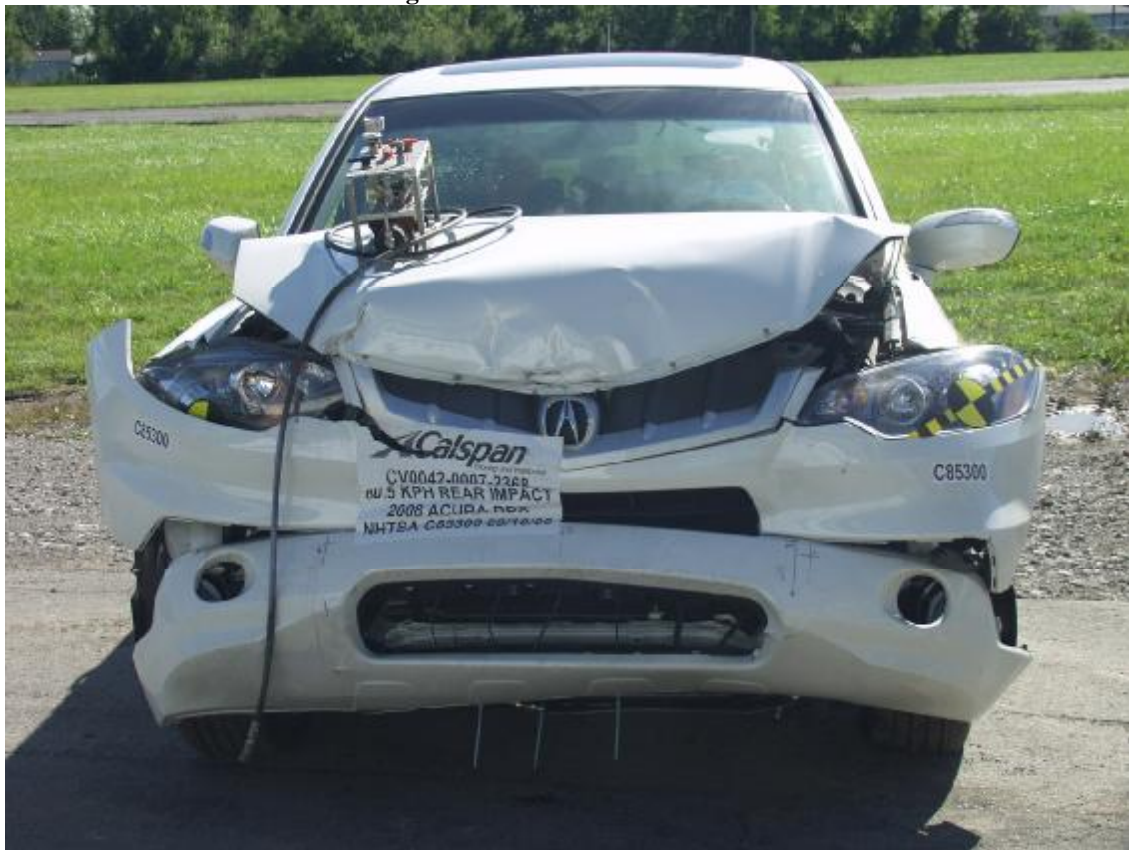
Figure A-4: Post-Test Front View

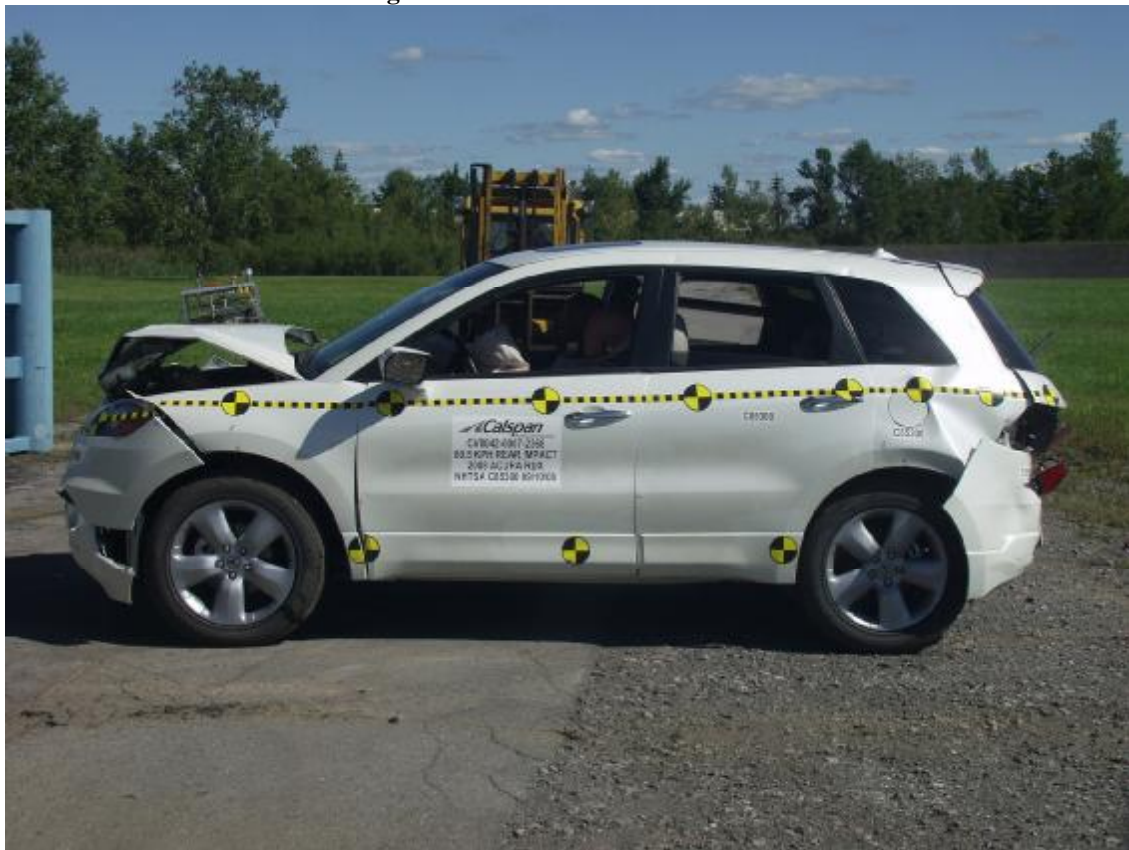
Figure A-6: Post-Test Left Side View

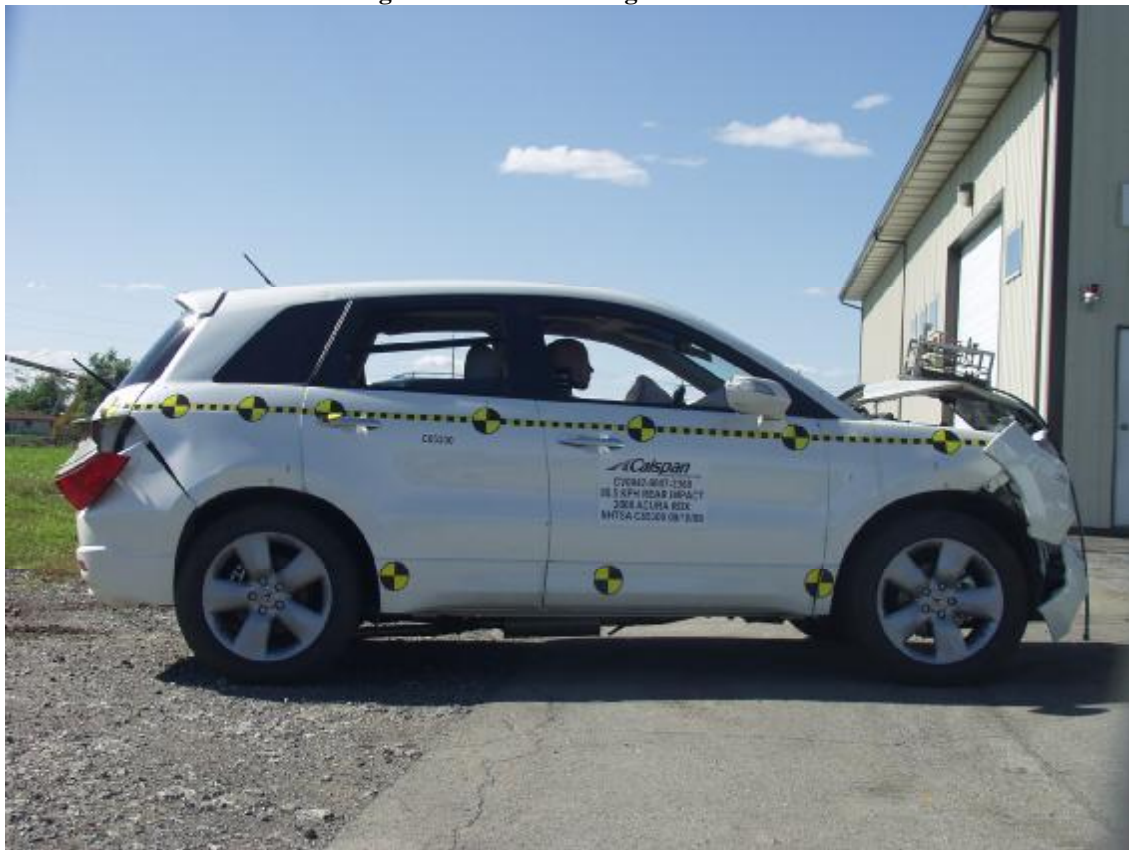
Figure A-8: Post-Test Right Side View

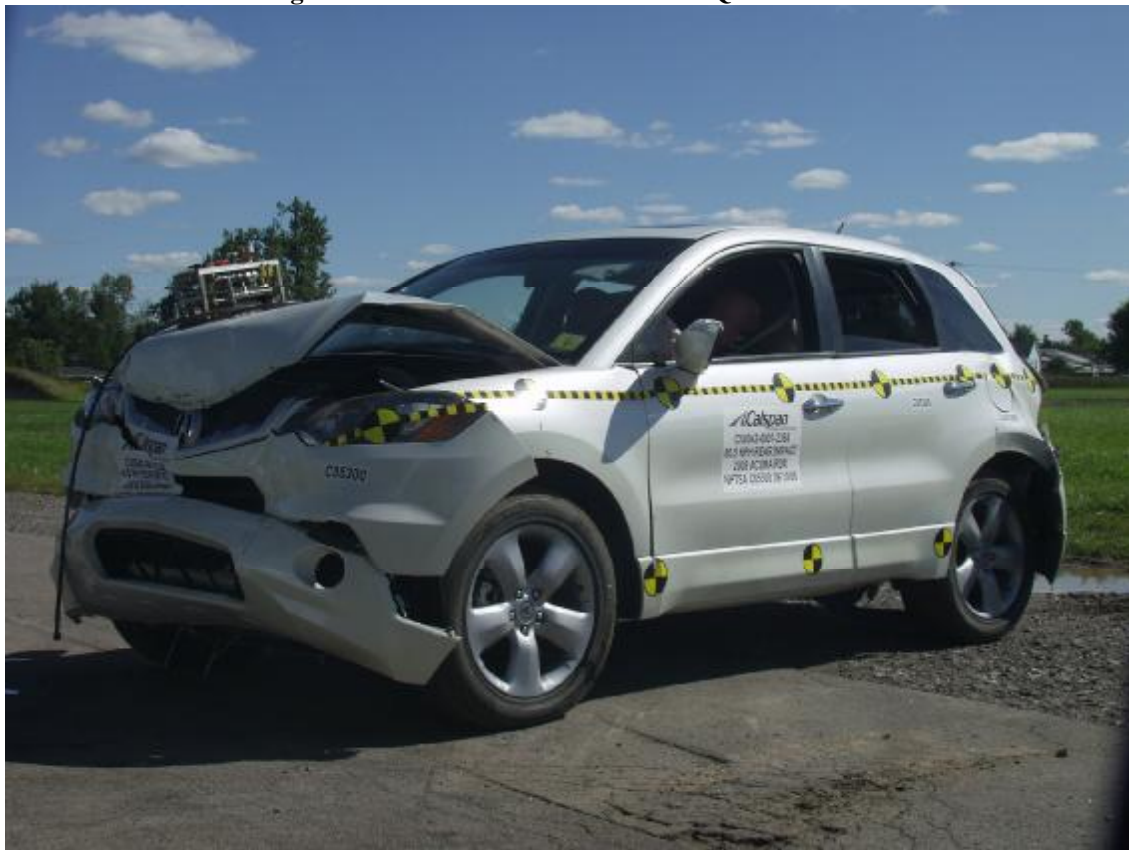
Figure A-10: Post-Test Left Front Three-Quarter View

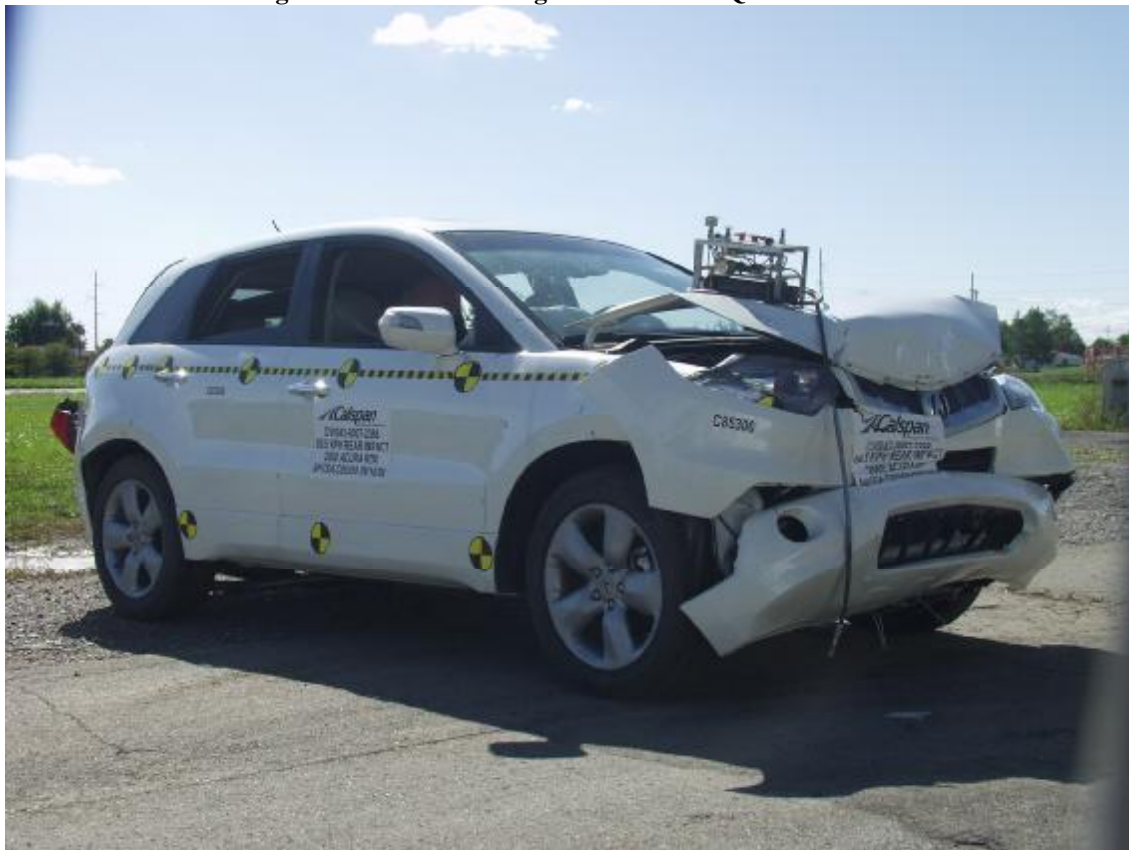
Figure A-12: Post-Test Right Front Three-Quarter View

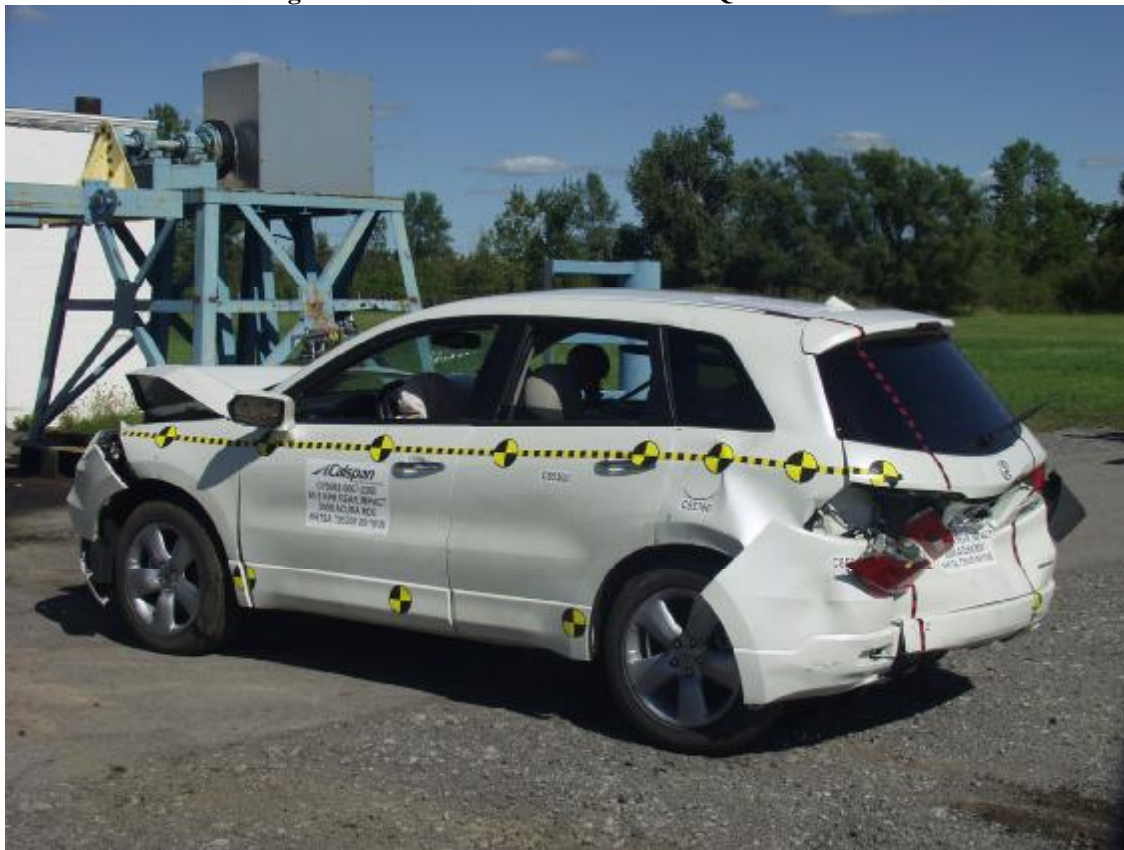
Figure A-14: Post-Test Left Rear Three-Quarter View

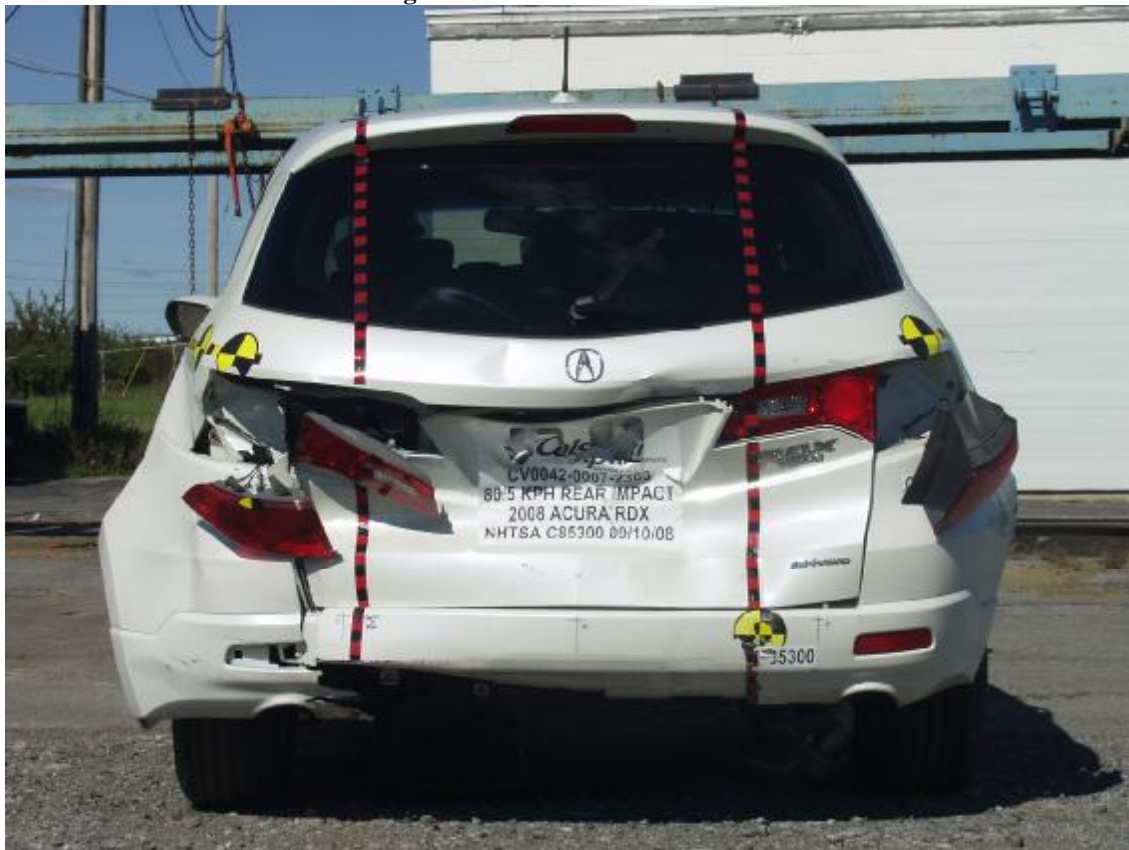
Left Side	Centerline	Right Side
Pre-Test	4453	4594	4454
Post-Test	4069	4176	4143
Crush	384	418	311

Figure A-18: Post-Test Rear View

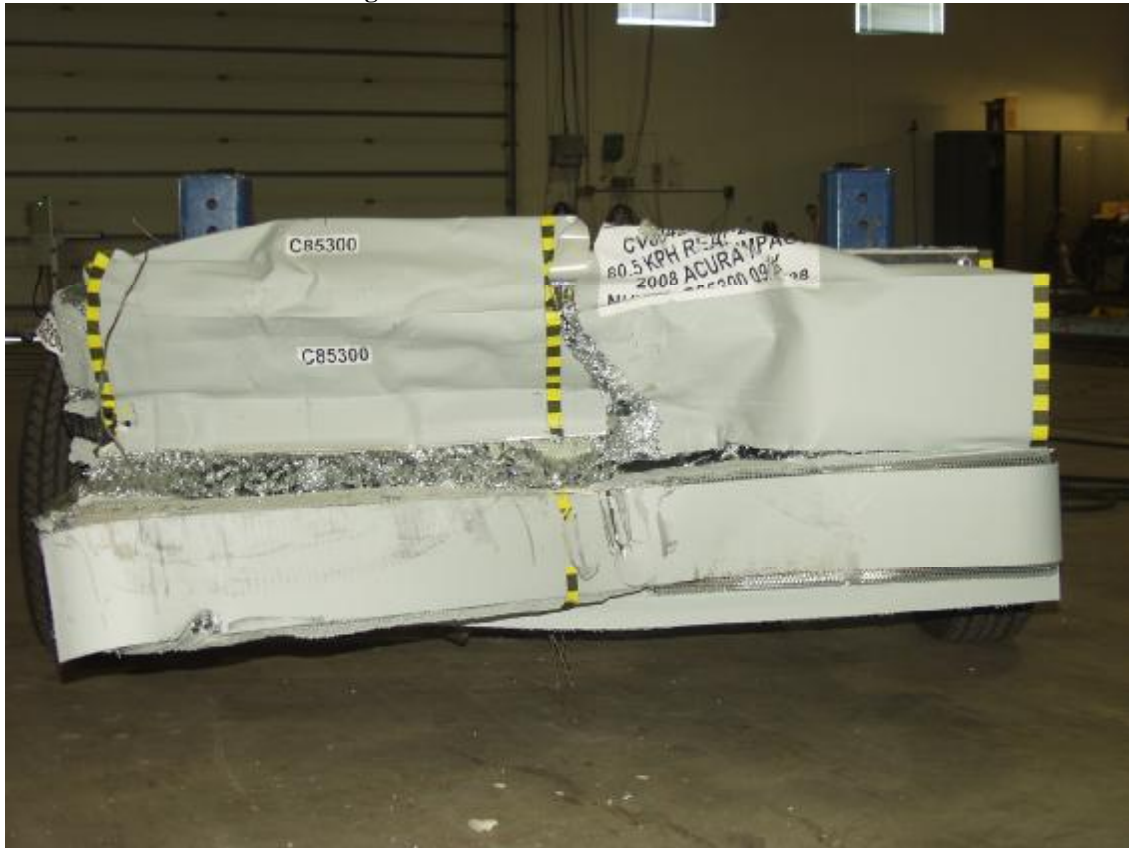
Figure A-20: Post-Test MDB Front View

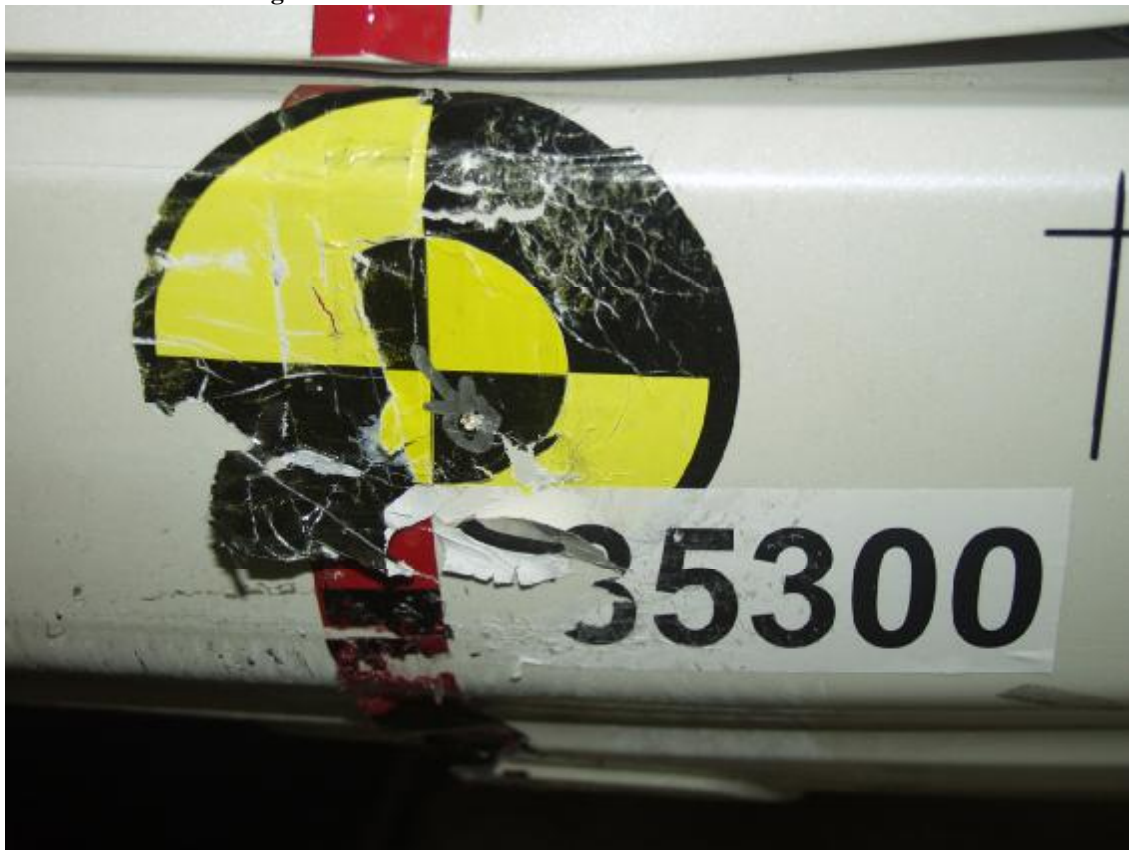
-11 mm Vertical distance from target center (+ is above) Tolerance: ±40 mm

7 mm Horizontal distance from target center (+ is right) Tolerance: ±50 mm

Figure A-28: Post-Test Impact Target View

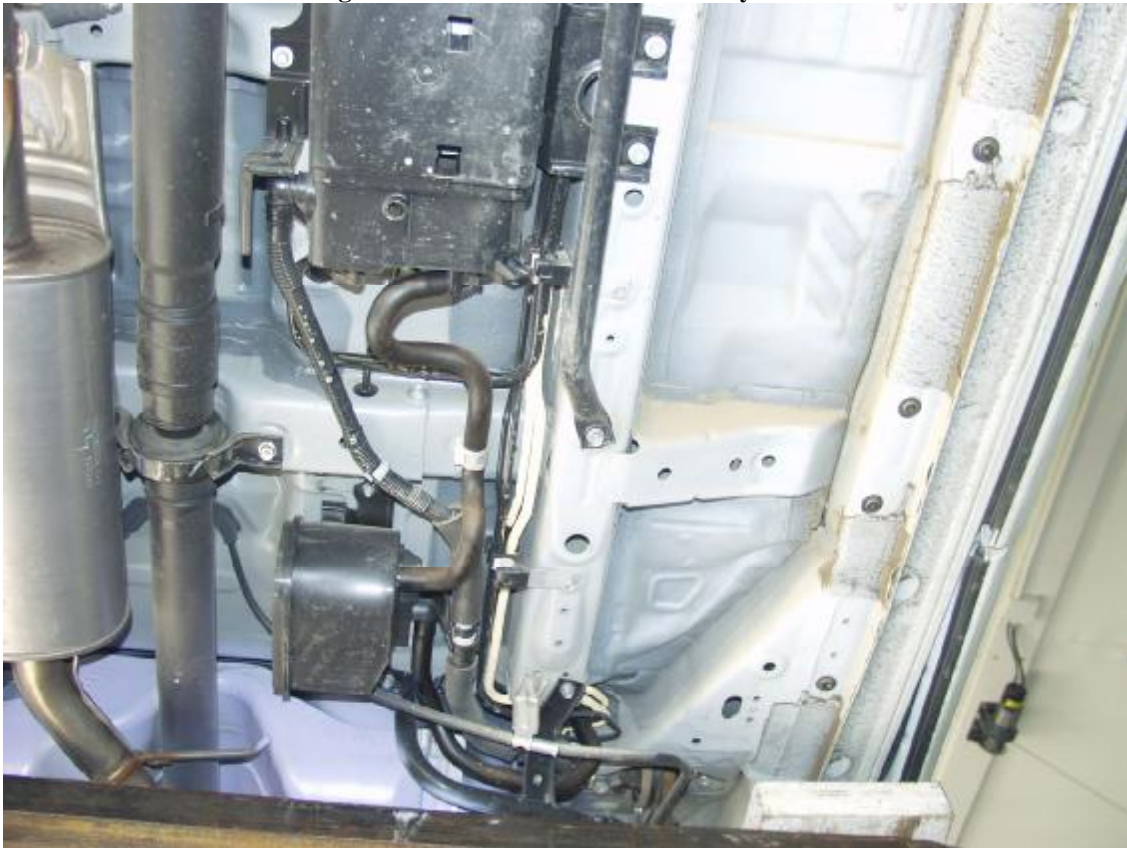
Figure A-32: Post-Test Mid Underbody View

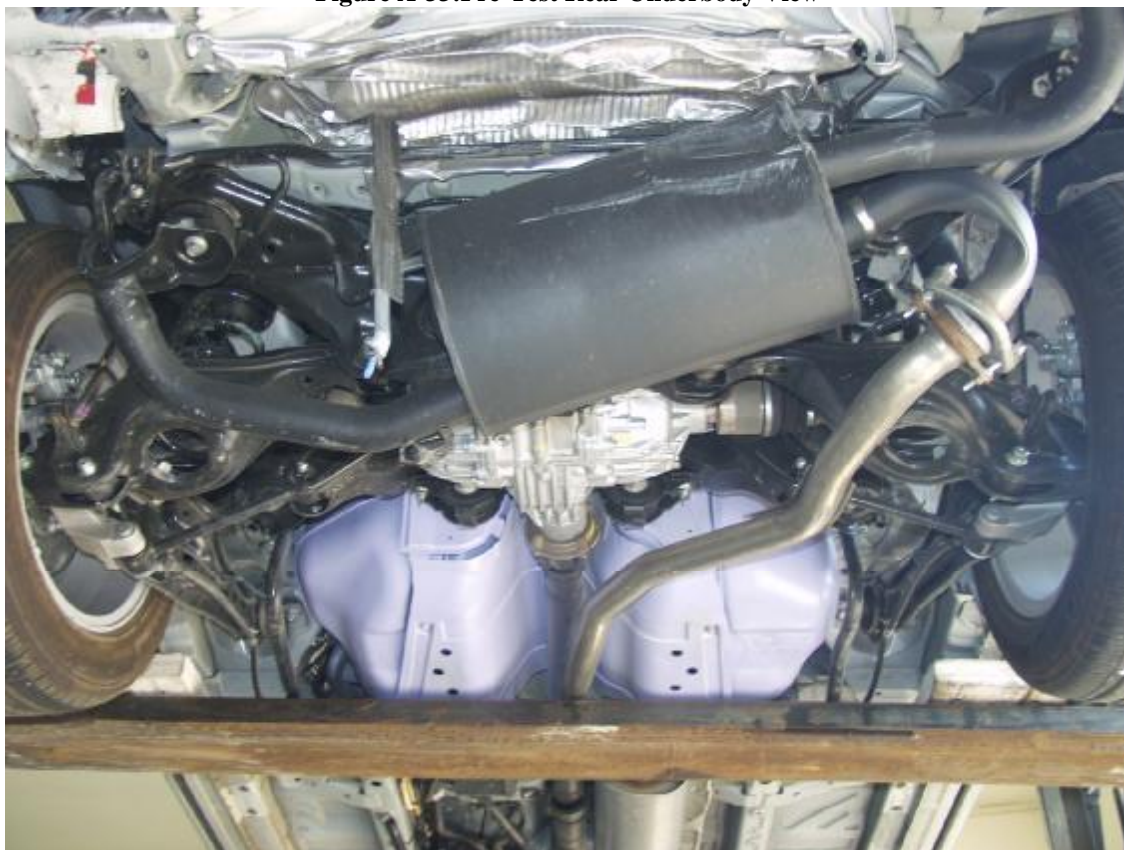
Figure A-34: Post-Test Rear Underbody View

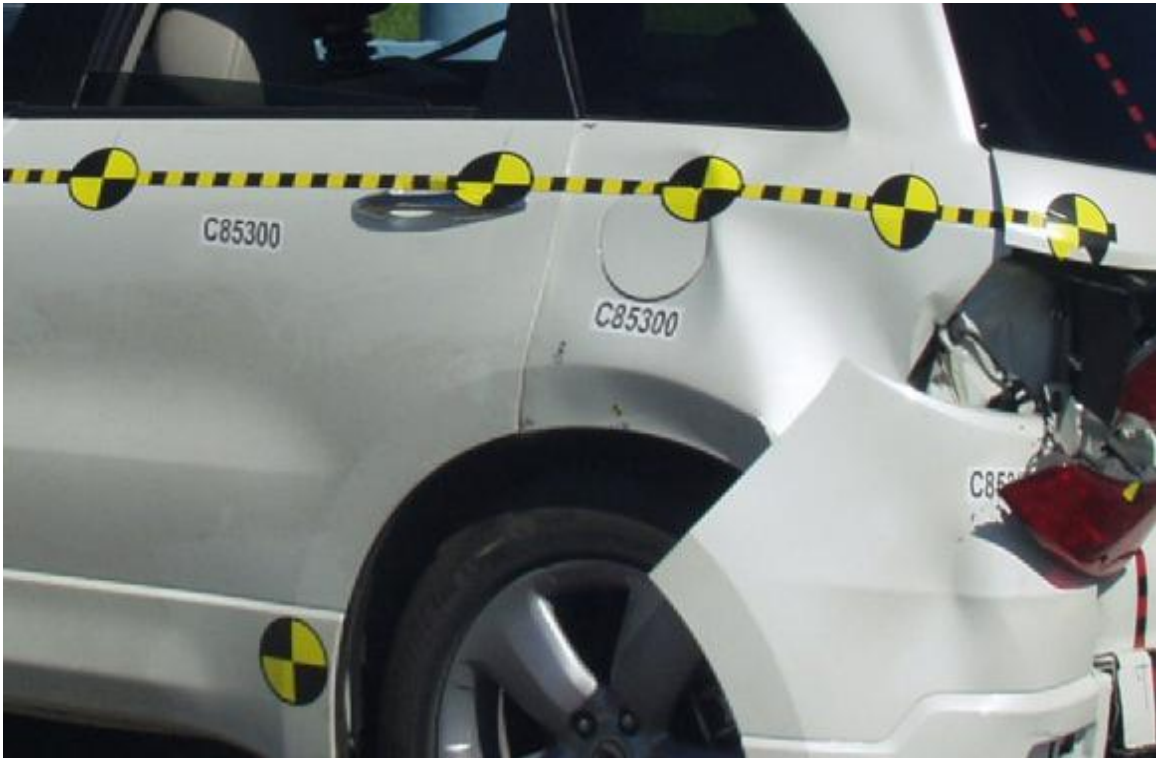
Figure A-36: Post-Test Fuel Filler Cap View
