REPORT NUMBER 214-GTL-06-005

SAFETY COMPLIANCE TESTING FOR FMVSS NO. 214S SIDE IMPACT PROTECTION (STATIC)

FUJI HEAVY INDUSTRIES LTD.
2006 SUBARU B9 TRIBECA, MPV
NHTSA NO. C65501

FINAL REPORT

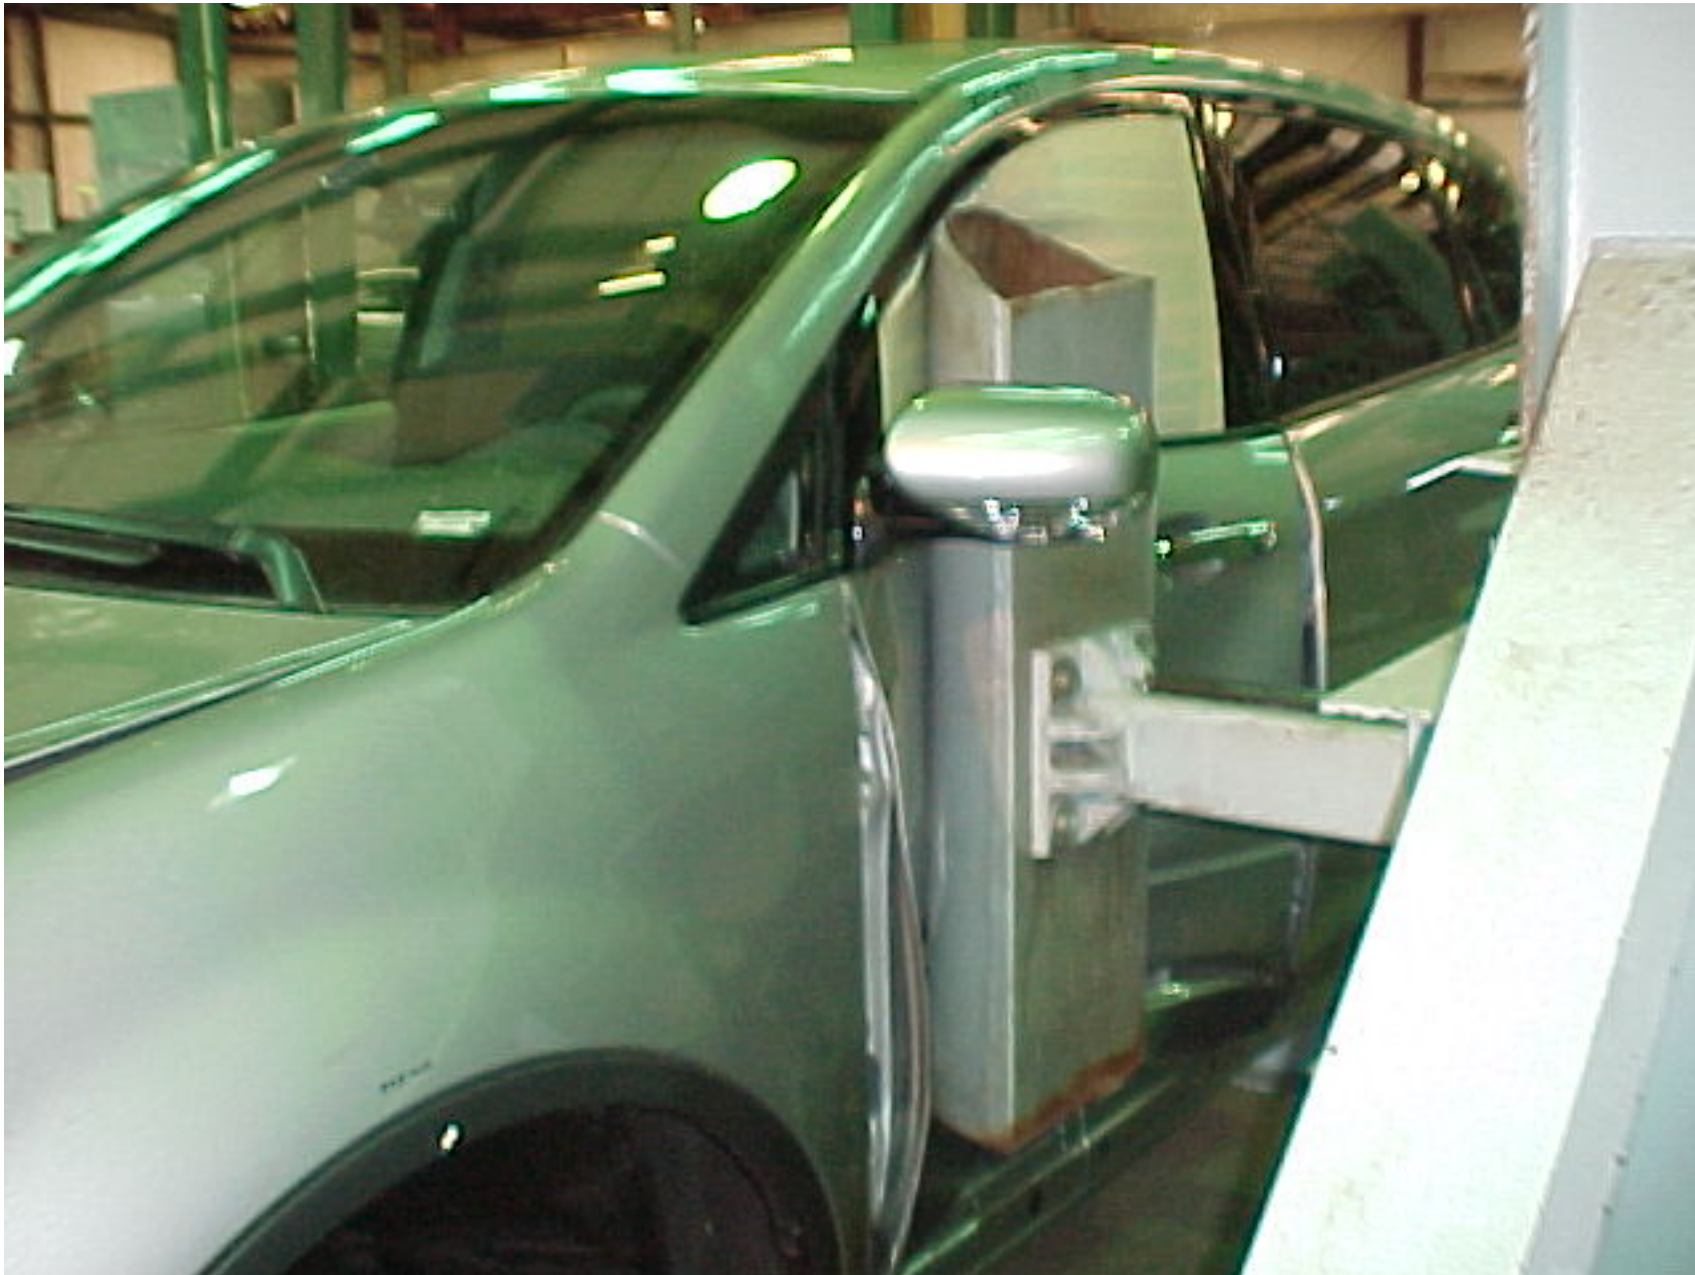
FIGURE 5.14
LOAD DEVICE AGAINST DOOR @ MAX LOAD -
TEST 1

- A. The initial crush resistance was 3251 lbs.
 B. The intermediate crush resistance was 6686 lbs.
 C. The peak crush resistance was 16,254 lbs at 10.30 inches
 D. The rate of loading was .2"/sec

NOTE: TEST #5587 WAS STOPPED AT 16,254 LBS. DUE TO LIMITATIONS OF TEST EQUIPMENT. THIS LOAD WAS 2.3 TIMES THE REQUIRED 7000 LB. LOAD.

- A. The initial crush resistance was 3268 lbs.
- B. The intermediate crush resistance was 6776 lbs.
- C. The peak crush resistance was 16,307 lbs at 10.3 inches

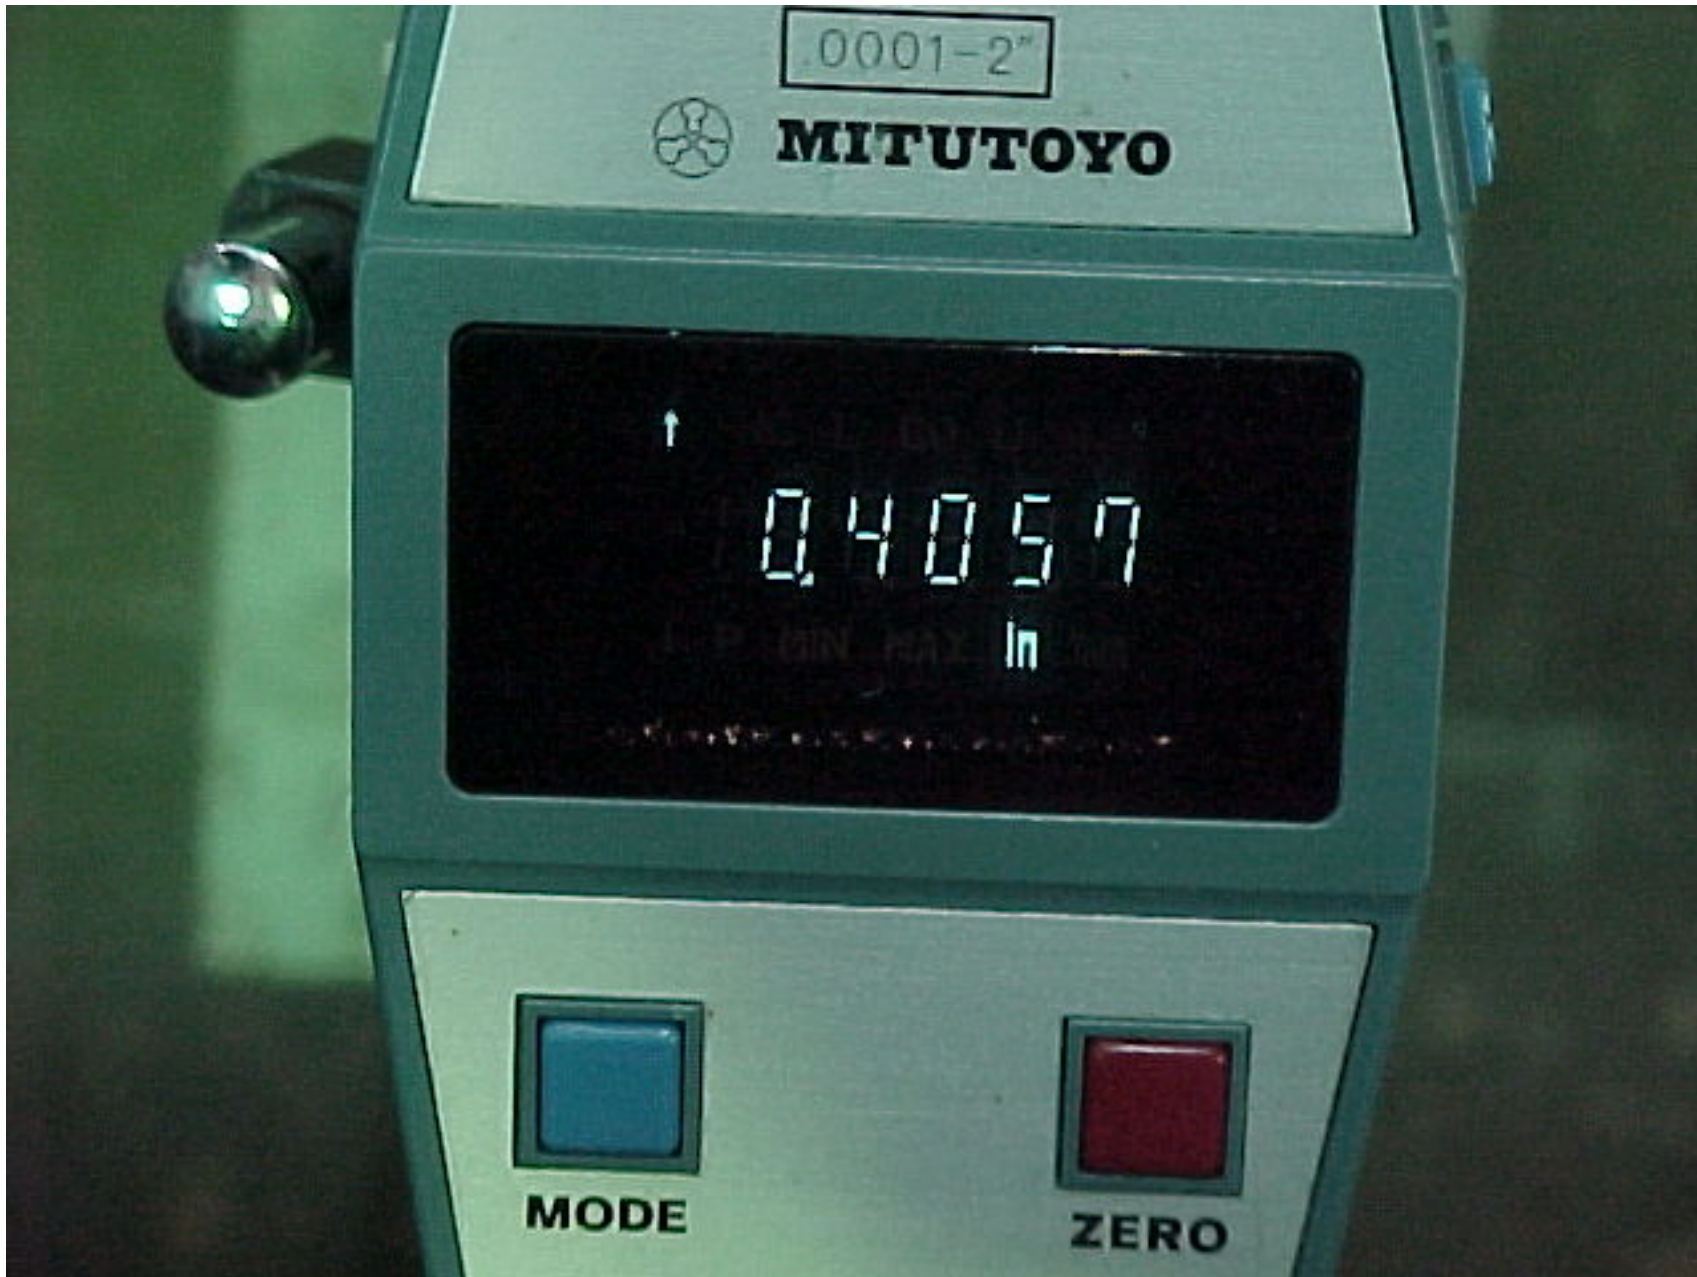
FIGURE 5.15
DIAL INDICATOR AT MAX LOAD – TEST 1

LOADING DEVICE TRAVEL	DIAL INDICATOR	INCLINOMETER
0 inches	<u>0.0000</u>	<u>0</u>
2 inches	<u>0.0190</u>	<u>0</u>
4 inches	<u>0.0875</u>	<u>0</u>
6 inches	<u>0.1690</u>	<u>0</u>
12 inches	<u>0.4057</u>	<u>0</u>
<u>10.3</u> Inches (full travel)	<u>0.4057</u>	<u>0</u>
<u>0</u> Inches (removal)	<u>0.2705</u>	<u>0</u>

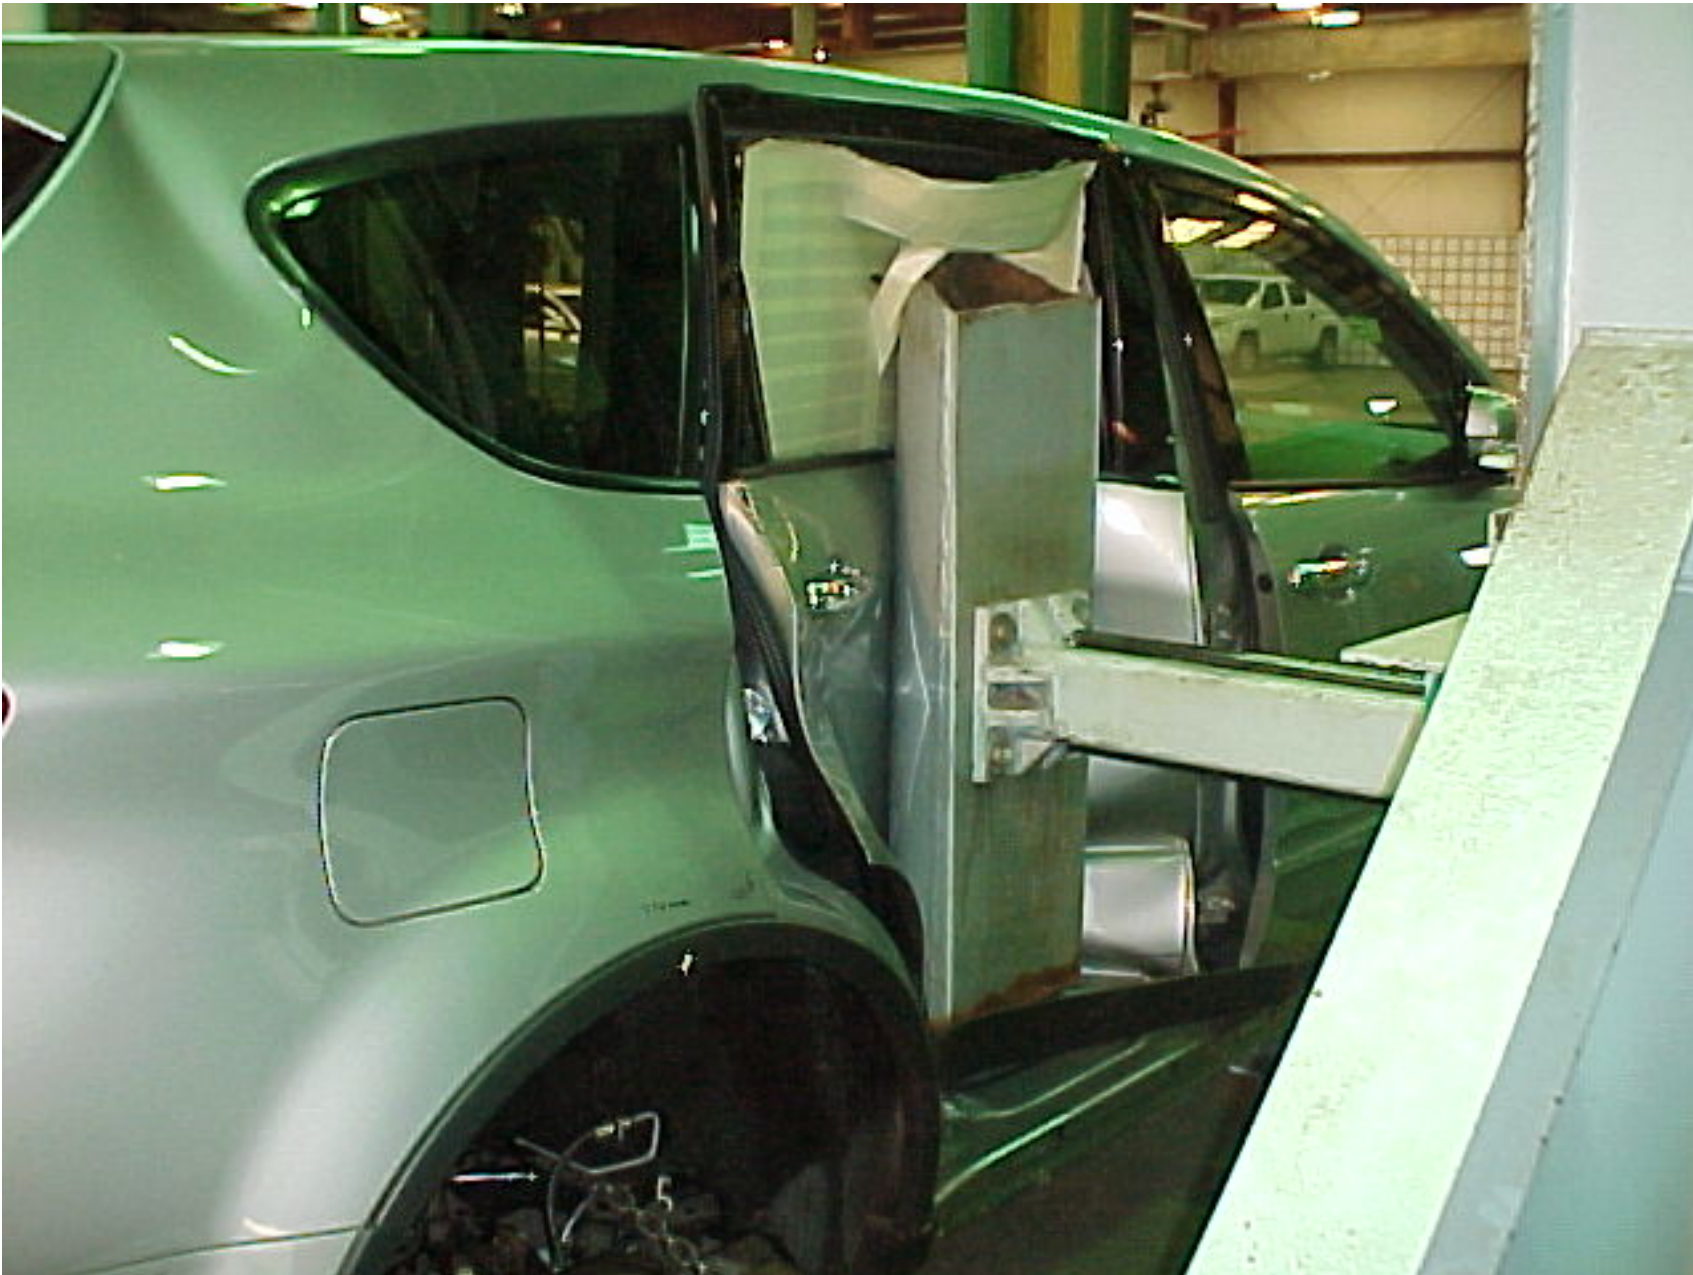
FIGURE 5.21
LOAD DEVICE AGAINST DOOR @ MAX LOAD -
TEST 2

- A. The initial crush resistance was 2826 lbs.
 B. The intermediate crush resistance was 5189 lbs.
 C. The peak crush resistance was 14,367 lbs at 15.00 inches
 D. The rate of loading was .2"/sec

- A. The initial crush resistance was 2829 lbs.
- B. The intermediate crush resistance was 5231 lbs.
- C. The peak crush resistance was 14,393 lbs at 15.00 inches

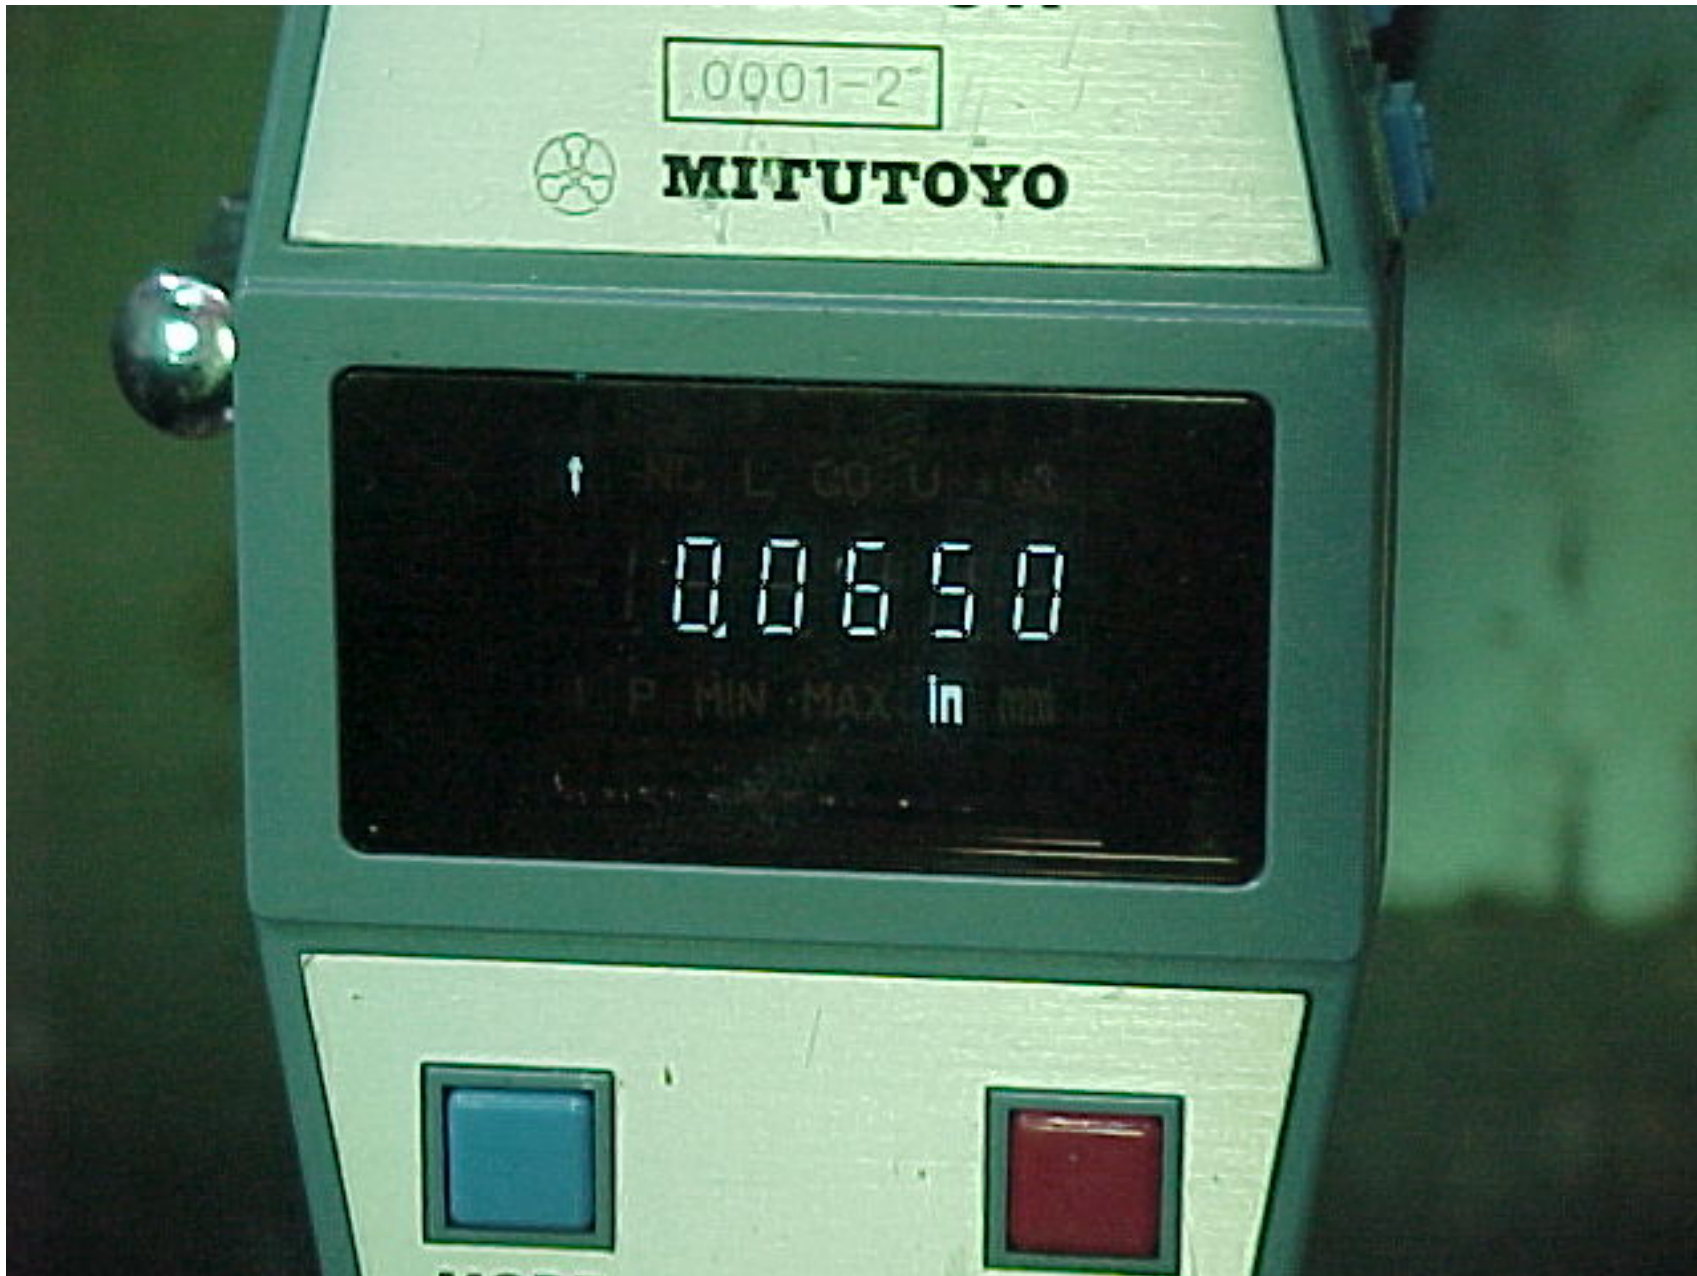
FIGURE 5.22
DIAL INDICATOR AT MAX LOAD – TEST 2

LOADING DEVICE TRAVEL	DIAL INDICATOR	INCLINOMETER
0 inches	<u>0.0000</u>	<u>0</u>
2 inches	<u>0.0190</u>	<u>0</u>
4 inches	<u>0.0375</u>	<u>0</u>
6 inches	<u>0.0536</u>	<u>0</u>
12 inches	<u>0.0819</u>	<u>0</u>
<u>15.00</u> Inches (full travel)	<u>0.0650</u>	<u>0</u>
<u>0</u> Inches (removal)	<u>0.0403</u>	<u>0</u>

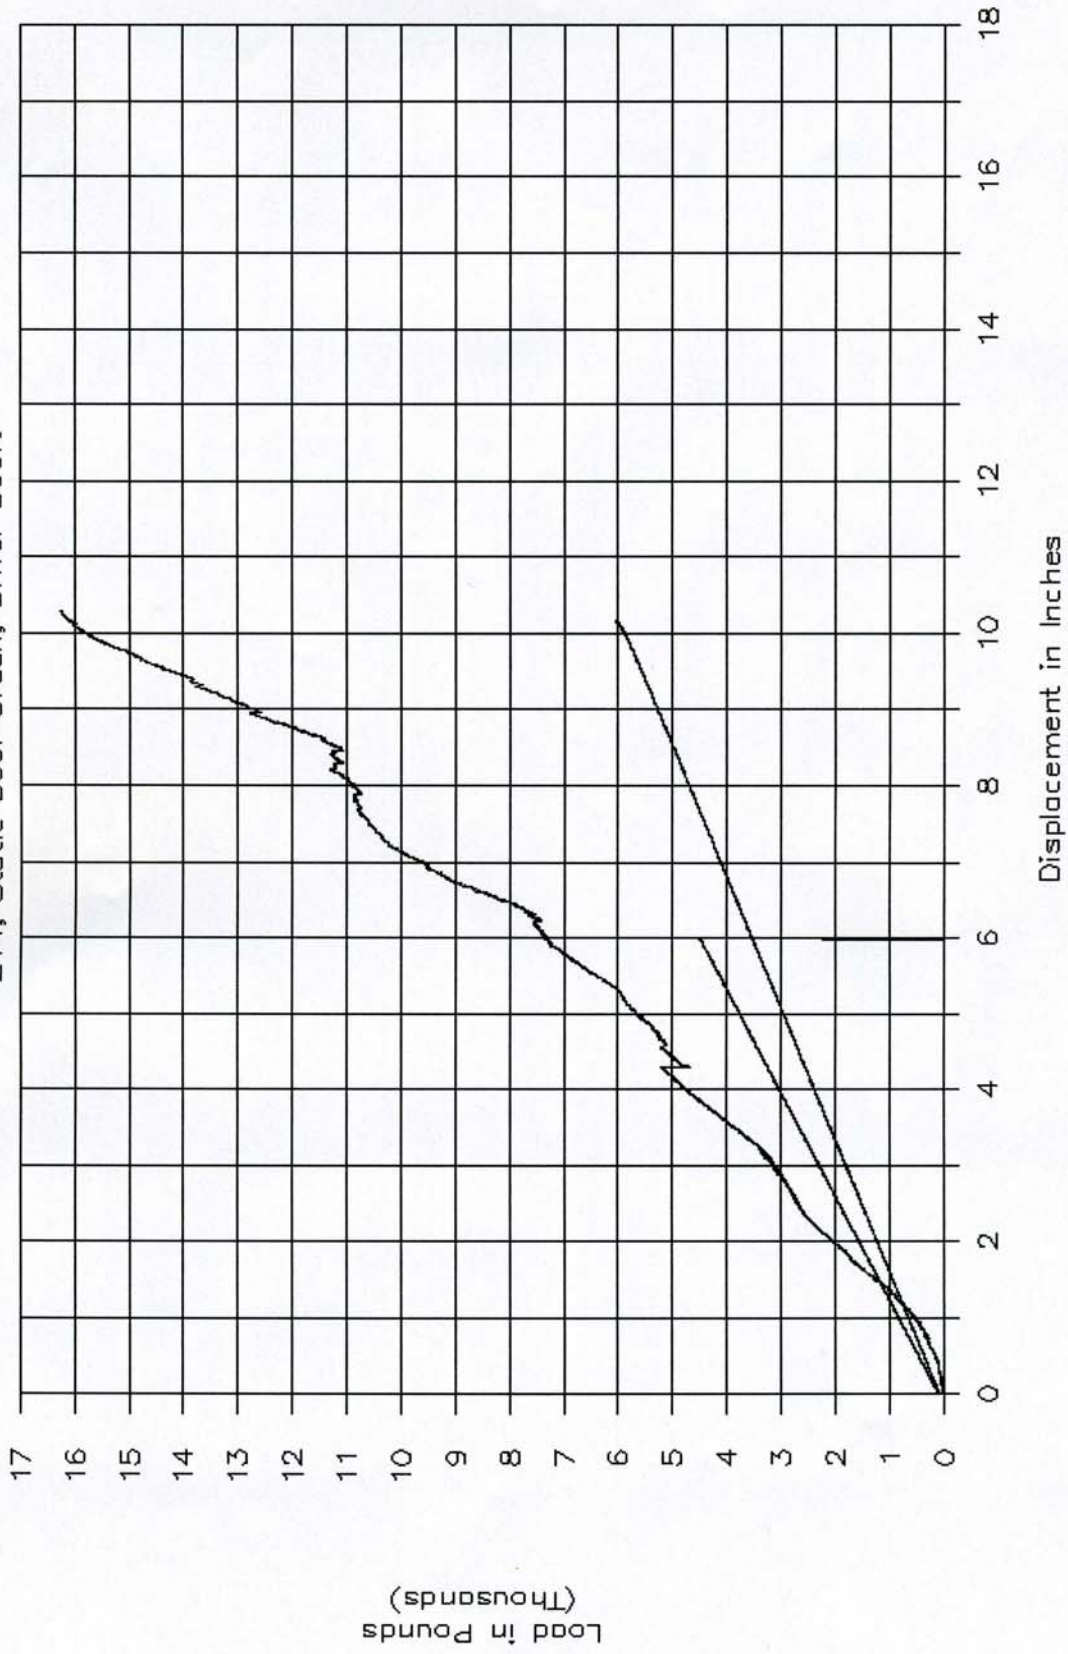
GTL 5587

214, Static Door Crush, Driver Door.

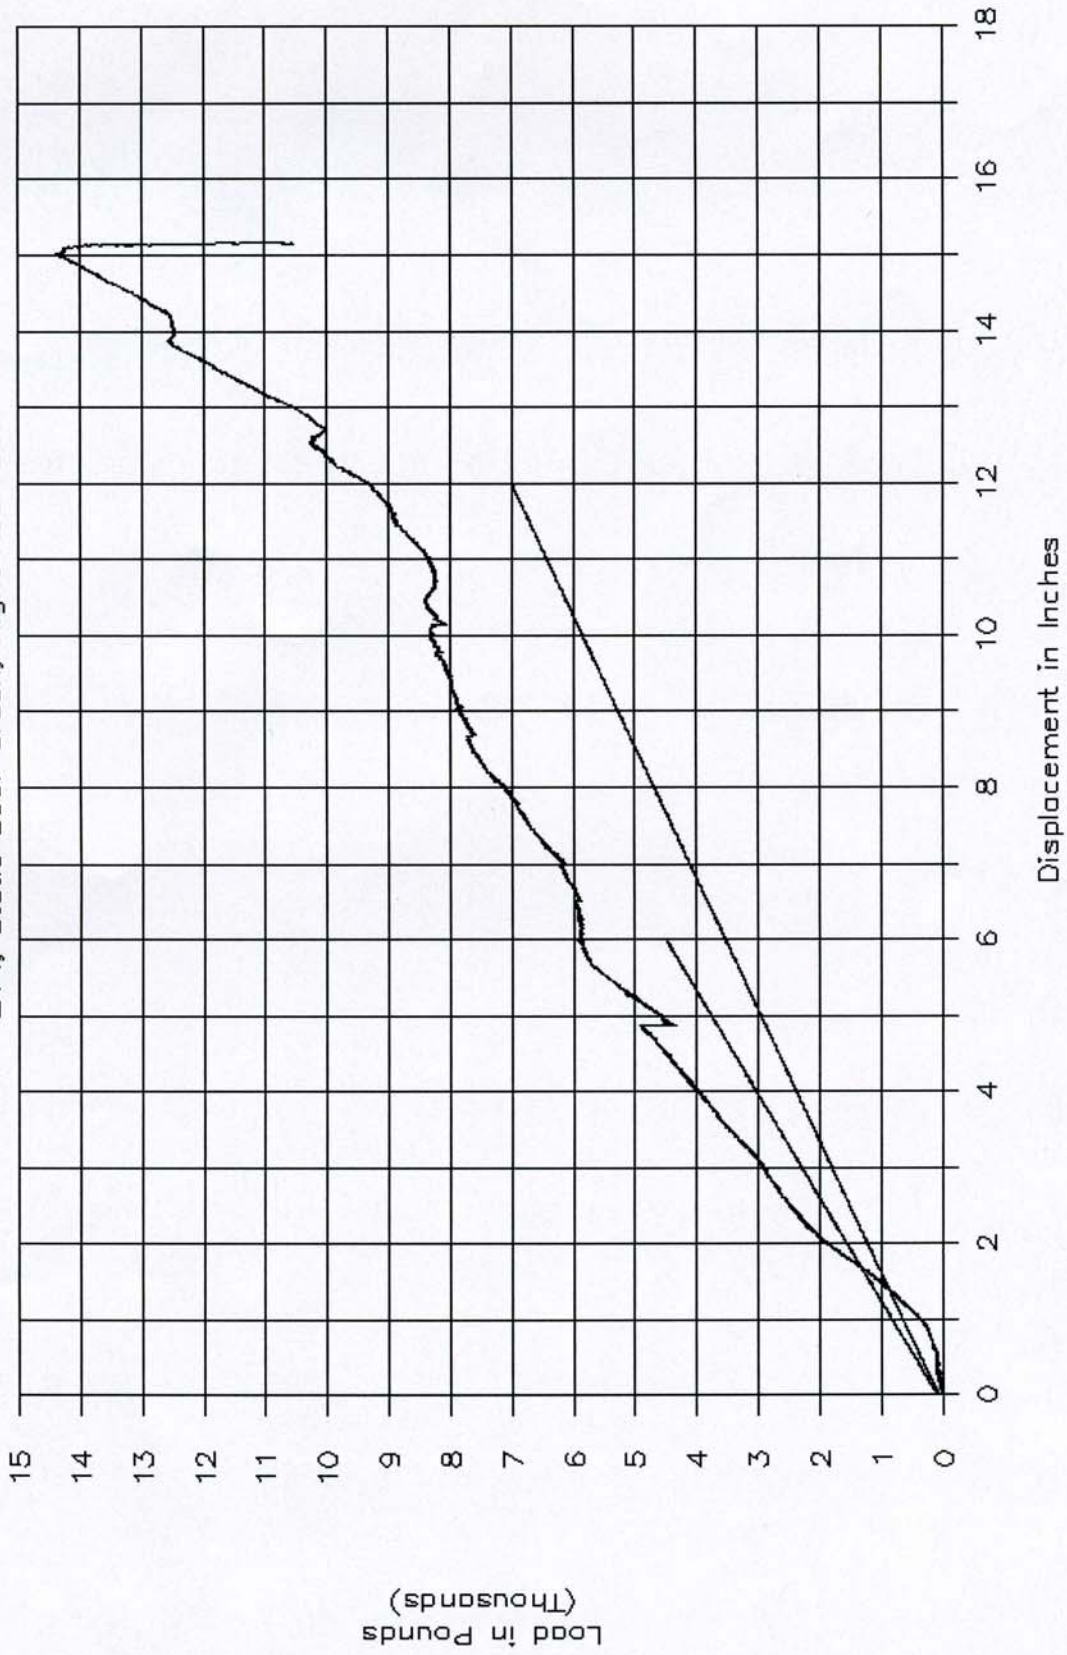
GTL 5588

214, Static Door Crush, Right Rear Door
