REPORT NUMBER 111-GTL-06-001

SAFETY COMPLIANCE TESTING FOR FMVSS NO. 111 REARVIEW MIRRORS

HYUNDAI MOTOR COMPANY
2006 HYUNDAI SONATA, PASSENGER CAR
NHTSA NO. C60502

FINAL REPORT

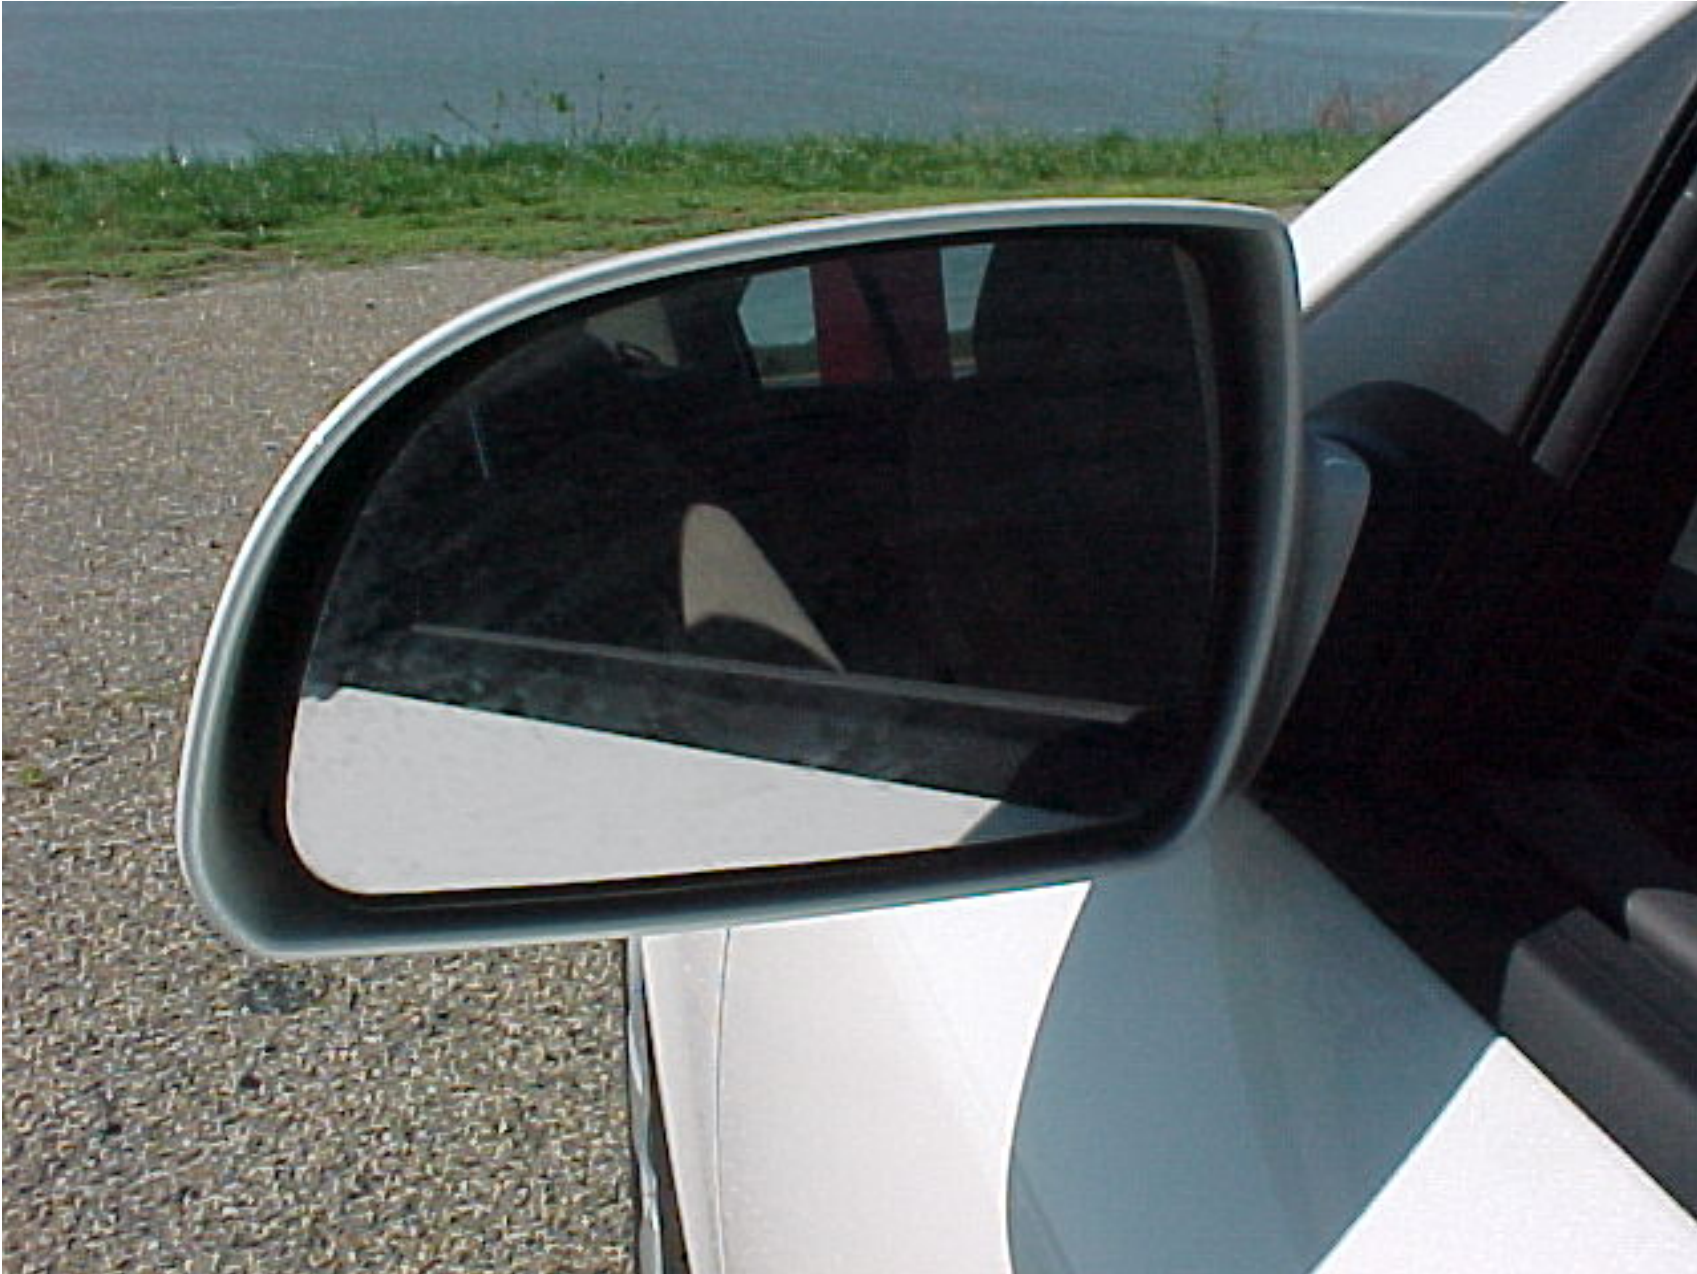
FIGURE 5.7
DRIVER SIDE REAR VIEW MIRROR AND MOUNTING

PASS	FAIL	COMMENTS
STABLE SUPPORT	X		
DOES NOT PROTRUDE BEYOND VEHICLE BODY	X		Mirror does protrude farther than the widest part of the vehicle body but the protrusion is required to meet the field of view requirements.
NOT OBSCURED BY UNWIPED PORTION OF WINDSHIELD	X		
ADJUSTABLE BY TILTING	X		
ADJUSTABLE FROM DRIVER SEAT	X		
FREE OF SHARP EDGES	X		
FIELD-OF-VIEW	X		
REFLECTANCE	X		
UNIT MAGNIFICATION	X

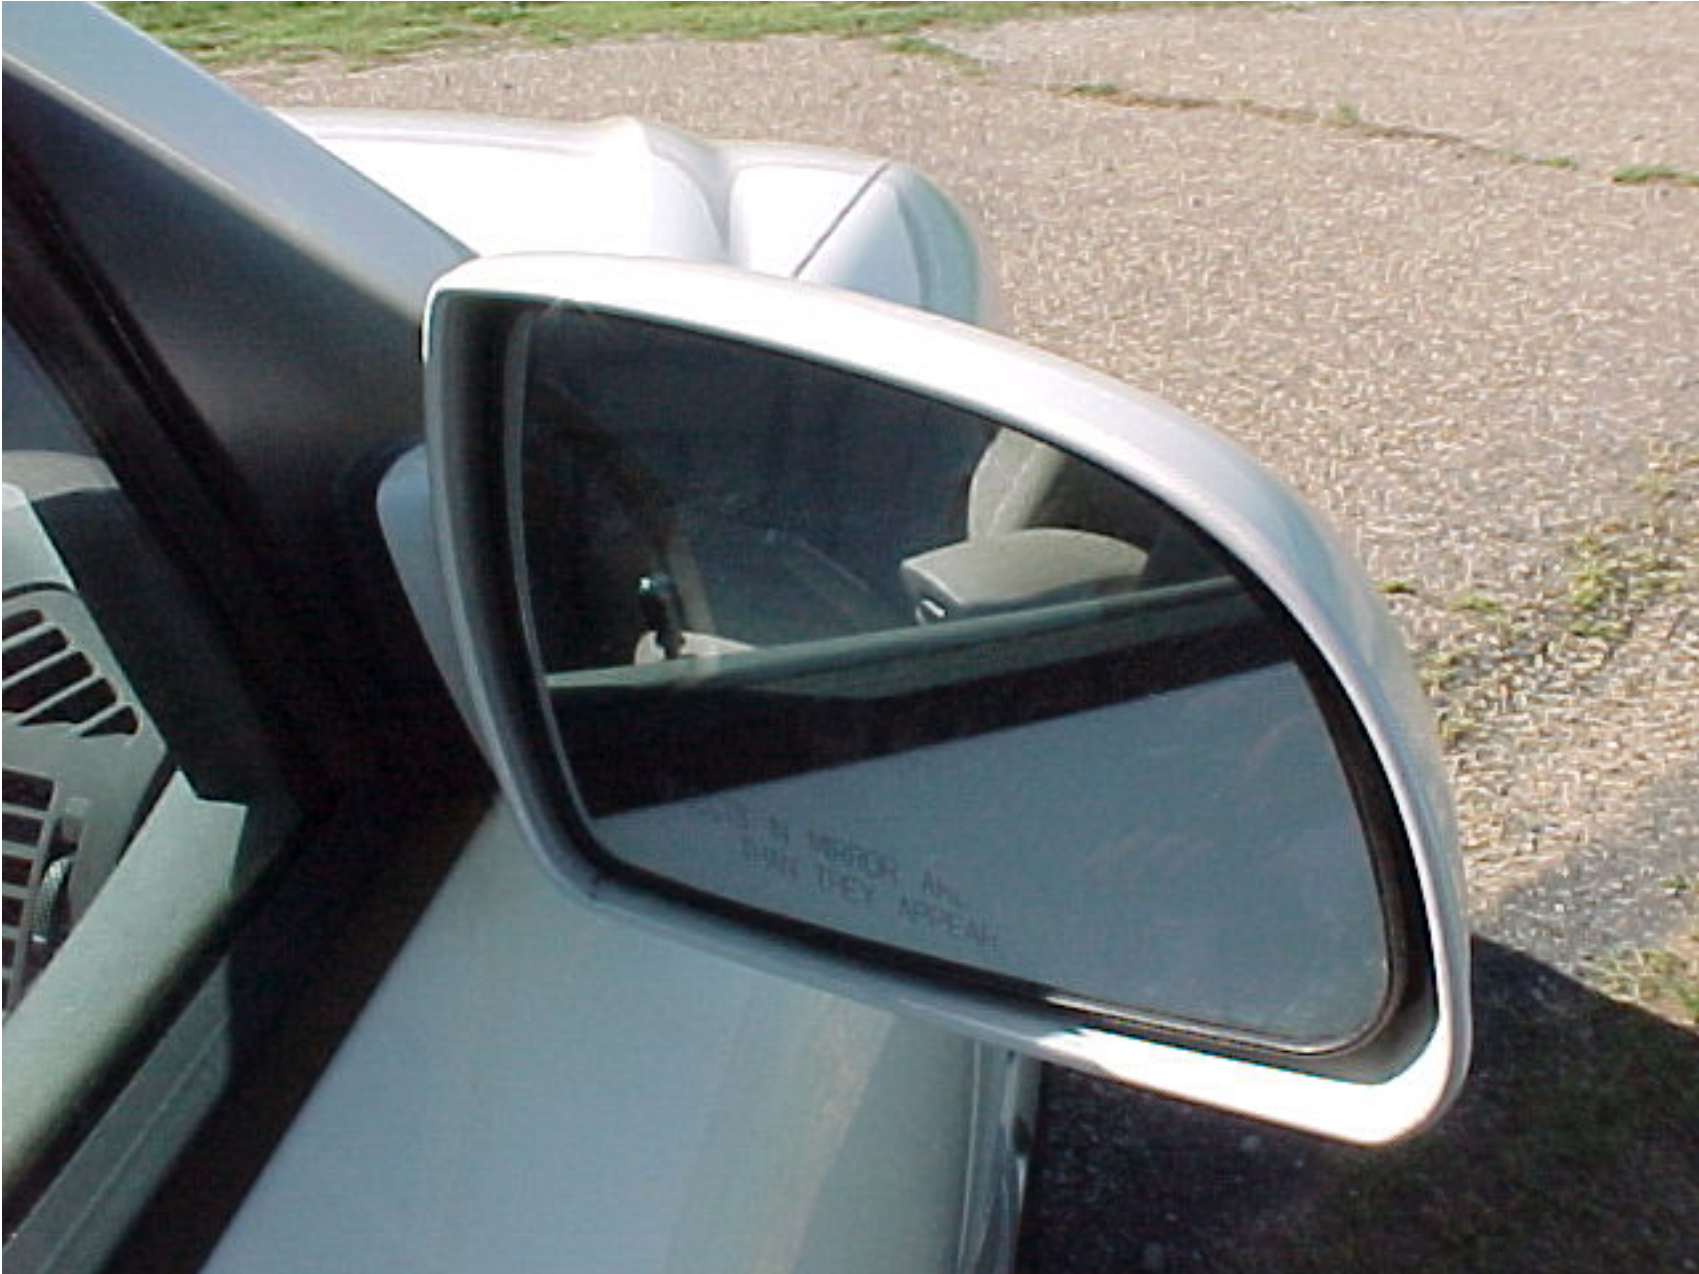
FIGURE 5.8
PASSENGER SIDE REAR VIEW MIRROR AND
MOUNTING

PASS	FAIL	COMMENTS
STABLE SUPPORT	X		See Remarks
ADJUSTABLE BY TILTING	X		
REFLECTANCE	X		
FREE OF SHARP EDGES	X		
UNIT MAGNIFICATION or			
CONVEX	X

REMARKS: This vehicle is equipped with an outside passenger side rear view mirror that is not required by FMVSS No. 111. Each passenger car whose inside rear view mirror does not meet the field of view requirements of the standard shall have an outside mirror of unit magnification or a convex mirror installed on the passenger's side.

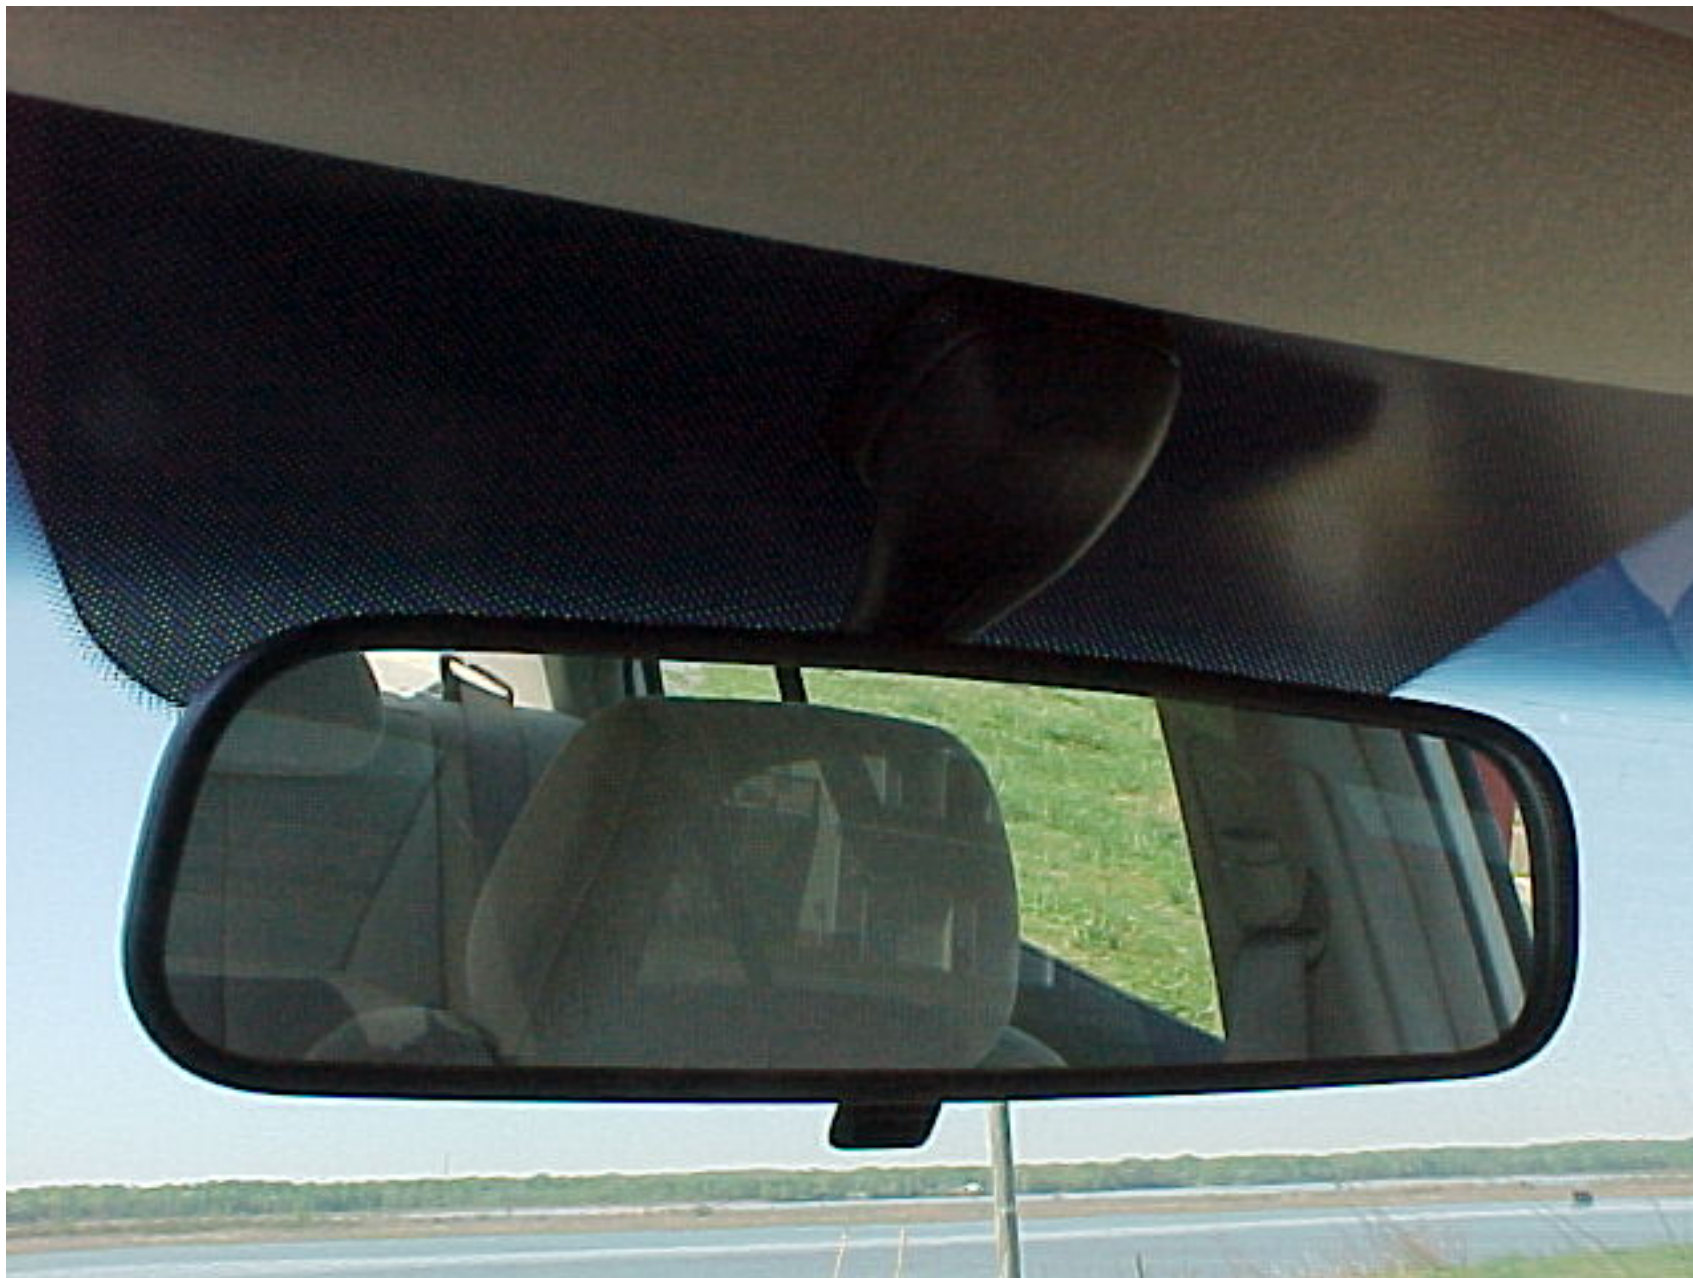
FIGURE 5.9
INSIDE REARVIEW MIRROR AND MOUNTING

MIRROR IS MOUNTED TO A LINK ARM WITH A BALL PIVOT WHICH LETS THE MIRROR PIVOT UP/DOWN AND LEFT/RIGHT. THE LINK ARM IS MOUNTED TO THE HEADLINER WITH A SPRING CLIP TO ALLOW BREAKAWAY PROTECTION.

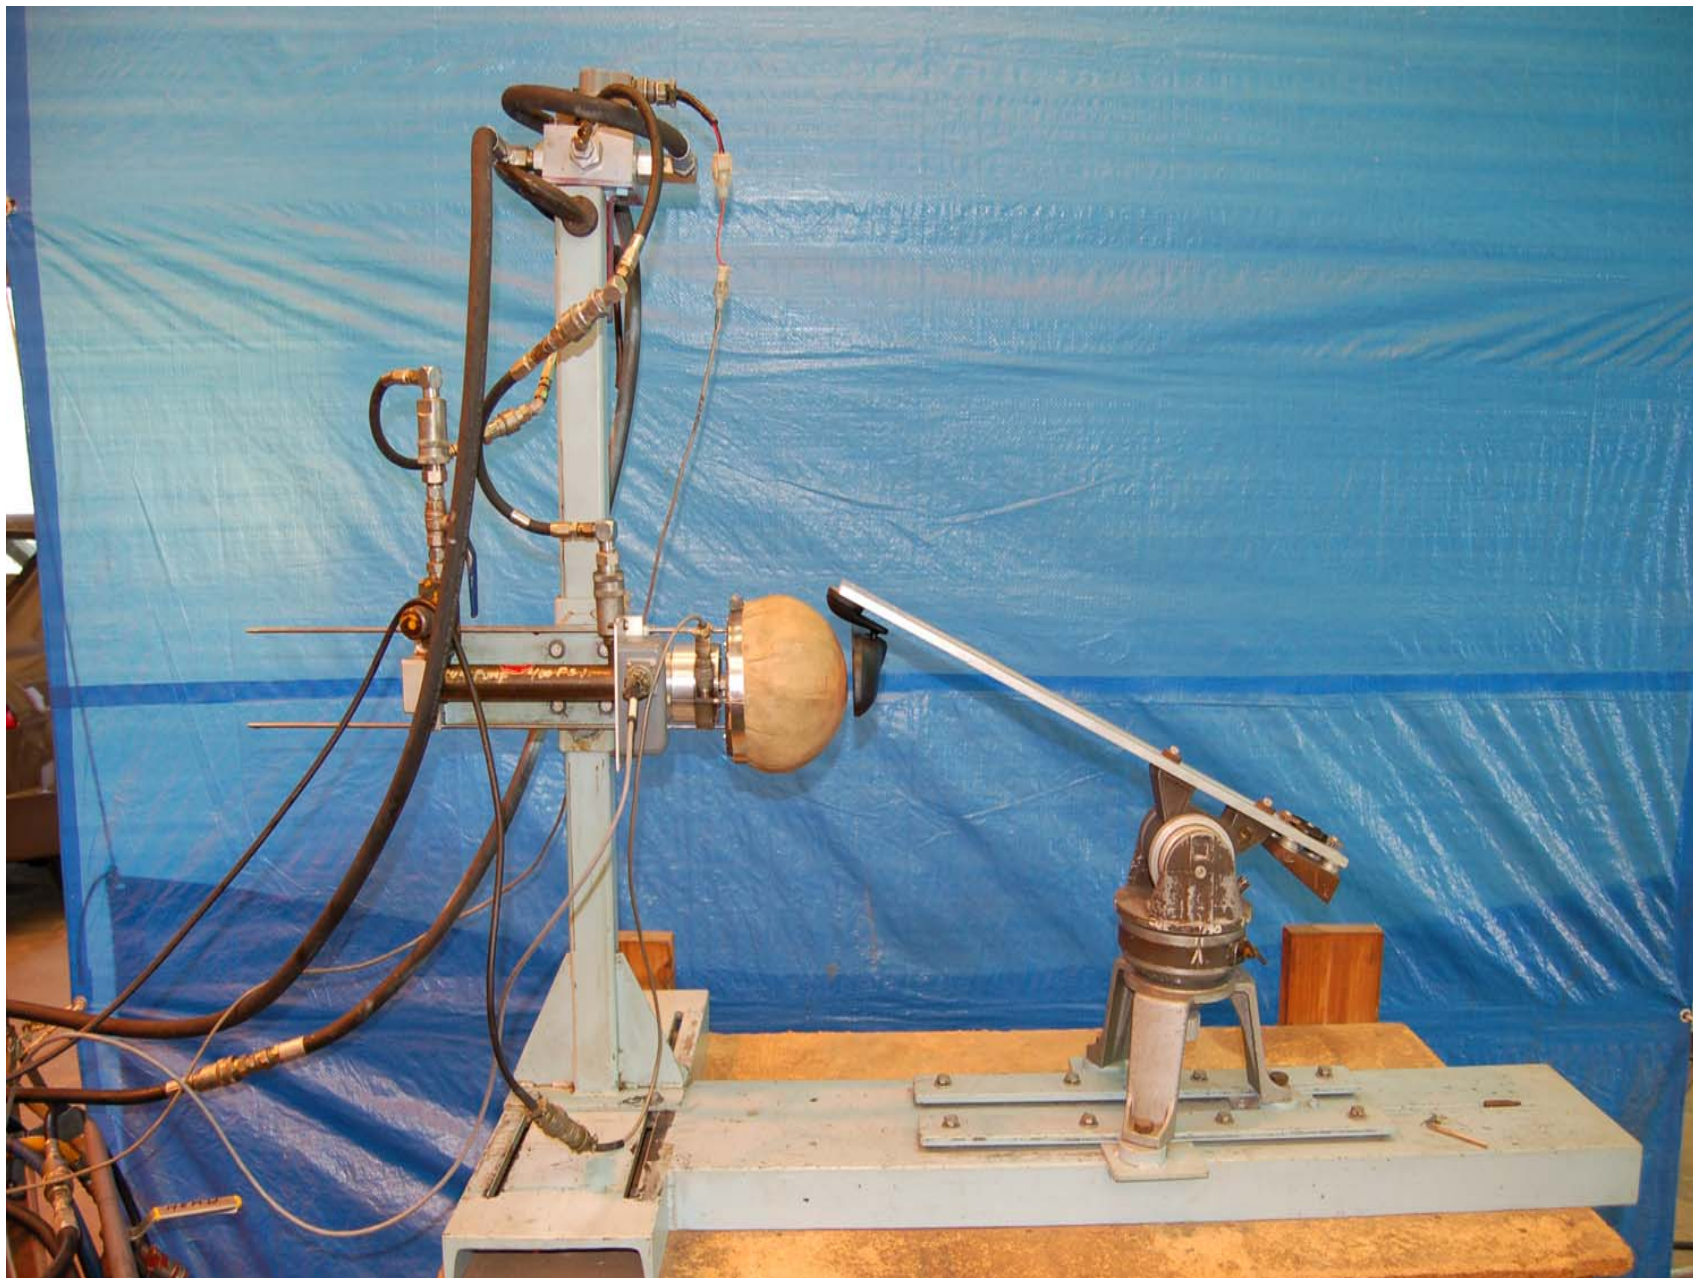
FIGURE 5.12
BREAK AWAY TEST SET-UP

REMARKS: * THE +45° APPROACH ANGLE COULD NOT BE TESTED DUE TO THE DESIGN OF THE MIRROR/MIRROR MOUNT/HEADLINER OF THE VEHICLE. THE GREATEST ANGLE THAT COULD BE REACHED WAS 10°.

DESCRIPTION OF MIRROR MOVEMENT (DEFLECT COLLAPSE OR BREAKAWAY):
FIRST MOVEMENT OF MIRROR WITHOUT INCREASE IN LOAD WAS MIRROR PIVOTING ON BALL JOINT. IF LOADING WAS CONTINUED, THE MIRROR ARM WOULD SEPARATE FROM THE HEADLINER MOUNT DUE TO THE SPRING LOADED MOUNTING CLIP.

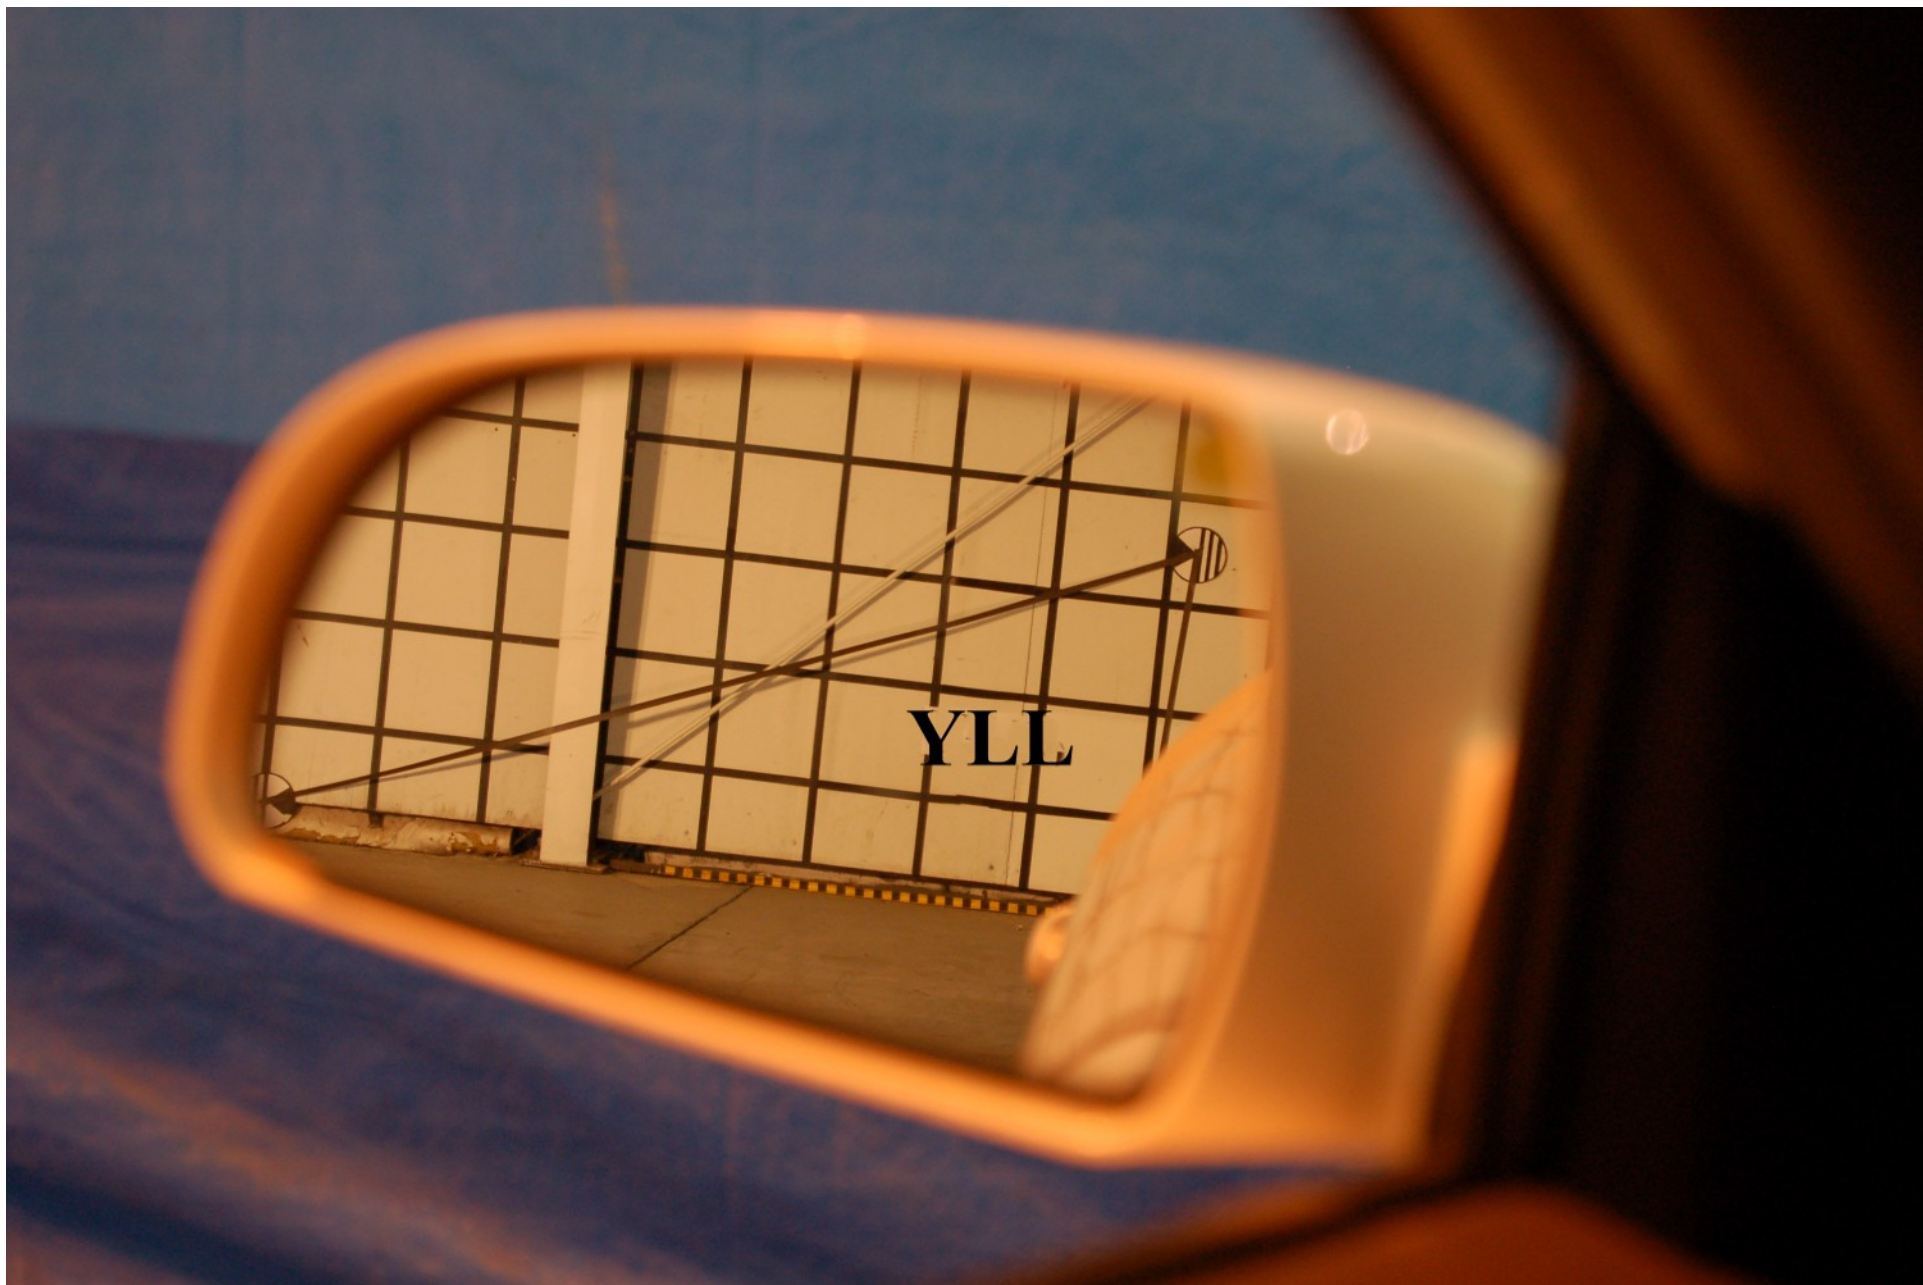
FIGURE 5.15
OUTSIDE MIRROR LEFT EYE FIELD OF VIEW

ENTIRE TRIANGULAR TEST TARGET AREA ON SCREEN VISIBLE? (Y/N) _____ NO*

REMARKS: *The triangular test target area is partially obscured by a rear body contour that is allowed by FMVSS No. 111.
