REPORT NUMBER 111-GTL-06-002

# SAFETY COMPLIANCE TESTING FOR FMVSS NO. 111 REARVIEW MIRRORS

FORD MOTOR CO.  
2006 FORD FUSION, PASSENGER CAR  
NHTSA NO. C60202

**FINAL REPORT**

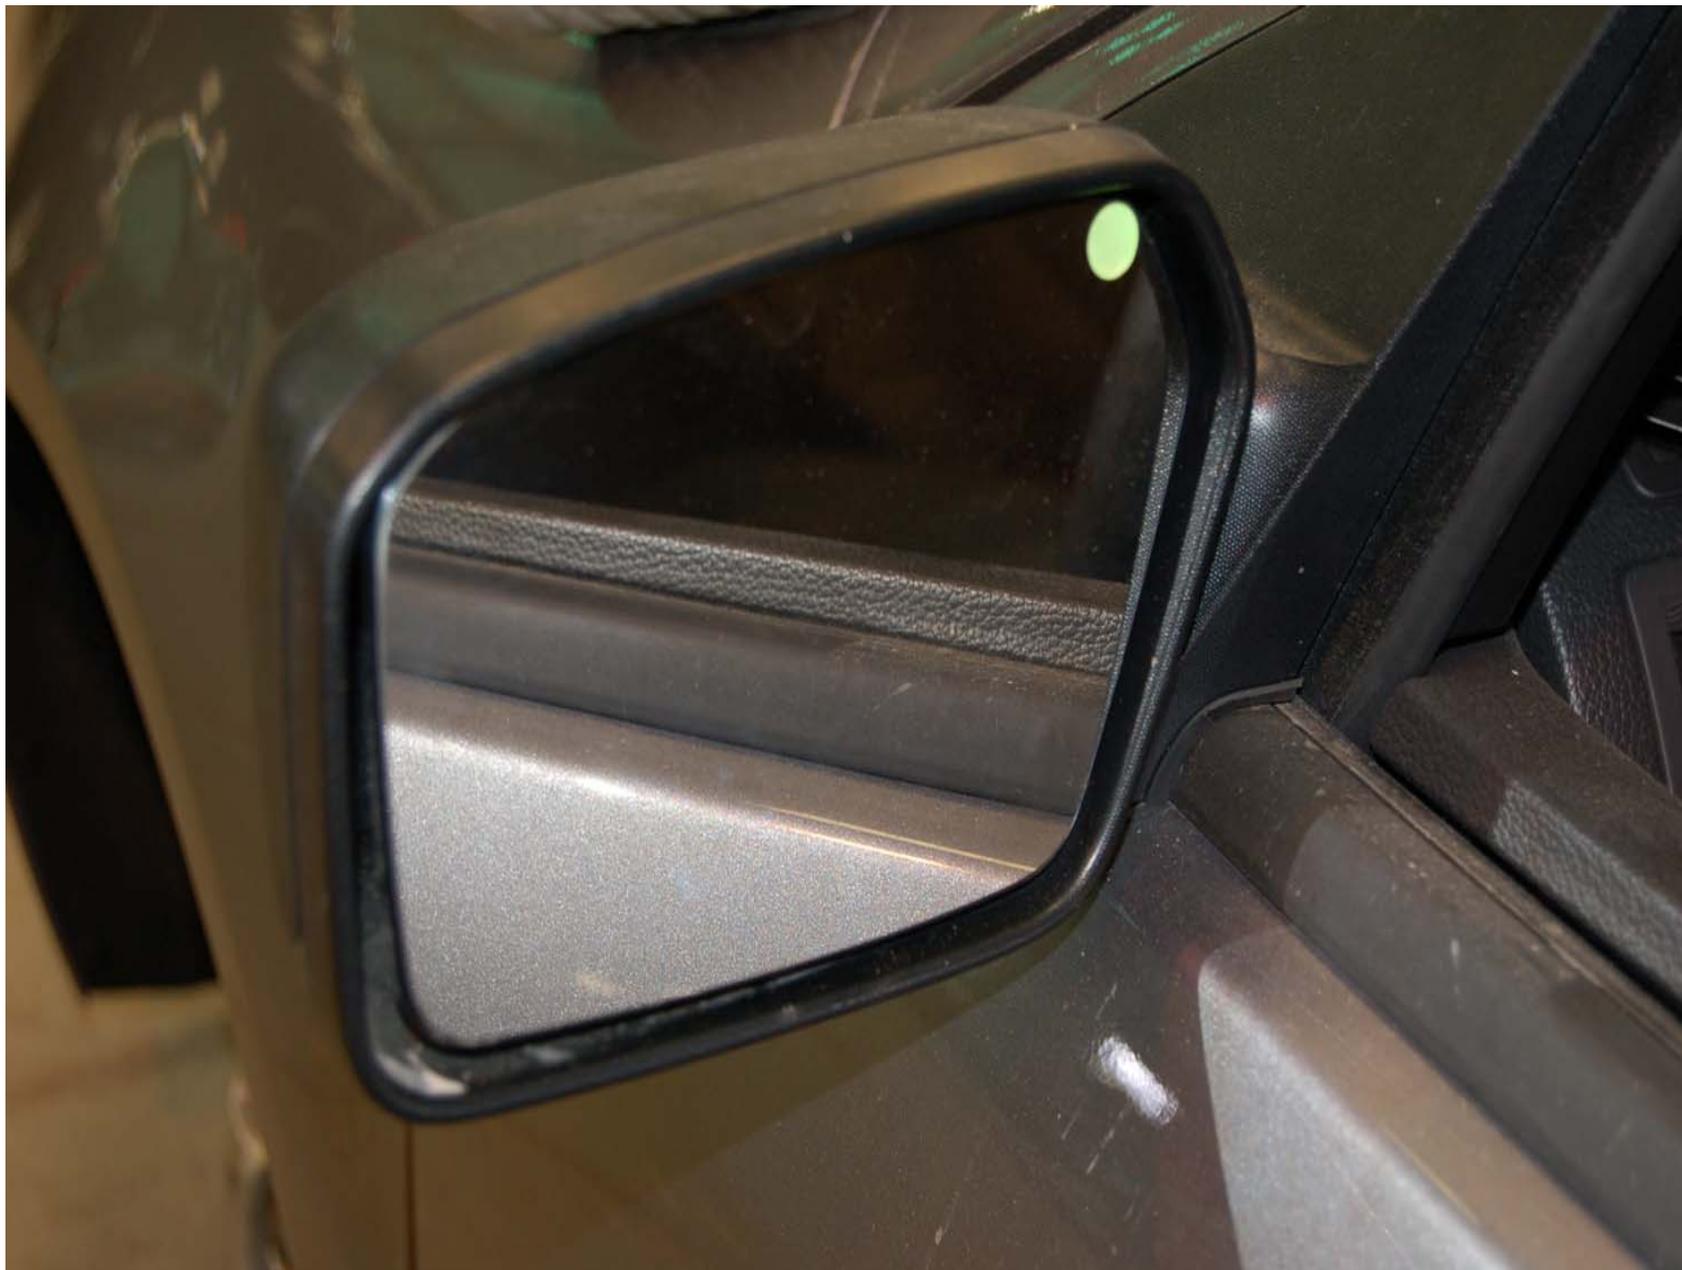
FIGURE 5.7  
DRIVER SIDE REAR VIEW MIRROR AND MOUNTING

PASS	FAIL	COMMENTS
STABLE SUPPORT	X		
DOES NOT PROTRUDE BEYOND VEHICLE BODY	X		Mirror does protrude farther than the widest part of the vehicle body but the protrusion is required to meet the field of view requirements.
NOT OBSCURED BY UNWIPED PORTION OF WINDSHIELD	X		
ADJUSTABLE BY TILTING	X		
ADJUSTABLE FROM DRIVER SEAT	X		
FREE OF SHARP EDGES	X		
FIELD-OF-VIEW	X		
REFLECTANCE	X		
UNIT MAGNIFICATION	X

MIRROR PROTRUDES BEYOND VEHICLE TANGENT PLANE? (Y/N) \_\_\_\_\_ YES \_\_\_\_\_

PROTRUSION REQUIRED TO MEET FIELD OF VIEW REQUIREMENTS? (Y/N) YES

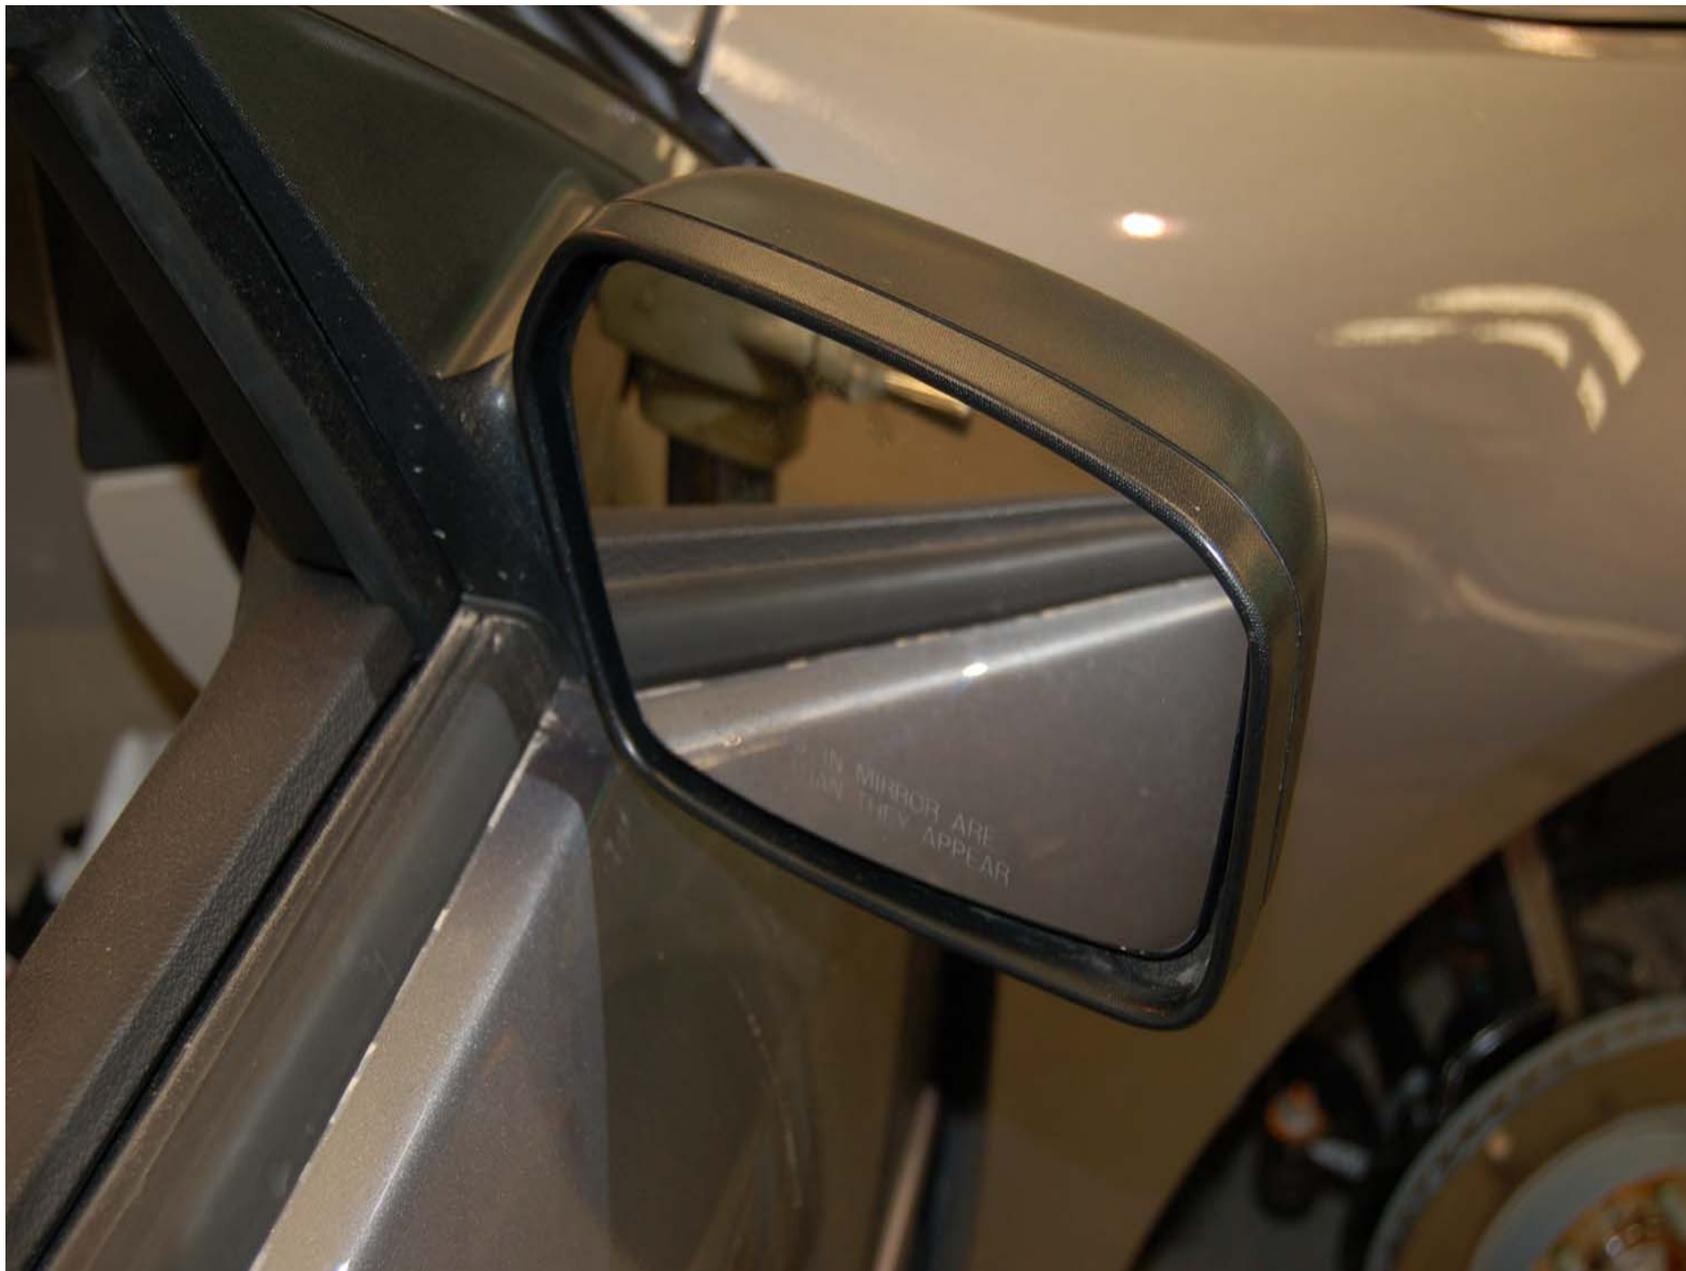
FIGURE 5.8  
PASSENGER SIDE REARVIEW MIRROR AND  
MOUNTING

REMARKS: This vehicle is equipped with an outside passenger side rear view mirror that is not required by FMVSS No. 111. Each passenger car whose inside rear view mirror does not meet the field of view requirements of the standard shall have an outside mirror of unit magnification or a convex mirror installed on the passenger's side.

PASSENGER SIDE MIRROR TYPE (convex or unit magnification) \_\_\_\_\_ CONVEX \_\_\_\_\_

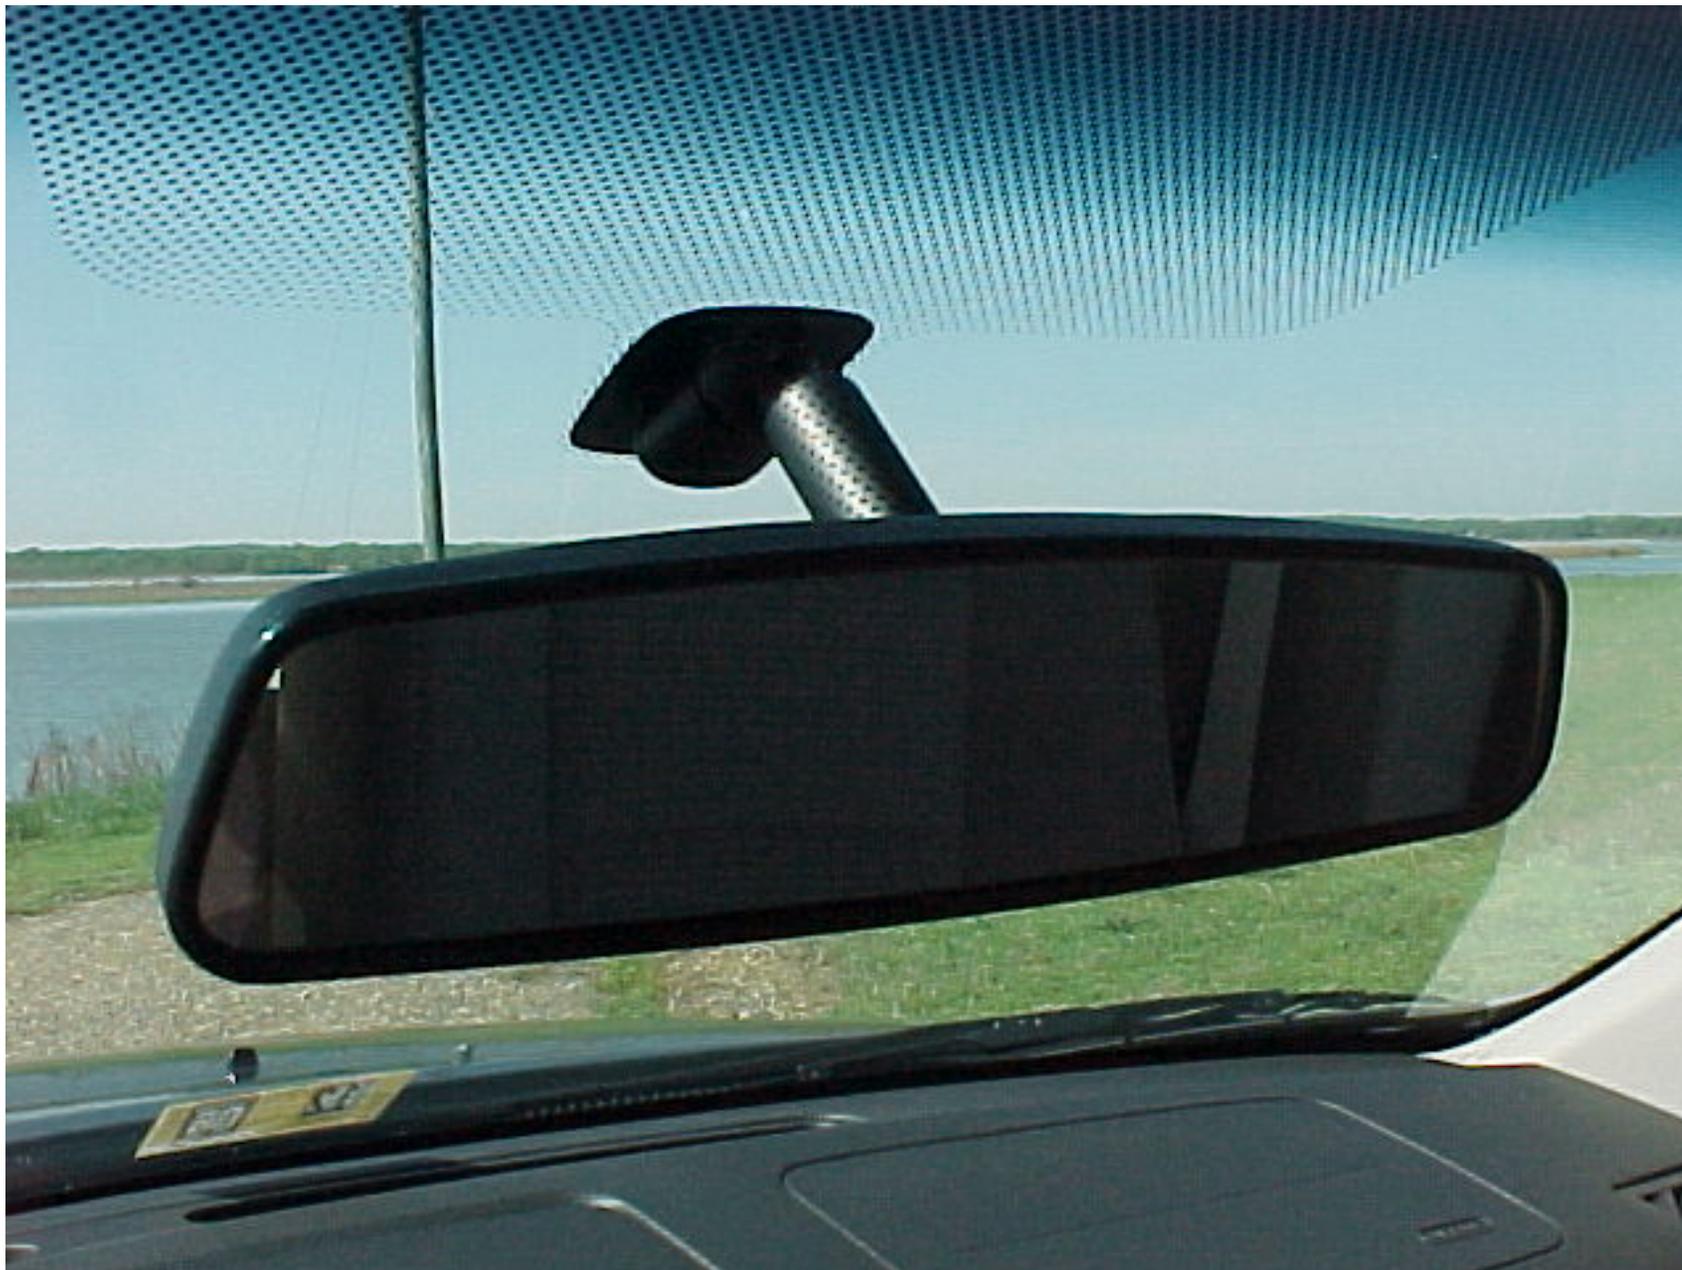
FIGURE 5.9  
INSIDE REARVIEW MIRROR & MOUNTING

MIRROR IS MOUNTED WITH A DUAL BALL LINK PIVOT ARM TO A BASE WHICH IS ATTACHED TO THE WINDSHIELD GLASS WITH ADHESIVE.

DESCRIPTION OF MIRROR MOVEMENT (DEFLECT, COLLAPSE OR BREAKAWAY):  
FIRST MOVEMENT OF MIRROR WITHOUT INCREASE IN LOAD WAS MIRROR PIVOTING ON BALL JOINT.

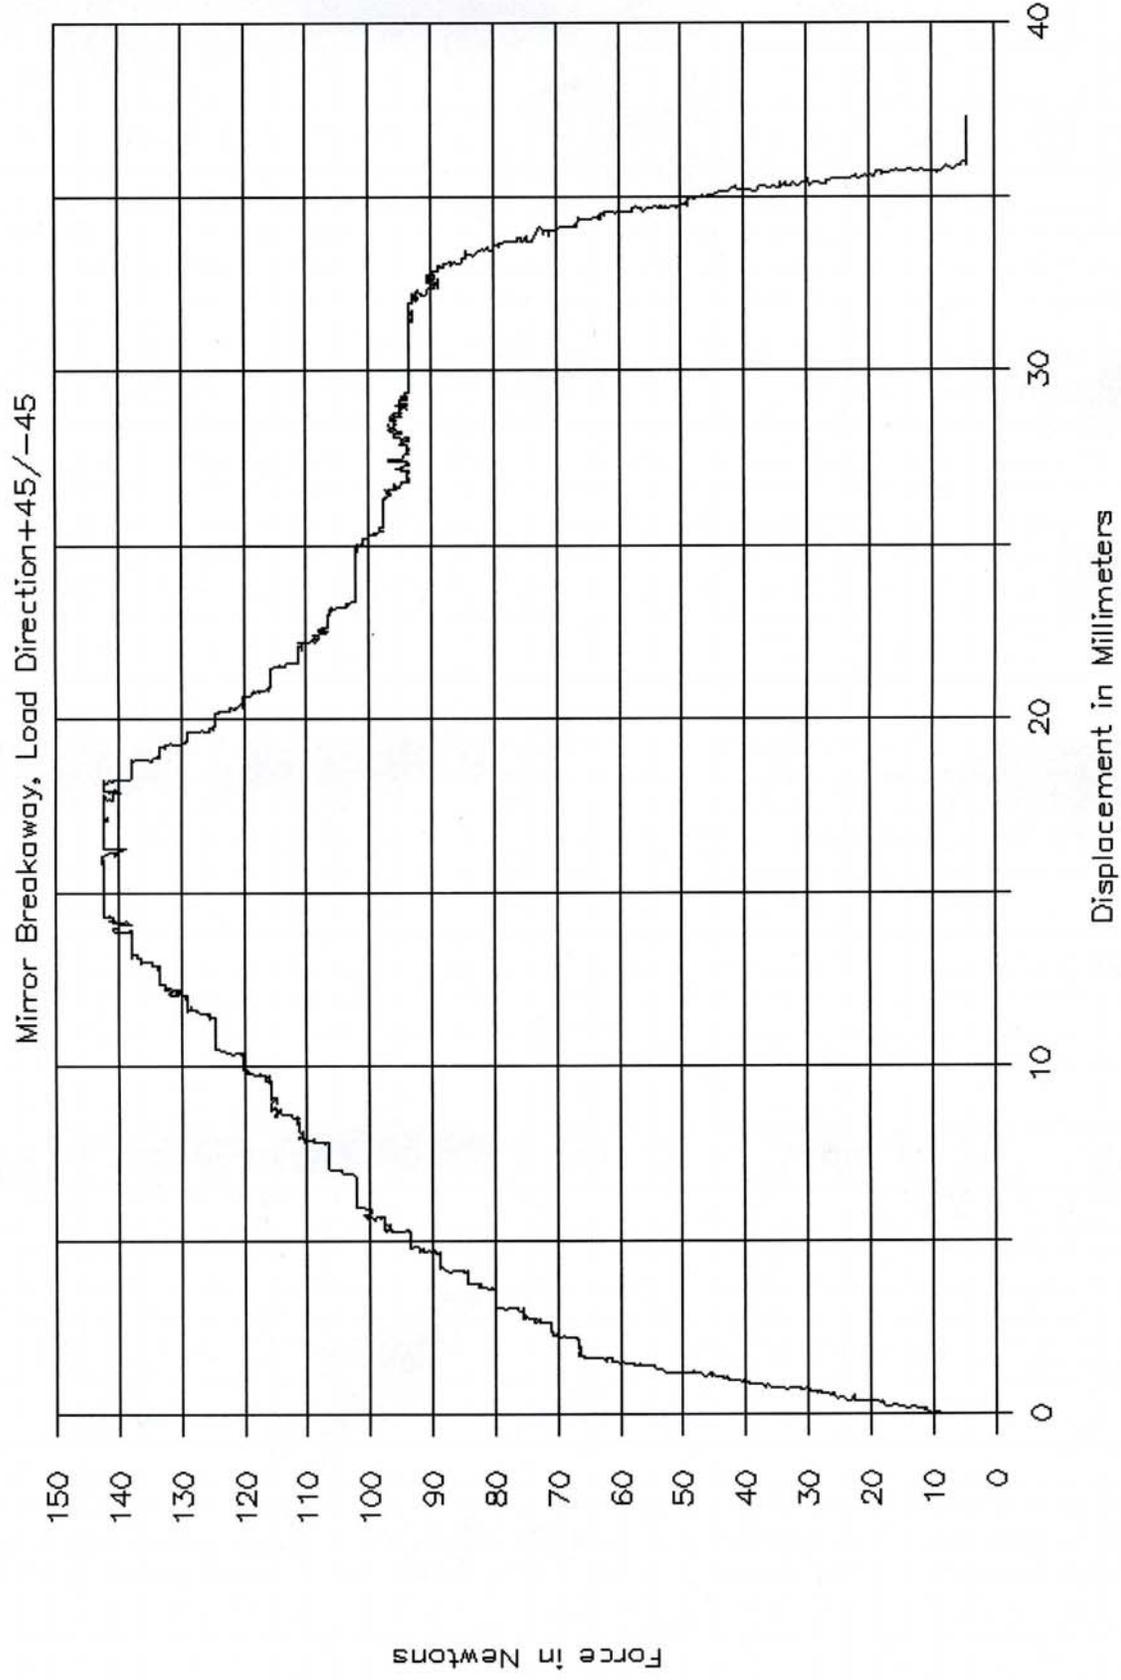
# GTL 5545

TEST NO	LOAD DIRECTION (Vertical/Horizontal)	MAXIMUM FORCE (N)	PASS	FAIL
1 (GTL 5545)	+45°/-45°	142	X	
2 (GTL 5546)	+45°/90°	133	X	
3 (GTL 5547)	+45°/+45°	116	X	
4 (GTL 5548)	-45°/+45°	62	X	
5 (GTL 5549)	-45°/90°	58	X	
6 (GTL 5550)	-45°/-45°	41	X	
7 (GTL 5551)	0°/90°	355	X
