REPORT NUMBER 111-GTL-06-003

SAFETY COMPLIANCE TESTING FOR FMVSS NO. 111 REARVIEW MIRRORS

MITSUBISHI MOTORS NORTH AMERICA, INC.
2006 MITSUBISHI ECLIPSE, PASSENGER CAR
NHTSA NO. C65600

FINAL REPORT

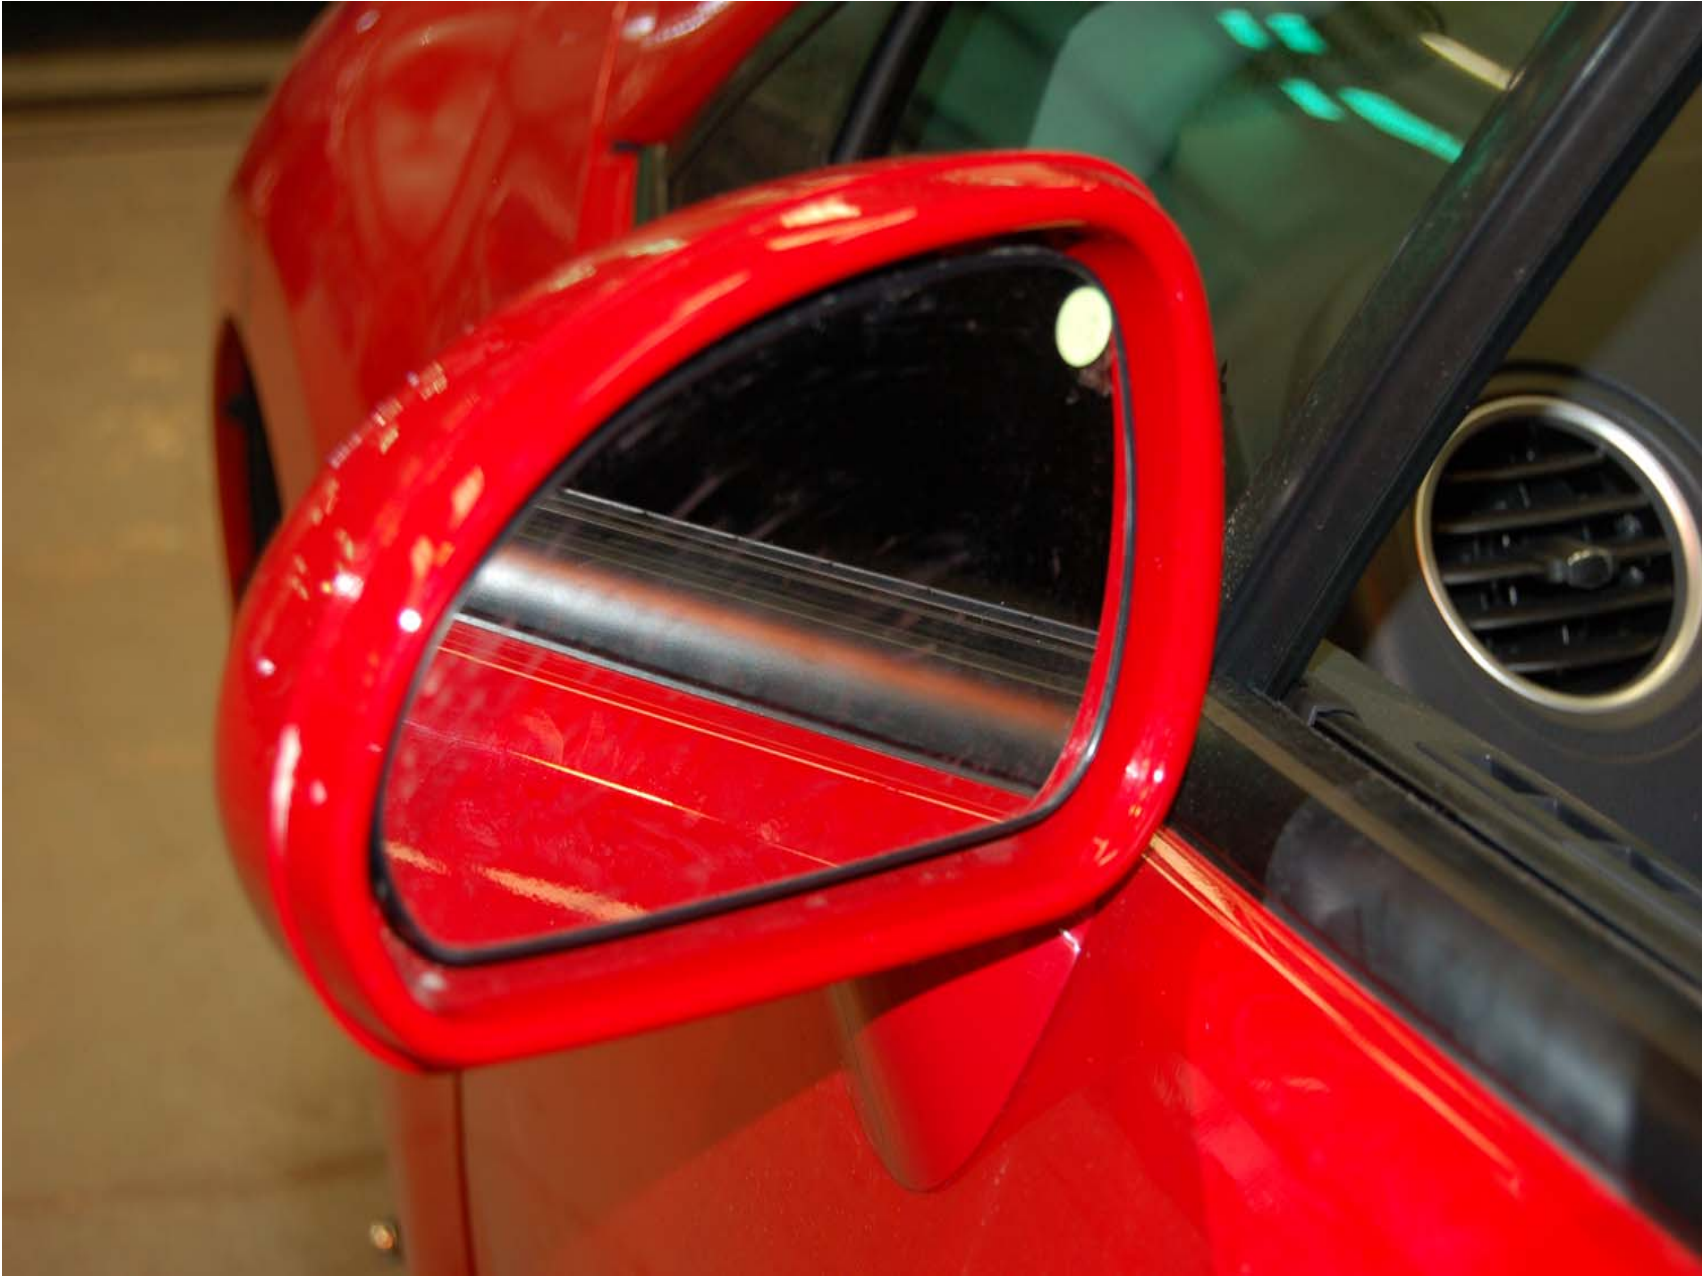
FIGURE 5.7
DRIVER SIDE REARVIEW MIRROR & MOUNTING

PASS	FAIL	COMMENTS
STABLE SUPPORT	X		
DOES NOT PROTRUDE BEYOND VEHICLE BODY	X		Mirror does protrude farther than the widest part of the vehicle body but the protrusion is required to meet the field of view requirements.
NOT OBSCURED BY UNWIPED PORTION OF WINDSHIELD	X		
ADJUSTABLE BY TILTING	X		
ADJUSTABLE FROM DRIVER SEAT	X		
FREE OF SHARP EDGES	X		
FIELD-OF-VIEW	X		
REFLECTANCE	X		
UNIT MAGNIFICATION	X

DRIVER'S SIDE OUTSIDE: 95 mm X 170 mm FLAT GLASS MIRROR WITH
4-WAY ELECTRIC ADJUST.

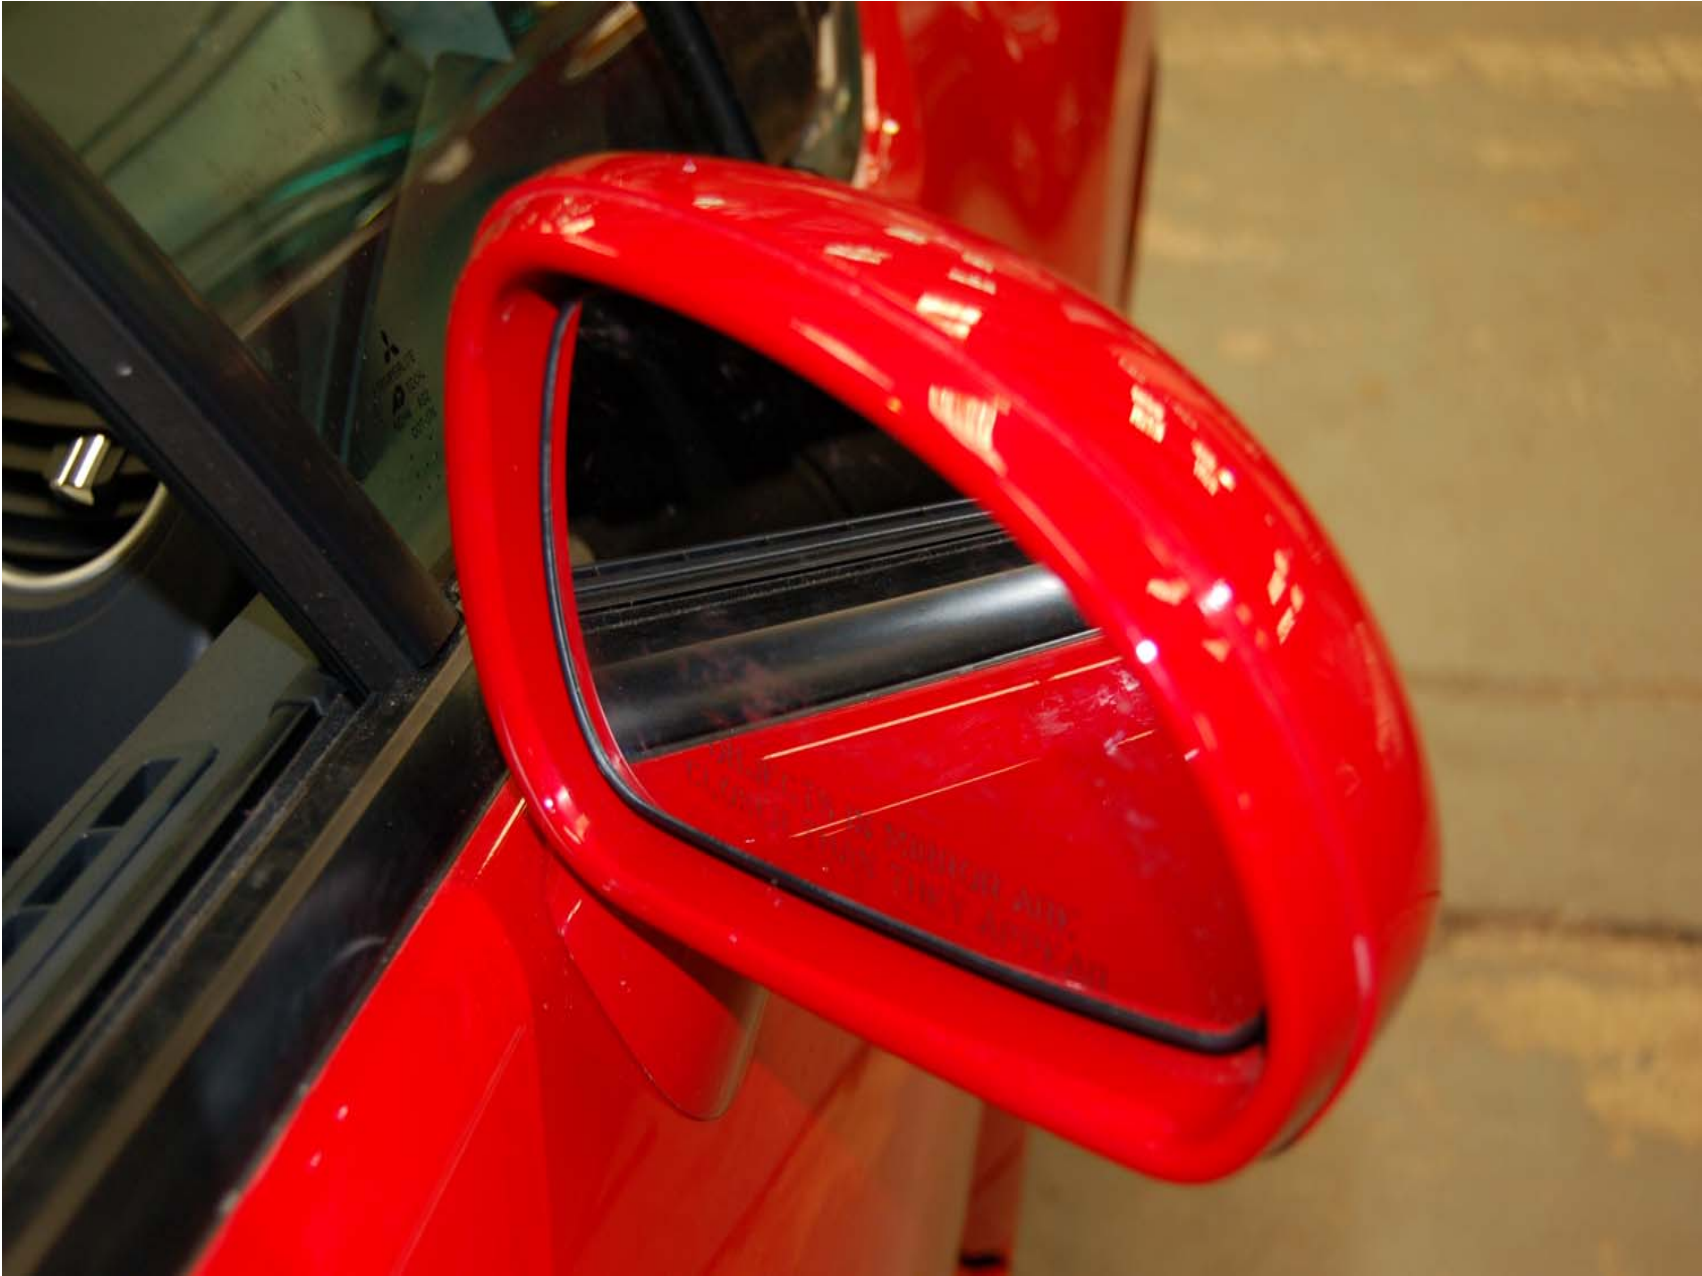
FIGURE 5.8
PASSENGER SIDE REARVIEW MIRROR AND
MOUNTING

REMARKS: This vehicle is equipped with an outside passenger side rear view mirror that is not required by FMVSS No. 111. Each passenger car whose inside rear view mirror does not meet the field of view requirements of the standard shall have an outside mirror of unit magnification or a convex mirror installed on the passenger's side.

PASSENGER'S SIDE OUTSIDE: 95 mm X 170 mm CONVEX GLASS MIRROR
WITH 4-WAY ELECTRIC ADJUST.

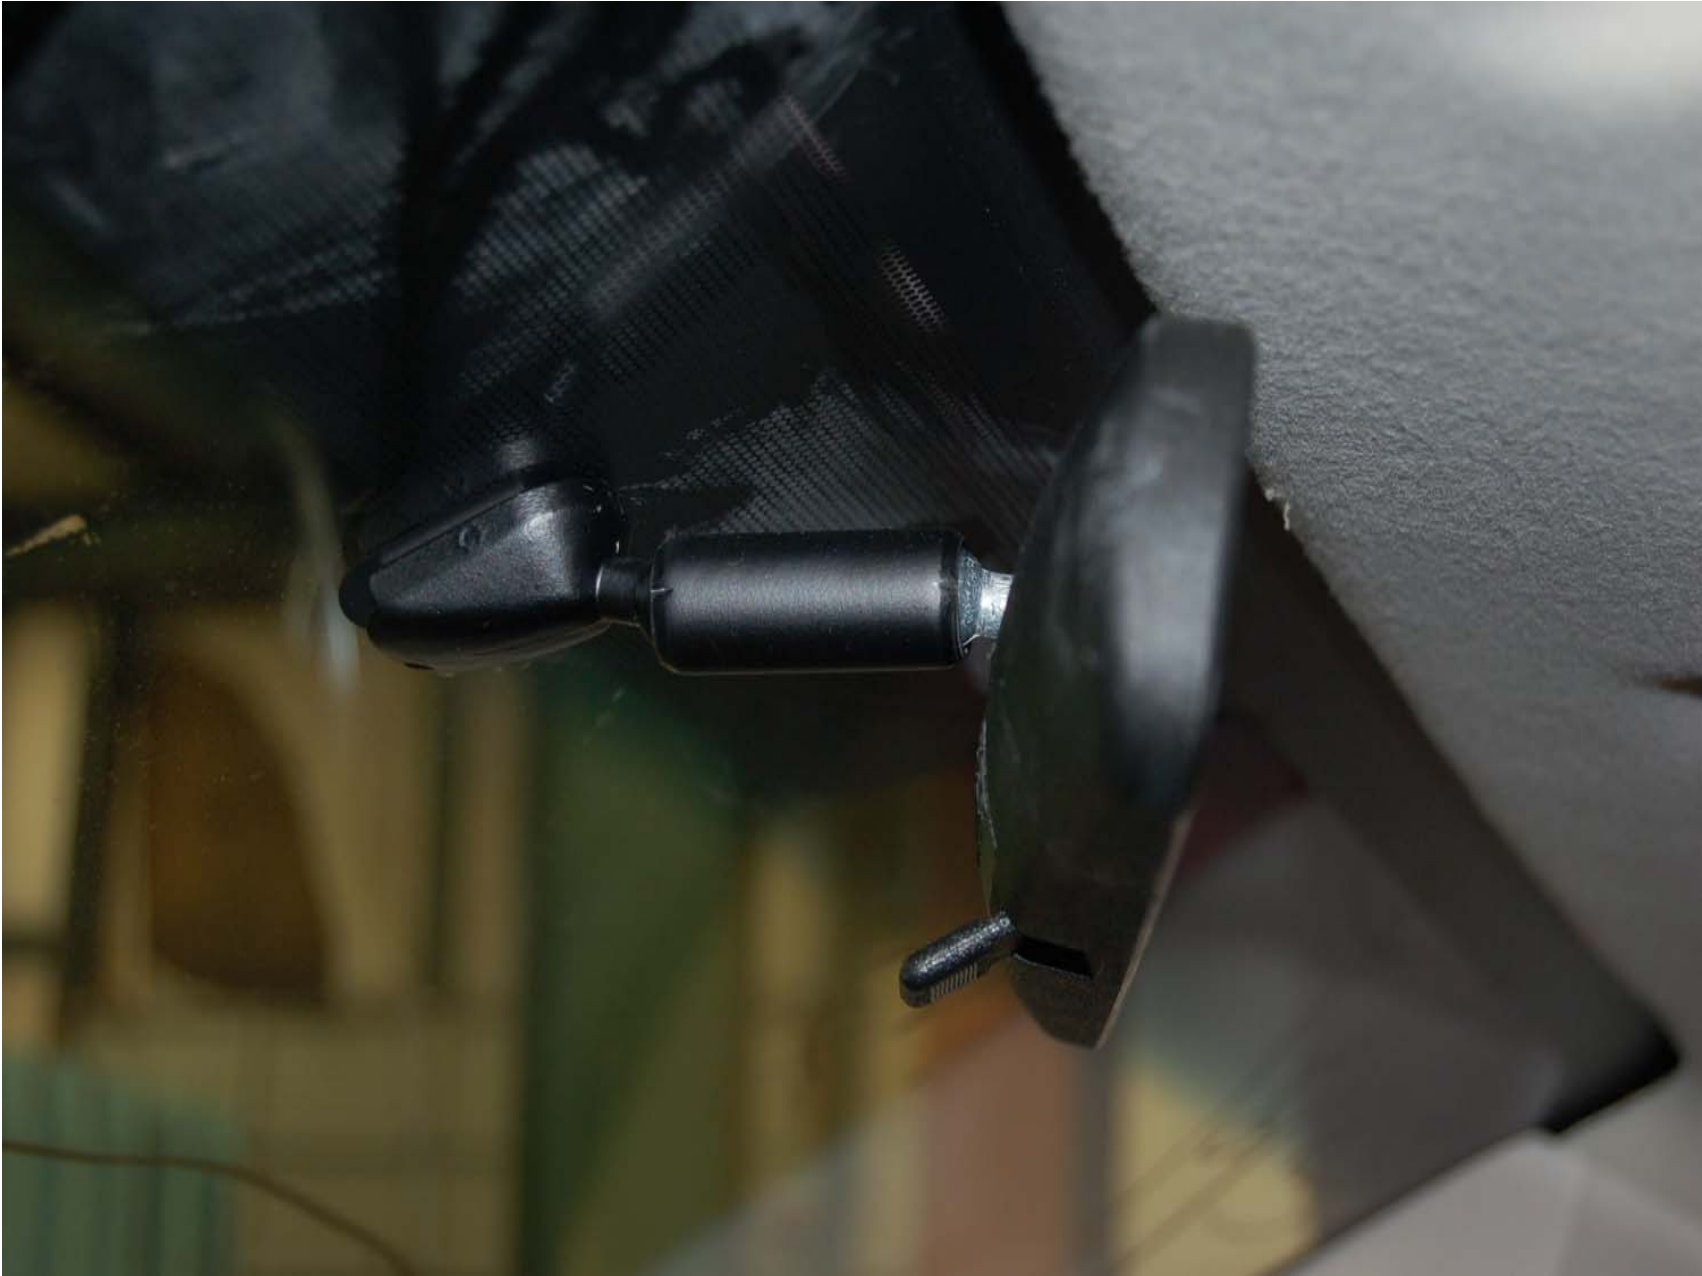
FIGURE 5.9
INSIDE REARVIEW MIRROR AND MOUNTING

INSIDE REARVIEW: 55 mm X 230 mm FLAT GLASS MIRROR WITH MANUAL
2-POSITION DAY/NIGHT.

MOUNTING OF MIRROR (INSIDE) DESCRIPTION:
MIRROR MOUNTED THROUGH DUAL BALL LINK JOINT TO WINDSHIELD MOUNT
WHICH IS ATTACHED TO GLASS WITH ADHESIVE.

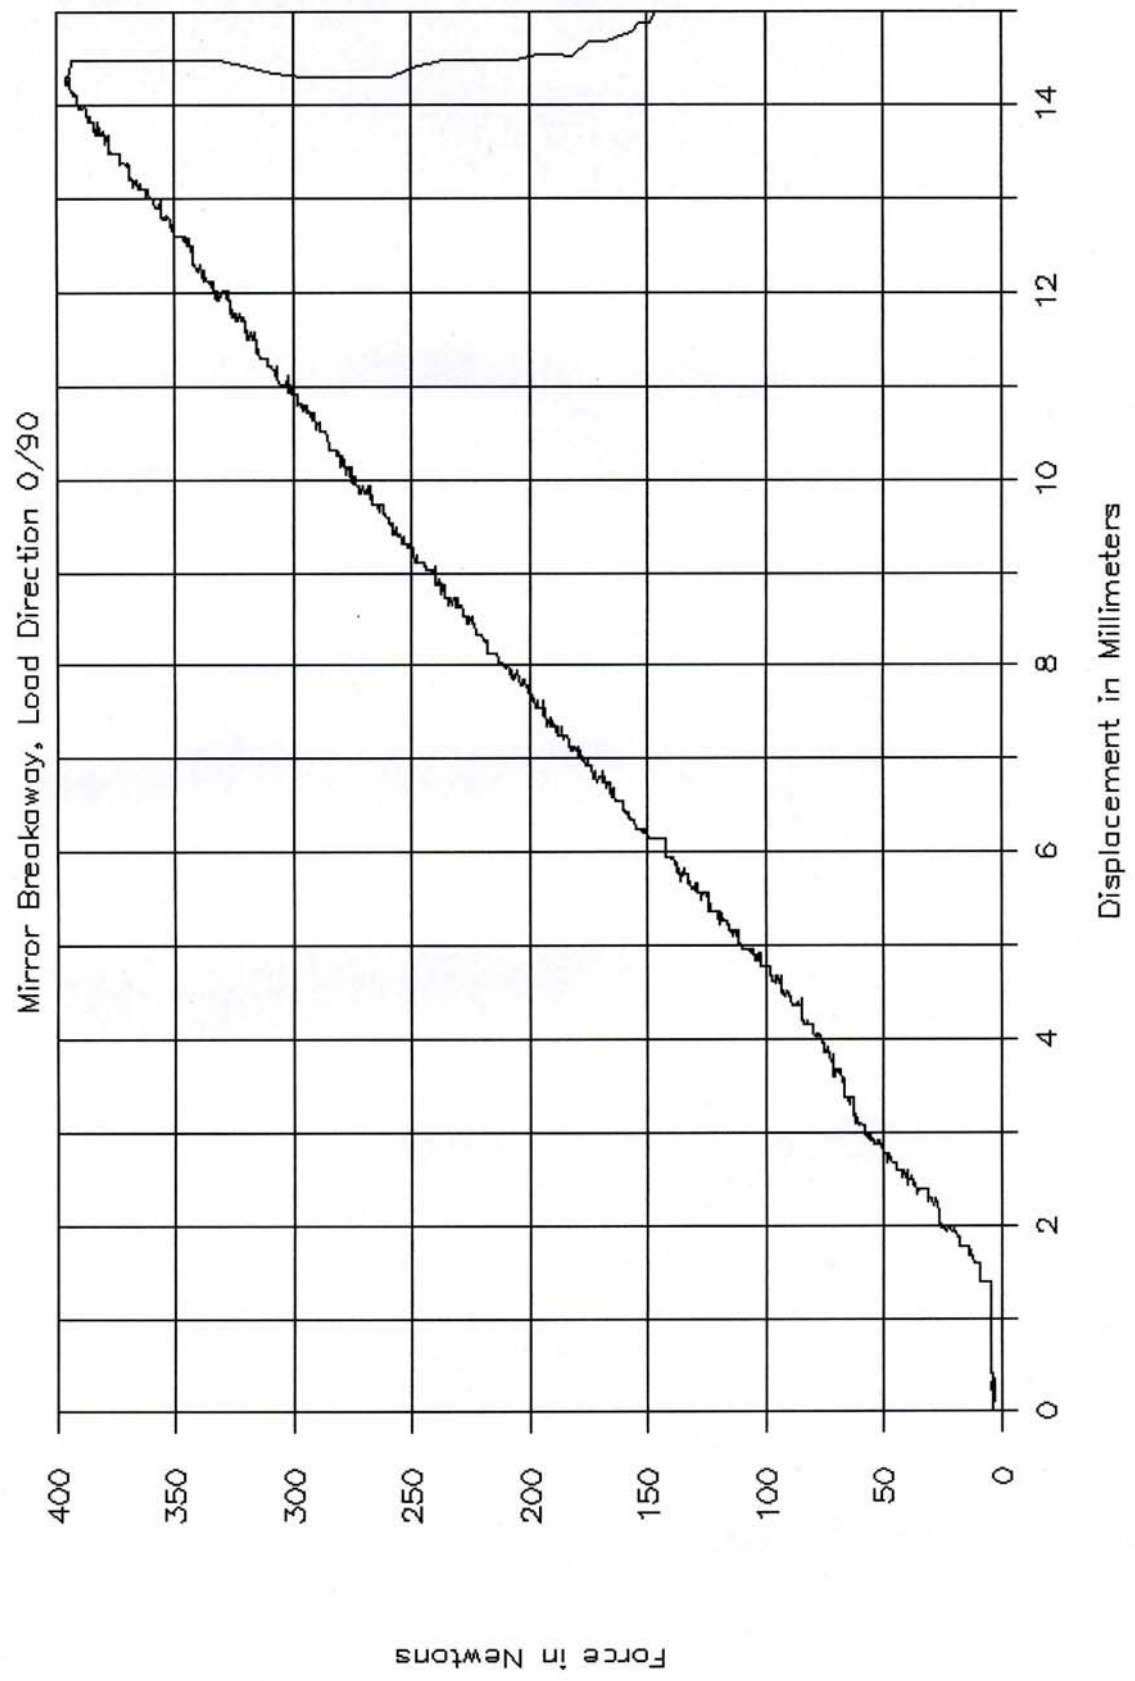
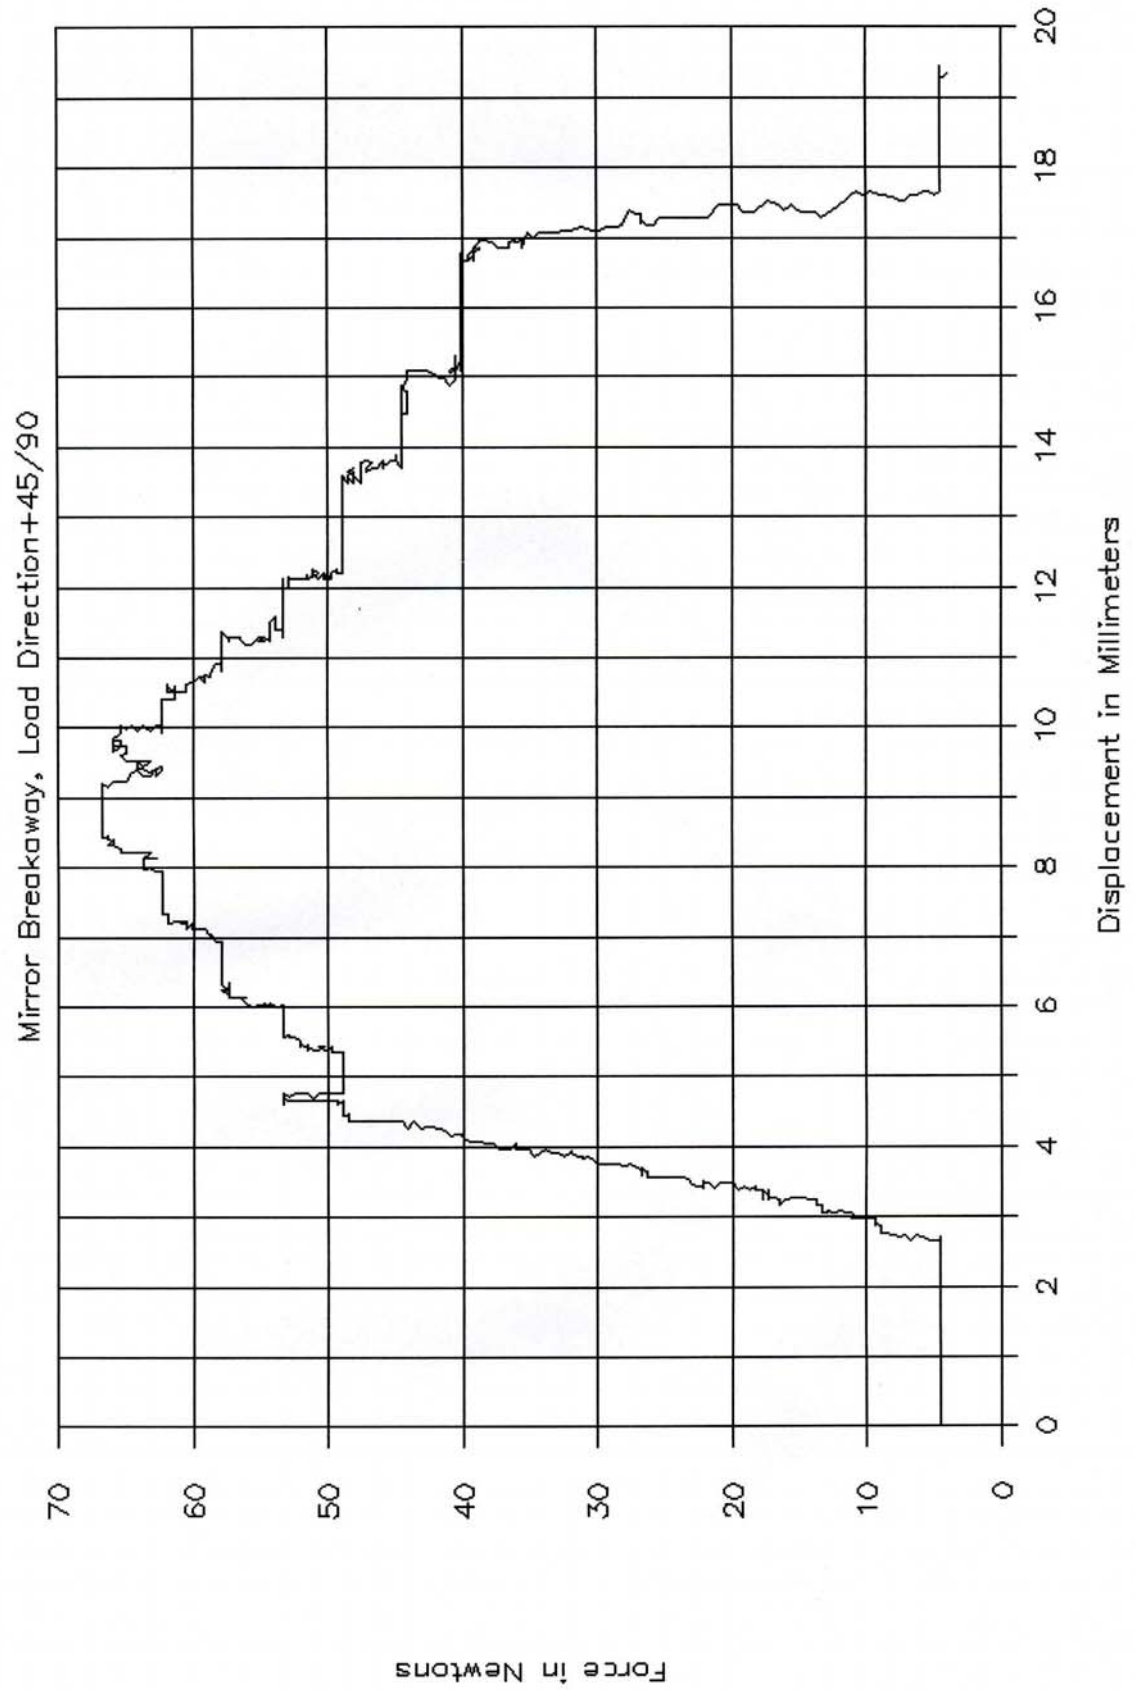
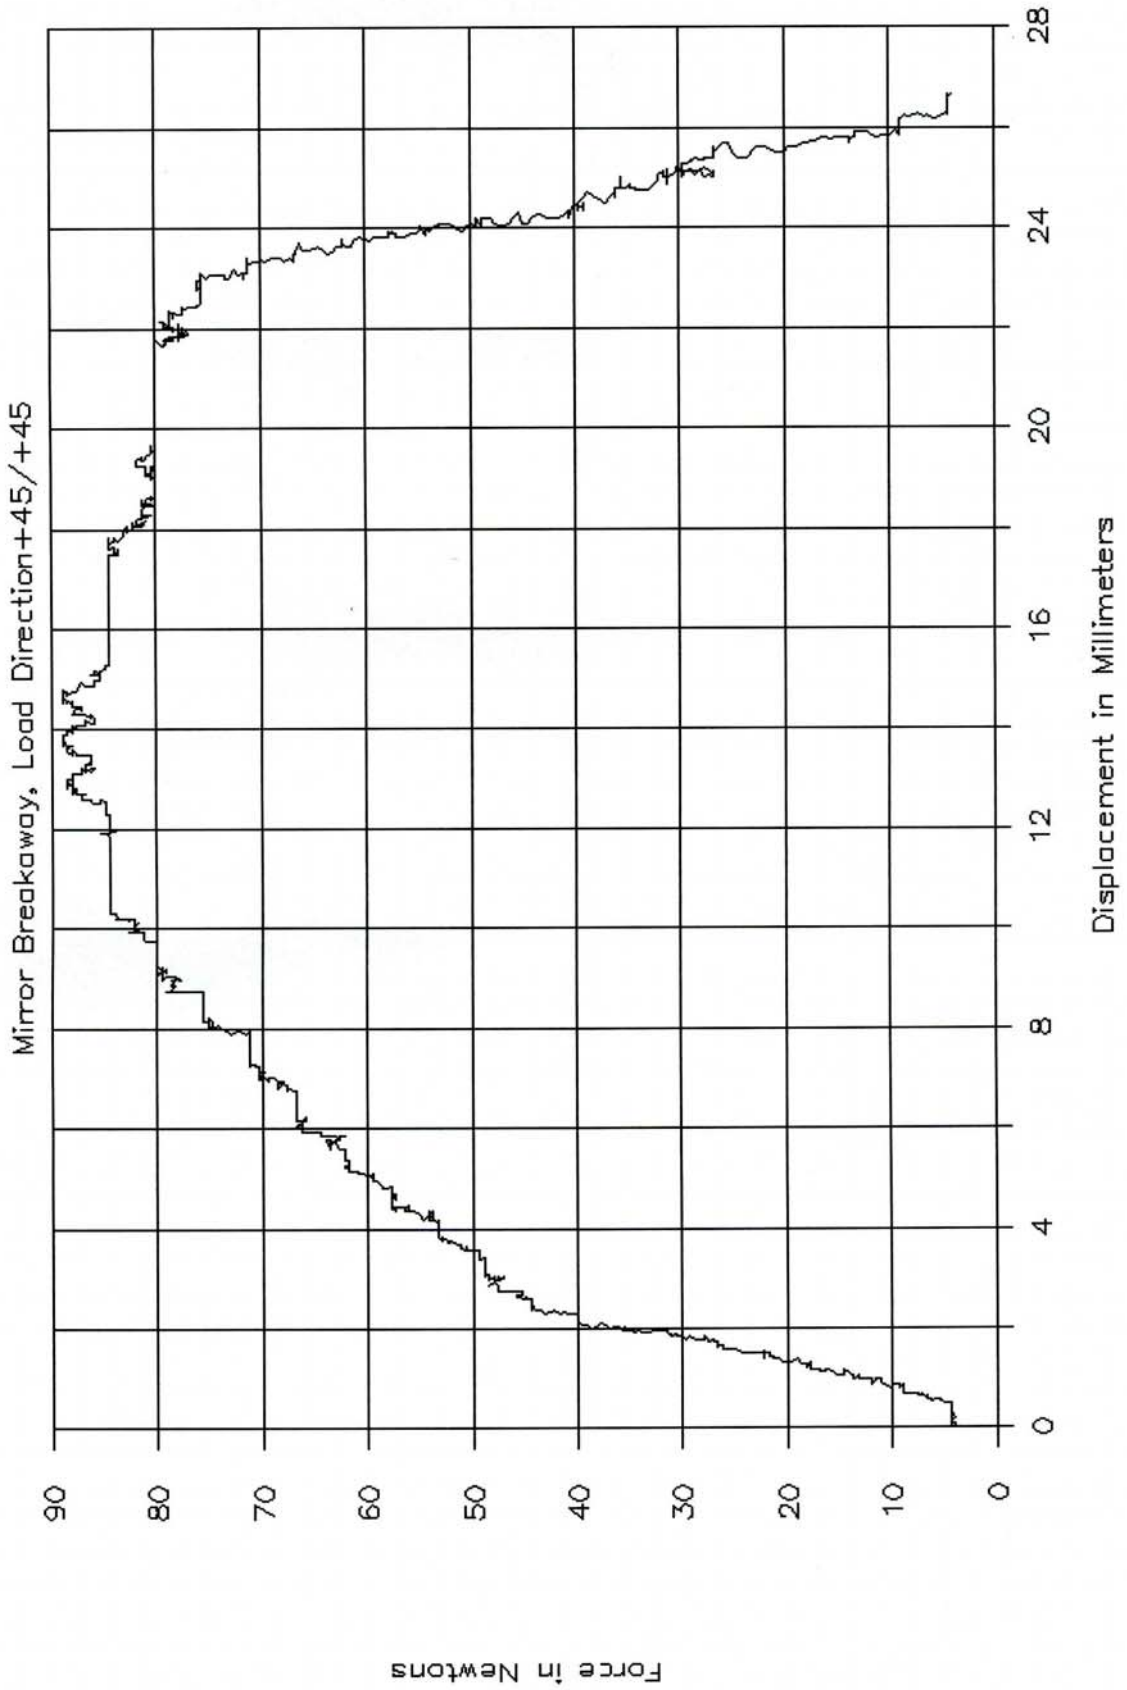
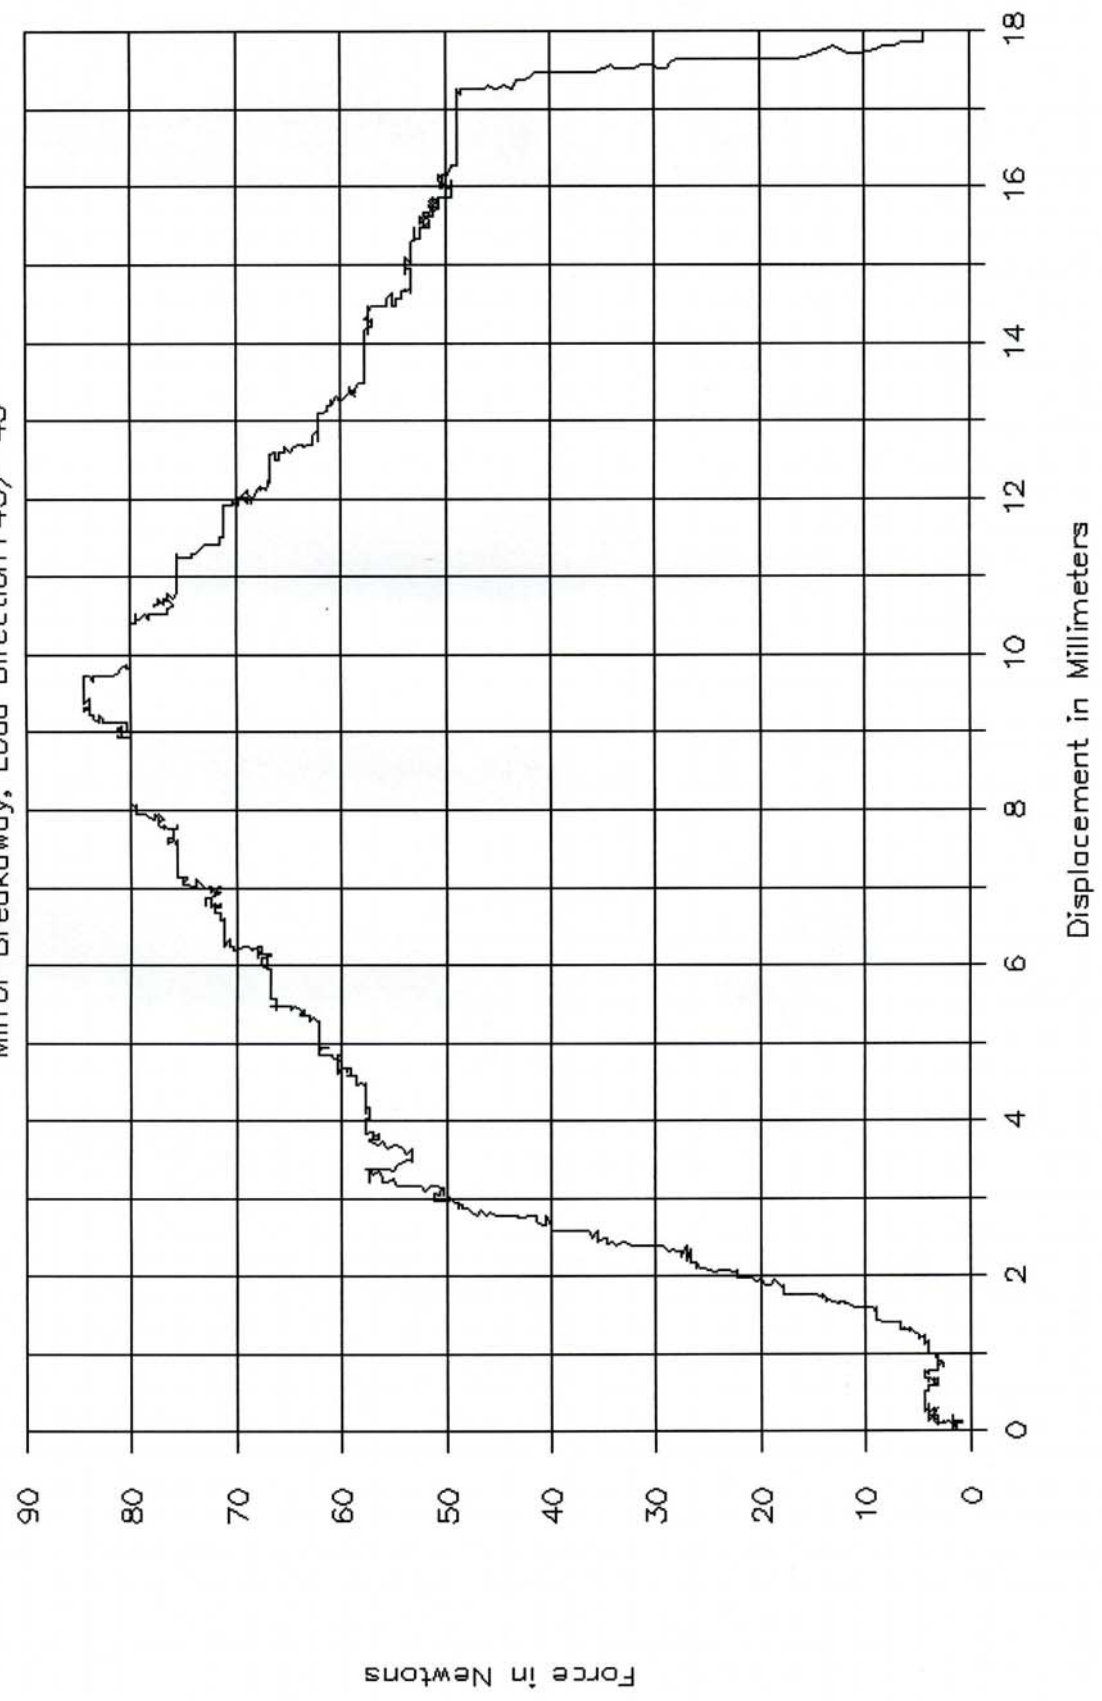
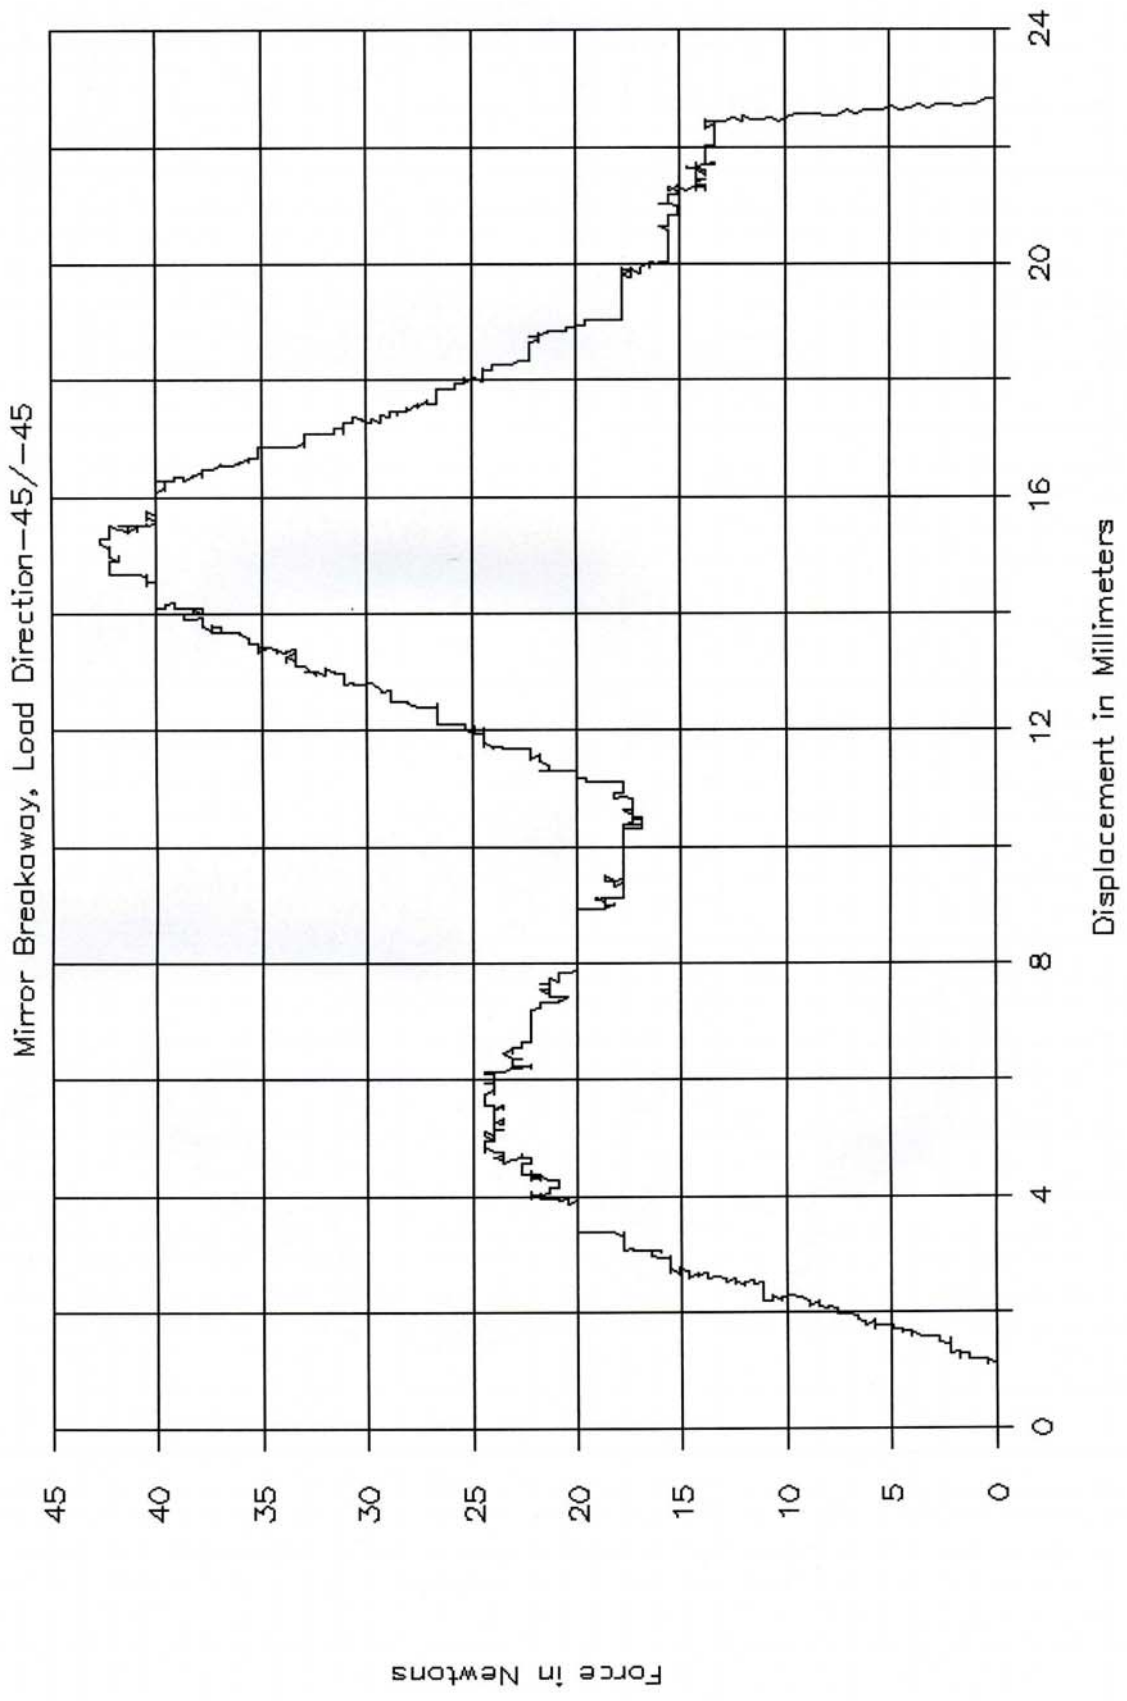
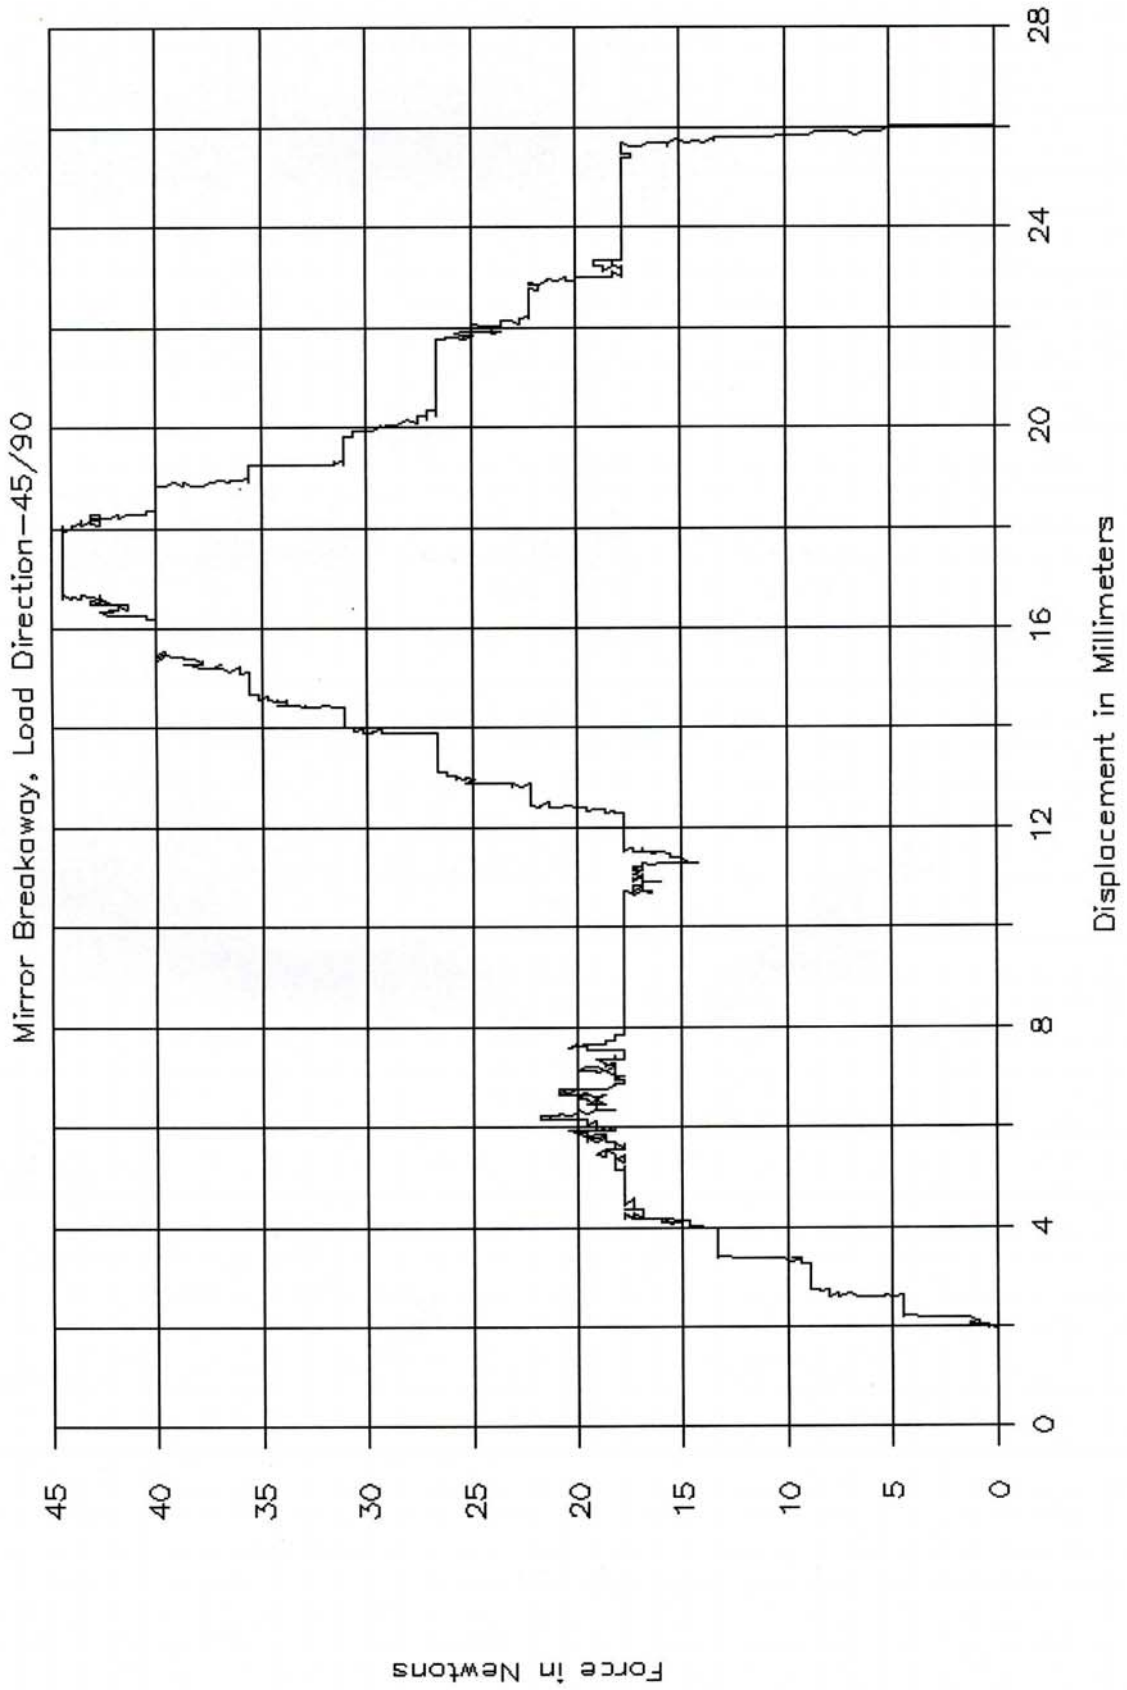
SECTION 6
FORCE VS. DISPLACEMENT PLOTS

TEST NO	LOAD DIRECTION (Vertical/Horizontal)	MAXIMUM FORCE (N)	PASS	FAIL
1 (GTL 5552)	0°/90°	396	X	
2 (GTL 5553)	+45°/90°	67	X	
3 (GTL 5554)	+45°/+45°	89	X	
4 (GTL 5555)	+45°/-45°	85	X	
5 (GTL 5556)	-45°/-45°	43	X	
6 (GTL 5557)	-45°/90°	45	X	
7 (GTL 5558)	-45°/+45°	22	X

DESCRIPTION OF MIRROR MOVEMENT (DEFLECT, COLLAPSE, OR BREAKAWAY)
 FIRST MOVEMENT OF MIRROR WITHOUT INCREASE IN LOAD IS DUE TO MOVEMENT
 OF BALL LINKS AND CONNECTOR SHAFT.
