REPORT NUMBER 111-GTL-06-005

SAFETY COMPLIANCE TESTING FOR FMVSS NO. 111 REARVIEW MIRRORS

HONDA OF CANADA MFG.,
DIVISION OF HONDA CANADA INC.
2006 HONDA RIDGELINE, TRUCK
NHTSA NO. C65300

FINAL REPORT

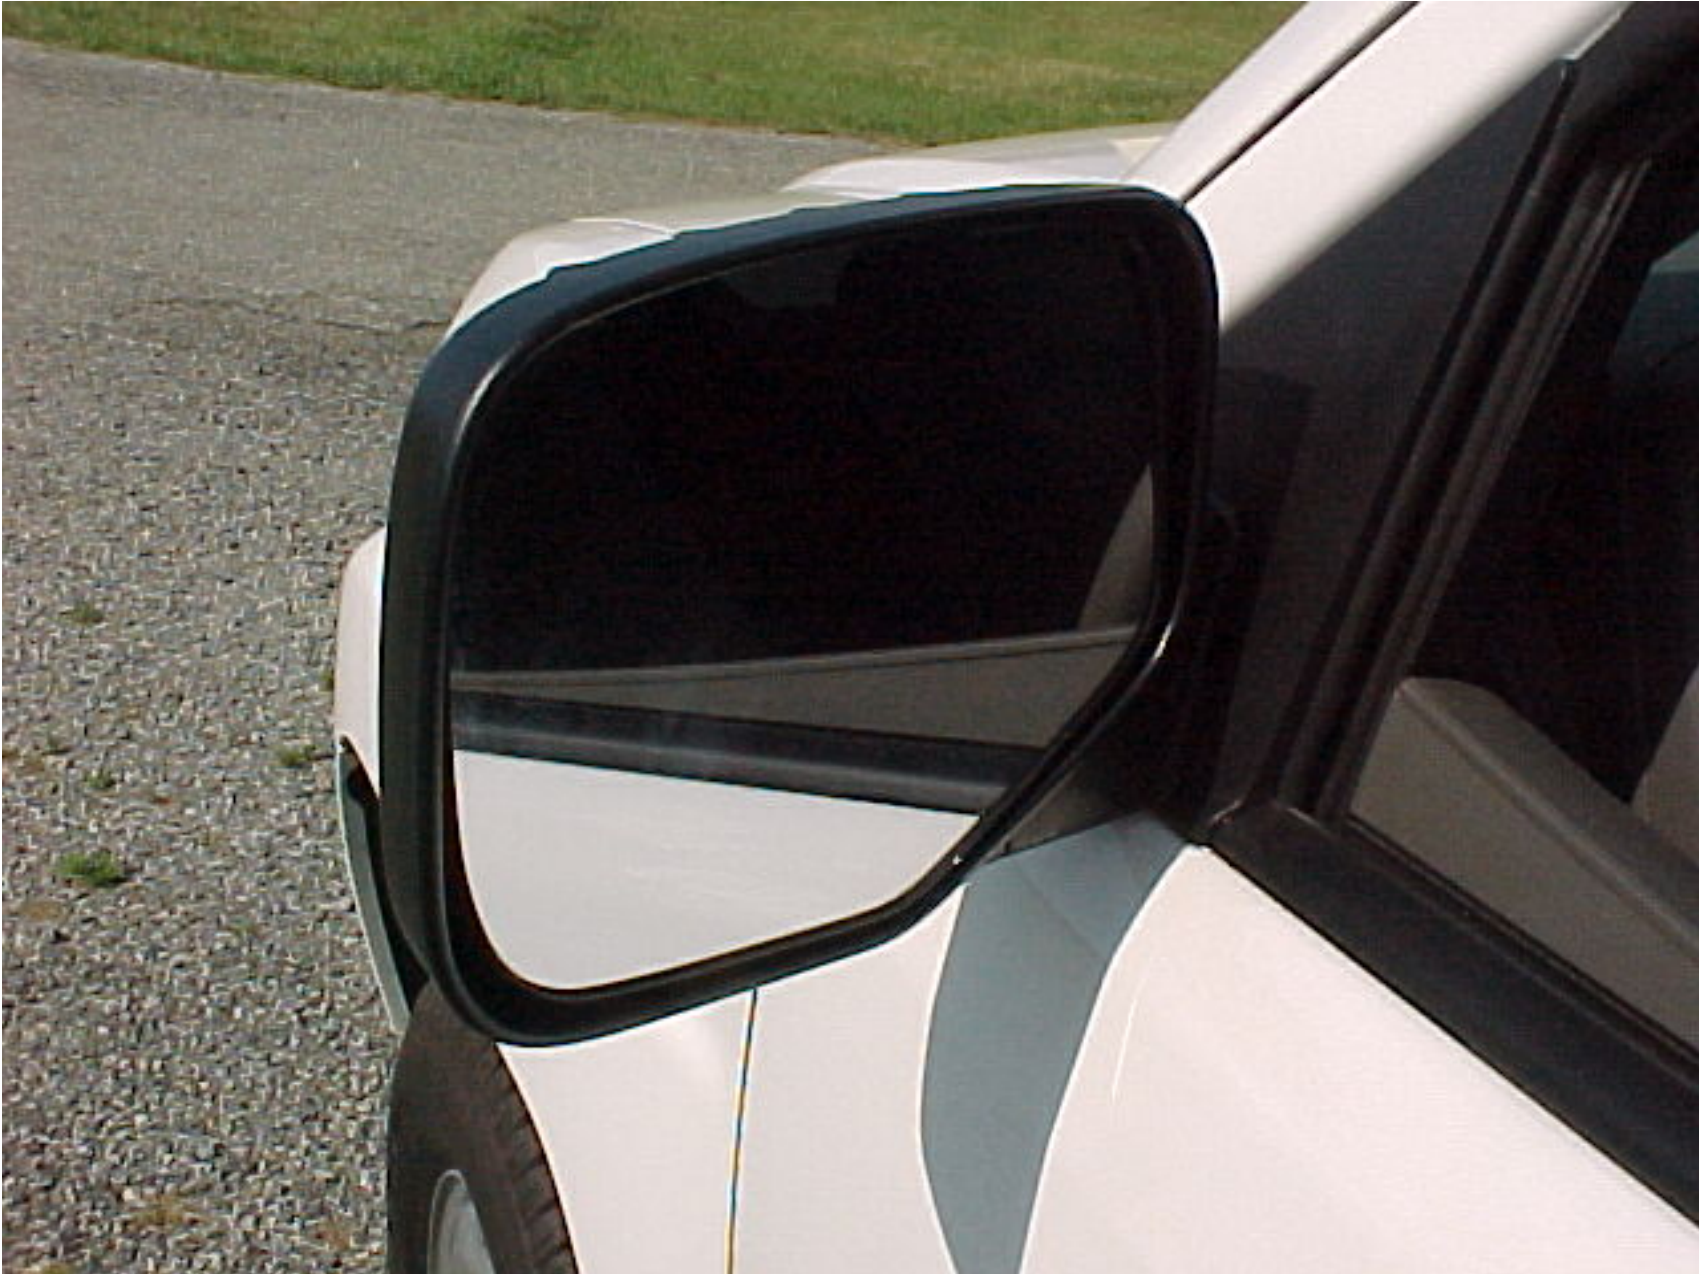
FIGURE 5.7
DRIVER SIDE REARVIEW MIRROR AND MOUNTING

PASS	FAIL	COMMENTS
STABLE SUPPORT	X		See Remarks
DOES NOT PROTRUDE BEYOND VEHICLE BODY	X		Mirror does protrude farther than the widest part of the vehicle body but the protrusion is required to meet the field of view requirements.
NOT OBSCURED BY UNWIPED PORTION OF WINDSHIELD	X		
ADJUSTABLE BY TILTING	X		
ADJUSTABLE FROM DRIVER SEAT	X		
FREE OF SHARP EDGES	X		
FIELD-OF-VIEW	X		
REFLECTANCE	X		
UNIT MAGNIFICATION	X

*Bottom inside corner of triangle is obscured by left rear fender flare. FMVSS 111 allows the area to be partially obscured by the rear body contour.

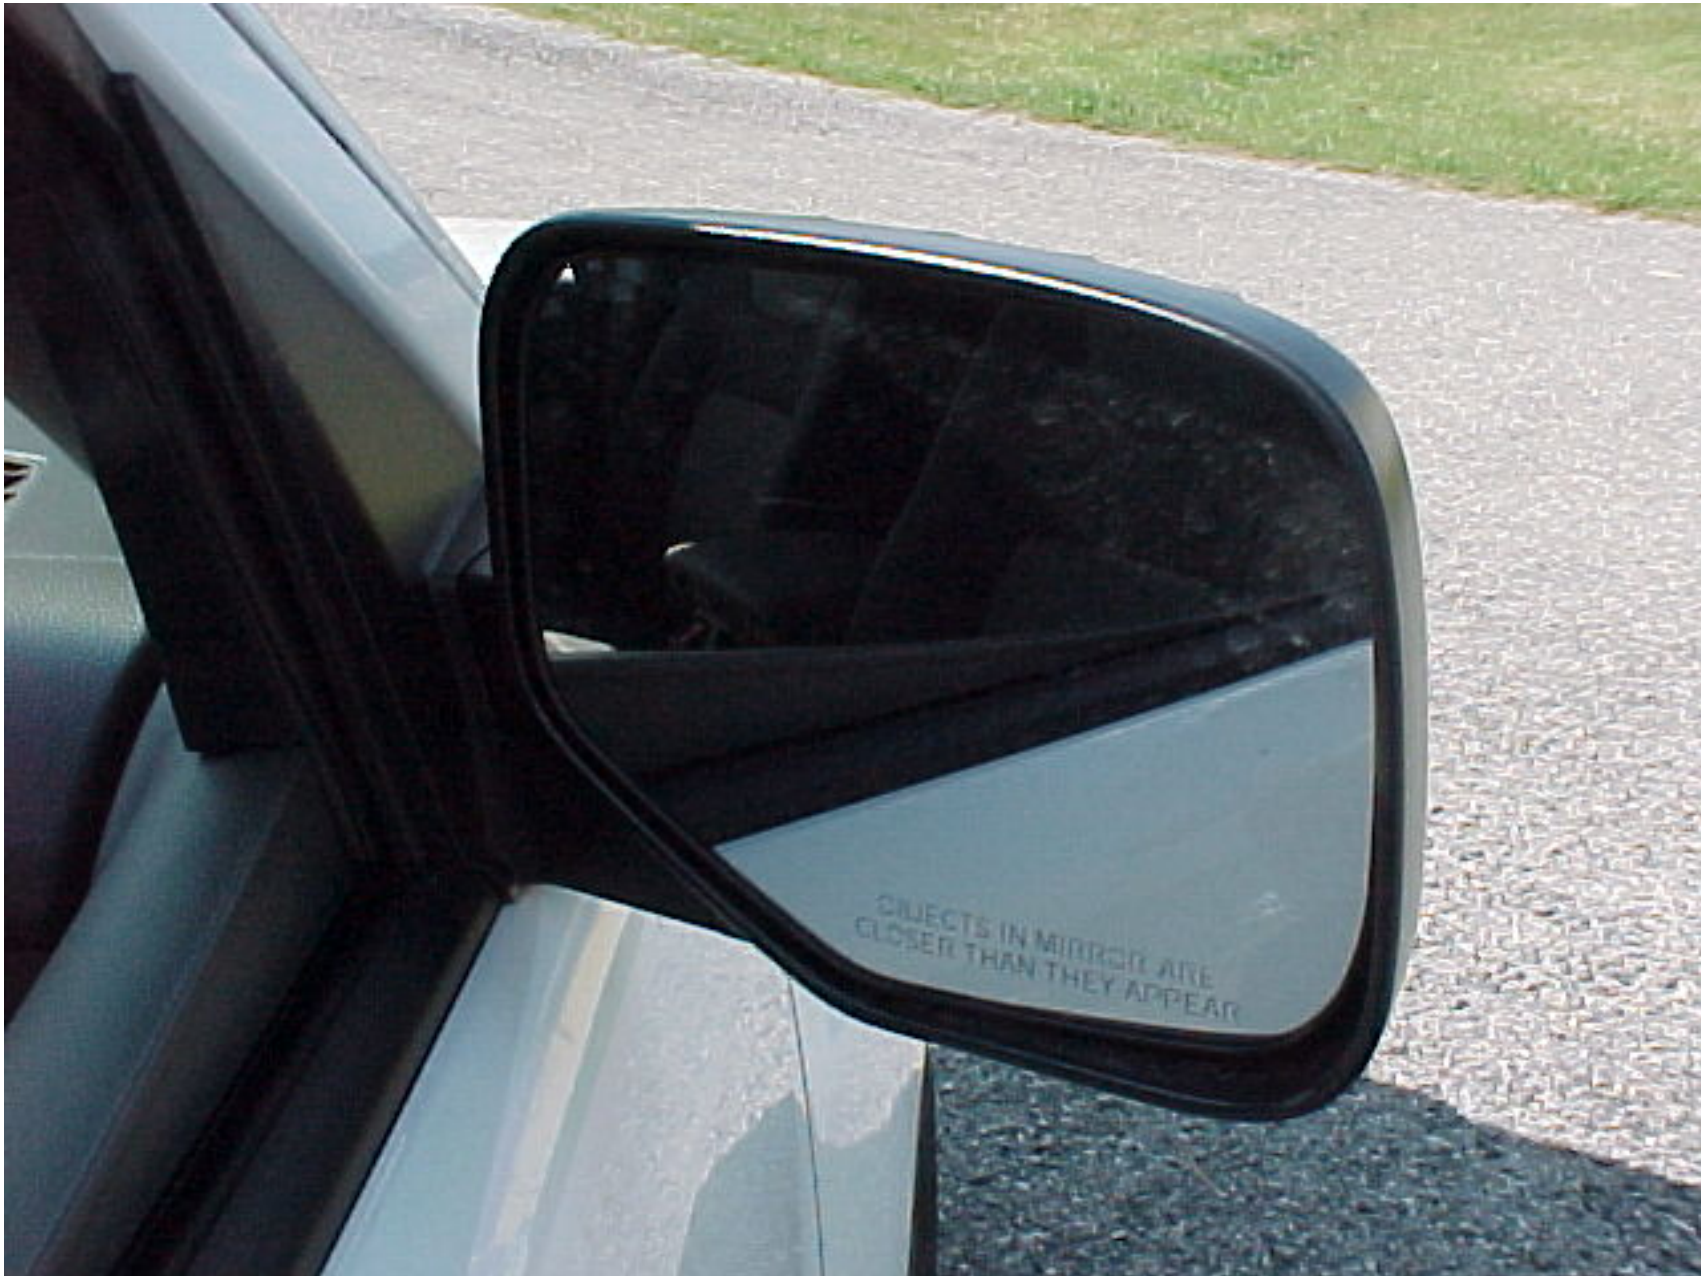
FIGURE 5.8
PASSENGER SIDE REARVIEW MIRROR AND
MOUNTING

The passenger's side mirror was a convex mirror and was properly marked at the lower edge of the mirror's reflective surface with the words, "**Objects in Mirror Are Closer Than They Appear.**"

This vehicle is equipped with an outside passenger side rear view mirror that is not required by FMVSS No. 111. Each passenger car whose inside rear view mirror does not meet the field of view requirements of the standard shall have an outside mirror of unit magnification or a convex mirror installed on the passenger's side.

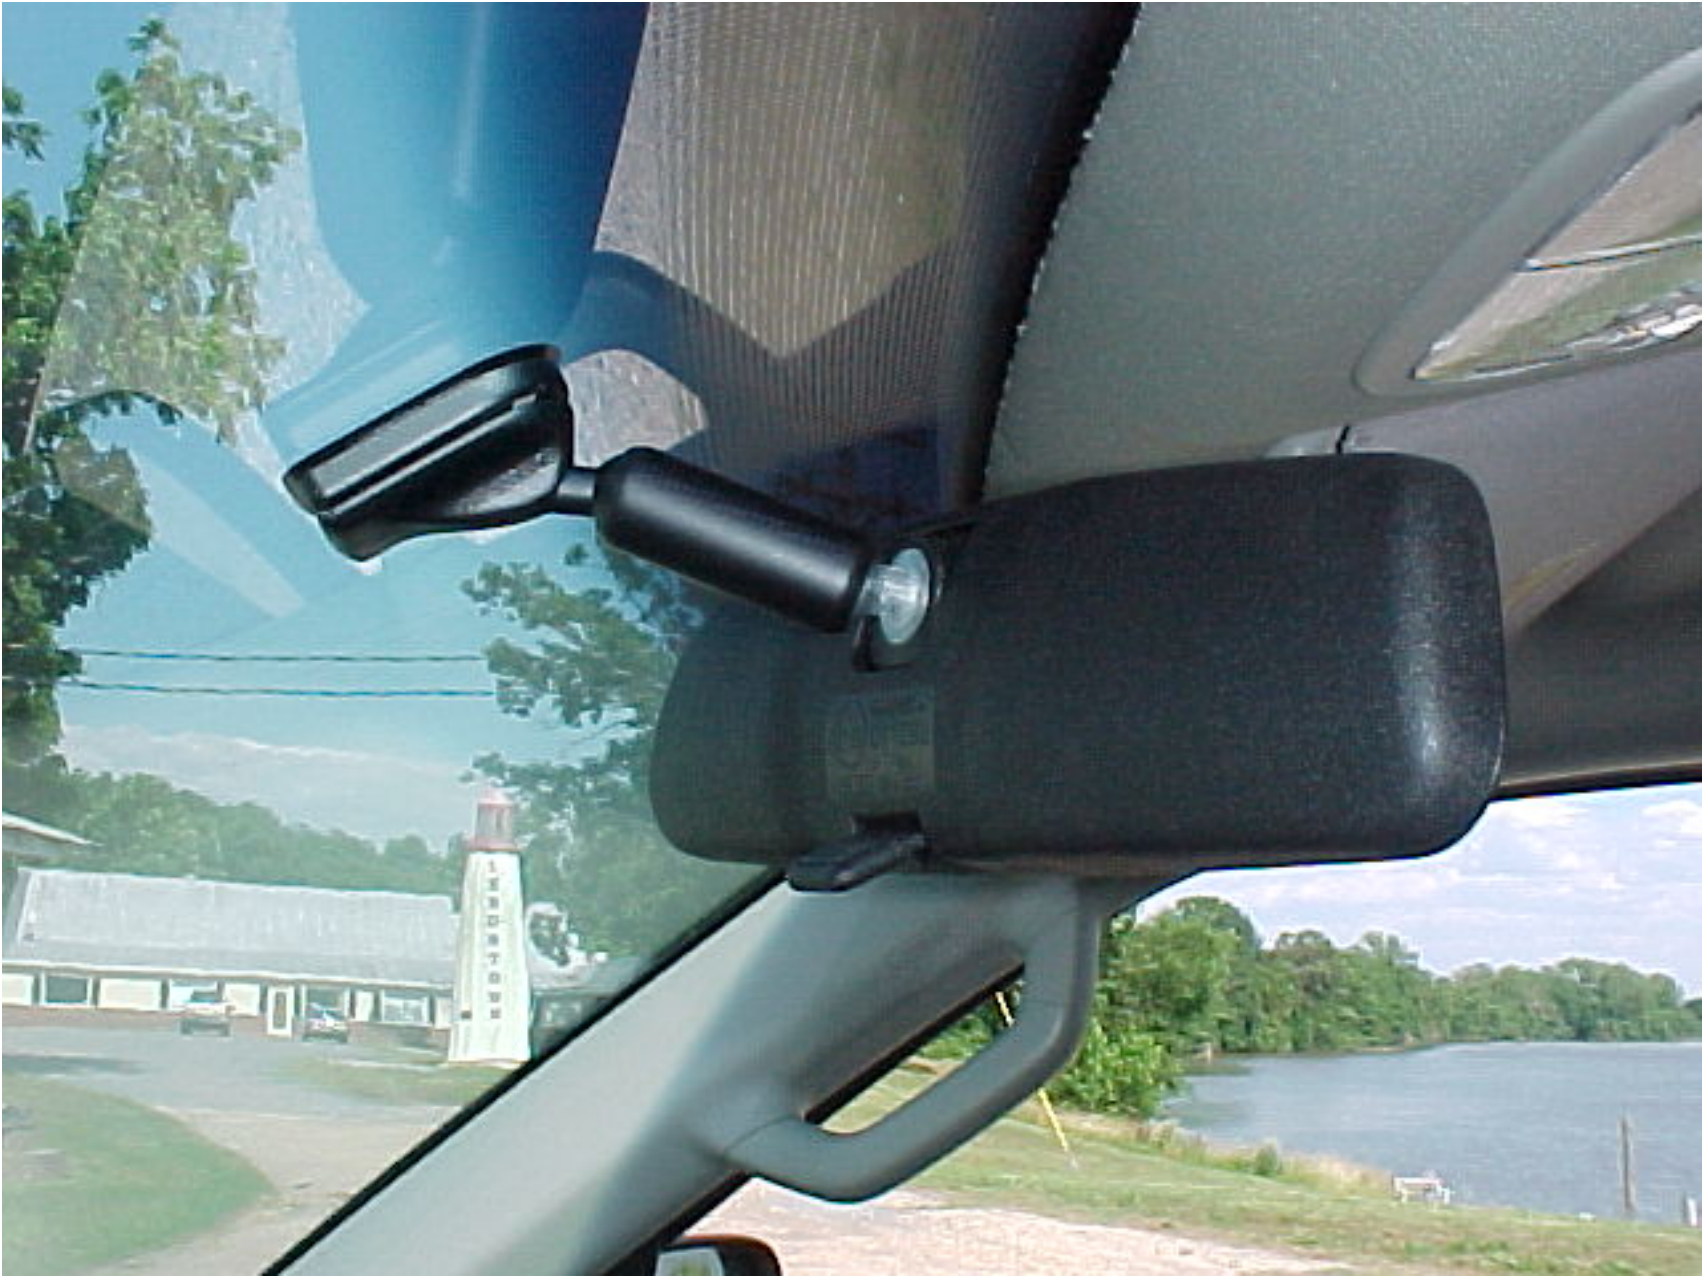
FIGURE 5.9
INSIDE REARVIEW MIRROR AND MOUNTING

MIRROR IS MOUNTED TO WINDSHIELD GLASS THROUGH A DUAL BALL LINK JOINT.

THE WINDSHIELD MOUNT IS ATTACHED TO GLASS WITH HIGH STRENGTH ADHESIVE.

THE BALL LINK IS ATTACHED TO THE WINDSHIELD MOUNT WITH A SPRING CLIP.

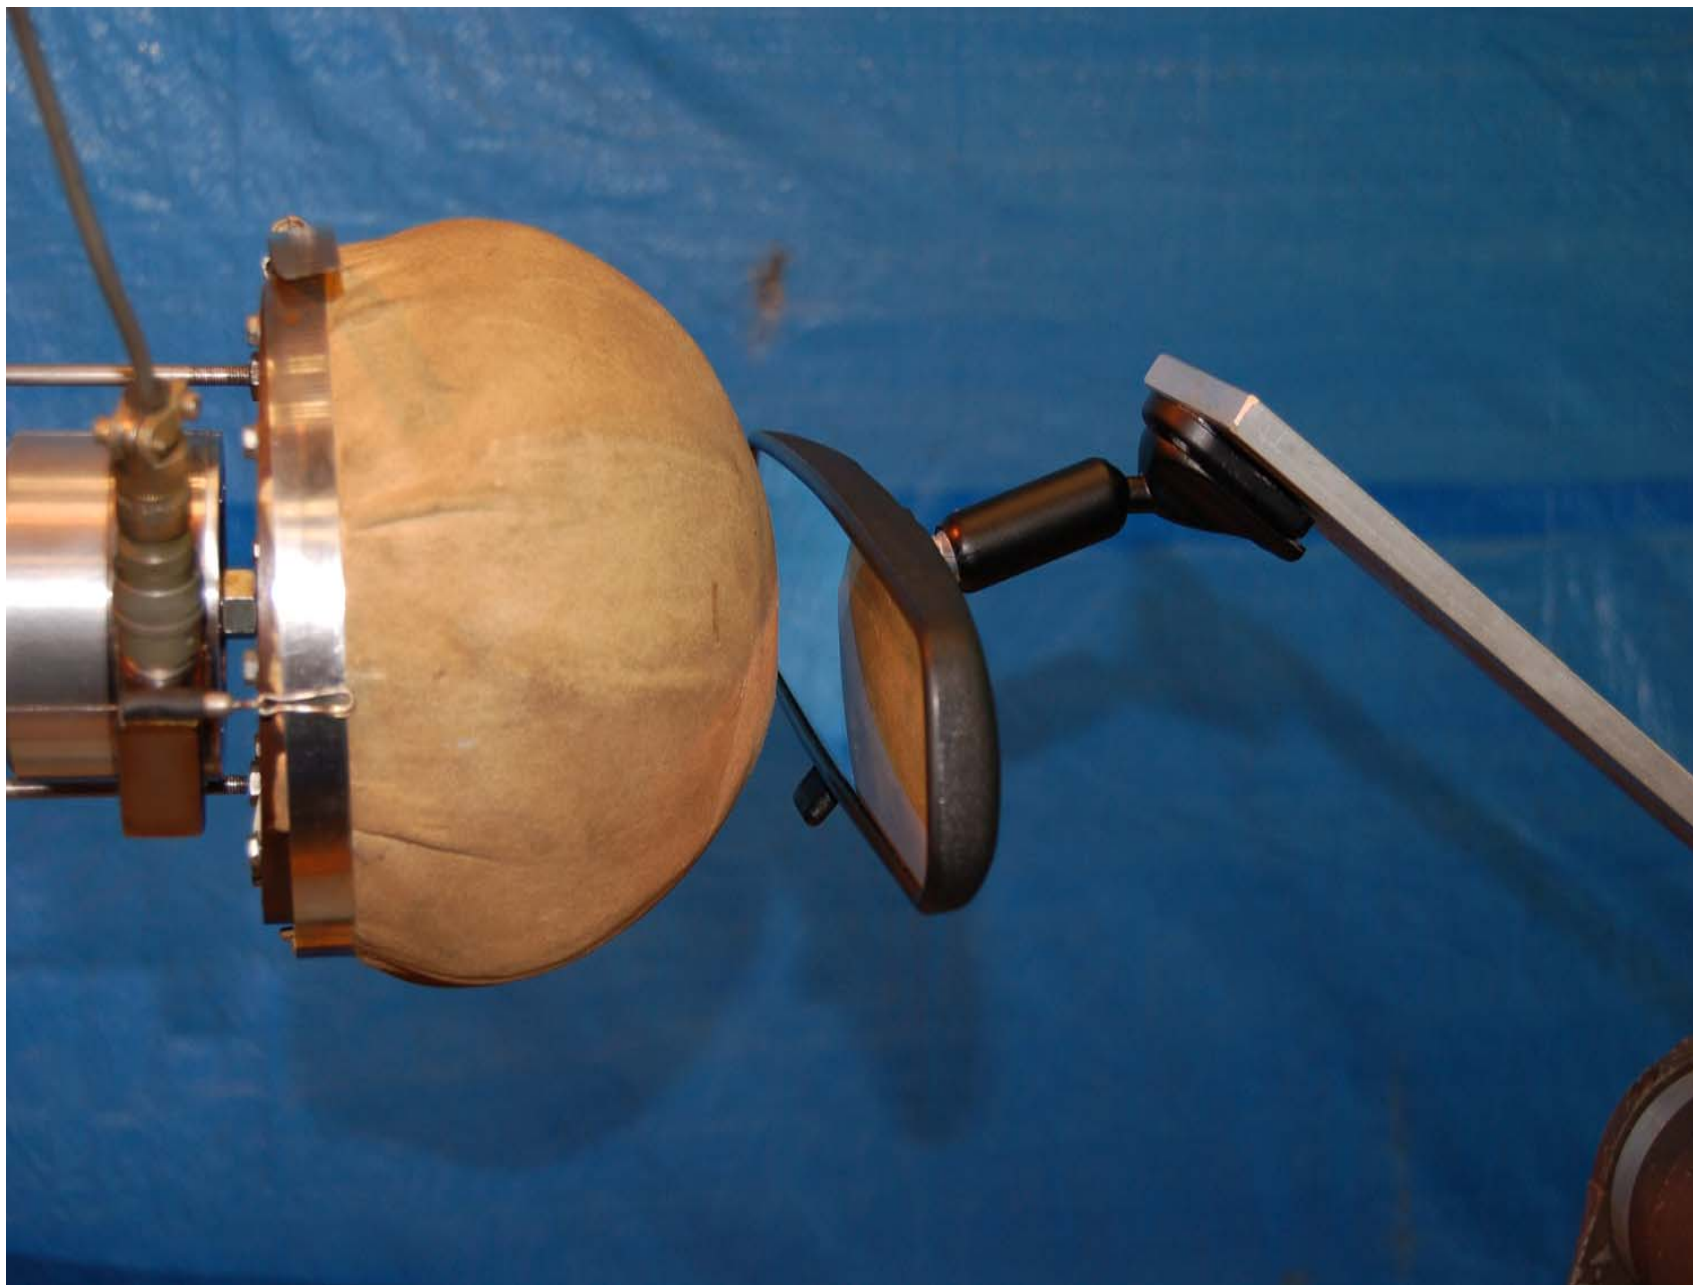
FIGURE 5.12
BREAK-AWAY TEST SET-UP

SPRING MOUNTING CLIP BENT ON TEST #5573 AND WAS STRAIGHTENED BEFORE TEST # 5574

DESCRIPTION OF MIRROR MOVEMENT (DEFLECT, COLLAPSE OR BREAKAWAY): BALL LINK JOINTS MOVE OR LINK SEPARATES FROM WINDSHIELD MOUNT DUE TO SPRING CLIP RELEASING.
