REPORT NUMBER: 301-MGA-2007-001

**SAFETY COMPLIANCE TESTING FOR FMVSS 301R
FUEL SYSTEM INTEGRITY – REAR IMPACT**

**FORD MOTOR COMPANY
2006 FORD EXPEDITION XLT 4X2
NHTSA NUMBER: C60206**

**PREPARED BY:
MGA RESEARCH CORPORATION
5000 WARREN ROAD
BURLINGTON, WI 53105**

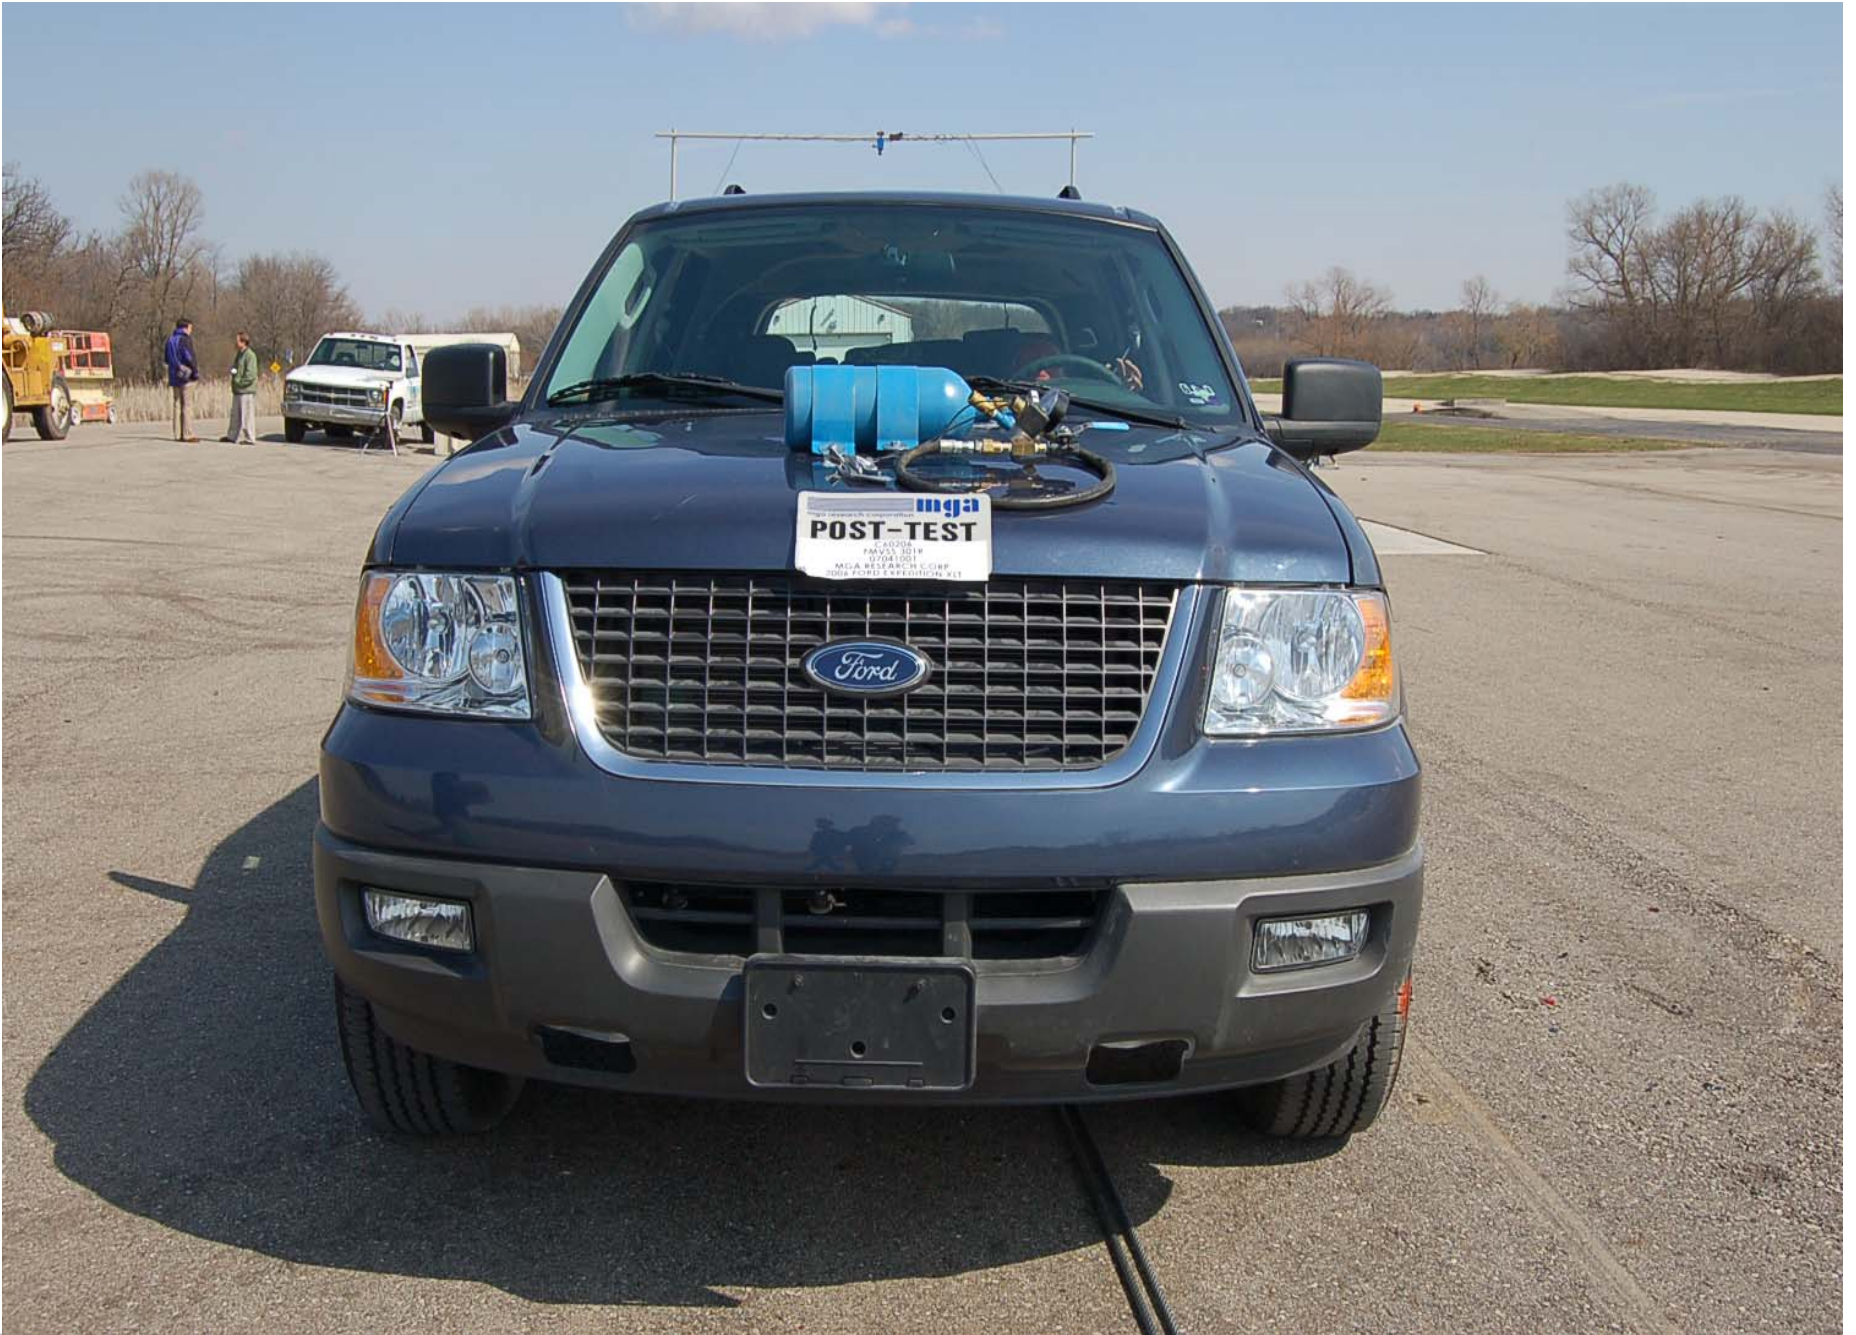
A-4.

Post-Test Front View of Vehicle

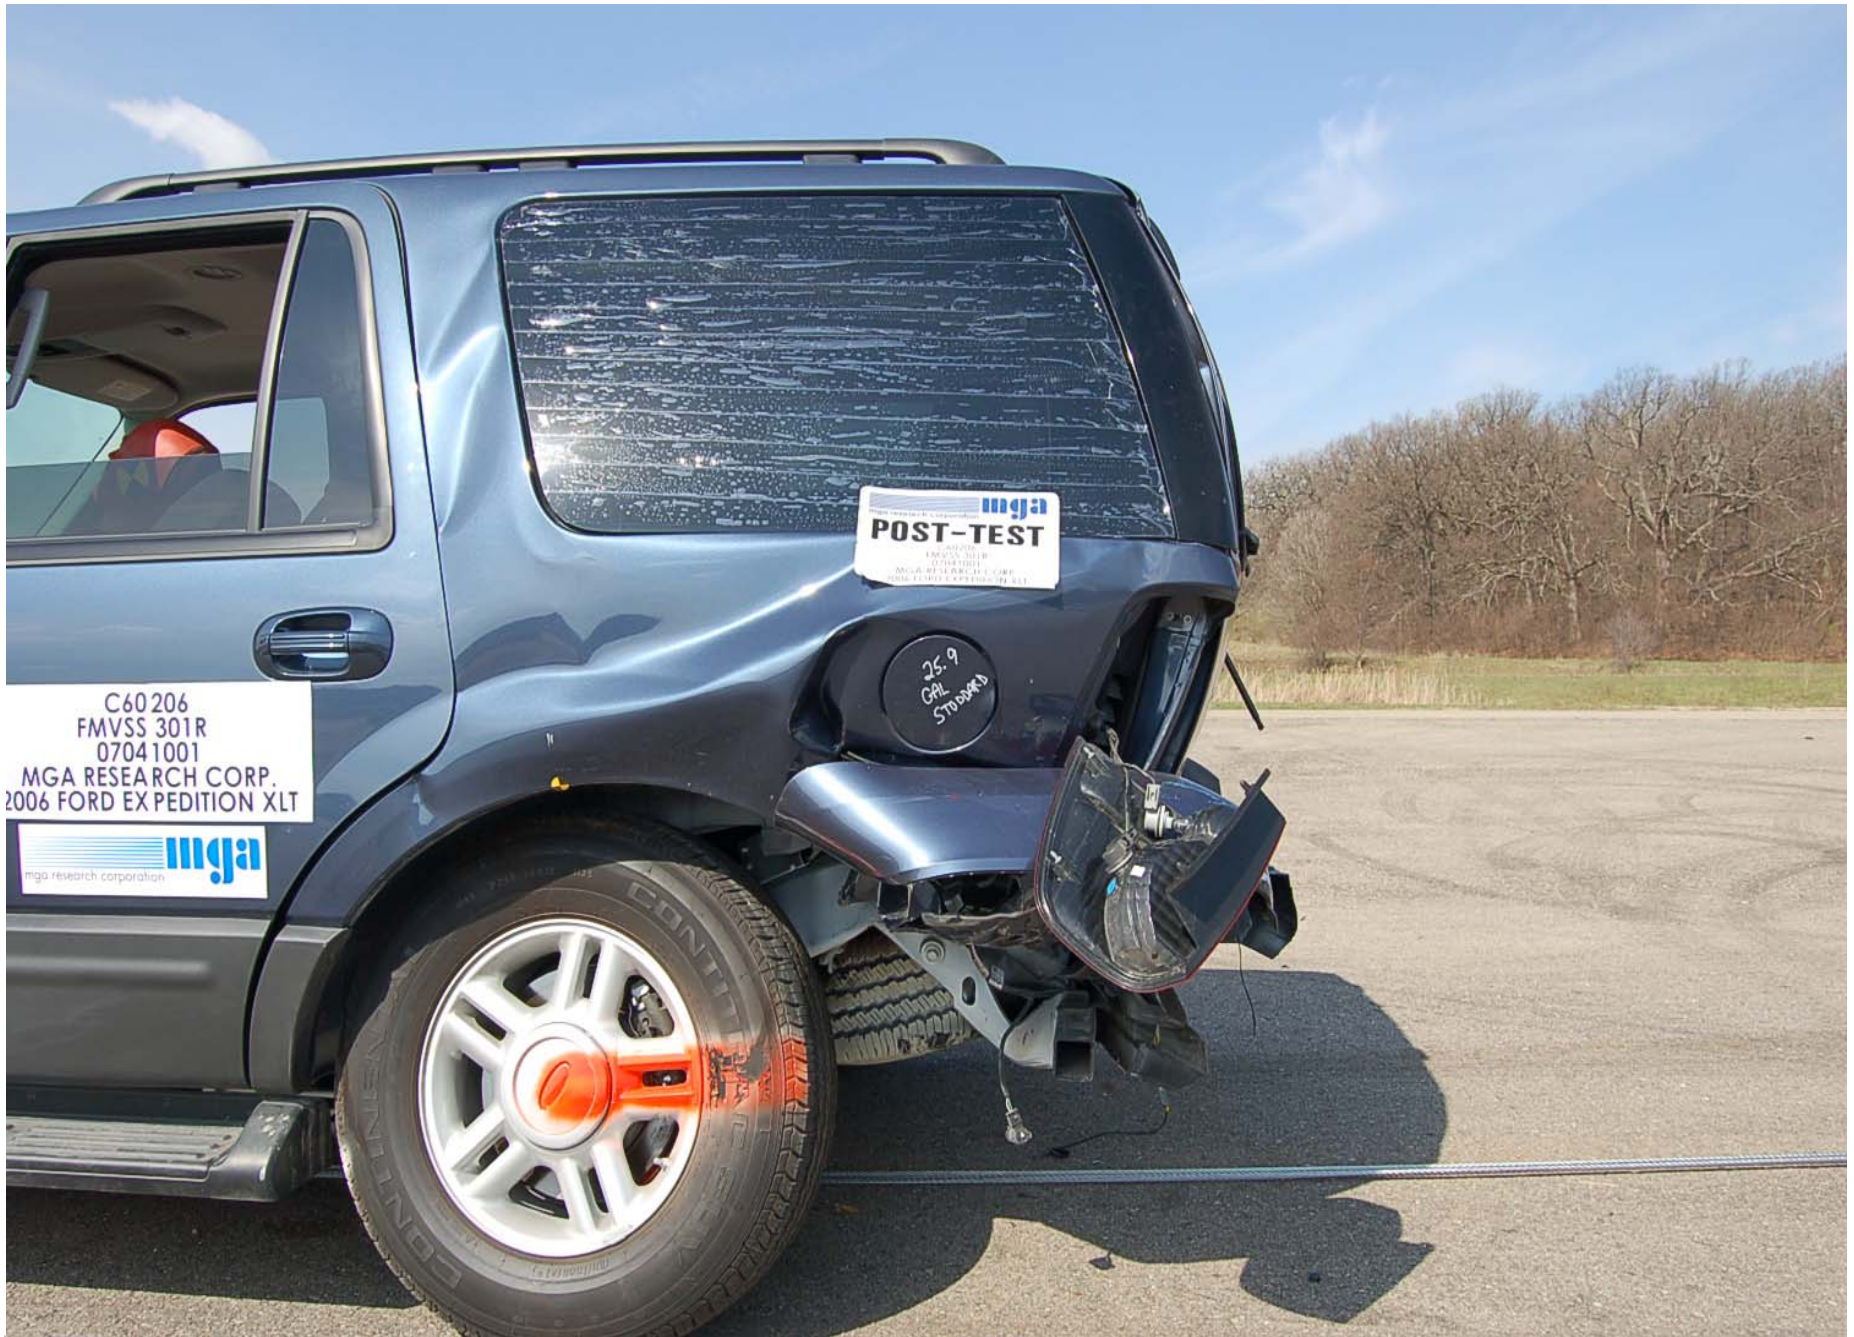
A-6.

Post-Test Left Rear Closeup View of Vehicle

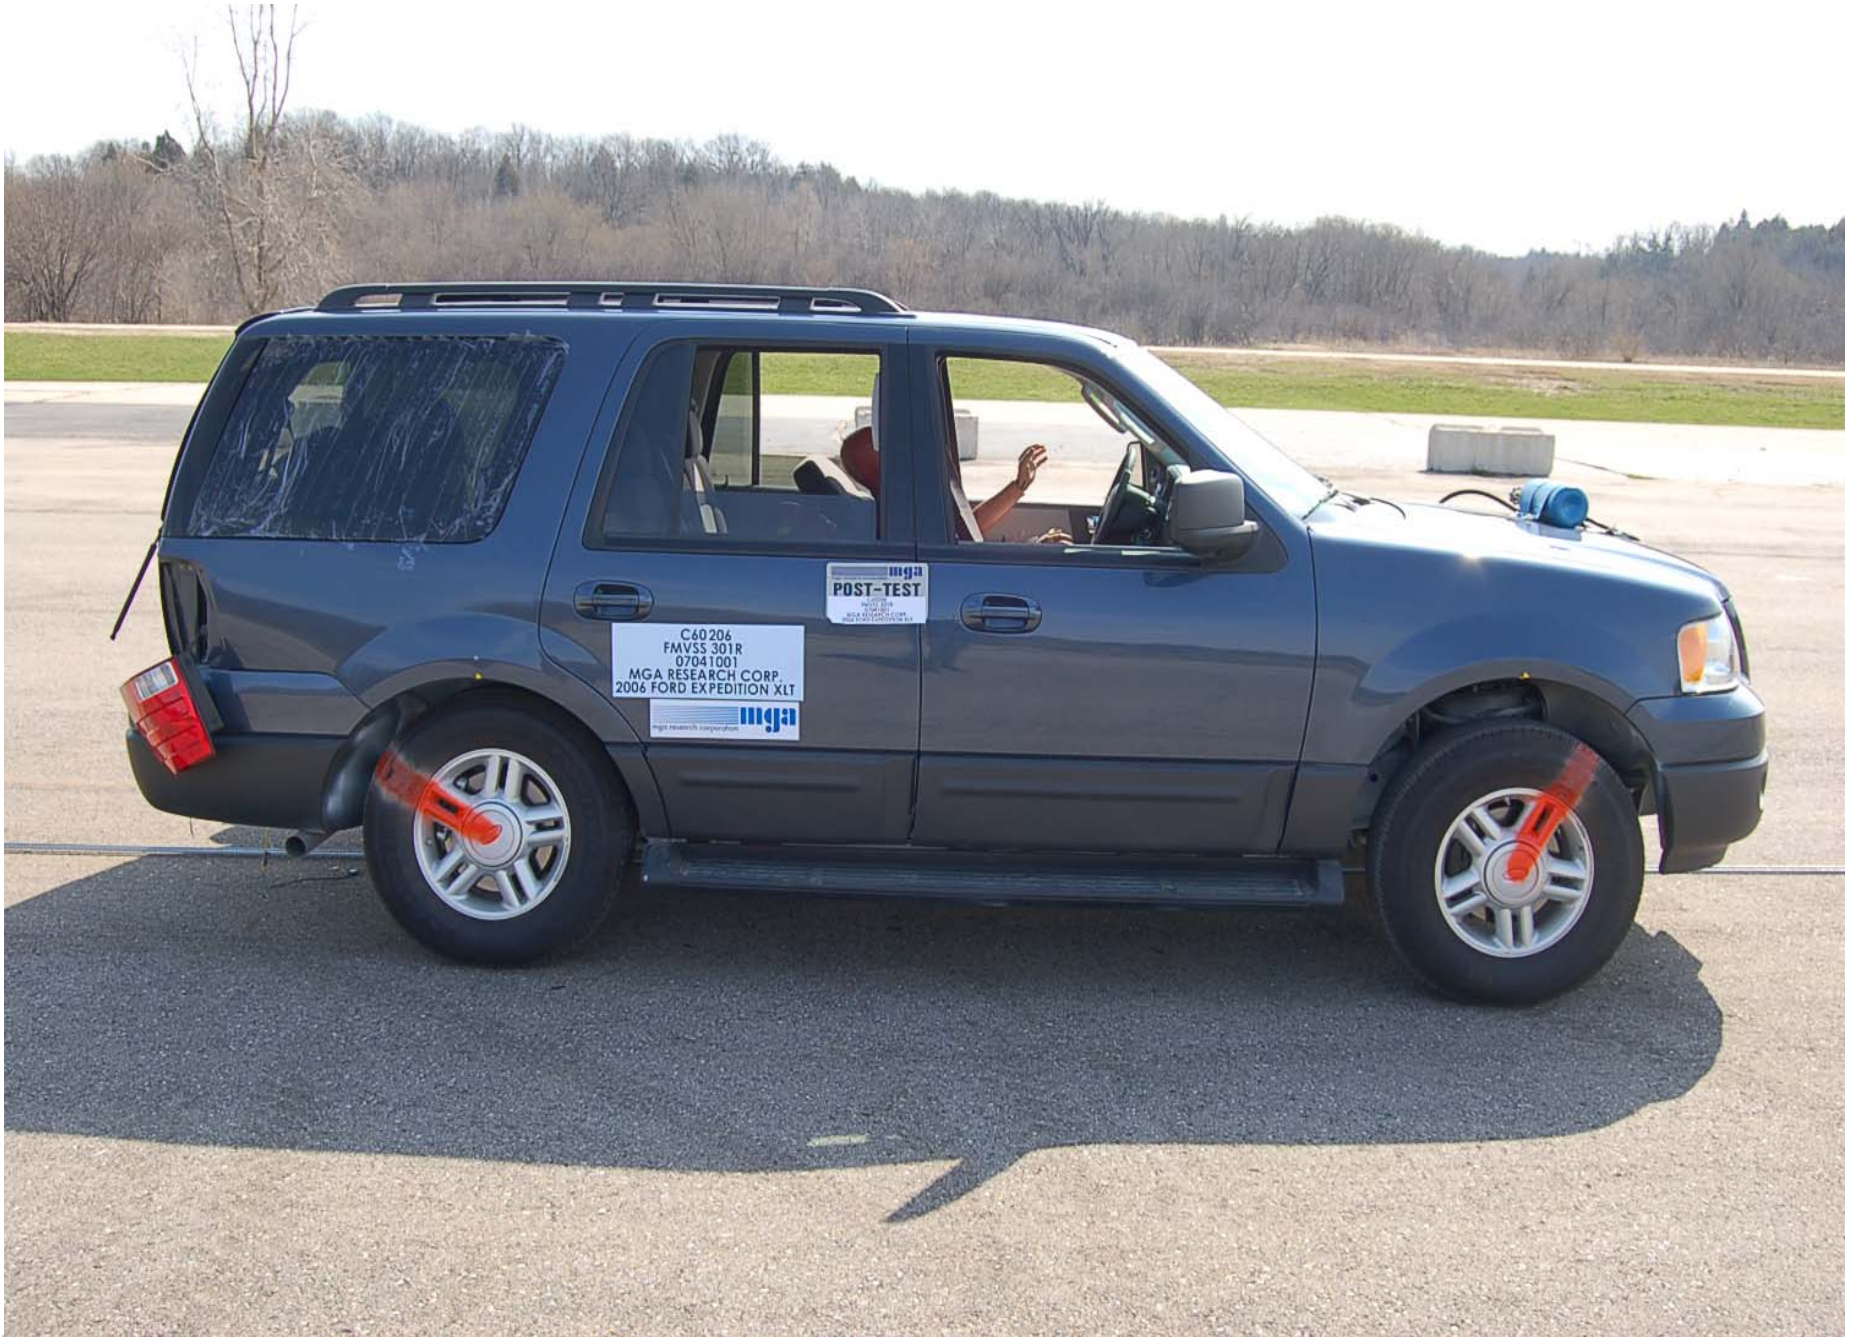
A-8.

Post-Test Right Side View of Vehicle

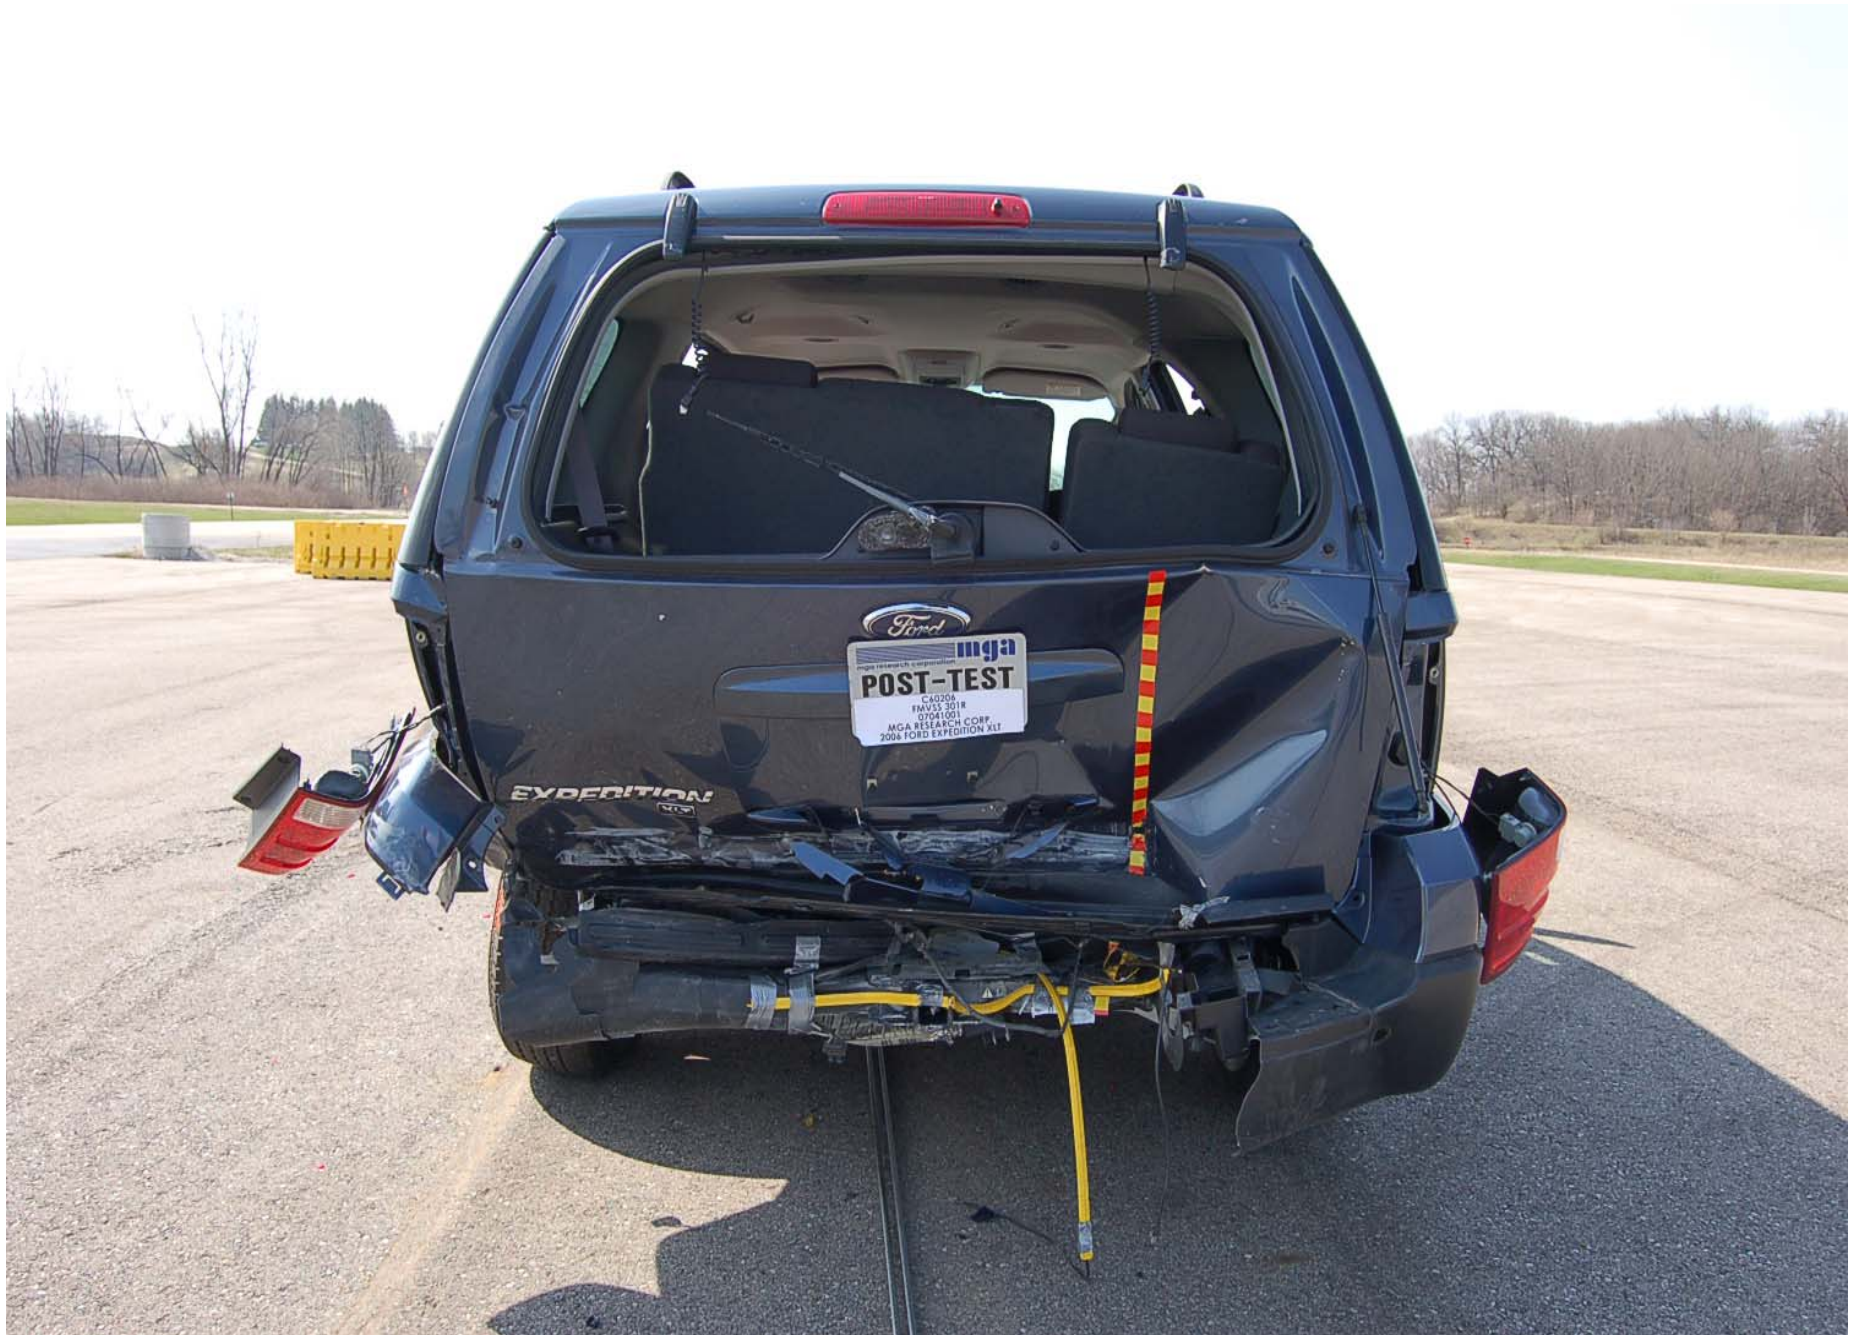
A-10.

Post-Test Rear View of Vehicle

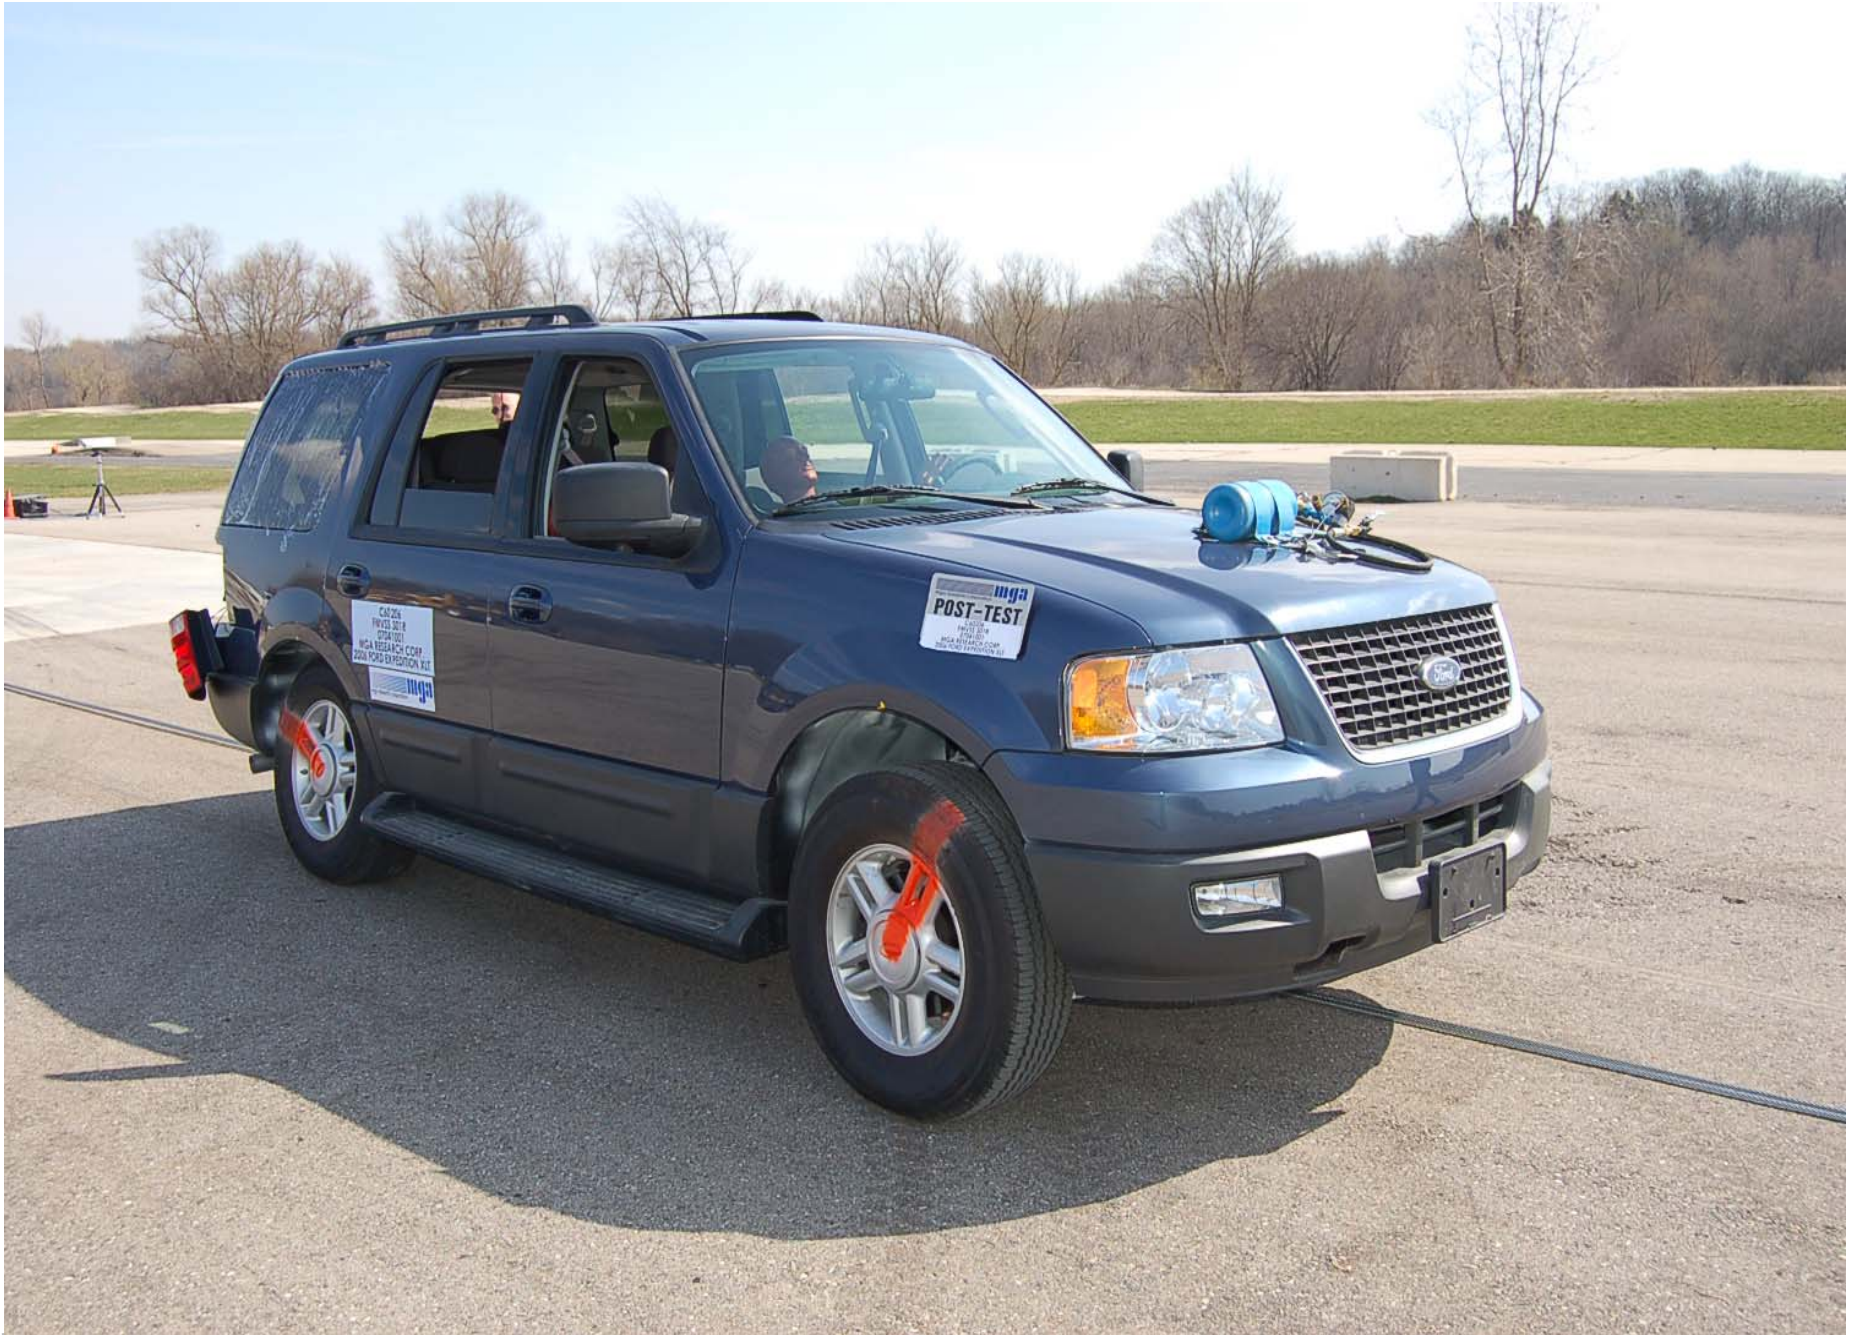
A-12.

Post-Test 3/4 Frontal View From Right Side of Vehicle

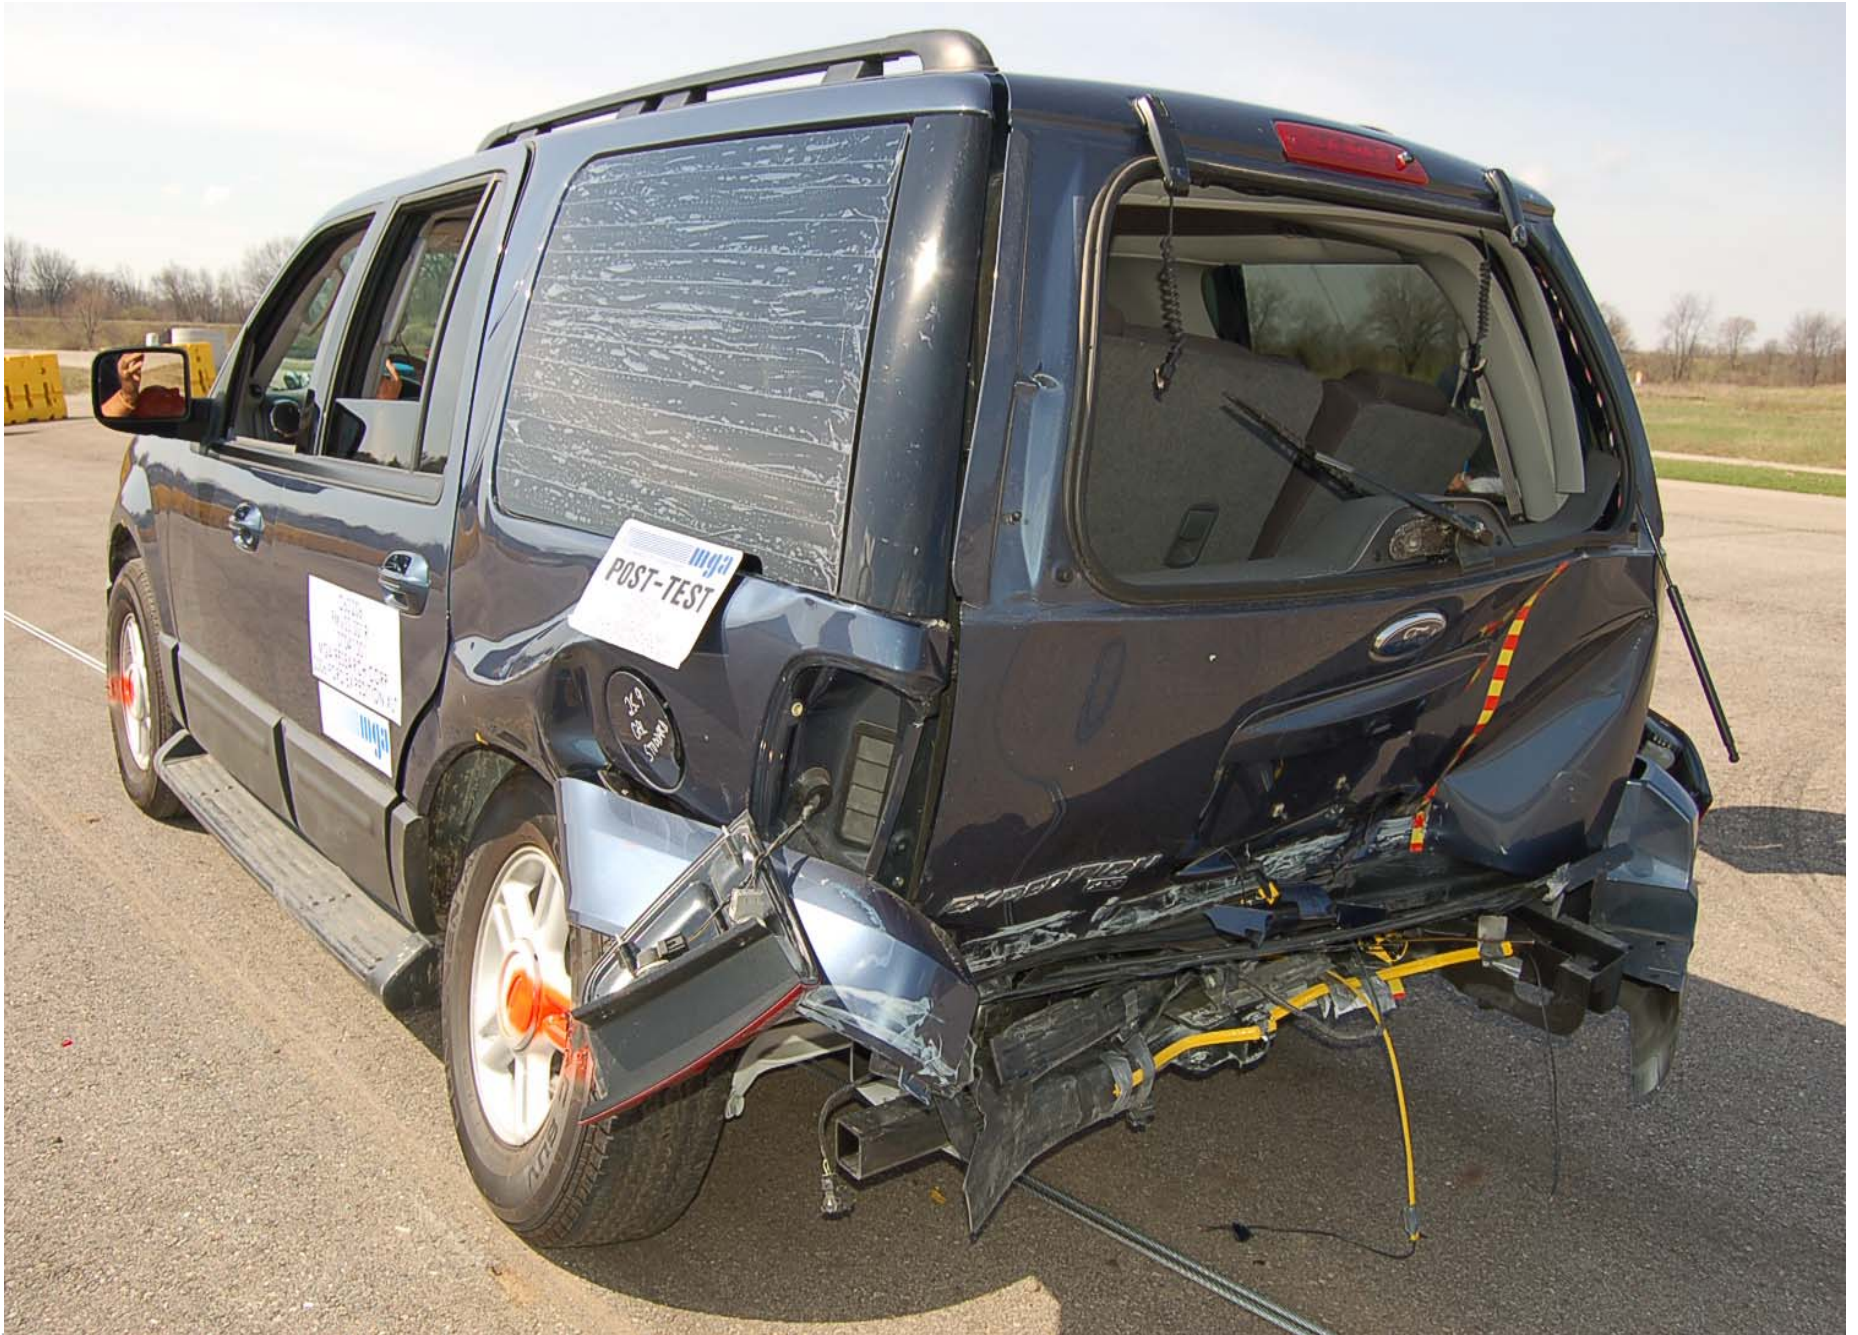
A-14.

Post-Test ¾ Rear View From Left Side of Vehicle

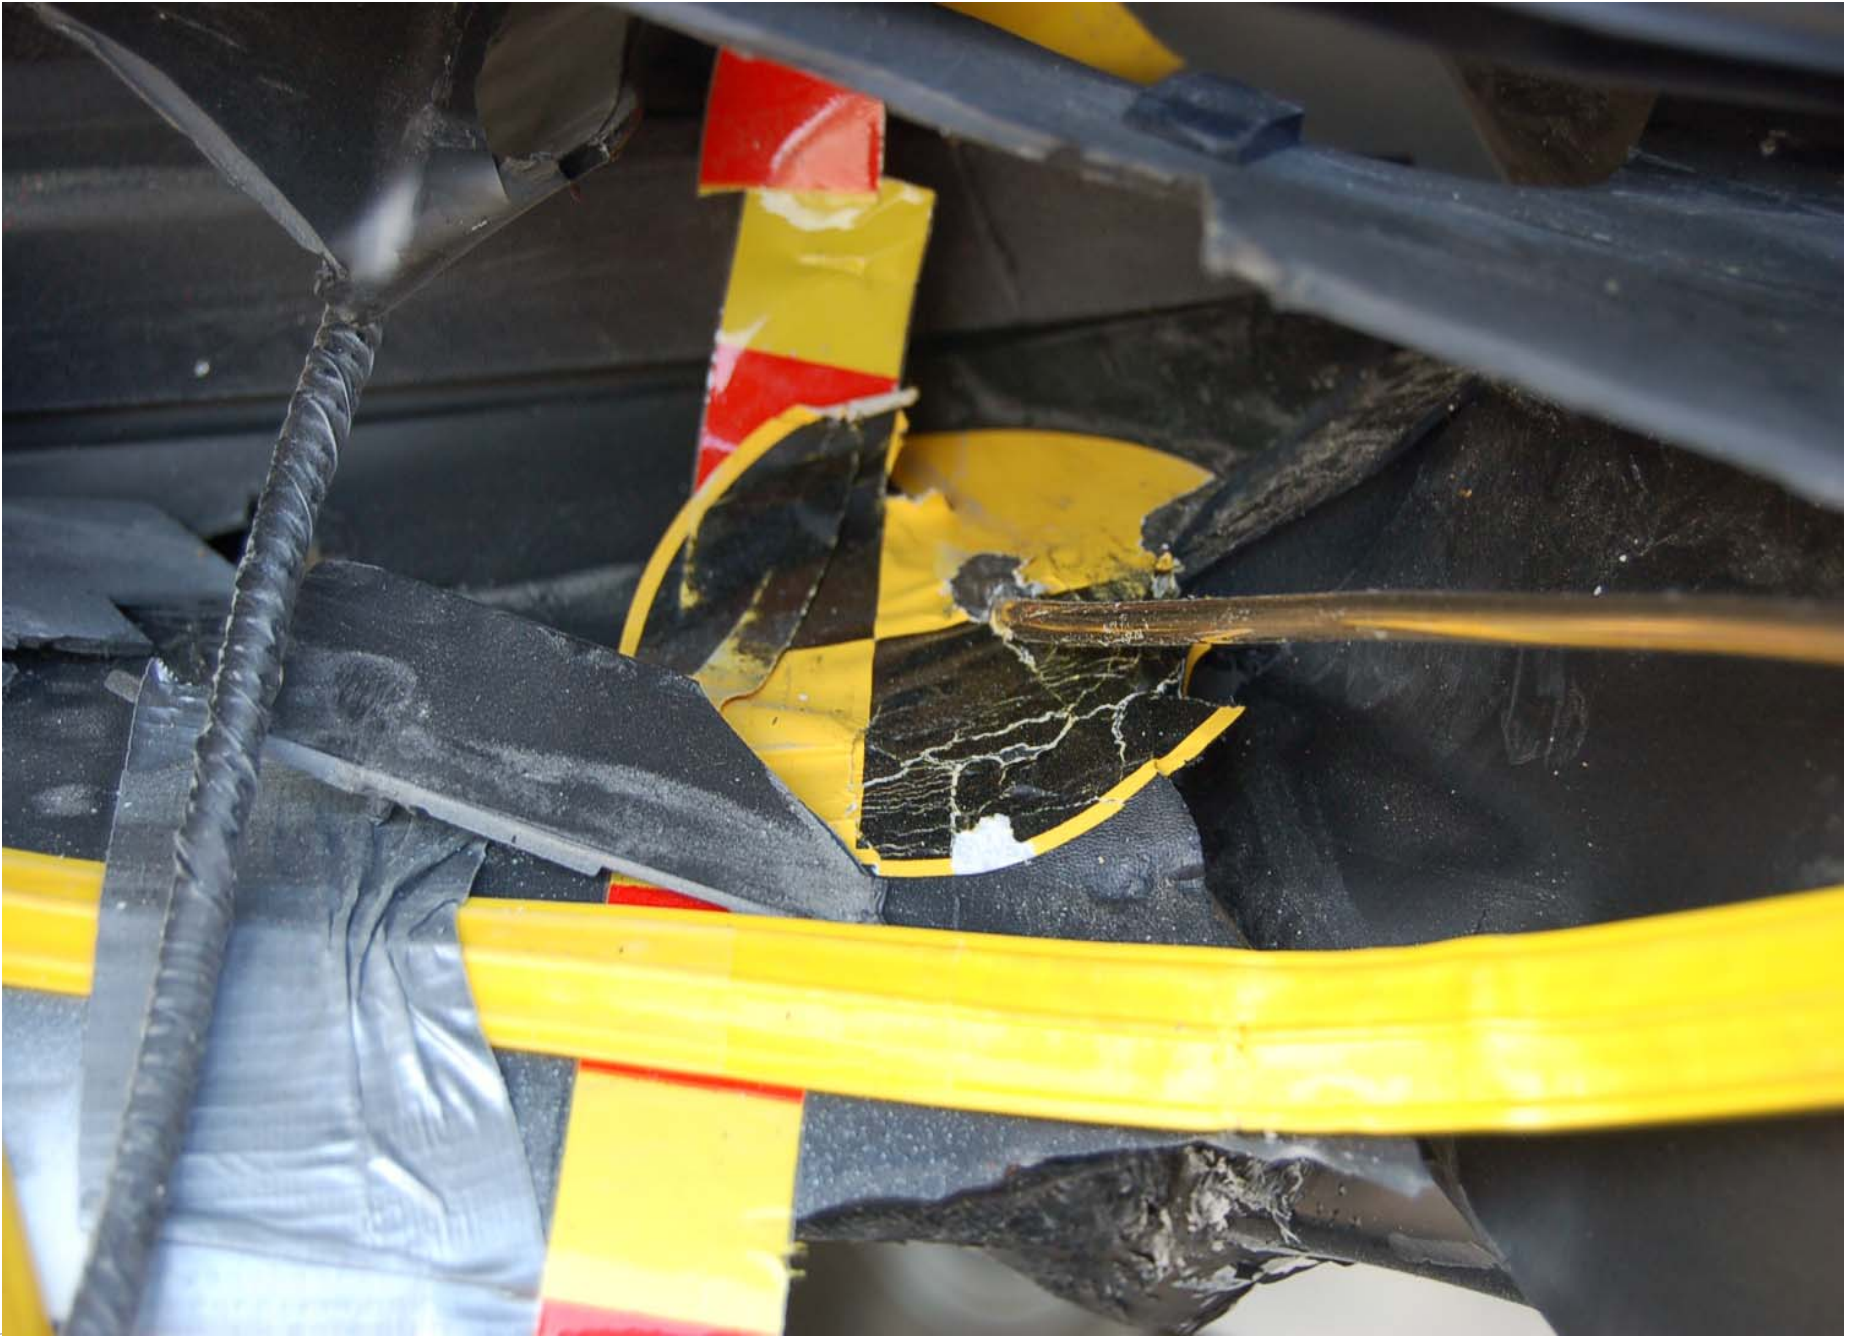
A-15.

Units: mm
Vertical distance from target center (+ above target / - below target)	1 mm above
Horizontal distance from target center (+ to the right / - to the left)	17 mm to the right

Post-Test Impact Point

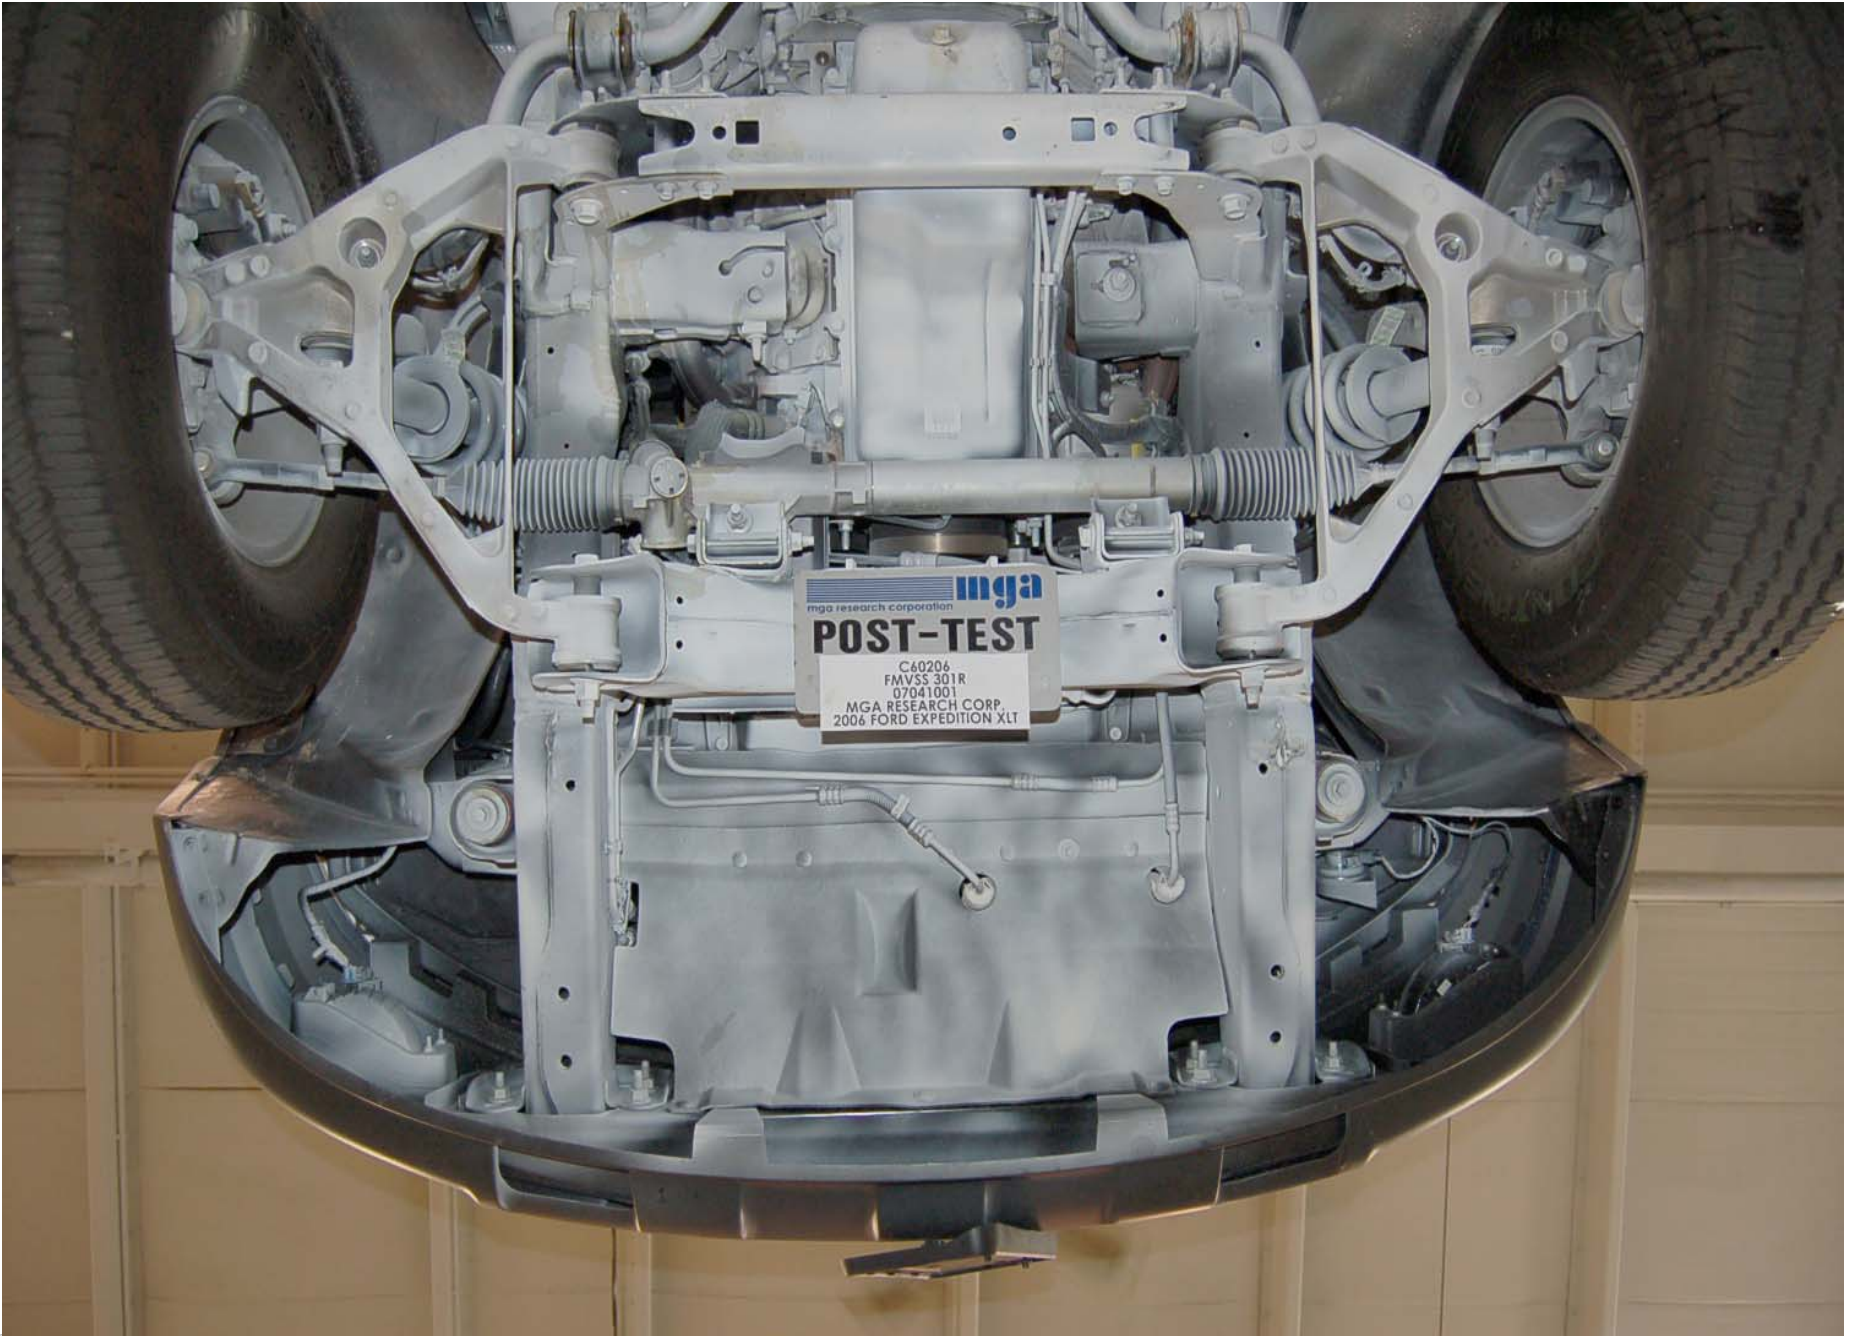
A-17.

Post-Test Underbody View 1

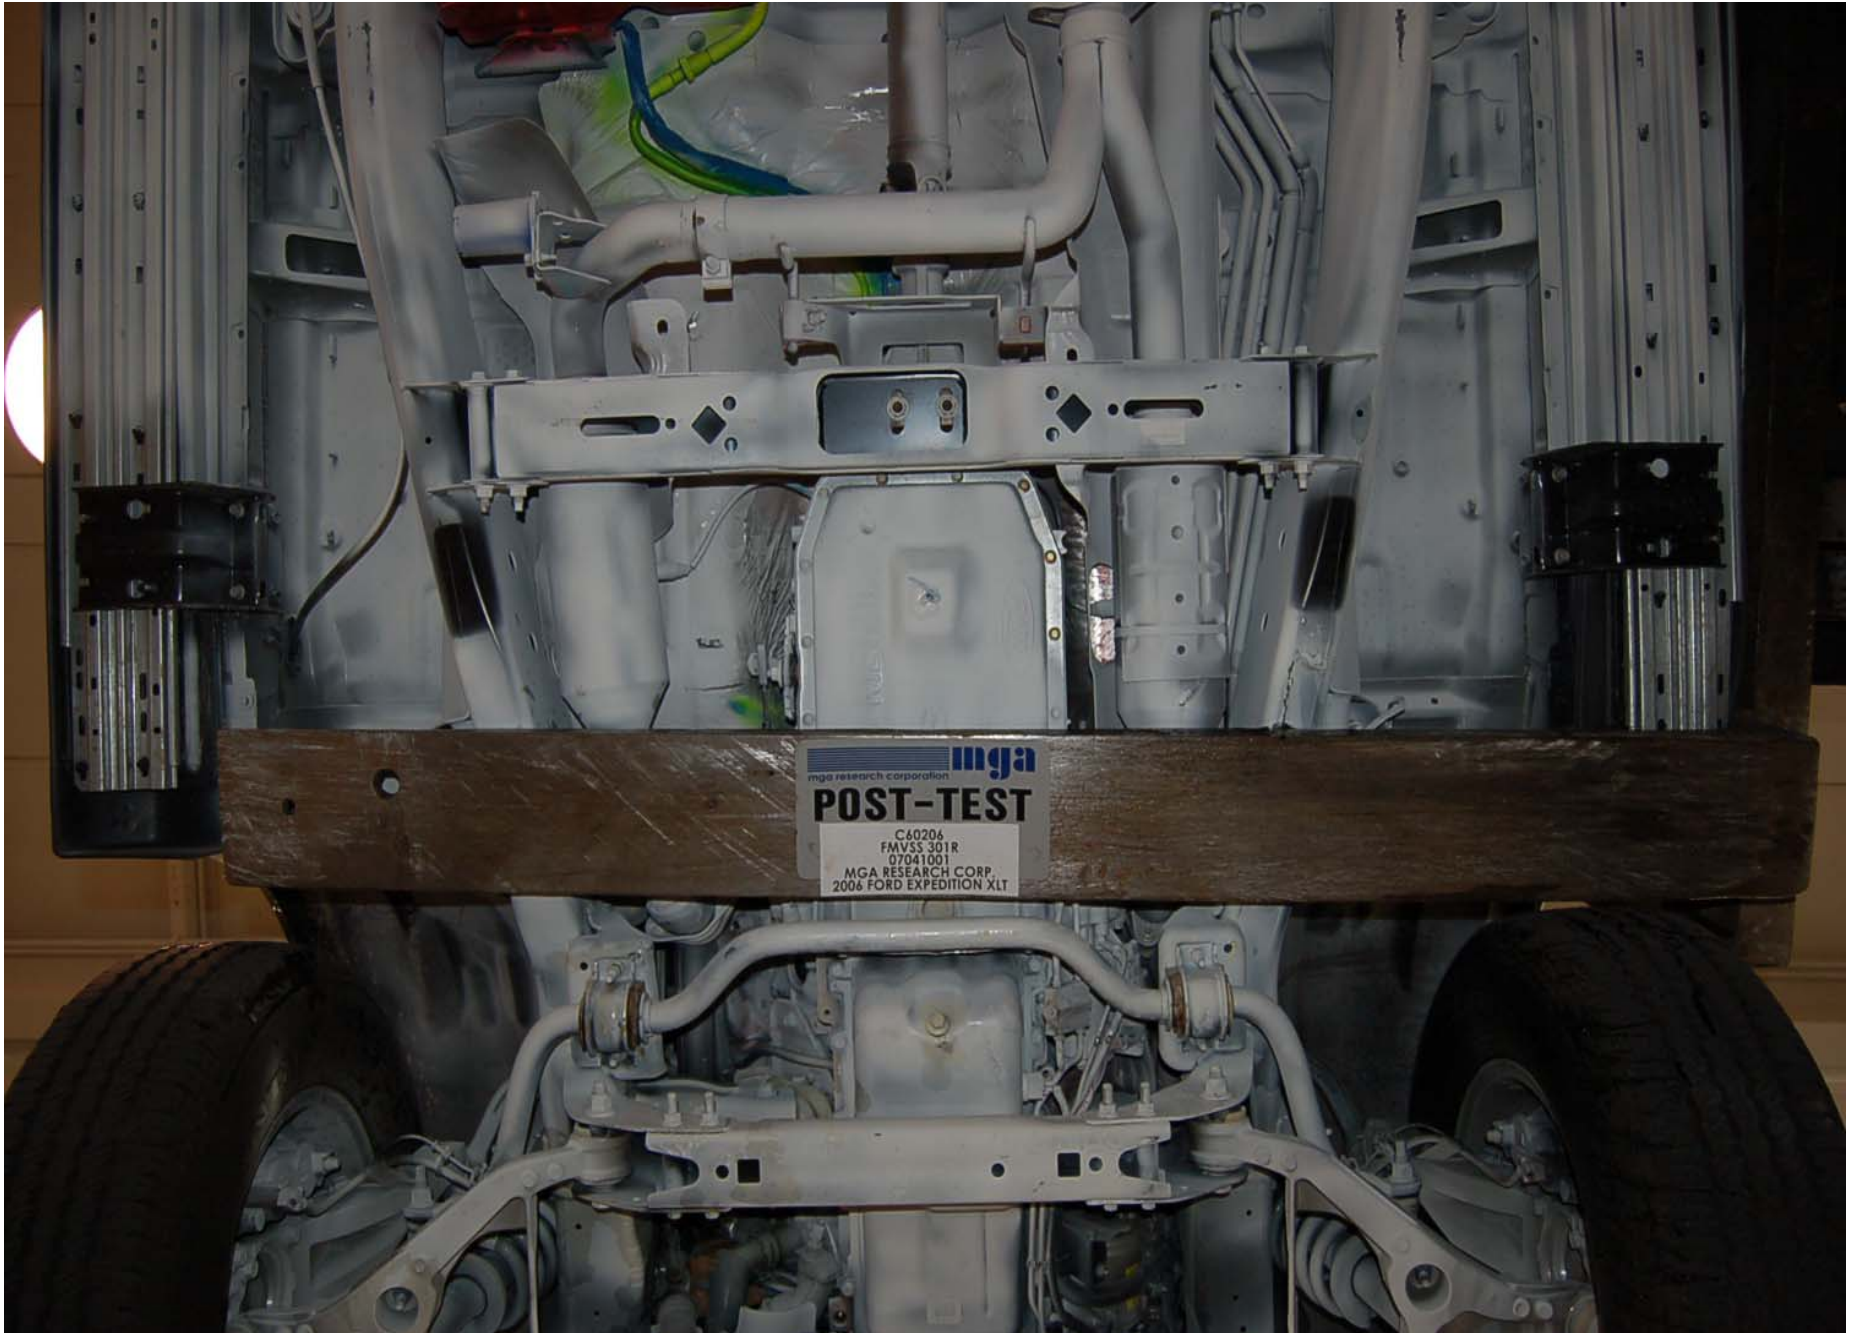
A-19.

Post-Test Underbody View 2
