REPORT NUMBER: 301-MGA-2007-001

**SAFETY COMPLIANCE TESTING FOR FMVSS 301R
FUEL SYSTEM INTEGRITY – REAR IMPACT**

**FORD MOTOR COMPANY
2006 FORD EXPEDITION XLT 4X2
NHTSA NUMBER: C60206**

**PREPARED BY:
MGA RESEARCH CORPORATION
5000 WARREN ROAD
BURLINGTON, WI 53105**

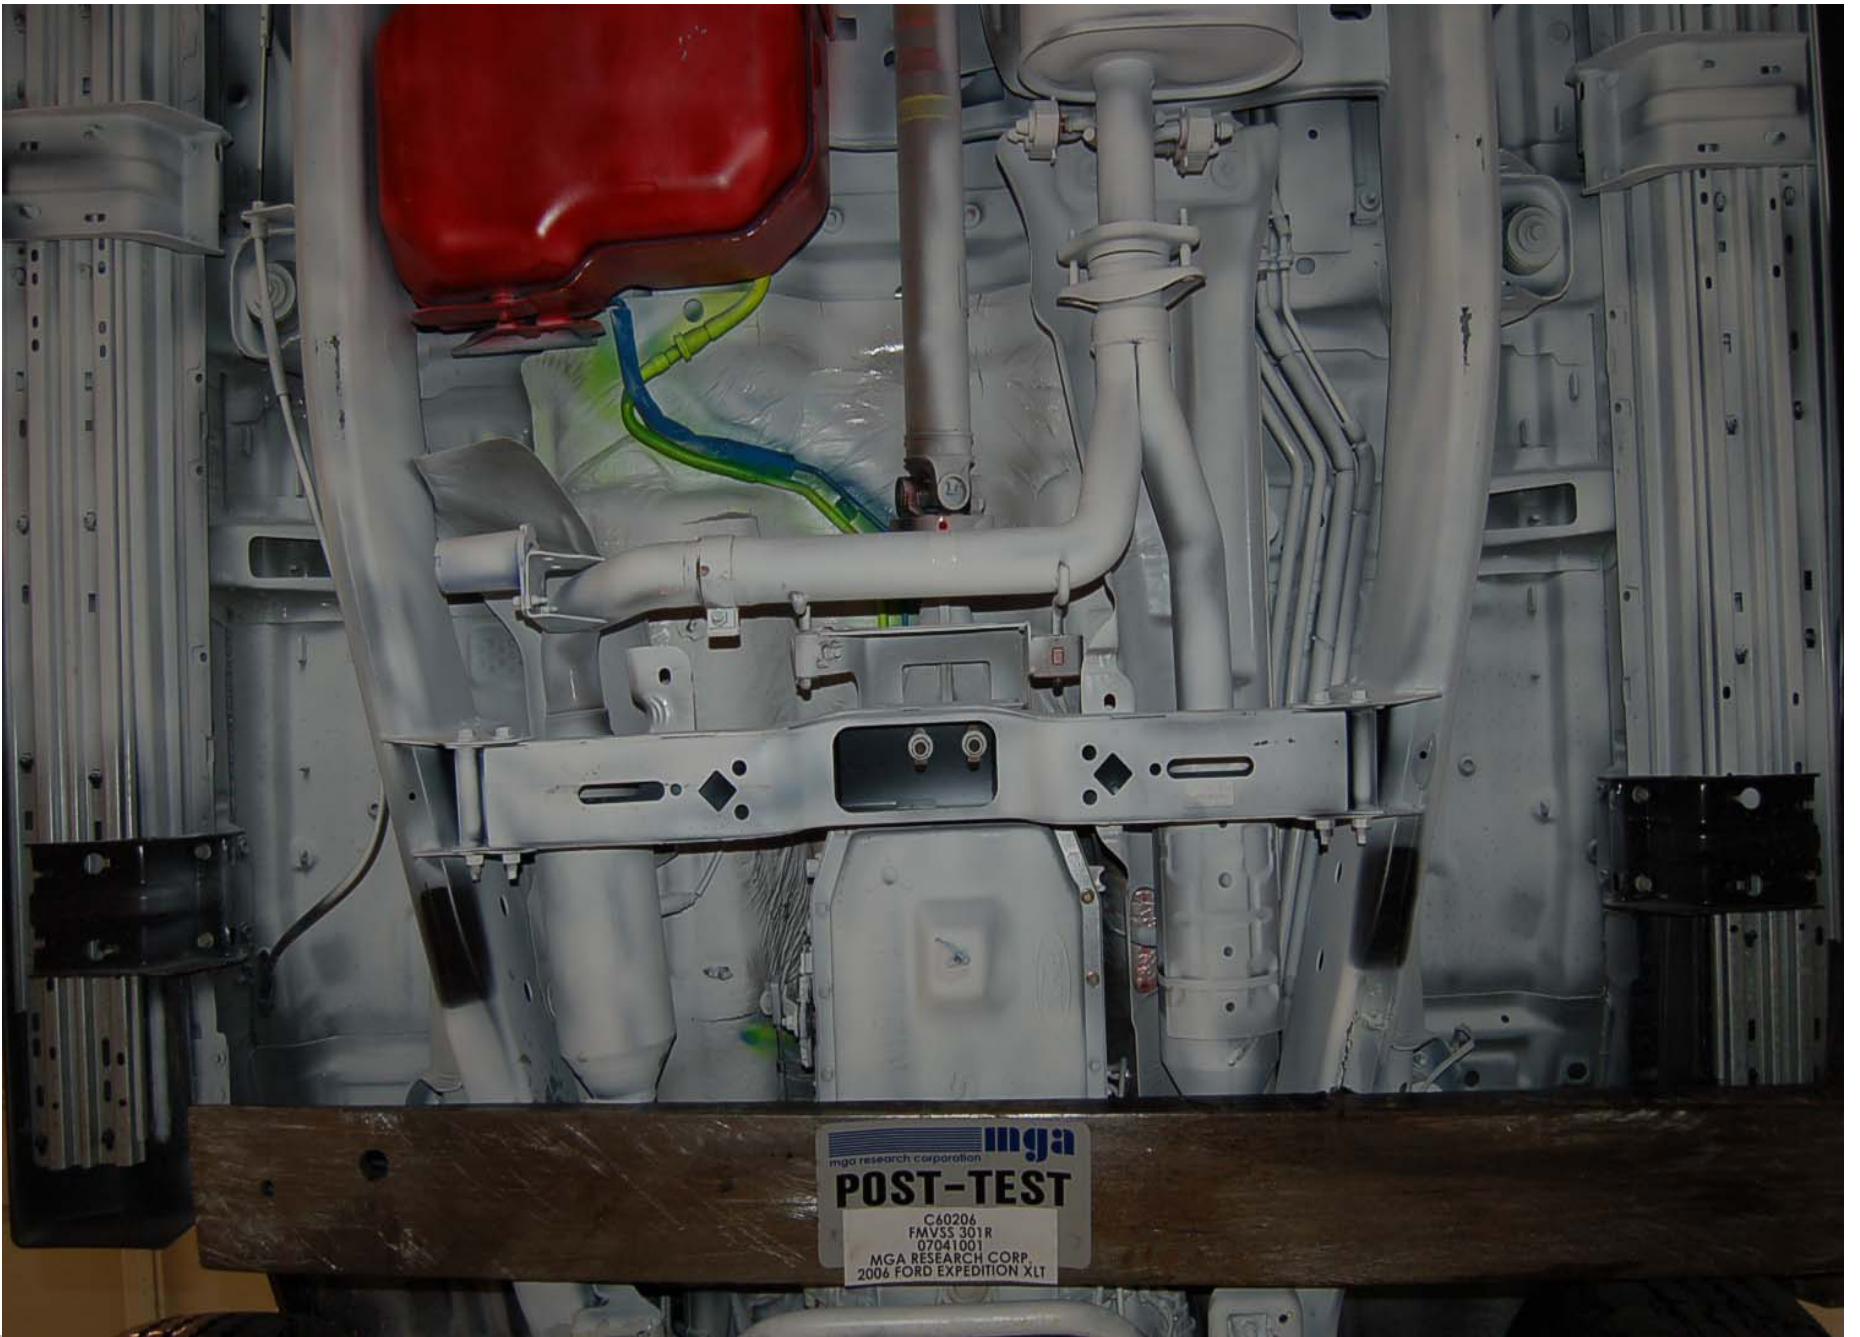
A-21.

Post-Test Underbody View 3

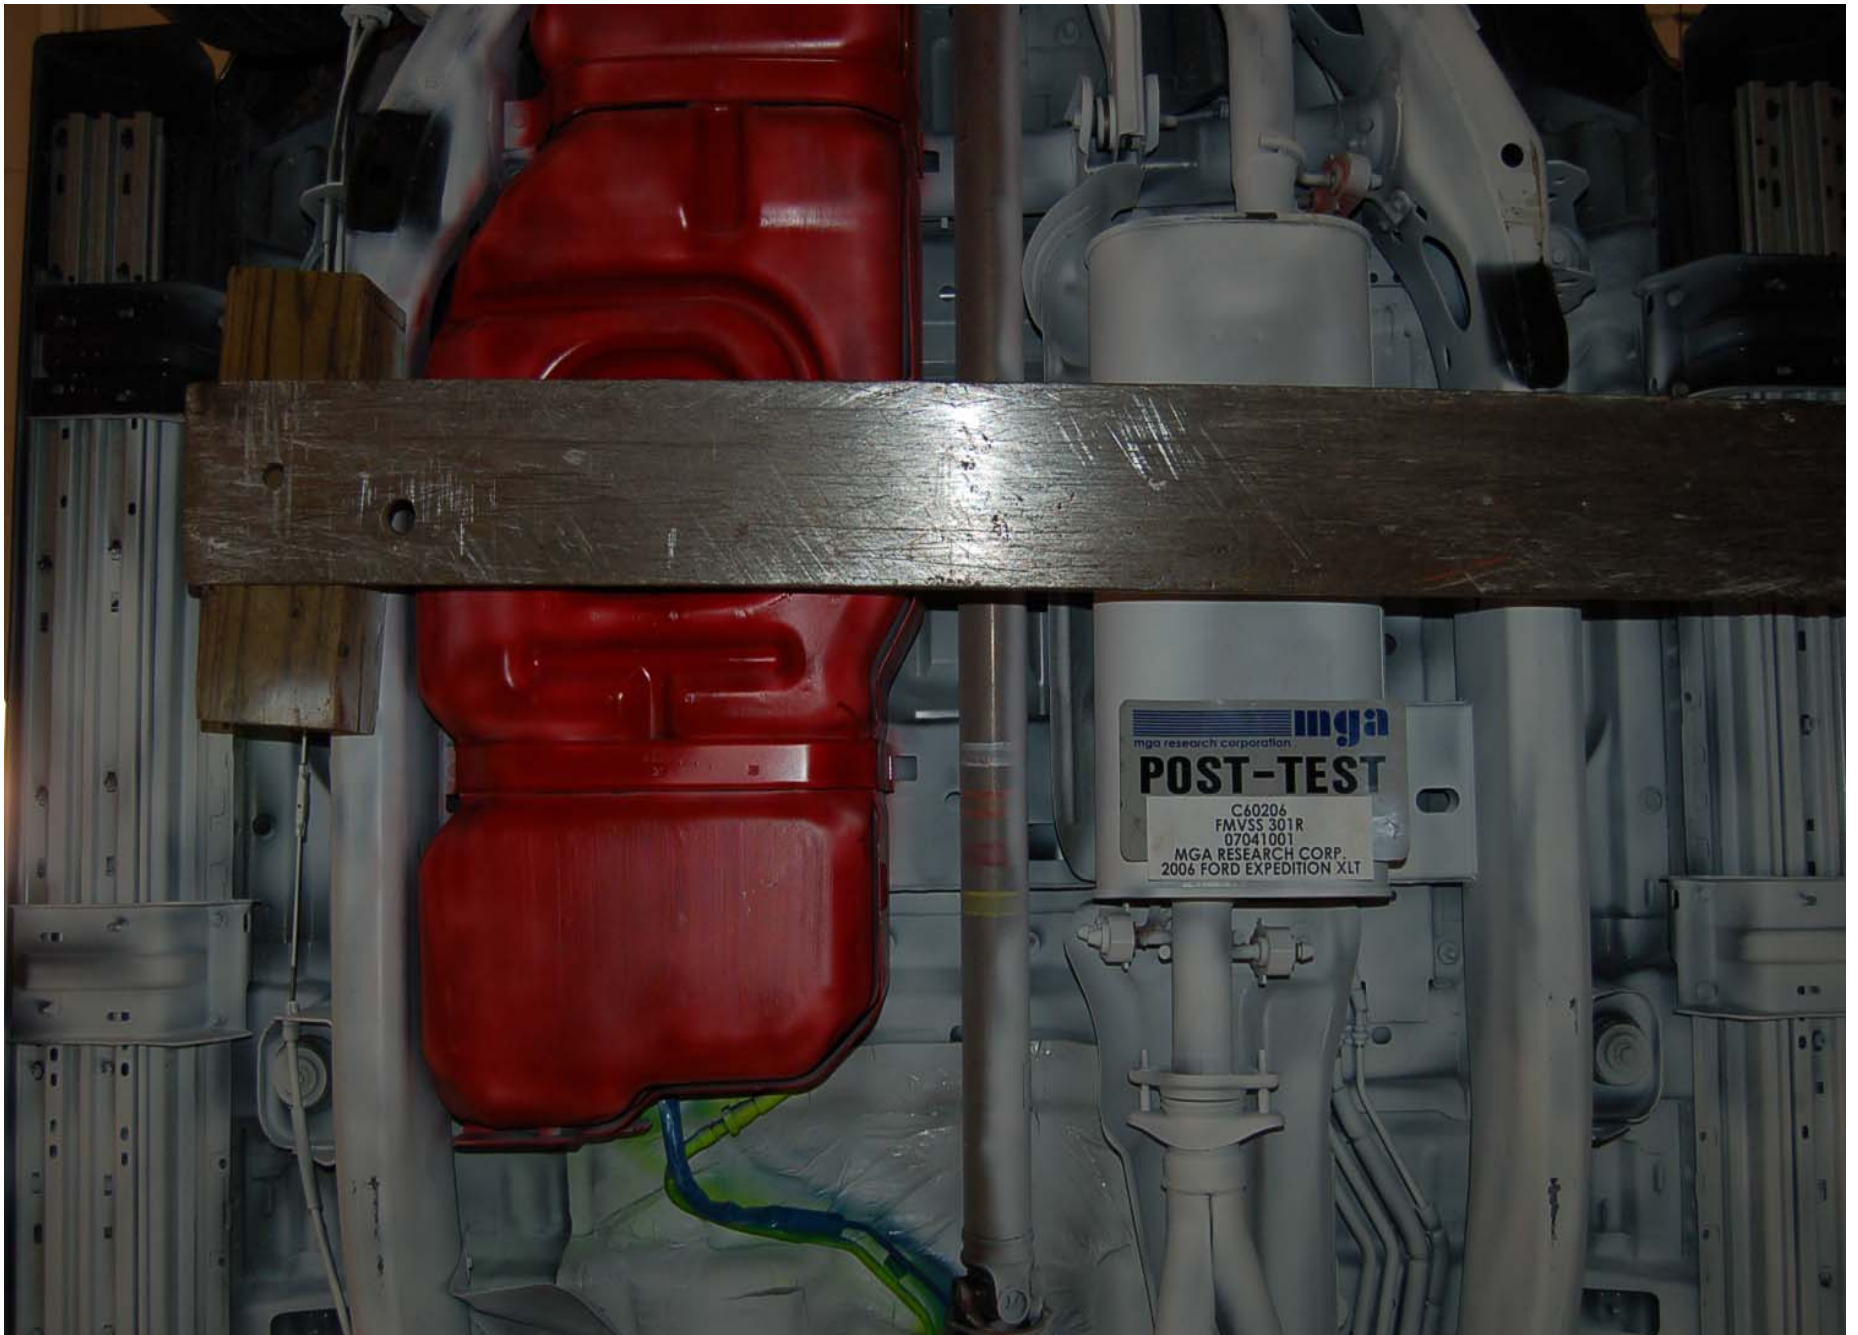
A-23.

Post-Test Underbody View 4

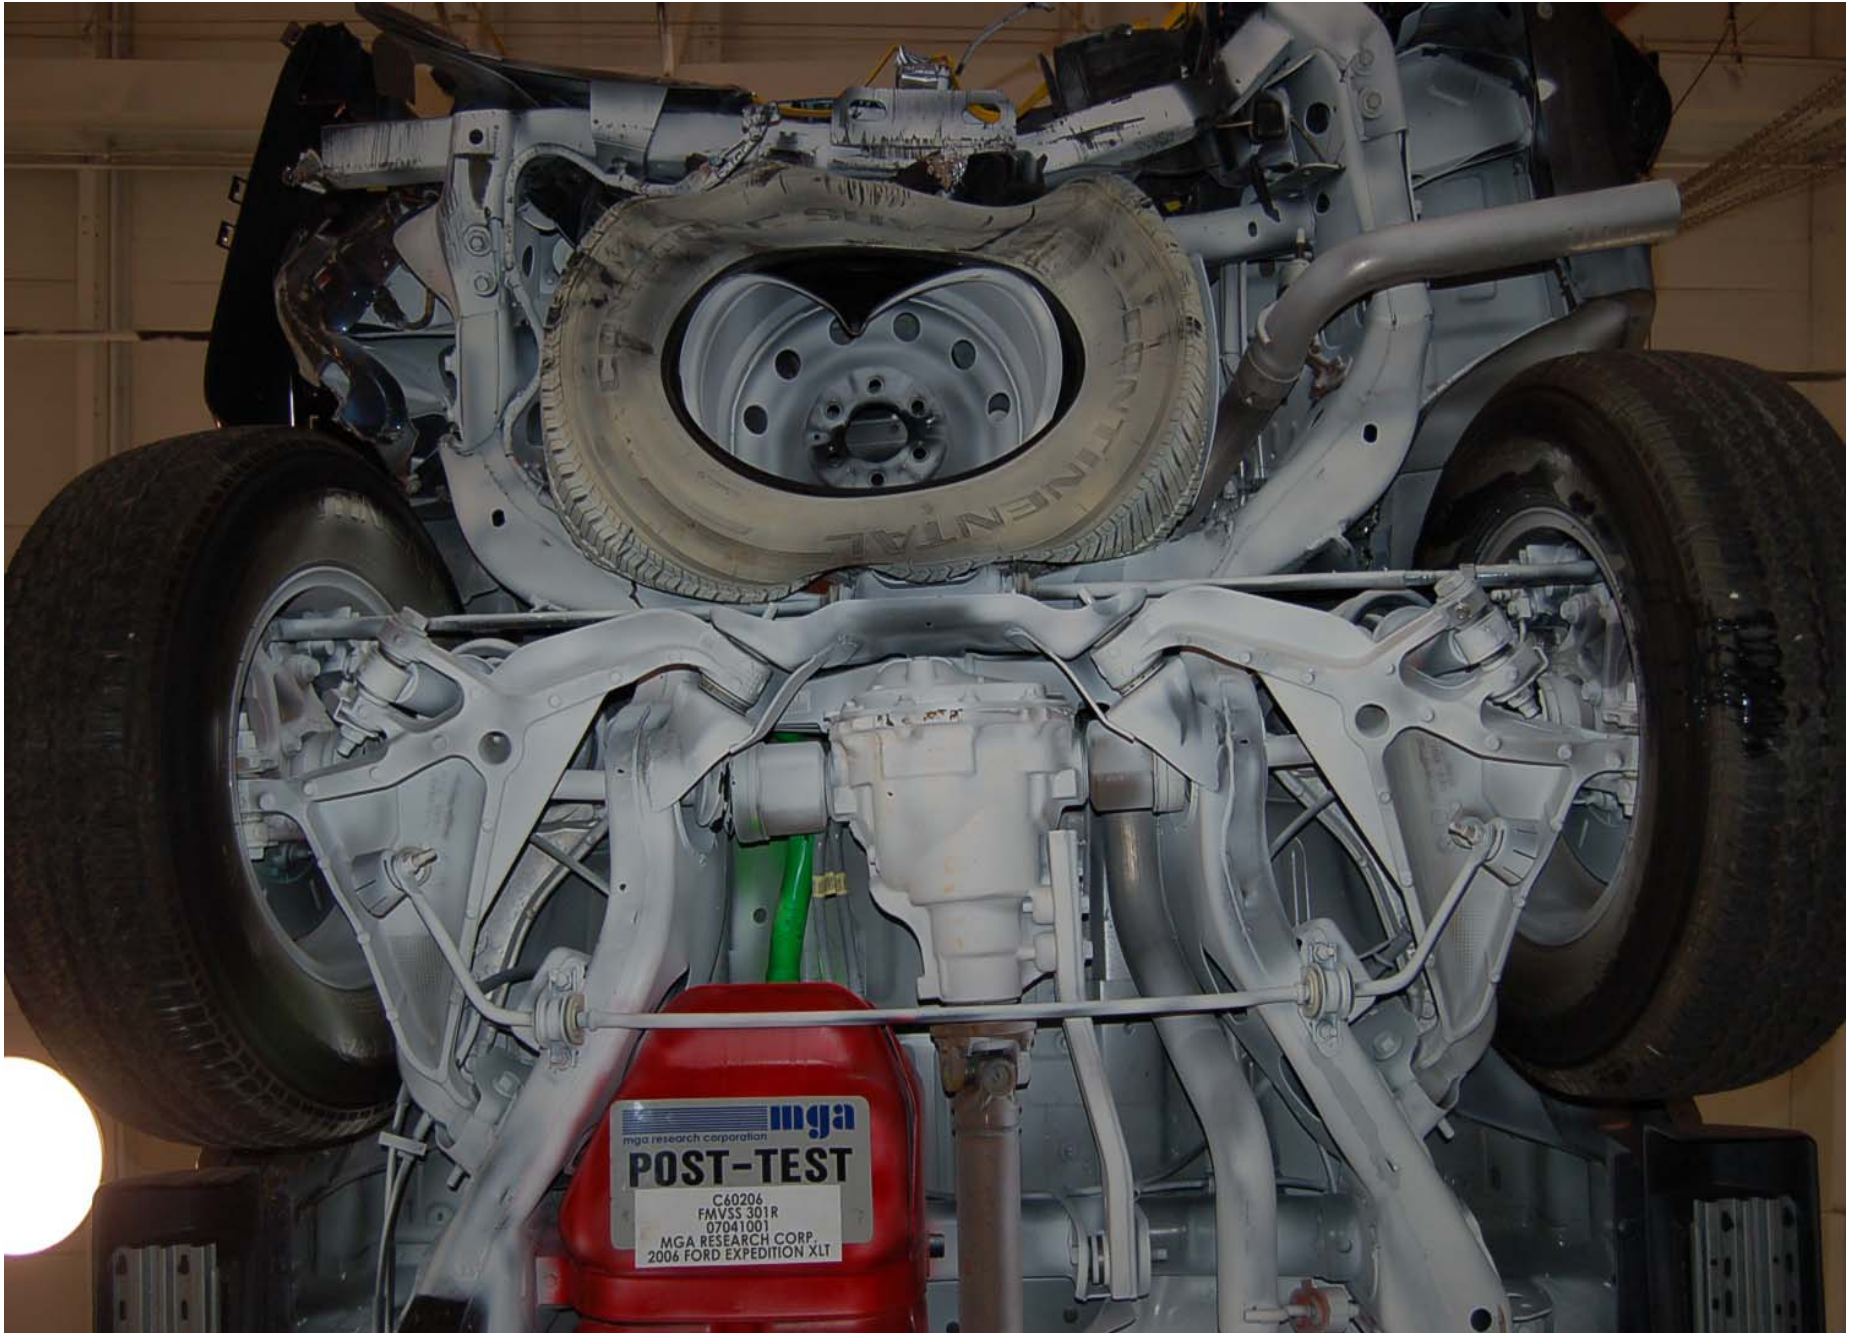
A-25.

Post-Test Underbody View 5

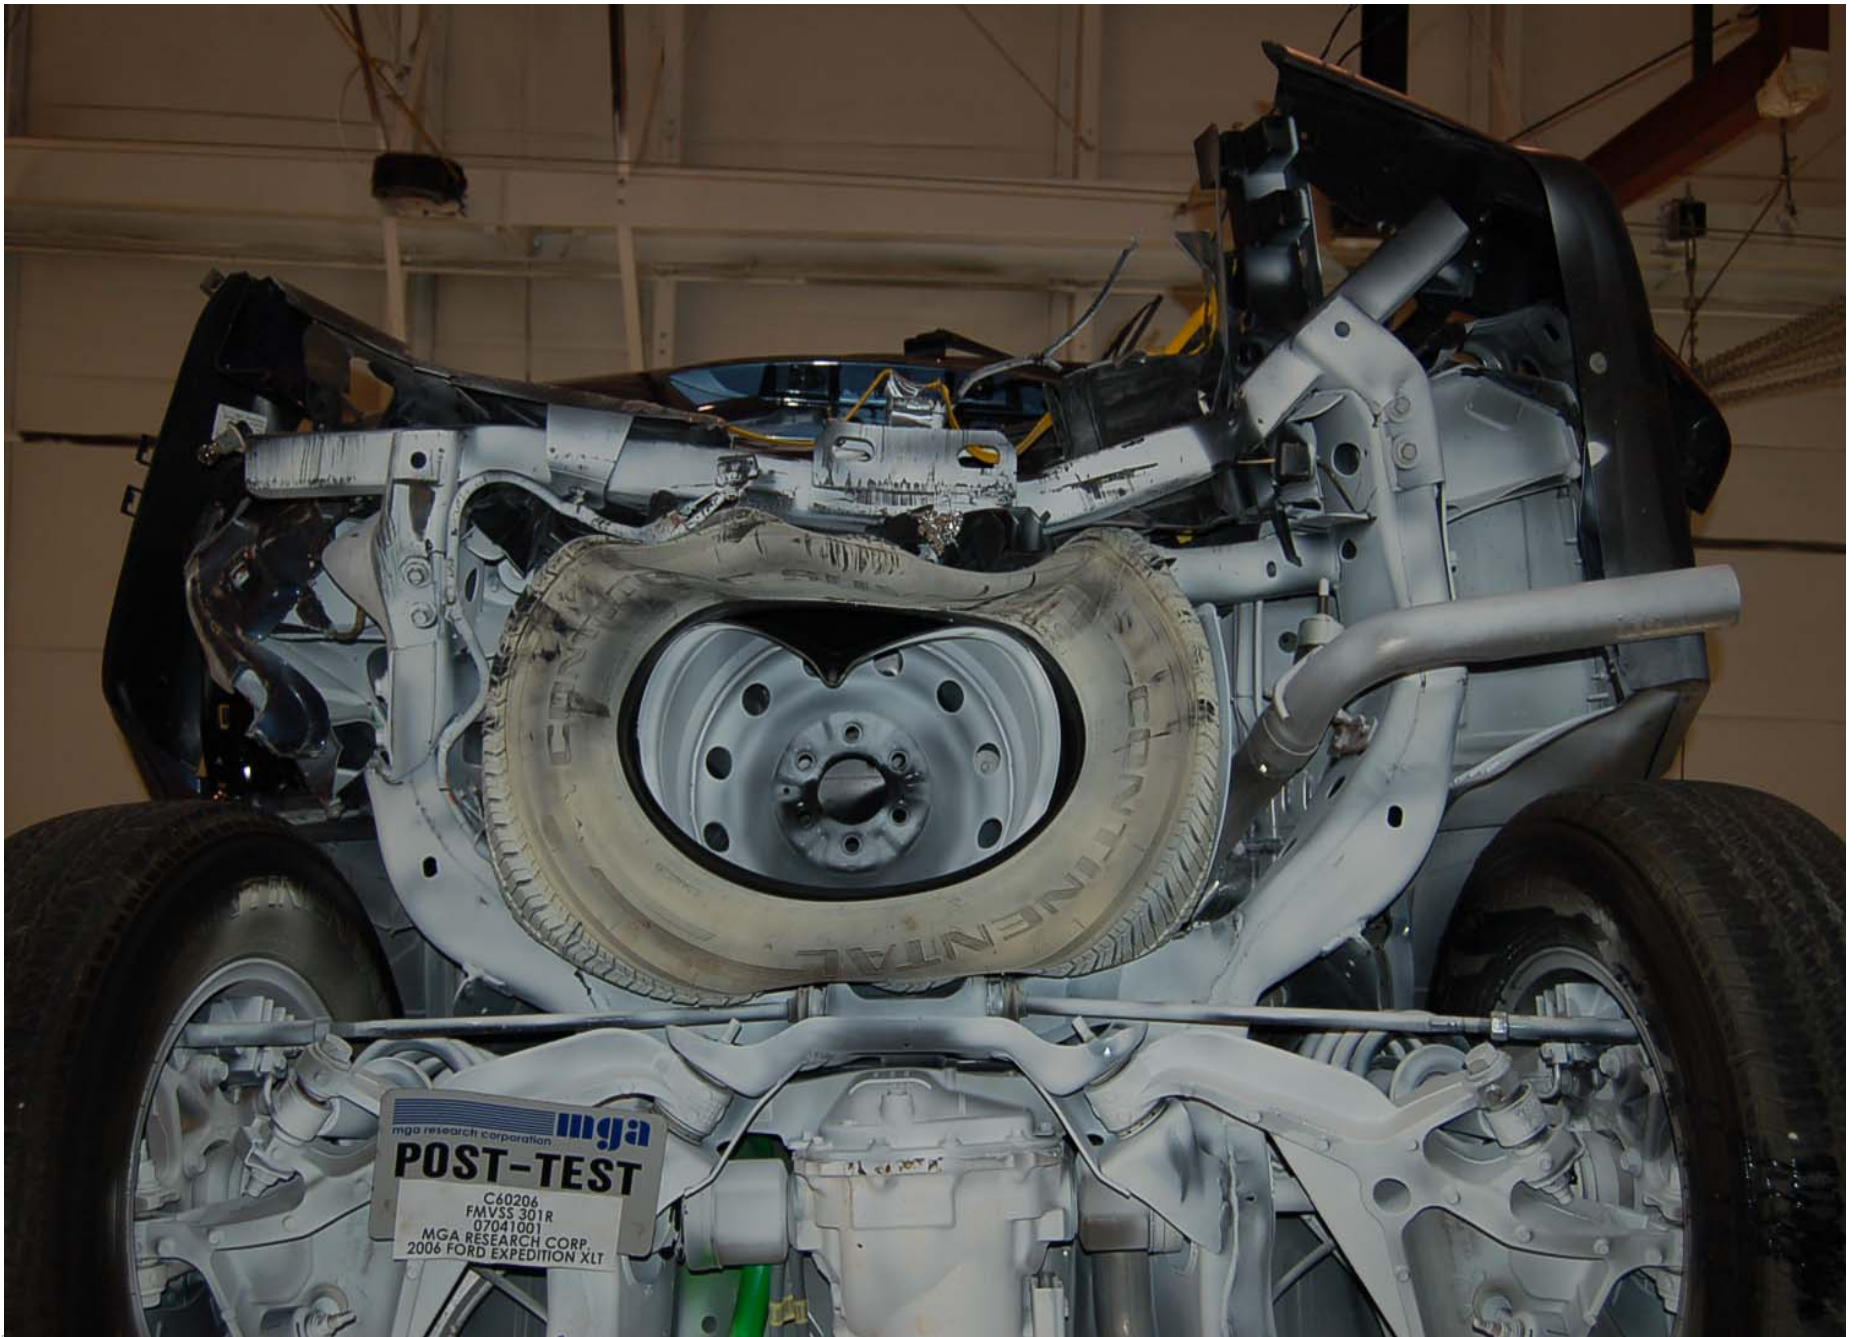
Post-Test Underbody View 6

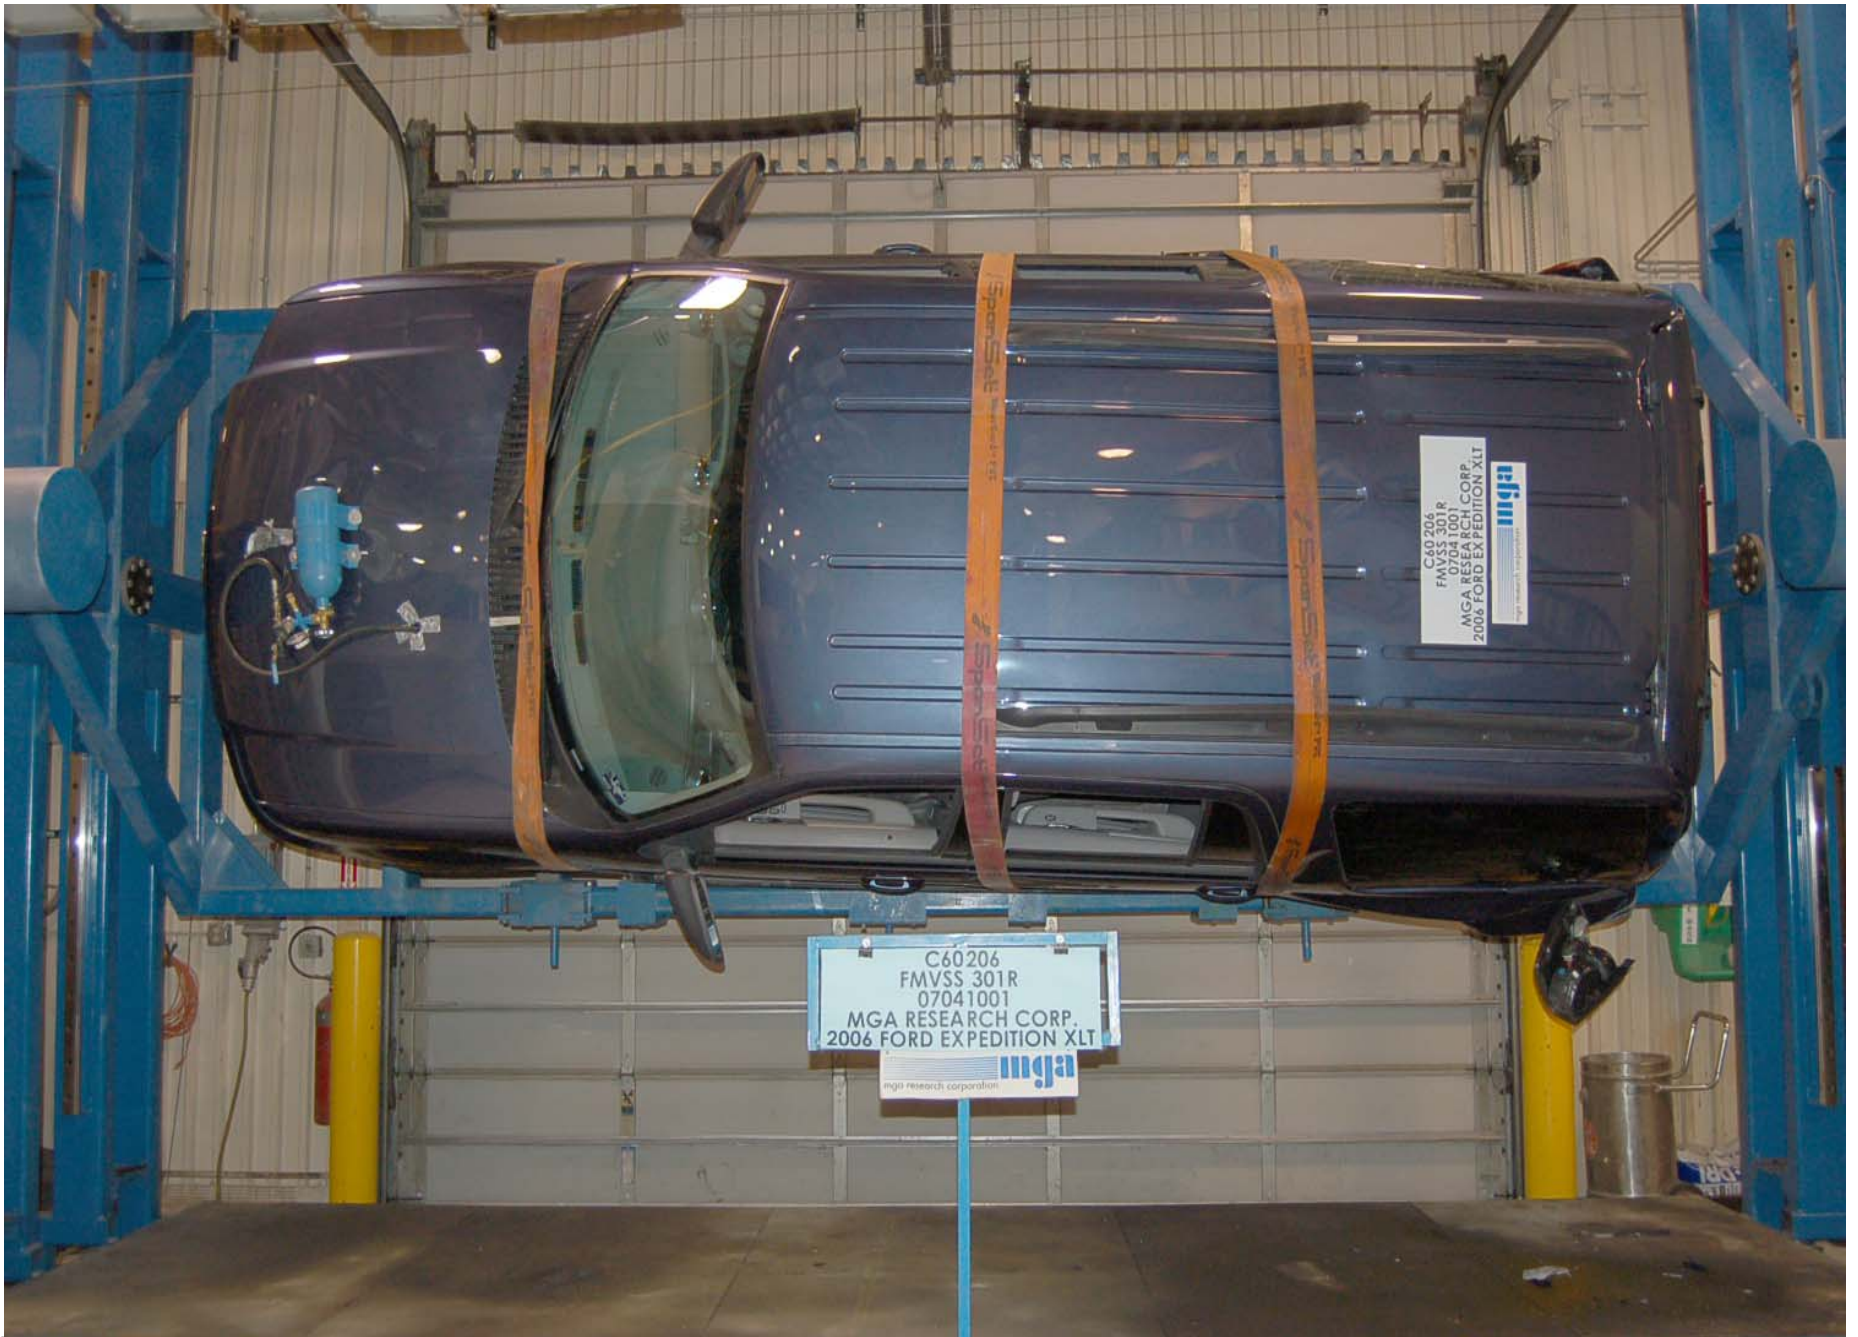
0° TO 90° Rotation Time (sec) = 119 sec

Test Phase	Spillage (g)	Spillage Details
First 5 minutes from onset of rotation	0	
Sixth minute from onset of rotation	0	
Seventh minute from onset of rotation	0	
Eight minute if required	N/A

Static Rollover at 90 Degrees

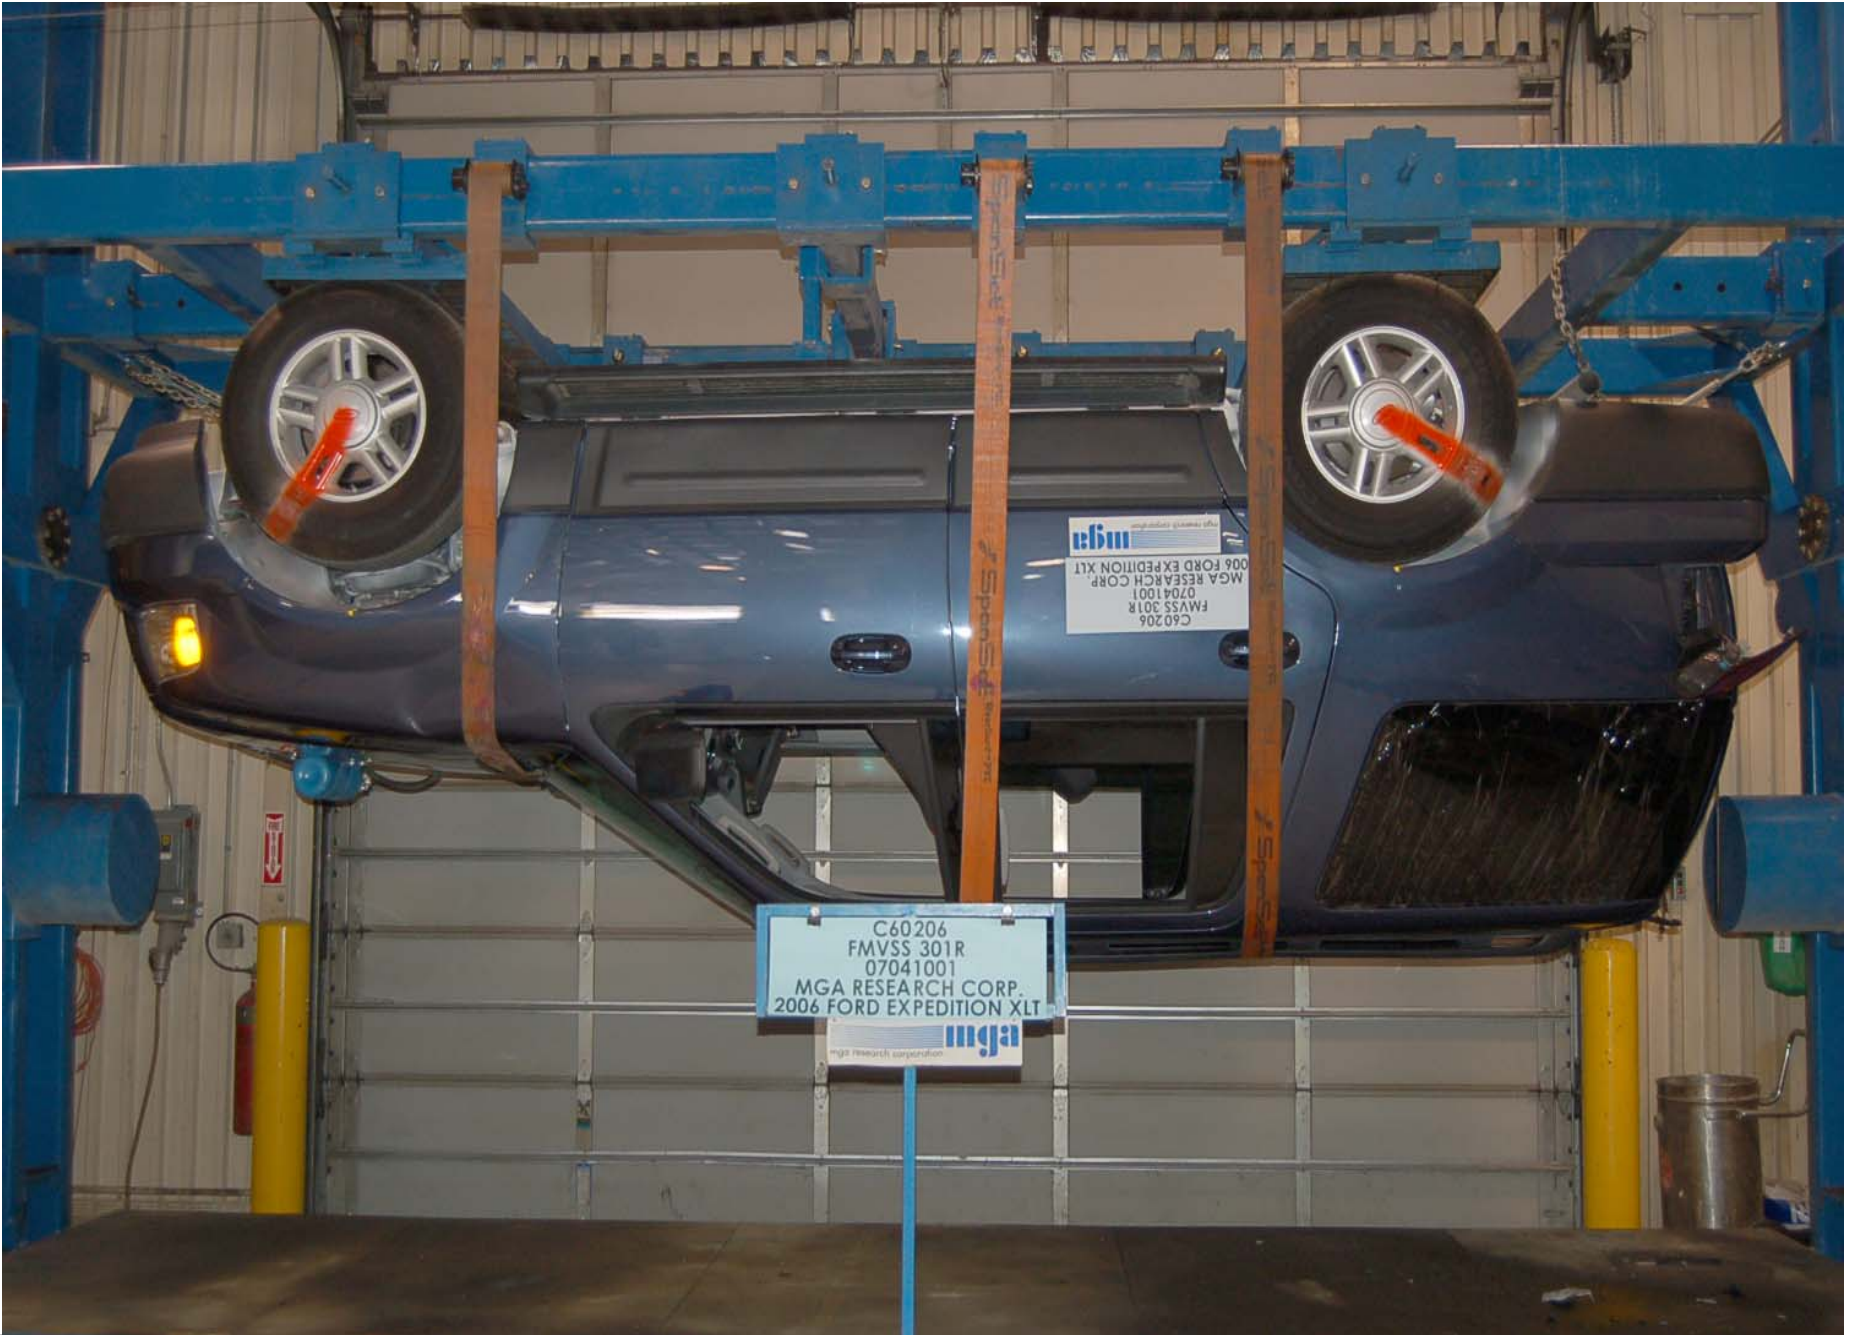
90° TO 180° Rotation Time (sec) = 115 sec

Test Phase	Spillage (g)	Spillage Details
First 5 minutes from onset of rotation	0	
Sixth minute from onset of rotation	0	
Seventh minute from onset of rotation	0	
Eight minute if required	N/A

Static Rollover at 180 Degrees

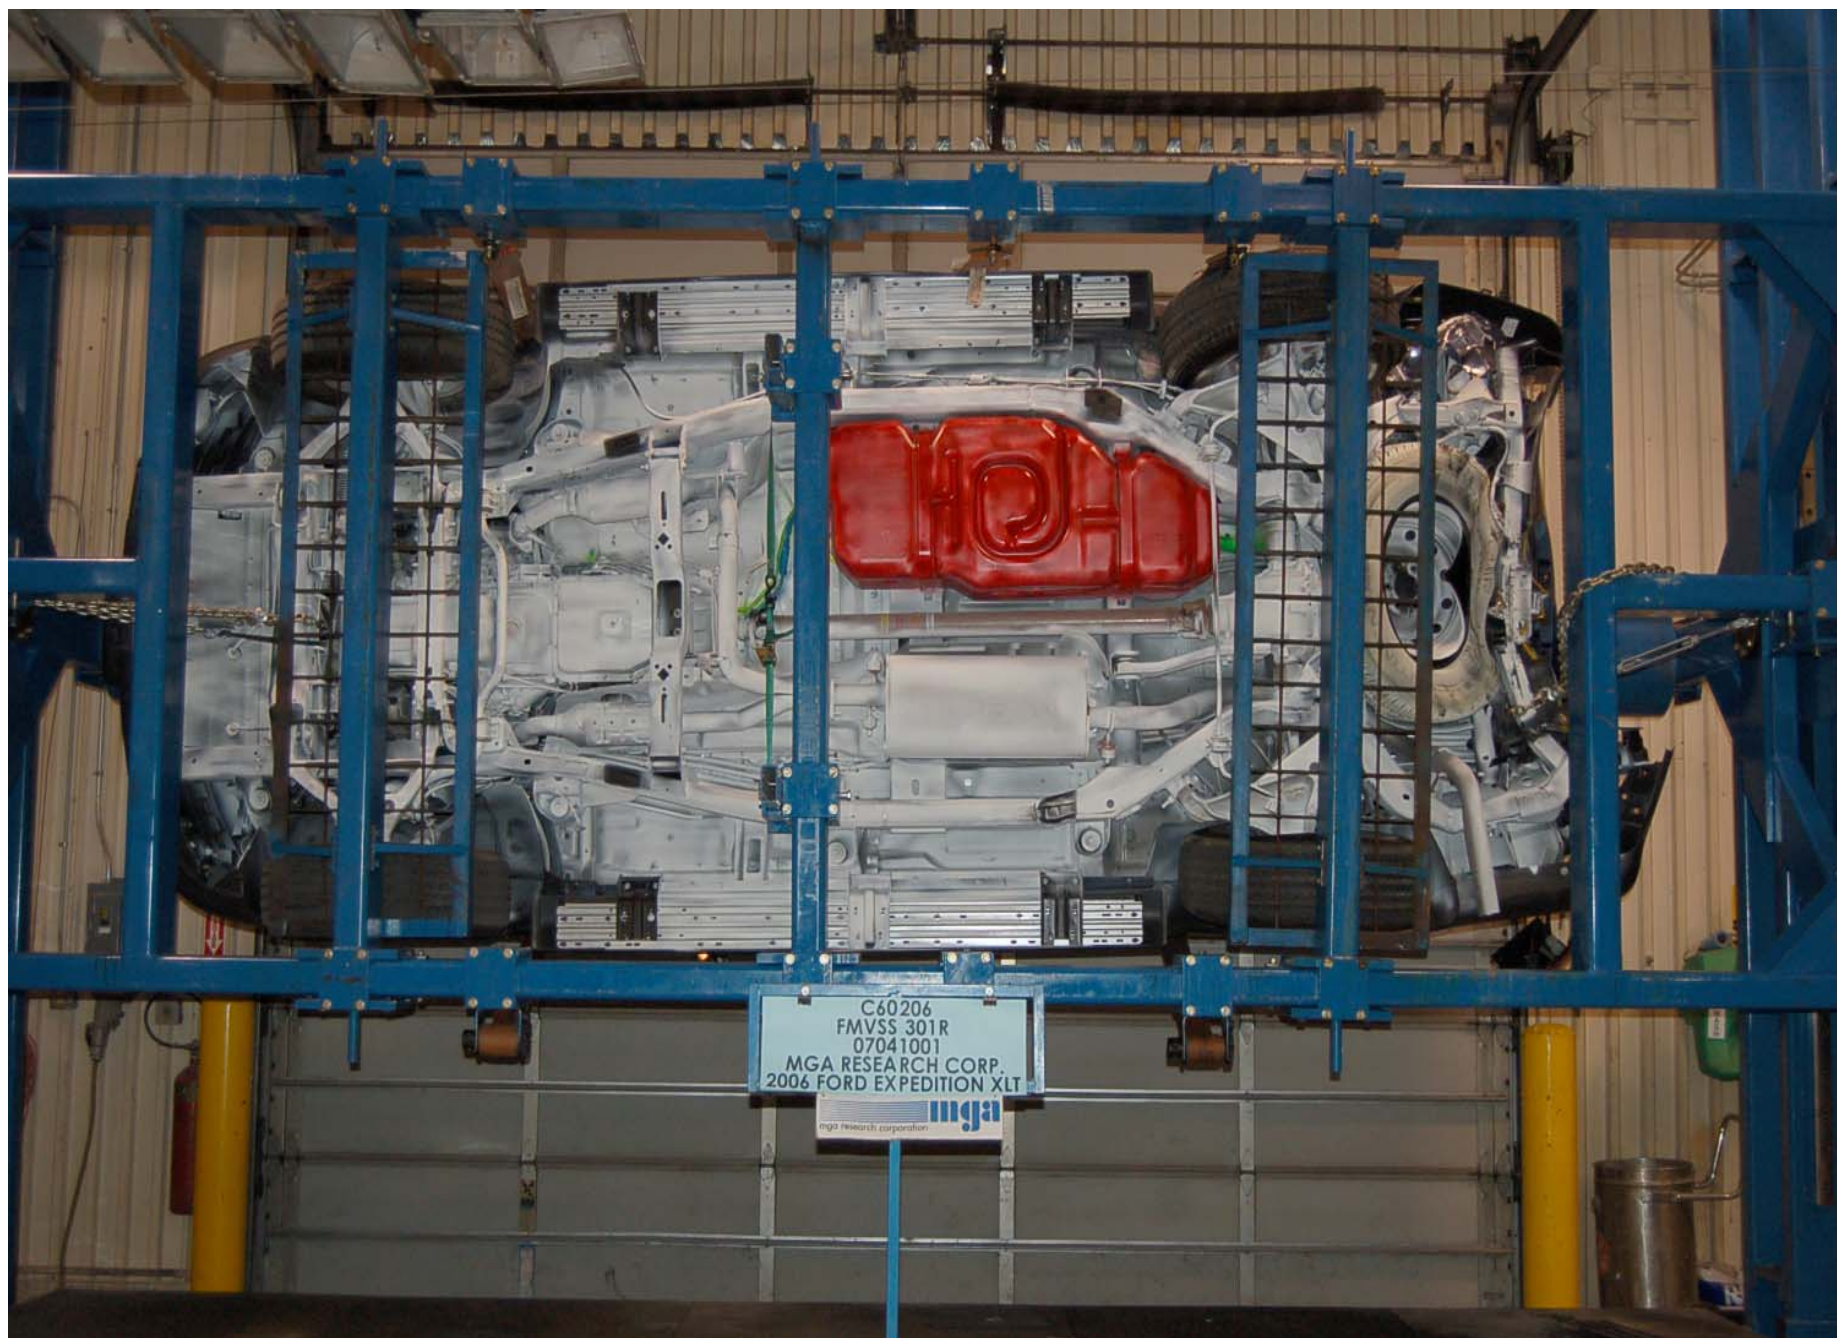
180° TO 270° Rotation Time (sec) = 116 sec

Test Phase	Spillage (g)	Spillage Details
First 5 minutes from onset of rotation	0	
Sixth minute from onset of rotation	0	
Seventh minute from onset of rotation	0	
Eight minute if required	N/A

Static Rollover at 270 Degrees

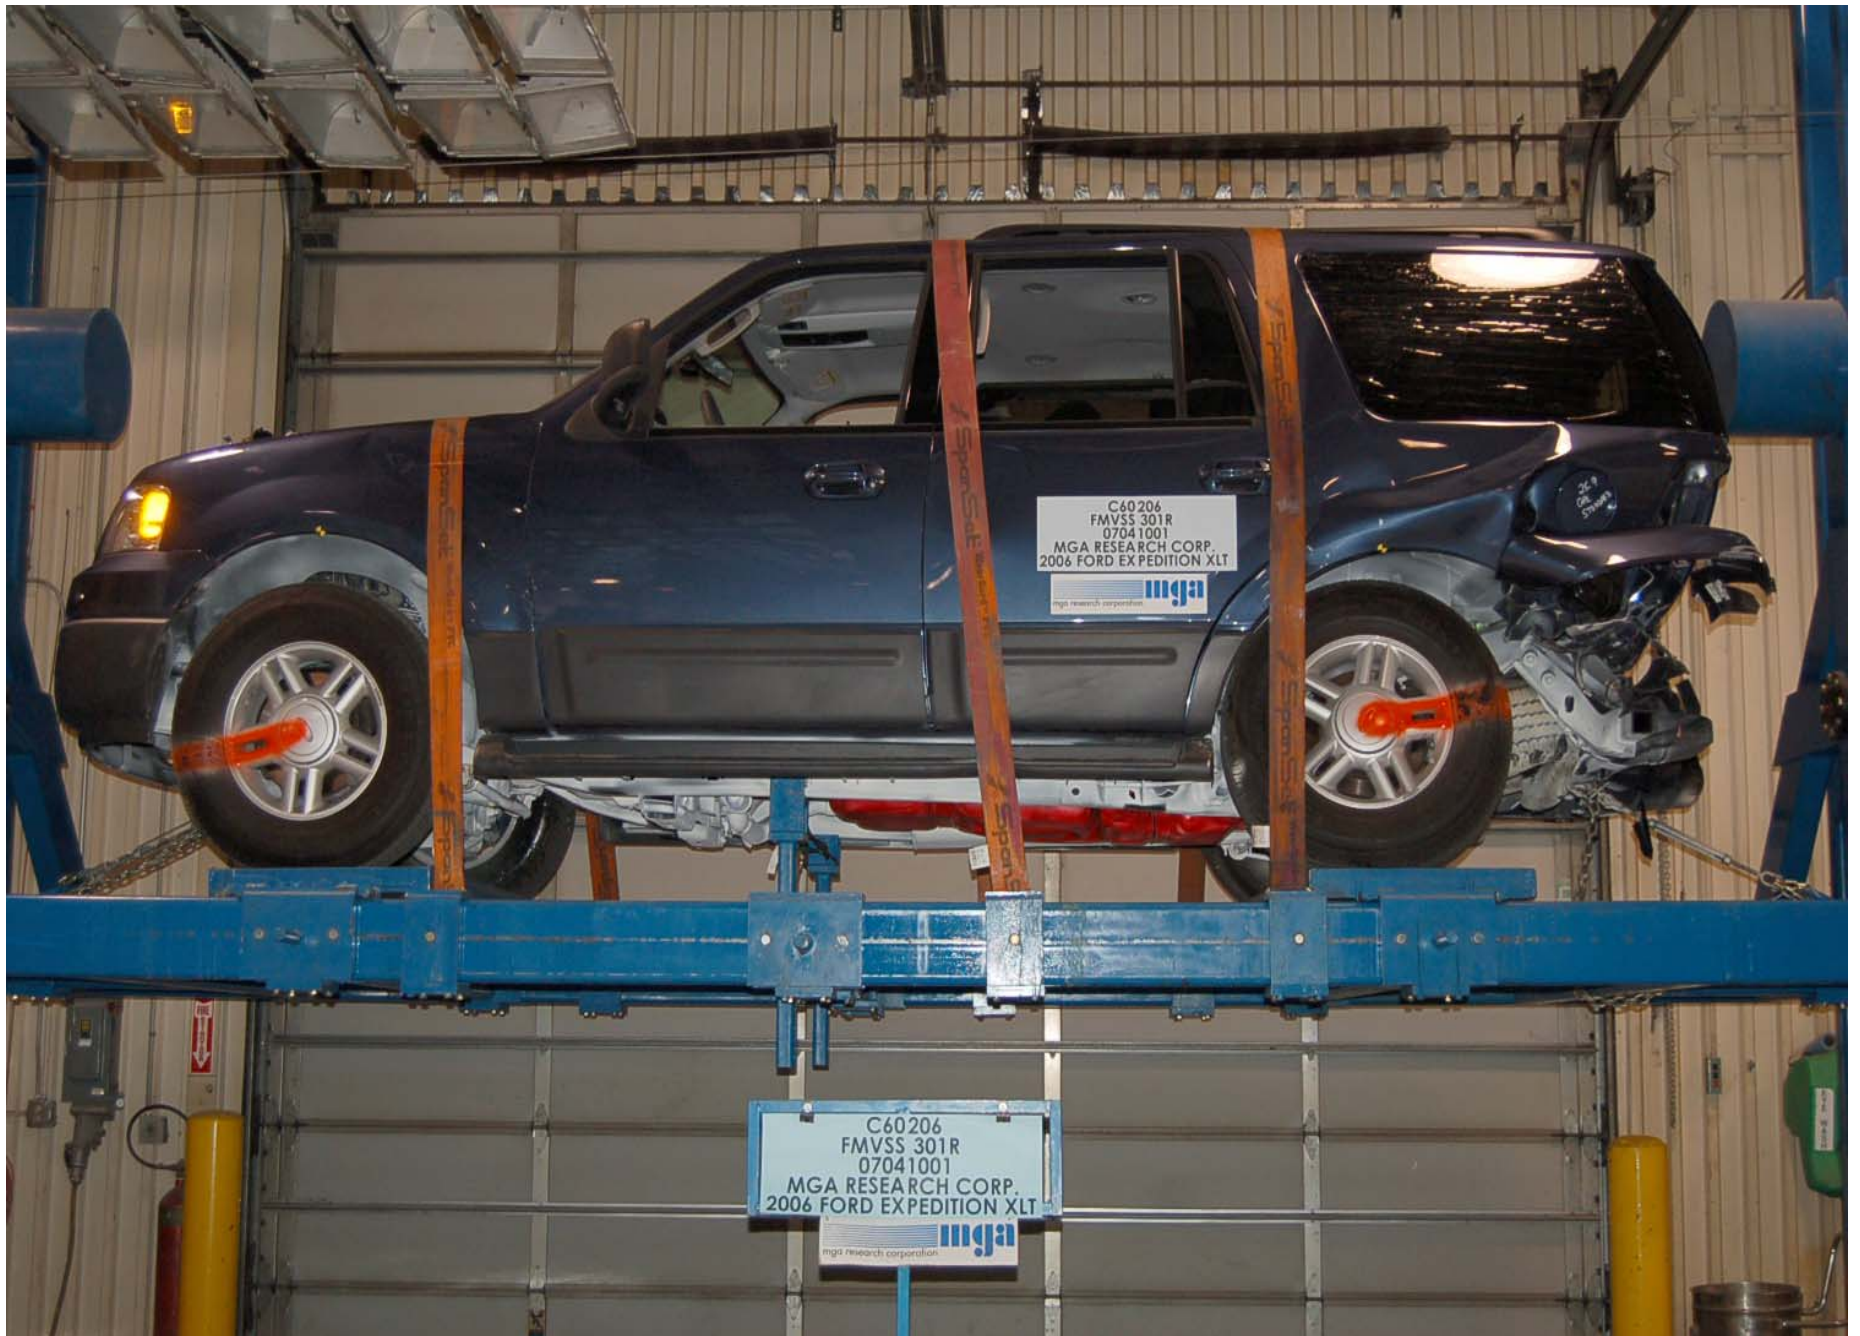
270° TO 360° Rotation Time (sec) = 116 sec

Test Phase	Spillage (g)	Spillage Details
First 5 minutes from onset of rotation	0	
Sixth minute from onset of rotation	0	
Seventh minute from onset of rotation	0	
Eight minute if required	N/A

Static Rollover at 360 Degrees
