REPORT NUMBER 124-GTL-07-005

SAFETY COMPLIANCE TESTING FOR FMVSS 124 ACCELERATOR CONTROL SYSTEMS

SUZUKI MOTOR CORPORATION
2007 SUZUKI AERIO,
4-DOOR PASSENGER CAR
NHTSA NO. C70503

FINAL REPORT

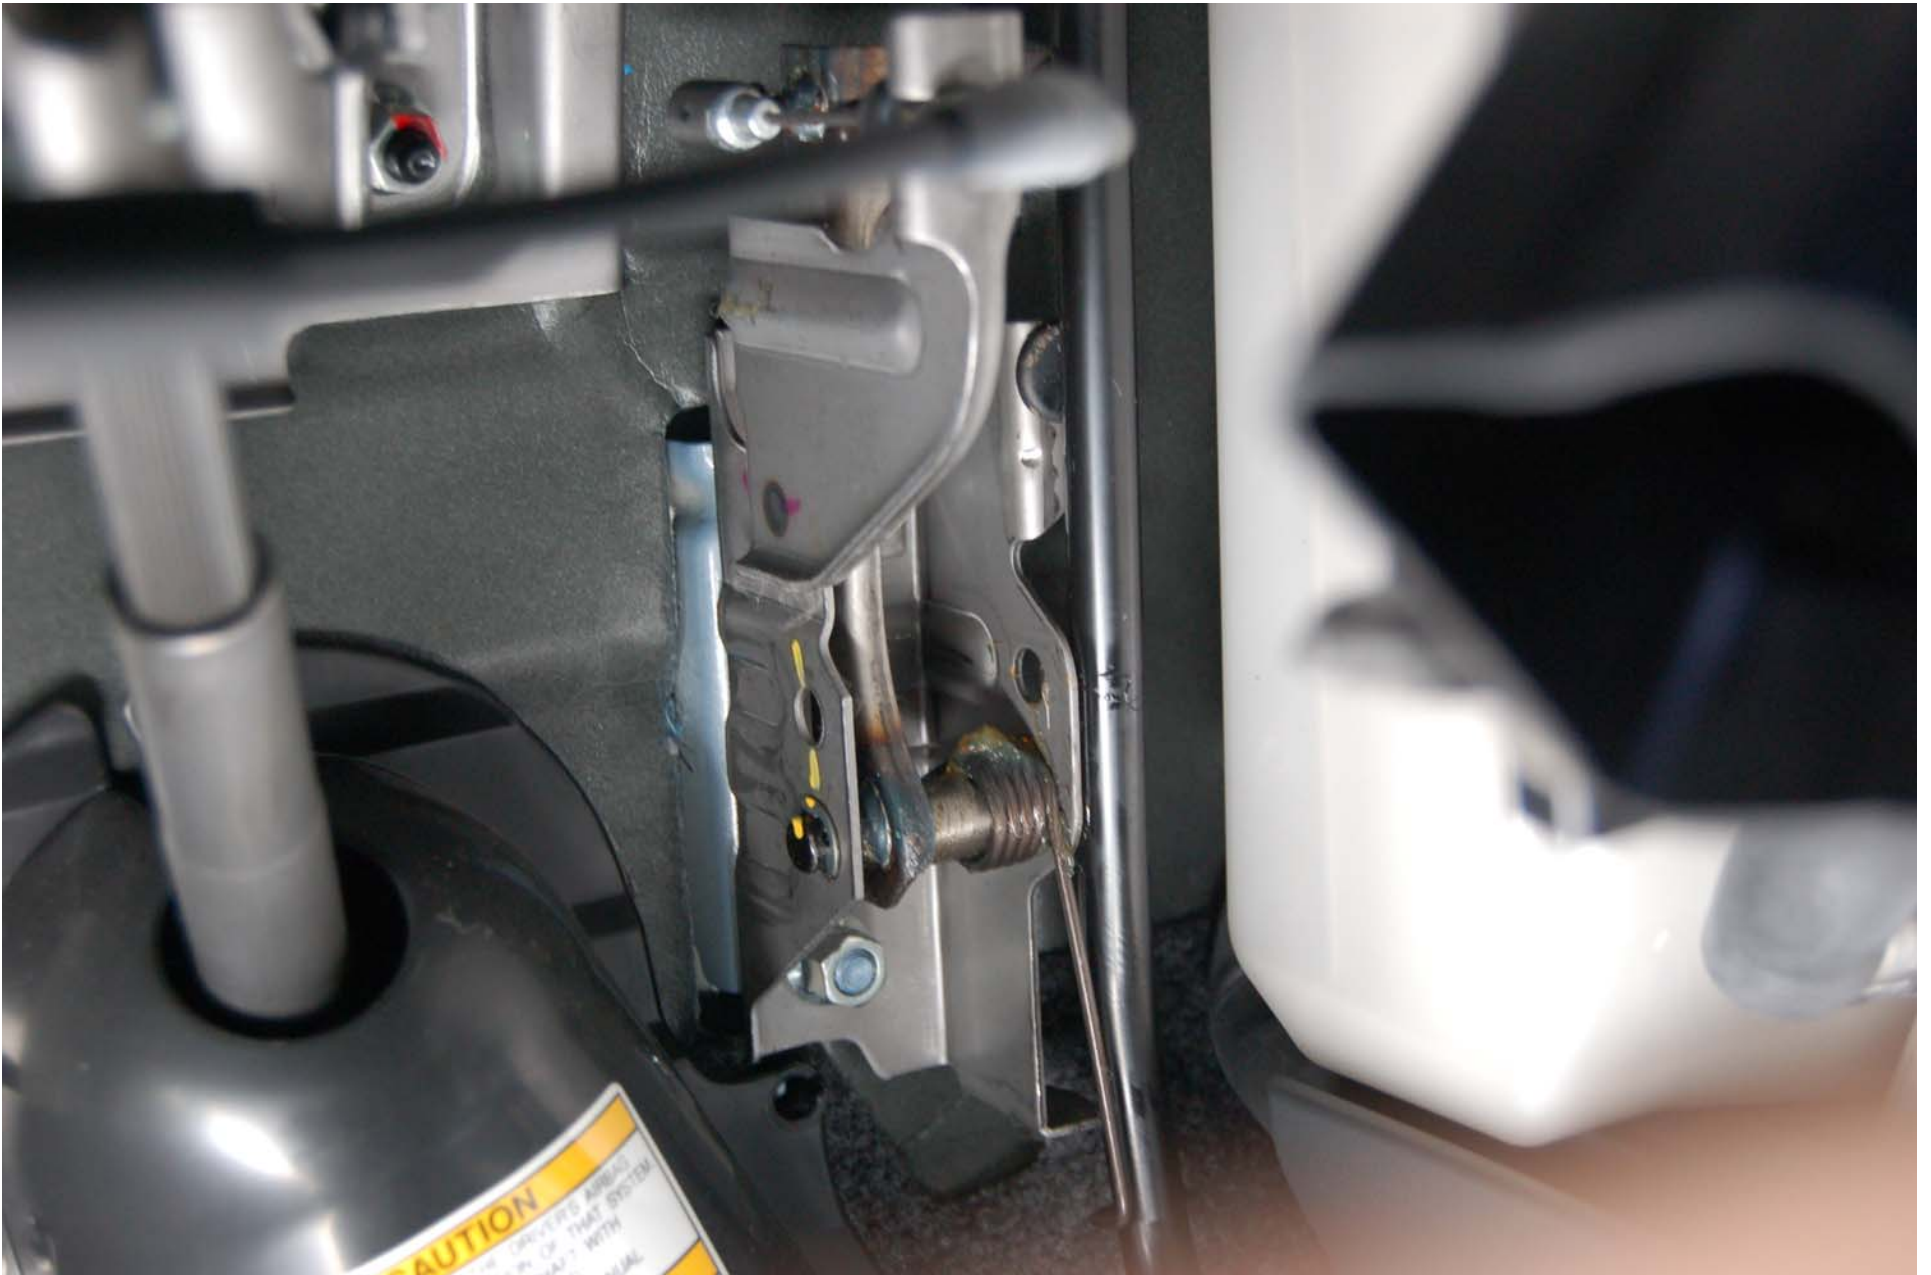
FIGURE 5.8
ACCELERATOR RETURN SPRING #3

SYSTEM CONDITION: #3 SPRING DISCONNECTED LOCATED ON ACCELERATOR PEDAL

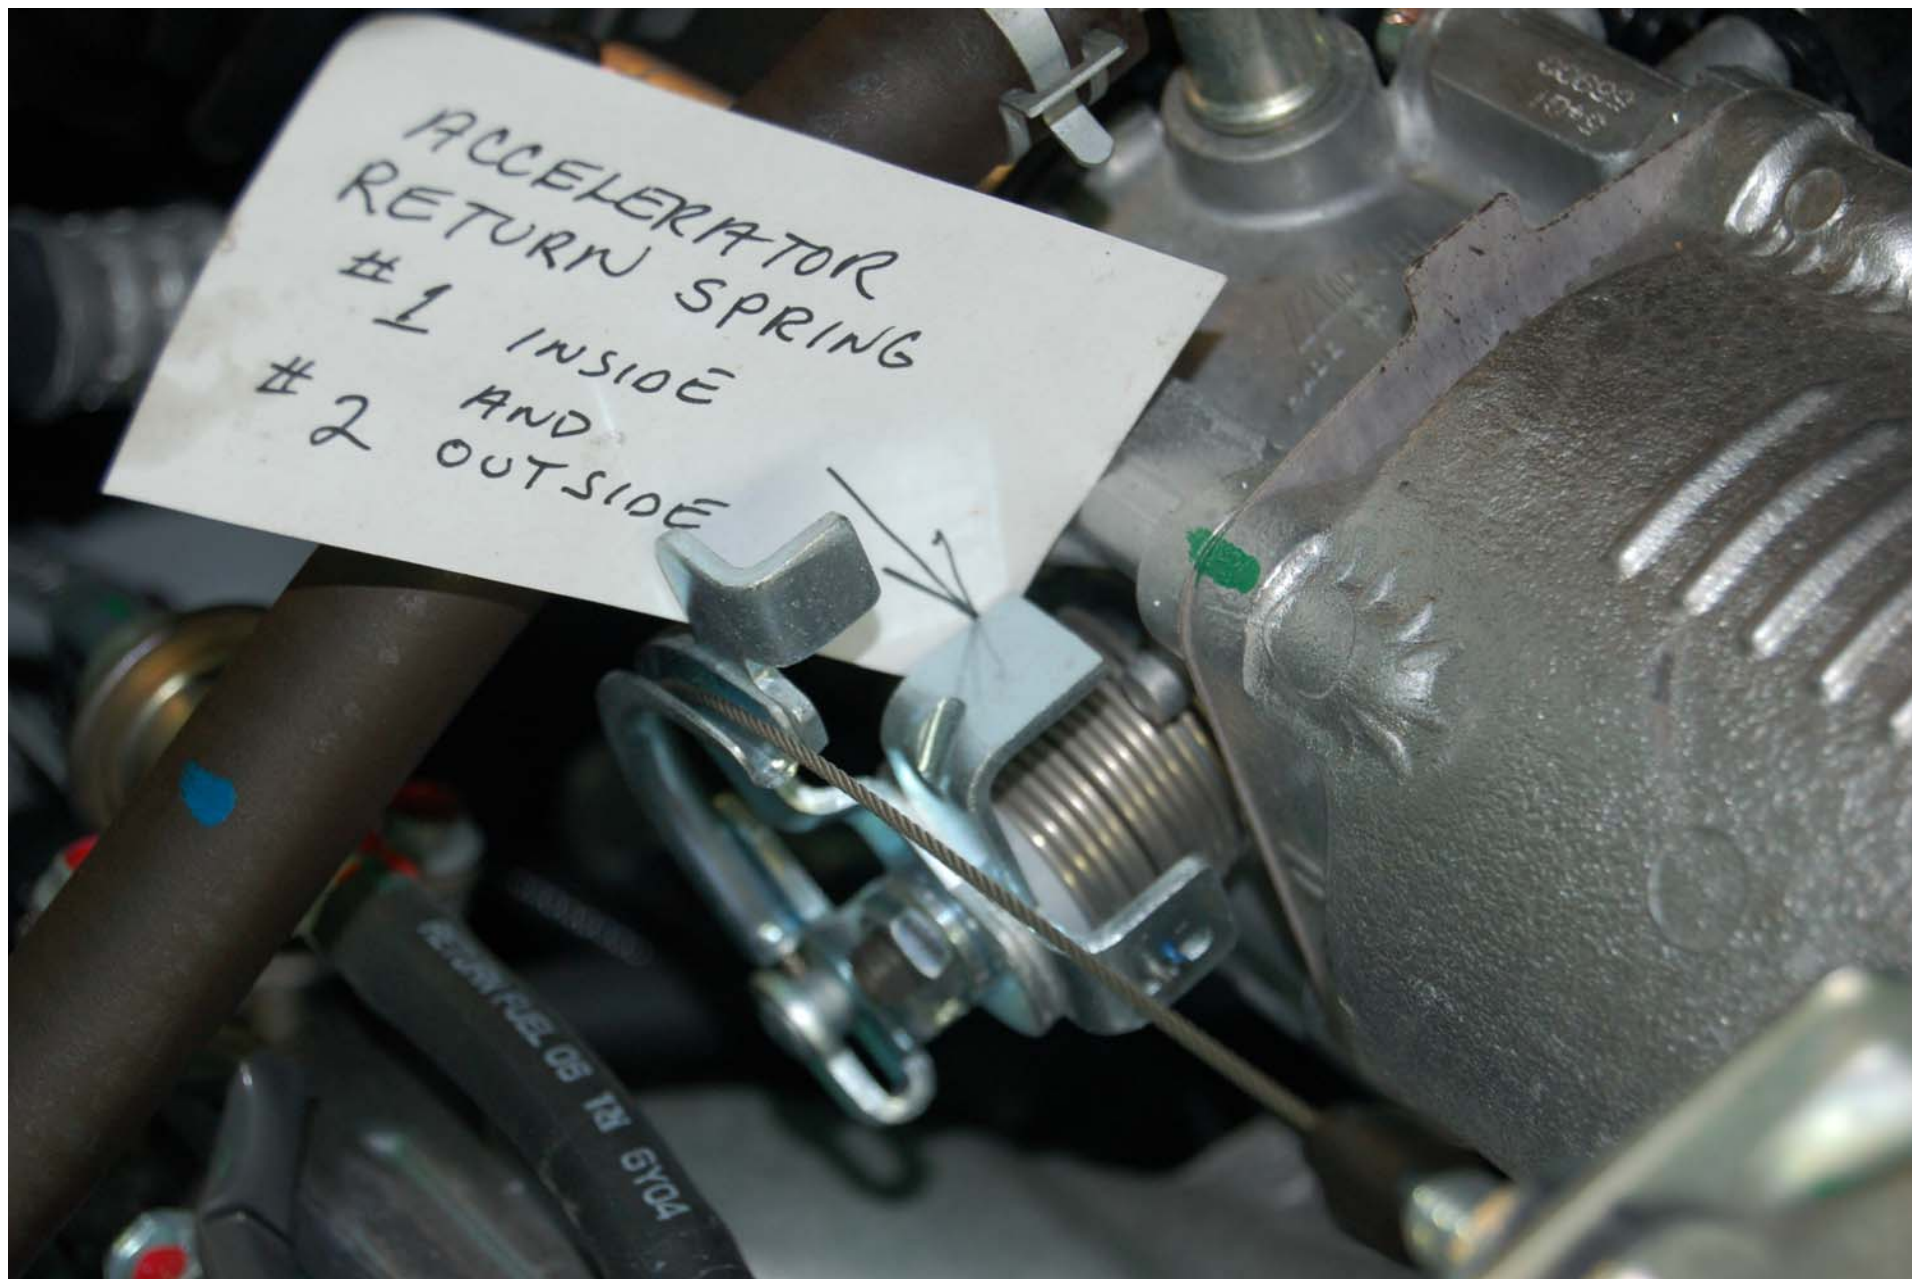
FIGURE 5.10
THROTTLE RETURN SPRINGS #1 AND #2

SYSTEM CONDITION: #1 SPRING DISCONNECTED LOCATED ON THROTTLE BUTTERFLY

SYSTEM CONDITION: #2 SPRING DISCONNECTED LOCATED ON THROTTLE BUTTERFLY
