**SAFETY COMPLIANCE TESTING FOR  
FMVSS NO. 214S  
SIDE IMPACT PROTECTION (STATIC)**

**HYUNDAI MOTOR COMPANY  
2009 HYUNDAI GENESIS, PASSENGER CAR  
NHTSA NO. C90501**

**FINAL REPORT**

1. Report No. 214-GTL-09-005	2. Government Accession No. N/A	3. Recipient's Catalog No. N/A
4. Title and Subtitle Final Report of FMVSS 214 Compliance Testing of 2009 HYUNDAI GENESIS PASSENGER CAR NHTSA No. C90501		5. Report Date August 12, 2009

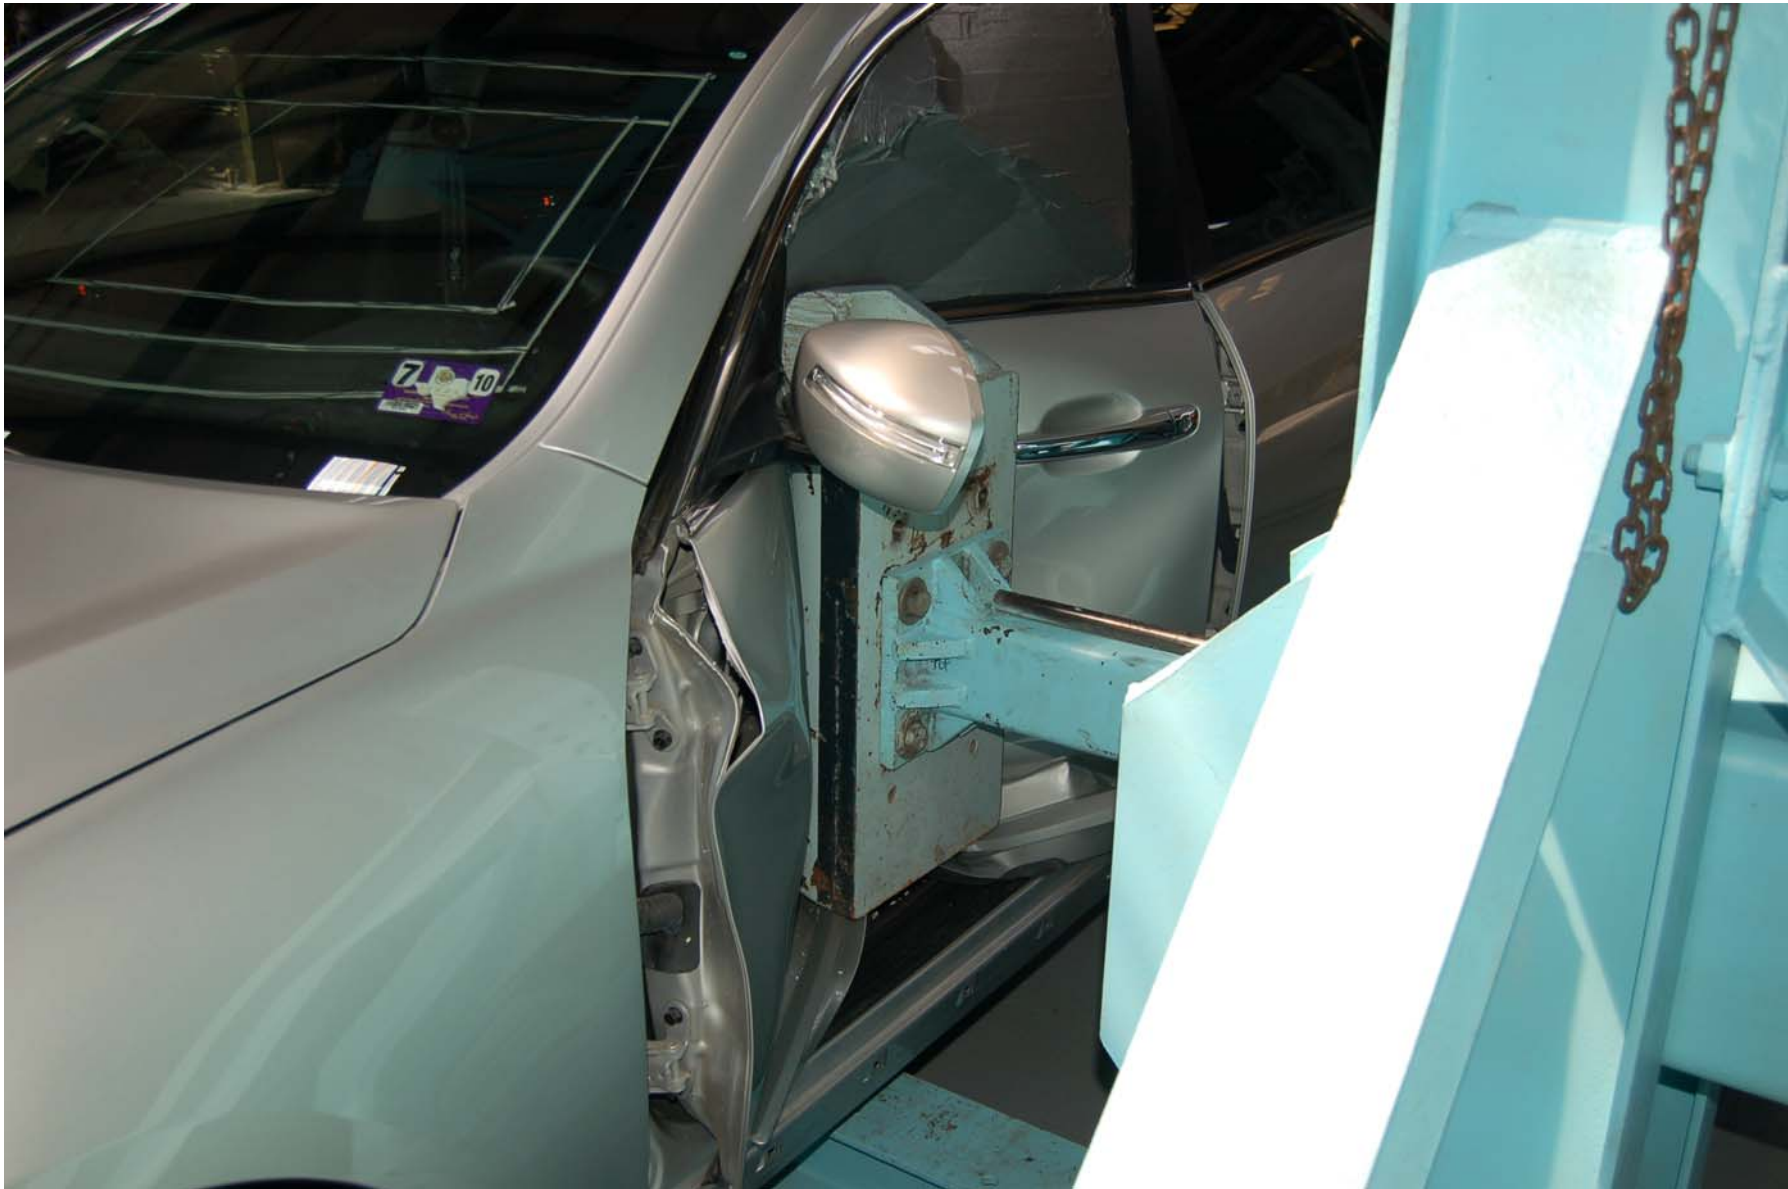
- A. The initial crush resistance was 3354 lbs.  
 B. The intermediate crush resistance was 5917 lbs.  
 C. The peak crush resistance was 11,128 lbs at 12.2 inches  
 D. The rate of loading was .2"/sec

FIGURE 5.16  
LOAD DEVICE AGAINST DOOR @ MAX LOAD – TEST 1

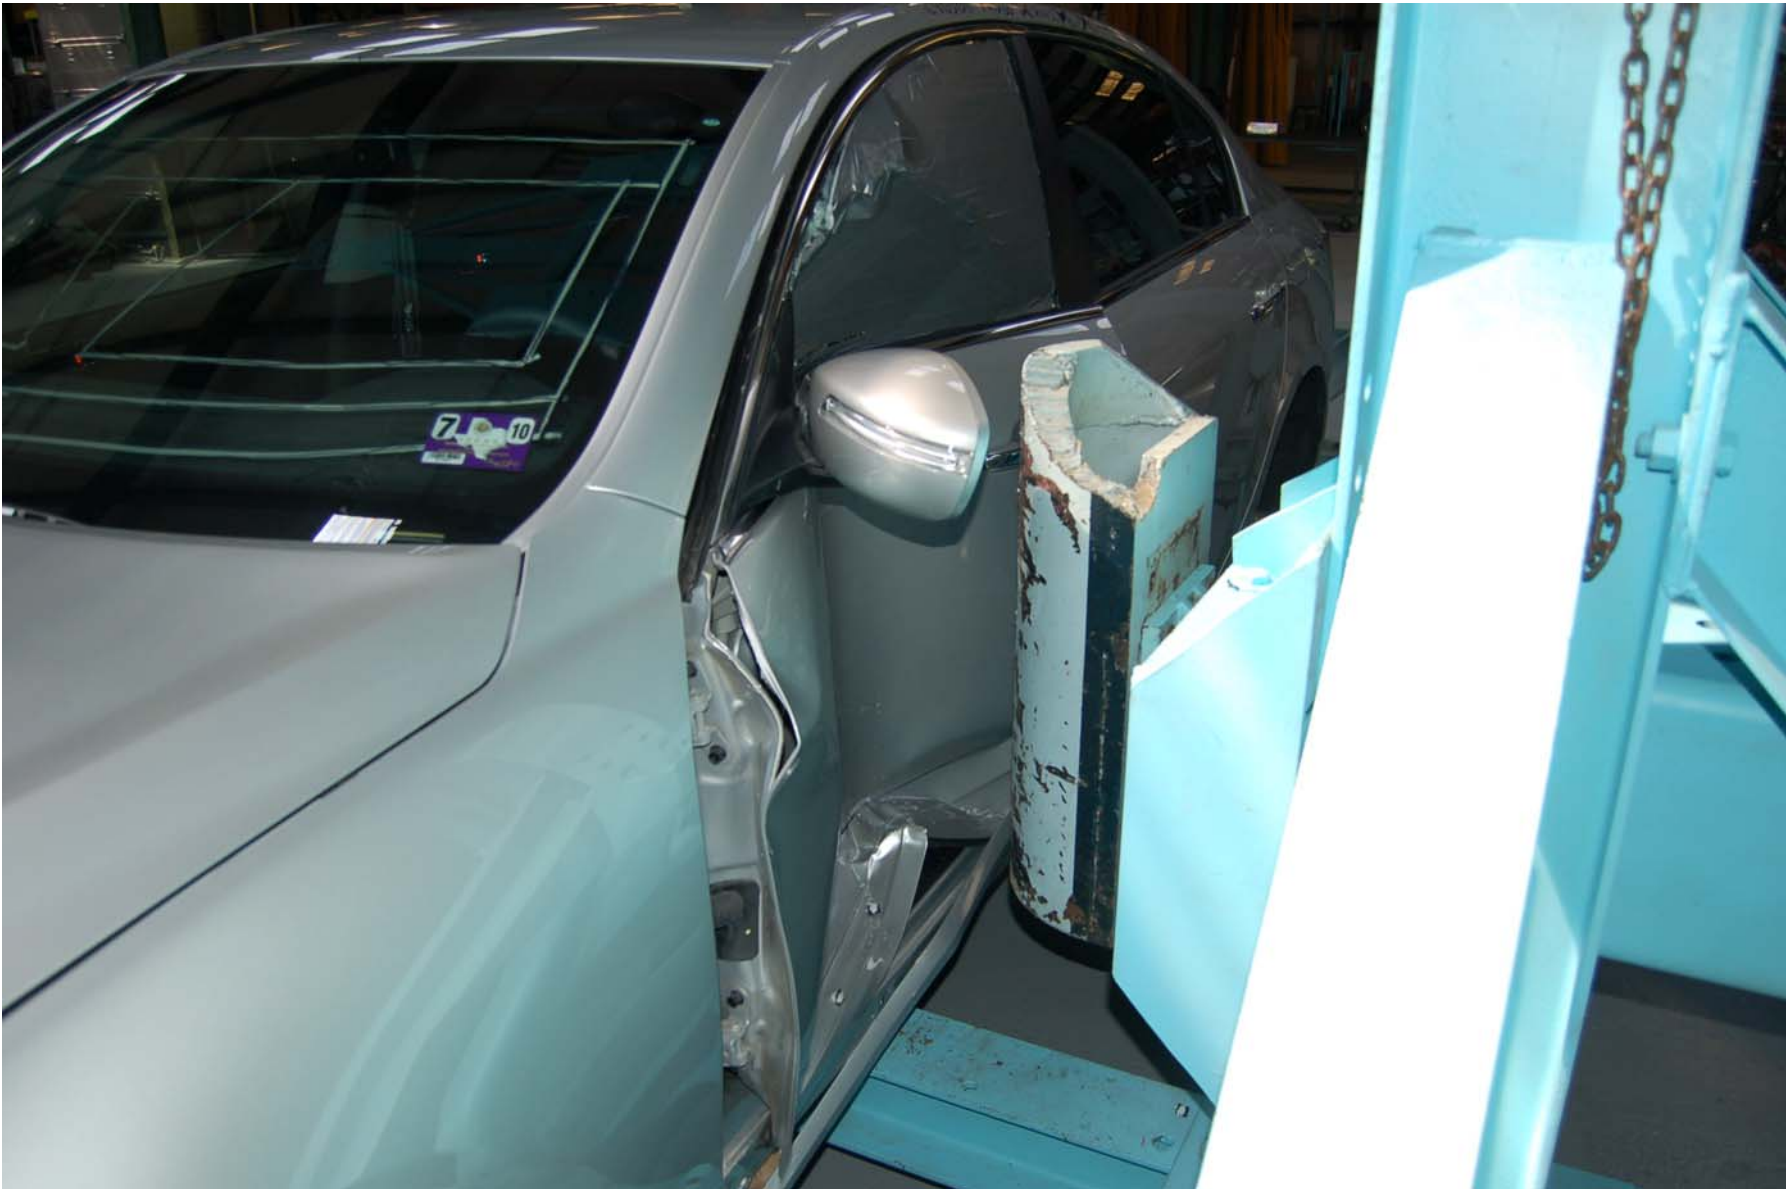
FIGURE 5.19  
POST TEST DOOR OUTSIDE – TEST 1

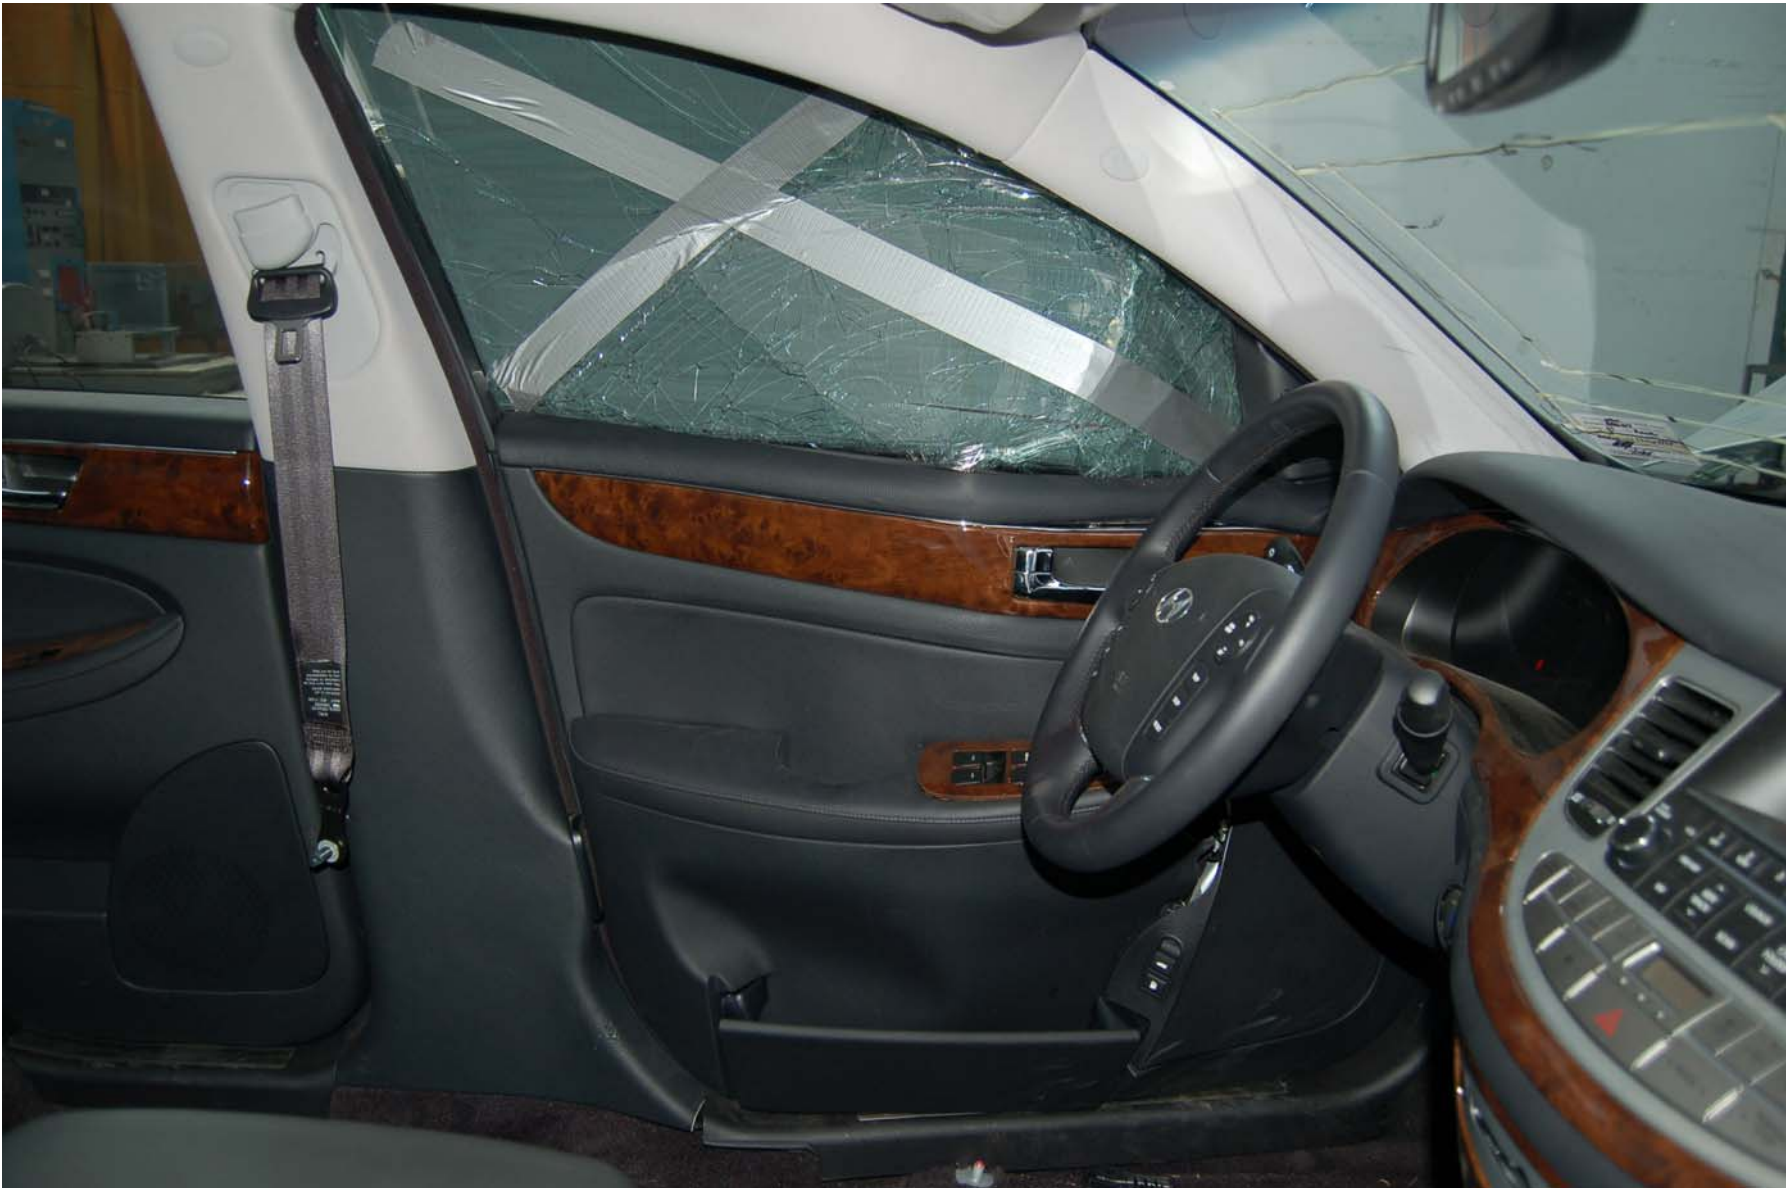
FIGURE 5.20  
POST TEST DOOR INSIDE – TEST 1

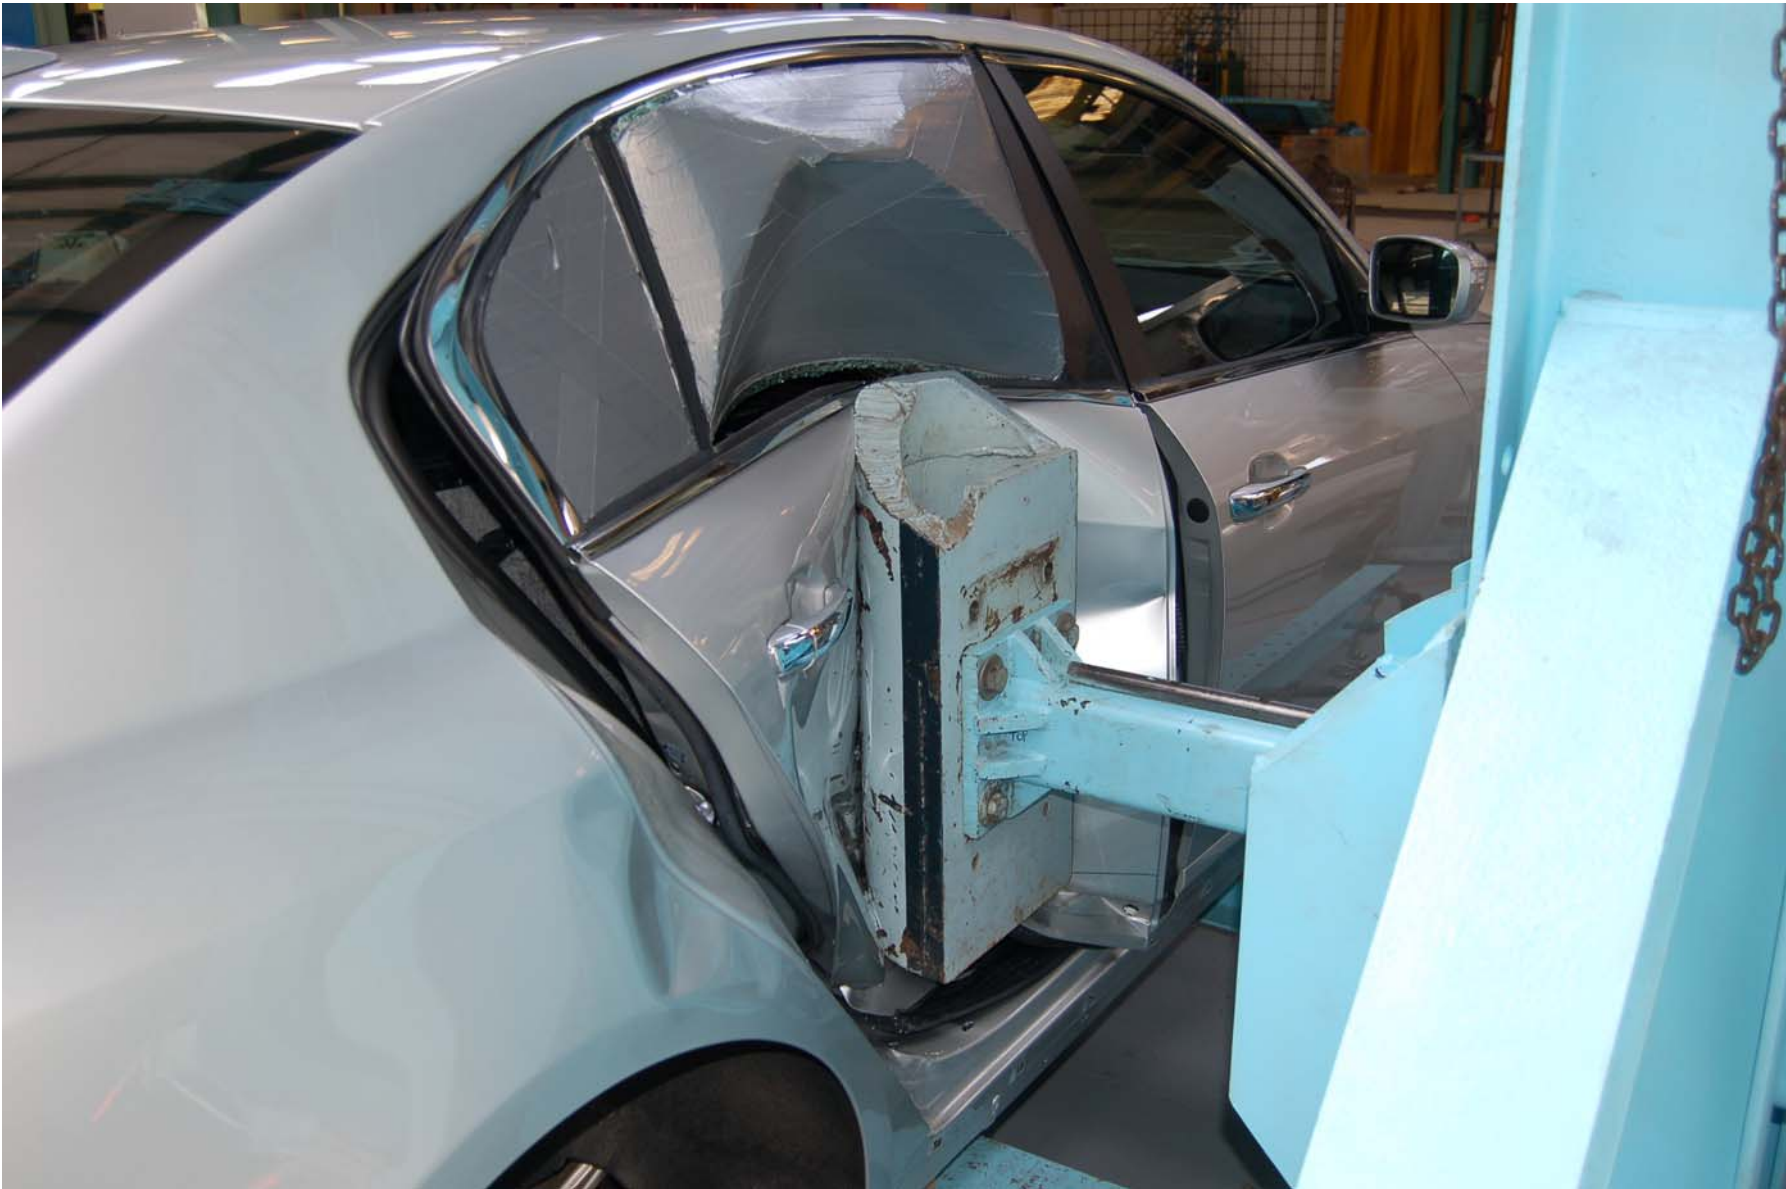
- A. The initial crush resistance was 4296 lbs.  
 B. The intermediate crush resistance was 6754 lbs.  
 C. The peak crush resistance was 13,755 lbs at 12.2 inches  
 D. The rate of loading was .2"/sec

FIGURE 5.26  
LOAD DEVICE AGAINST DOOR @ MAX LOAD – TEST 2

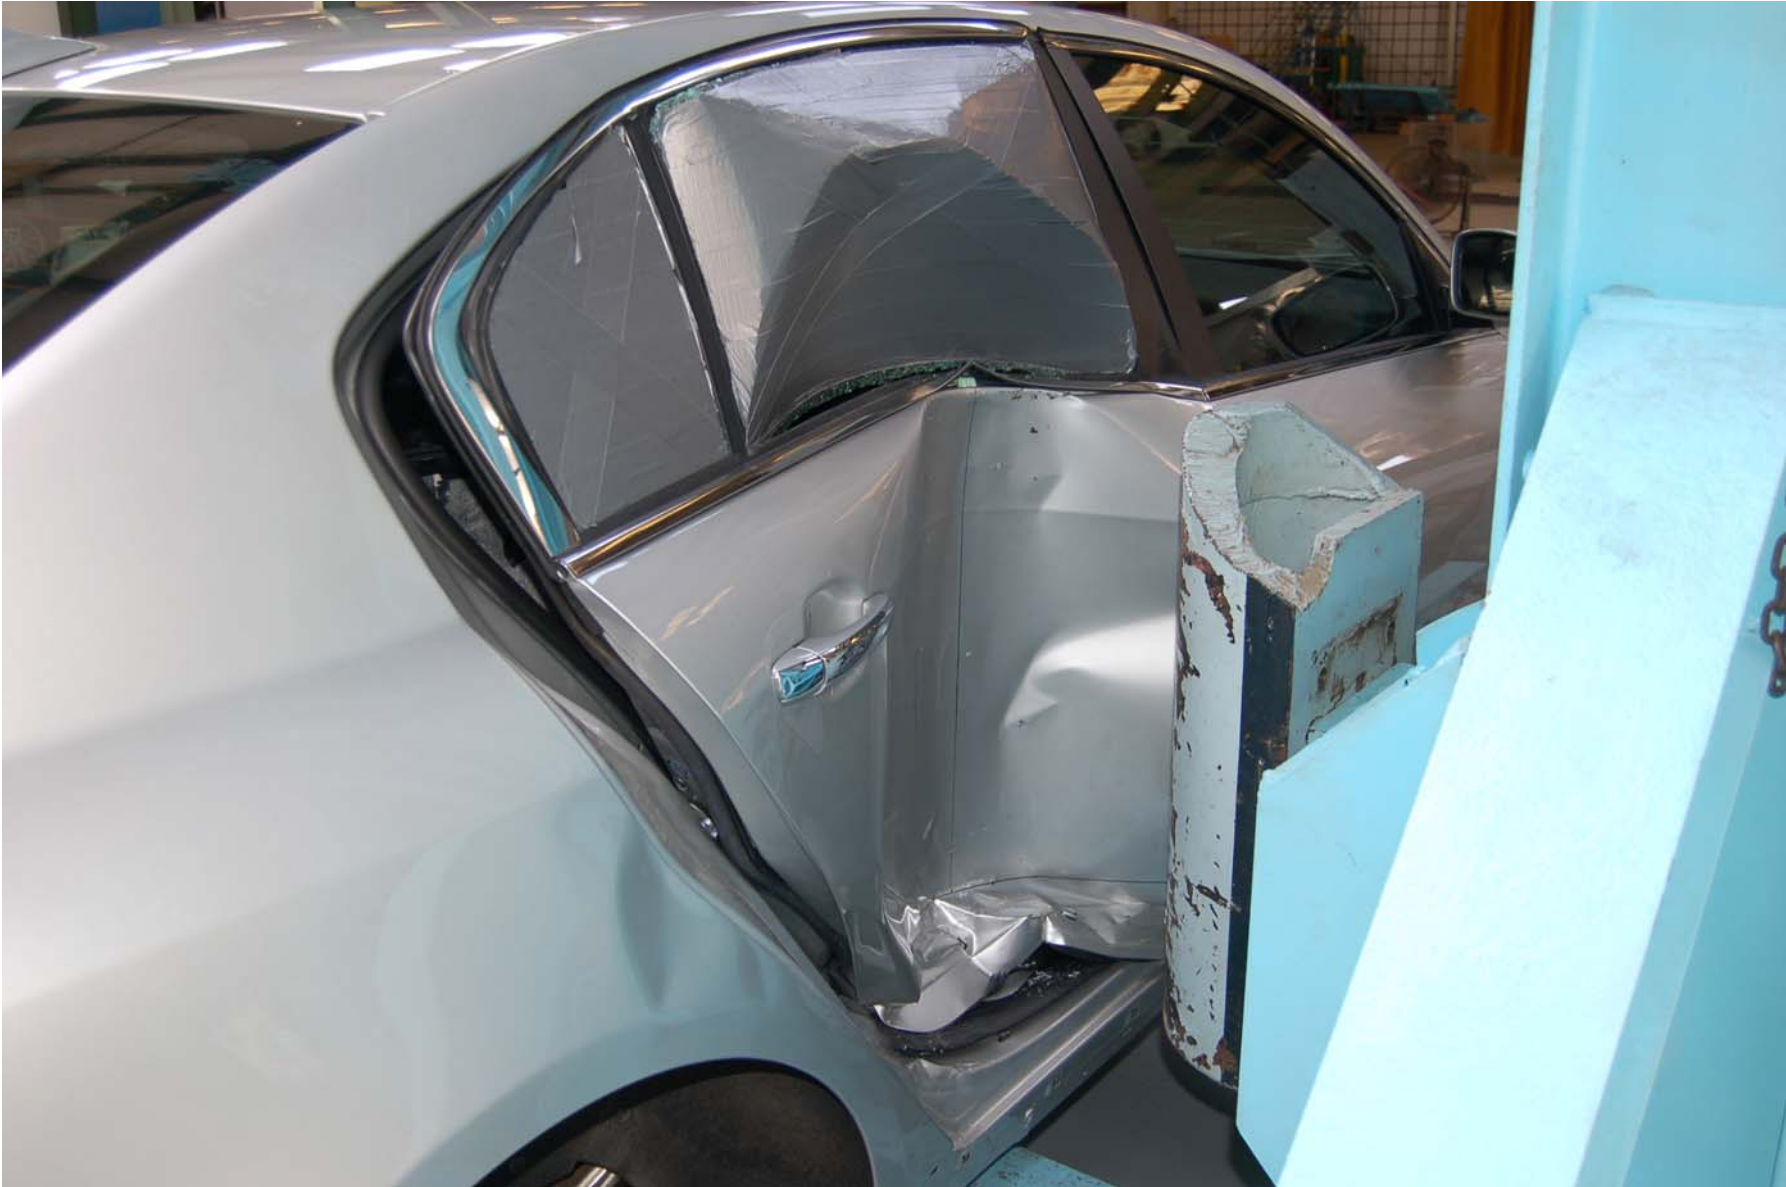
FIGURE 5.29  
POST TEST DOOR OUTSIDE – TEST 2

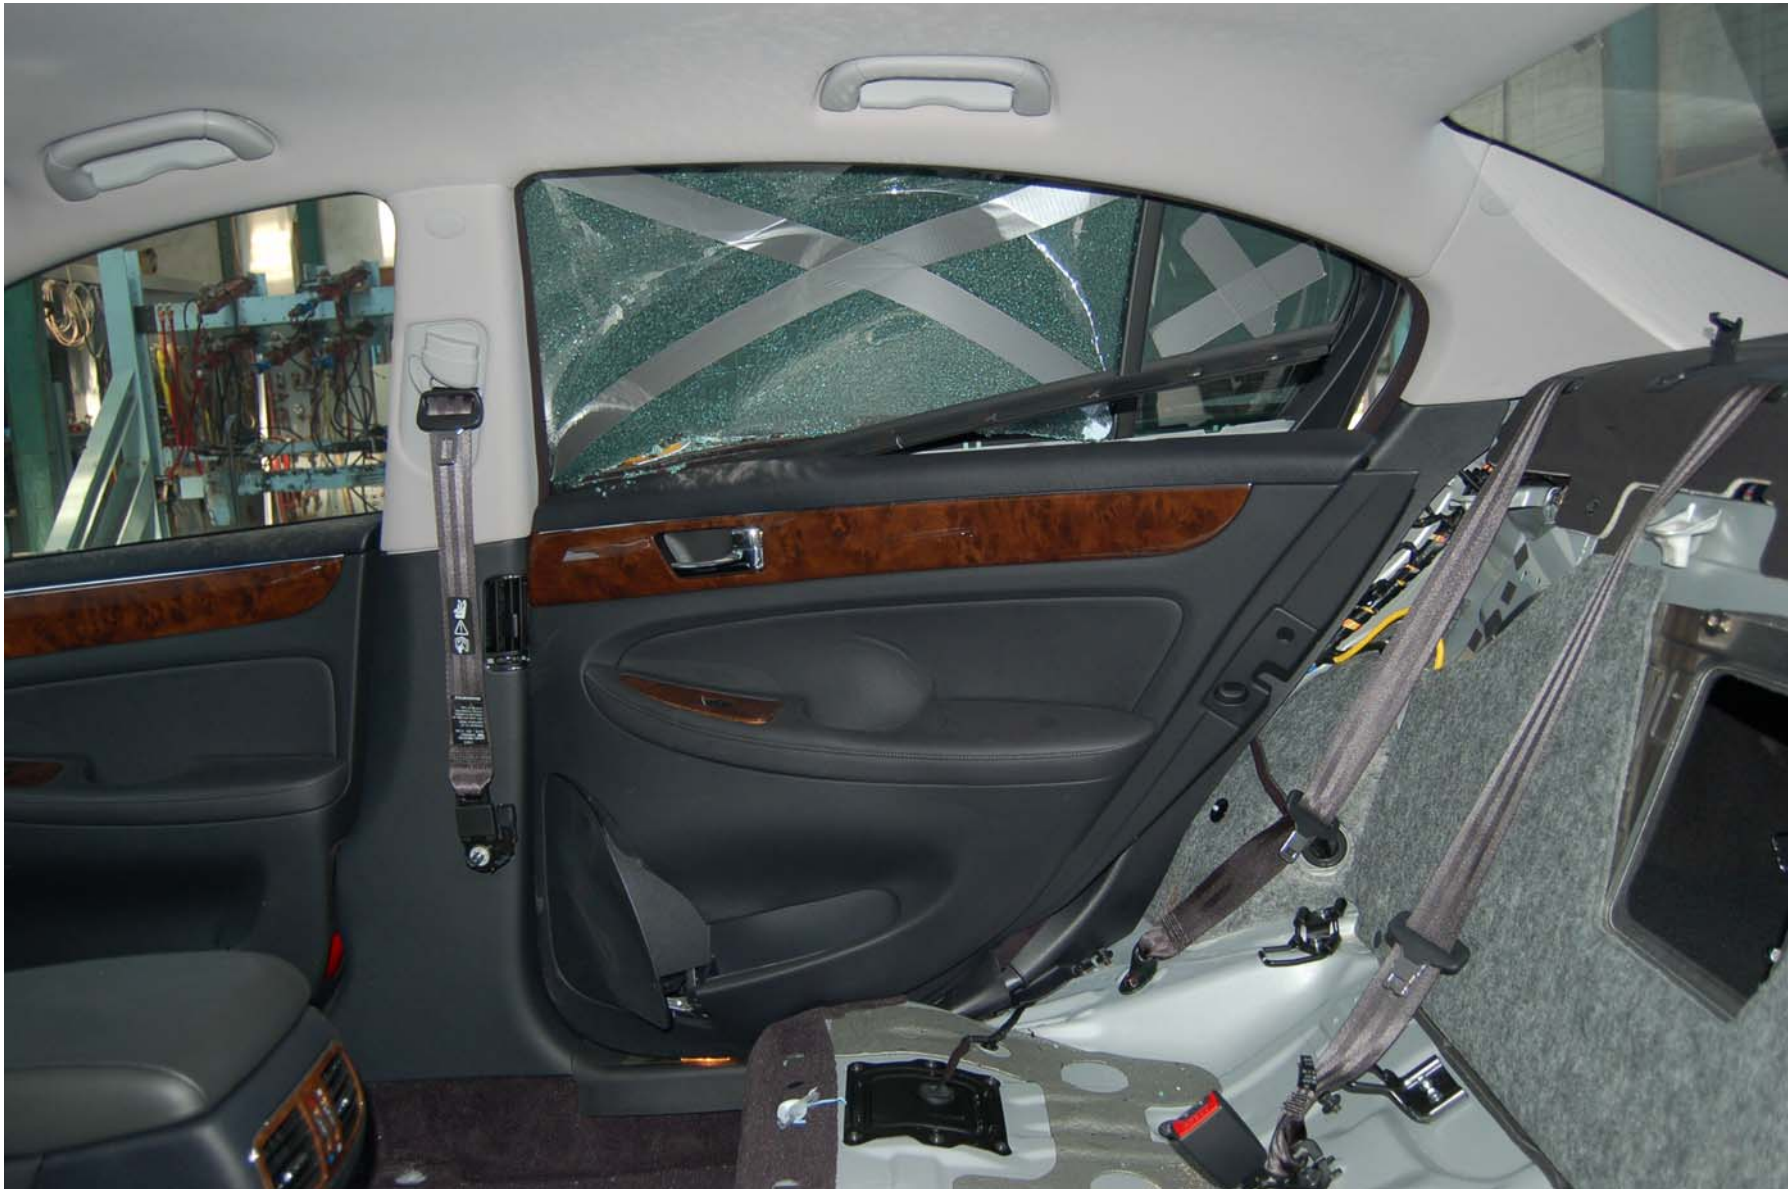
FIGURE 5.30  
POST TEST DOOR INSIDE – TEST 2

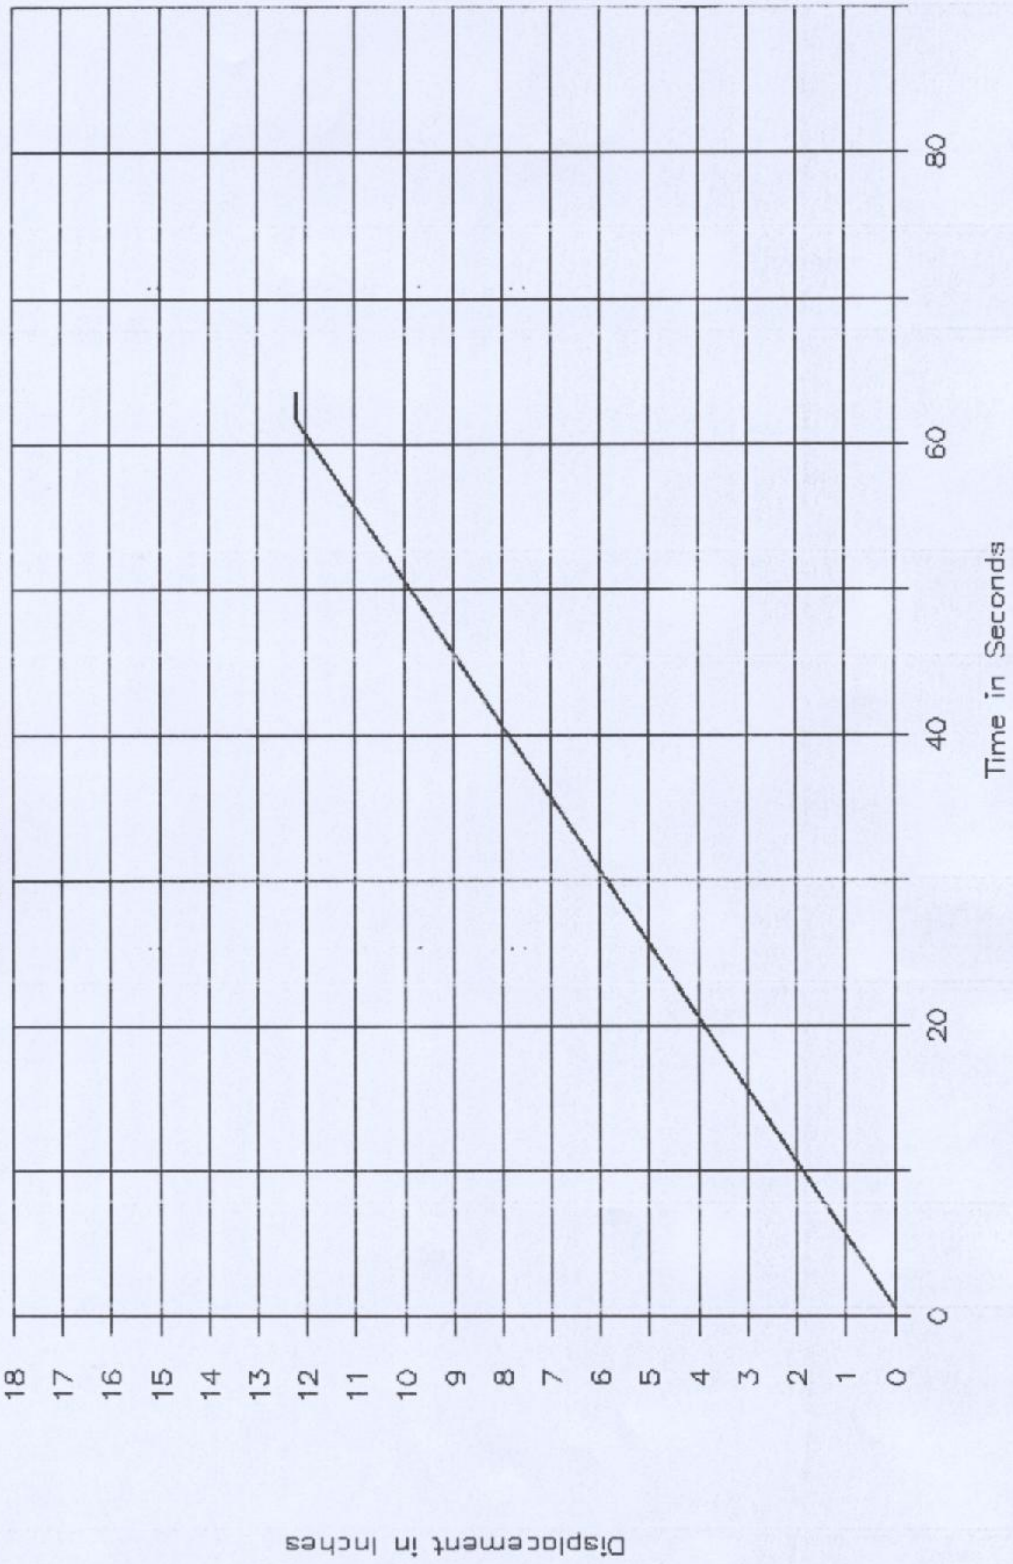
- A. The initial crush resistance was 3354 lbs.
- B. The intermediate crush resistance was 5917 lbs.
- C. The peak crush resistance was 11,128 lbs at 12.2 inches

214, Static Door Crush, Left Front Door

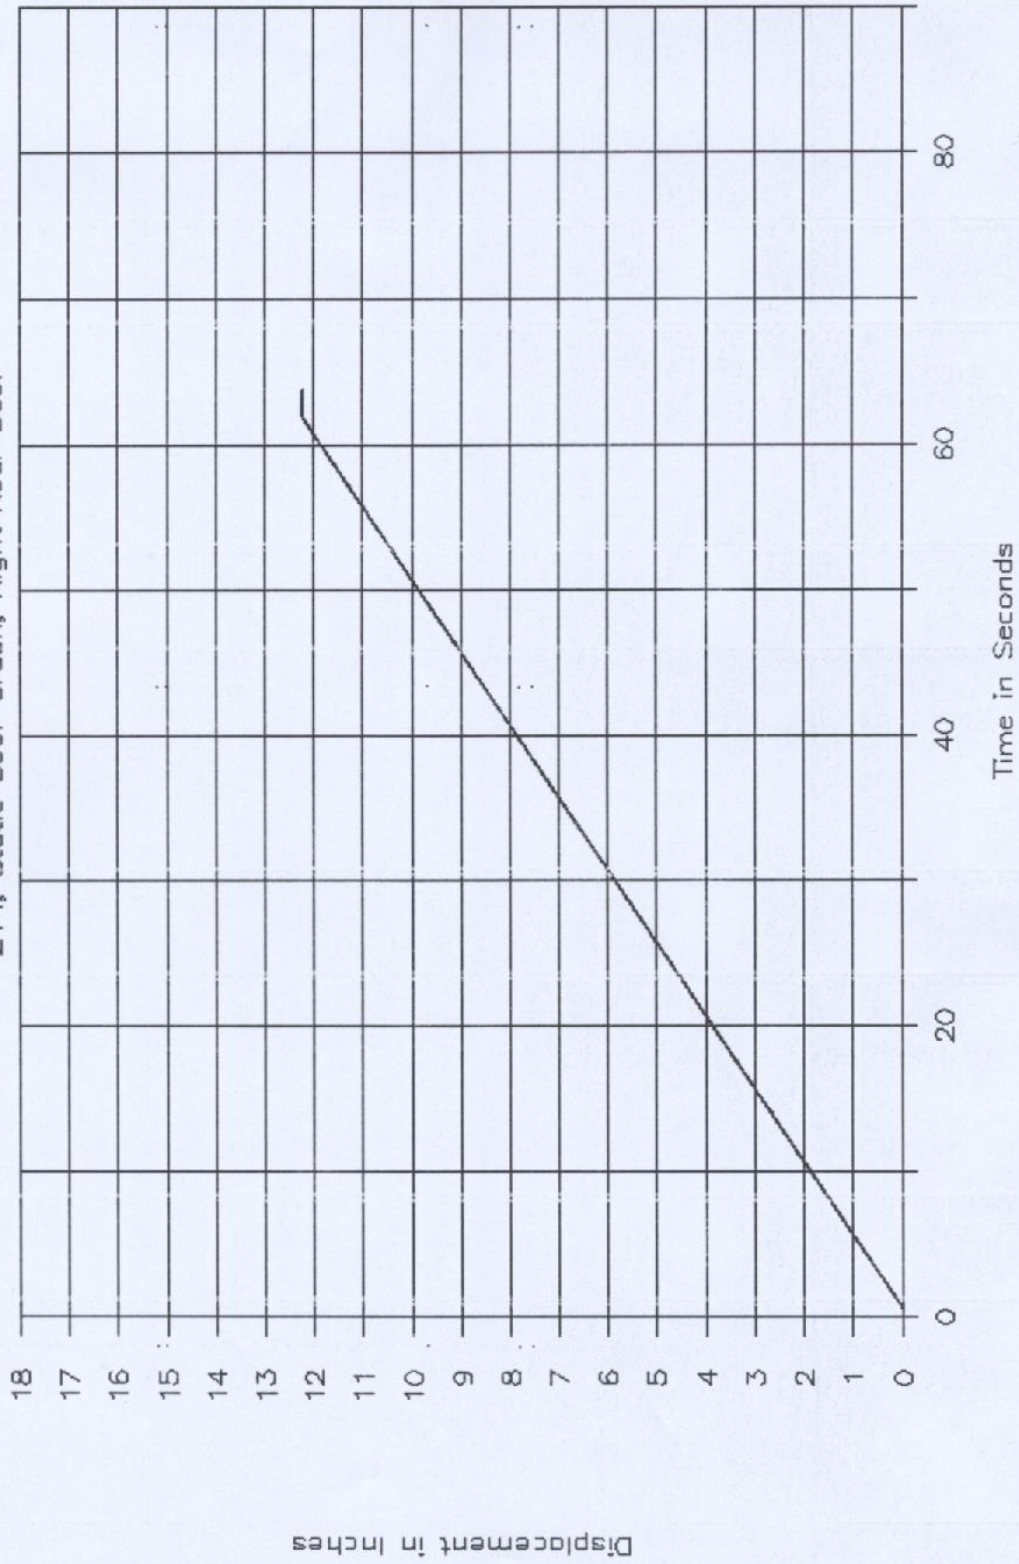
- A. The initial crush resistance was 4296 lbs.
- B. The intermediate crush resistance was 6754 lbs.
- C. The peak crush resistance was 13,755 lbs at 12.2 inches

214, Static Door Crush, Right Rear Door
