**SAFETY COMPLIANCE TESTING FOR
FMVSS NO. 214S
SIDE IMPACT PROTECTION (STATIC)**

**HONDA MOTOR CO., LTD. OF JAPAN
2009 HONDA FIT, PASSENGER CAR
NHTSA NO. C95302**

FINAL REPORT

1. Report No. 214-GTL-09-004	2. Government Accession No. N/A	3. Recipient's Catalog No. N/A
4. Title and Subtitle Final Report of FMVSS 214 Compliance Testing of 2009 HONDA FIT PASSENGER CAR NHTSA No. C95302		5. Report Date August 12, 2009

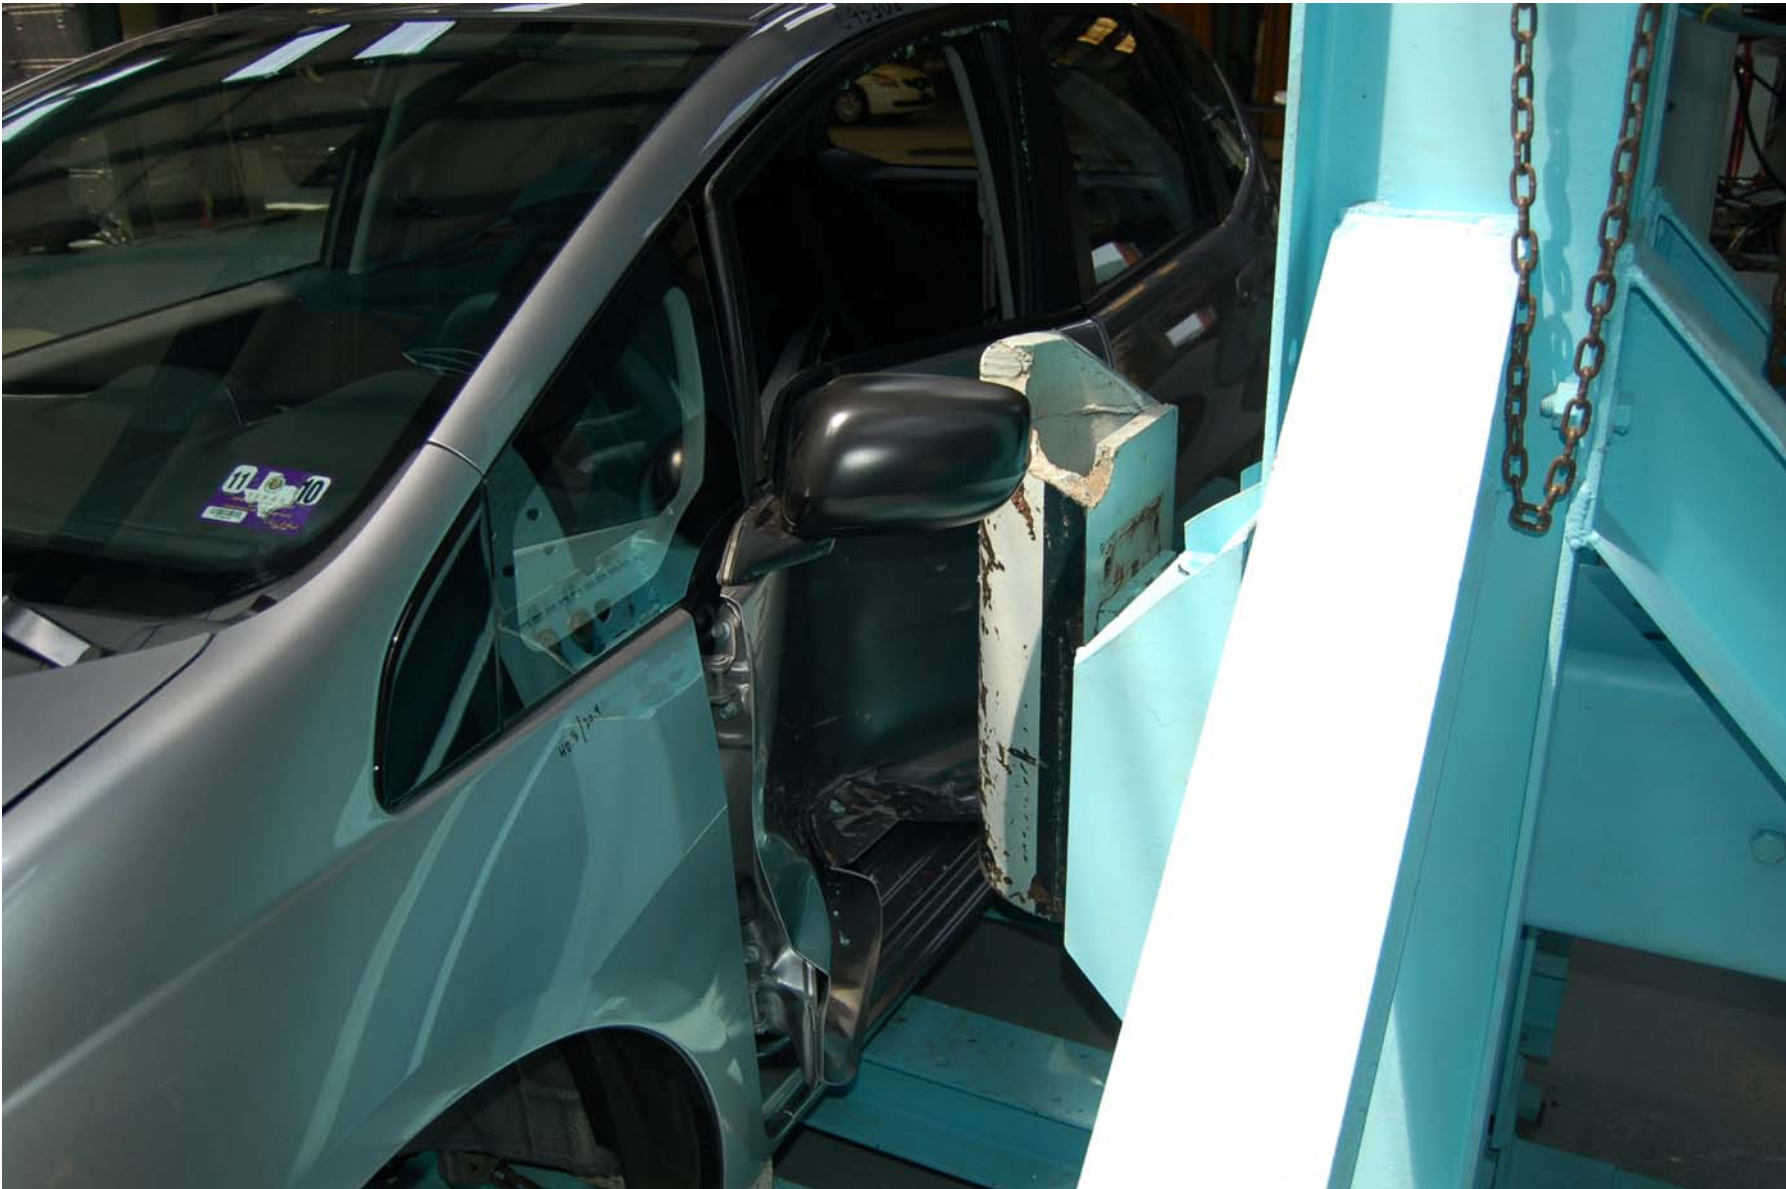
FIGURE 5.19
POST TEST DOOR OUTSIDE – TEST 1

- A. The initial crush resistance was 3265 lbs.
 B. The intermediate crush resistance was 5347 lbs.
 C. The peak crush resistance was 9938 lbs at 12.2 inches
 D. The rate of loading was .2"/sec

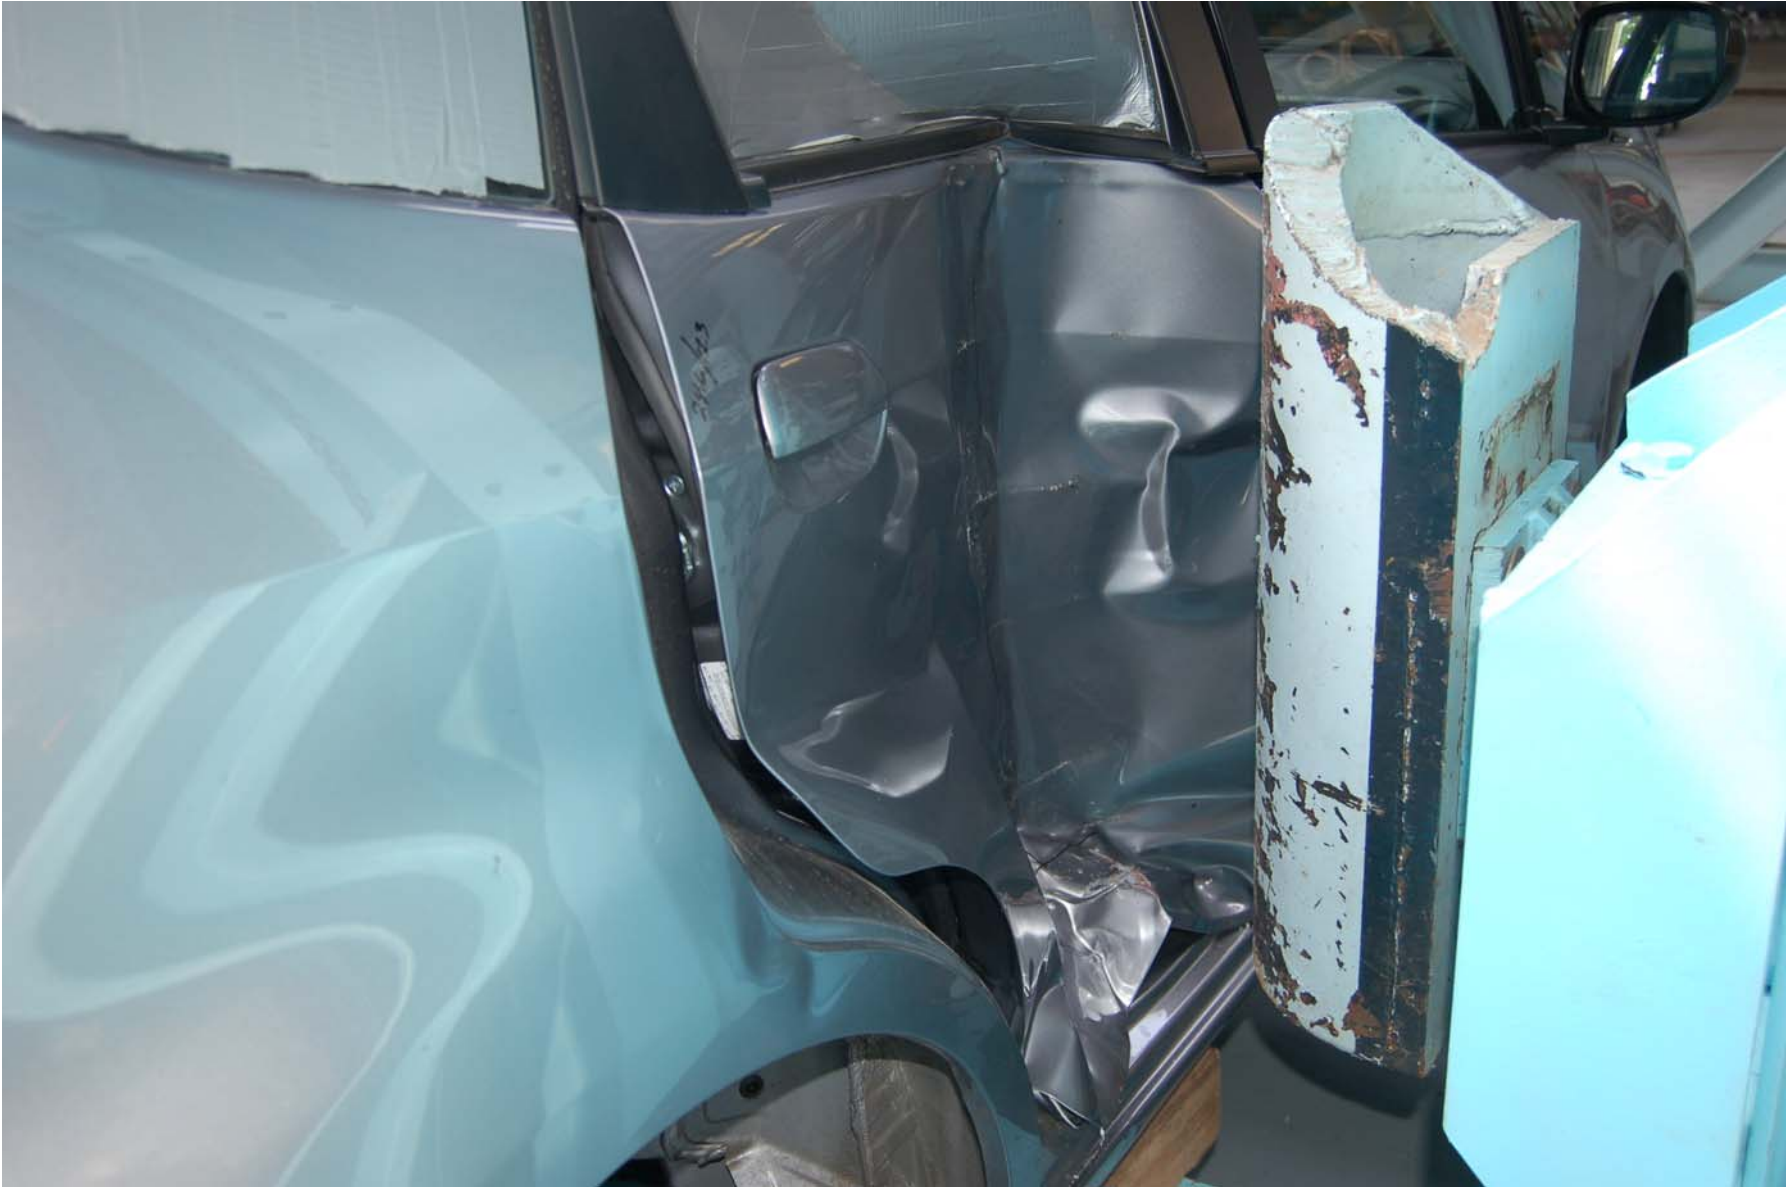
FIGURE 5.29
POST TEST DOOR OUTSIDE – TEST 2

- A. The initial crush resistance was 4913 lbs.
 B. The intermediate crush resistance was 7256 lbs.
 C. The peak crush resistance was 12,088 lbs at 12.1 inches
 D. The rate of loading was .2"/sec

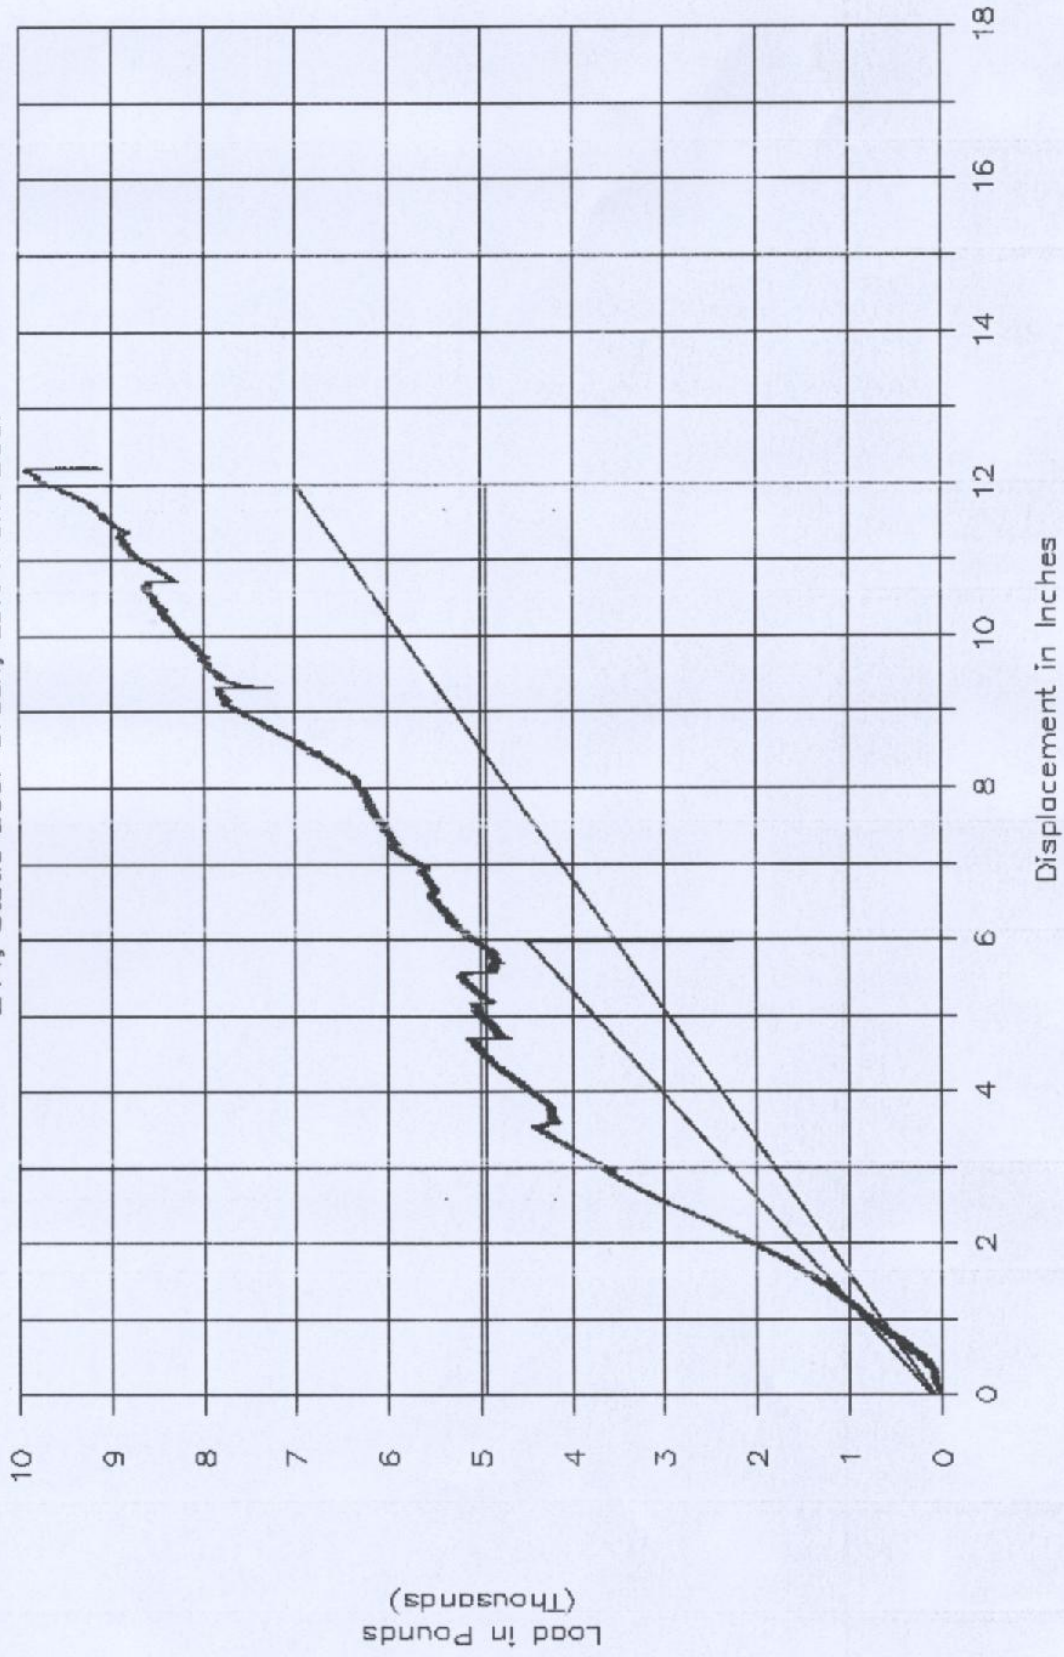
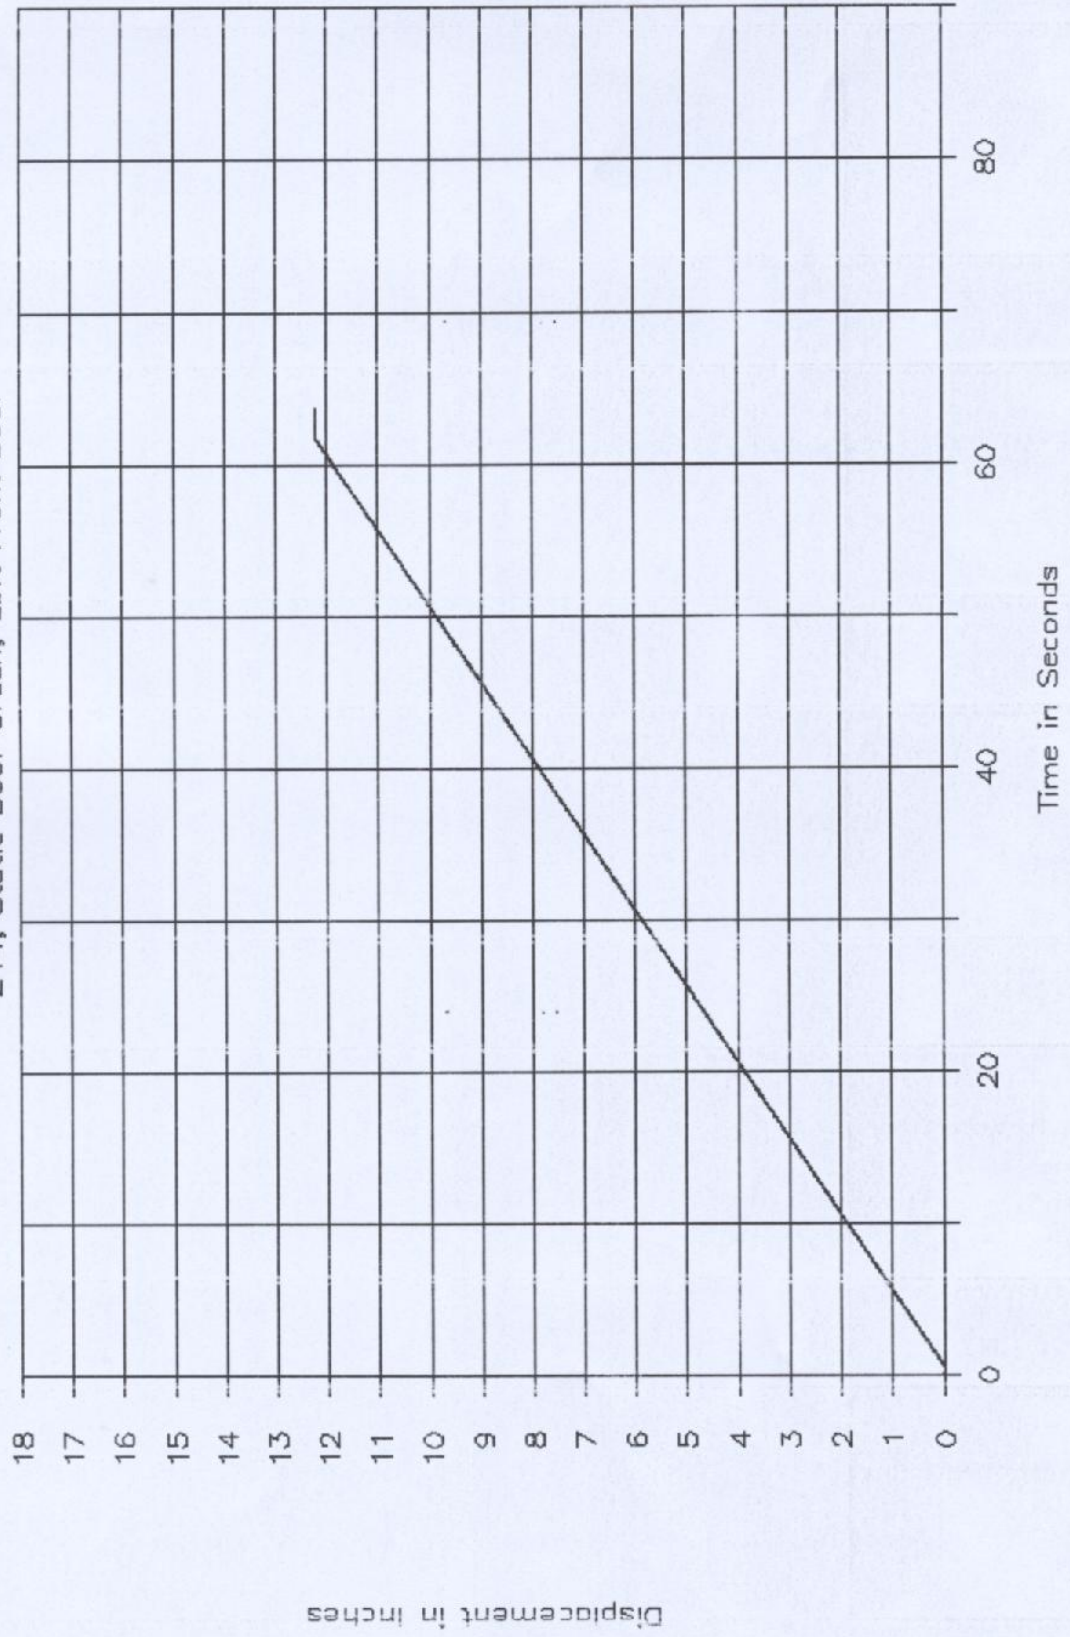
214, Static Door Crush, Left Front Door

- A. The initial crush resistance was 3265 lbs.
- B. The intermediate crush resistance was 5347 lbs.
- C. The peak crush resistance was 9938 lbs at 12.2 inches

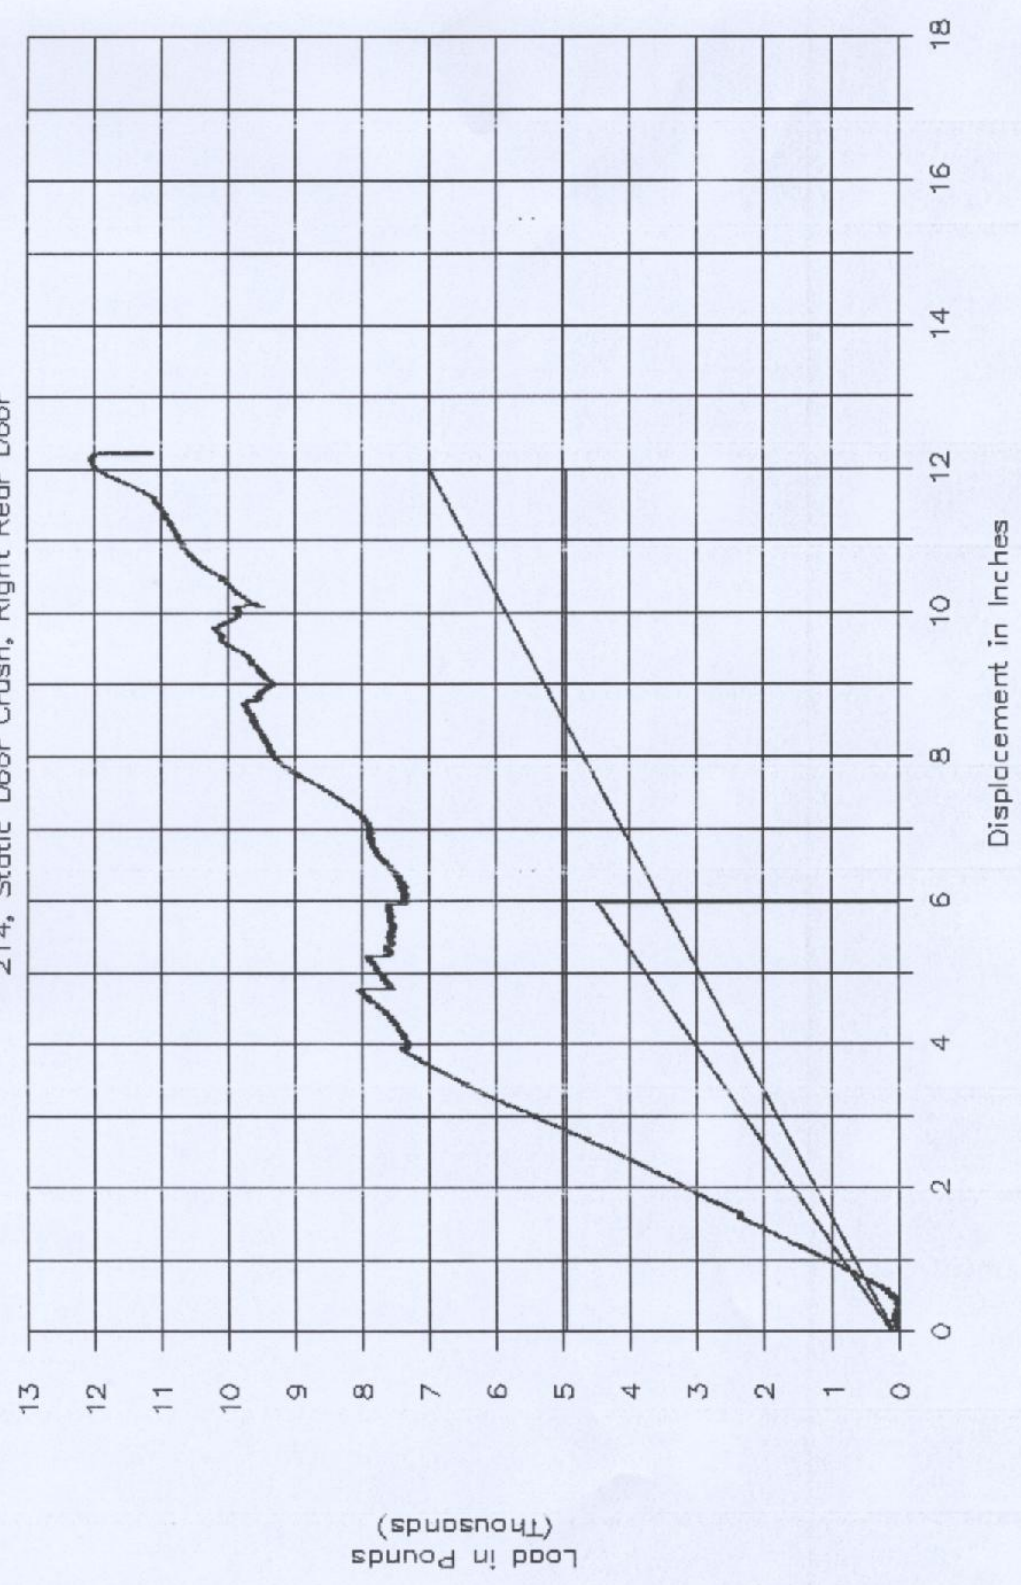
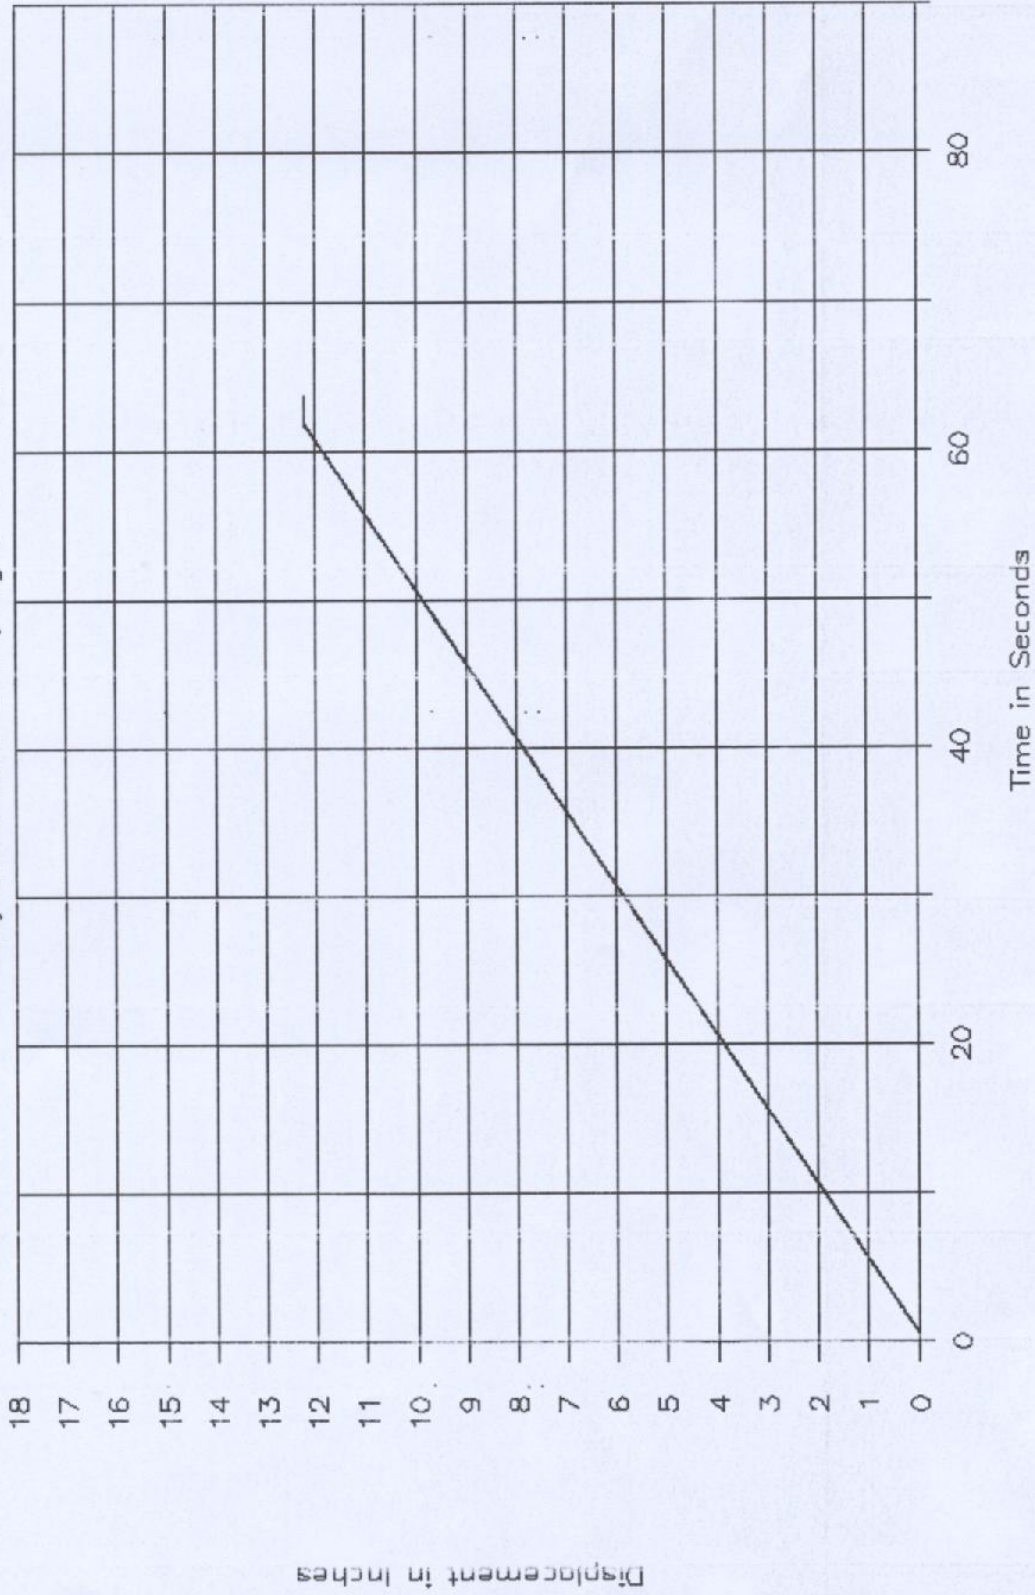
214, Static Door Crush, Right Rear Door

- A. The initial crush resistance was 4913 lbs.
- B. The intermediate crush resistance was 7256 lbs.
- C. The peak crush resistance was 12,088 lbs at 12.1 inches
