REPORT NUMBER: 201-CAL-09-02

**SAFETY COMPLIANCE TESTING FOR FMVSS 201
OCCUPANT PROTECTION IN INTERIOR IMPACT**

**CHRYSLER LLC.
2009 DODGE JOURNEY**

NHTSA NUMBER: C90301

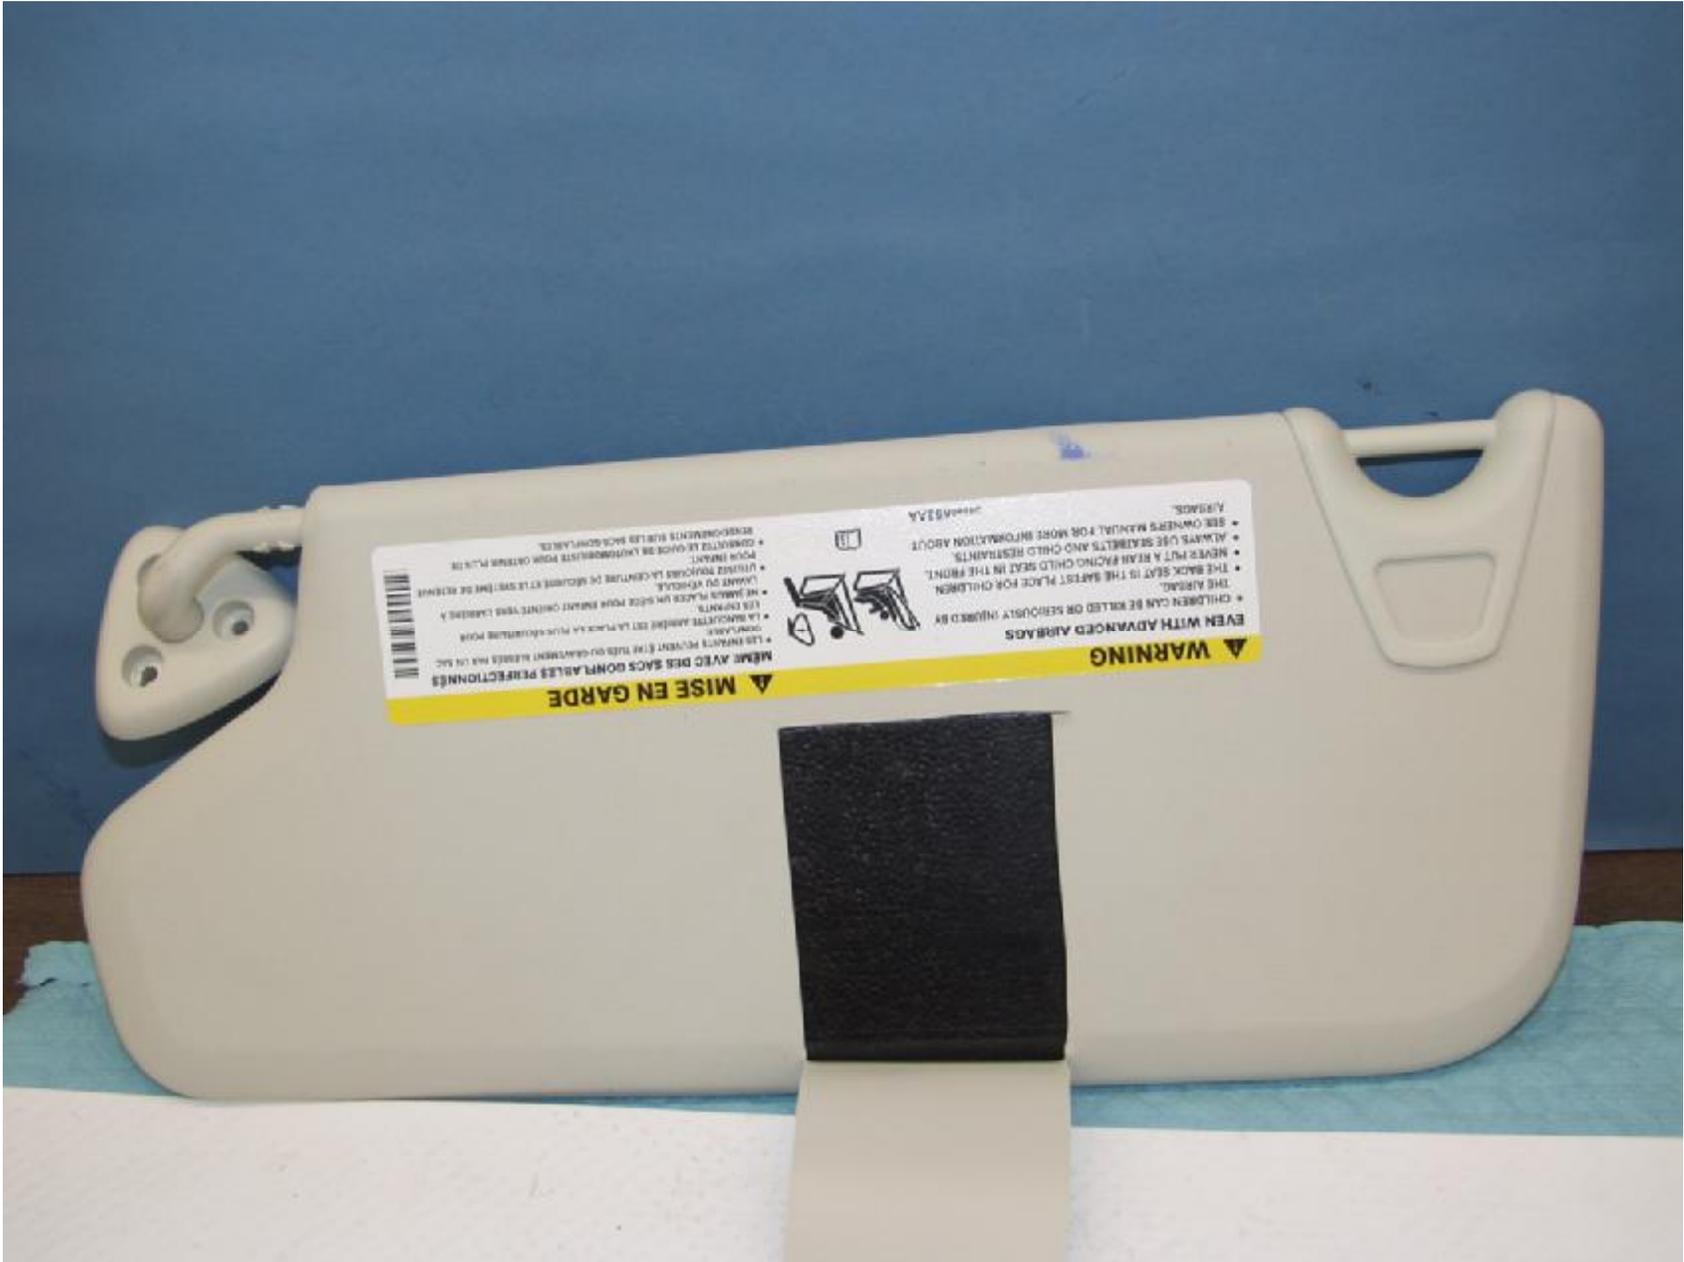
Figure A-7 : SUN VISOR CONSTRUCTION

1. Are sun visors constructed of or covered with energy absorbing material?

YES (PASS): X

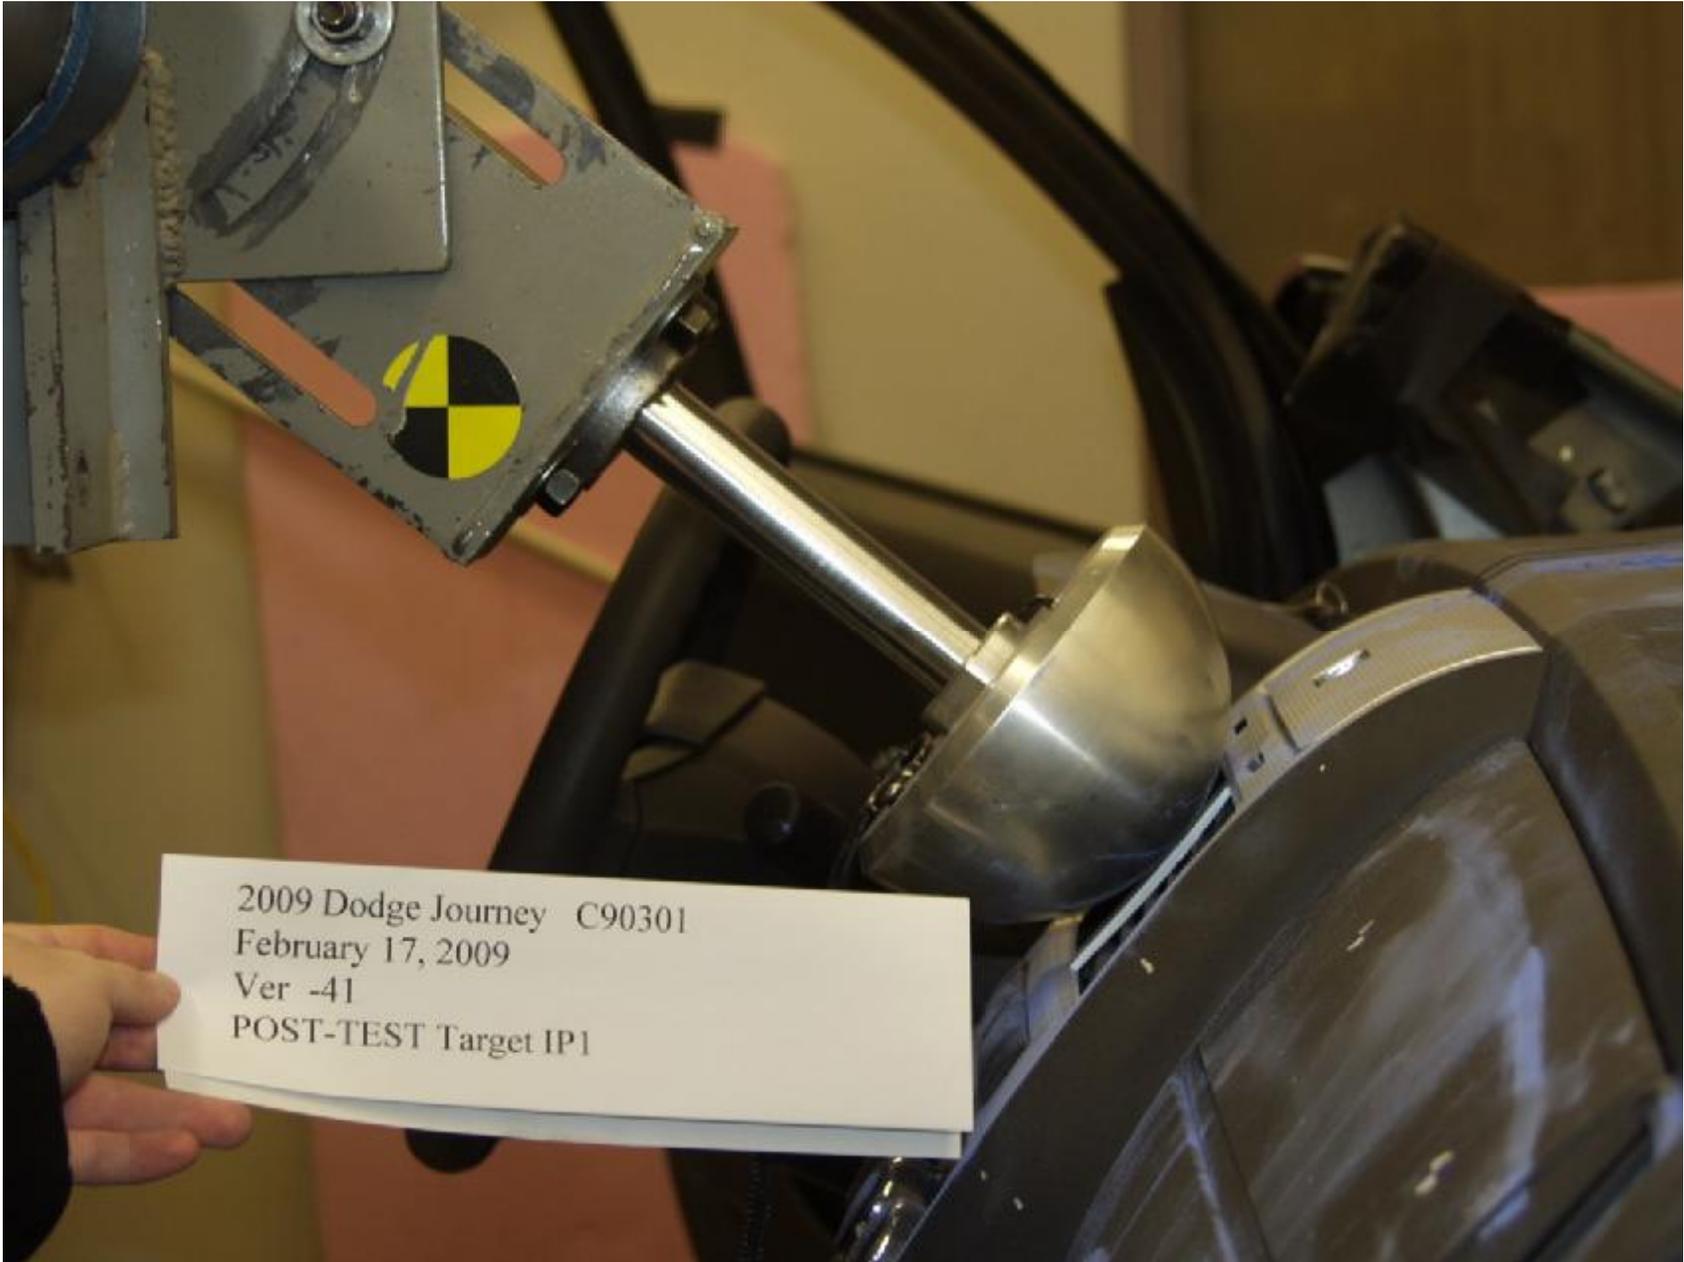
Figure A-16 : INSTRUMENT PANEL IMPACT #1 POST-TEST

IMPACT LOCATION AND NUMBER				VELOCITY (kph)	PEAK ACCELERATION (3 ms Clip) Gs
TARGET	X (mm)	Y (mm)	ANGLE (degrees)		
IP1 CENTER CLUSTER VENT	651	0	41	18.66	47.58
IP2 LEFT SIDE GLOVE BOX COVER	600	263	44	18.55	75.44
IP3 RIGHT SIDE GLOVE BOX COVER	602	516	45	18.65	74.67

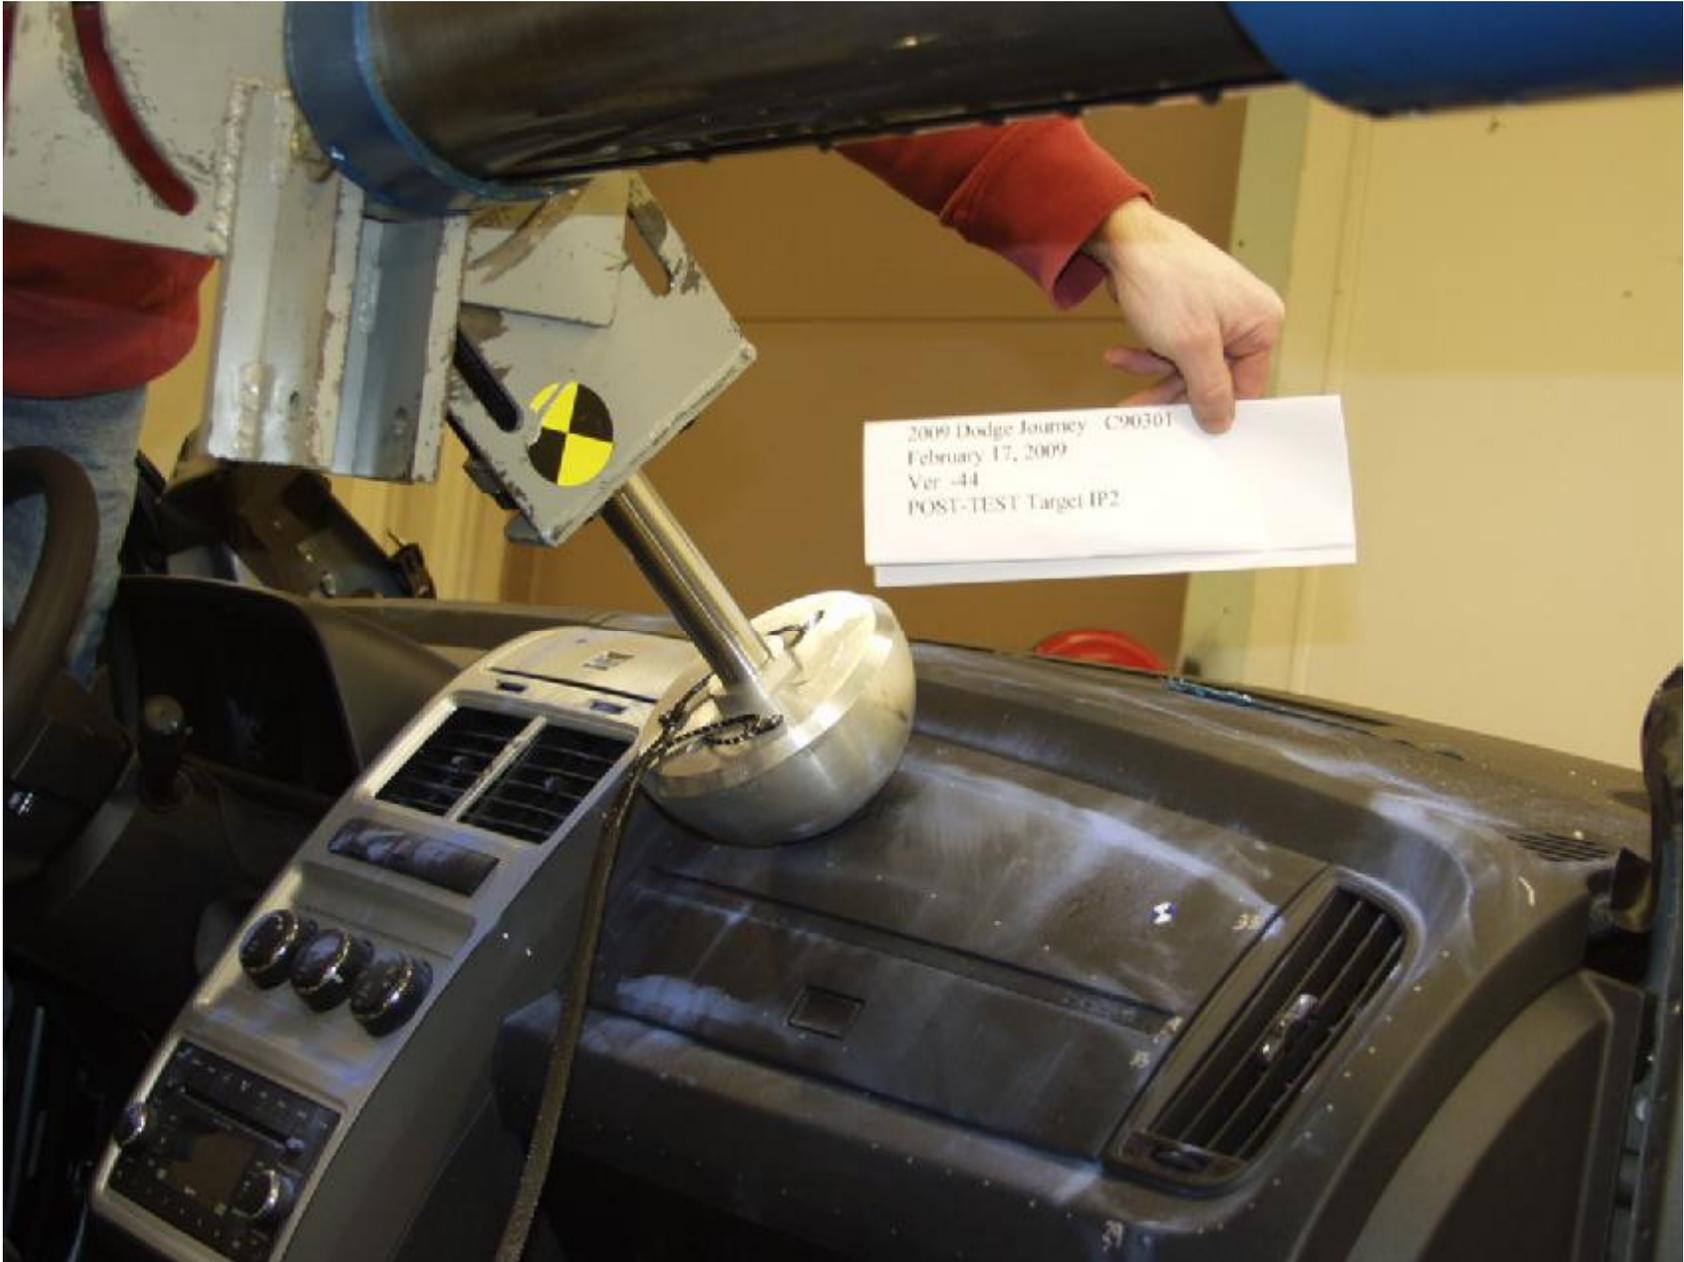
Figure A-18 : INSTRUMENT PANEL IMPACT #2 POST-TEST

The selected impact areas on the test vehicle appeared to comply with the performance requirements of FMVSS 201, although two of the impacts resulted in decelerations of 75.44 g's and 74.67 g's whereas the standard requires not exceeding a deceleration of 80g's.

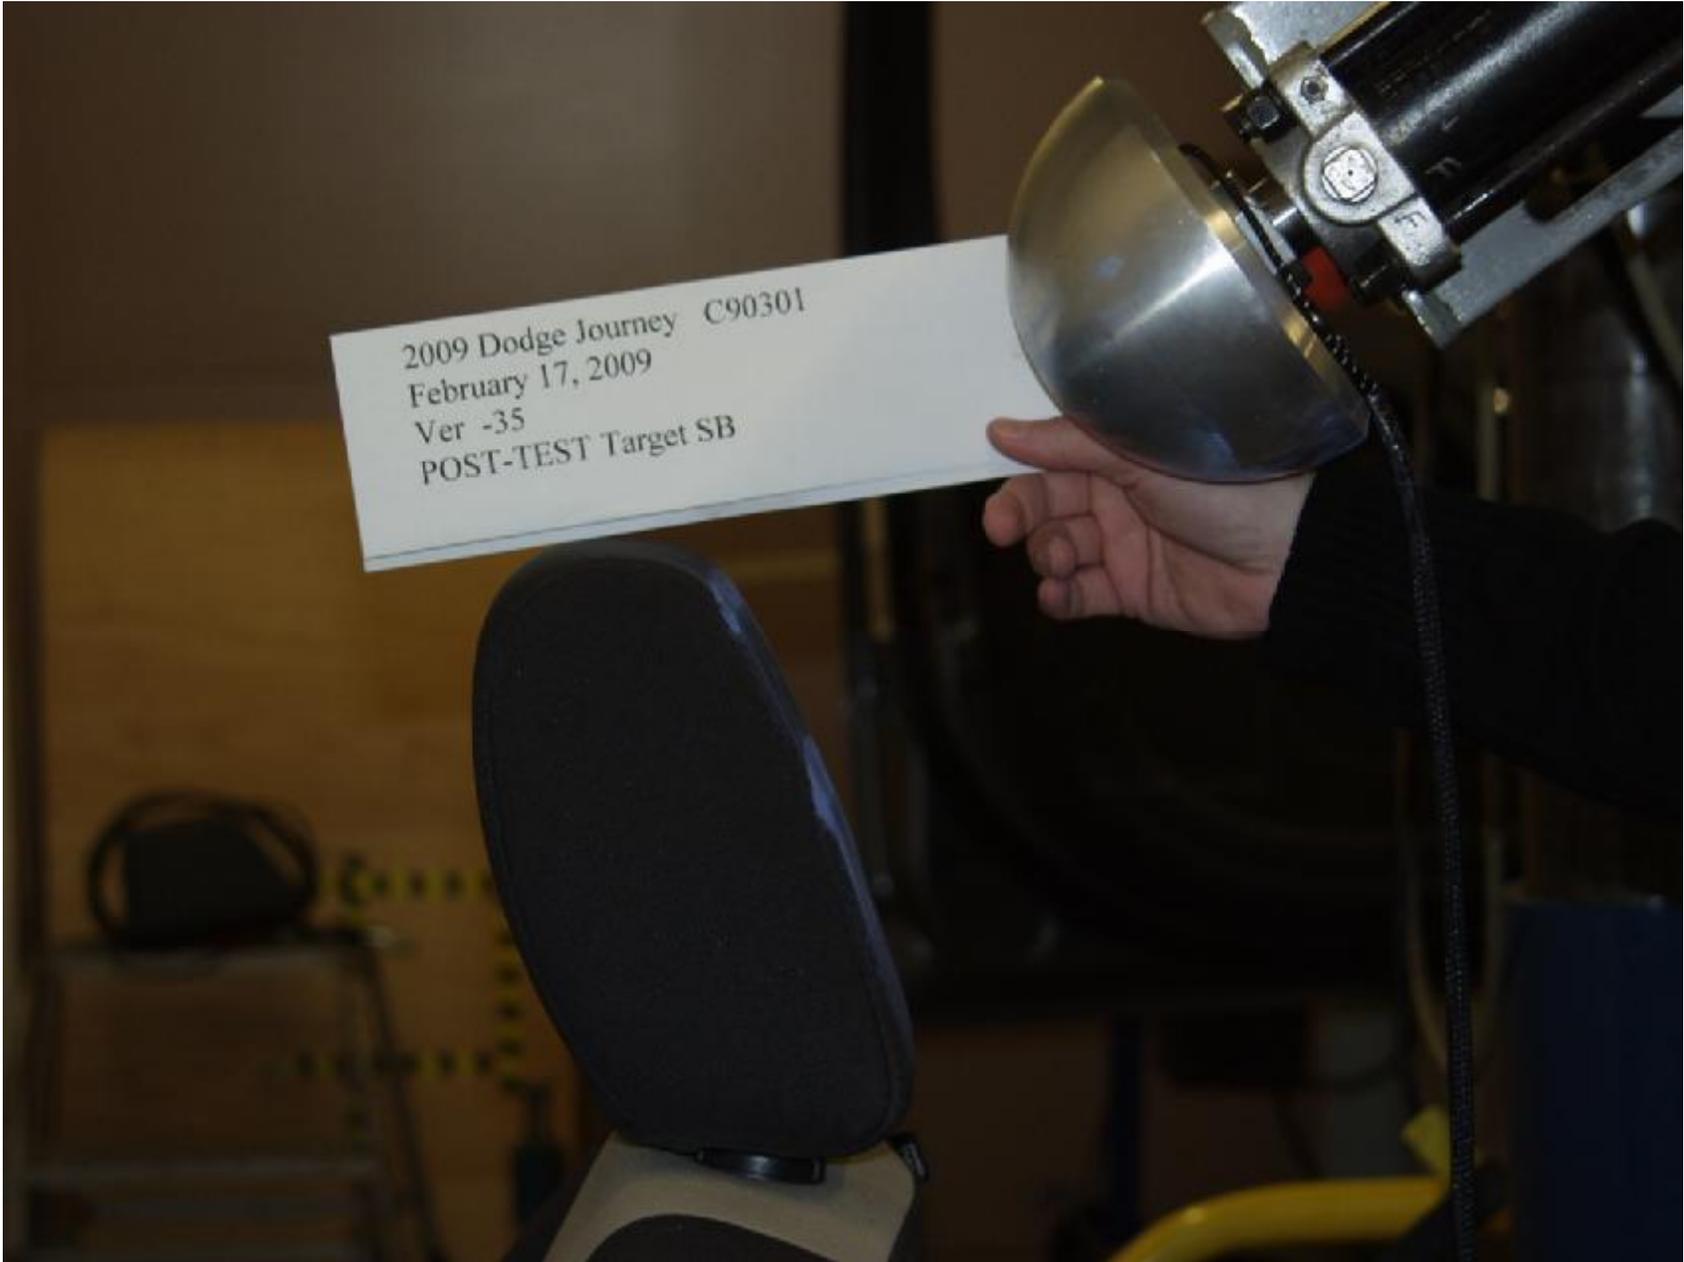
Figure A-23 : HEAD RESTRAINT IMPACT AREA POST-TEST

IMPACT LOCATION AND NUMBER				VELOCITY (kph)	PEAK ACCELERATION (3 ms Clip) Gs
TARGET	X (mm)	Y (mm)	ANGLE (degrees)		
SEAT BACK HEAD RESTRAINT	1794	365	35	23.69	42.41

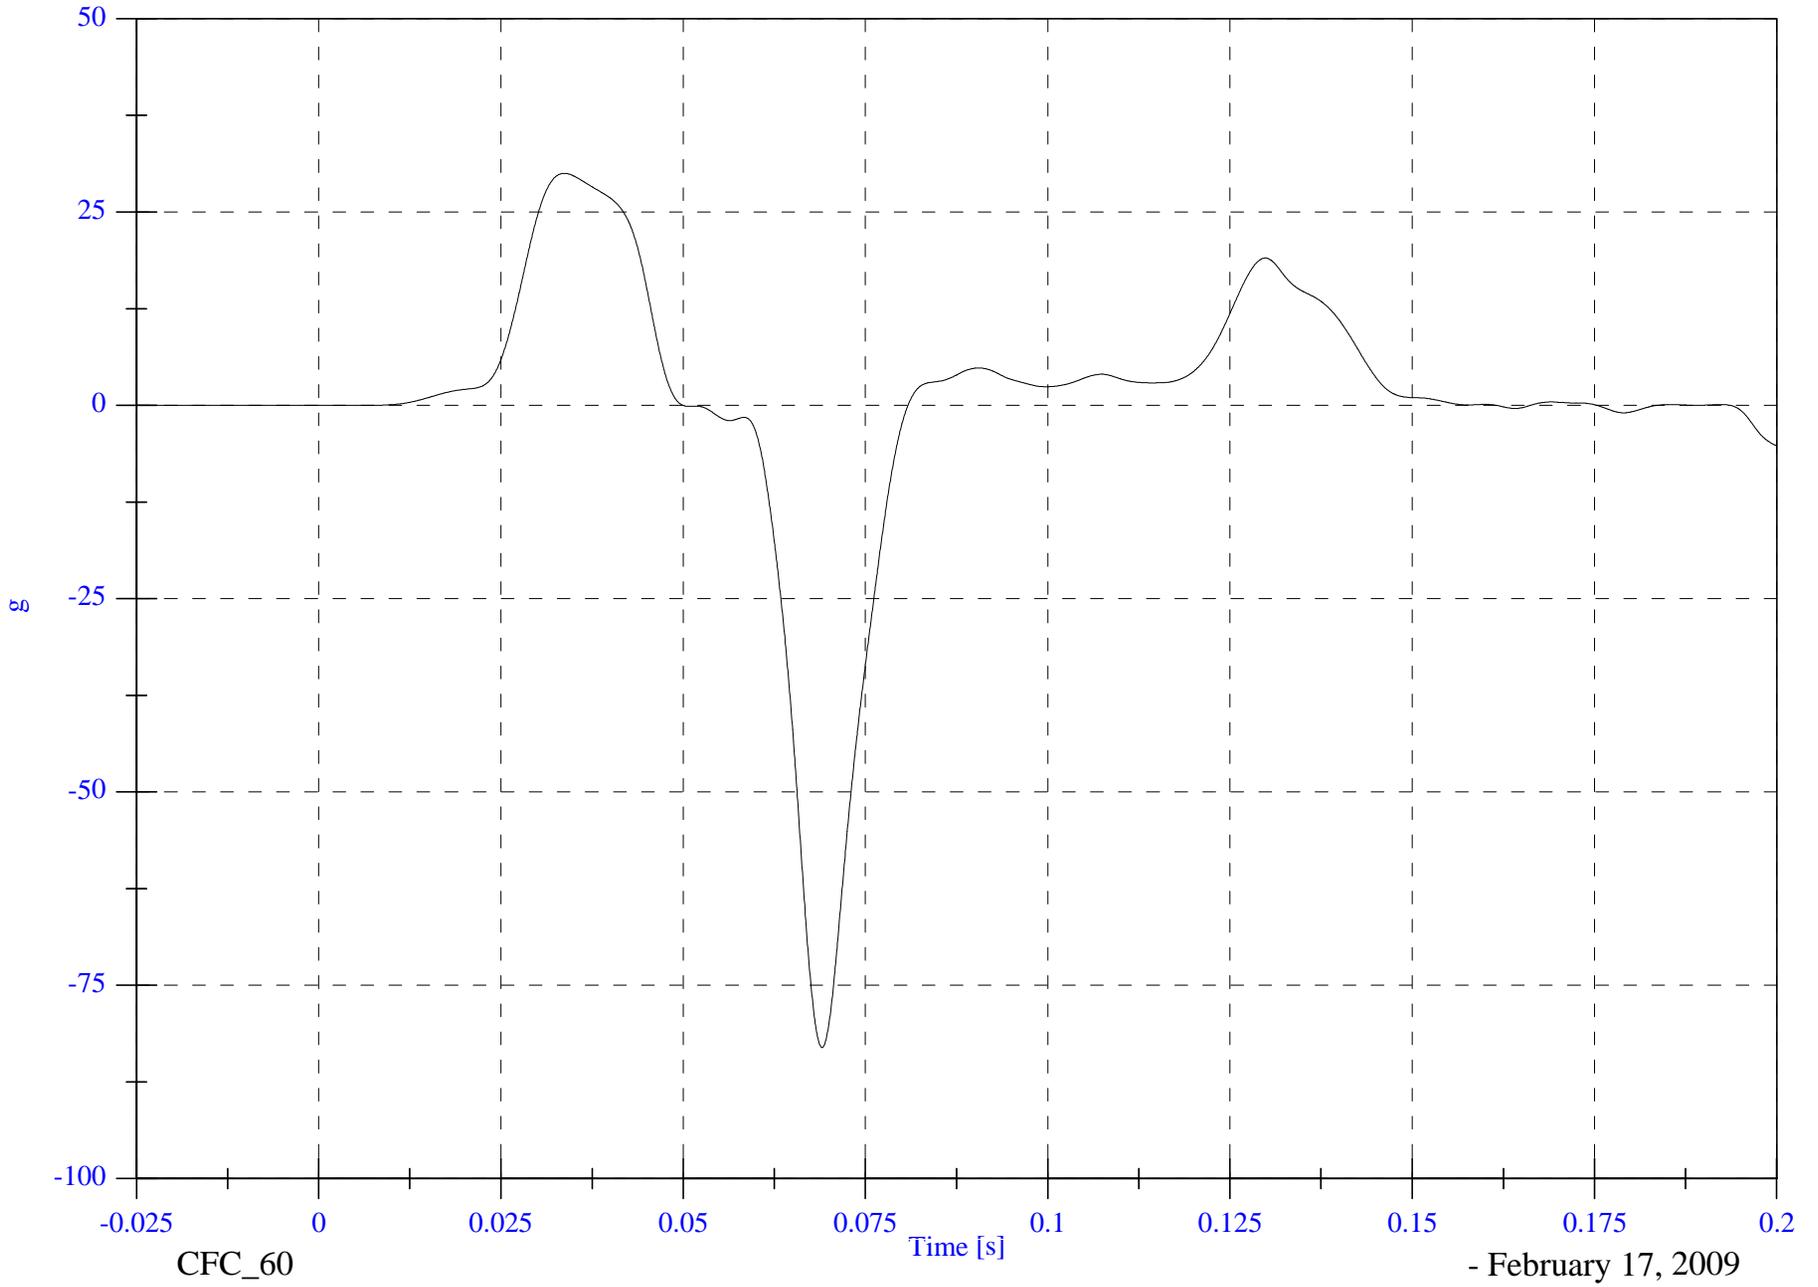
C90301 LEFT SIDE GLOVE BOX COVER IMPACT PLOT #1

Max: 30.0 [g] at 0.034 [s]

Min: -83.0 [g] at 0.069 [s]

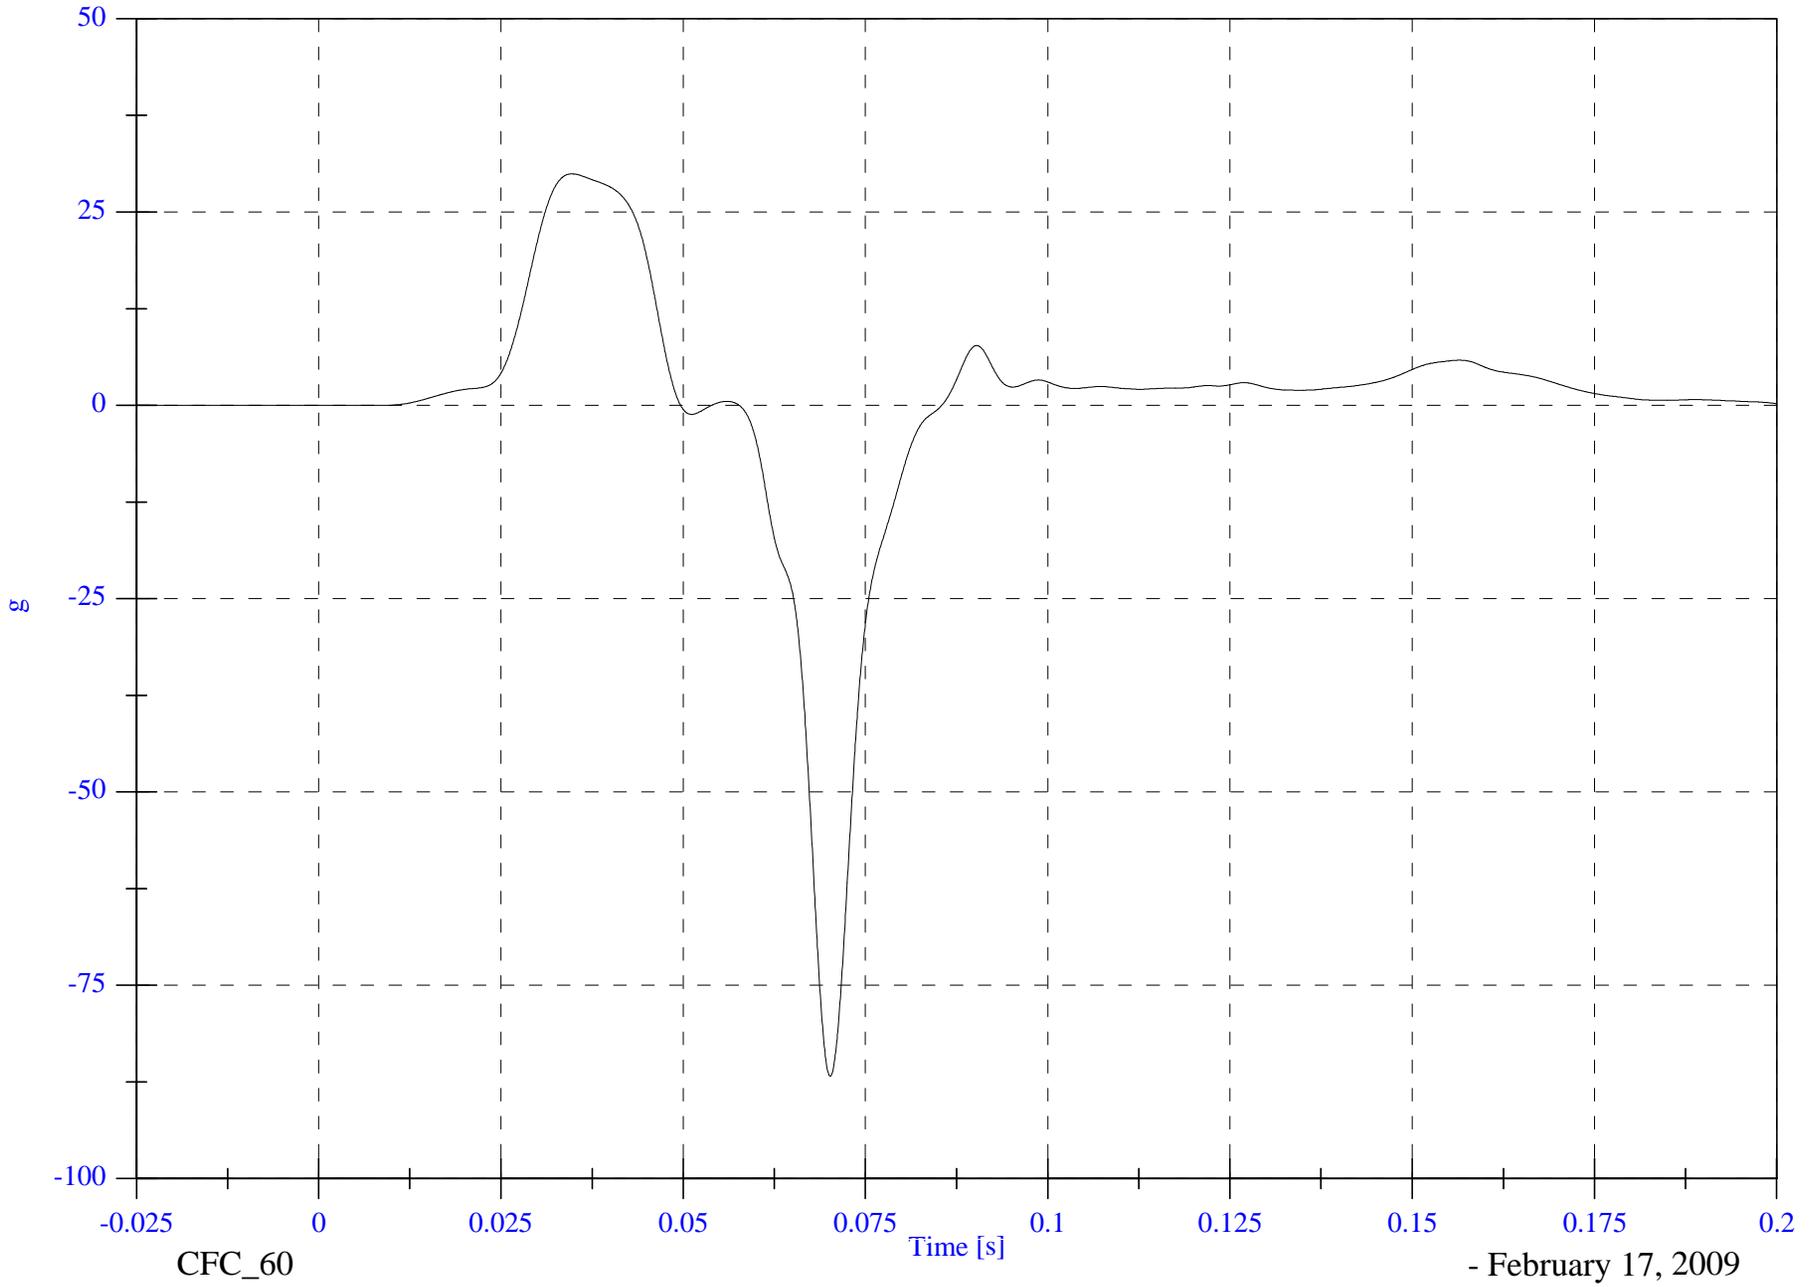
C90301 RIGHT SIDE GLOVE BOX COVER IMPACT PLOT #1

Max: 29.9 [g] at 0.035 [s]

Min: -86.8 [g] at 0.070 [s]
