REPORT NUMBER: 201UI-CAL-09-09

**SAFETY COMPLIANCE TESTING FOR FMVSS 201
OCCUPANT PROTECTION IN INTERIOR IMPACT
UPPER INTERIOR HEAD IMPACT PROTECTION**

**KIA MOTORS CORPORATION
2009 KIA SEDONA**

NHTSA NUMBER: C90502

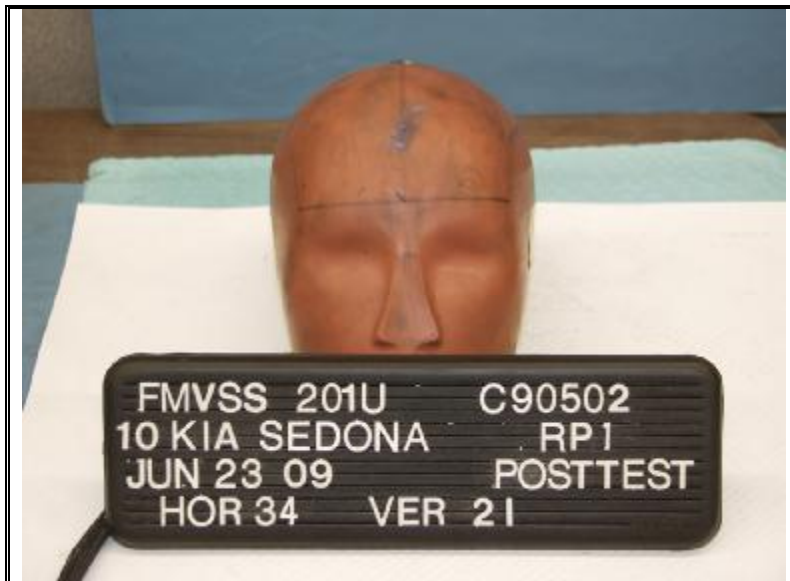
POST-IMPACT RP1 HEADFORM (2009 KIA SEDONA)

Free Motion HIC	175.6
HIC(d)	298.9
Impact Velocity (kph)	23.83
HIC T1 (msec)	3.7
HIC T2 (msec)	24.1

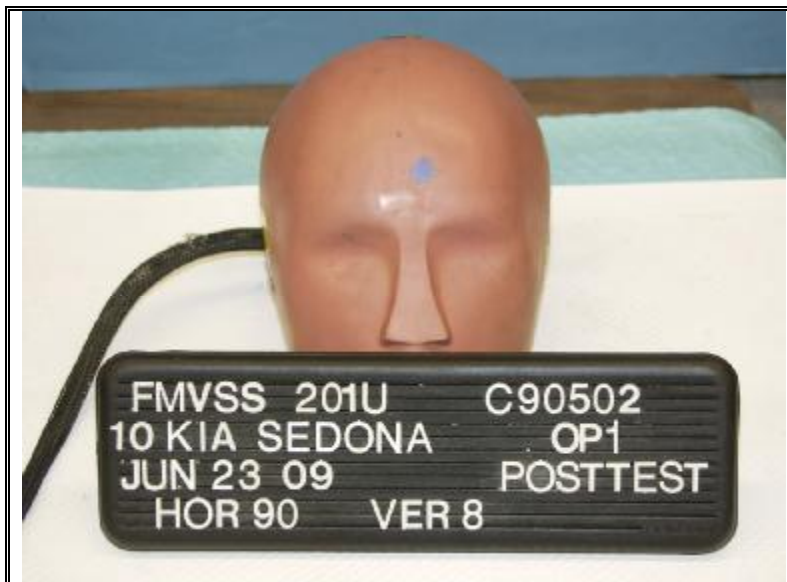
POST-IMPACT OP1 HEADFORM (2009 KIA SEDONA)

Free Motion HIC	589.0
HIC(d)	610.7
Impact Velocity (kph)	N/A*
HIC T1 (msec)	5.1
HIC T2 (msec)	15.4

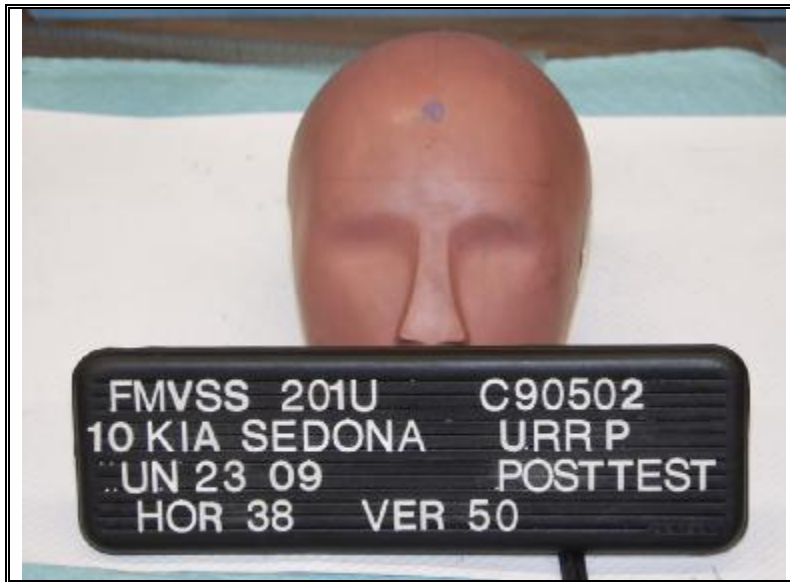
POST-IMPACT URRP HEADFORM (2009 KIA SEDONA)

Free Motion HIC	501.7
HIC(d)	544.9
Impact Velocity (kph)	23.5
HIC T1 (msec)	3.1
HIC T2 (msec)	12.8

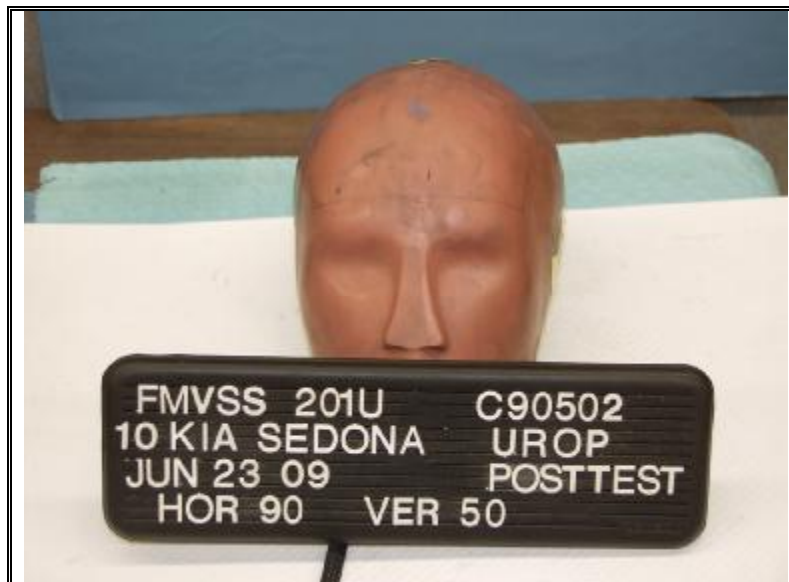
POST-IMPACT UROP HEADFORM (2009 KIA SEDONA)

Free Motion HIC	379.5
HIC(d)	452.7
Impact Velocity (kph)	23.62
HIC T1 (msec)	4.0
HIC T2 (msec)	16.4

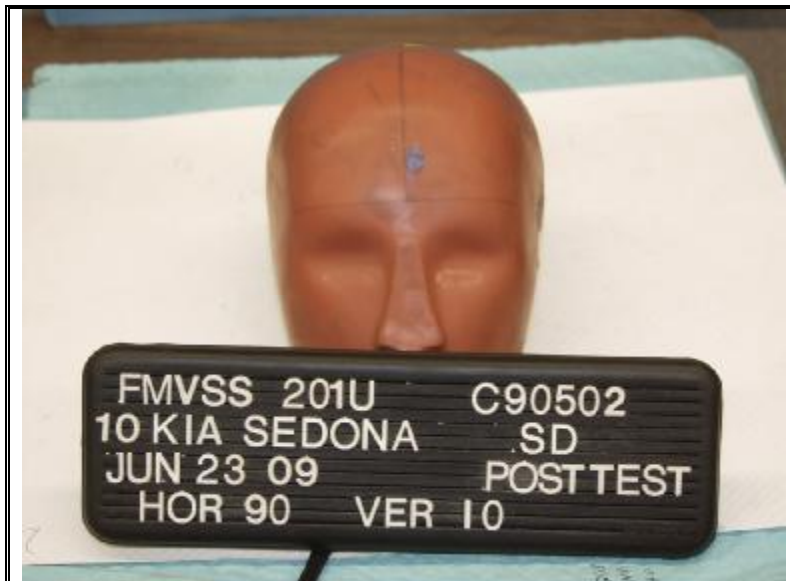
POST-IMPACT SD HEADFORM (2009 KIA SEDONA)

Free Motion HIC	72.7
HIC(d)	221.3
Impact Velocity (kph)	18.45
HIC T1 (msec)	3.6
HIC T2 (msec)	13.8

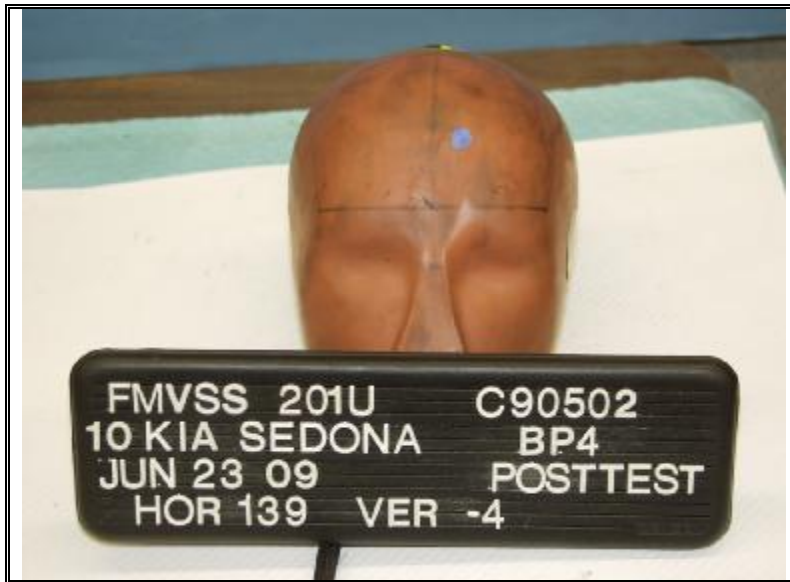
POST-IMPACT BP4 HEADFORM (2009 KIA SEDONA)

Free Motion HIC	286.2
HIC(d)	382.3
Impact Velocity (kph)	23.54
HIC T1 (msec)	2.5
HIC T2 (msec)	9.4

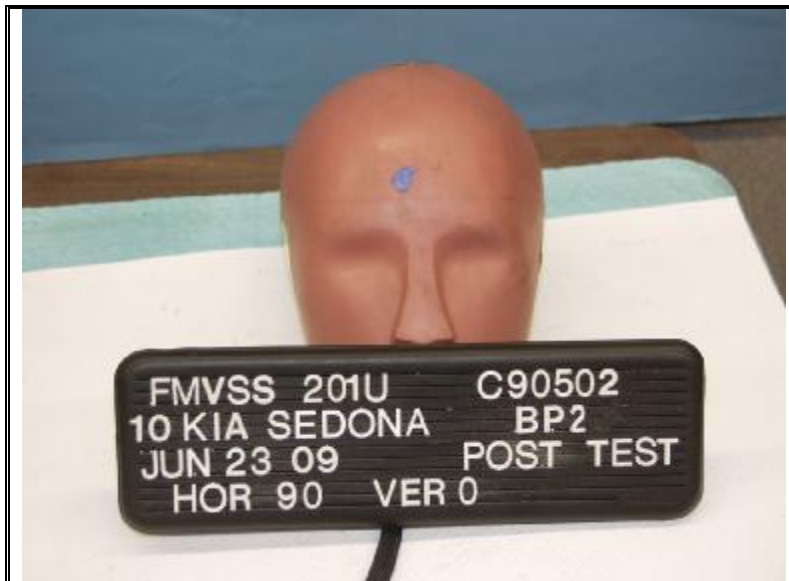
POST-IMPACT BP2 HEADFORM (2009 KIA SEDONA)

Free Motion HIC	377.3
HIC(d)	451.1
Impact Velocity (kph)	23.55
HIC T1 (msec)	5.1
HIC T2 (msec)	12.8

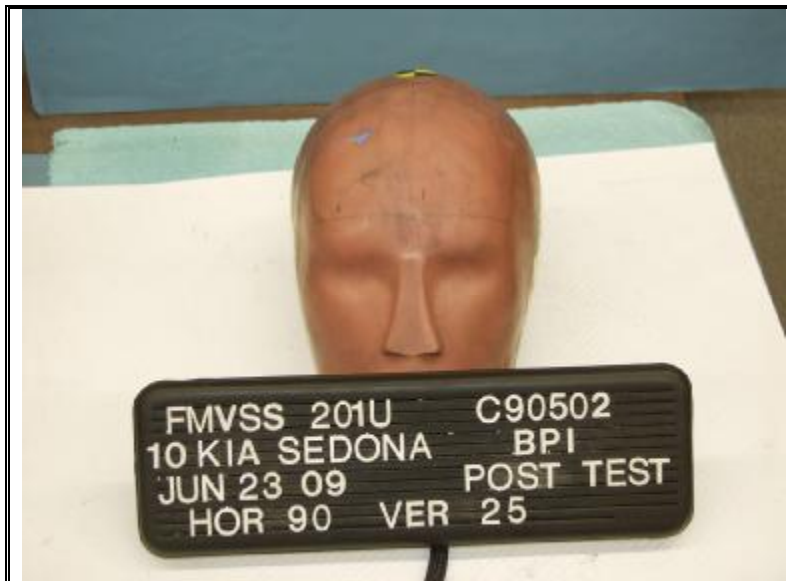
POST-IMPACT BP1 HEADFORM (2009 KIA SEDONA)

Free Motion HIC	552.7
HIC(d)	583.4
Impact Velocity (kph)	18.45
HIC T1 (msec)	6.3
HIC T2 (msec)	12.4

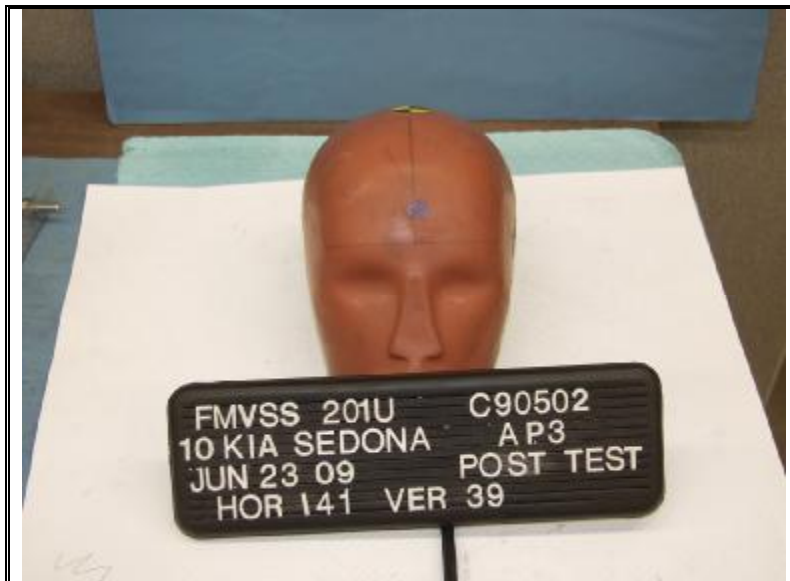
POST-IMPACT AP3 HEADFORM (2009 KIA SEDONA)

Free Motion HIC	244.9
HIC(d)	351.2
Impact Velocity (kph)	18.47
HIC T1 (msec)	1.6
HIC T2 (msec)	13.9

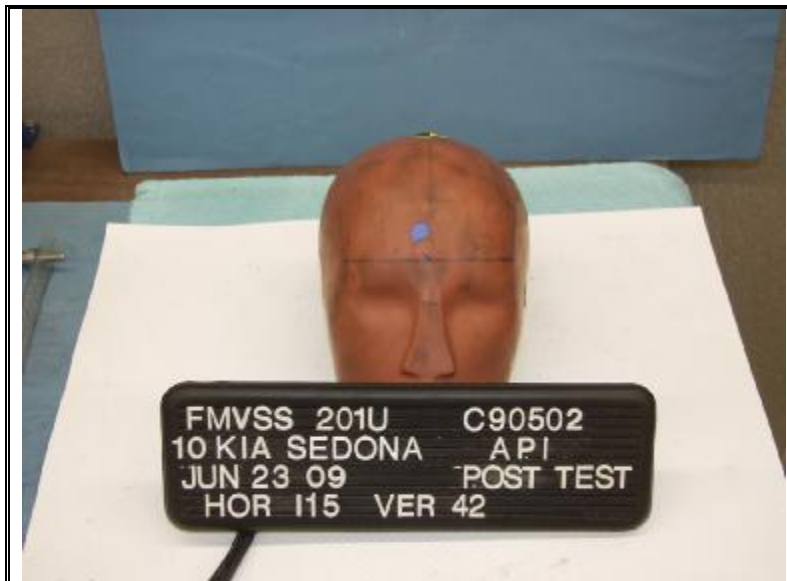
POST-IMPACT AP1 HEADFORM (2009 KIA SEDONA)

Free Motion HIC	630.1
HIC(d)	641.8
Impact Velocity (kph)	18.82
HIC T1 (msec)	6.8
HIC T2 (msec)	11.8

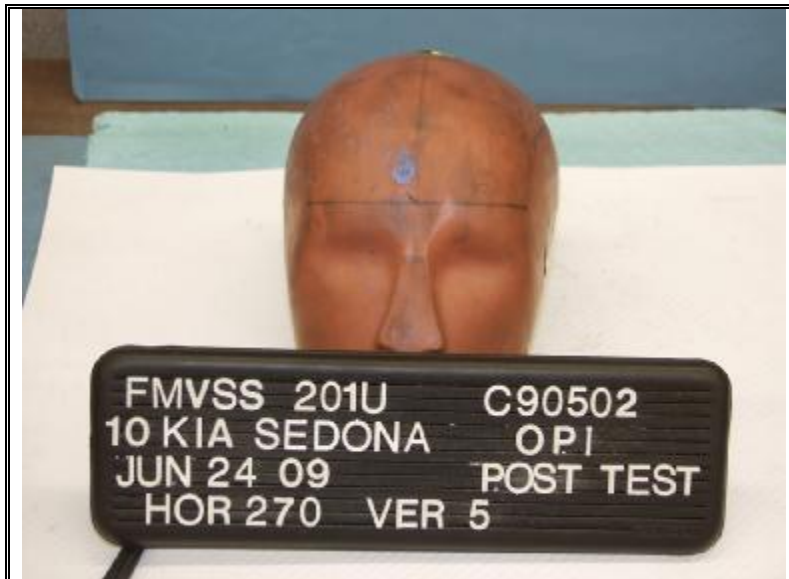
POST-IMPACT OP1 HEADFORM (2009 KIA SEDONA)

Free Motion HIC	523.2
HIC(d)	561.1
Impact Velocity (kph)	23.56
HIC T1 (msec)	4.7
HIC T2 (msec)	15.1

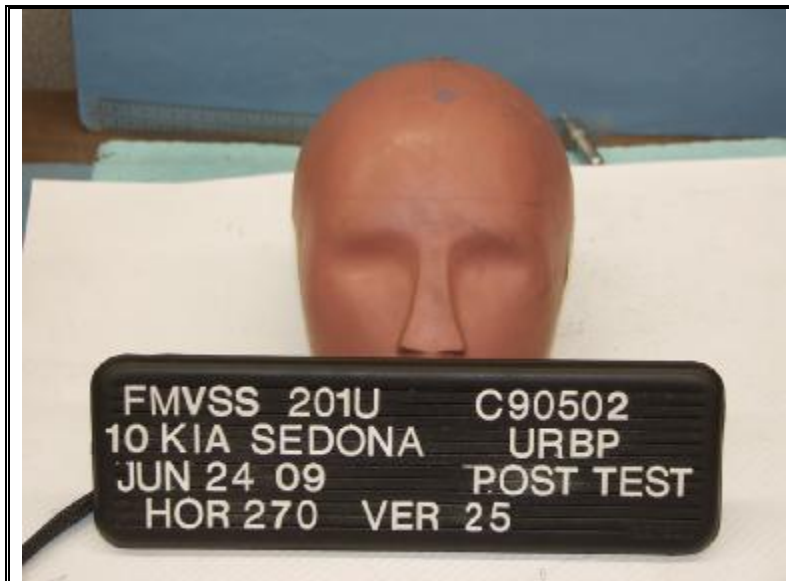
POST-IMPACT URBP HEADFORM (2009 KIA SEDONA)

Free Motion HIC	252.0
HIC(d)	356.0
Impact Velocity (kph)	23.8
HIC T1 (msec)	3.5
HIC T2 (msec)	17.2

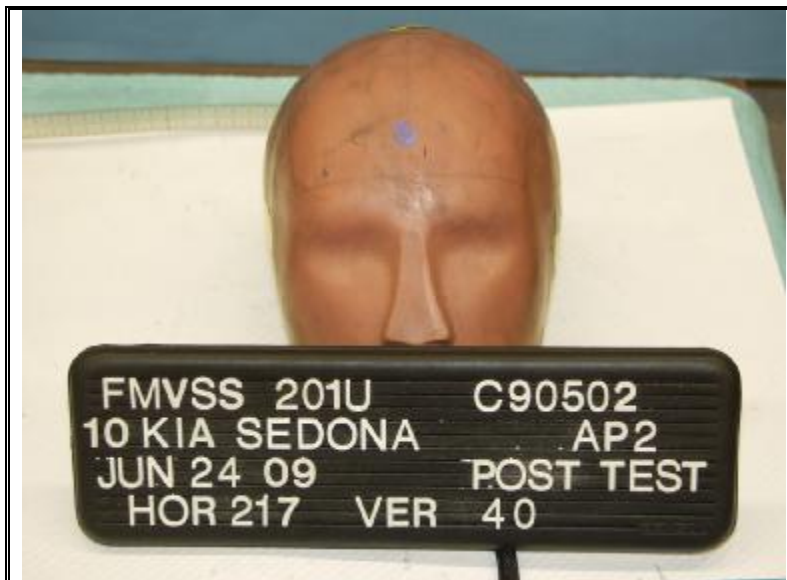
POST-IMPACT URBP HEADFORM (2009 KIA SEDONA)

Free Motion HIC	206.7
HIC(d)	322.4
Impact Velocity (kph)	18.38
HIC T1 (msec)	1.7
HIC T2 (msec)	15.2
