REPORT NUMBER: 301-MGA-2010-002

**SAFETY COMPLIANCE TESTING FOR FMVSS 301R
FUEL SYSTEM INTEGRITY – REAR IMPACT**

**AUTO ALLIANCE INTERNATIONAL, INC.
FOR MAZDA MOTOR CORPORATION
2010 MAZDA 6
NHTSA NUMBER: CA5402**

**PREPARED BY:
MGA RESEARCH CORPORATION
5000 WARREN ROAD
BURLINGTON, WI 53105**

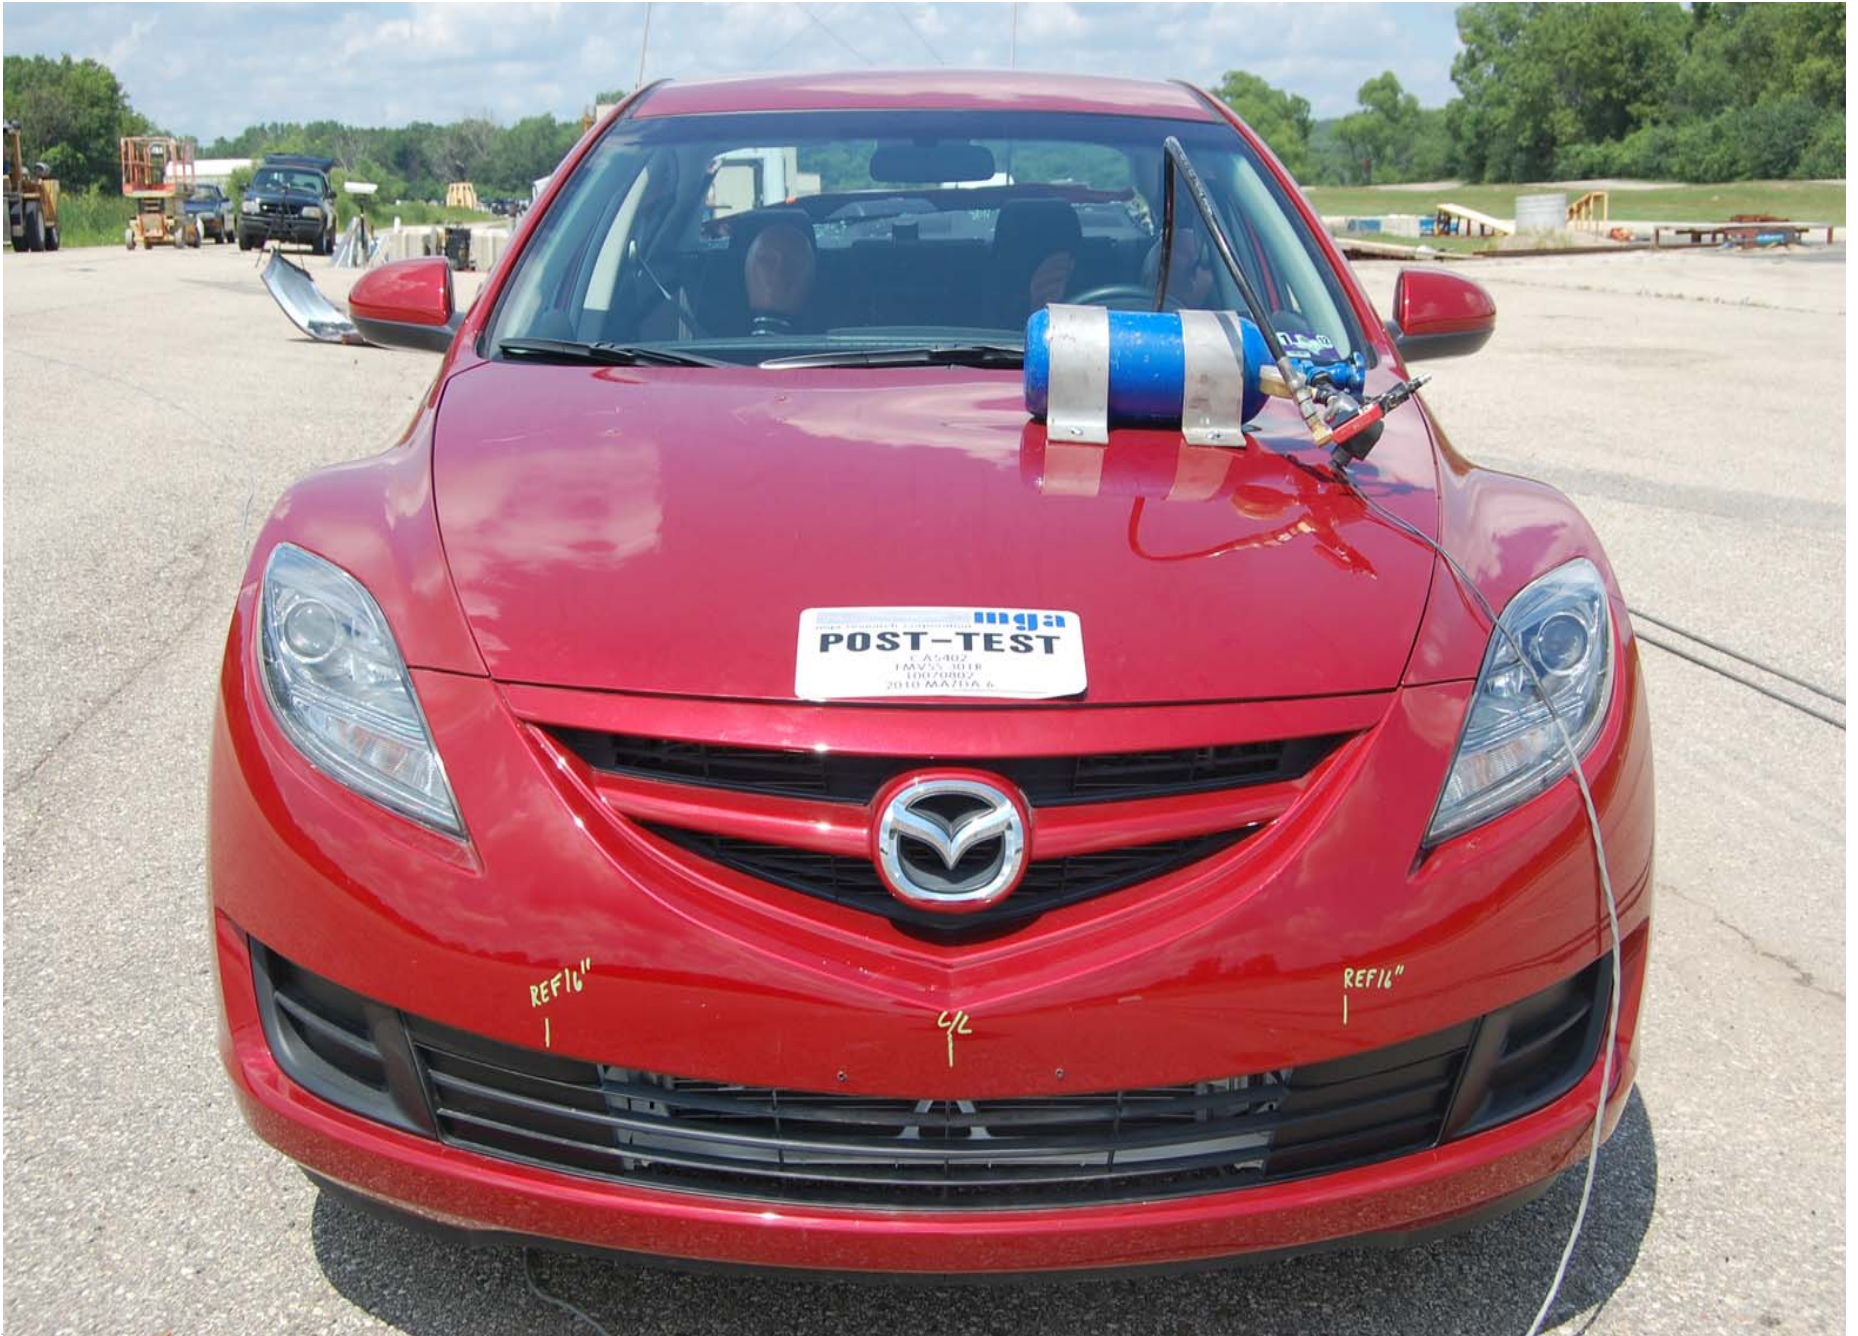
A-4.

Post-Test Front View of Vehicle

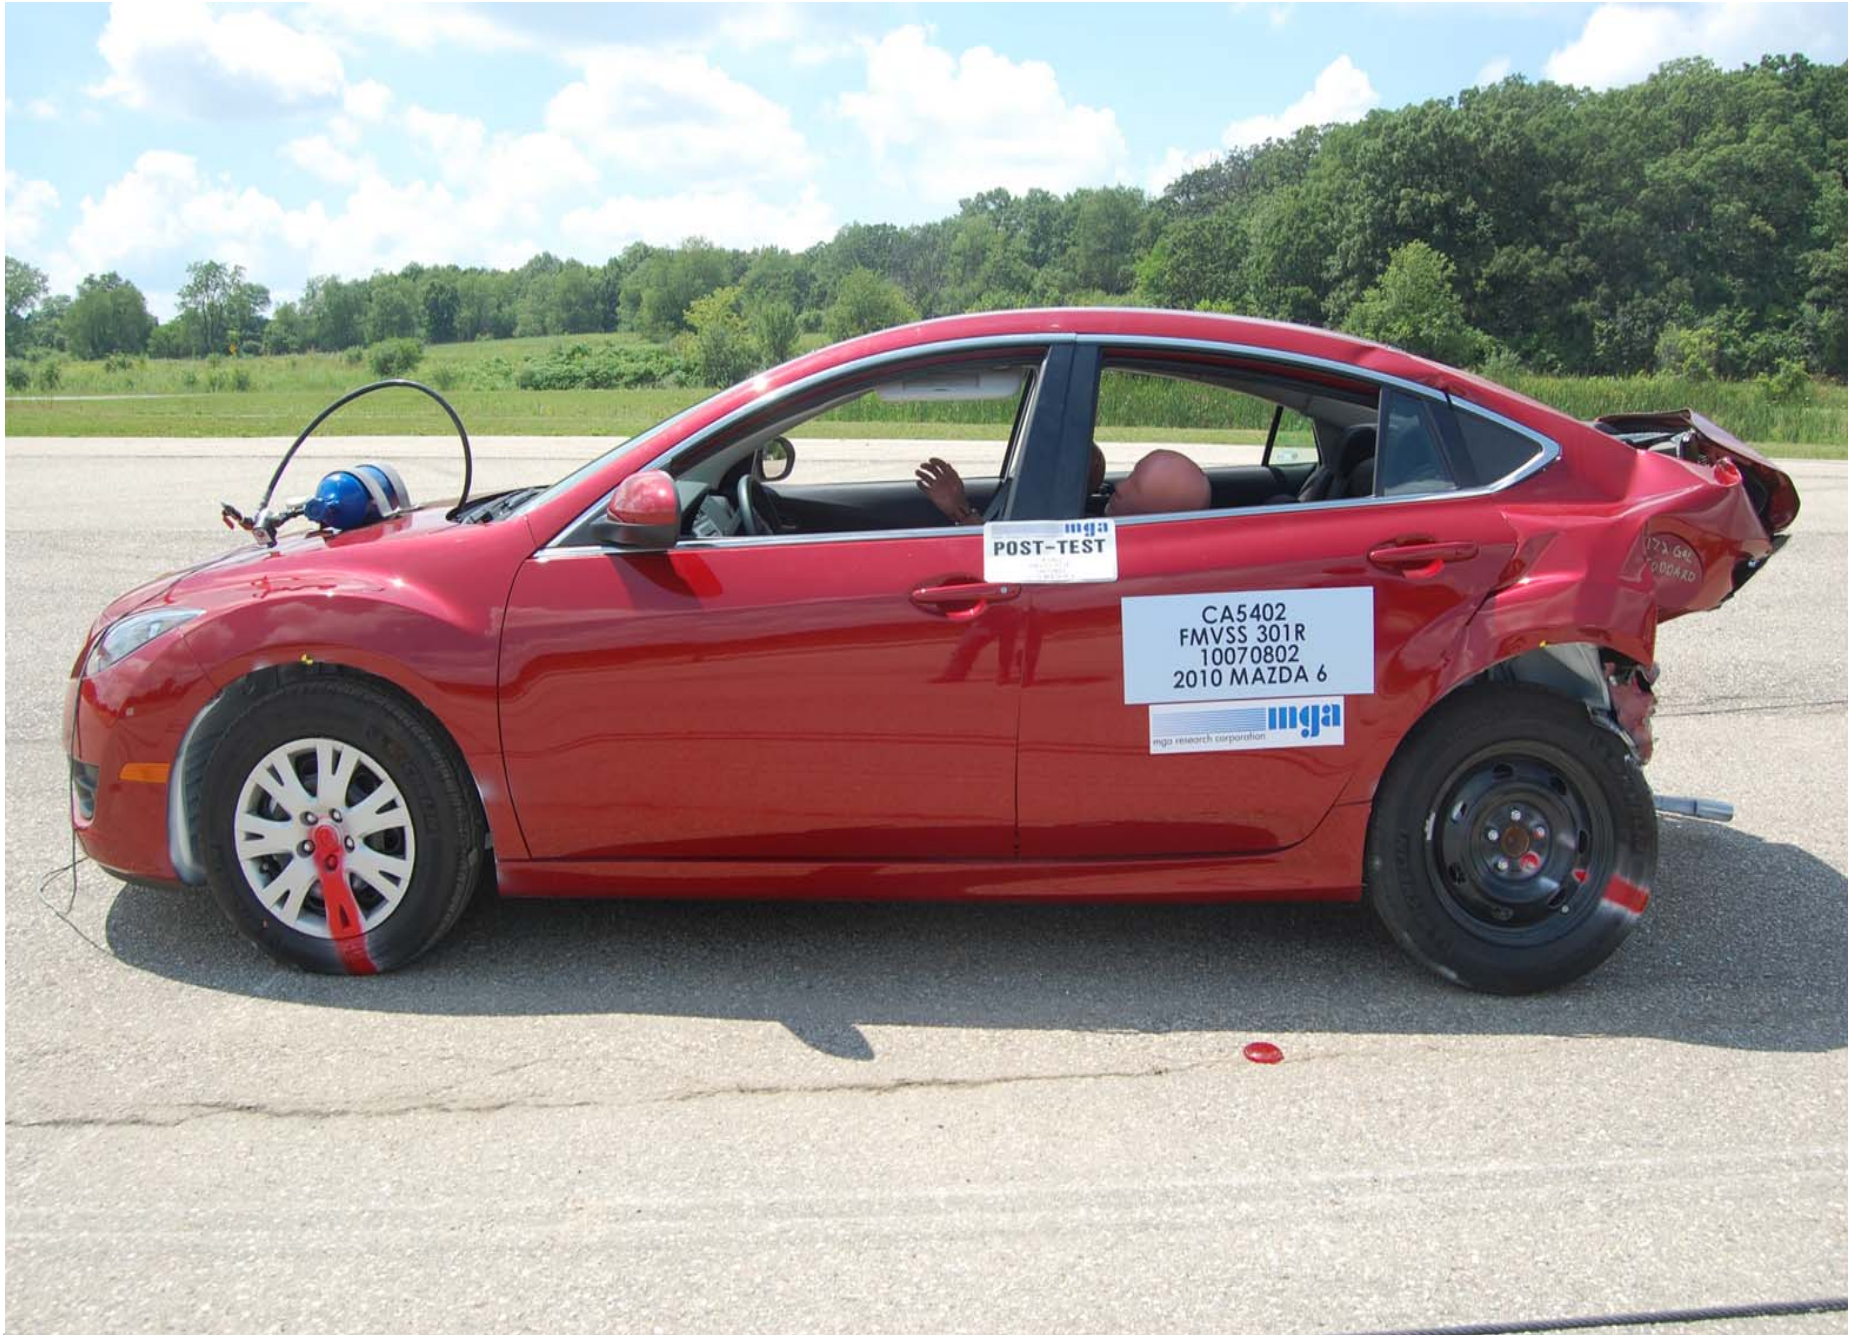
A-6.

Post-Test Left Side View of Vehicle

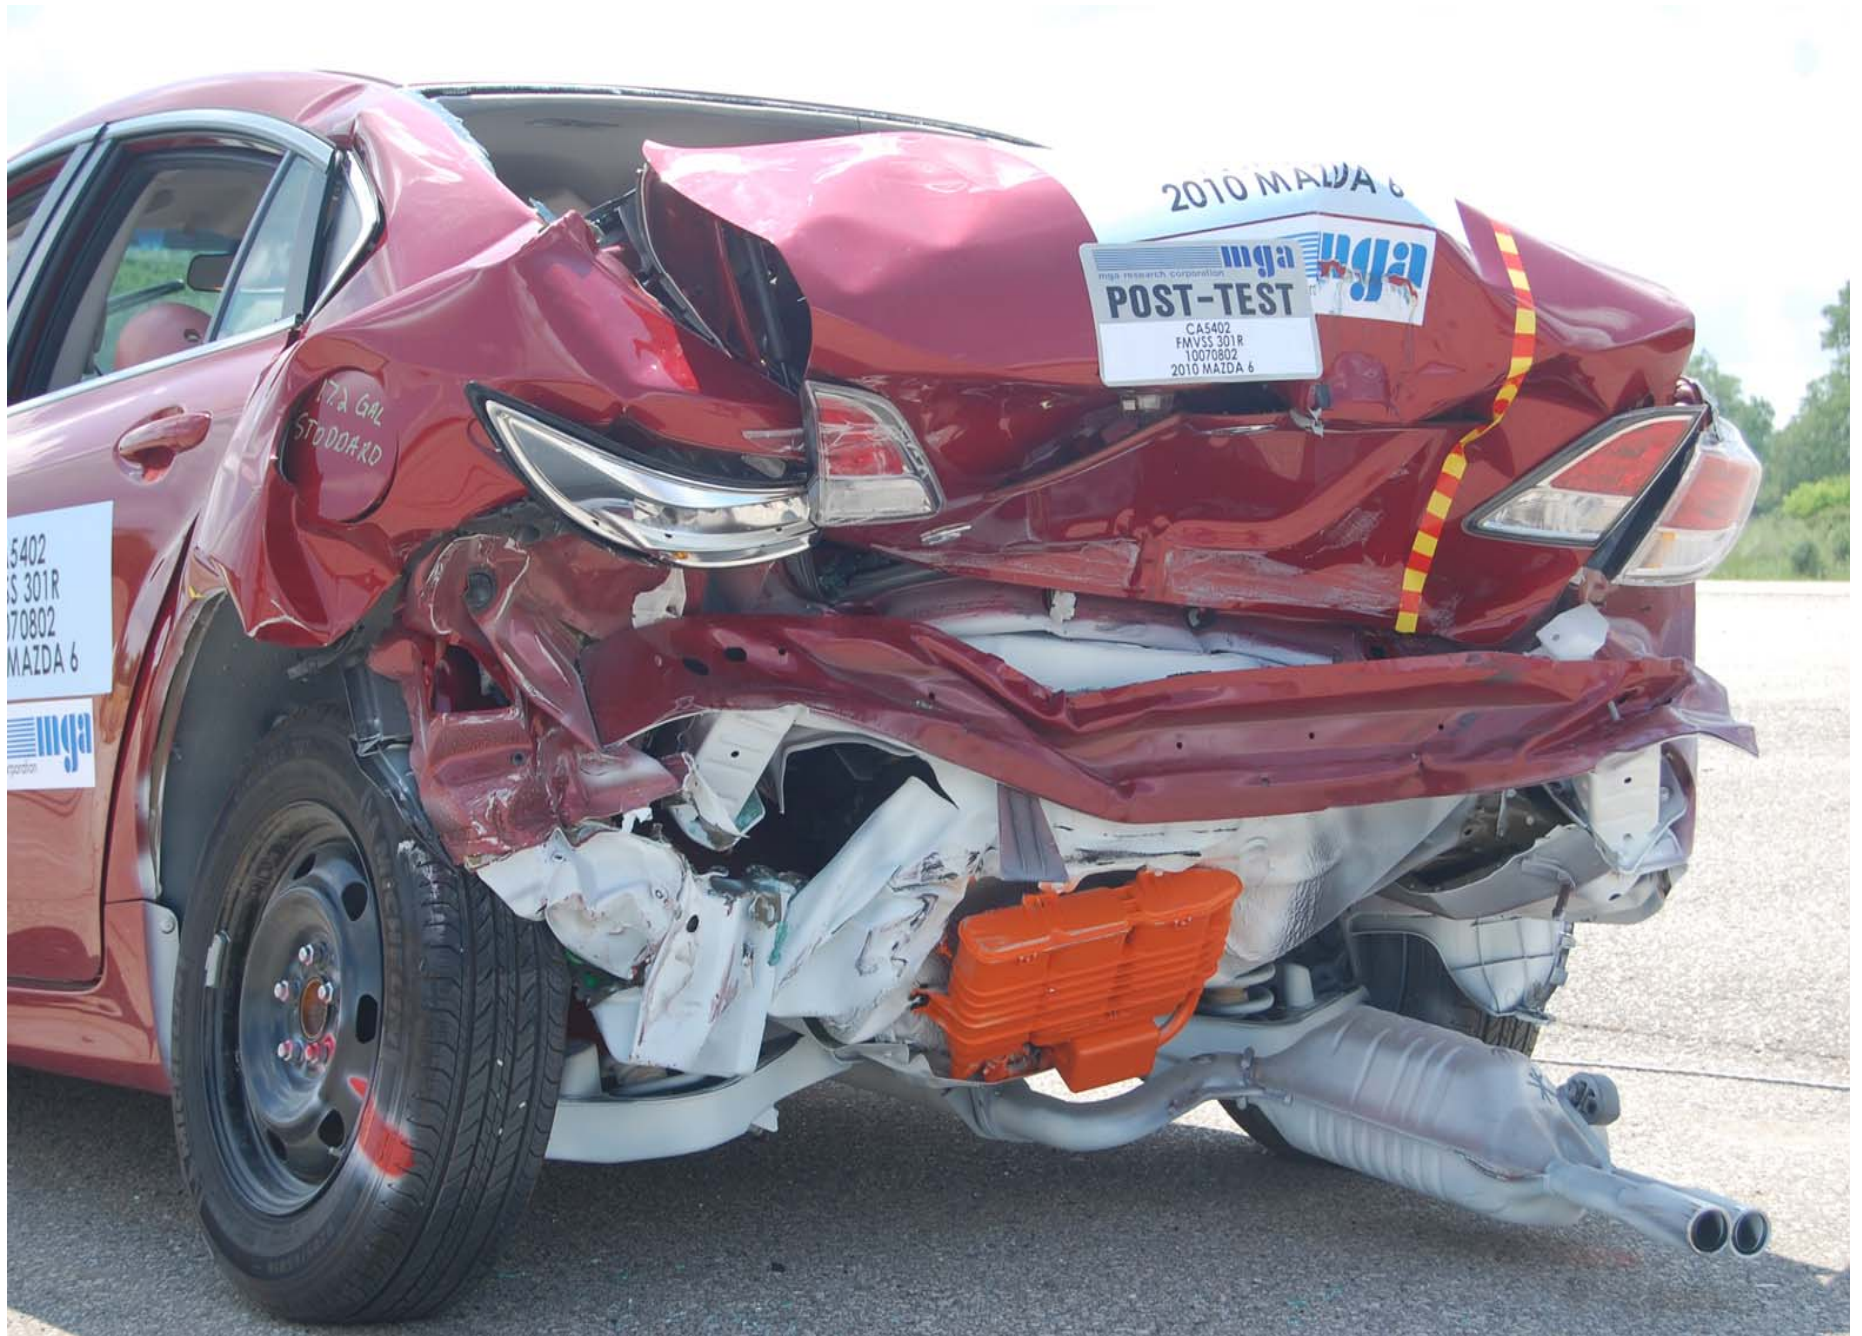
Post-Test Left Rear Close-up View of Vehicle

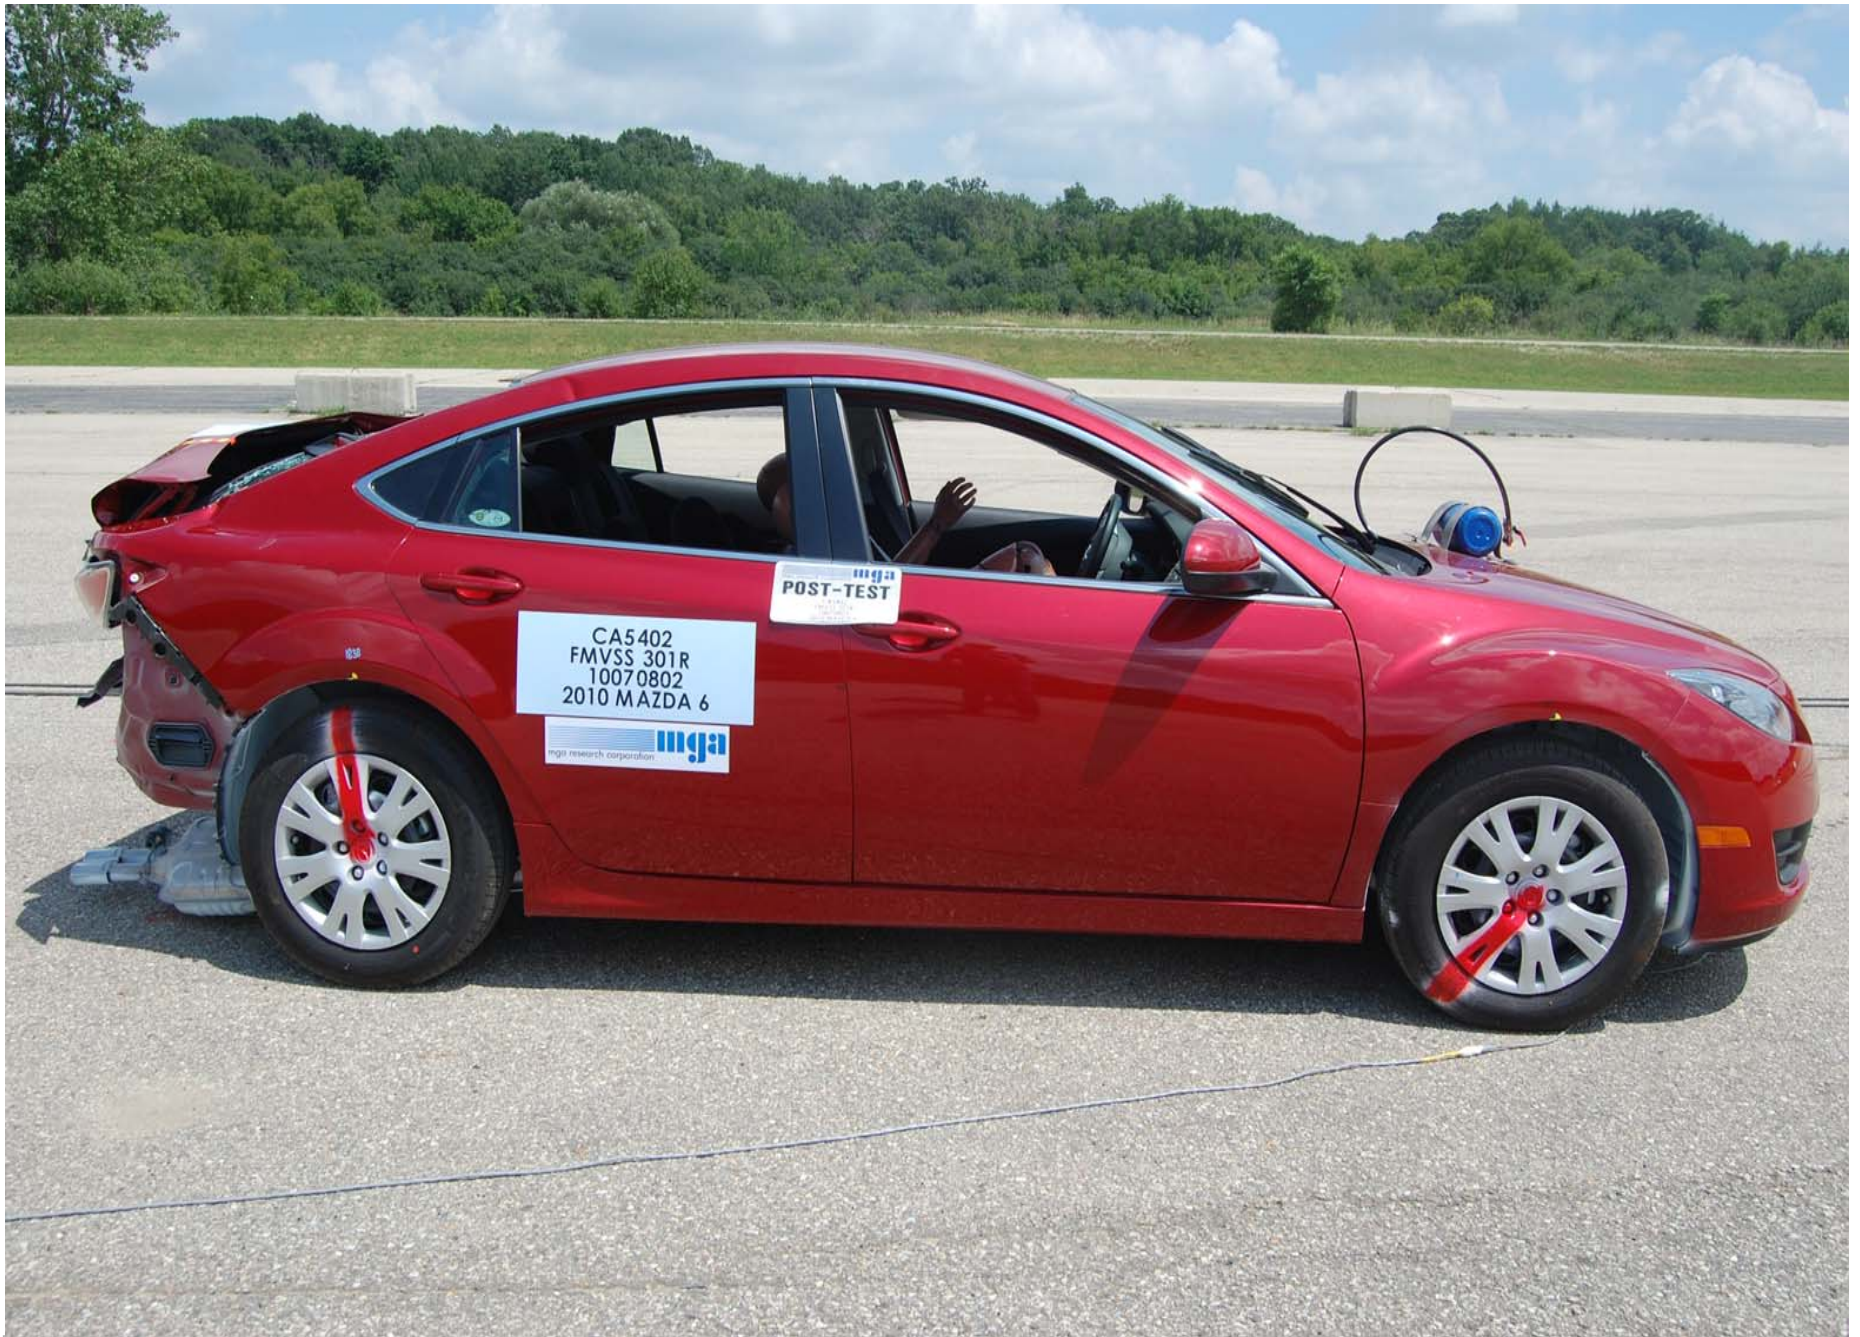
A-10.

Post-Test Right Side View of Vehicle

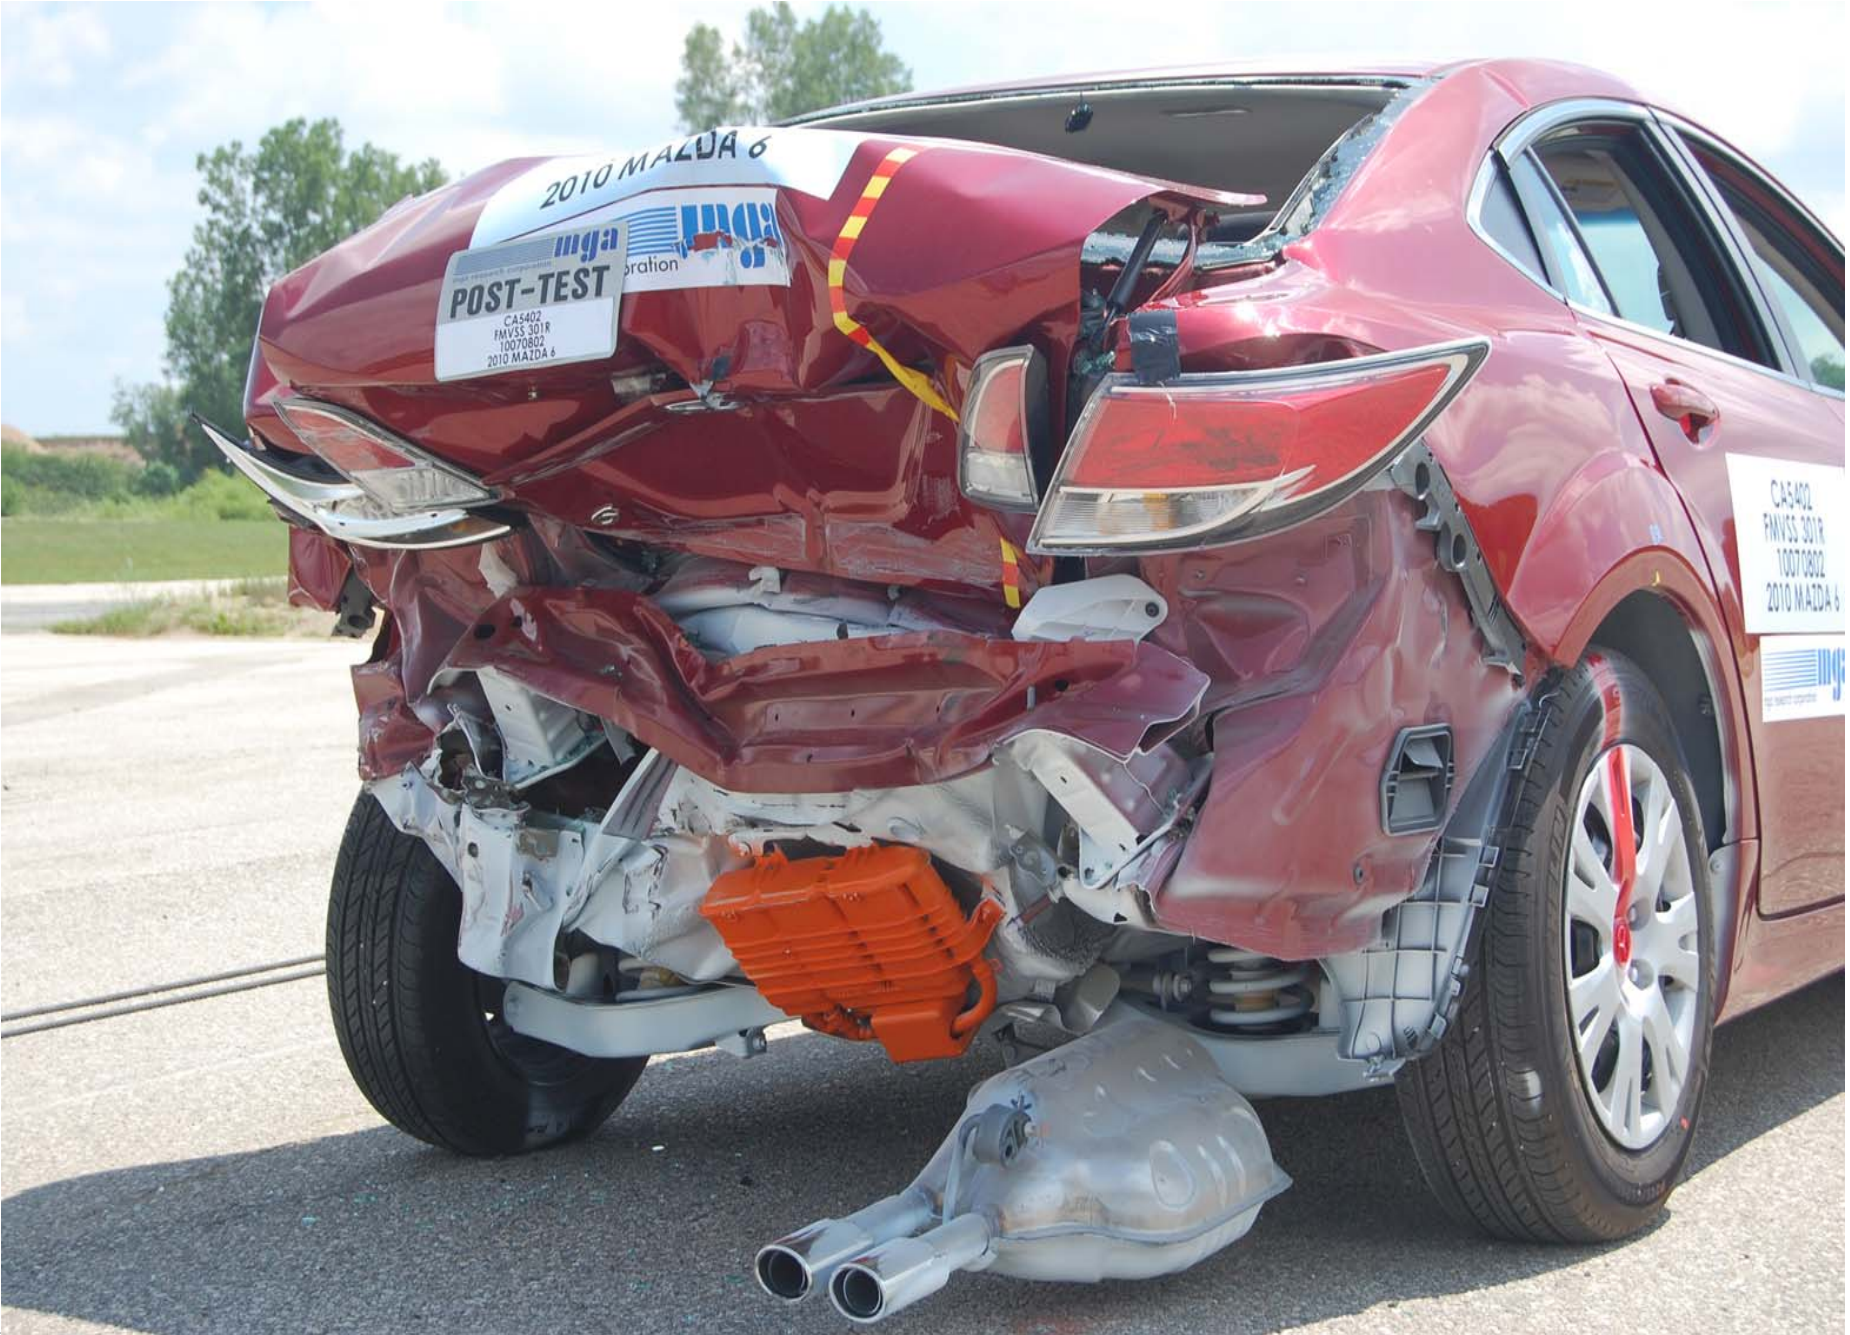
A-12.

Post-Test Right Rear Close-up View of Vehicle

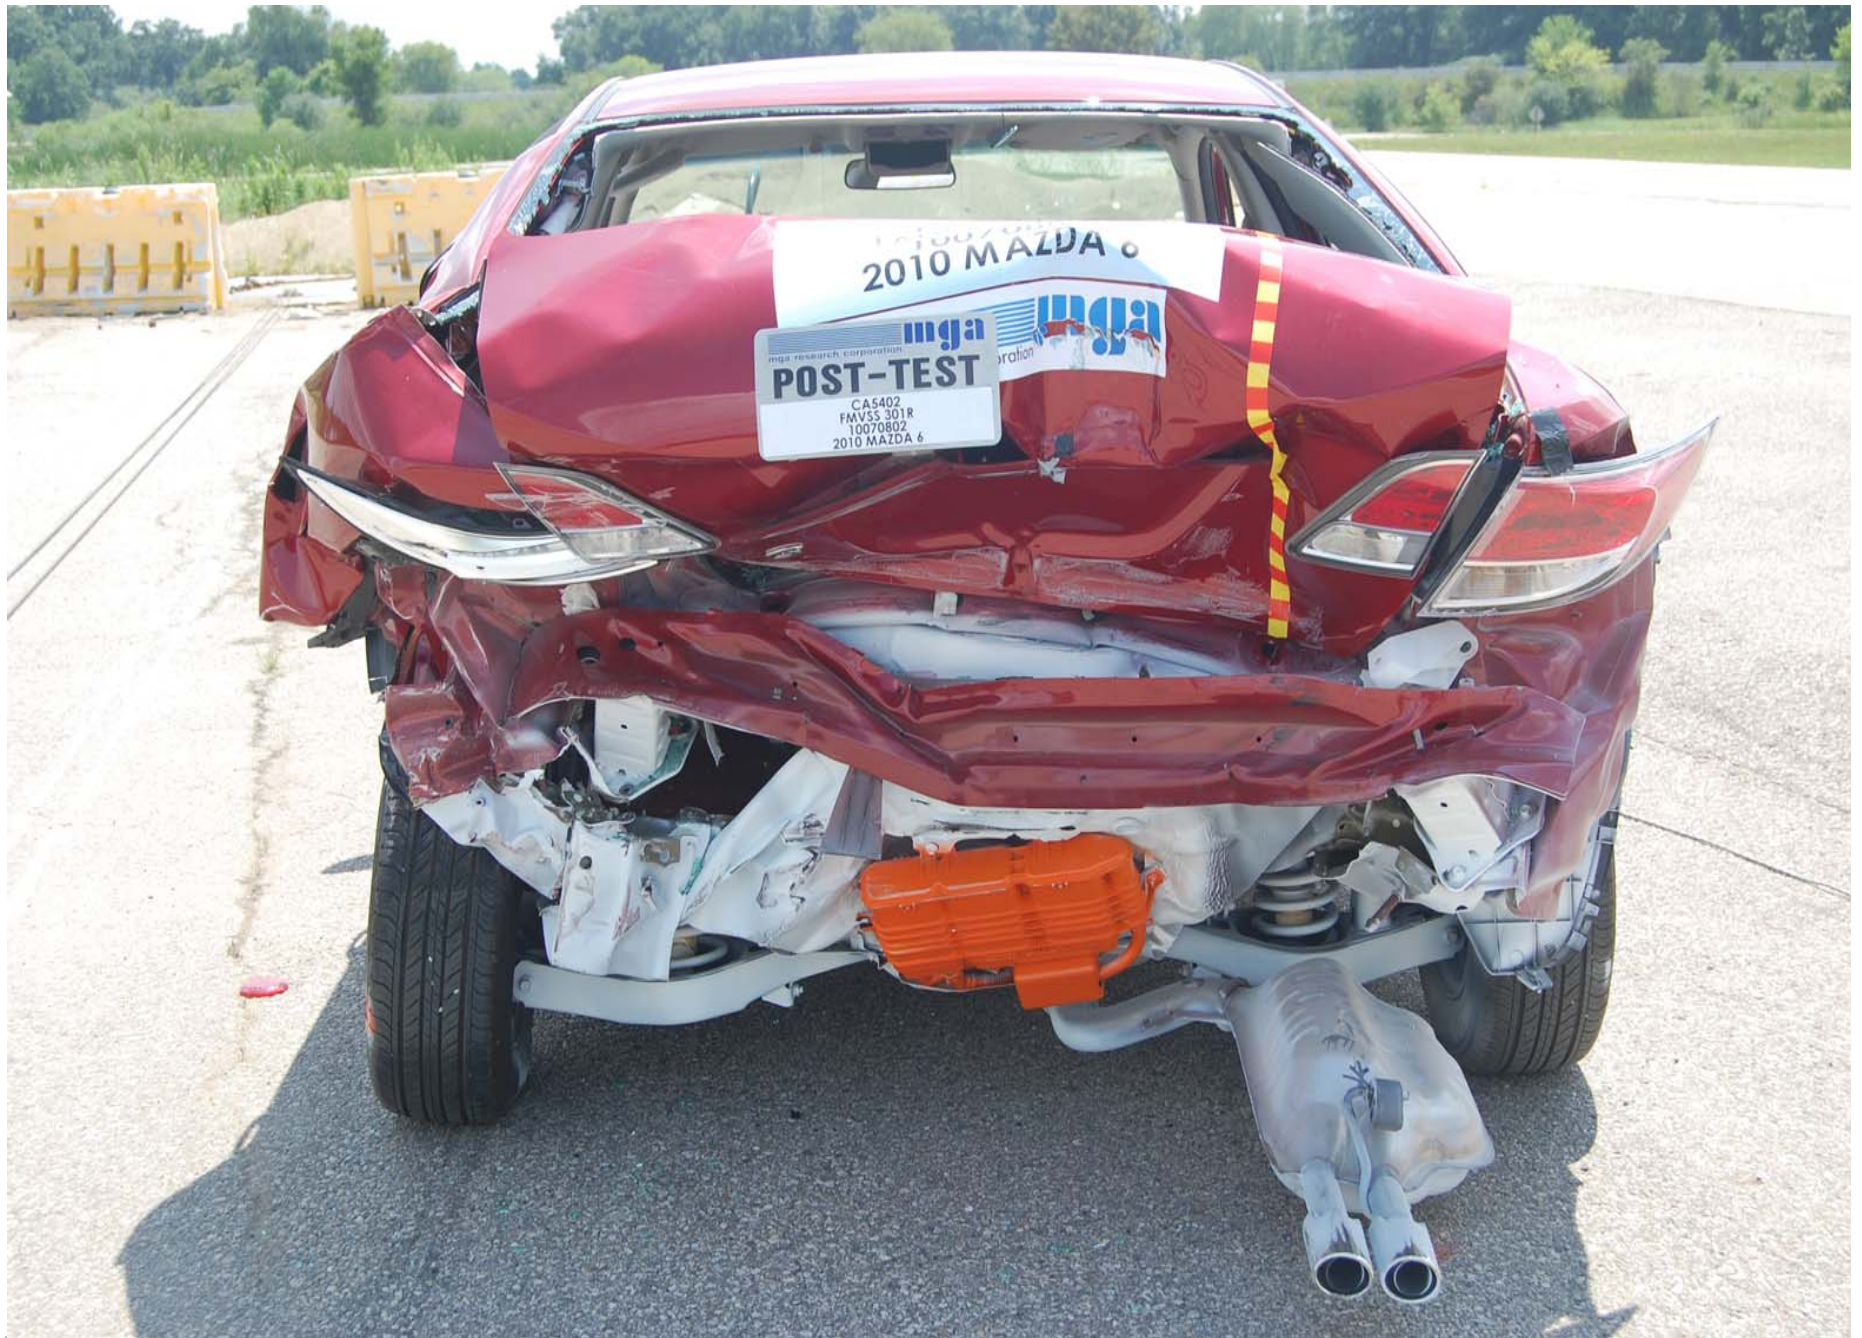
A-14.

Post-Test Rear View of Vehicle

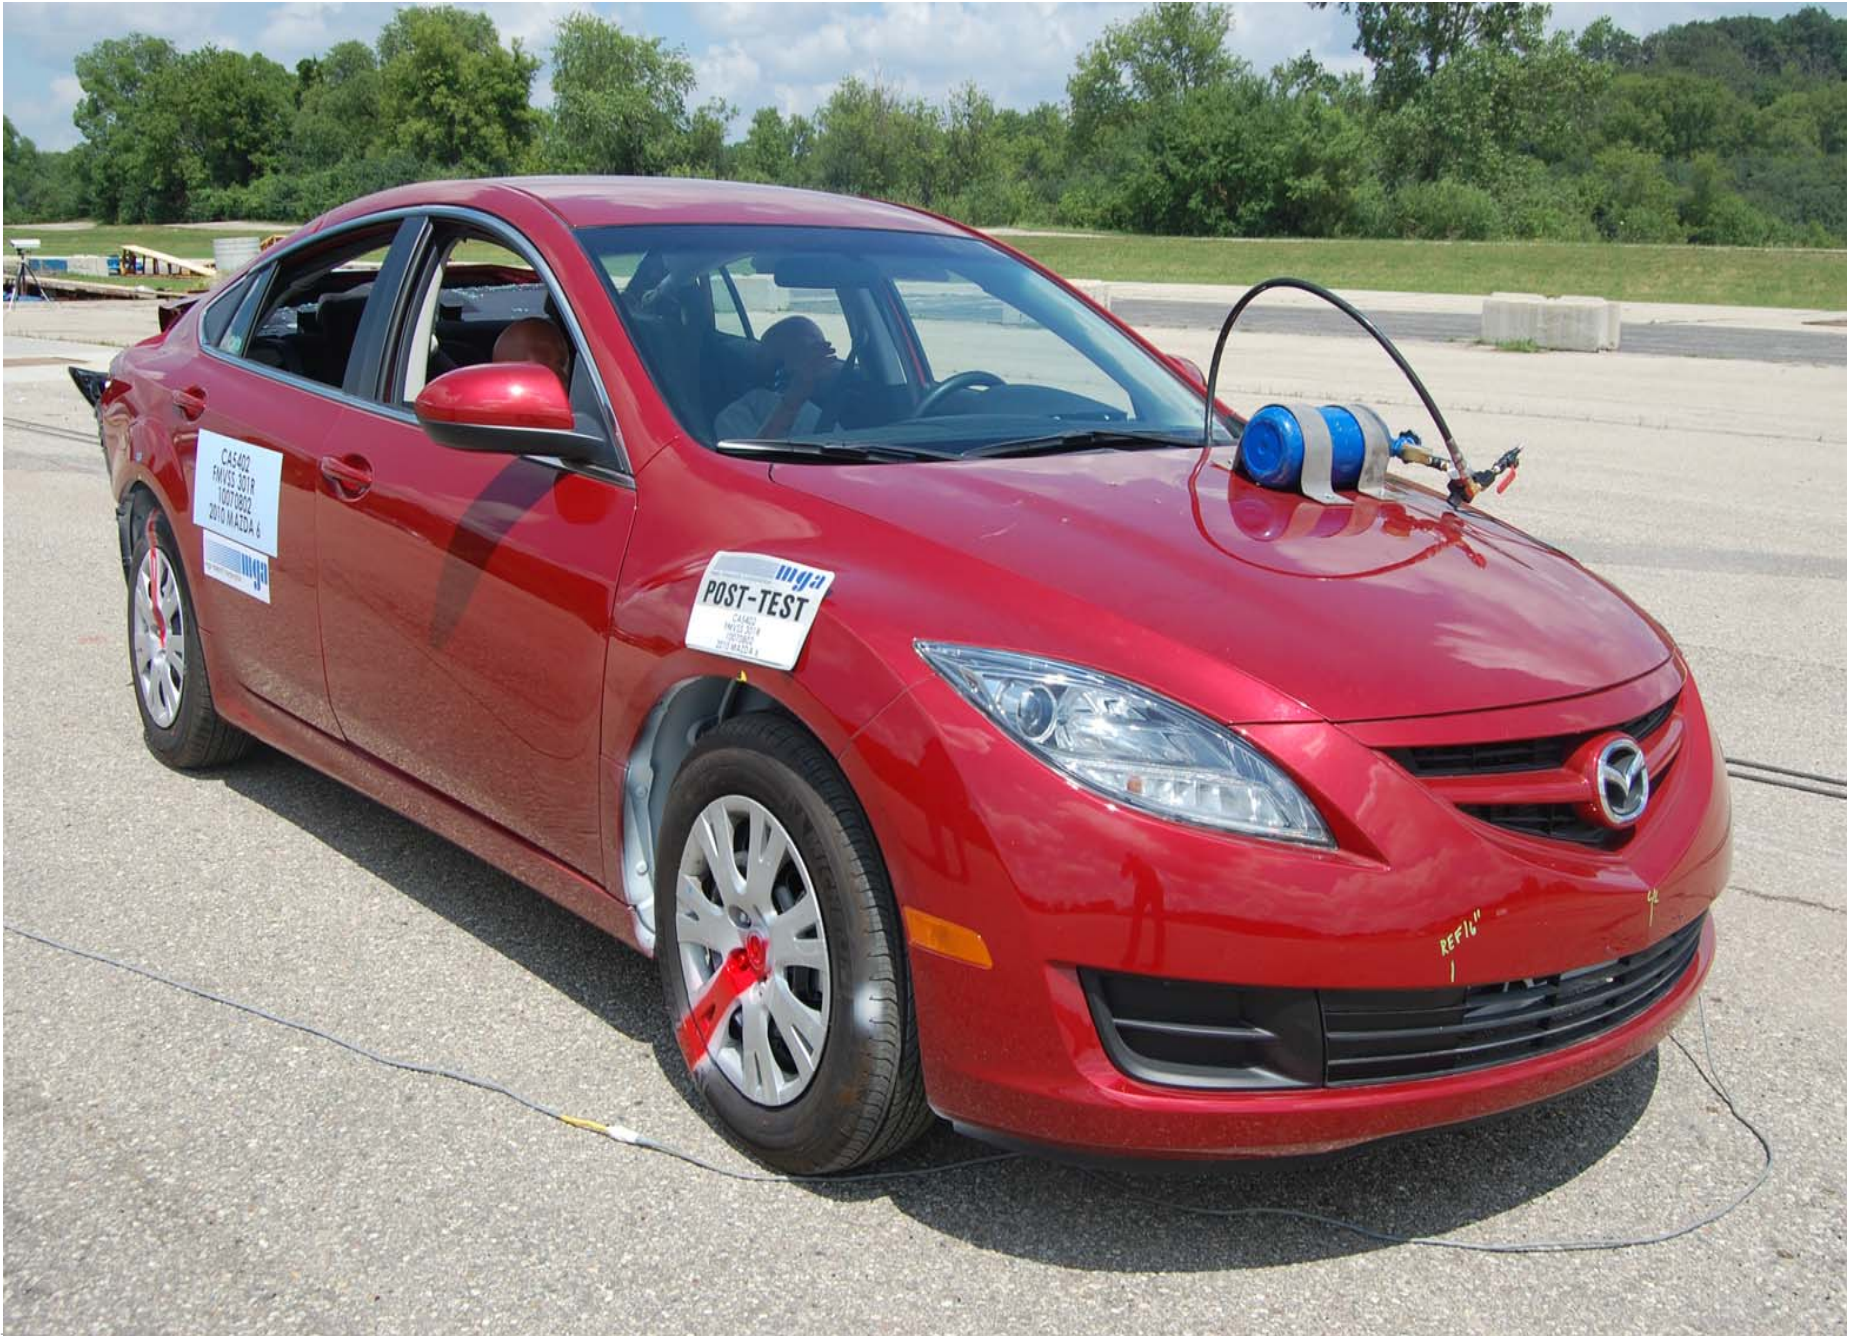
Post-Test ¾ Frontal View From Right Side of Vehicle

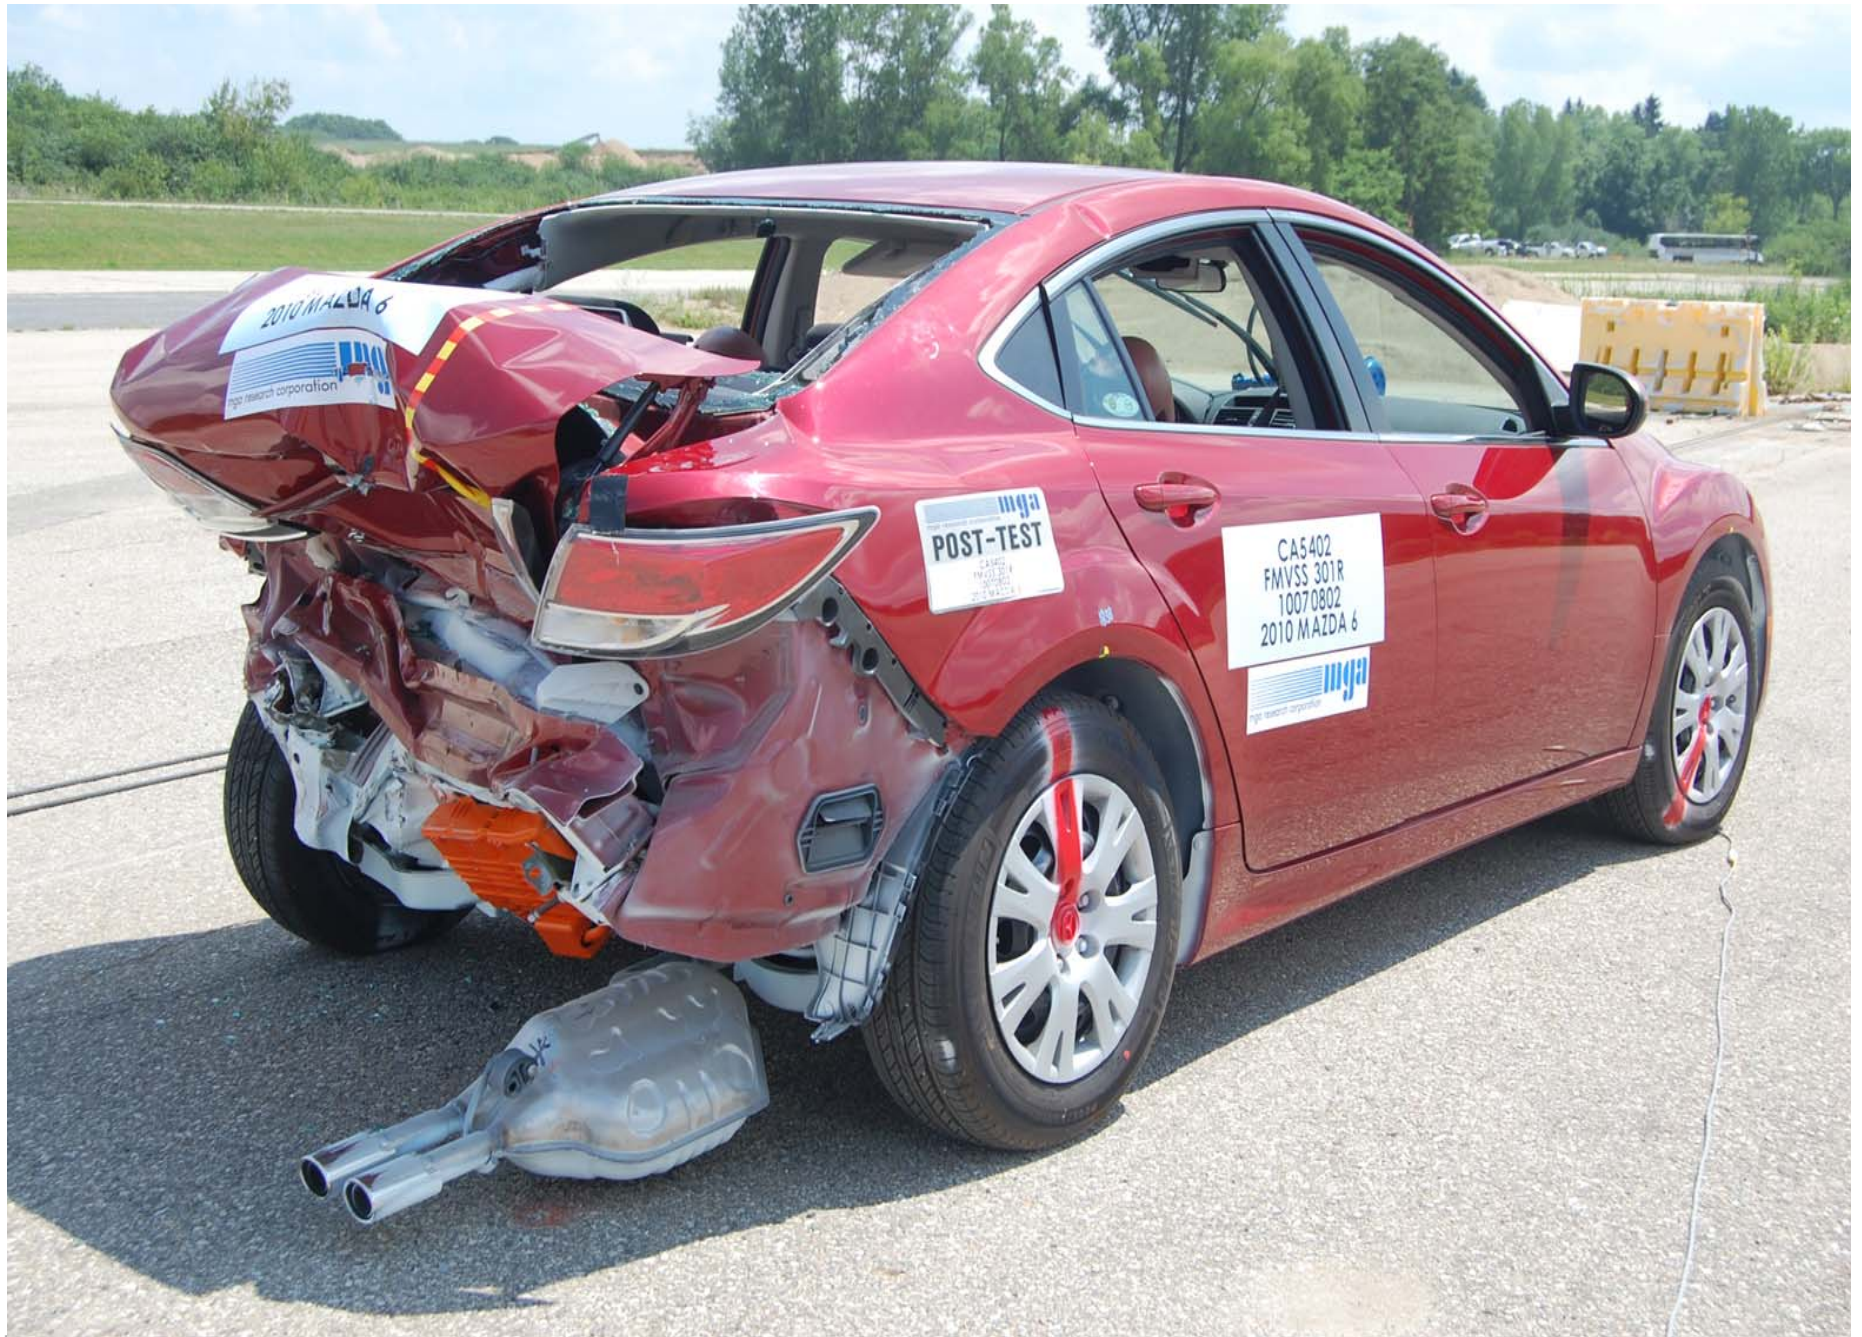
Post-Test ¾ Rear View From Right Side of Vehicle

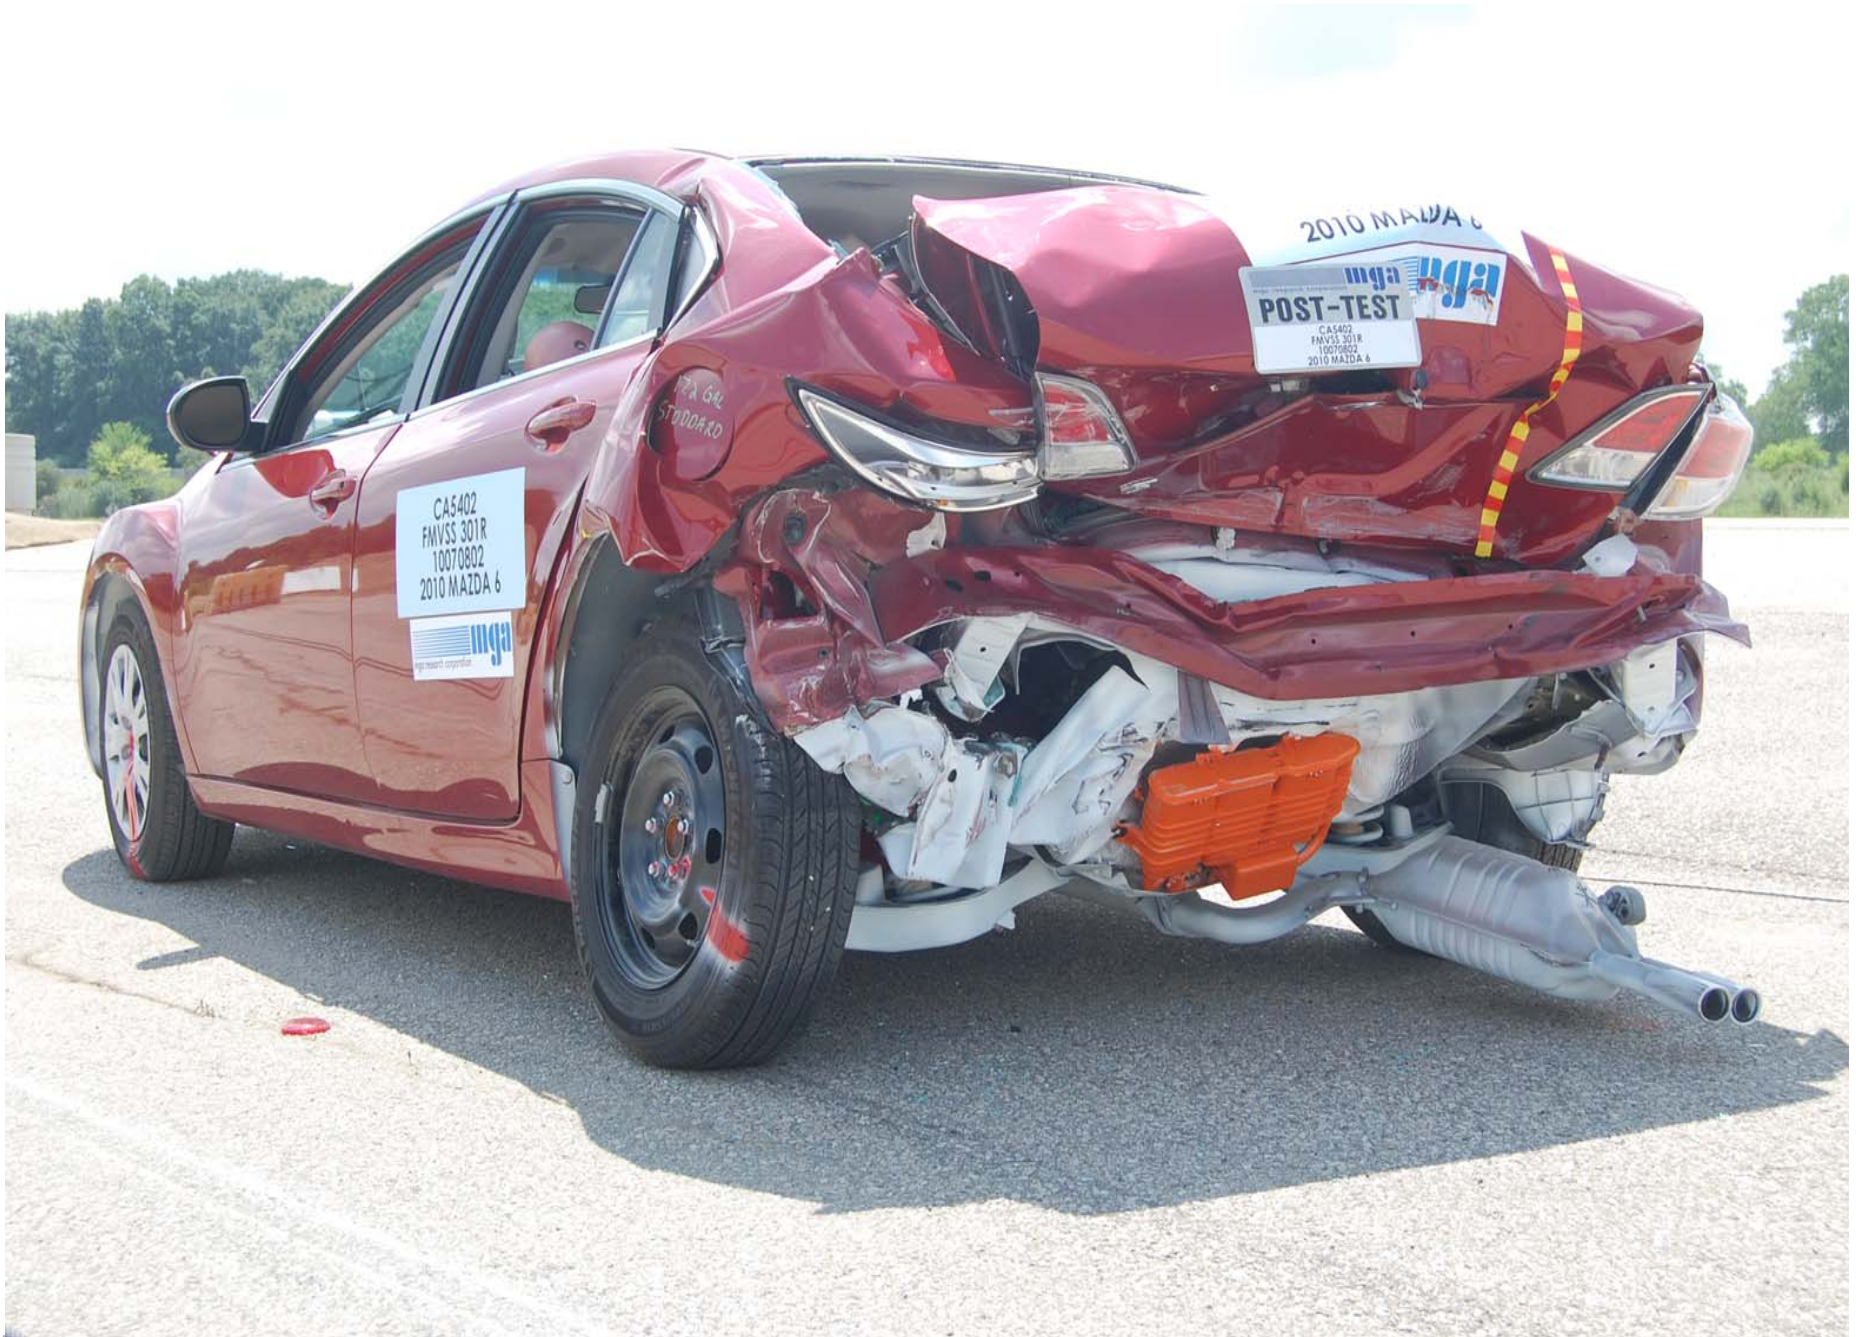
A-20.

Post-Test ¾ Rear View From Left Side of Vehicle
