REPORT NUMBER: 301-MGA-2010-002

**SAFETY COMPLIANCE TESTING FOR FMVSS 301R
FUEL SYSTEM INTEGRITY – REAR IMPACT**

**AUTO ALLIANCE INTERNATIONAL, INC.
FOR MAZDA MOTOR CORPORATION
2010 MAZDA 6
NHTSA NUMBER: CA5402**

**PREPARED BY:
MGA RESEARCH CORPORATION
5000 WARREN ROAD
BURLINGTON, WI 53105**

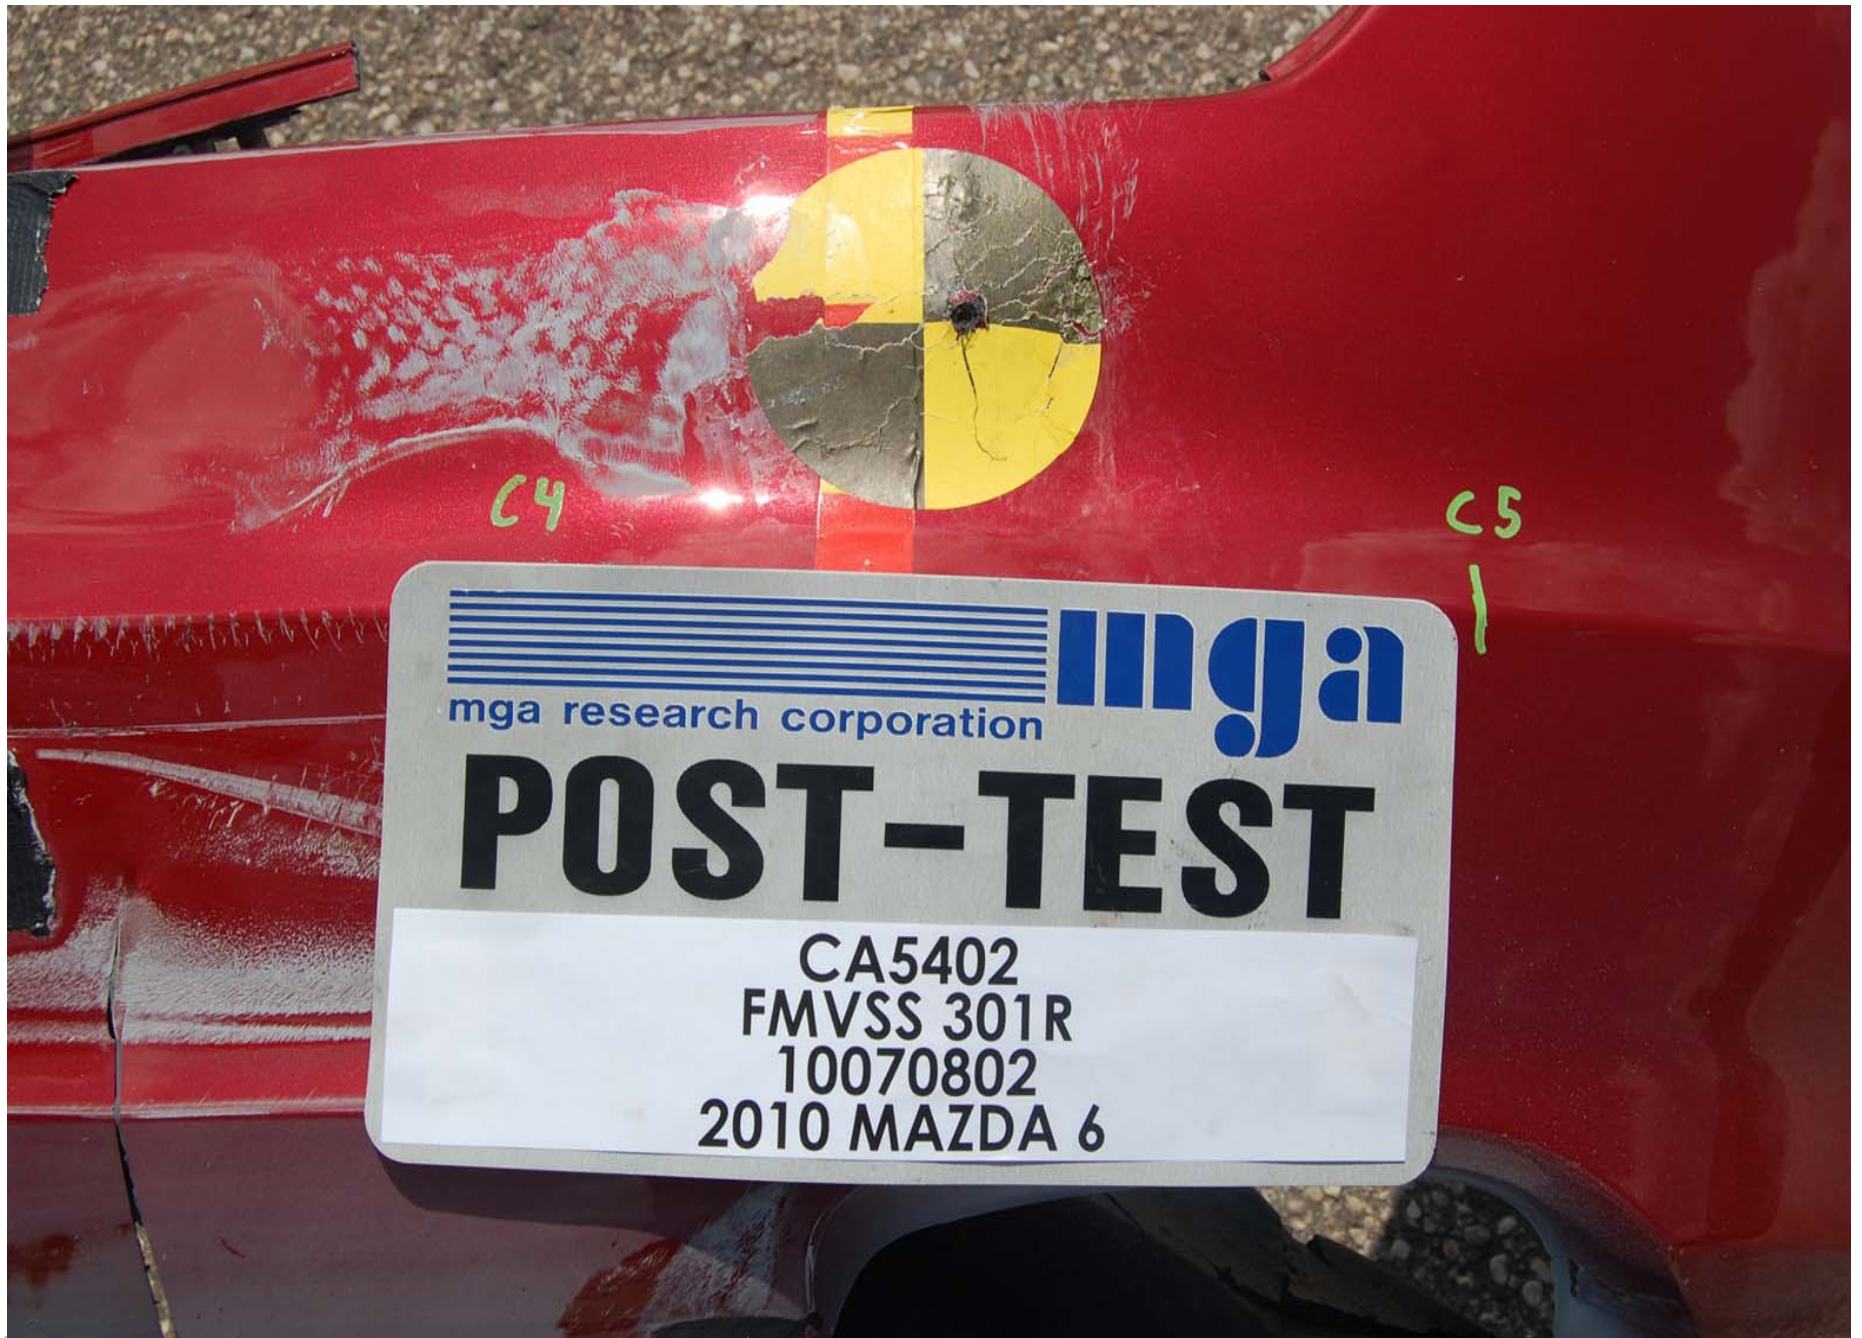
Post-Test Impact Point

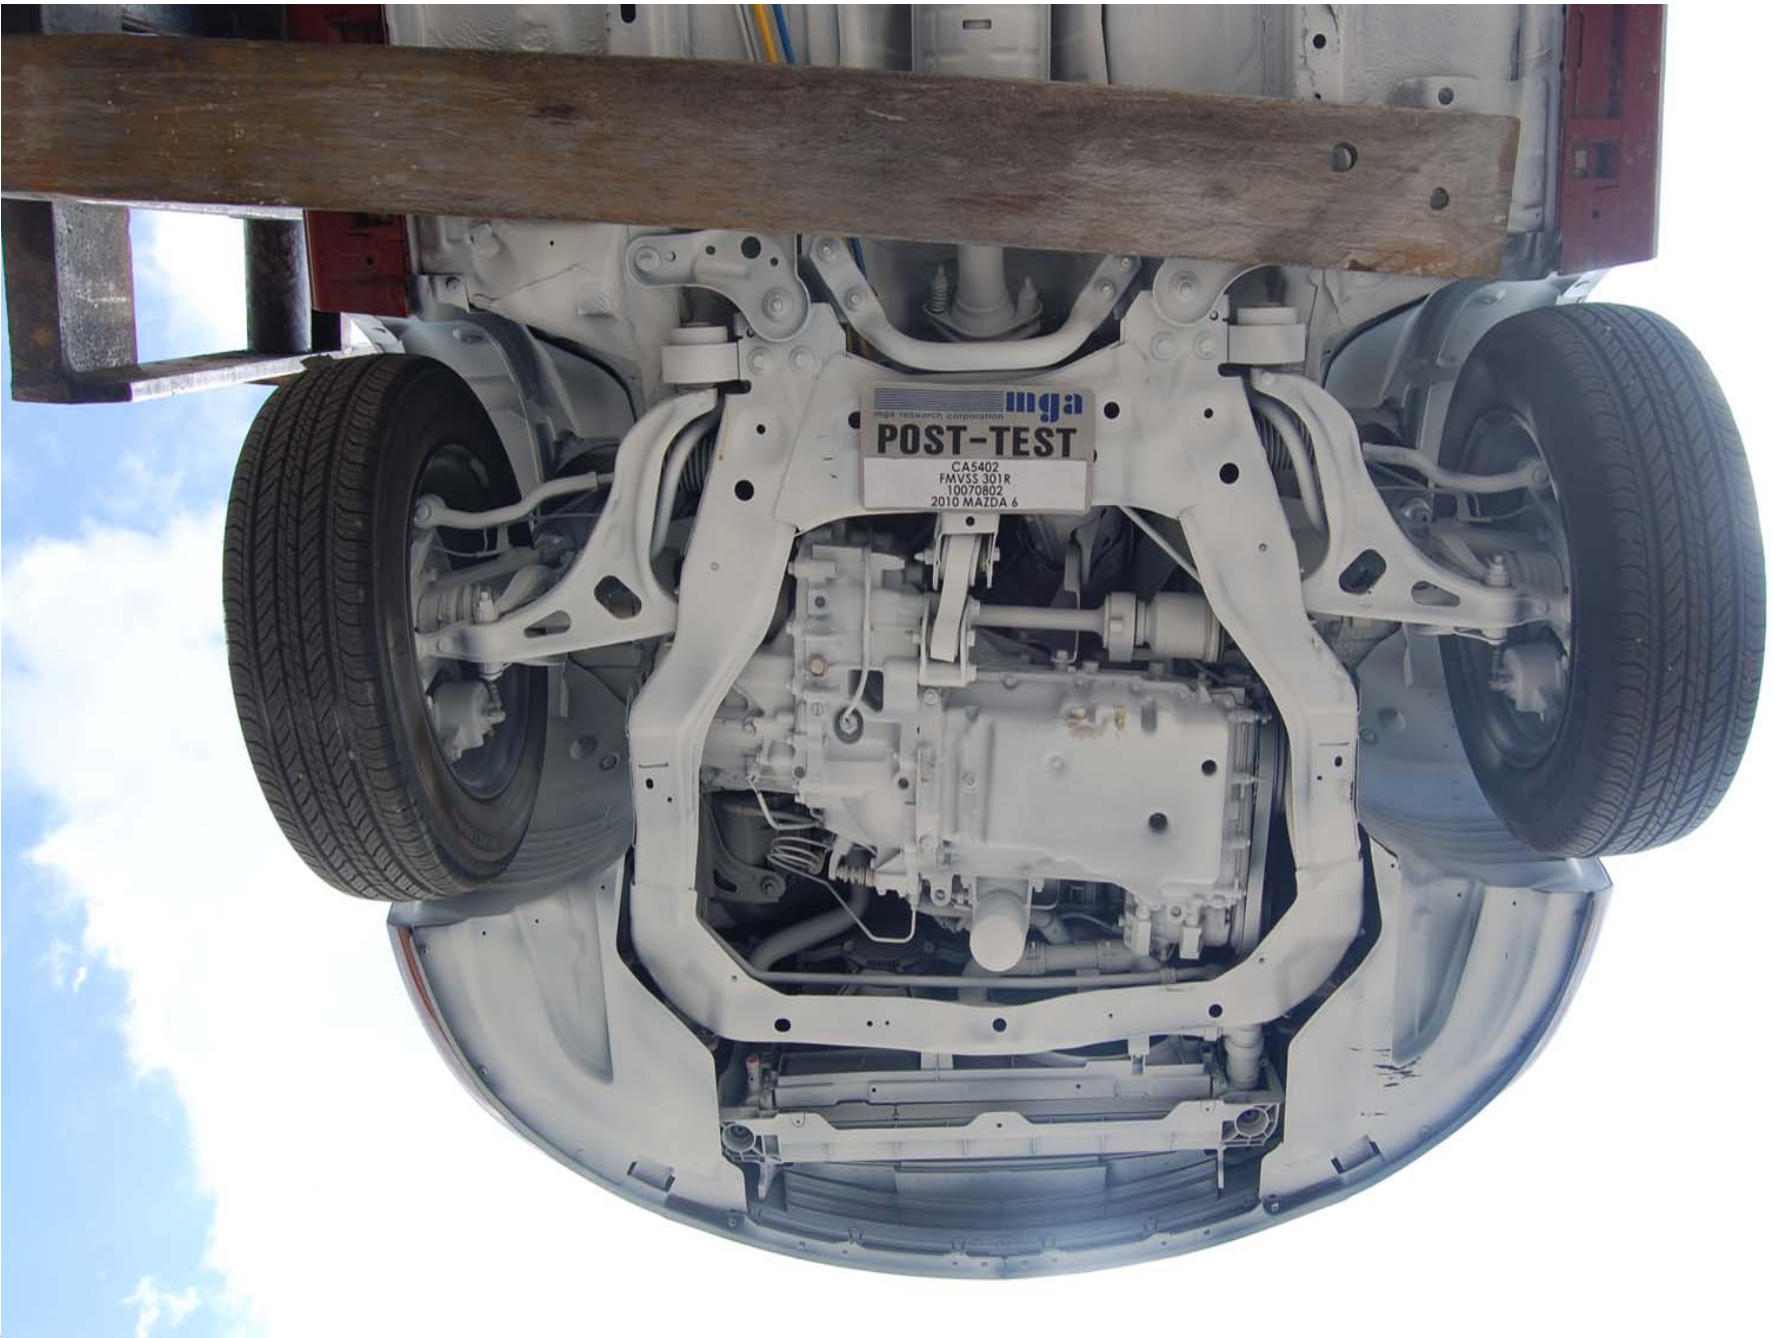
Post-Test Underbody View 1

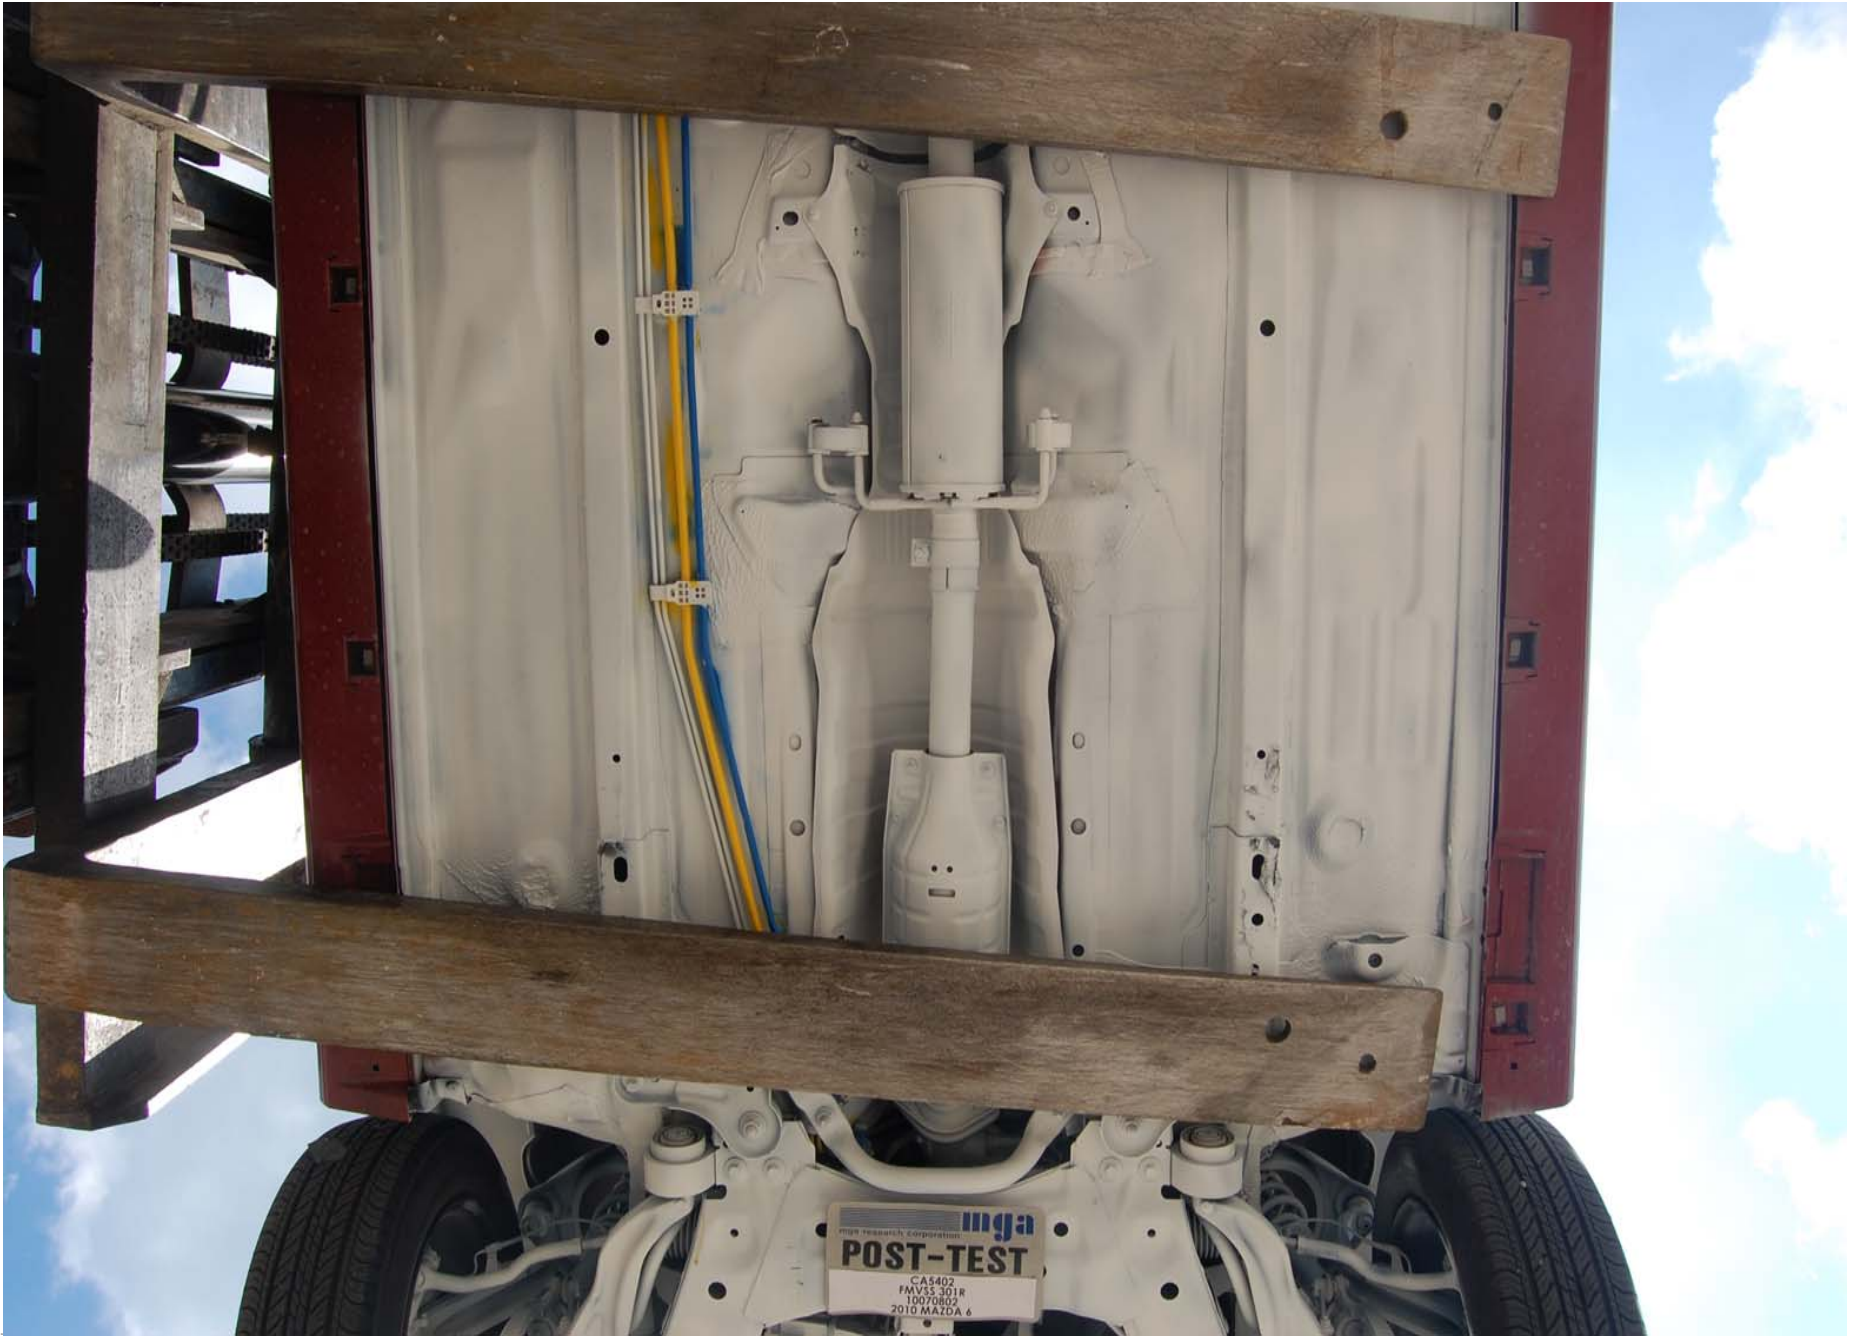
A-26.

Post-Test Underbody View 2

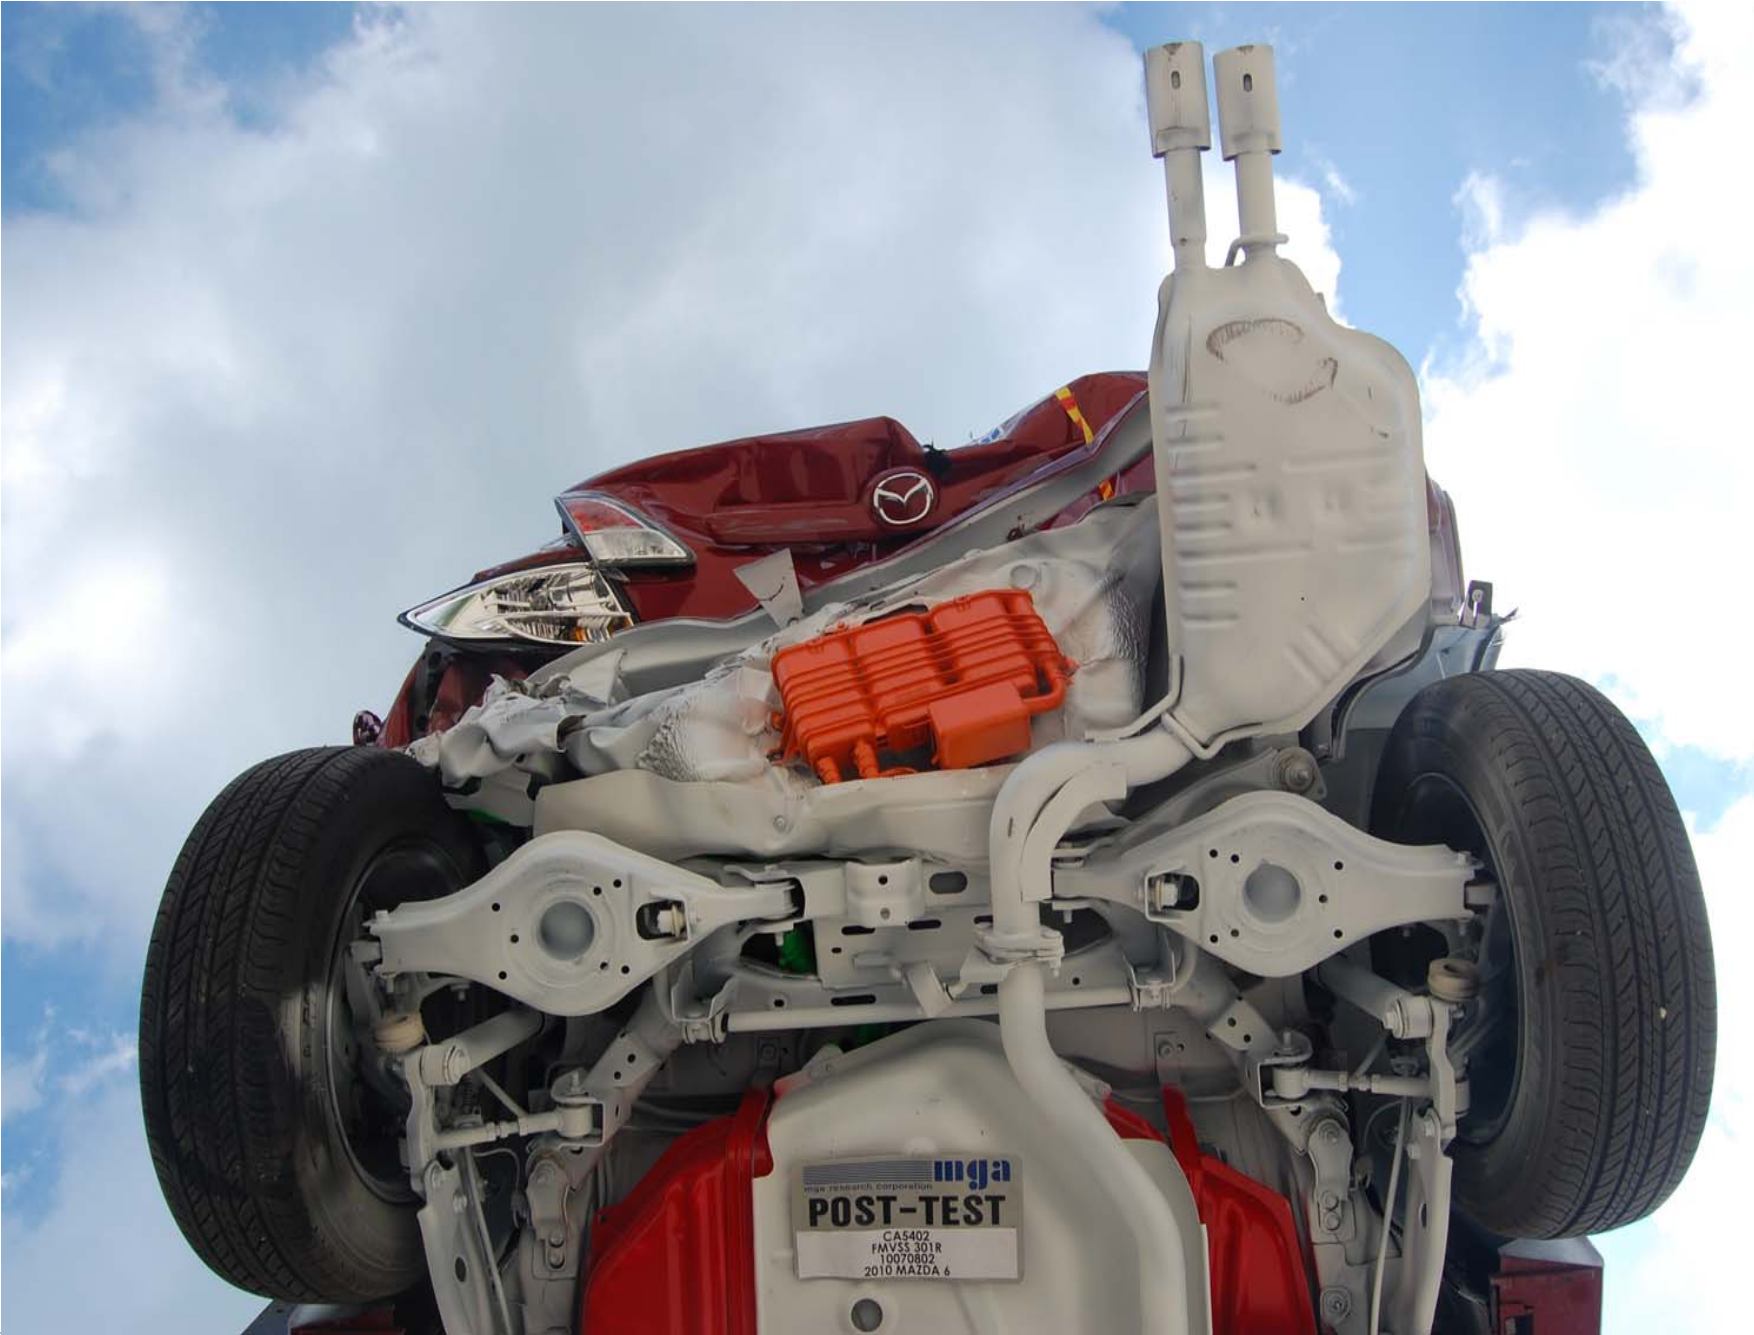
Post-Test Underbody View 3

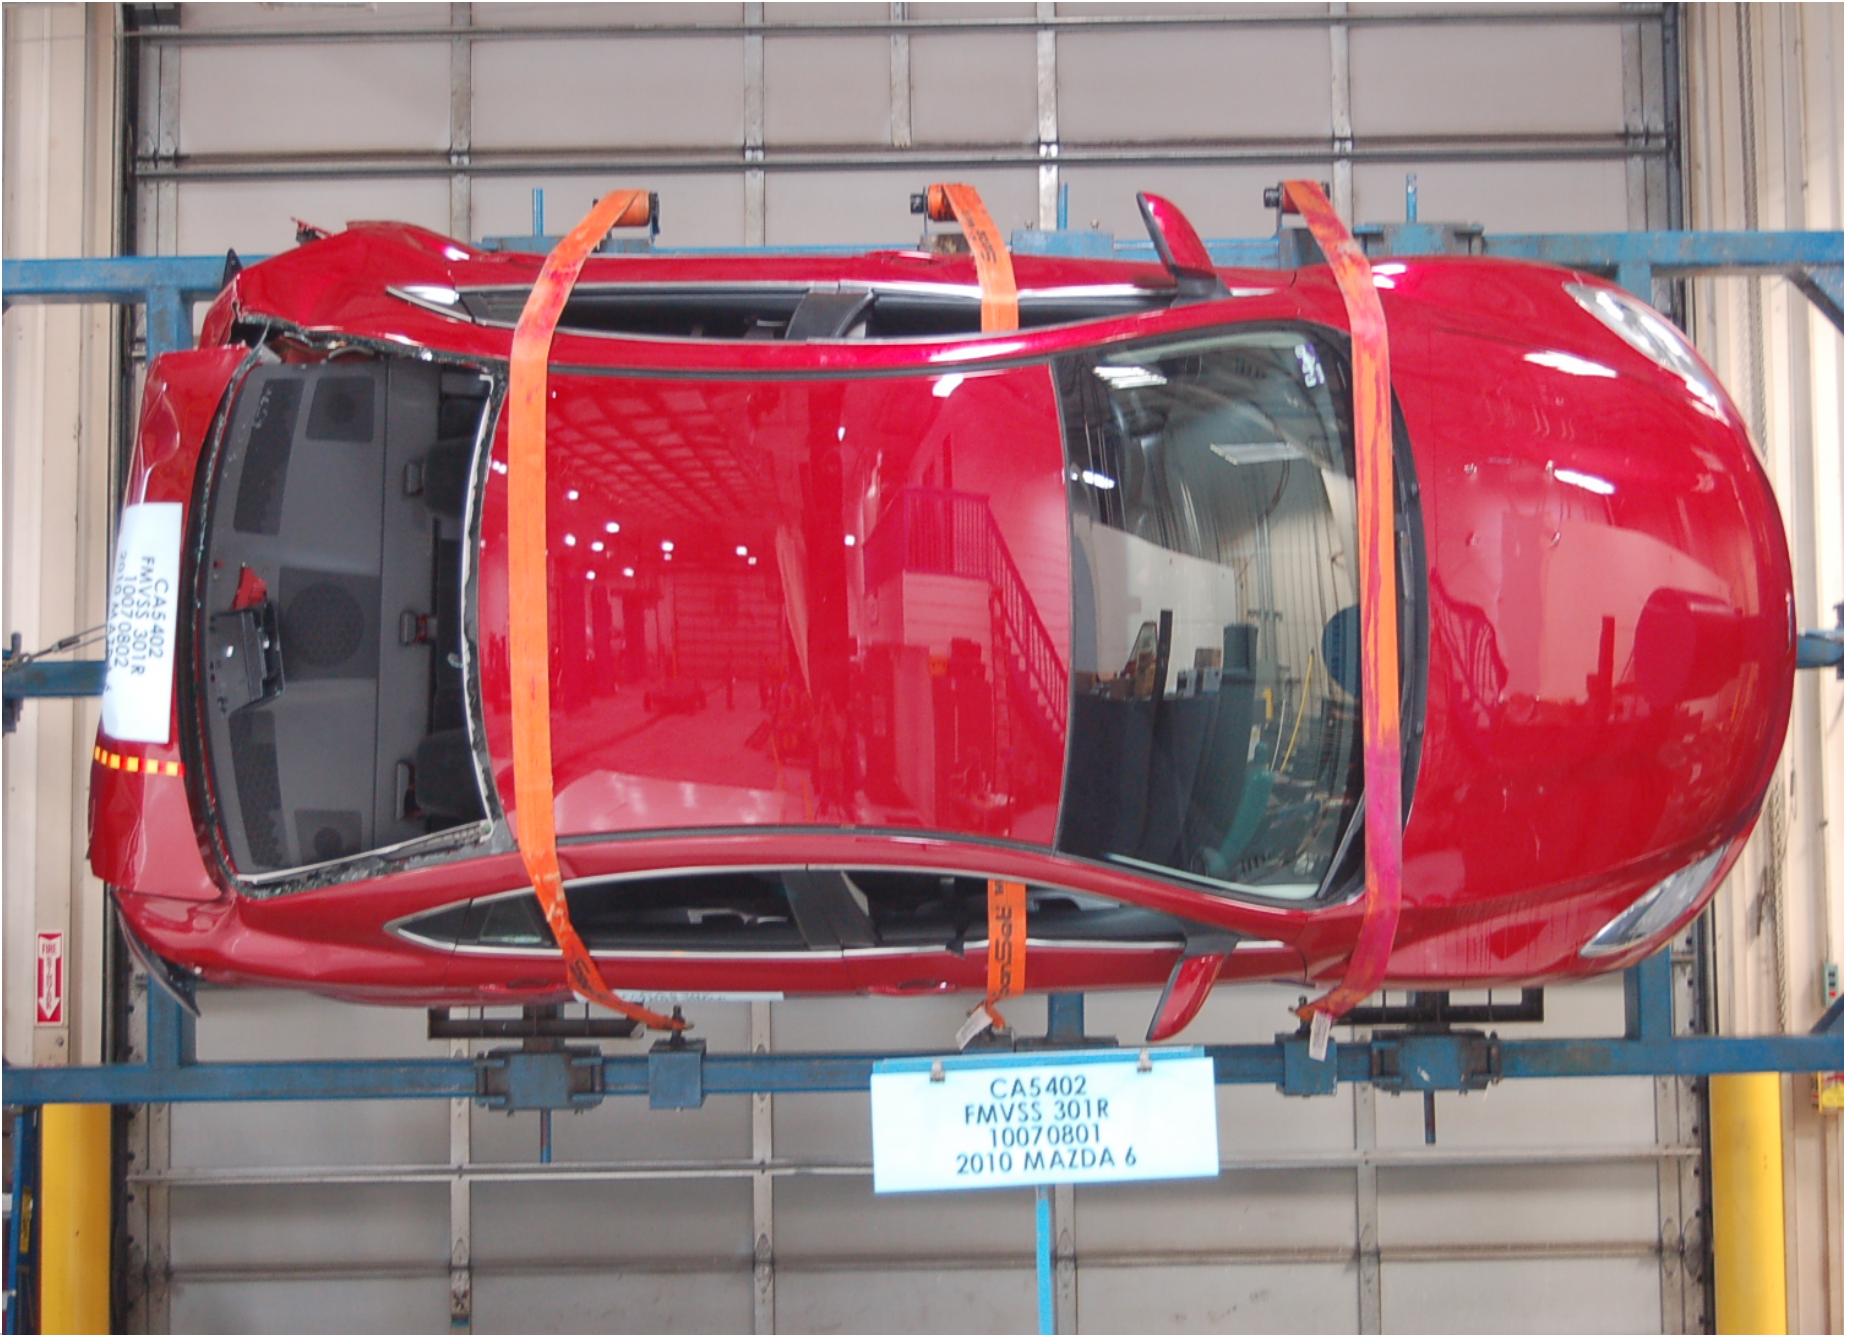
A-37.

0° TO 90° Rotation Time (sec) = 125 sec

Test Phase	Spillage (g)	Spillage Details
First 5 minutes from onset of rotation	0	
Sixth minute from onset of rotation	0	
Seventh minute from onset of rotation	0	
Eight minute if required	N/A

Static Rollover at 90 Degrees

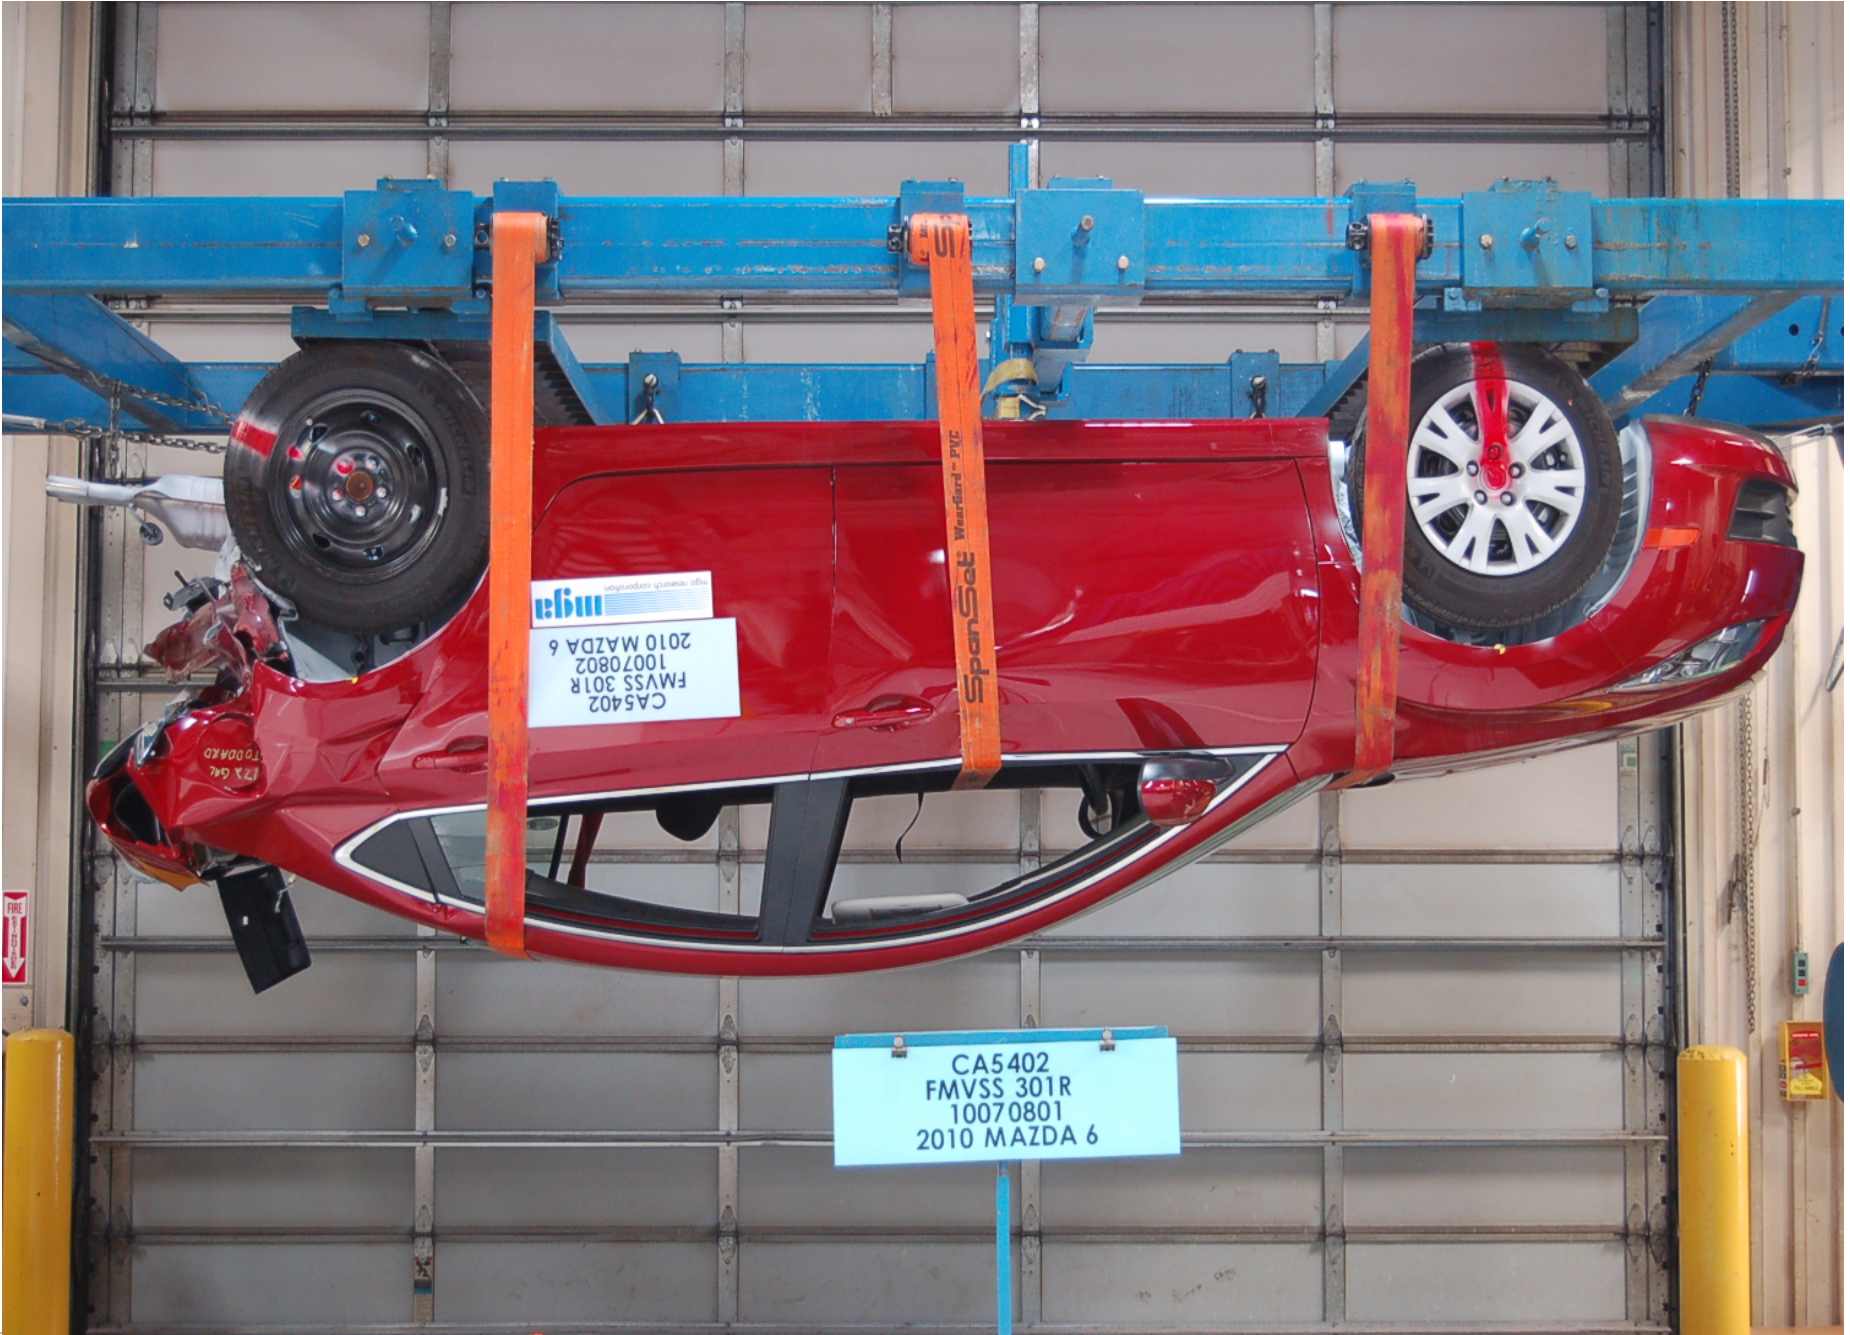
A-38.

90° TO 180° Rotation Time (sec) = 114 sec

Test Phase	Spillage (g)	Spillage Details
First 5 minutes from onset of rotation	0	
Sixth minute from onset of rotation	0	
Seventh minute from onset of rotation	0	
Eight minute if required	N/A

Static Rollover at 180 Degrees

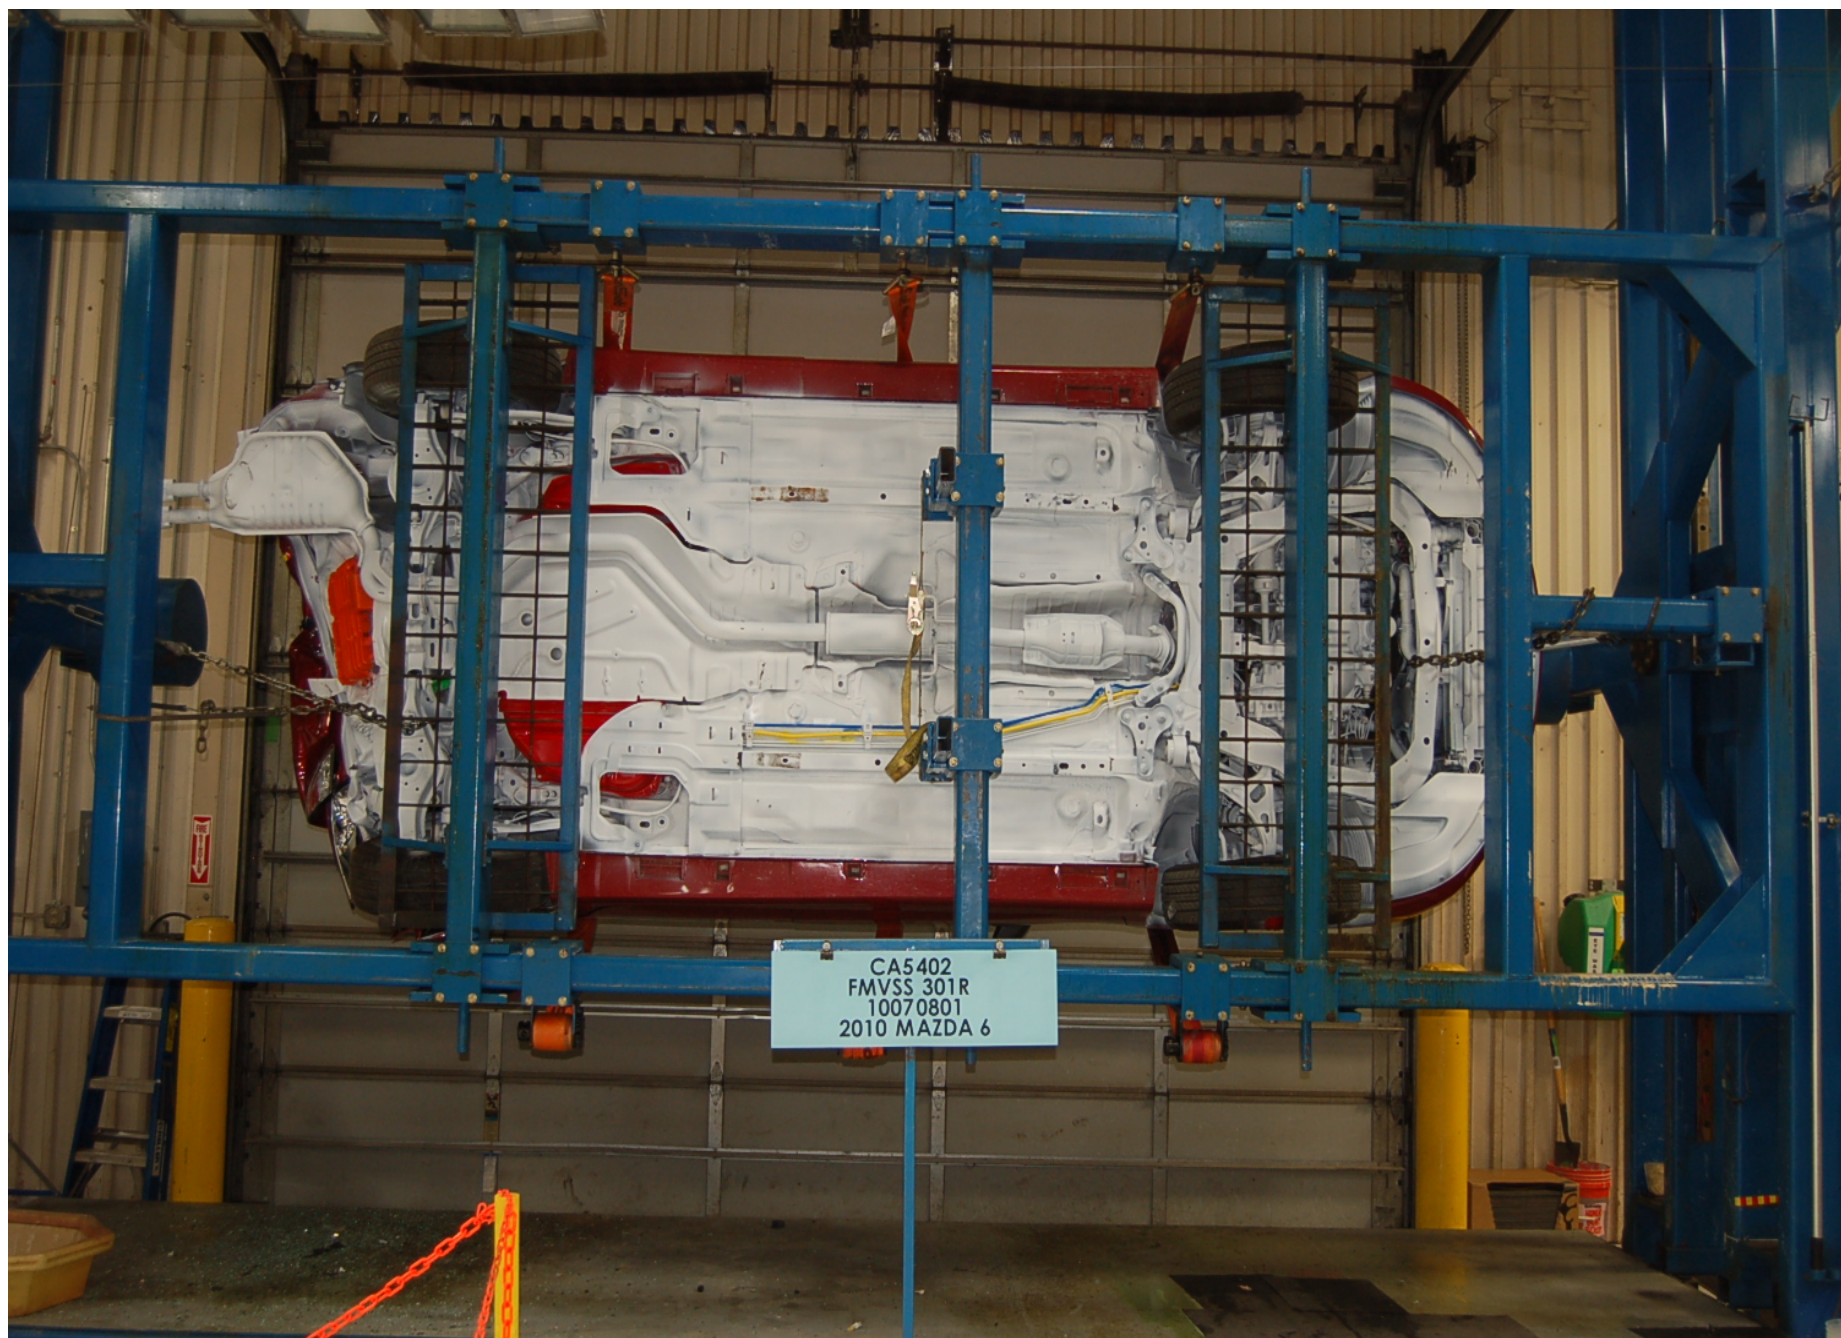
A-39.

180° TO 270° Rotation Time (sec) = 106 sec

Test Phase	Spillage (g)	Spillage Details
First 5 minutes from onset of rotation	0	
Sixth minute from onset of rotation	0	
Seventh minute from onset of rotation	0	
Eight minute if required	N/A

Static Rollover at 270 Degrees

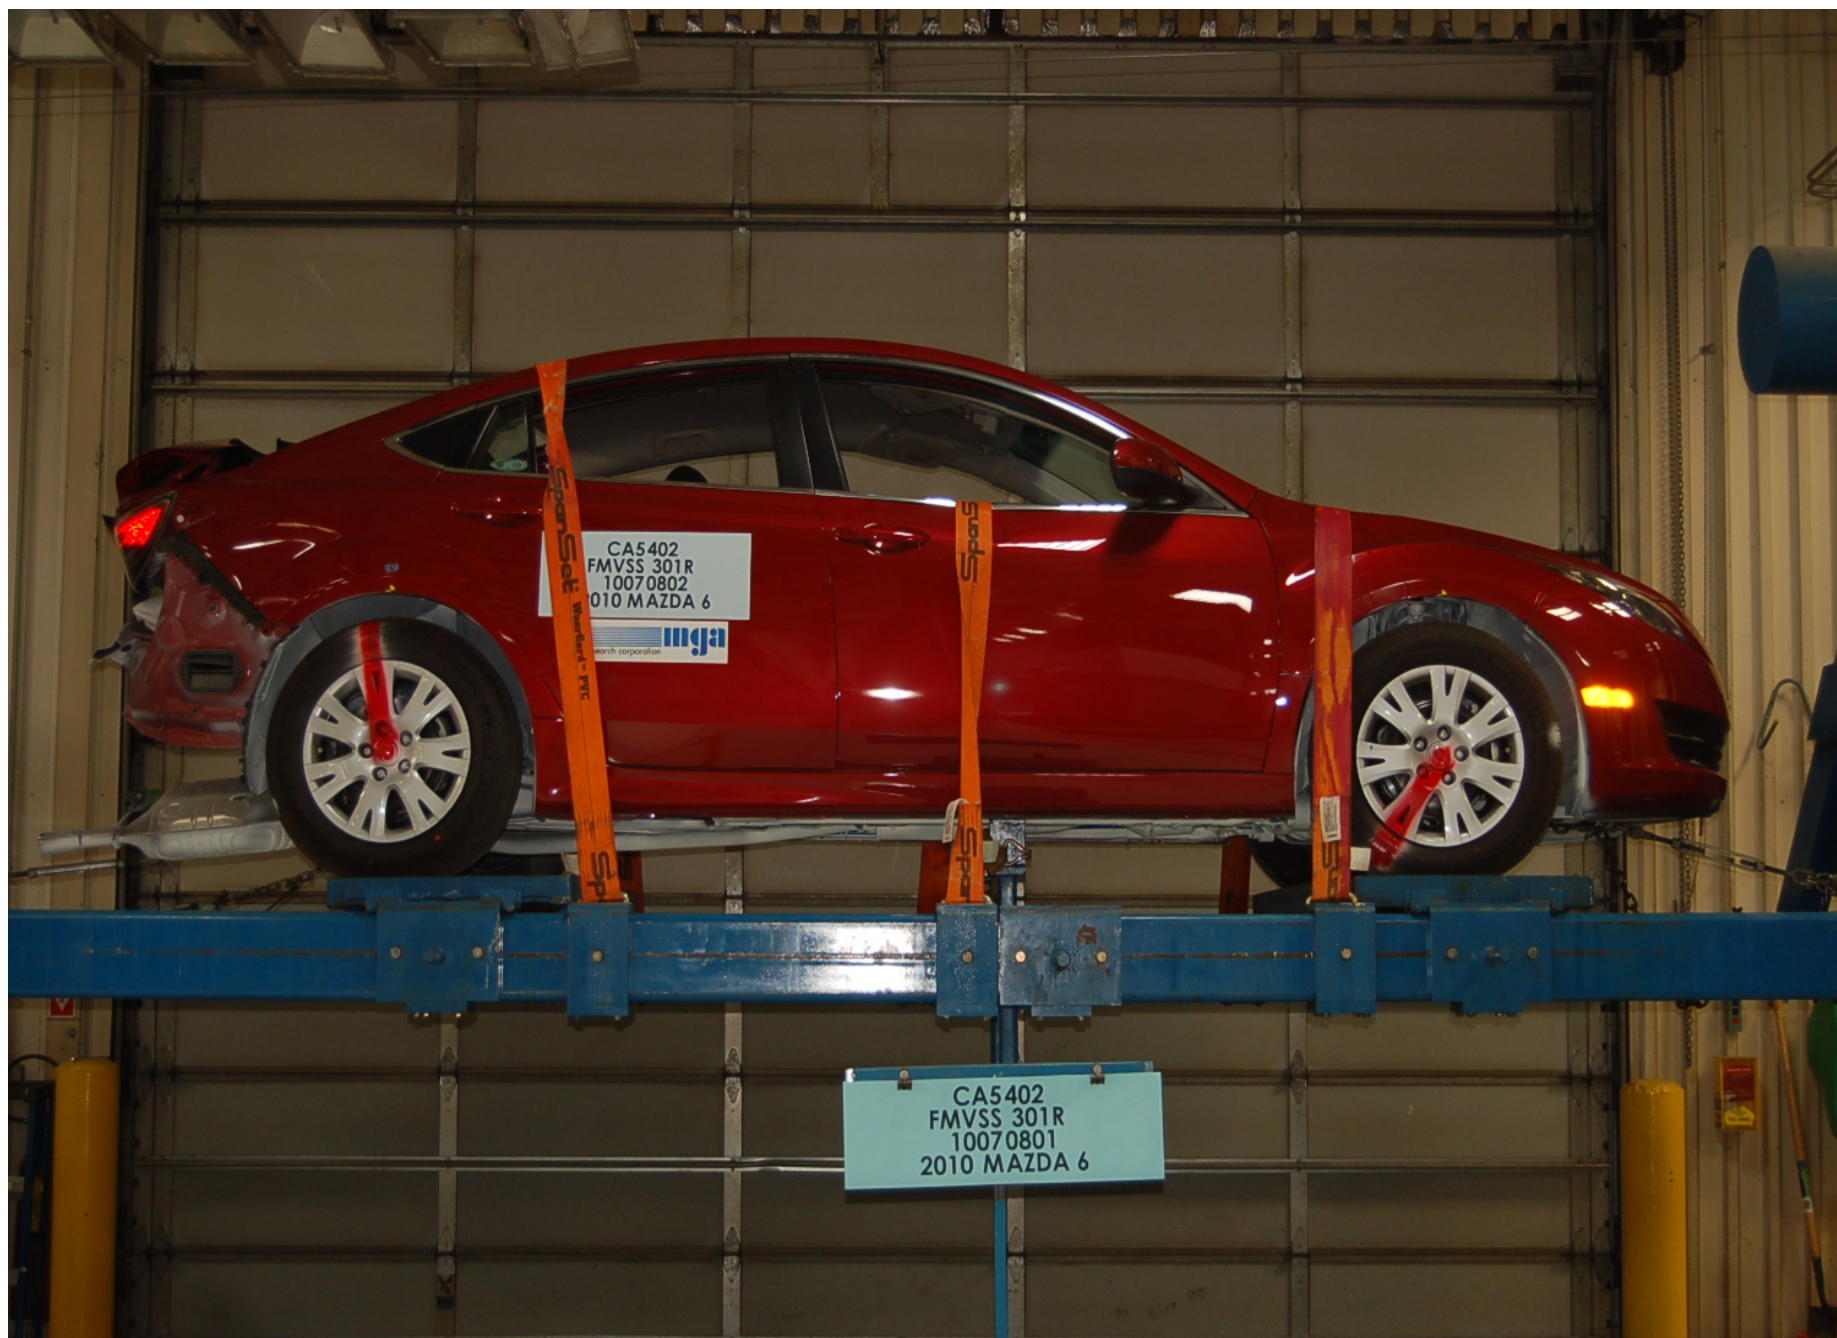
A-40.

270° TO 360° Rotation Time (sec) = 119 sec

Test Phase	Spillage (g)	Spillage Details
First 5 minutes from onset of rotation	0	
Sixth minute from onset of rotation	0	
Seventh minute from onset of rotation	0	
Eight minute if required	N/A

Static Rollover at 360 Degrees
