**REPORT NUMBER: 301-MGA-2011-001**

**SAFETY COMPLIANCE TESTING FOR FMVSS 301R  
FUEL SYSTEM INTEGRITY – REAR IMPACT**

**KIA MOTORS CORPORATION  
2011 KIA OPTIMA  
NHTSA NUMBER: CB0506**

**PREPARED BY:  
MGA RESEARCH CORPORATION  
5000 WARREN ROAD  
BURLINGTON, WI 53105**

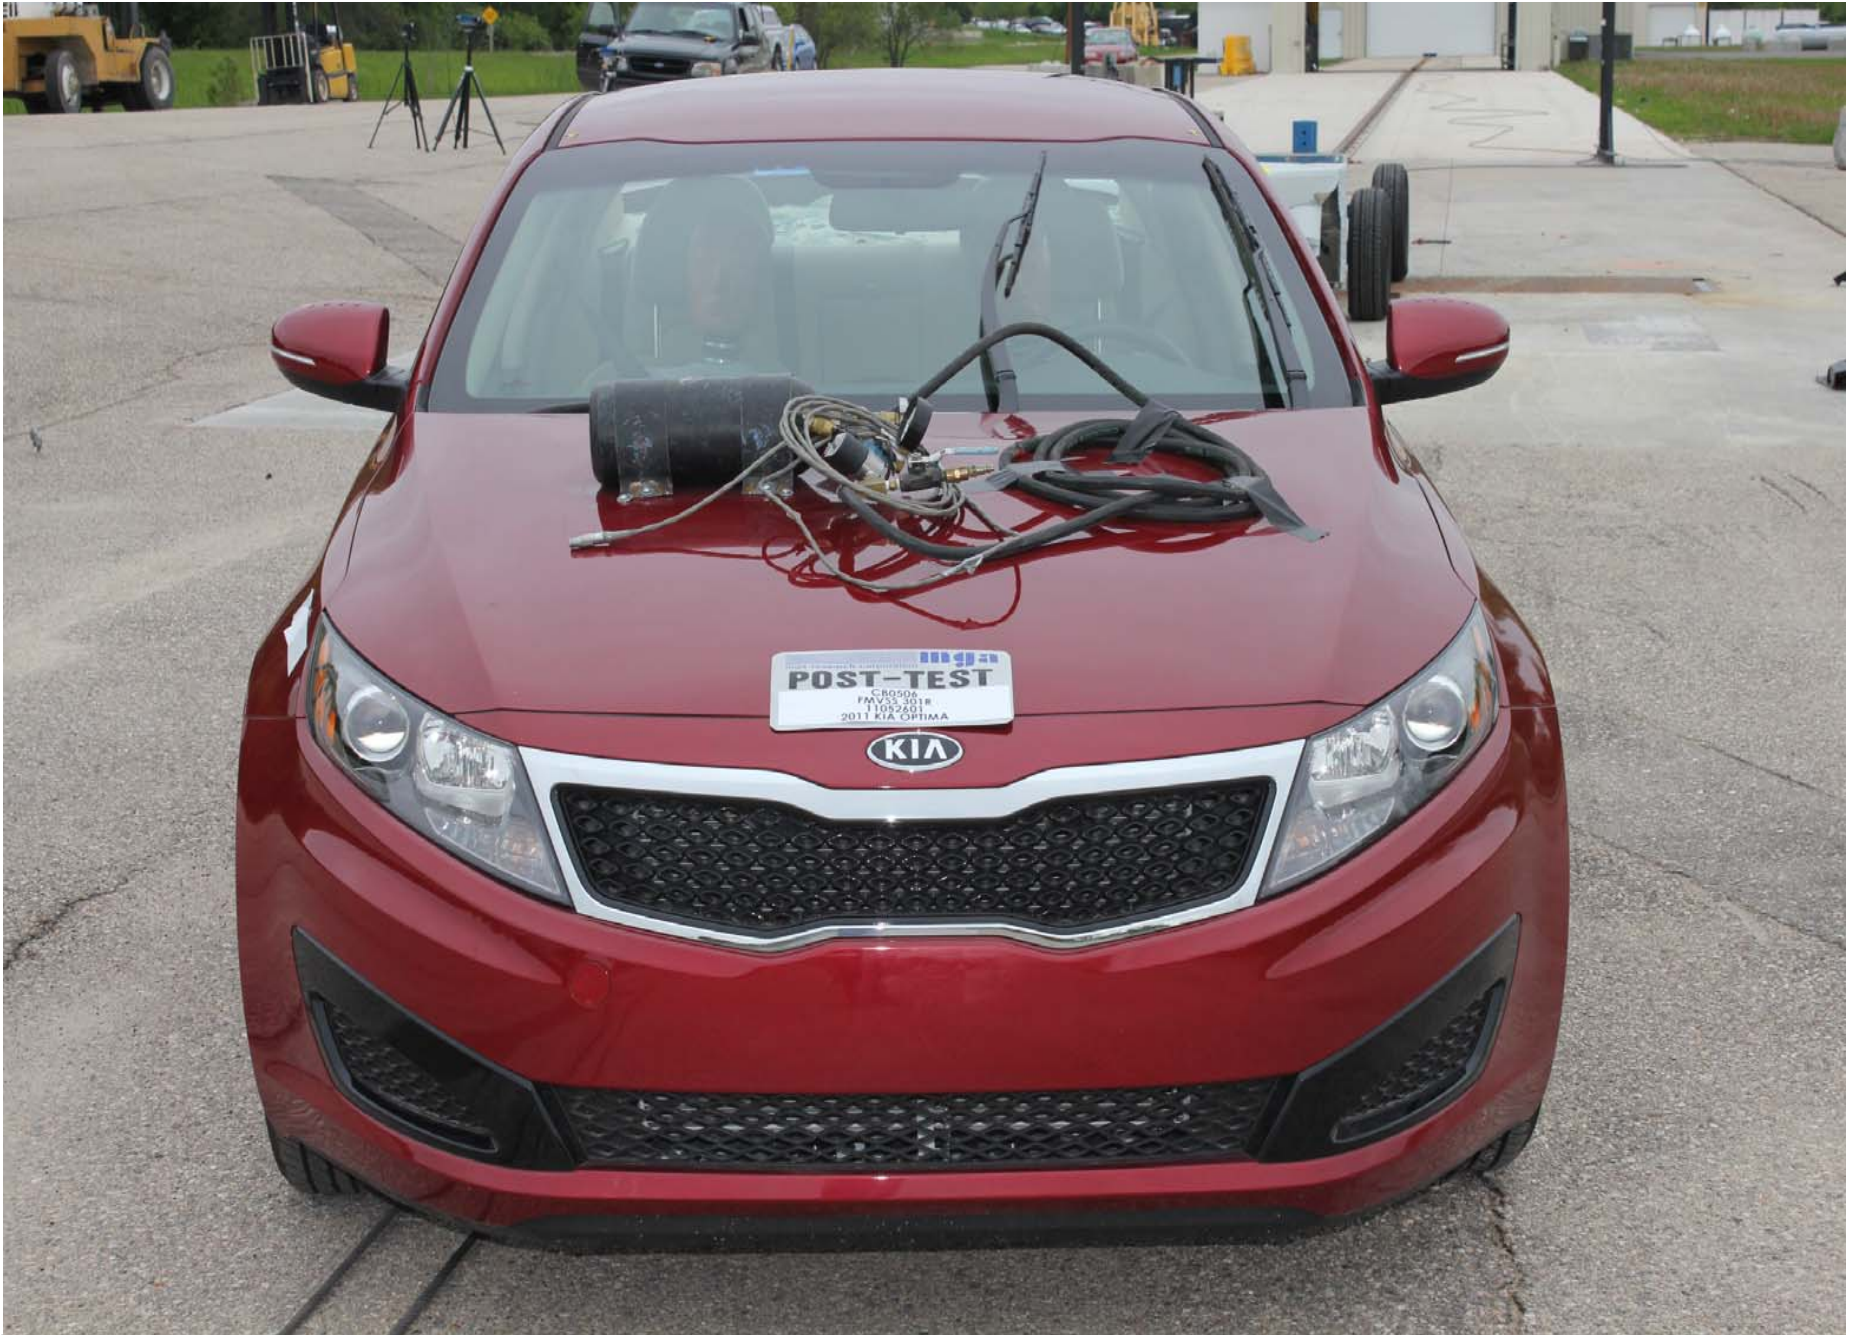
A-4.

Post-Test Front View of Vehicle

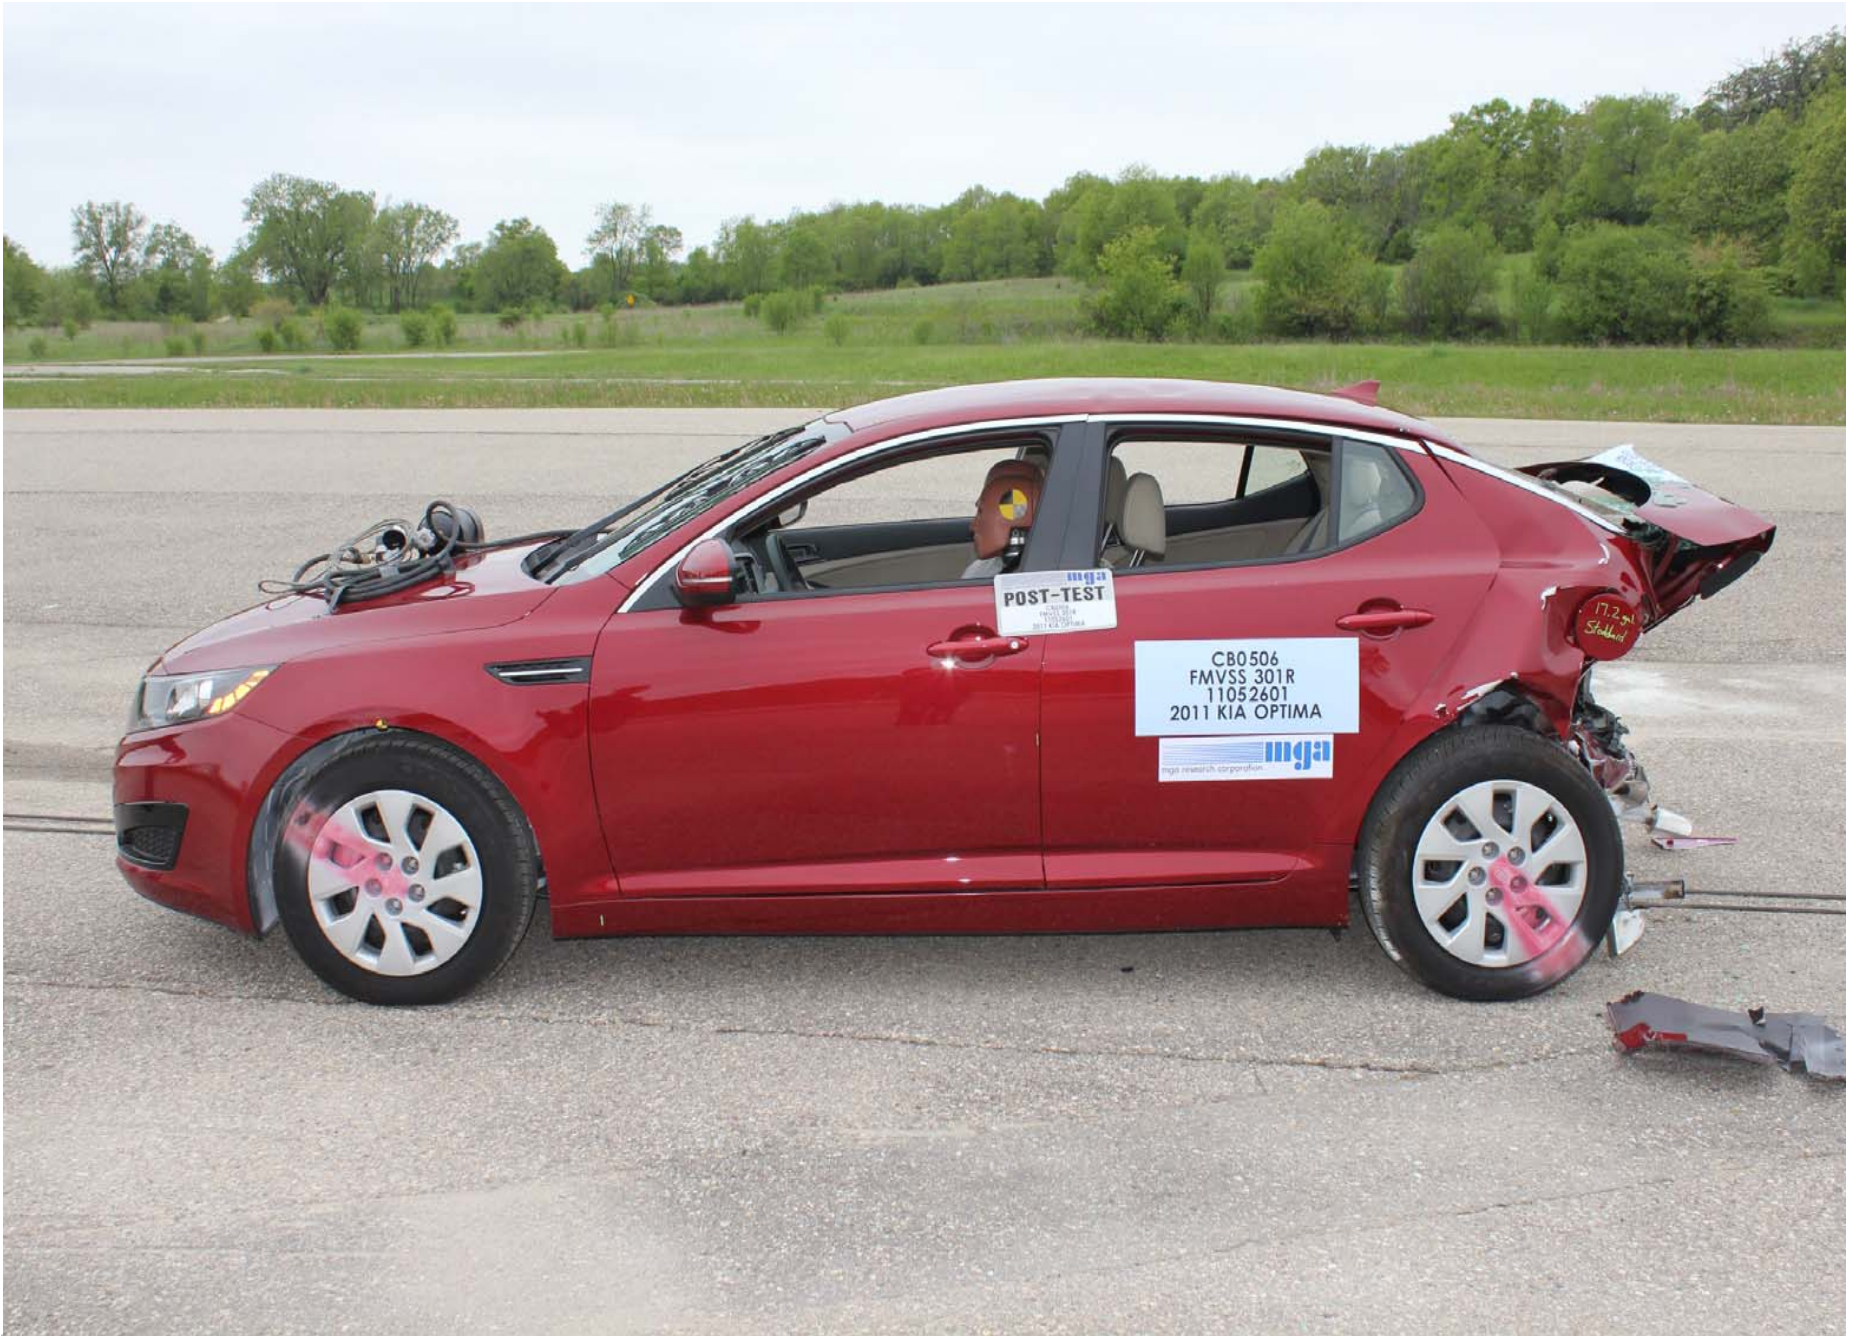
Post-Test Left Side View of Vehicle

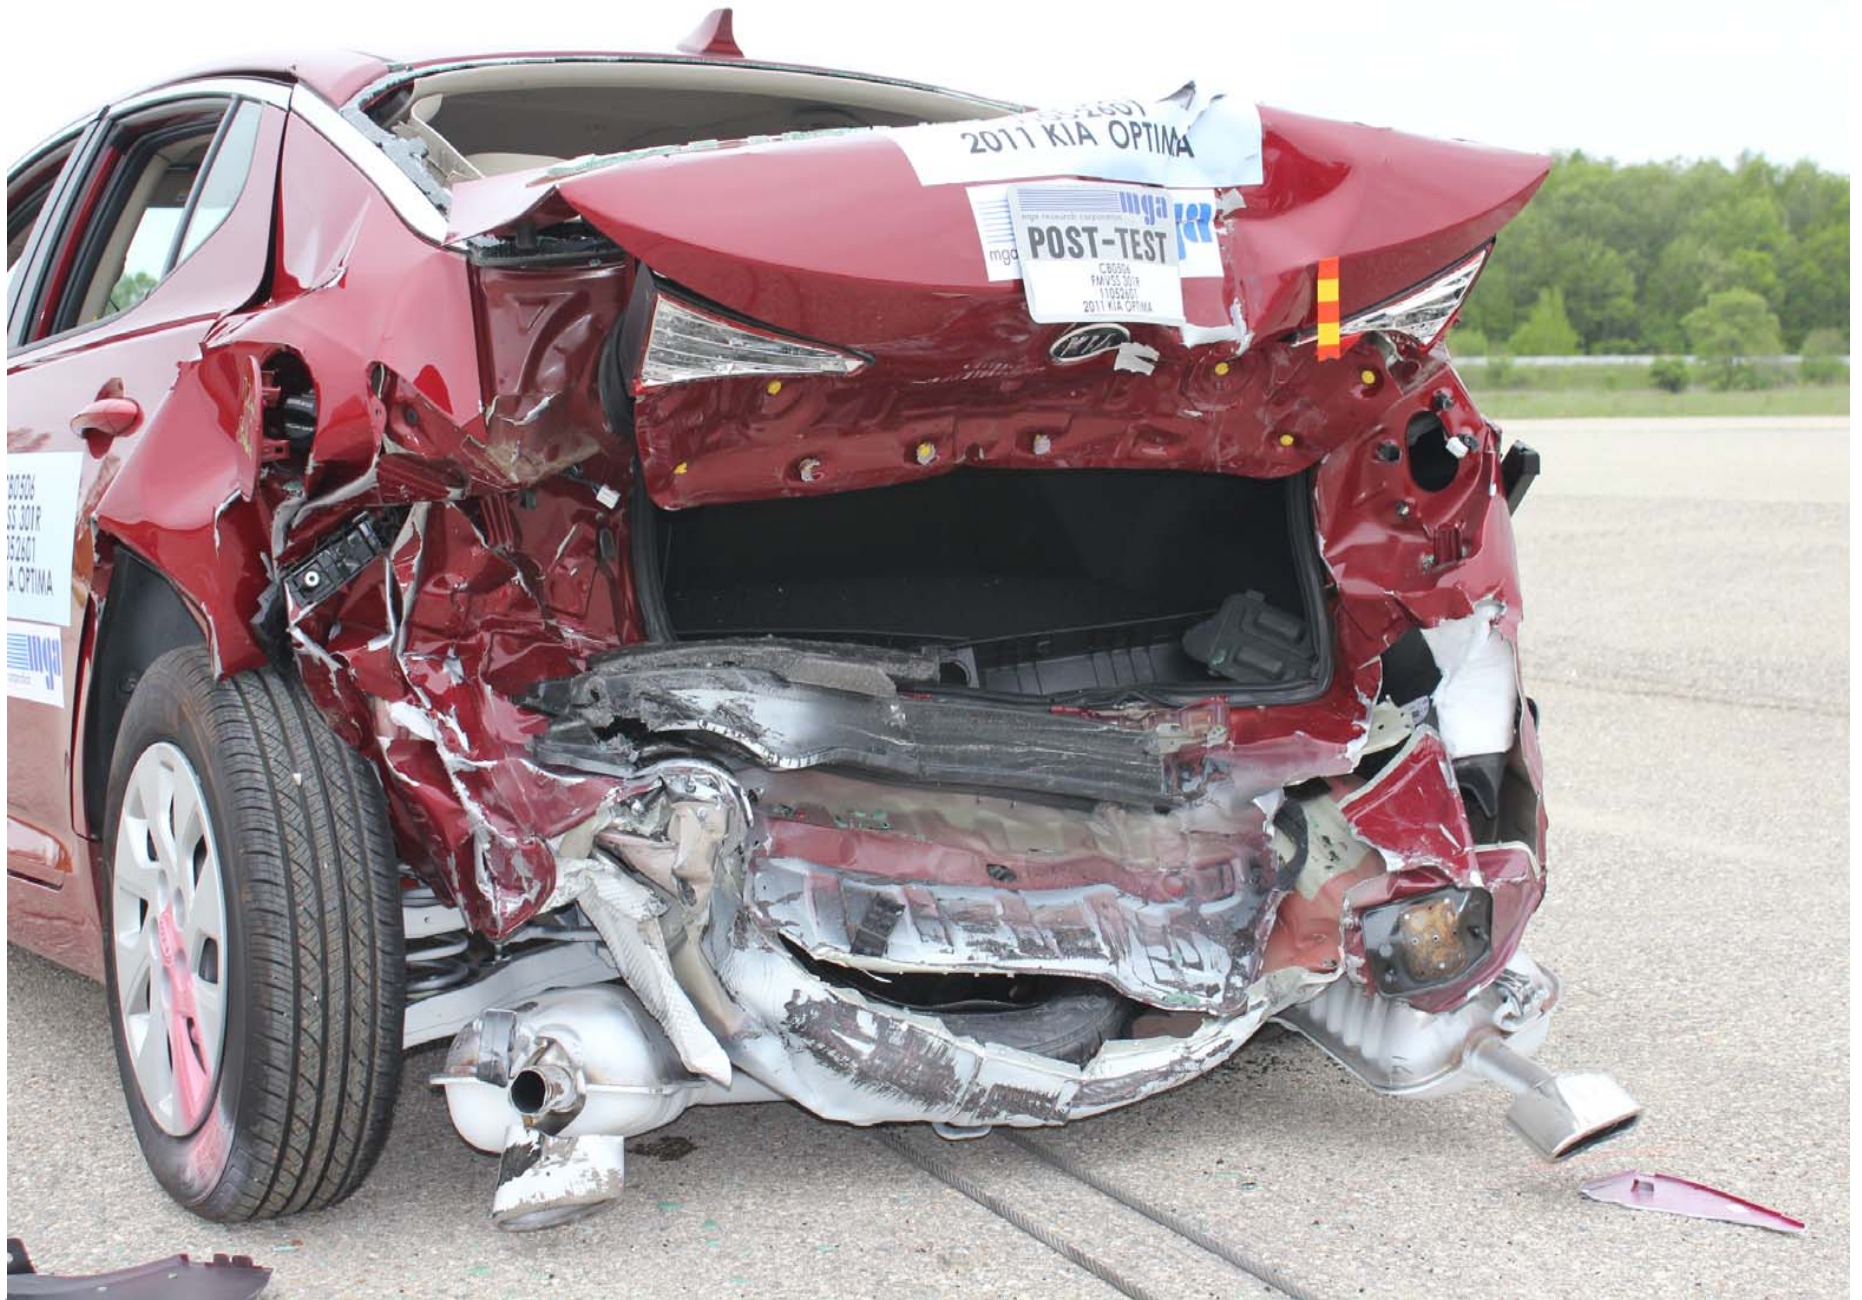
Post-Test Left Rear Close-up View of Vehicle

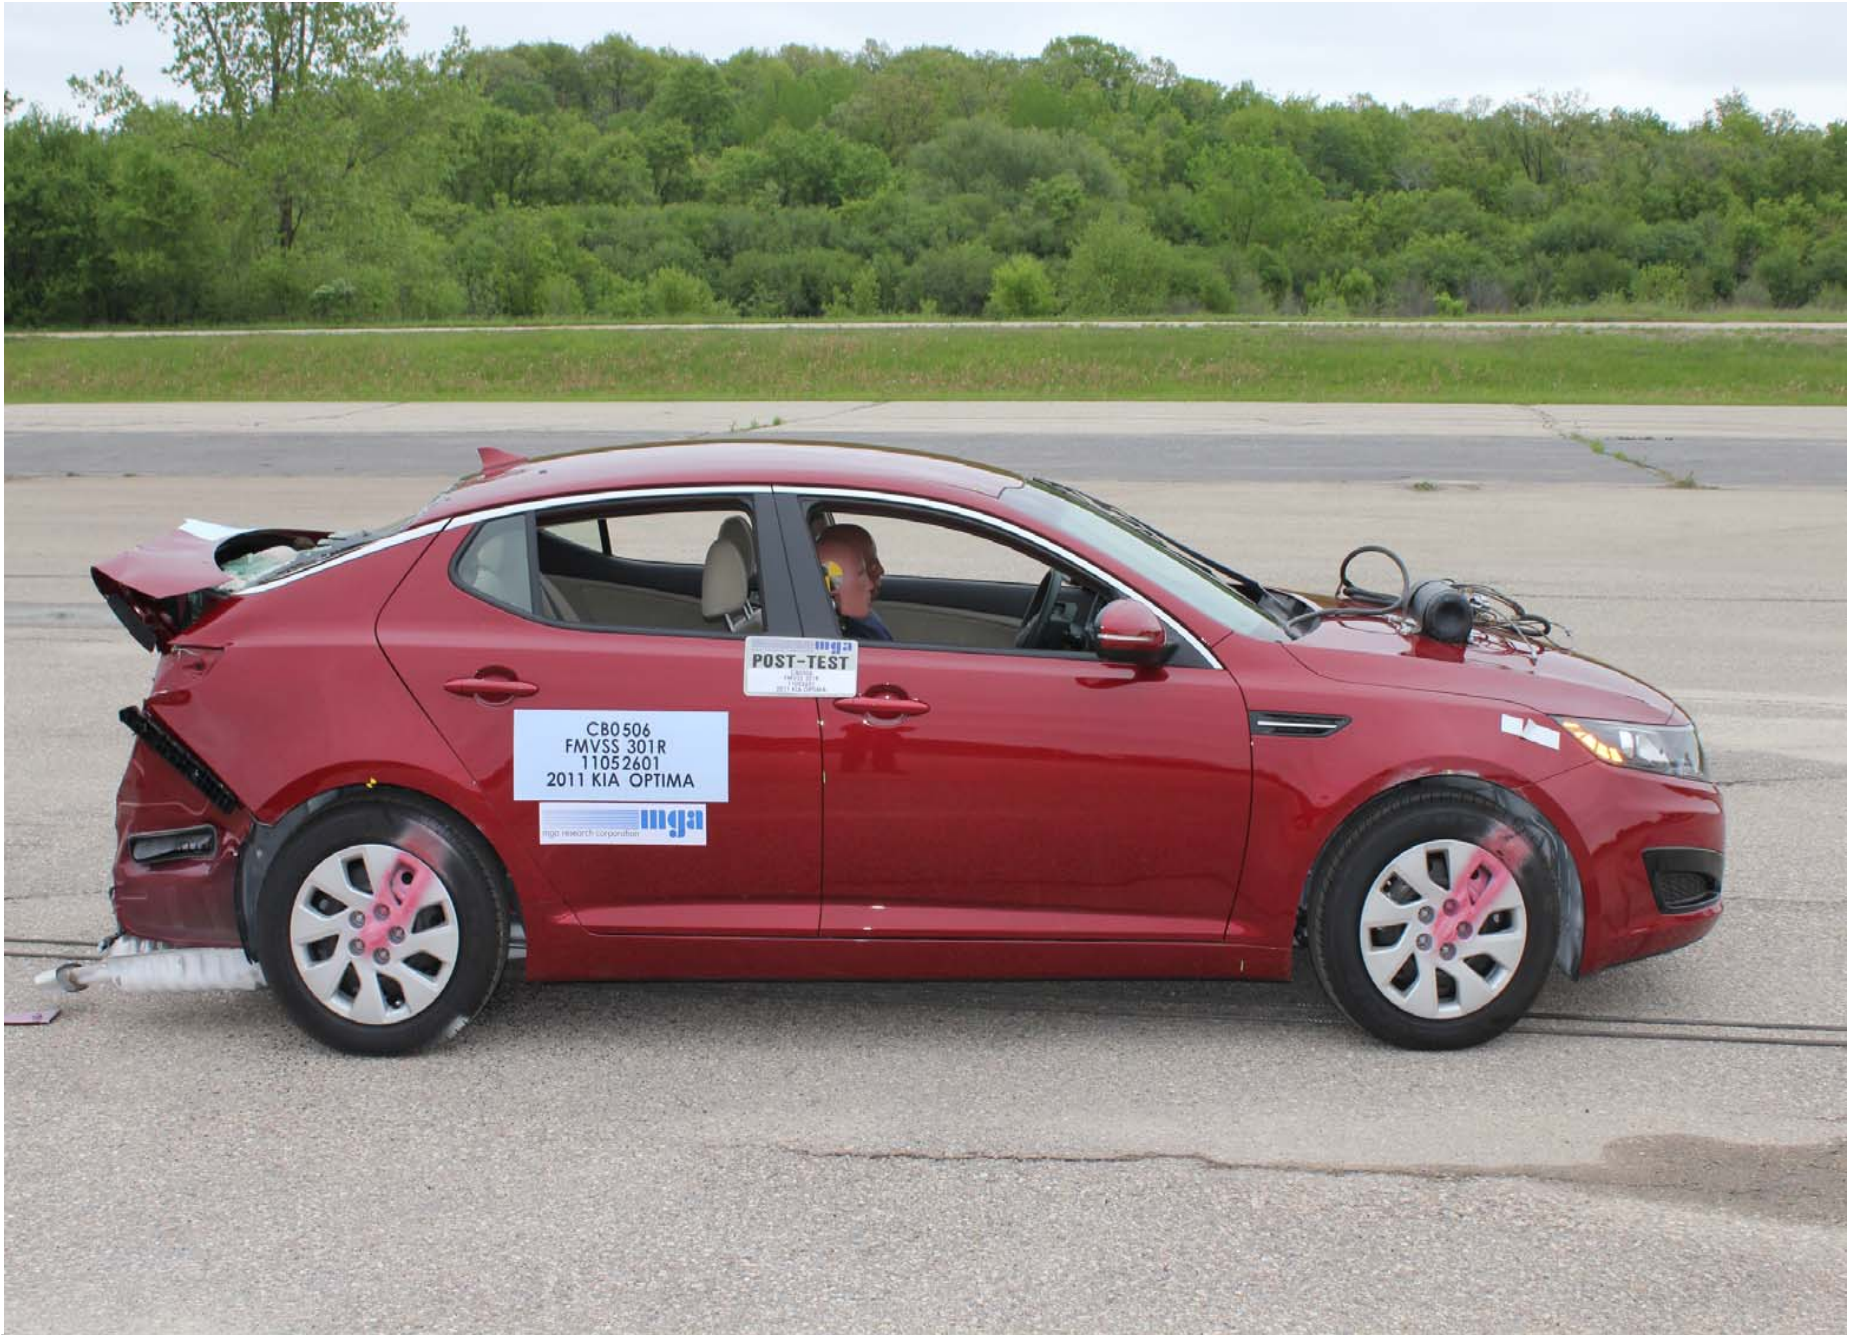
A-10.

Post-Test Right Side View of Vehicle

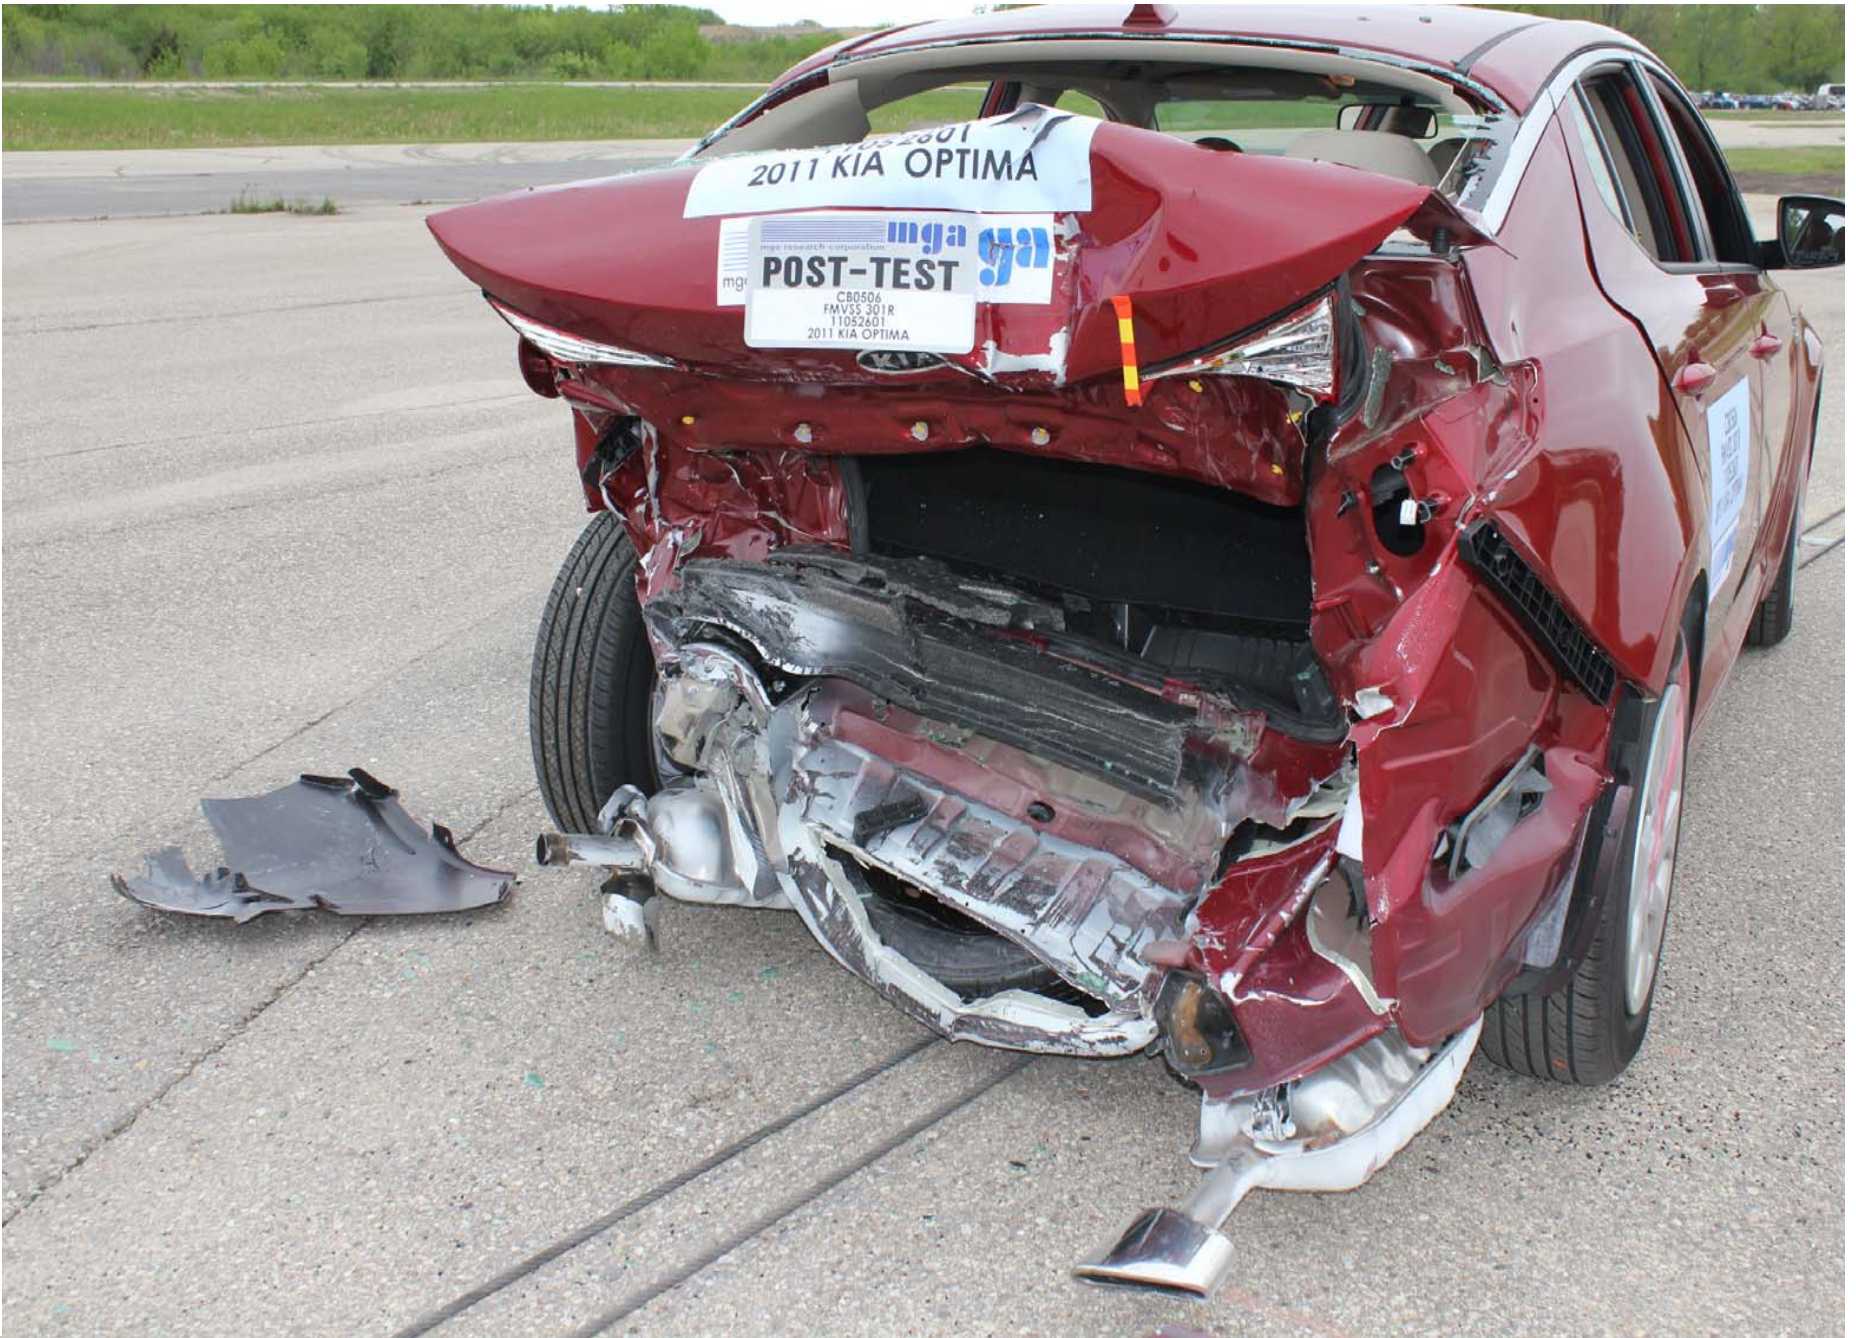
A-12.

Post-Test Right Rear Close-up View of Vehicle

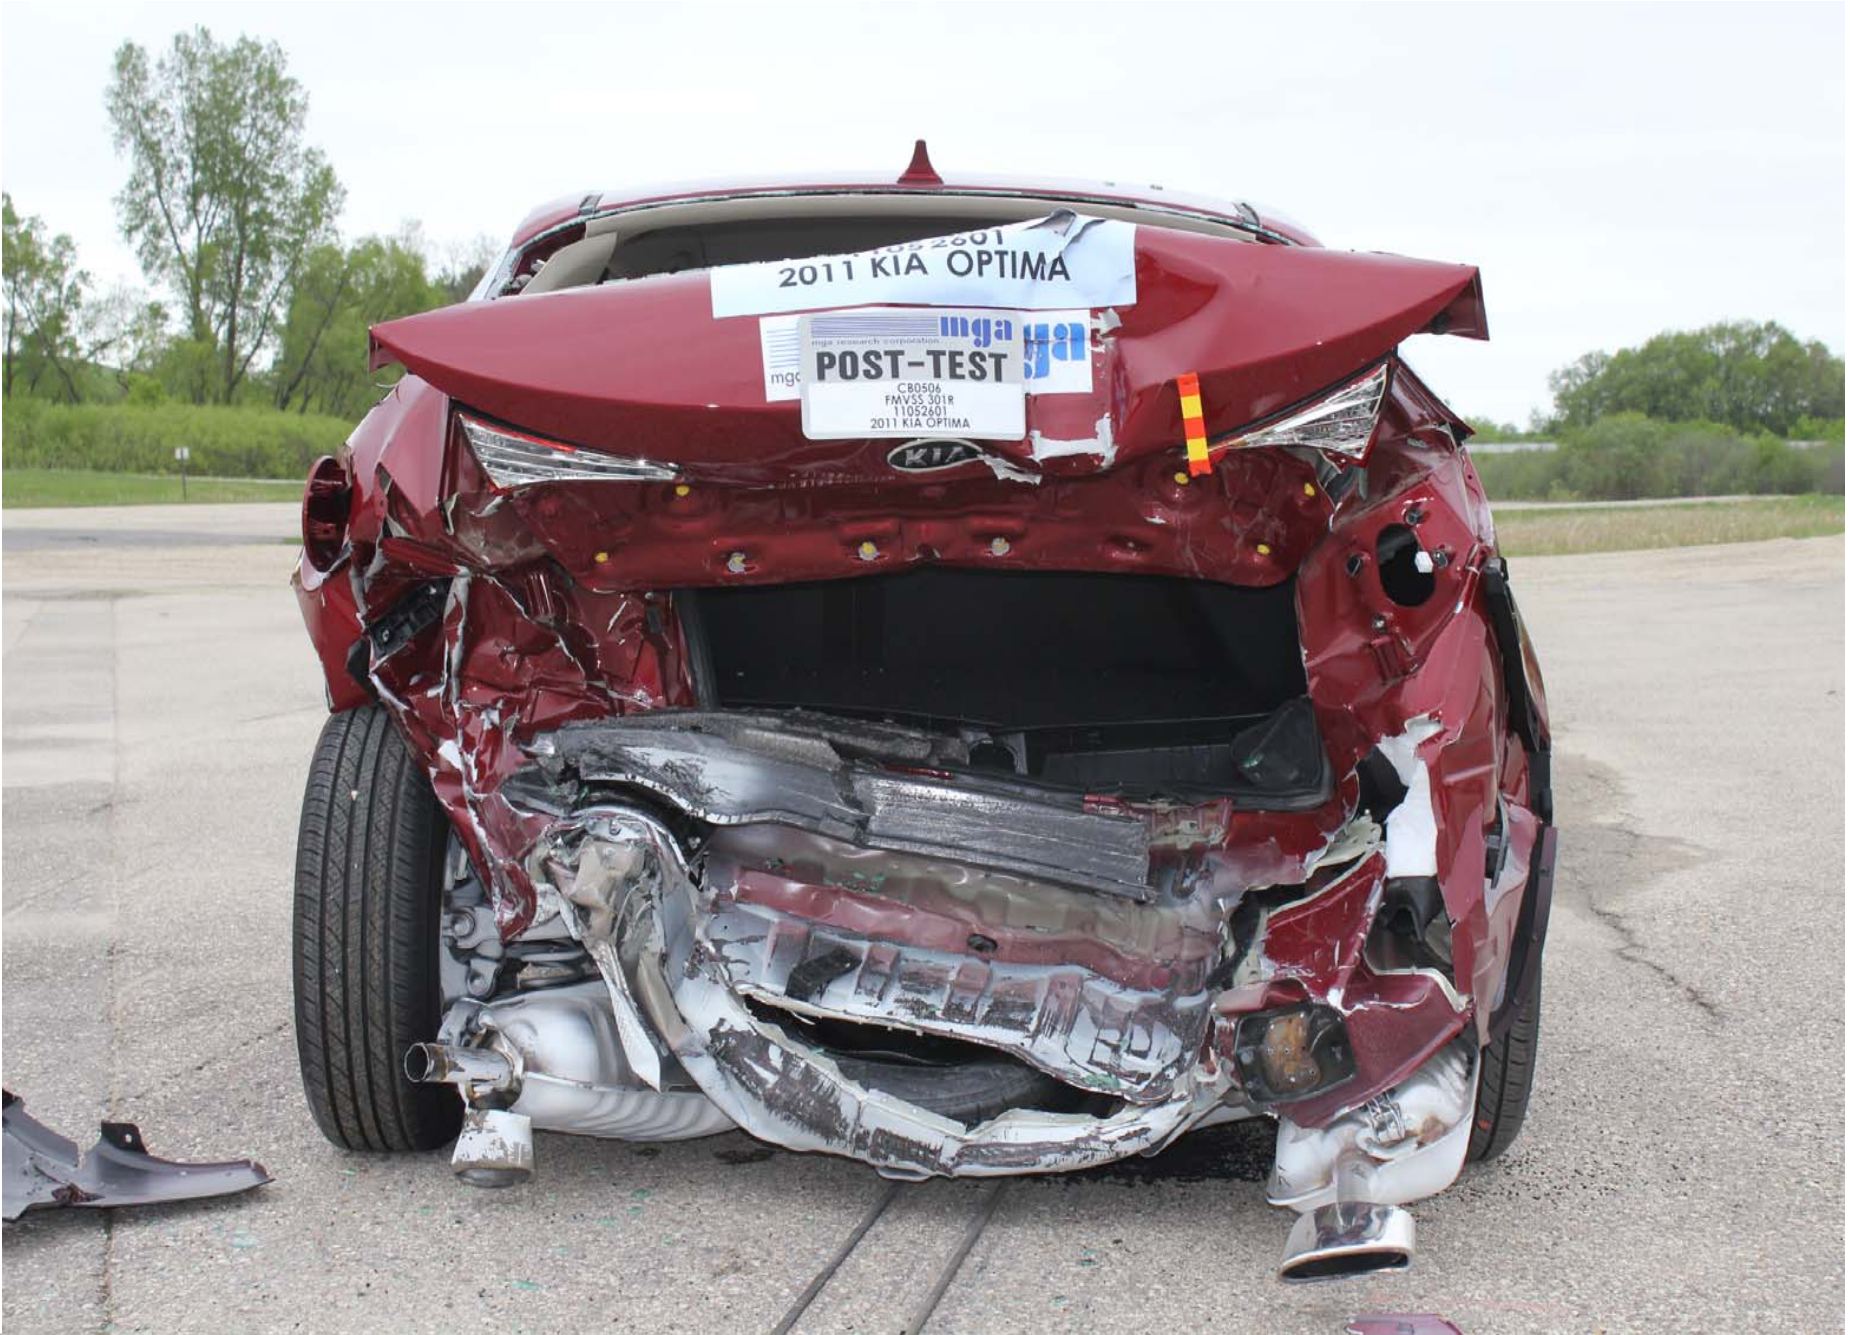
A-14.

Post-Test Rear View of Vehicle

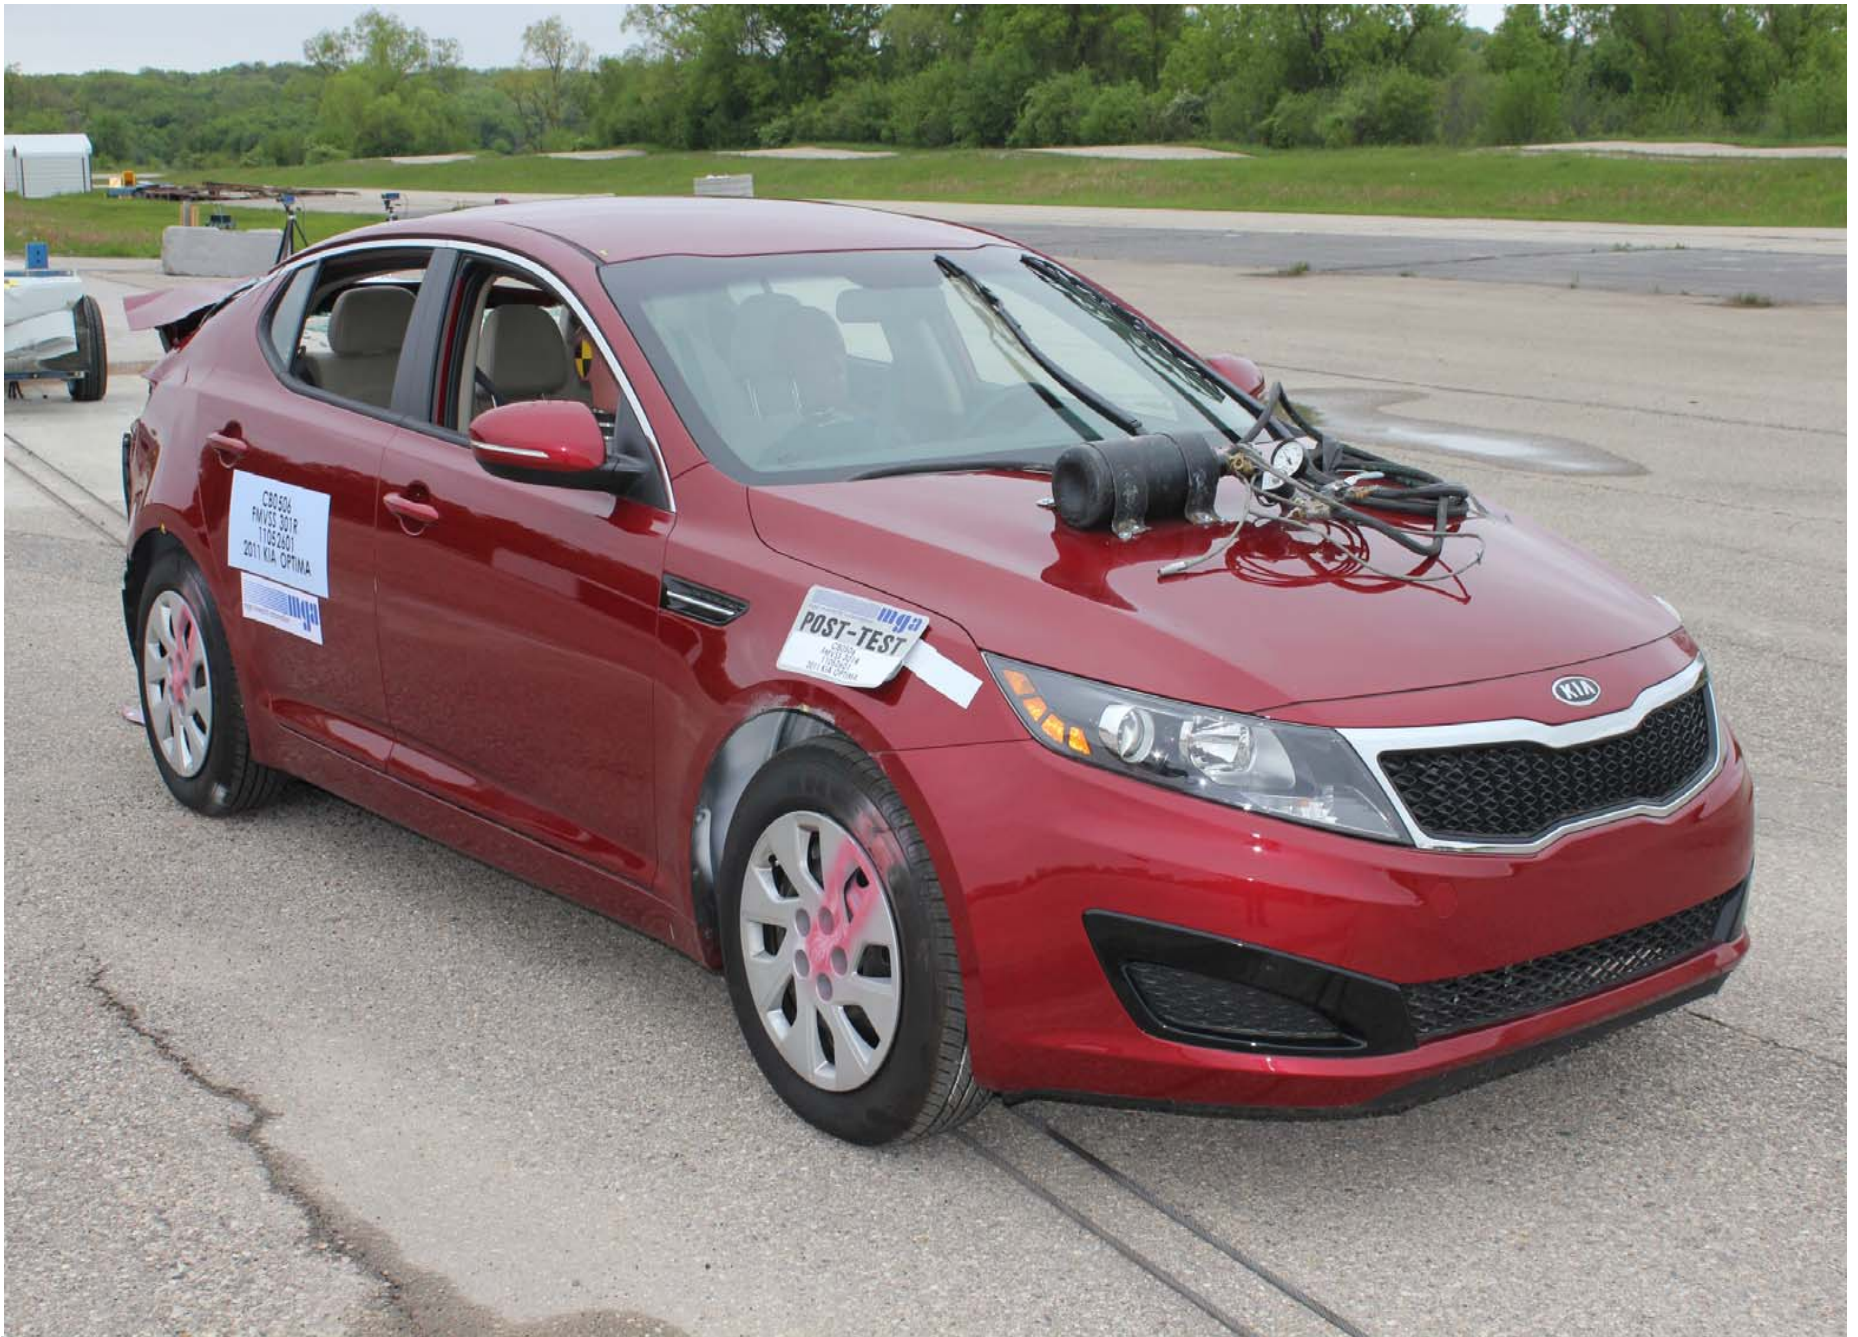
A-16.

Post-Test  $\frac{3}{4}$  Frontal View From Right Side of Vehicle

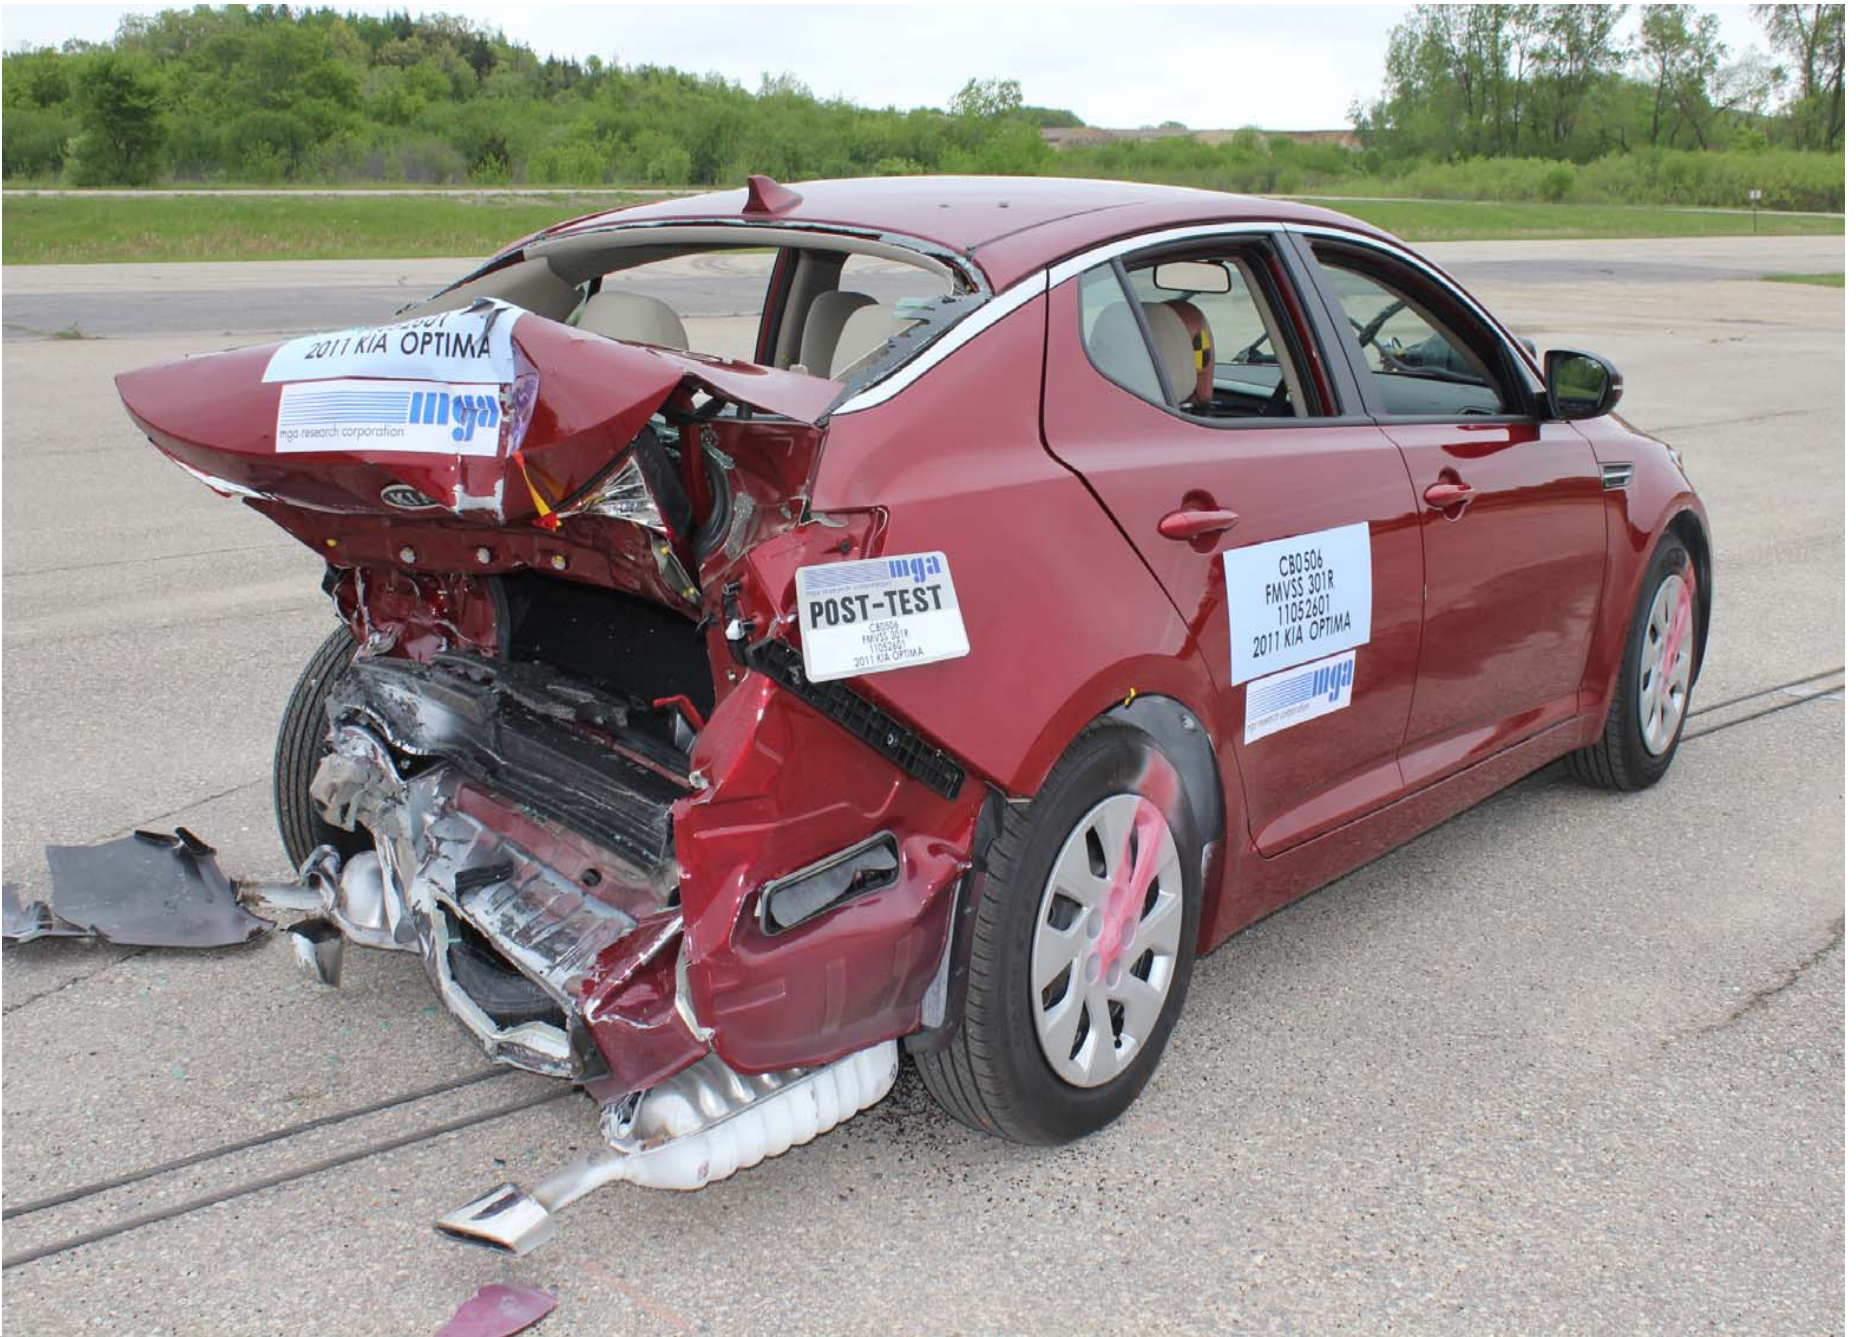
Post-Test  $\frac{3}{4}$  Rear View From Right Side of Vehicle

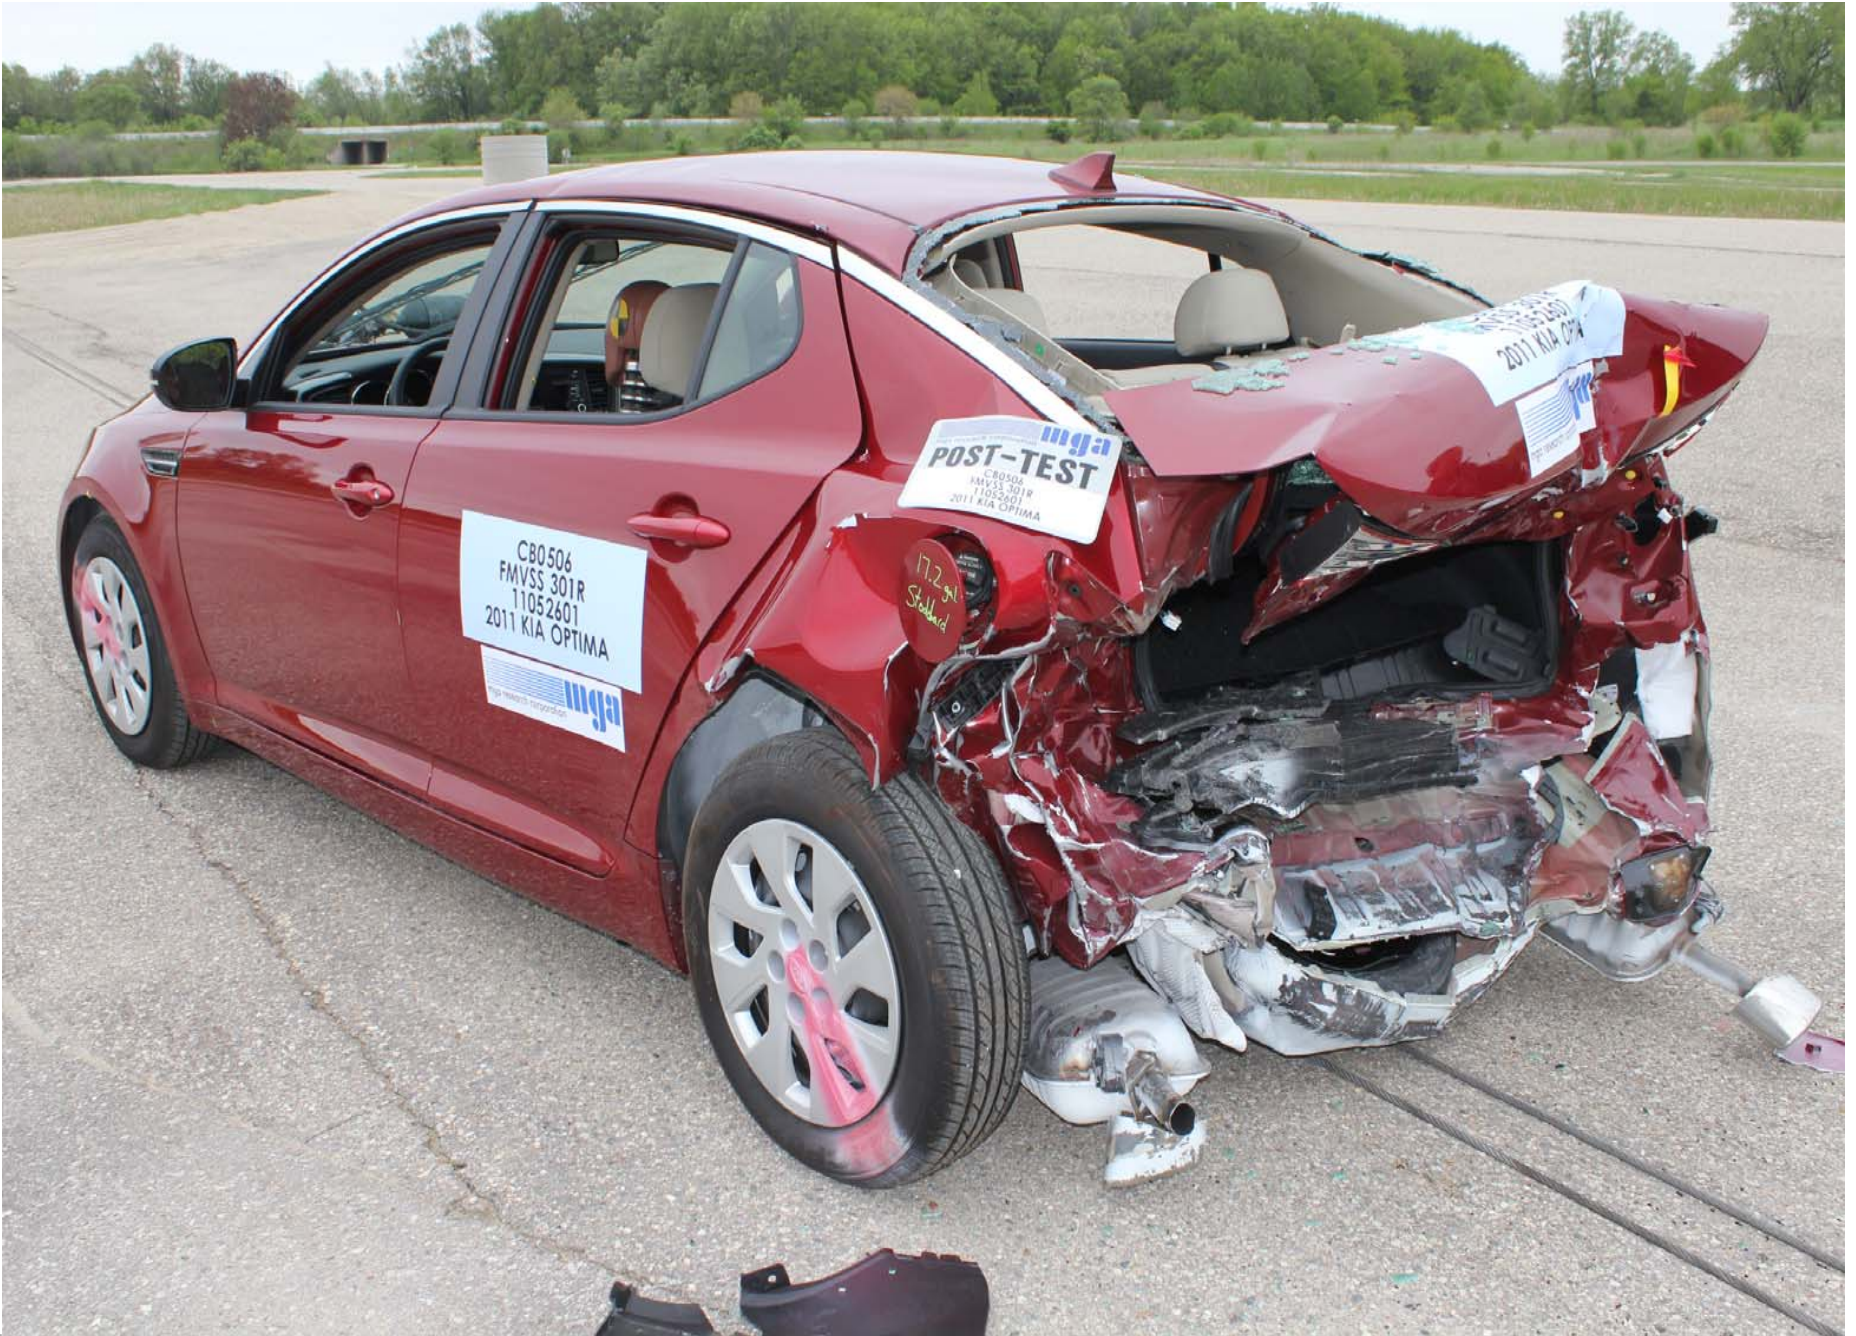
Post-Test ¾ Rear View From Left Side of Vehicle
