**REPORT NUMBER: 301-MGA-2011-001**

**SAFETY COMPLIANCE TESTING FOR FMVSS 301R  
FUEL SYSTEM INTEGRITY – REAR IMPACT**

**KIA MOTORS CORPORATION  
2011 KIA OPTIMA  
NHTSA NUMBER: CB0506**

**PREPARED BY:  
MGA RESEARCH CORPORATION  
5000 WARREN ROAD  
BURLINGTON, WI 53105**

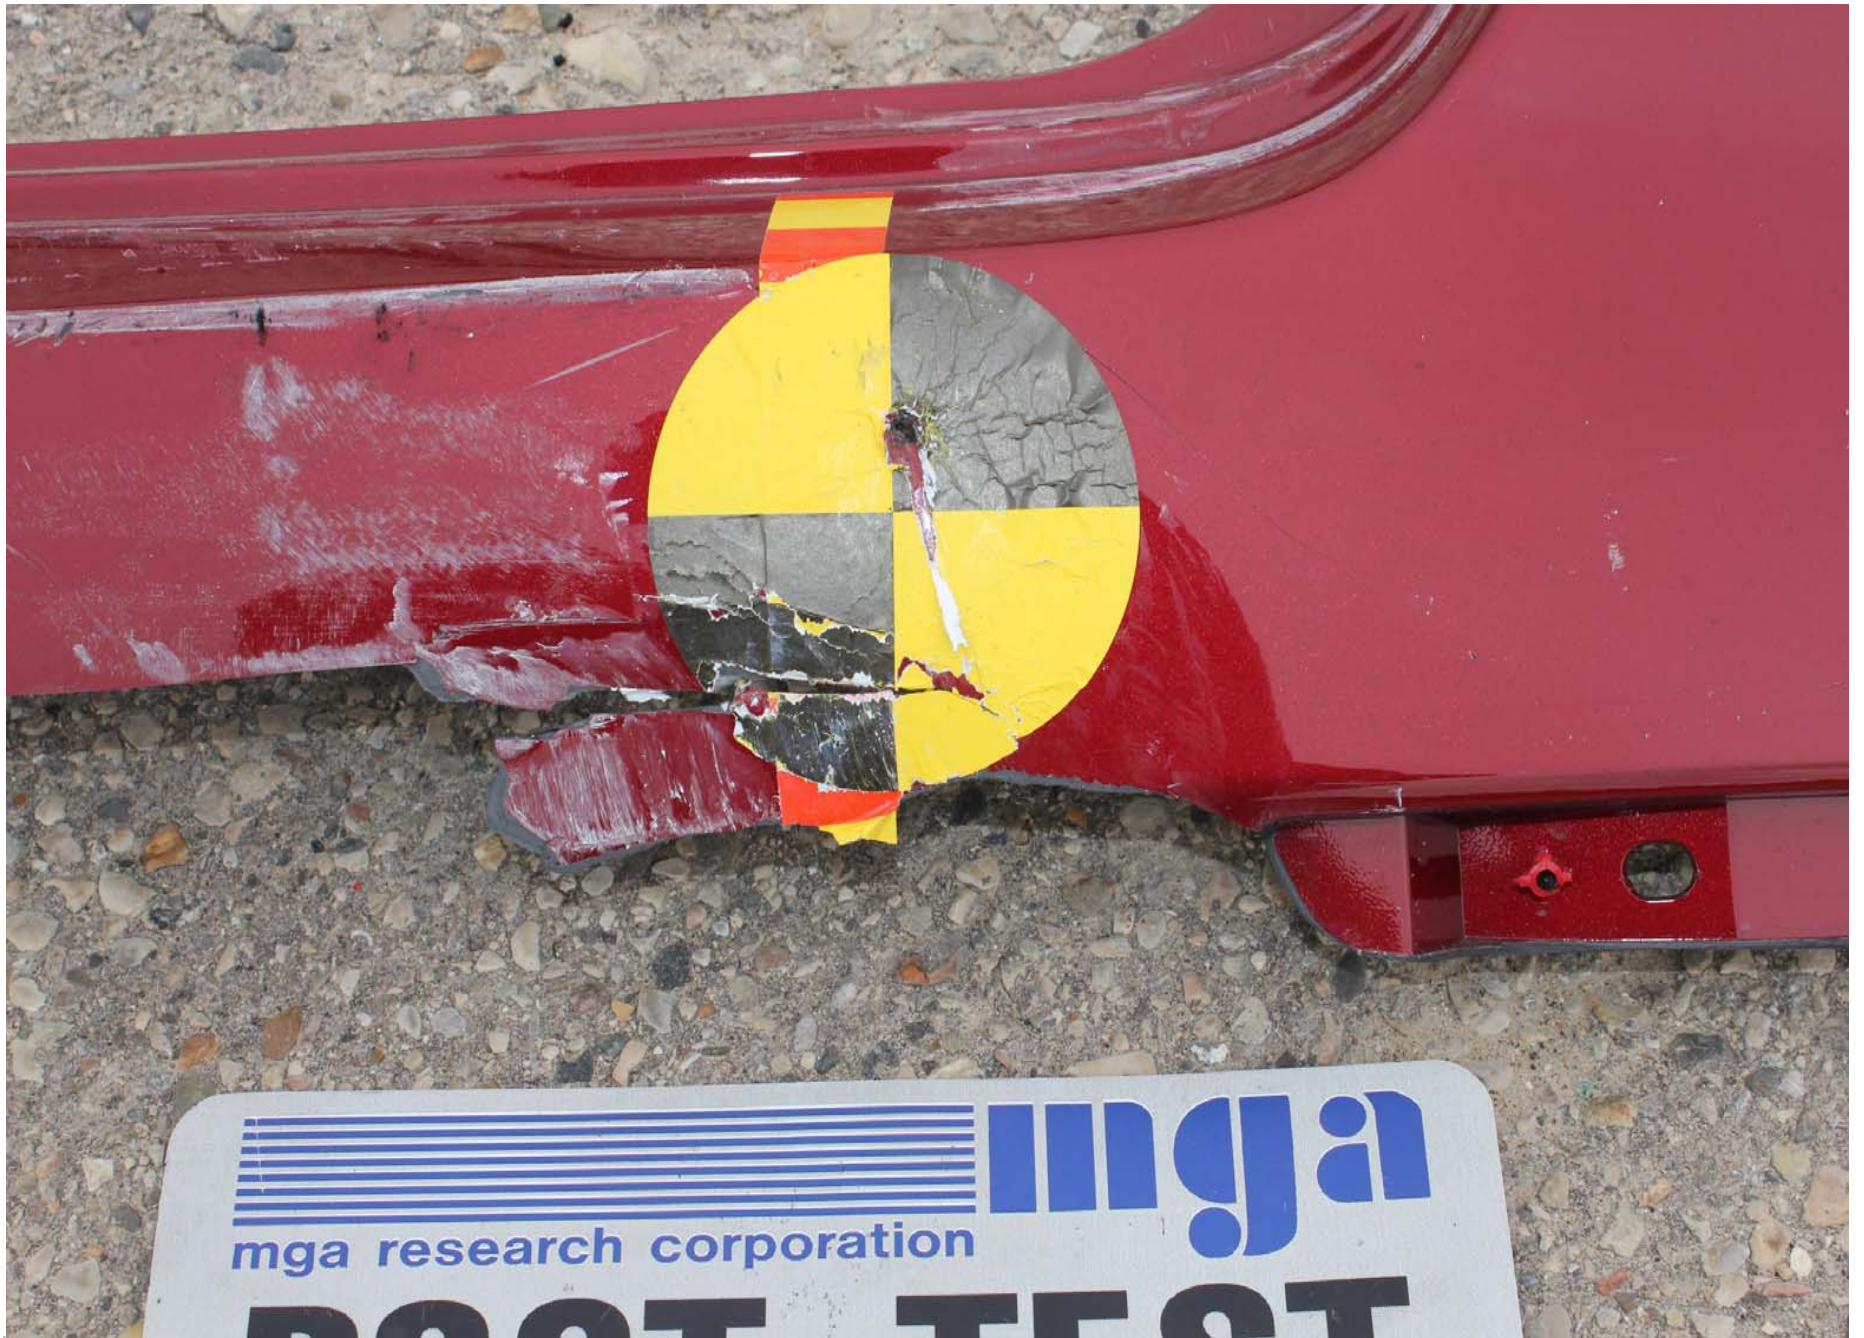
A-22.

Post-Test Impact Point

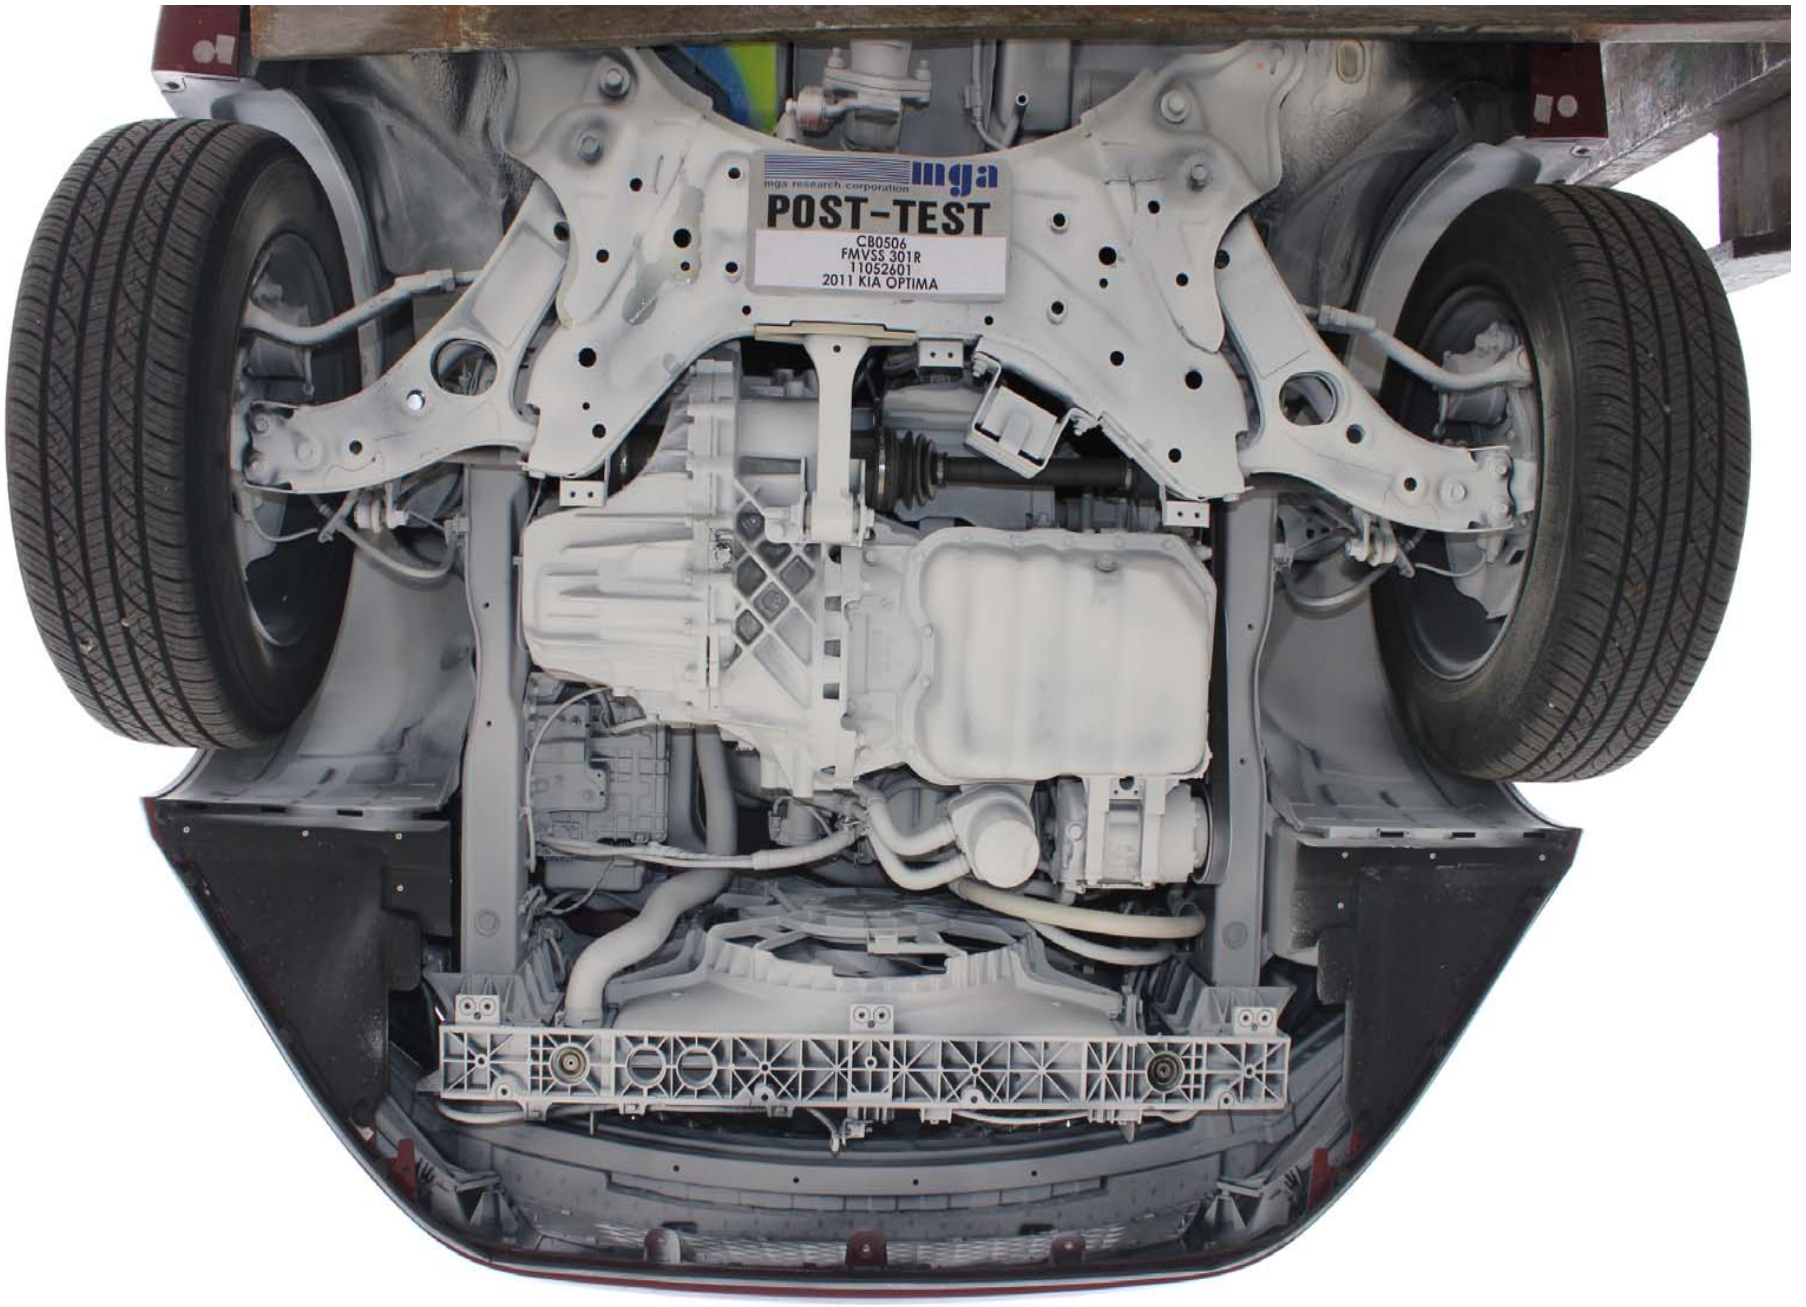
A-24.

Post-Test Underbody View 1

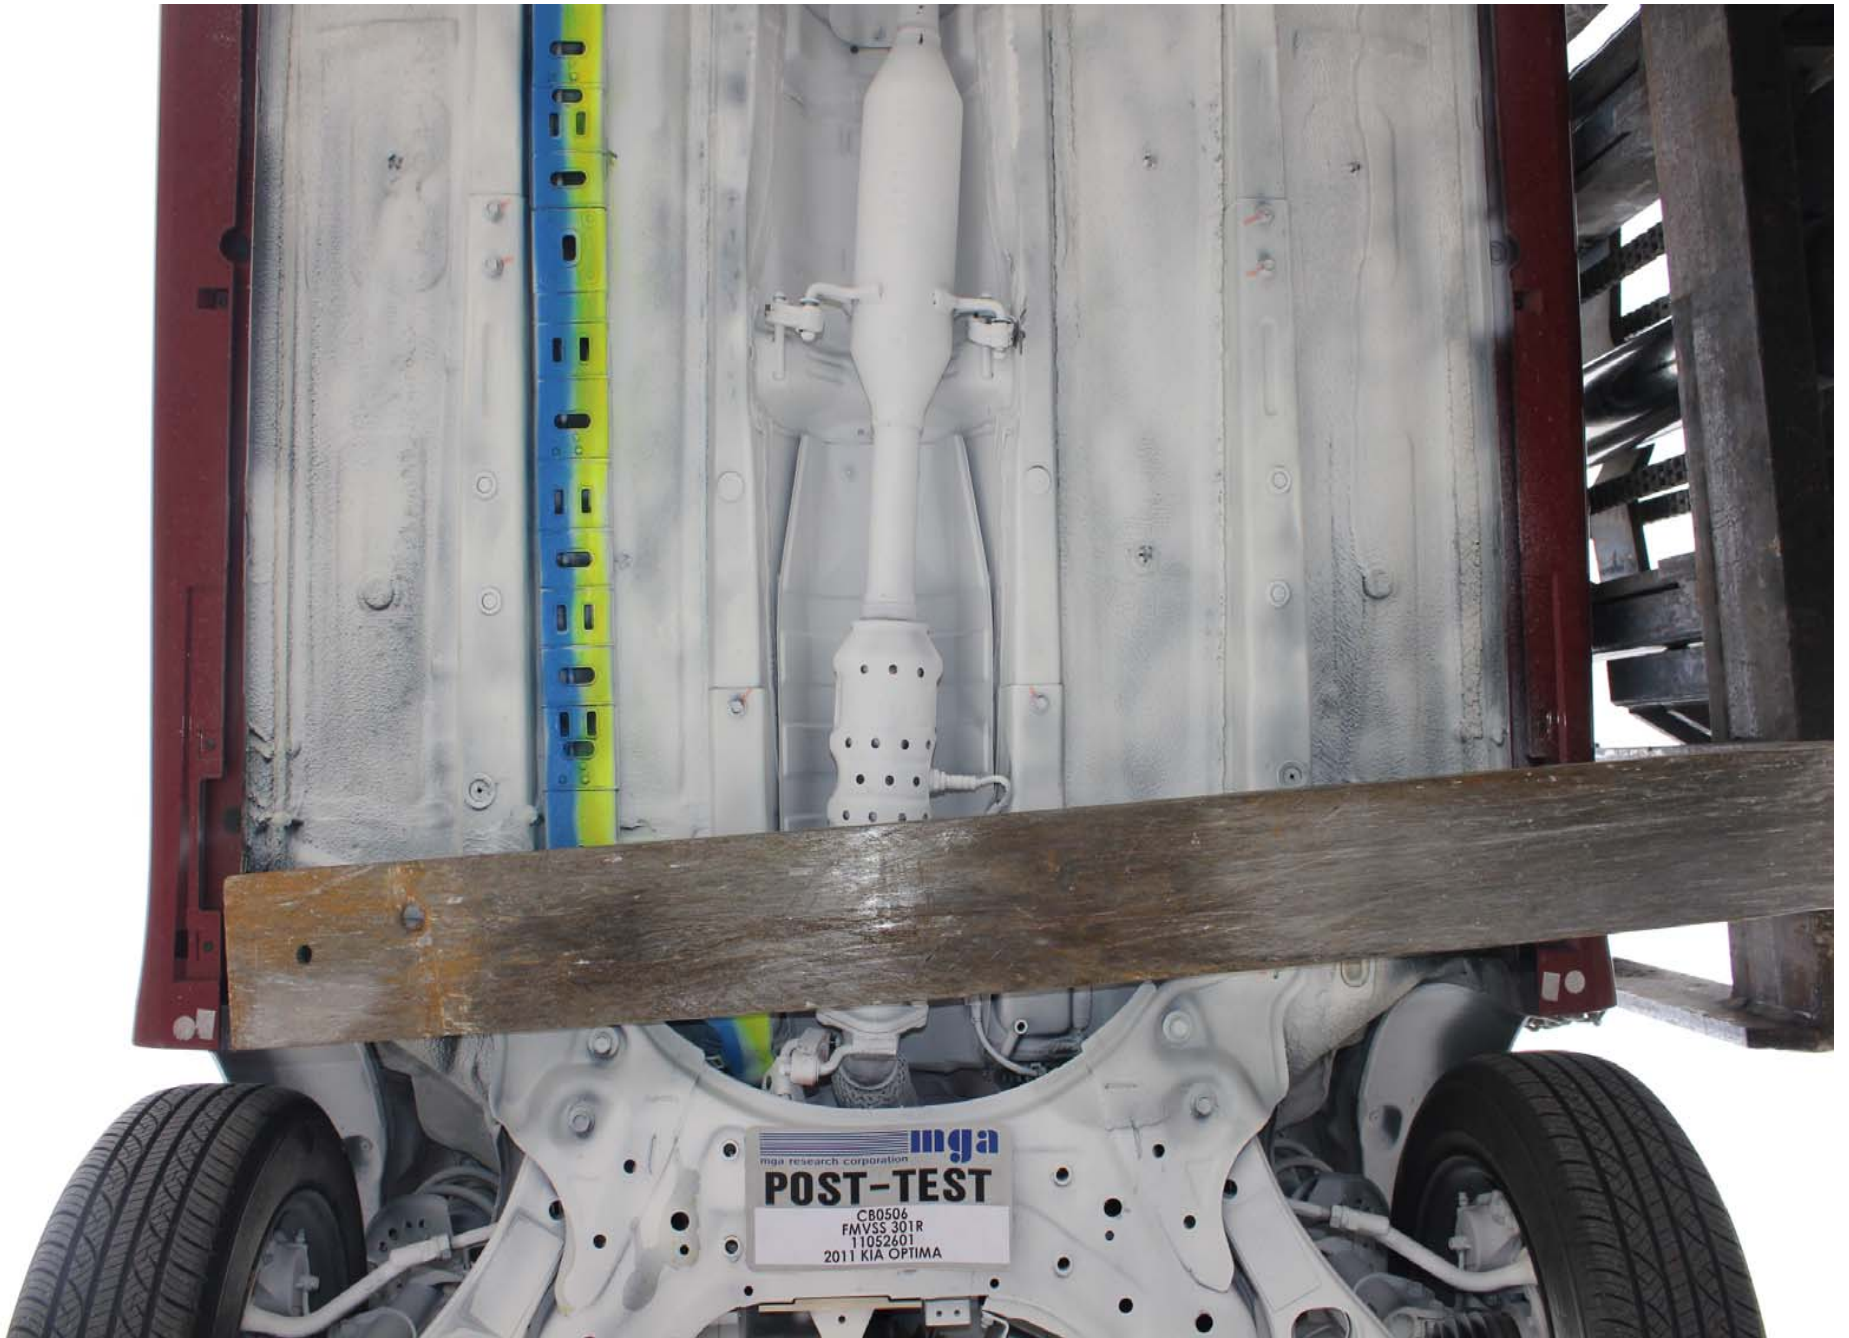
A-26.

Post-Test Underbody View 2

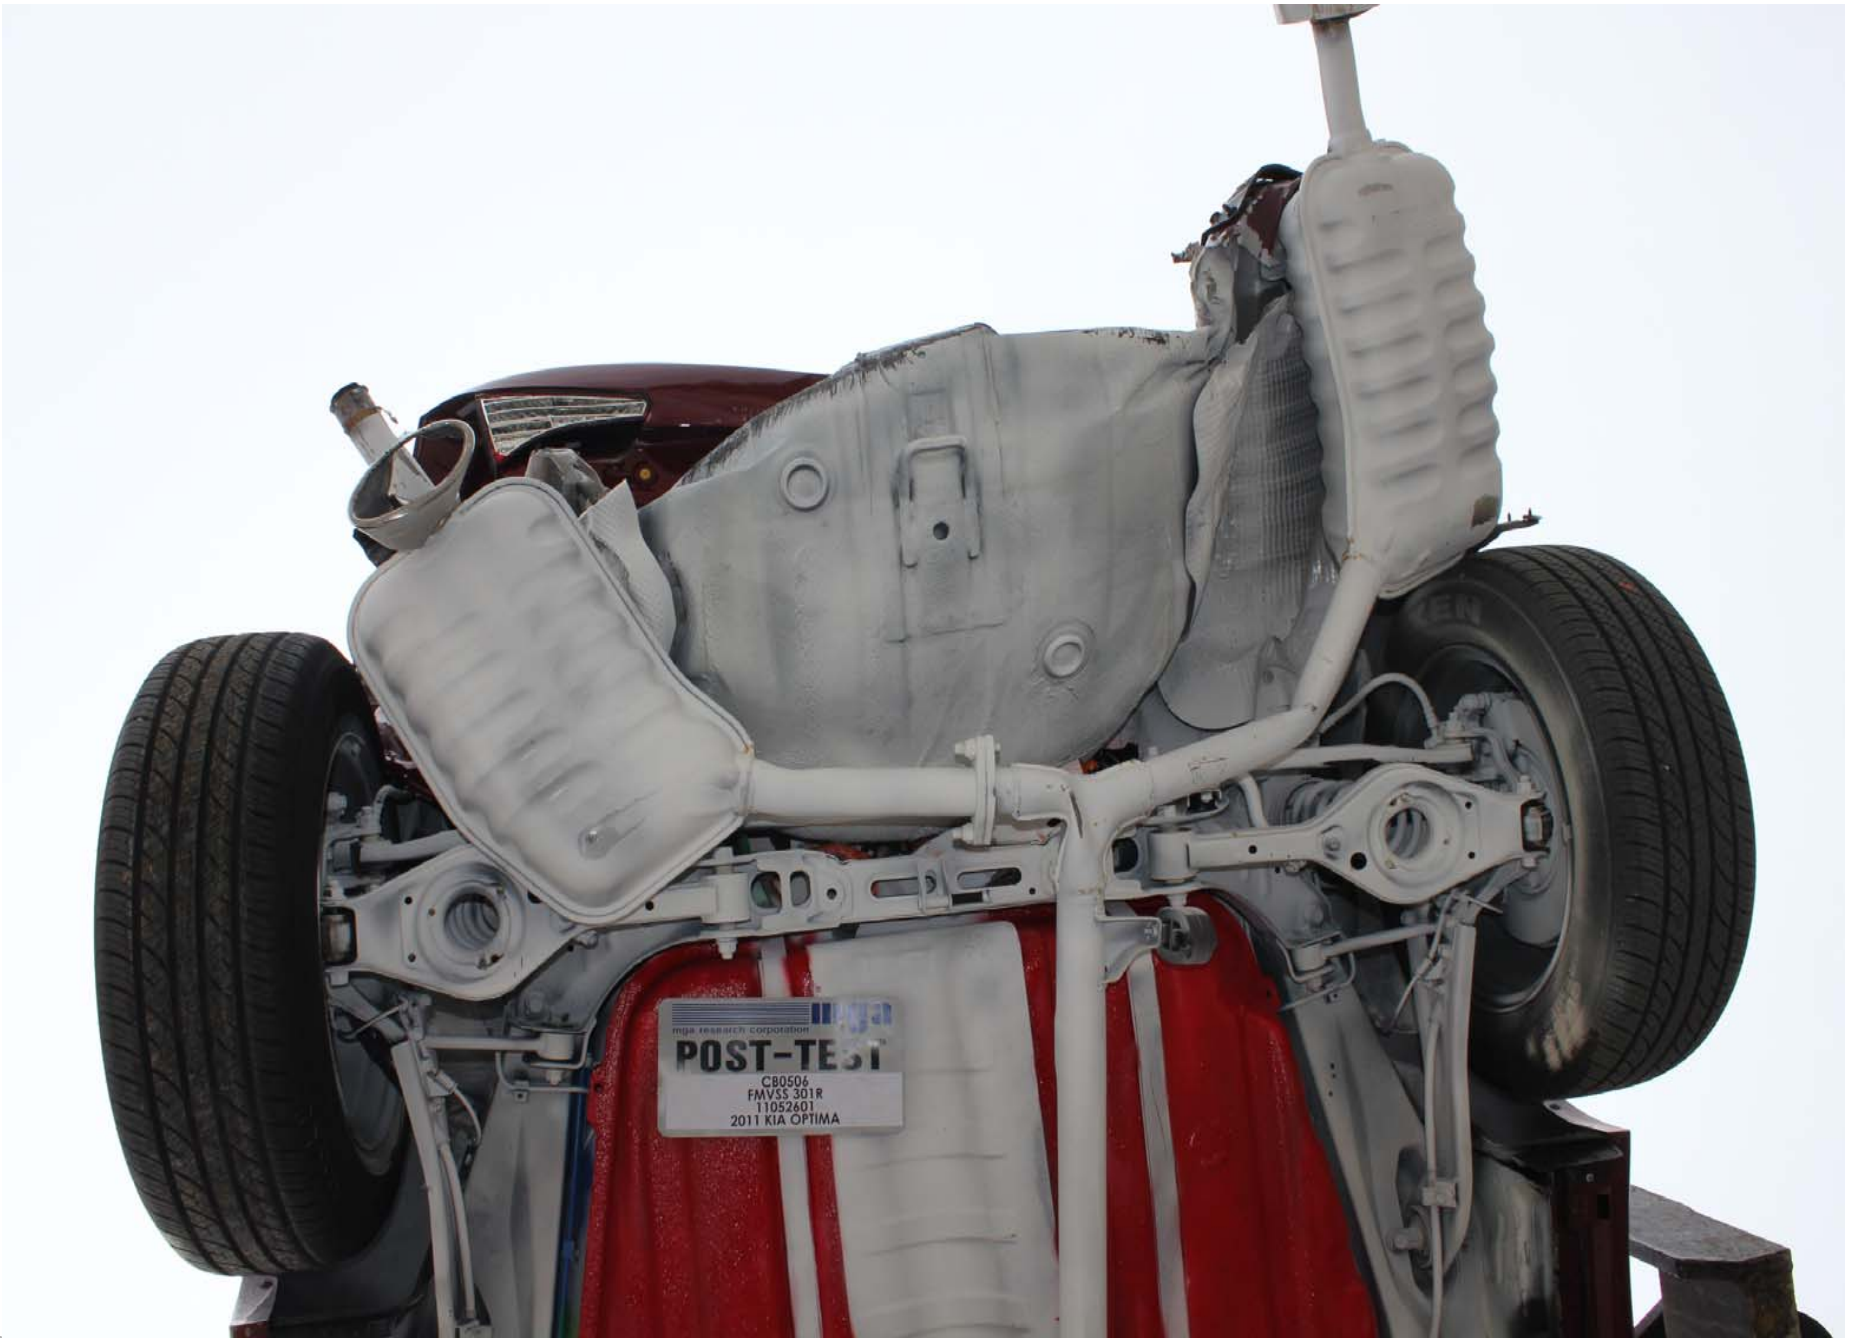
A-28.

Post-Test Underbody View 3

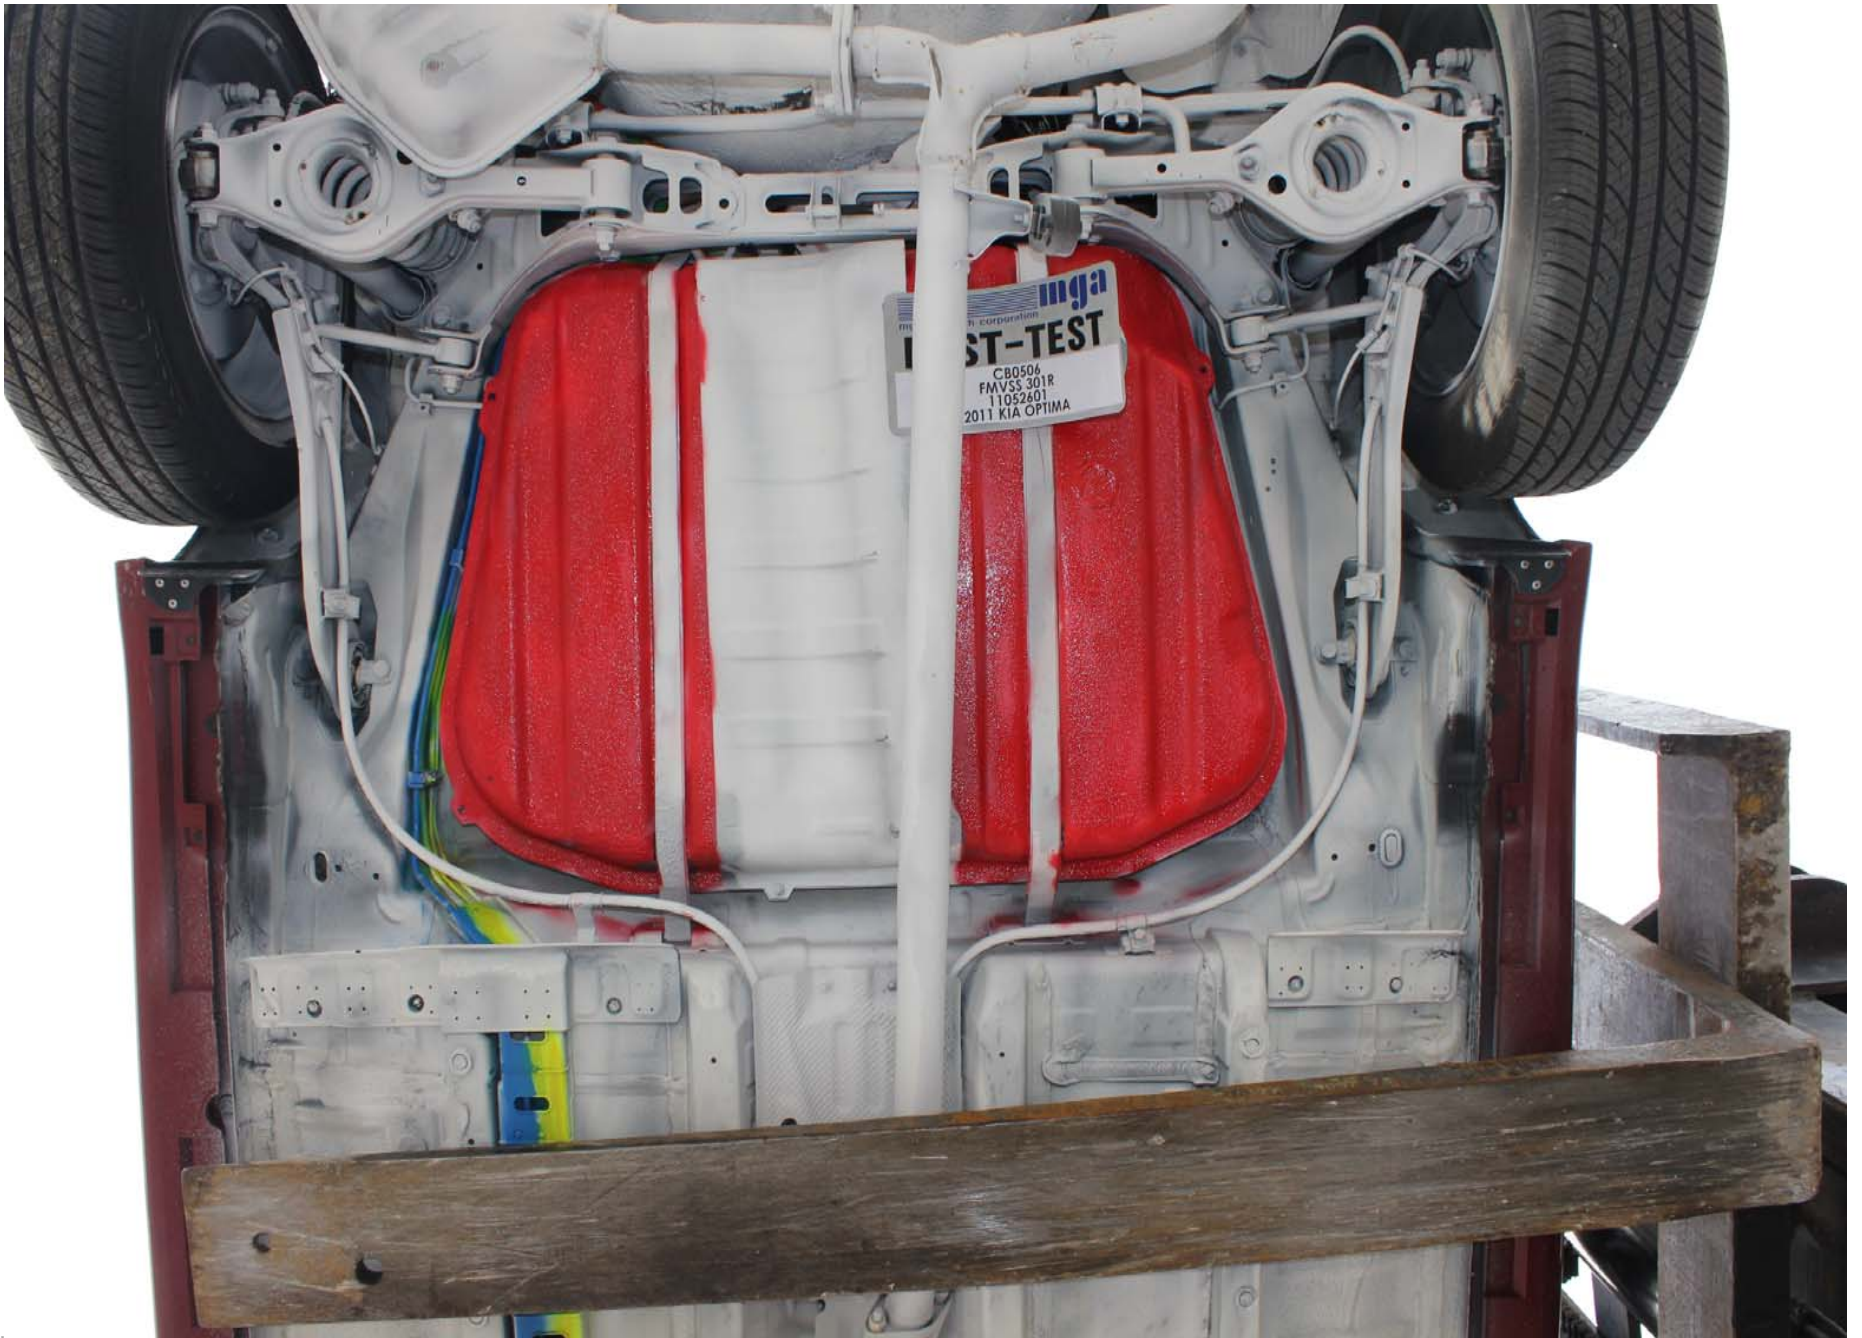
A-30.

Post-Test Underbody View 4

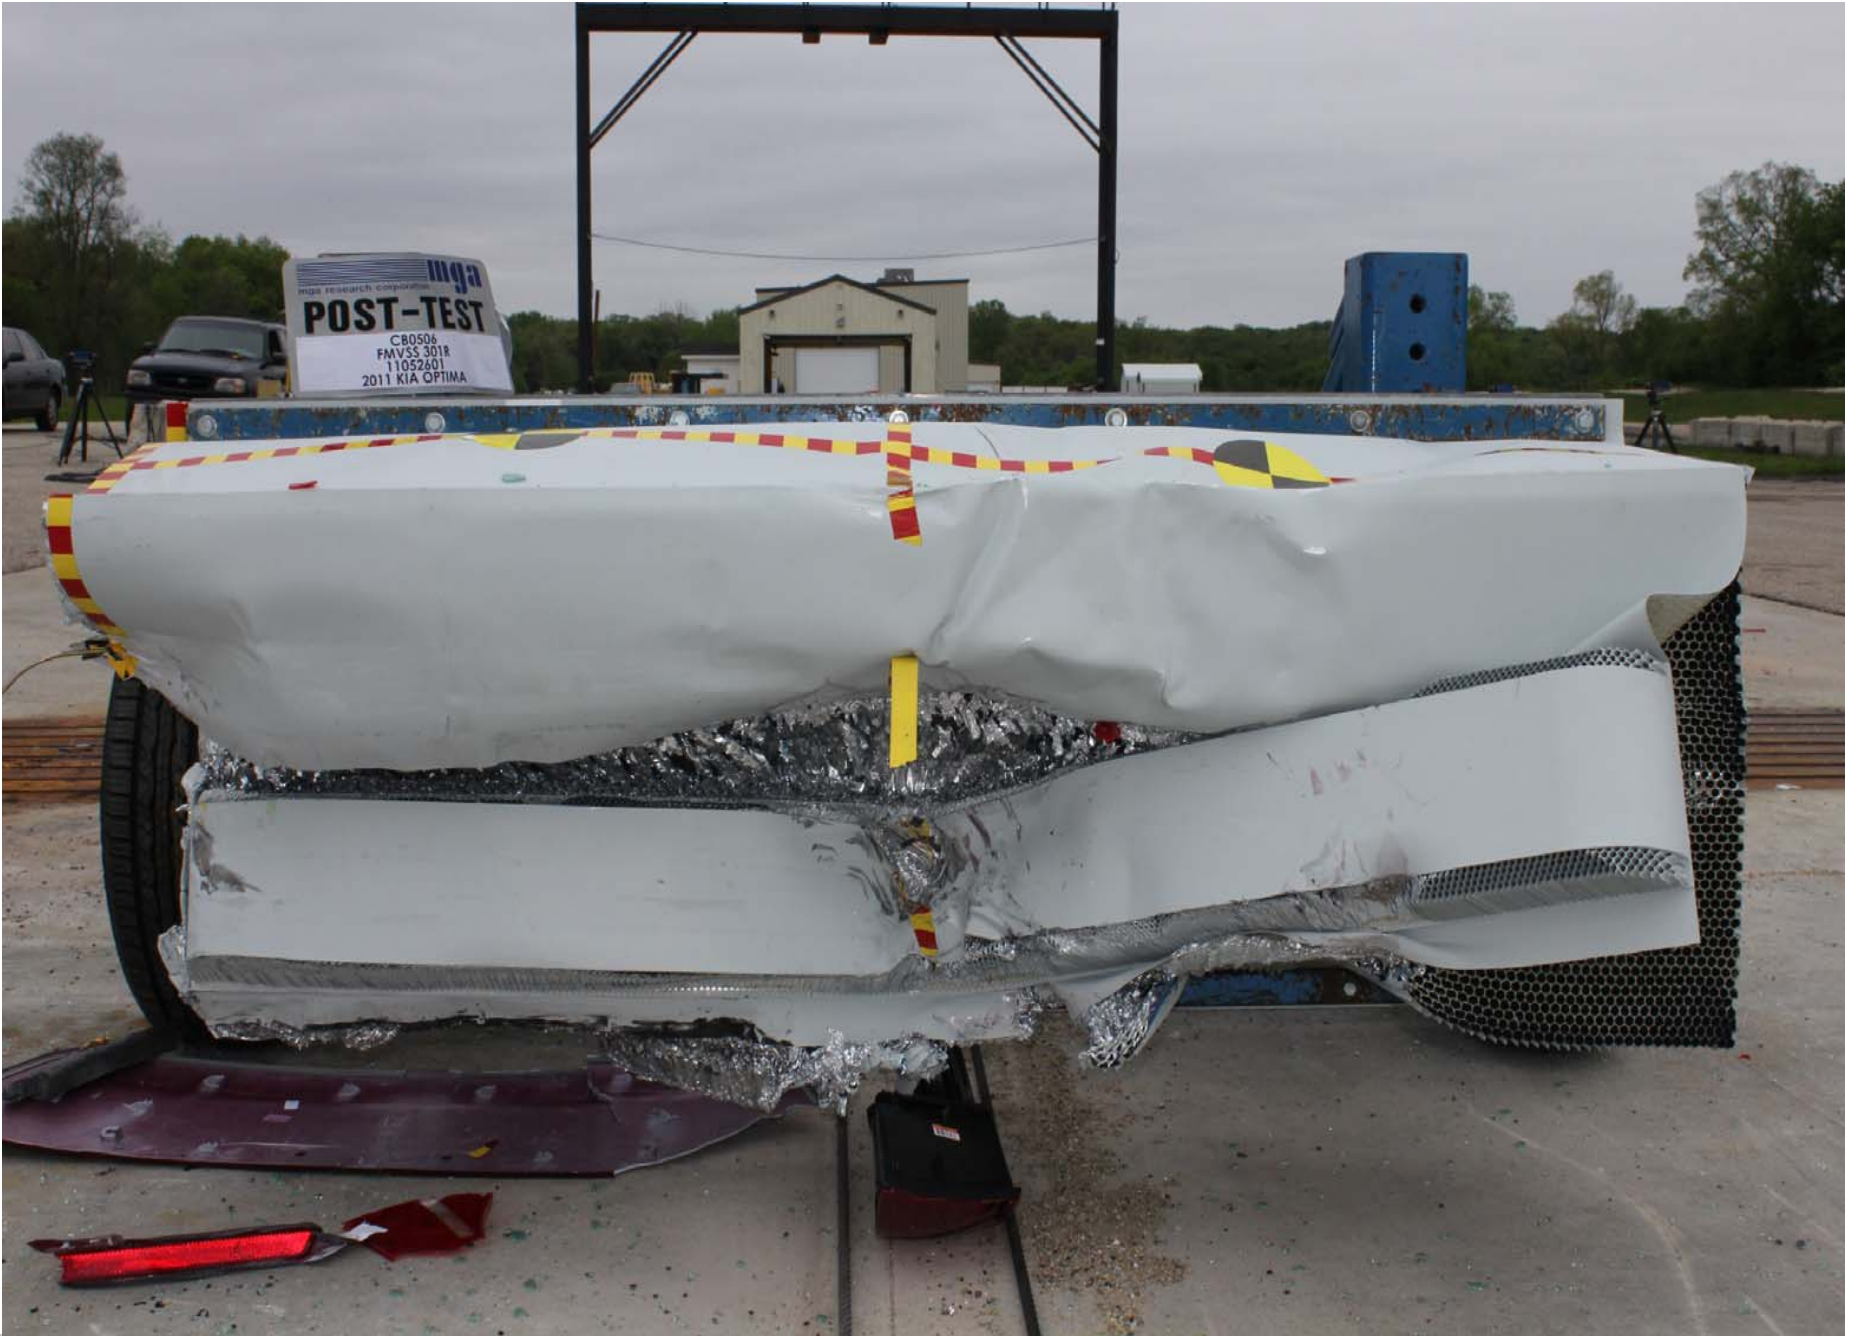
A-32.

Post-Test Front View of MDB

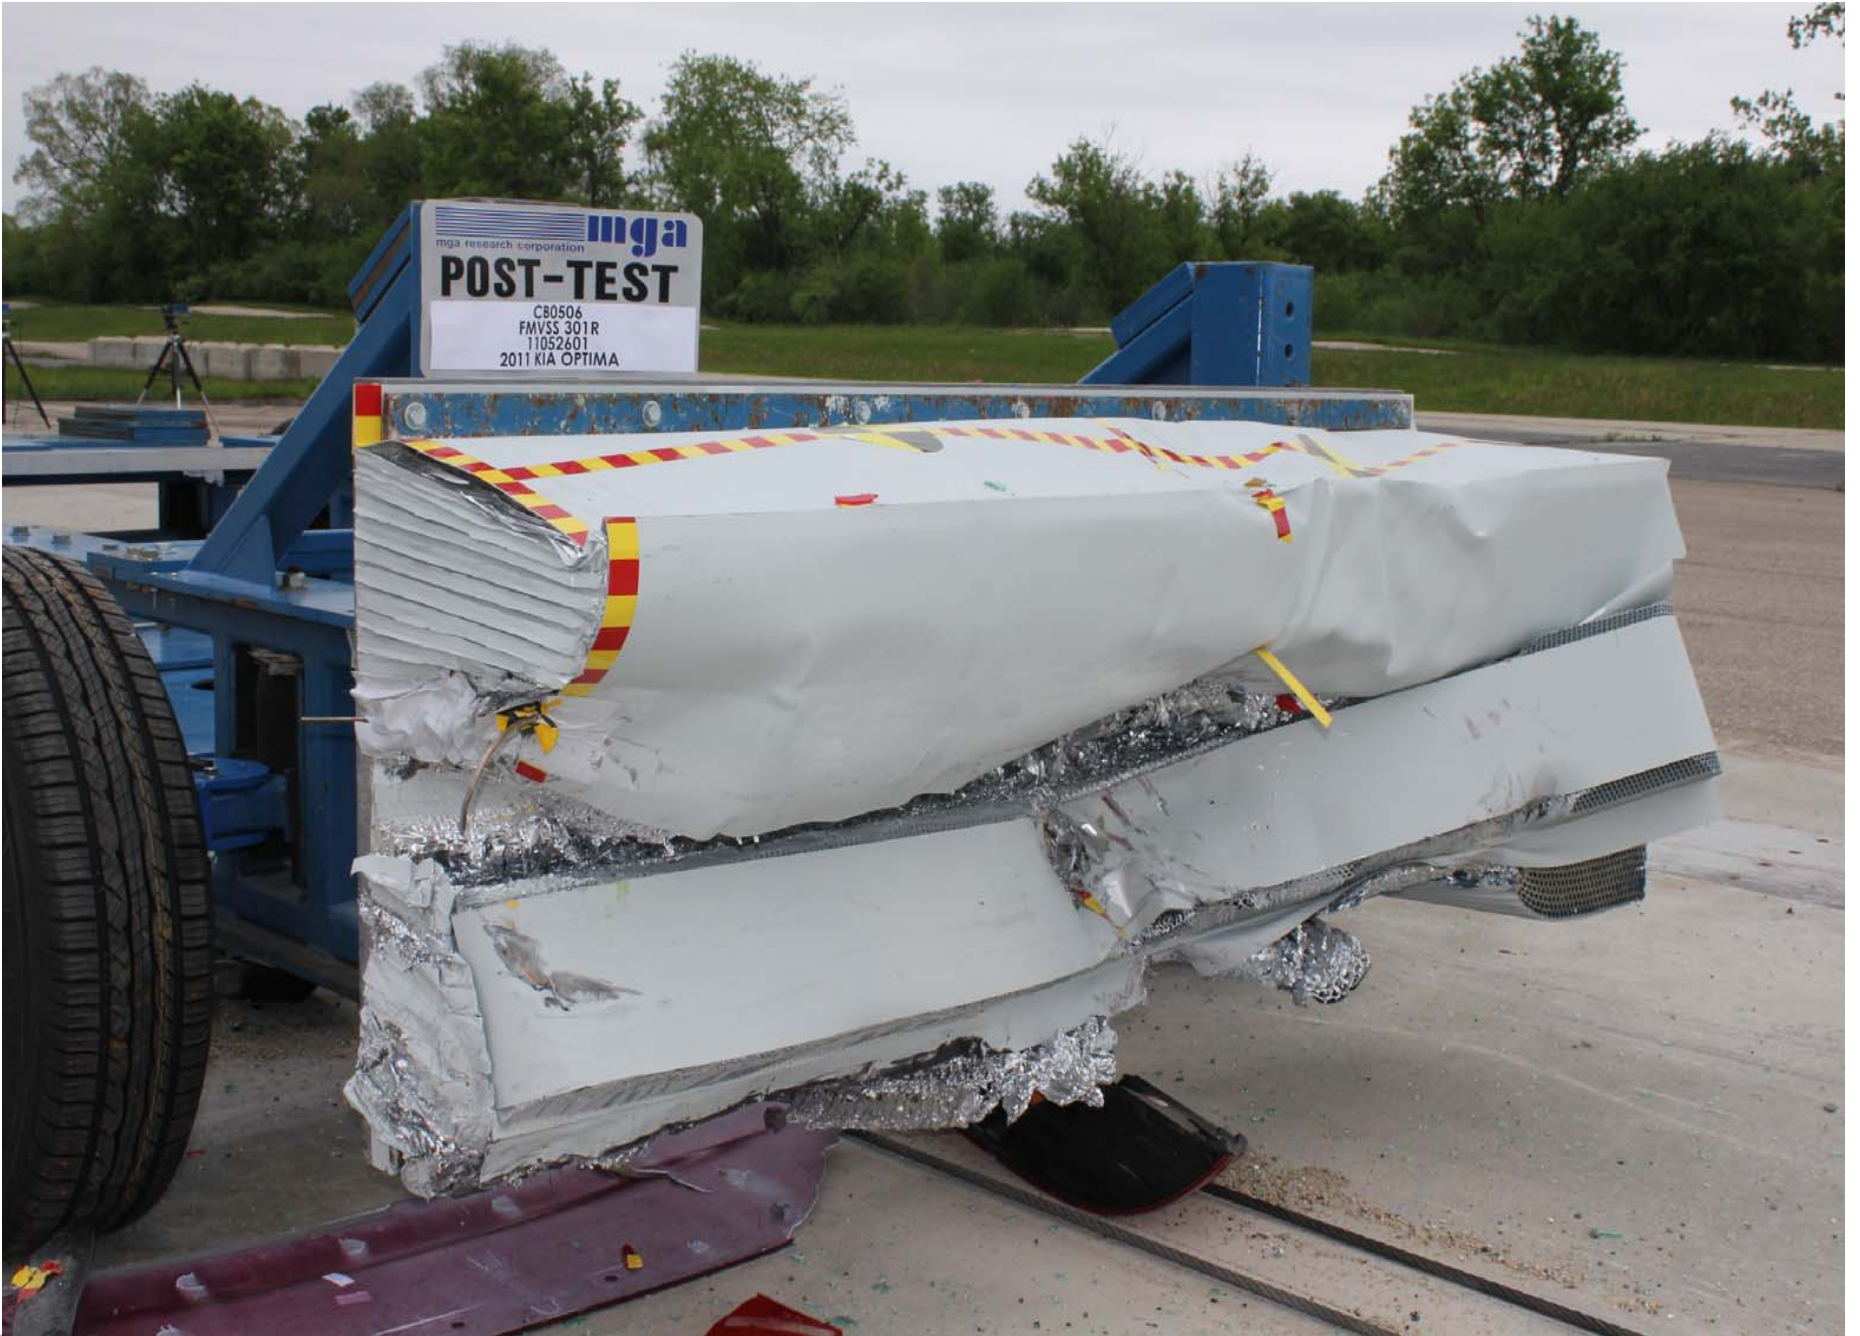
A-34.

Post-Test ¾ Right Side View of MDB

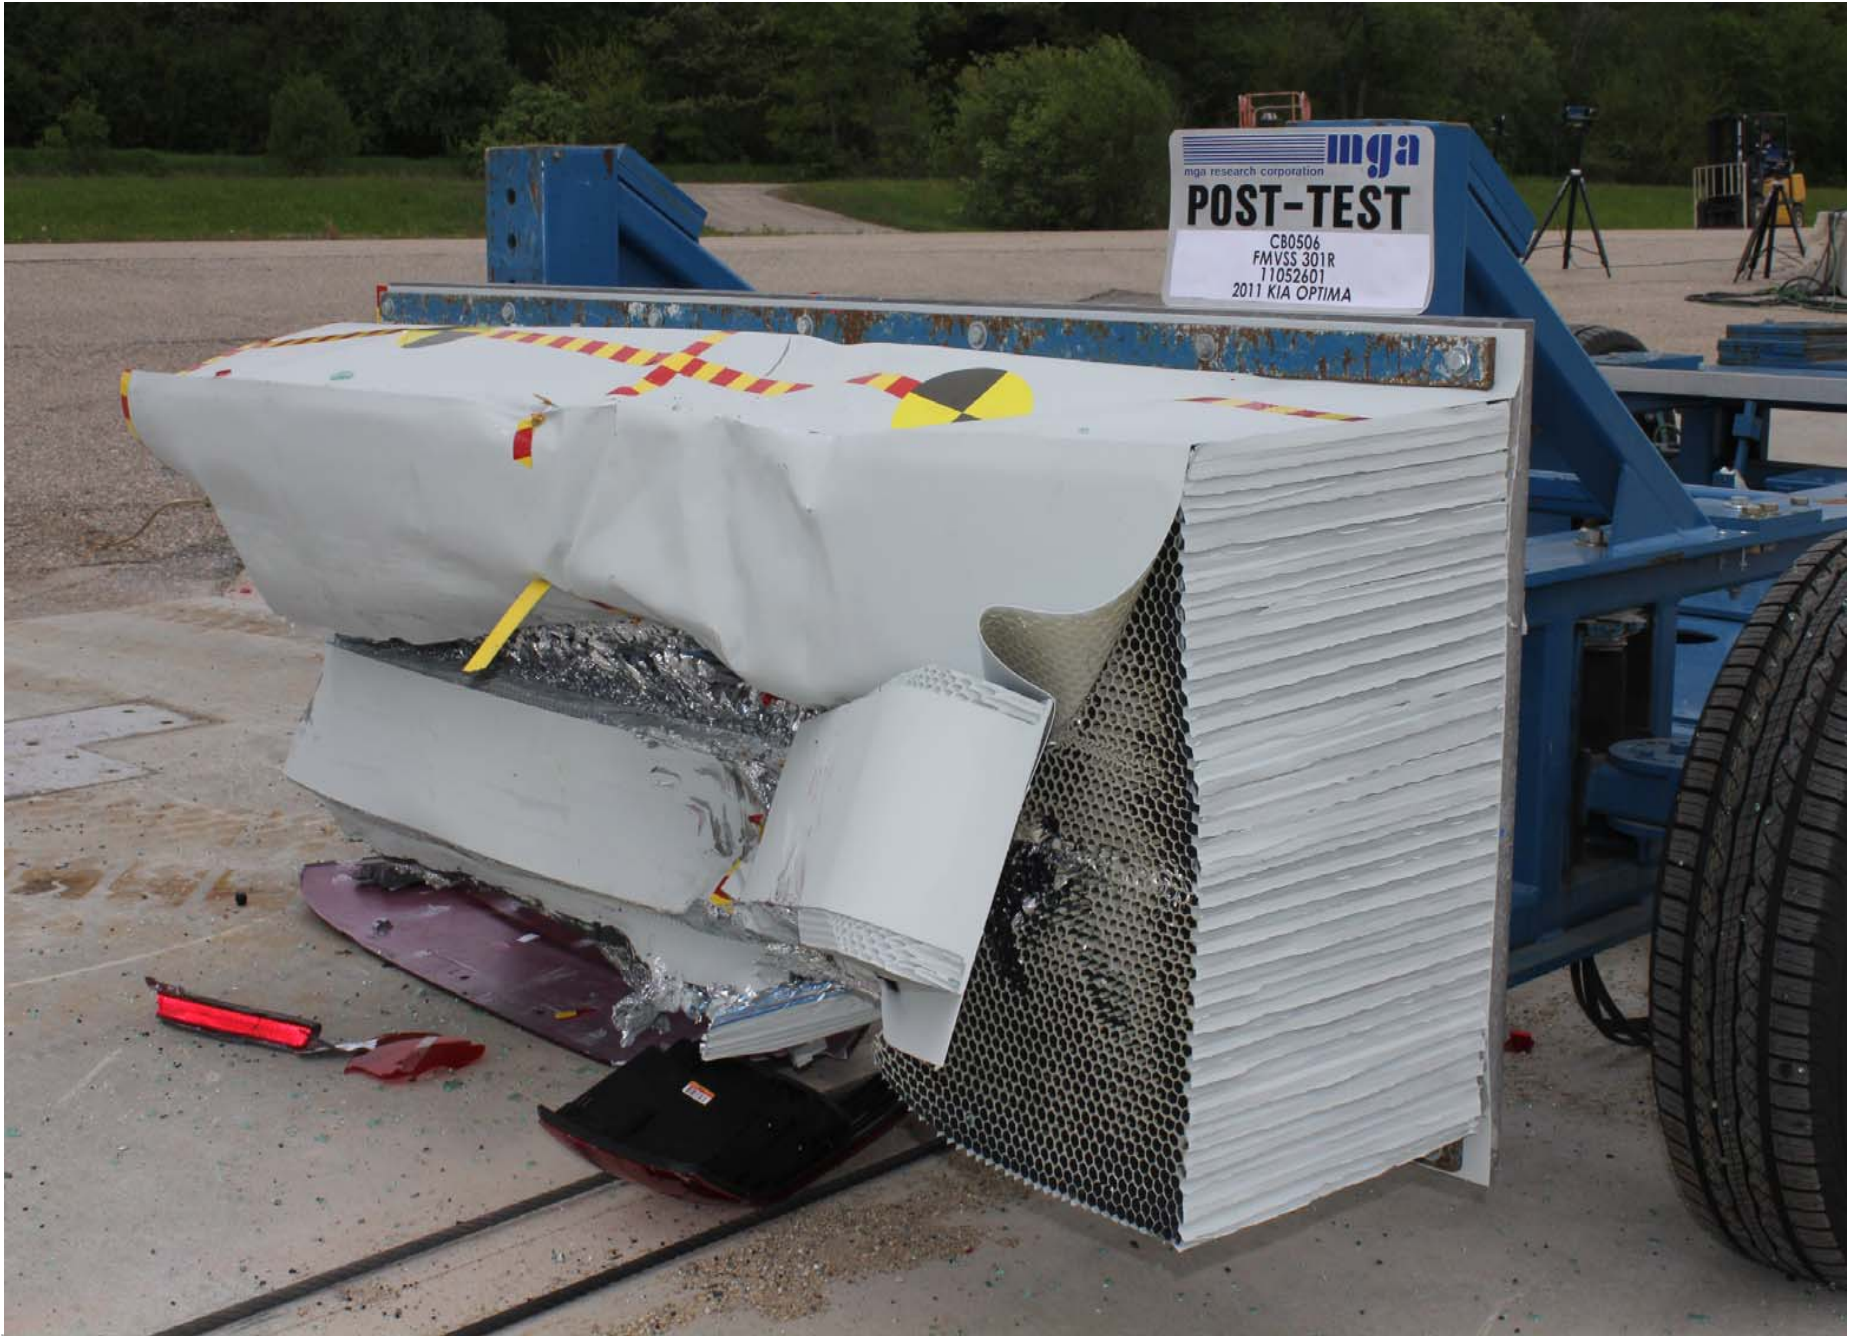
Post-Test  $\frac{3}{4}$  Left Side View of MDB

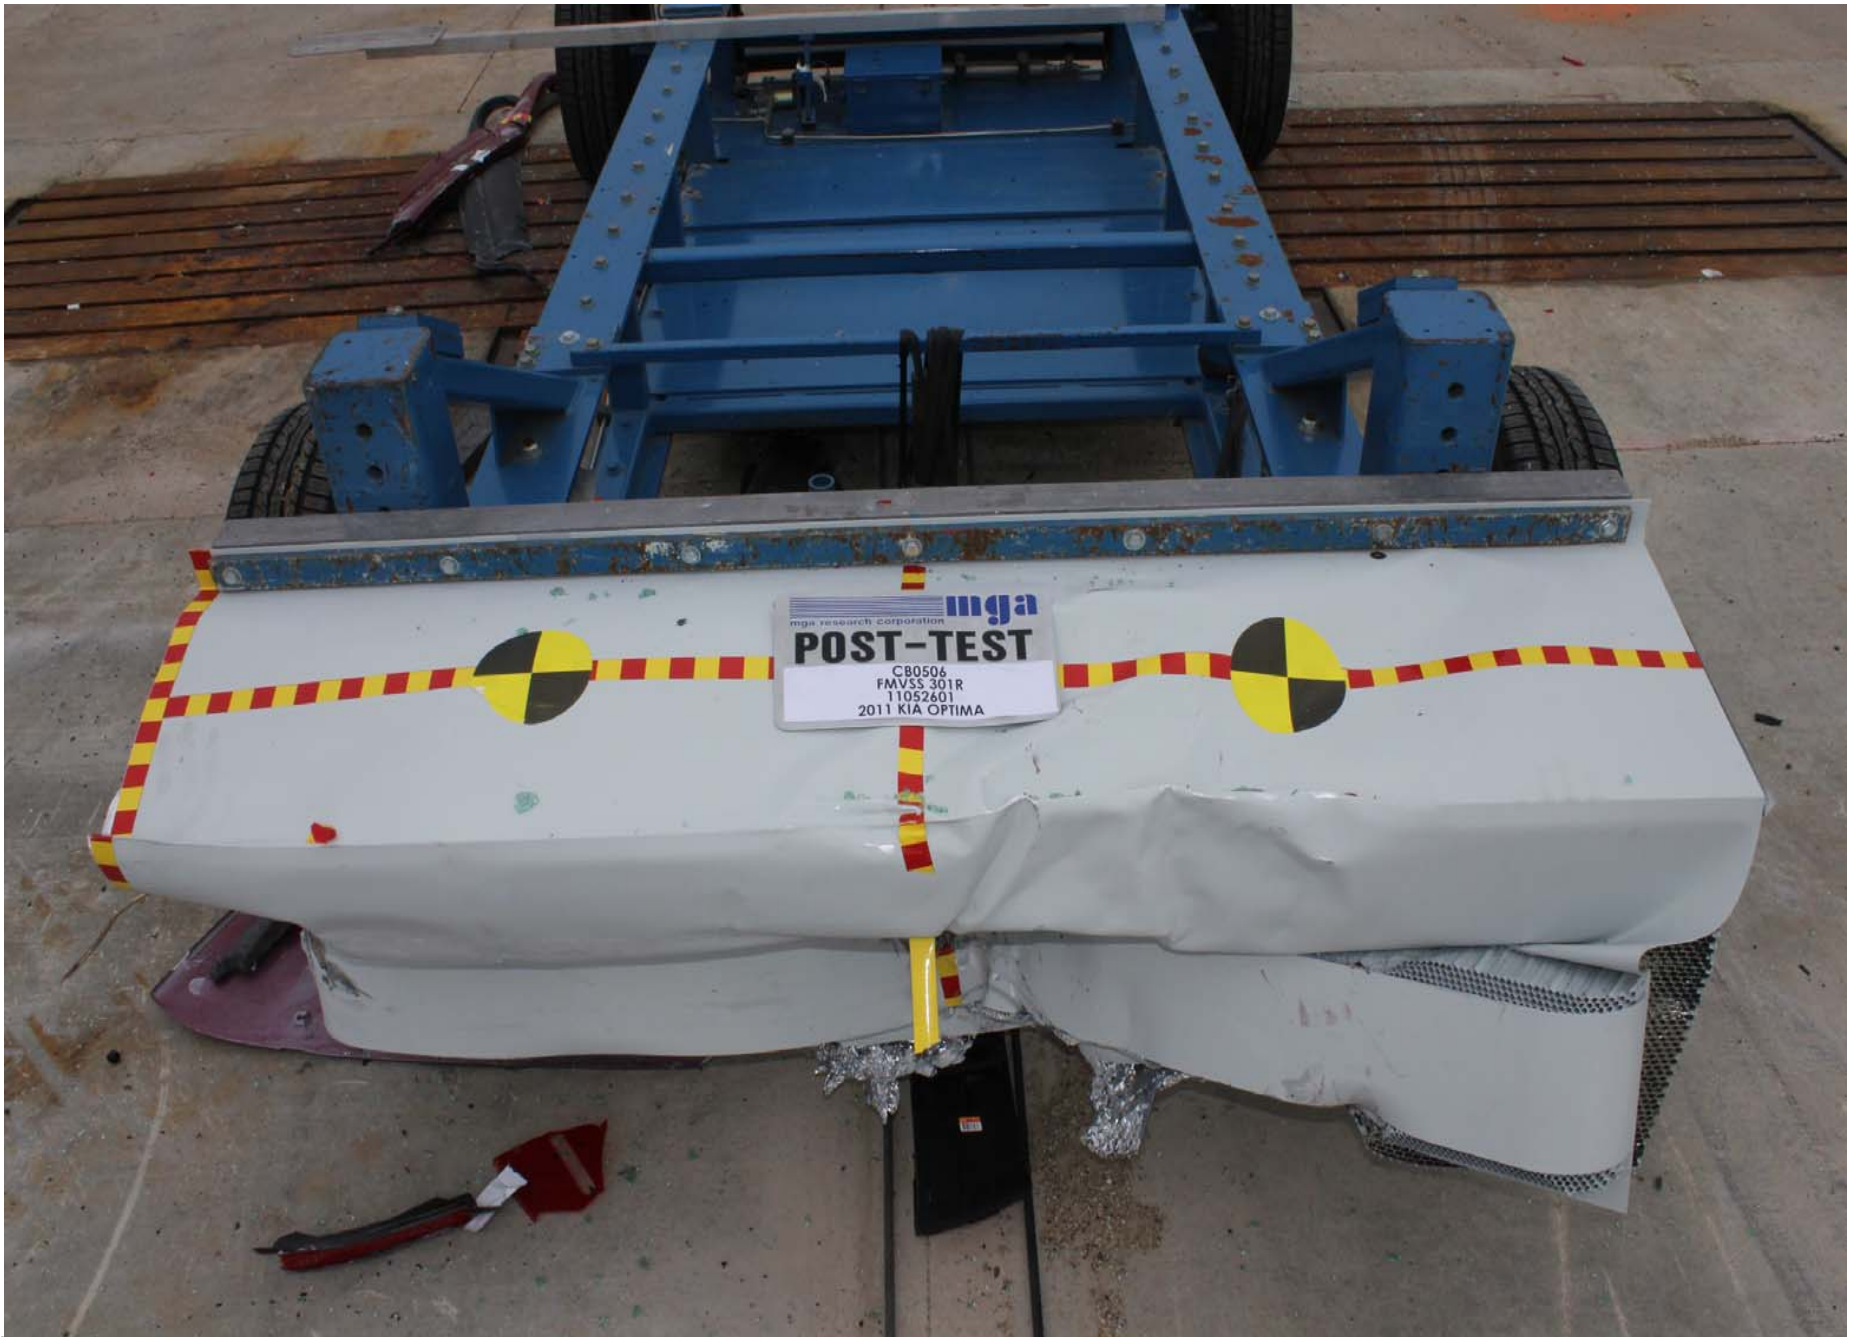
A-38.

Post-Test Top View of MDB
