CALSPAN ON-SITE ROLLOVER CRASH INVESTIGATION

SCI CASE NO.: CA12005

VEHICLE: 2012 NISSAN ROGUE

CRASH DATE: FEBRUARY 2012

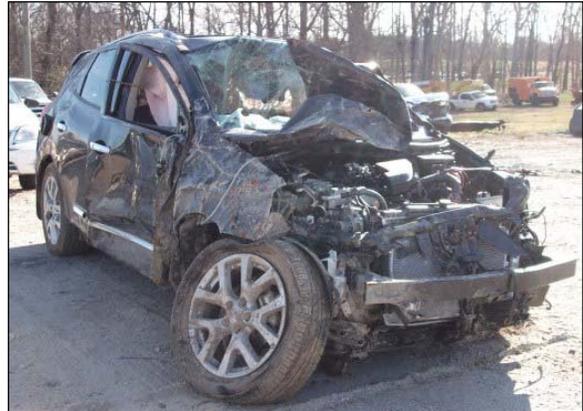
Figure 1: Involved 2012 Nissan Rogue.

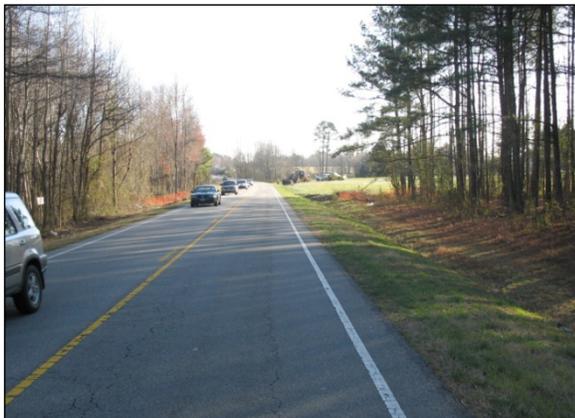
The crash occurred on a two-lane roadway in a rural area during early-morning hours. The asphalt-surfaced roadway was oriented in a north-south direction, and delineated by a solid yellow line with a broken line that restricted passing for the northbound direction. At the time of the crash, the Nissan was traveling in the 3.1 m (10.2 ft) wide northbound lane, which was supported by a 0.7 m (2.3 ft) wide east asphalt shoulder. The roadway was straight and level for an extended period. The 3.1 m (10.2 ft) wide southbound travel lane was also supported by a 0.7 m (2.3 ft) wide west asphalt shoulder. A north-facing view of the roadway and pre-crash travel trajectory Nissan is depicted in **Figure 2**.

Figure 2: North-facing view of the Nissan's pre-crash travel trajectory.

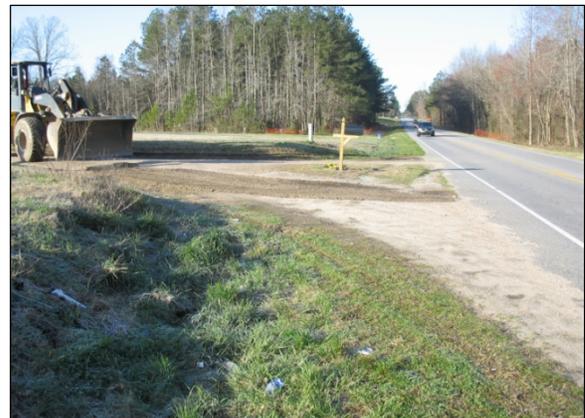
Figure 3: South-facing look back view of the Nissan's trajectory from final rest.

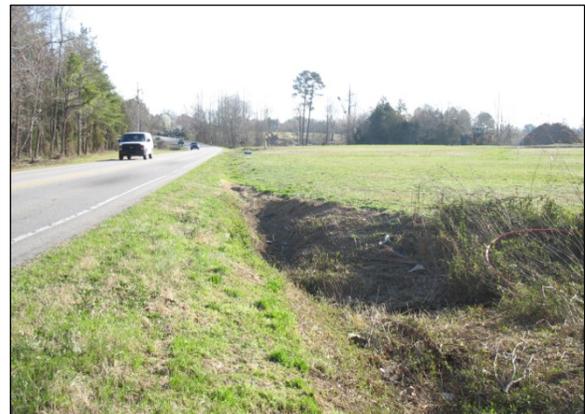
The first event occurred when the Nissan entered the 1.4 m (4.5 ft) deep drainage ditch (**Figure 4**). The initial plane of contact was the Nissan's frontal plane, at the right front bumper corner and undercarriage. This impact was of sufficient magnitude to result in the actuation of the Nissan's front safety belt retractor pretensioners and the deployment of its frontal air bag system. Due to the depth of the ditch and the roadside's negative slope, the right plane of the Nissan also impacted the east bank of the ditch. As the right front fender, right A-pillar, and right doors engaged the ground, a clockwise (CW) rotation to the Nissan was induced.

Figure 4: North-facing view of the Nissan's crash sequence trajectory.

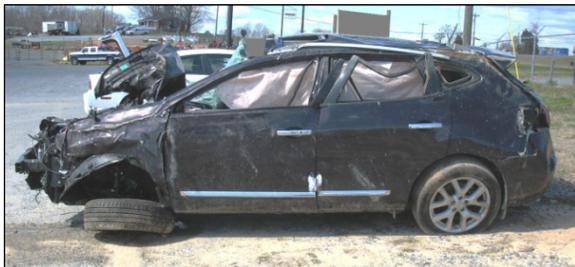
The Event 2 rollover sequence resulted in direct and induced damage across the entire left, top, right, and undercarriage planes, with extension to both the front and back planes. On the left side (**Figure 6**), the suspension arm of the left front axle position was fractured and the tie rod and drive axle were partially separated. The left front fender was deformed laterally. The forward and upper portions of the left front window frame were completely separated from the left front door, and the entire left rear window frame was crushed vertically. Multiple overlapping patterns of body surface abrasions in varying vertical, horizontal, and longitudinal directions were present across all portions of the left plane. Patches of embedded grass and soil were dispersed throughout.

Figure 6: Event 2 damage pattern to the left plane of the Nissan.

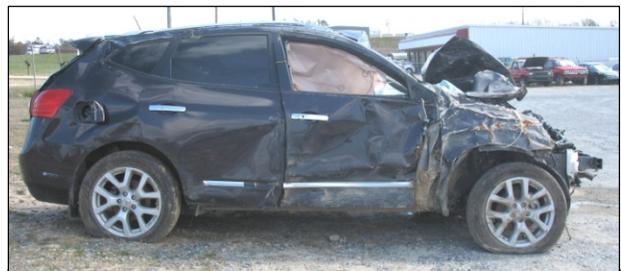
The right plane sustained damage from the rollover that overlapped the Event 1 damage profile (**Figure 7**). This included body deformation and surface abrasions to the right front fender and both right side doors. Other damage attributable to the rollover included the vertical and lateral deformation to the upper right A-pillar, right roof side rail, upper right D-pillar, right rear fender, and fuel filler-cap door.

Figure 7: Event 2 damage pattern to the right plane of the Nissan.

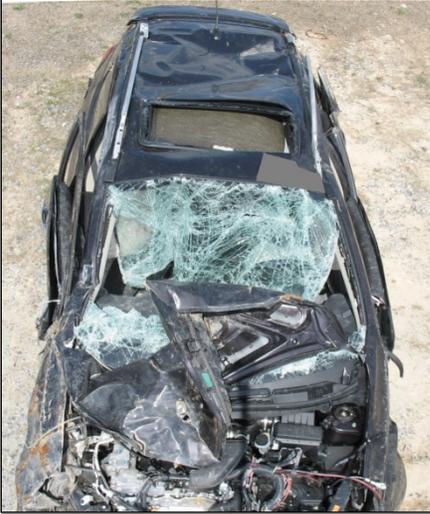
On the Nissan's top plane (**Figure 8**) was minor body deformation to the roof. Both roof-rack rails were fractured immediately forward of their rear mounting locations, with heavy multiple-axis abrasions. There was induced vertical deformation to the roof, with minor body surface abrasions. The forward portion of the hood had separated from its latch during the early stages of the rollover, and was subsequently deformed longitudinally. The entire hood was crushed together and folded over, which had penetrated the forward lower aspect of the center of the windshield.

Figure 8: Event 2 damage pattern to the Nissan's top plane.

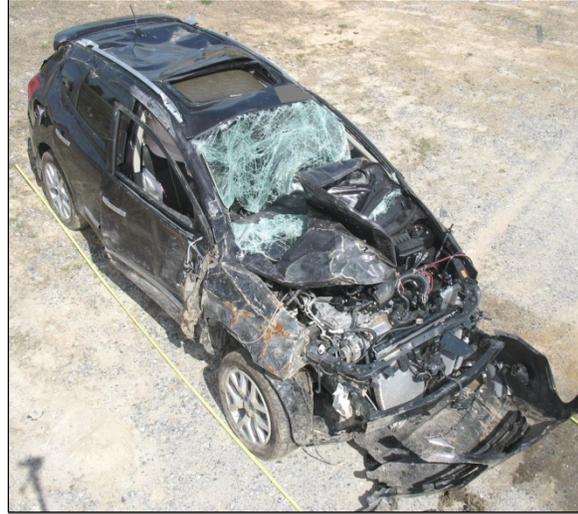
Figure 9: Overall view of the Nissan Rogue and the Events 1 and 2 overlapping damage patterns.

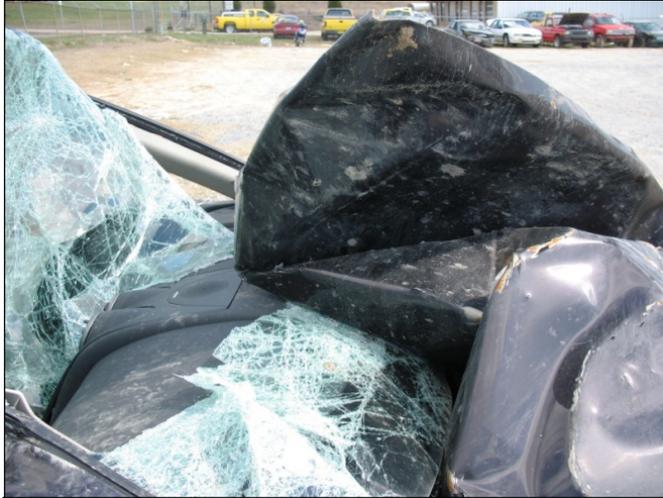
Interior damage sustained by the Nissan was attributable to supplemental restraint system deployment and occupant contact. The only measureable intrusion into the passenger compartment was the penetration of the deformed hood through the lower aspect of the windshield, with a magnitude of 22 cm (8.7 in). This intrusion is depicted in **Figure 10**.

Figure 10: Penetration of the deformed hood through the base of the Nissan's windshield glazing.

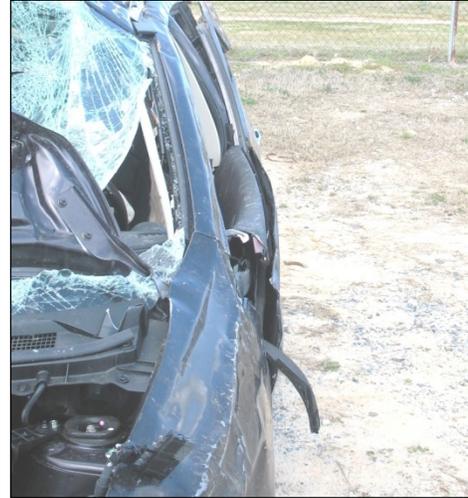
Figure 11: Extrusion of the Nissan's left front door due to occupant loading.

Occupant contact within the Nissan was confined to the interior components within the driver's seating position. Identified contact damage included deformation to the left front interior door panel, the displacement of the center console fascia surrounding the transmission shift lever, and scuffs to the left lower instrument panel from the driver's knees. All of these contacts were attributed to direct occupant interaction during the rollover sequence (Event 2). The deformation to the left front door consisted of obvious bowing extrusion of at least 8 cm (3 in) as a result of occupant loading that was magnified by the response of the individual's mass to the centrifugal forces of the rollover. **Figure 11** depicts the bowing extrusion of the left front door.

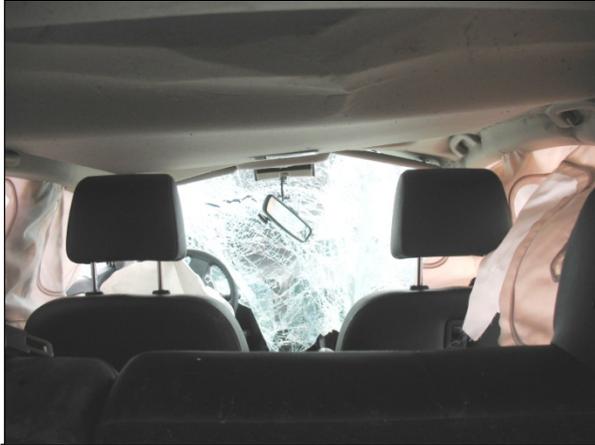
A forward-facing view of the involved Nissan's interior is depicted in **Figure 12**. It should be noted that the Nissan's headliner was displaced during the crash sequence, and was hanging unsecured from the vehicle's roof structure. That of an exemplar is depicted in **Figure 13** for exemplar purposes.

Figure 12: Forward-facing view of the Nissan's deployed IC air bags and suspended headliner.

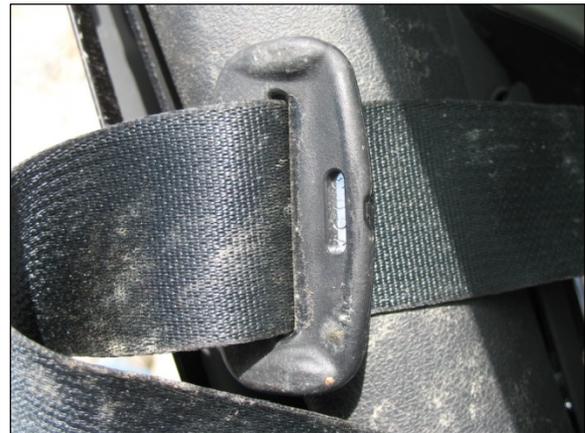
Both the driver's and front right passenger's retractor pretensioners actuated as a result of the frontal impact (Event 1), and the driver's belt webbing was locked in a used position. Loading abrasions on the latch plate from the belt webbing were consistent with occupant loading and evidenced restraint use (**Figure 14**). At the shoulder anchor location, the driver's safety belt webbing was gathered in the forward aspect of the D-ring with a polymer transfer extending 23 cm (9 in) down the webbing towards the latch plate.

Figure 14: Loading evidence on the driver's safety belt latch plate within the Nissan.

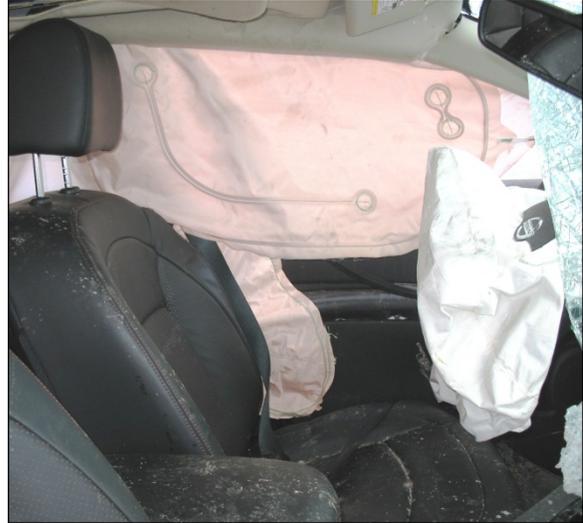
Figure 15: Deployed air bag systems for the driver's seating position within the Nissan Rogue.

The deployed air bags for the driver's seating position are depicted in **Figure 15**. As detailed previously, the vehicle had been obtained new and had only been in the driver's possession for approximately three months. The driver stated that because of this fact, none of the supplemental restraint systems had required maintenance or replacement. He further stated that the supplemental inflatable restraints warning light within the instrument panel was not illuminated at any time prior to the crash.

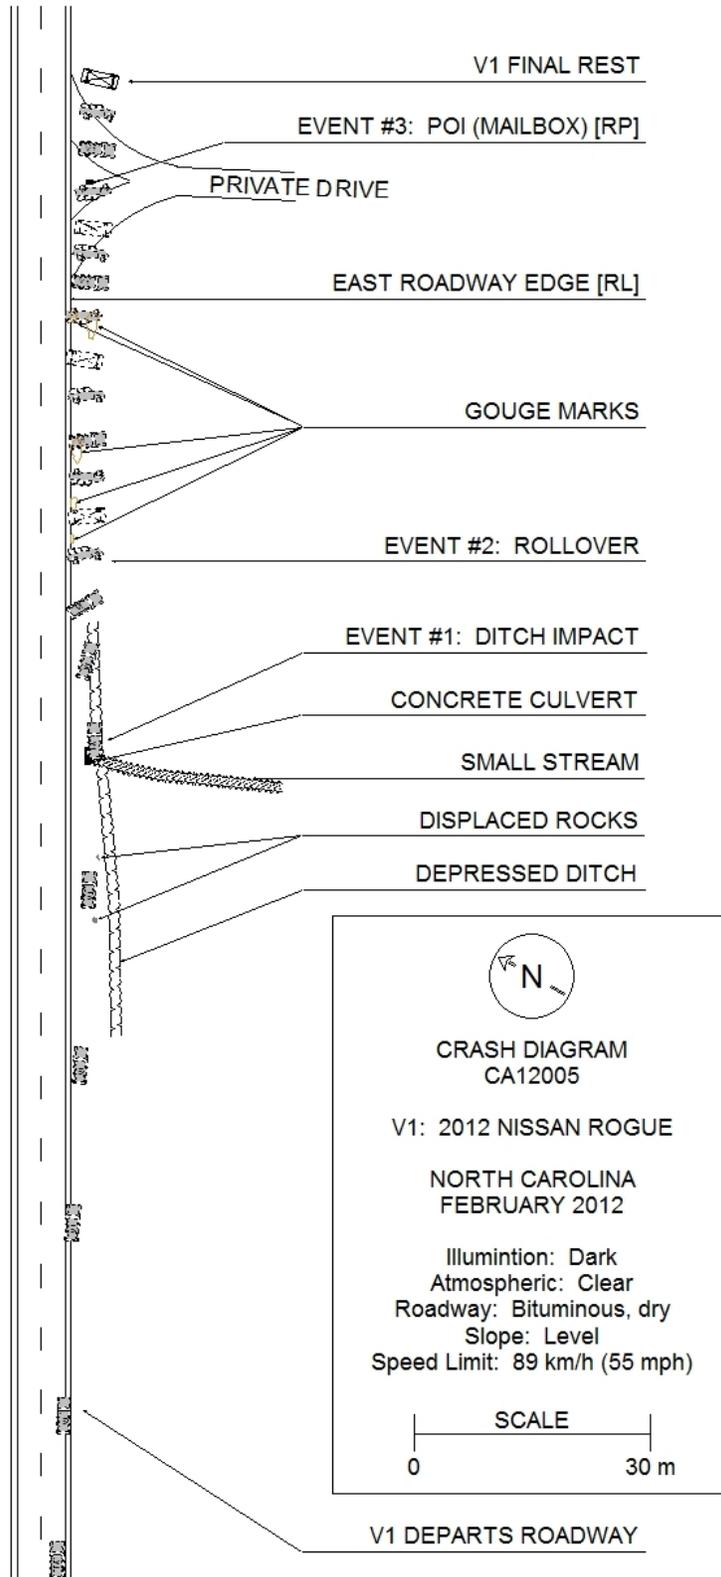
CRASH DIAGRAM

To the east of the roadway, the roadside transitioned down a slight negative slope into a ditch that ran essentially parallel to the travel lanes. The 0.5 m (1.5 ft) deep ditch was centered an average of 3.2 (10.5 ft) from the east roadway edge. At a convergence point for the roadside ditch with a land drainage ditch was a concrete culvert that redirected water into a sluice pipe beneath the roadway. The concrete fascia of the ditch was 2.3 m (7.5 ft) wide, centered 2.1 m (6.9 ft) from the roadway edge and 0.3-1.9 m (1-6.2 ft) below the roadway's surface. The roadside ditch extended north parallel to the roadway for 60.5 m (198.5 ft) toward a residential driveway, decreasing in depth and width. It transitioned to level ground at the edge of the gravel-surfaced driveway, which intersected the roadway in a Y-configuration. The south branch was 7.6 m (24.9 ft) wide, the center void was 10.1 m (33 ft) wide, and the north branch was 10.2 m (33.5 ft) wide. Within the center void was a residential mailbox, affixed to a non-breakaway 10x10 cm (4x4 in) wooden post that was approximately 1.1 m (3.5 ft) tall. The mailbox, which served as the Investigator's point of reference, was located precisely 73 m (239.5 ft) north of the center of the concrete sluice pipe and 2.9 m (9.5 ft) east of the roadway edge. The north branch of the driveway was bordered to its north by a slight (2.5 ft) positive embankment that transitioned to a shallow roadside drainage depression. A look back view from the vehicle's final rest position toward the residential driveway and mailbox is depicted in **Figure 3**. Speed was regulated by a posted limit of 89 km/h (55 mph). A Crash Diagram is included on page 14 of this technical report.

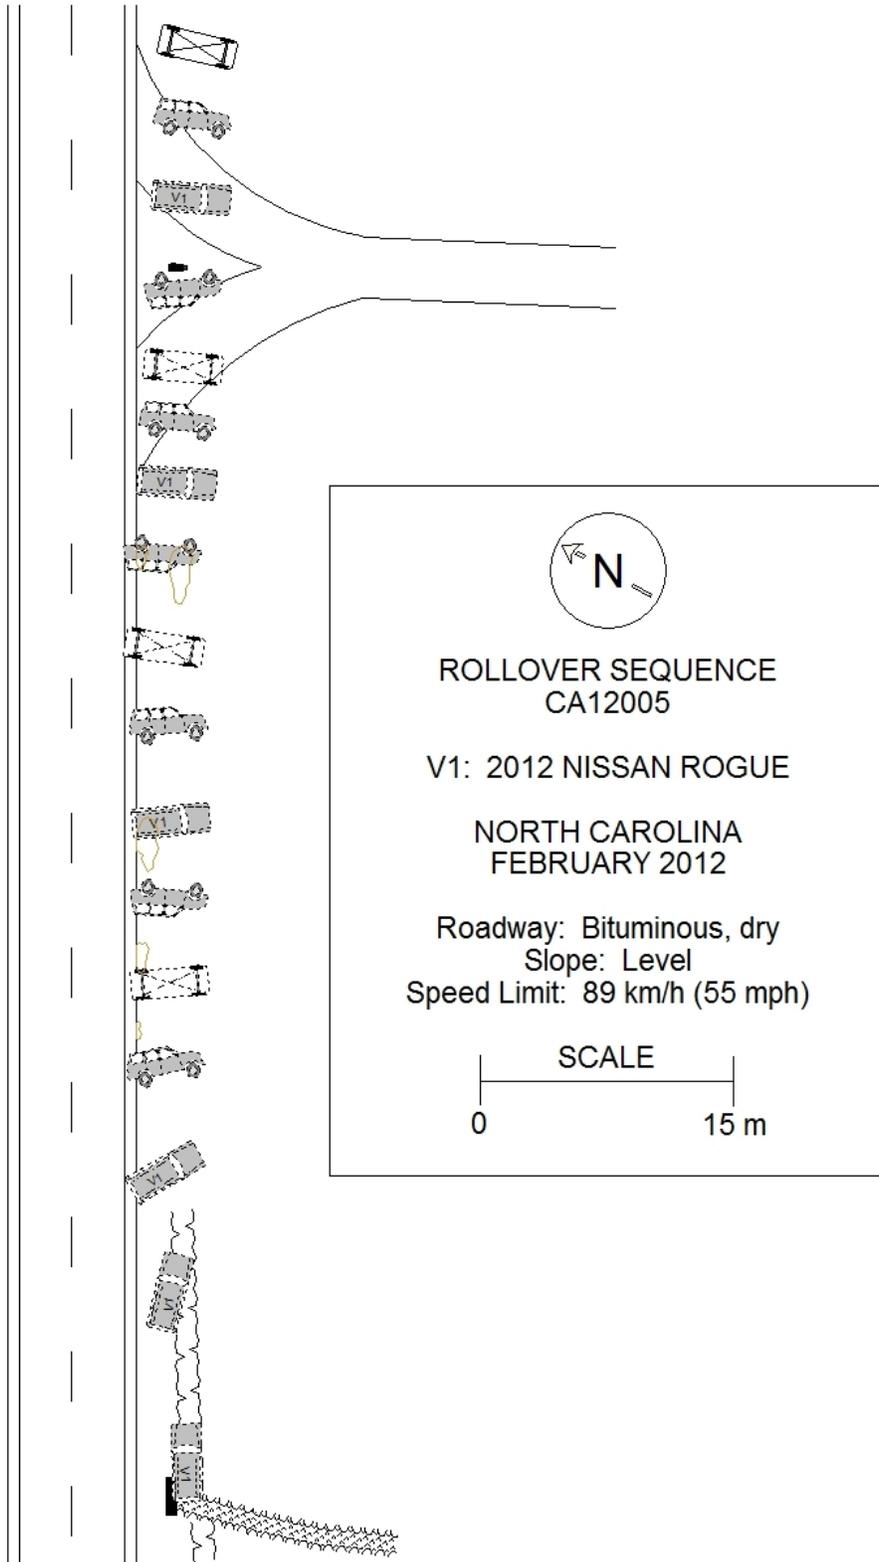
ROLLOVER SEQUENCE SCHEMATIC

Over the duration of the vehicle's rollover sequence, the Nissan completed fourteen quarter-turns over a distance of approximately 69 m (226 ft). Ultimately, the vehicle came to final rest on its top plane, straddling the ditch and slight embankment, facing east. This position was located 172.2 m (565 ft) north of the initial right roadside departure point, and was evidenced by vehicle debris, post-crash medical refuse, and gouge marks within the soil surface. The impact and rollover sequence is depicted in the Rollover Sequence Schematic, found on page 15 at the end of this technical report.
