CALSPAN ON-SITE INFLATABLE SAFETY BELT CRASH INVESTIGATION

SCI CASE NO.: CA12004

VEHICLE: 2012 FORD EXPLORER

CRASH DATE: DECEMBER 2011

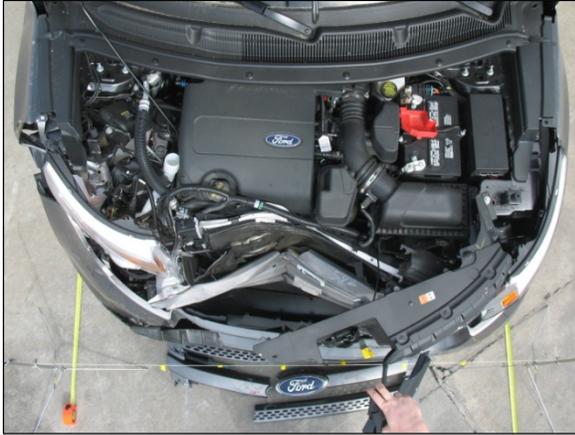
The Event 1 damage pattern consisted of longitudinal deformation and the partial separation of the front bumper fascia, disintegration of the grille and headlight assemblies, and body surface deformation/abrasions (**Figure 5**). Throughout this damage pattern was a reddish paint transfer.

Figure 5: Overhead view of the Event 1 frontal damage sustained by the Ford (note bumper beam deformation).

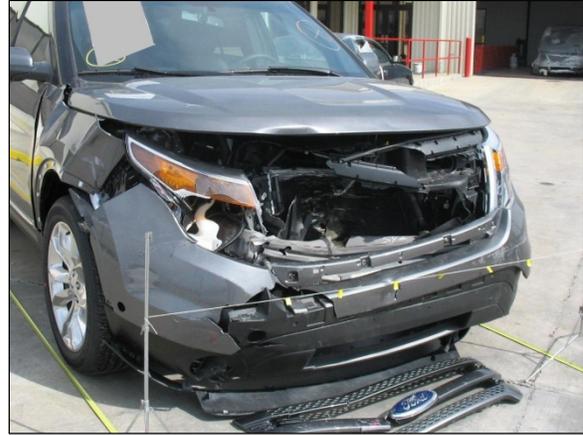
Figure 6: Frontal plane damage pattern and residual crush profile to the Ford from the Event 1 impact.

A residual crush profile (**Figure 6**) documented at the mid-bumper beam produced the following measurements: C1 = 0 cm, C2 = 13 cm (5.1 in), C3 = 24 cm (9.4 in), C4 = 38 cm (15 in), C5 = 26 cm (10.2 in), and C6 = 12 cm (4.7 in). The maximum crush was observed at the location of the C4 measurement. The Collision Deformation Classification (CDC) assigned to the 2012 Ford Explorer for the Event 1 damage pattern was 12FZEW2. The Damage Algorithm of the WinSMASH model was used to calculate the severity (delta-V) of the impact. The total calculated delta-V of the Ford for the Event 1 impact was 22 km/h (13.7 mph). The longitudinal and lateral components of this delta-V were -22 km/h (-13.7 mph) and -4 km/h (-2.5 mph), respectively.

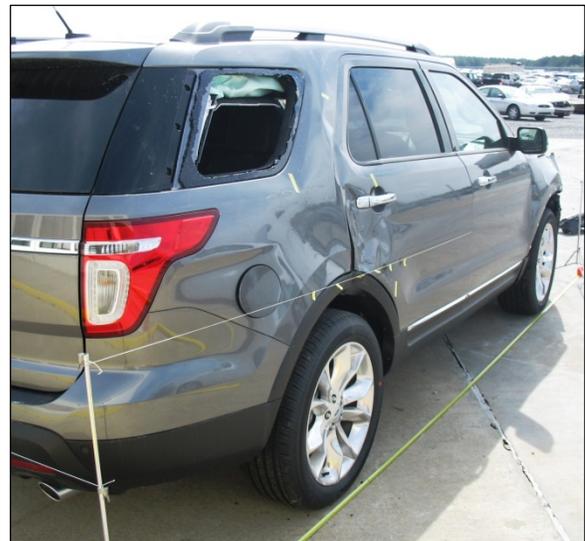
The right plane sustained minor damage as a result of the side-slap impact (Event 2), with damage located on the right rear aspect door, right rear fender, and C-pillar areas. Direct contact damage began 40 cm (15.7 in) forward of the right rear axle and extended 61 cm (24 in) rearward. This damage pattern included minor lateral displacement and deformation to the right rear door panel, right rear fender, and right C-pillar, with disintegration of the glazing above the right rear axle. A residual crush profile with Field-L of 70 cm (27.6 in) documented at mid-door level (**Figure 7**) produced the following measurements: C1 = 0 cm, C2 = 1 cm (0.4 in), C3 = 1 cm (0.4 in), C4 = 6 cm (2.4 in), C5 = 1 cm (0.4 in), and C6 = 0 cm.

Figure 7: Event 2 damage pattern to the right plane of the Ford.

Maximum crush was measured at C4, located at the forward aspect of the right rear fender, above the right rear axle position. The CDC corresponding to the Event 2 damage pattern was 03RZHW2. The Damage Algorithm of the WinSMASH model was used to calculate the severity (delta-V) of the impact. The total calculated delta-V of the Ford for the Event 2 impact was 3 km/h (1.9 mph). The longitudinal and lateral components of this delta-V were zero and -3 km/h (-1.9 mph), respectively.

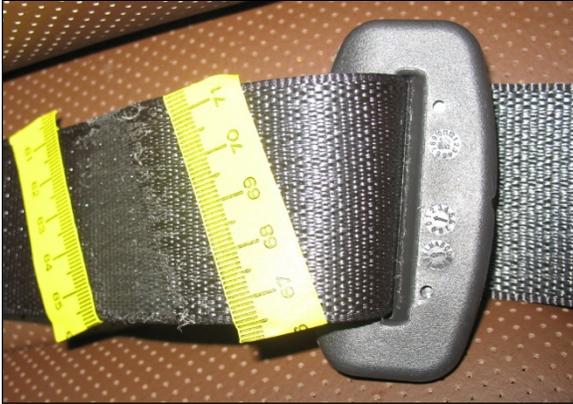
Both the driver's and front right passenger's respective retractor and buckle pretensioners had actuated as a result of the frontal impact (Event 1). According to data imaged from the Ford's EDR, retractor and buckle pretensioner deployment was commanded at 26.5 and 31.5 milliseconds, respectively, after AE. Both front row belt webbings were locked in used positions by the actuation of the retractor pretensioners, with 149 cm (58.7 in) of the driver's webbing and 145 cm (57 in) of the front right passenger's exposed. Abrasions and longitudinal stretching of the webbing material's threads in the areas of the sliding latch plates on both belt systems was consistent with occupant loading and evidenced restraint usage. These areas of loading were present 80-84 cm (31.5-33 in) and 86-90 cm (33.9-35.4 in) from the left and right D-ring anchor points, respectively, as depicted in **Figures 8 and 9**.

Figure 8: Loading evidence on the driver's safety belt webbing and latch plate within the Ford.

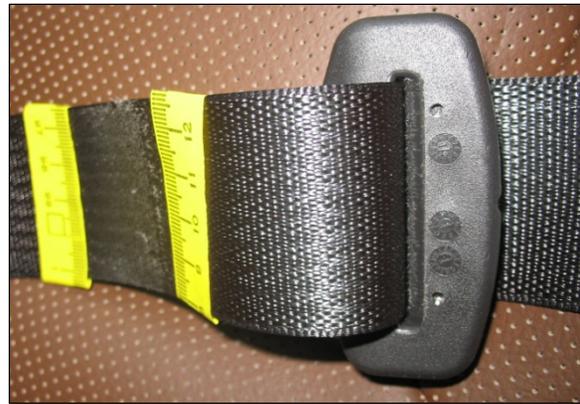
Figure 9: Latch plate and safety belt webbing loading from the Ford's front right passenger.

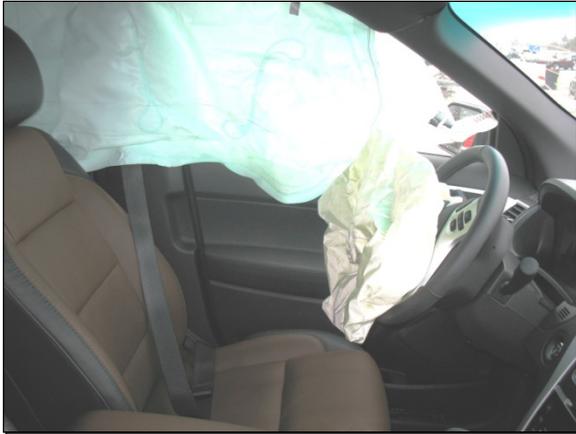
The driver's position steering wheel hub-mounted air bag deployed as a result of the Event 1 impact during the crash. It deployed through the I-configuration cover flaps of the module without damage. In its deflated state, the air bag was circular in shape with an overall diameter of 52 cm (20.5 in), with interior tethers stitched to the lower aspect of the bag's face. There were two 3.5 cm (1.4 in) diameter vents on the rear of the bag, evenly spaced from the centerline, at its upper aspect. The alphanumeric sequence 312311 630d was located on the rear of the air bag. Contact evidence was limited to slight scuffing on the face of the air bag from probable driver interaction.

Figure 10: Deployed air bag systems within the front left seating position of the Ford.

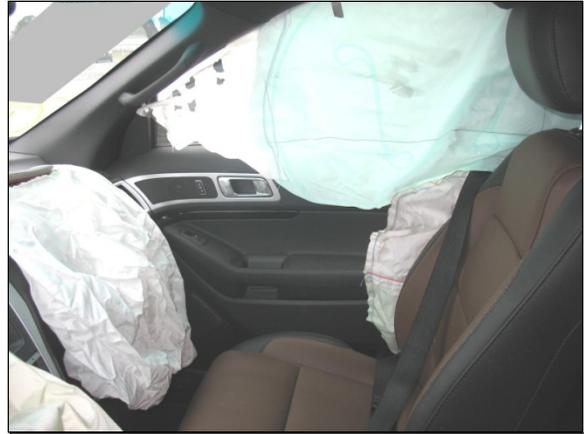
The front right passenger's frontal air bag deployed through a cover flap from the top of the right instrument panel. To provide occupant protection, it was designed to deploy rearward toward the occupant approximately 40 cm (15.7 in). In its deflated state, the air bag's overall height and width were 60 cm (23.6 in) and 55 cm (21.7 in), respectively. There was a 5 cm (2 in) vent on either side of the air bag. A bar code and label affixed to the air bag within the module declared that the air bag was constructed of semicrystalline polyamide (PA66 nylon) material, and was manufactured in Mexico. A scuff was present on the lower right quadrant of the air bag's face, attributed to probable interaction with the front right passenger.

Figure 11: Deployed air bag systems within the front right seating position of the Ford.

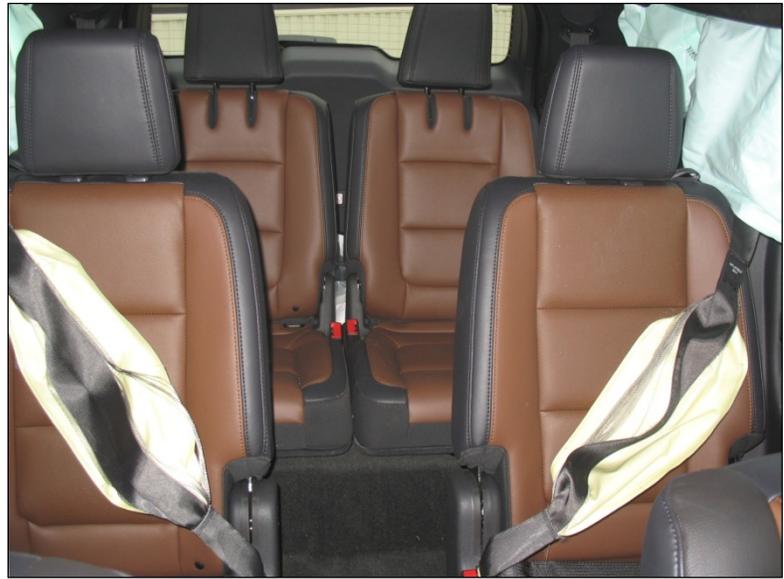
Figure 17: Deployed second row inflatable safety belts within the Ford at the time of SCI inspection.

At the time of the SCI inspection, both rear inflatable safety belts were deployed (**Figure 17**). The air bags within the shoulder portion of both second row inflatable safety belt systems measured 53 cm (20.9 in) long and 21.5 cm (8.5 in) wide in their deflated state. The inflatable safety belt air bag was enclosed within a 76 cm (29.9 in) section of non-continuous loop webbing that was 4.4 cm (1.7 in) wide and 0.4 cm (0.16 in) thick. It deployed through a 55 cm (21.7 in) long portion of the webbing, beginning 20 cm (7.9 in) above the latch plate.

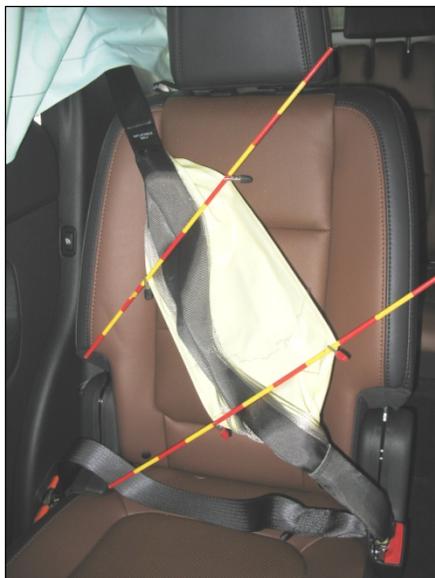
The deployed air bag was rectangular in overall shape, gathered together at both ends. A close-up view of the second row right inflatable safety belt air bag is depicted in **Figure 18**, and the second row left inflatable safety belt system is depicted in **Figure 19**.

Figure 18: Second row right inflatable safety belt air bag within the Ford.

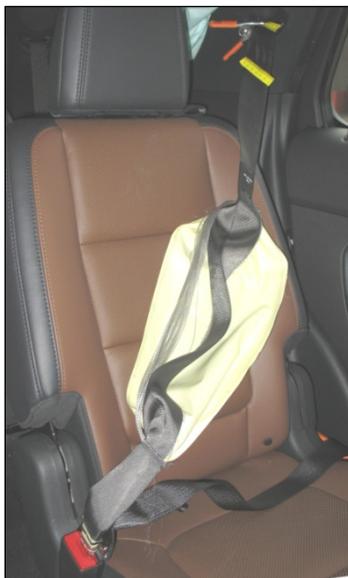
Figure 19: The Ford's second row left inflatable safety belt.

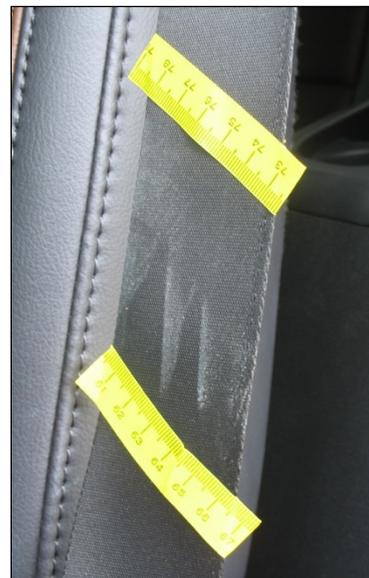
Figure 20: Second row left loading evidence within the Ford.

Loading evidence from occupant interaction was identified during the SCI inspection on both second row inflatable safety belt systems. This consisted of abrasions to the webbing that were present 87-97 cm (34.25-38.2 in) and 96 cm (37.8 in) from the latch plate on the second row left and second row right systems, respectively. Loading on the second row left inflatable safety belt is depicted in **Figure 20**. Based on the inflatable safety belt systems' deployed statuses and their condition at the time of the SCI inspection, restraint usage by both second row occupants during the crash was confirmed.

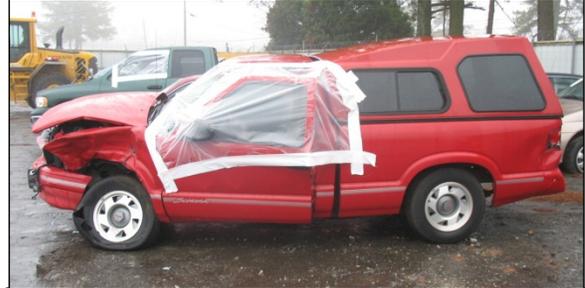
The left plane of the GMC sustained moderate damage as a result of the crash. This damage was distributed across two distinct patterns, at both the front and rear aspects. The frontal aspect damage to the left plane consisted of the lateral crush and deformation to the left front fender, left front bumper corner, left front axle, hood, and left A-pillar. This damage pattern resulted from the Event 1 impact engagement with the Ford. Direct and induced damage began at the left front bumper corner and extended 96 cm (37.8 in) and 103 cm (40.5 in), respectively, to the left A-pillar. A residual crush profile was documented at the upper door level, which produced the following measurements after appropriate stand and free space adjustments: C1 = 1 cm (0.4 in), C2 = 11 cm (4.3 in), C3 = 21 cm (8.3 in), C4 = 27 cm (10.6 in), C5 = 34 cm (13.4 in), and C6 = 28 cm (11 in).

The maximum crush was observed to the left front fender between C4 and C5, with a magnitude of 43 cm (16.9 in). The CDC assigned to the GMC for the Event 1 damage (**Figure 22**) was 10LFEW3. The Damage Algorithm of the WinSMASH model was used to calculate the severity (delta-V) of the crash. The total calculated delta-V of the GMC for the Event 1 impact was 34 km/h (21.1 mph). The longitudinal and lateral components of this delta-V were -17 km/h (-10.6 mph) and +29 km/h (+18 mph), respectively.

Figure 22: Forward left plane damage to the GMC from the Event 1 impact.

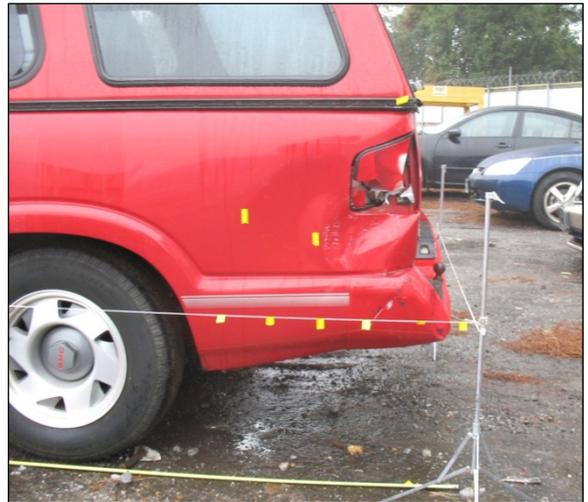
The rear aspect of the left plane sustained minor damage as a result of the Event 2 side-slap. This damage consisted of minor lateral crush and deformation to the left rear fender area on the side of the pickup bed, with disintegration of the left rear taillight assembly and minor lateral crush to the left rear bumper corner. Direct contact damage began at the left rear bumper corner and extended 38 cm (15 in) forward (**Figure 23**). The induced damage extended 57 cm (22.4 in) forward from the left rear bumper corner. A residual crush profile documented at mid-door level produced the following measurements after stand and free space adjustments: C1 = 13 cm (5.1 in), C2 = 5 cm (2 in), C3 = 9 cm (3.5 in), C4 = 4 cm (1.6 in), C5 = 2 cm (0.8 in), and C6 = 1 cm (0.4 in). Maximum crush was documented at C1. The CDC corresponding to the Event 2 damage pattern was 09LBEN1. The Damage Algorithm of the WinSMASH model was used to calculate the severity (delta-V) of the crash. The total calculated delta-V of the GMC for the Event 1 impact was 5 km/h (3.1 mph). The longitudinal and lateral components of this delta-V were zero and +5 km/h (+3.1 mph), respectively.

Figure 23: Event 2 damage pattern to the rear aspect of the GMC's left plane.
