DOT HS 812 530

May 2018

# **Special Crash Investigation On-Site Alleged Unintended Acceleration Crash Investigation Vehicle: 2008 Kia Optima Location: Tennessee Crash Date: December 2015**

**SPECIAL CRASH INVESTIGATIONS**  
**SCI CASE NO.: CR16001**  
**OFFICE OF DEFECTS INVESTIGATION**  
**ON-SITE ALLEGED UNINTENDED ACCELERATION CRASH INVESTIGATION**  
**VEHICLE: 2008 KIA OPTIMA**  
**LOCATION: TENNESSEE**  
**CRASH DATE: DECEMBER 2015**

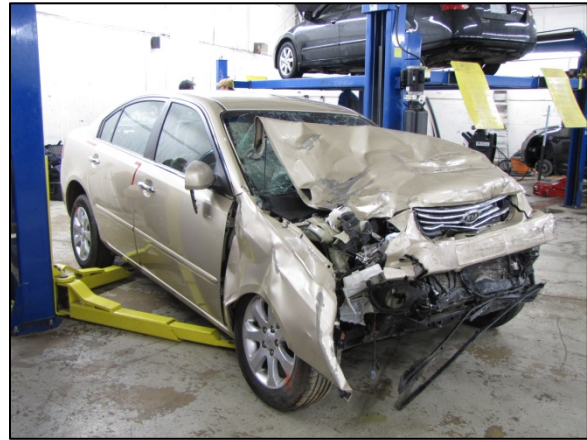
This on-site investigation involved the police-reported allegation of unintended acceleration of a 2008 Kia Optima (**Figure 1**) that may have contributed to a severe front-to-rear crash with a stopped 2003 Ford Windstar. The crash occurred when the Kia approached an intersection at a high rate of speed and struck the rear plane of the Ford Windstar, which was stopped at the controlled intersection. The Ford Windstar was then displaced through the intersection by the impact, and its front plane struck the front plane of a 2015 Ford F-150. At the time of the crash, the Kia was occupied by an 83-year-old belted female driver and a 75-year-old belted female in the front row right position. The Ford Windstar was occupied by a 48-year-old belted male driver, a 45-year-old belted female in the front row right position, and two 7-year-old males restrained in booster child restraint systems (CRS) in the second row. The Kia driver was extricated from the vehicle and transported to a regional trauma center with police-reported incapacitating (A-level) injuries. She died at the hospital three days post-crash due to complications of her injuries. Additionally, both 7-year-old males in the Ford Windstar sustained fatal injuries.

**Figure 1: Front right oblique view of the 2008 Kia Optima.**

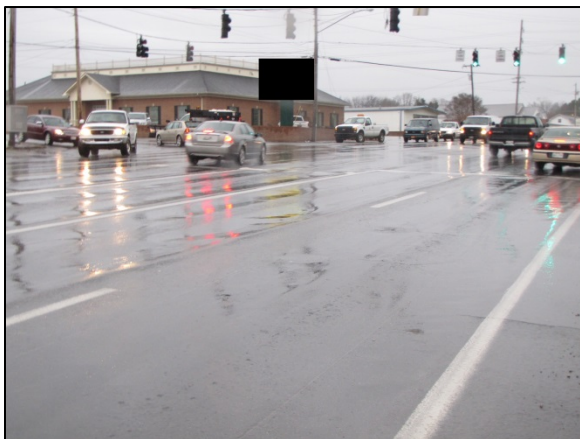
The physical environment of the crash site was documented during the SCI inspection using a Nikon Nivo 5.M+ total station measurement device. In the pre-crash trajectory for the Kia, the primary roadway descended into a sag and then transitioned to a positive 3.4 percent grade along a large radius right curvature to the intersection. This roadway was oriented southwest/northeast in direction and consisted of six lanes. The width of the travel lanes was 3.4 m (11.2 ft). Speed was regulated by a posted limit of 48 km/h (30 mph). At the intersection for the southwest travel direction, the lanes were configured with two left-turn-only lanes and two through lanes (**Figure 2**). The right-most lane also accommodated right-turning traffic into a parking lot located on the west side of the road. A double-yellow centerline separated the southwest lanes from the two northbound lanes. In the opposing (northeast) travel direction, the lanes were configured with one left-turn-only lane, two through lanes and one right turn-only lane.

**Figure 2: Southwest trajectory view of the lane configuration at the intersection.**

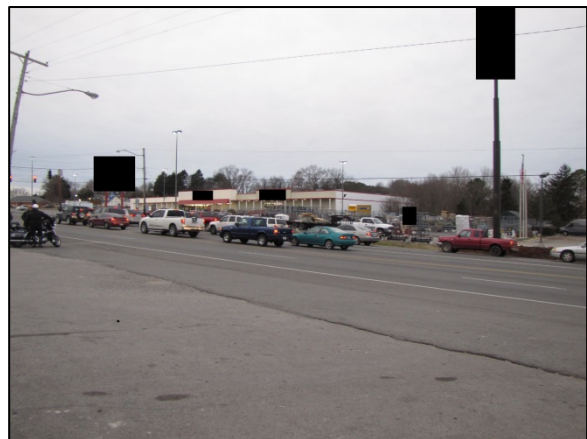
**Figure 3: Image depicting the approximate sight line of the surveillance camera.**

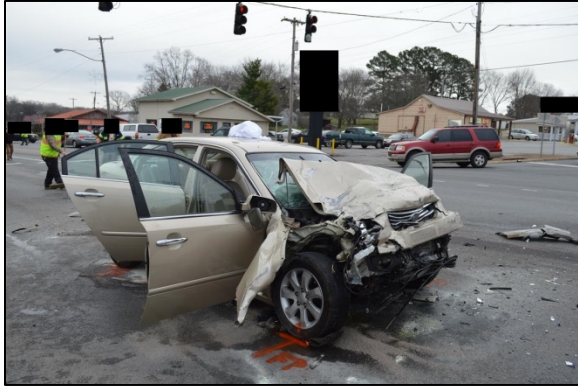
The front plane of the Kia struck the back plane of the stopped Ford Windstar in an in-line/100 percent overlap configuration (Event 1). The resulting force directions were 12 o'clock for the Kia and 6 o'clock for the Ford. Gouge marks in the asphalt pavement identified the area of the impact. The severity of the crash crushed the back plane of the Ford Windstar to the level of its C-pillars, resulting in collapse of the cargo space and severe intrusion into the passenger compartment. The frontal plane of the Kia also sustained severe crush, with engagement that extended to its A-pillars.

Figure 4: On-scene police image depicting the deformation and final rest position of the Kia Optima.

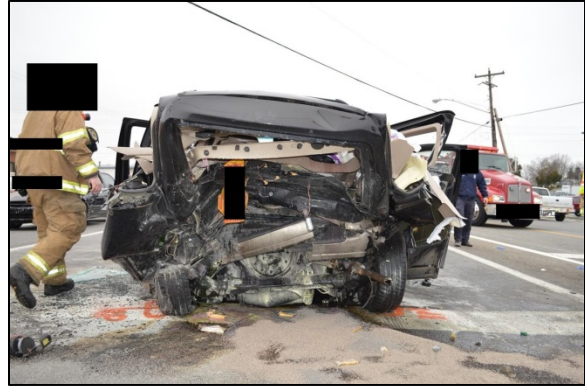
Figure 5: On-scene police image depicting the deformation and final rest position of the Ford Windstar.

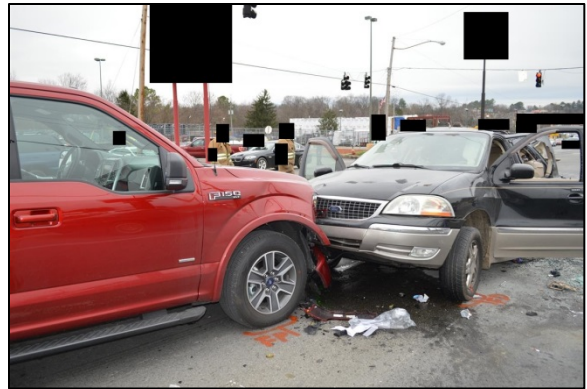
The impact momentum of the Kia displaced the Ford forward, as the vehicles crushed and then separated. The Ford Windstar was displaced forward and slightly to its left as it traveled 44 m (144 ft) across the intersection and entered the left north eastbound-through lane, directly toward the stopped 2015 Ford F-150 pickup truck. The front plane/center and right aspect of the Ford Windstar struck the front plane/center and right aspect of the Ford F150 (Event 2), which resulted in impact force directions of 12 o'clock for both vehicles. The force of this impact displaced both vehicles approximately 3.7 m (12.0 ft) to the southwest. At final rest, the front plane of the Ford Windstar was engaged against the front plane of the Ford F150 (**Figure 6**).

Figure 6: On-scene police image depicting the final rest positions of the Ford F-150 and Ford Windstar.

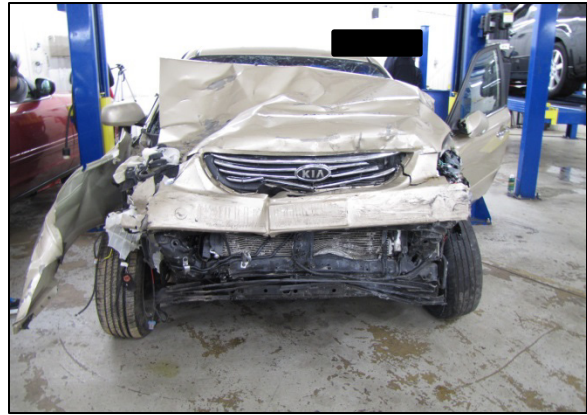
The 2008 Kia Optima (**Figure 7**) was a four-door sedan equipped with the EX trim package. It was identified by Vehicle Identification Number (VIN): KNAGE123885xxxxxx and was manufactured in Korea in February 2008. The front-wheel drive unibody platform had a 272 cm (107.1 in) wheelbase. The Kia was powered by a transverse-mounted 2.4 liter I-4 gasoline engine that was linked to a 5-speed automatic transmission. Its gross vehicle weight rating (GVWR) was 1,930 kg (4,255 lb), with specific gross axle weight ratings (GAWR) of 1,120 kg (2,469 lb) front and 1,020 kg (2,249 lb) rear. The Kia's curb weight was 1,422 kg (3,135 lb). Its service brakes were four-wheel discs with antilock brakes (ABS). The vehicle manufacturer's recommended tire size was P205/60R16 with cold tire pressure of 221 kPa (32 PSI) for all four axle positions. At the time of the crash, the Kia was equipped with Goodyear Eagle all-season radial tires of the recommended size.

**Figure 7: Front view of the Kia Optima.**

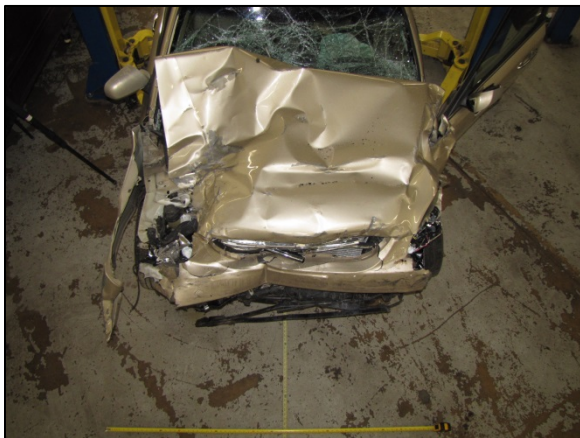
The combined width of the direct and induced damage to the Kia was distributed across the entire 152 cm (59.8 in) width of the front plane. The damage pattern was consistent with the in-line front-to-rear impact configuration (**Figure 8**). As the front plane crushed rearward, the hood buckled, tented upward, and was displaced into the windshield. The laminated windshield was fractured across its entire width. Both front fenders were crushed rearward into the lower A-pillars. The maximum extent of the direct contact between the vehicles was located at the left lower A-pillar, 30 cm (11.8 in) aft of the left front axle, due to the crush and overlapping engagement of the Kia with the Ford Windstar. Both of the Kia's front axle positions were displaced rearward and restricted, such that the left wheel base was reduced 13 cm (5.1 in) (**Figure 9**) and the right wheel base was reduced 8 cm (3.1 in). Residual crush accounting for free space was measured along the front bumper reinforcement by Nikon Total Station using a Field-L of 115 cm (45.2 in). The crush profile was as follows: C1 = 30 cm (11.8 in), C2 = 51 cm (20.0 in), C3 = 57 cm (22.4 in), C4 = 60 cm (23.6 in), C5 = 48 cm (18.9 in), C6 = 34 cm (13.4 in). The maximum crush was located 15 cm (5.9 in) right of center at C4. The Collision Deformation Classification (CDC) for this event was 12FDEW3.

**Figure 8:** Overhead view depicting the frontal crush of the Kia. The horizontal tape measure represents the original length of the vehicle.

A borderline reconstruction of the crash was calculated using the WinSMASH program. The results were considered high, due to the severity of the crash and the limited stiffness data available for the back plane of the Ford Windstar relative to the depth of crush. The total calculated velocity change ( $\Delta V$ ) of the Kia was 128 km/h (80 mph). The calculated BES was 61 km/h (38 mph).

Based on SCI field experience, the magnitude of the BES value was more consistent with the Kia's damage.

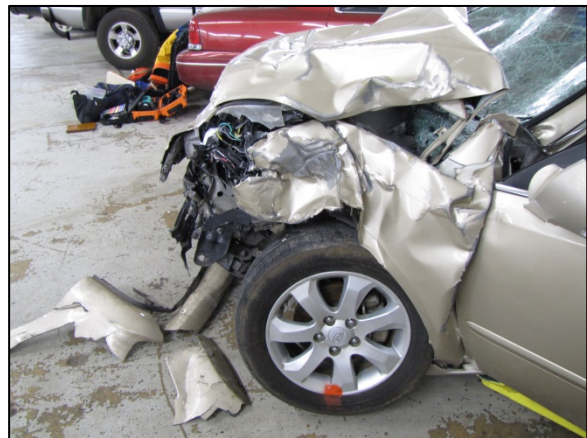
**Figure 9:** Left lateral view depicting the extent of crush to the Kia.

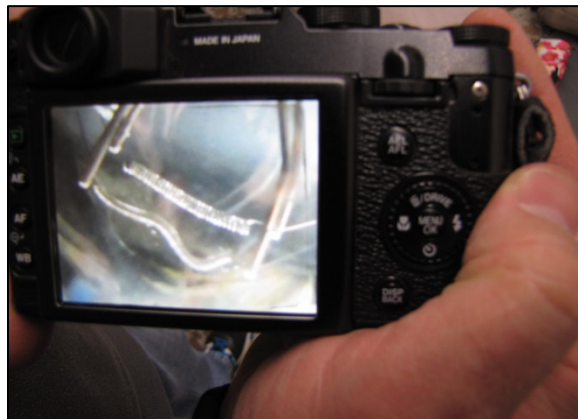
An assessment of the Kia's brake light bulbs was conducted during the joint SCI/Kia vehicle inspection. The bulbs were double filament bulbs with one filament used for taillights and turn signal and the other filament used for brake lights (**Figure 10**). The straight filament in the image was the brake light filament. The curve in the taillight filament was a natural curve from its manufacture. Both filaments were intact post-crash. If the brake light filament was illuminated at crash, the incandescent filament probably would have stretched and/or fractured due to the sudden deceleration produced by the impact. Since the filament was intact, it was determined that the brake lights were not on pre-crash and that the driver was not applying the brakes in an attempt to slow the Kia. This determination was consistent with the observations of the video surveillance footage. Additionally, the brake rotors did not appear scorched or heat stressed based on a limited visual inspection. The rotors only exhibited surface rust, consistent with the vehicle's storage since the time of the crash. The tires were not removed during the inspection.

**Figure 10:** Image depicting the condition of the brake light filaments in the Kia.

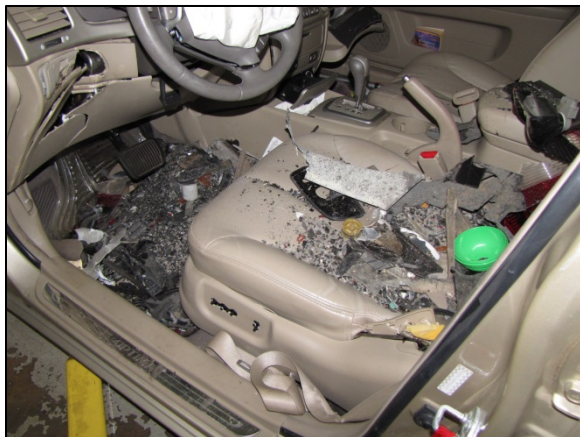
The Kia's interior damage (**Figure 11**) consisted of component intrusion associated with the exterior force of the crash, the deployment of the frontal air bags, and interior contact associated with occupant motion. The maximum intrusion was located at the left toe pan and floor, with associated intrusion of the foot controls. It should be noted that the intrusion of the left instrument panel was altered post-crash by rescue personnel, as a hydraulic ram was used to push the lower A-pillar and instrument panel forward to extricate the driver from the Kia.

Based on exemplar measurements, the longitudinal intrusion of the toe pan measured 13 cm (5.1 in) at the left aspect, 10 cm (3.9 in) along the centerline of the brake pedal, and 7 cm (2.8 in) adjacent to the accelerator pedal. The lateral width of the foot well was unchanged at 53 cm (20.8 in). The floor was buckled and intruded vertically adjacent to the accelerator. The toe of the accelerator pedal was trapped by contact with the floor. Refer to the *Foot Control Section* of this report below for further detail. The longitudinal intrusion of the right toe pan measured 10 cm (4.1 in).

**Figure 11:** Image depicting the condition of the Kia's interior at the time of the SCI inspection.

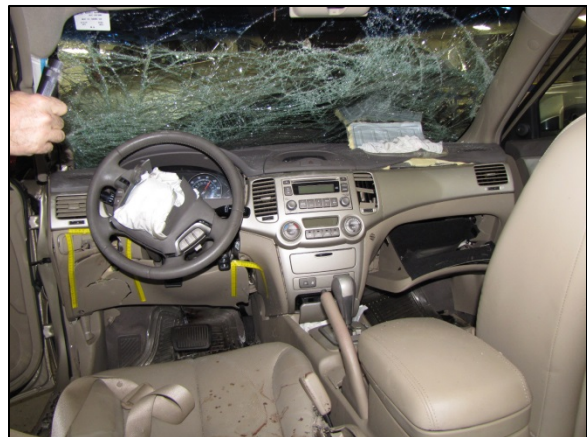
**Figure 12:** Interior image of the Kia depicting the contacts to the driver bolster.

The 8-way powered driver seat was adjusted to a mid-to-rear track position that measured 6 cm (2.5 in) forward of full rear. Although restrained by the 3-point lap and shoulder seat belt, the driver slid forward on the seat cushion and loaded the deployed driver air bag with her chest. This contact and loading also deformed the lower aspect of the steering wheel rim forward approximately 1 cm (0.5 in). The driver's left knee heavily loaded the left mid and lower instrument panel, 20 cm (7.9 in) left of the steering column (**Figure 12**).

The left instrument panel was also fractured and deformed to a residual depth of 3 cm (1.2 in). The driver's right knee engaged the right aspect of the lower instrument panel 23 cm (9 in) left of the vehicle's centerline, adjacent to the center console. This contact also fractured and deformed the plastic panel. Fabric transfers from the driver's pant legs were present at both knee contact locations.

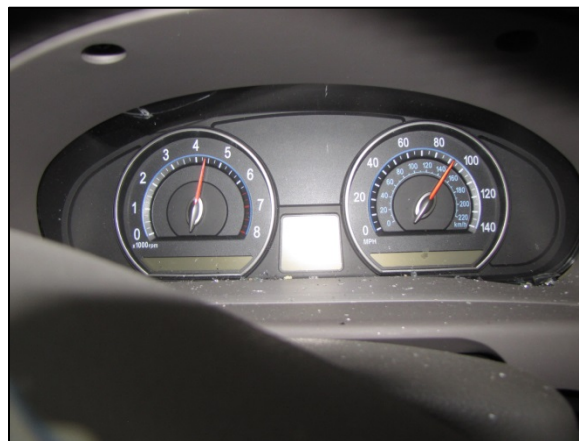
The police investigation performed at the time of the crash observed that the gauges of the Kia's combination meter (tachometer and speedometer) displayed elevated values. These gauges were still stuck in their respective positions at the time of the SCI inspection (**Figure 13**). The tachometer read approximately 4,300 RPM and the speedometer reading was approximately 148 km/h (92 mph). The displayed values were within the performance limits of the vehicle. The gauge displays of the combination meter operated via stepper motors. These stepper motors responded to the voltage changes transmitted from the engine and transmission sensors by the rotation of the display needles to the current performance values. At impact, the force of the collision suddenly removed the voltage source (the battery) from the communication loop. Absent this voltage to drive the stepper motors, the display needles were stuck at the approximate performance values that existed at the time of the impact. Possible error could be introduced into the displayed values through multiple sources, including wheel spin and transient voltage spikes. Although unconfirmed indicators of the Kia's speed and performance at impact, the gauge displays were in general agreement with the SCI crash reconstruction and the vehicle speed calculated from the surveillance video.

**Figure 13: View of the tachometer and speedometer in the Kia at the time of the SCI inspection.**

It was noted that during the process of imaging the Kia's diagnostic data that the status of the gauge displays changed. To image the vehicle, 12-volt power was applied through the fuse panel to the instrument panel and combination meter. This application of electrical power caused the stepper motors to reset the tachometer and speedometer gauges to zero. The police also observed during their on-scene investigation that the Kia's ignition key was turned to the Accessory Position and the transmission was in Neutral. It remains unknown if a first responder or tow operator changed the state of these controls post-crash or if driver action immediately prior to the impact was involved.

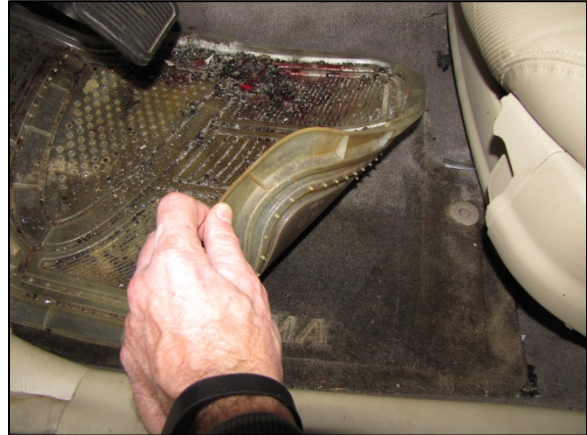
The Kia was configured with OEM equipped carpeted floors with OEM carpeted floor mats in the front positions. The floor mats were secured in place by the pins that were positioned at the aft area of the mats. An additional aftermarket vinyl floor mat was placed over the OEM floor mat of the Kia (**Figure 14**). This mat was compliant to form fit over the contour of the floor and toe pan. Numerous molded pins on the bottom side of the mat engaged the carpeted mat and held the aftermarket mat in place. At the time of the SCI inspection, this mat was firmly in place and did not interfere with the movement of the accelerator pedal. It was determined through the course of the post-crash inspection that the OEM and aftermarket mats did not play a role in this crash.

**Figure 14:** Interior image of the floor mats in the driver compartment of the Kia.

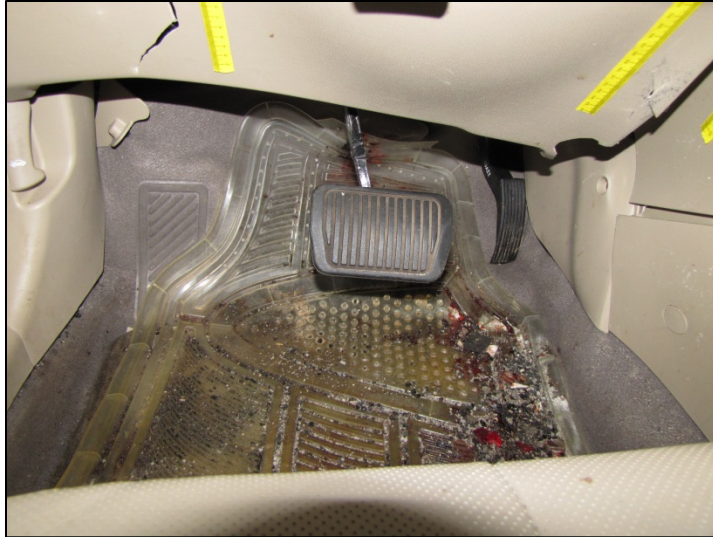
The Kia Optima used an electronic throttle control for powertrain management. Driver input was provided through the accelerator pedal that used a position sensor to control the throttle input. The accelerator pedal assembly consisted of a molded plastic arm, shaped in an S-pattern, which was attached to the position sensor. The position sensor was fastened to the toe pan such that the pedal was suspended. The position sensor was identified by the following number: DA20051A-3L100. Based on exemplar measurements, the static undamaged clearance between the toe of the accelerator pedal and the floor pan was 11 cm (4.2 in). When the pedal was fully depressed, the floor clearance reduced to 2 cm (0.8 in). The physical dimensions of the foot of the accelerator pedal measured 4 cm x 10 cm (1.6 in x 4.0 in), width by length. The offset distance between the accelerator and brake pedals measured 8 cm (3.3 in). The horizontal centerline of the brake pedal measured 19 cm (7.5 in) above the floor, while that of the accelerator pedal measured 17 cm (6.5 in).

The crash induced longitudinal intrusion of the toe pan and vertical intrusion of the floor pan that jammed the pedal (**Figure 15**). The upper curve of the arm was jammed by the toe pan. The toe of the pedal was jammed by the floor (**Figure 16**). The deformed toe pan also caused the accelerator assembly to rotate clockwise into near-contact with the center console. The gap between the accelerator and the center console measured 5 cm (2.0 in) in an exemplar vehicle.

Figure 15: Image depicting the brake and accelerator pedals of the Kia at the time of the SCI inspection.

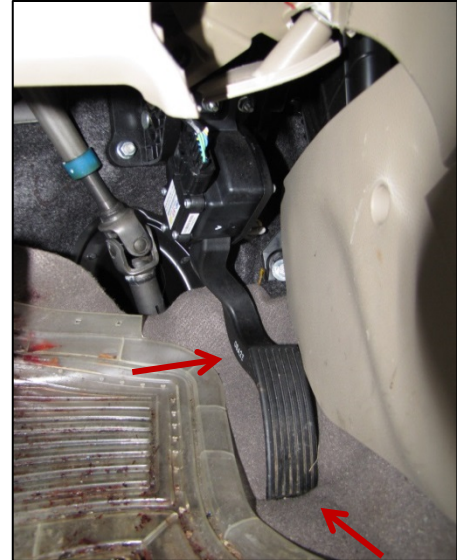
Figure 16: Image depicting the post-impact jammed accelerator pedal of the Kia.

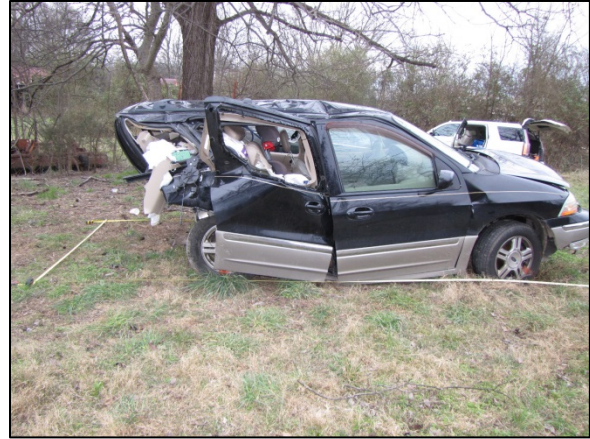
The 2003 Ford Windstar (**Figure 17**) was a seven-passenger minivan identified by the VIN: 2FMZA53443Bxxxxx. The Ford was manufactured in May 2003 and was equipped with the SEL trim package. The digital odometer read 294,507 km (182,998 miles). The body was configured on a 307 cm (121.0 in) wheelbase and had hinged front doors, second row sliding doors and a rear lift gate. The front wheel drive platform was powered by a 3.8 liter gasoline engine that was linked to a 4-speed automatic transmission with a steering column-mounted shifter. The service brakes were power-assisted front disc/rear drum with ABS. The GVWR was placarded at 2,549 kg (5,620 lb), with axle ratings of 1,315 kg (2,900 lb) front and 1,251 kg (2,760 lb) rear). The curb weight was 1,761 kg (2,882 lb).

**Figure 17:** Right side view of the Ford Windstar depicting the back plane damage.

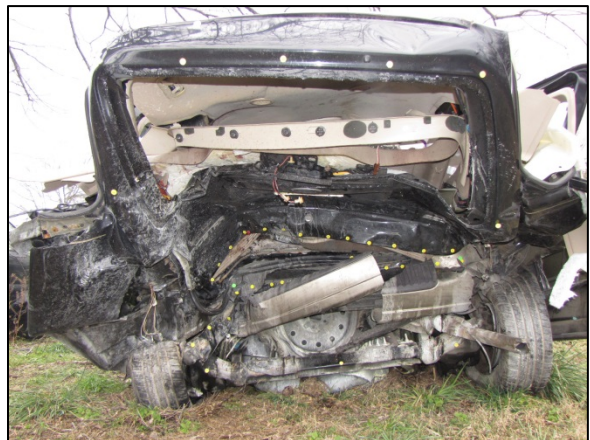
The Ford sustained impact damage to its front and rear planes, consistent with the events of the crash. Direct contact and induced damage to the vehicle's back plane extended across the entire 152 cm (59.8 in) end-width (**Figure 18**). The force of the Event 1 impact compressed the rear structure forward to the rear axle and C-pillars. As a result, the cargo area was completely collapsed, with intrusion through the third and into the second rows of the occupant compartment. The left and right wheelbase dimensions of the Ford Windstar were reduced 18 cm (7.1 in) and 34 cm (13.4 in), respectively. Residual crush was documented along the rear bumper reinforcement with a Field-L of

**Figure 18:** Image depicting the damage to the back plane of the Ford Windstar.

122 cm (48.0 in) as follows: C1 = 105 cm (41.3 in), C2 = 145 cm (57.1 in), C3 = 149 cm (58.7 in), C4 = 142 cm (55.9 in), C5 = 142 cm (55.9 in), C6 = 134 cm (52.8 in). The CDC assigned to this damage pattern was 06BDEW5.

Reconstruction of the crash calculated through the use of the WinSMASH program produced results that were considered too high based on SCI field experience. These high results were probably due to the severity of the crash, the age of the vehicle, and the limited stiffness data available for the back plane of the Ford Windstar relative to the depth of crush. The total calculated velocity change (delta-V) of the Ford was 104 km/h (65 mph) and the BES) was 144 km/h (89 mph). Conservation-of-momentum calculations estimated that the delta-V of the Ford was approximately 64 to 72 km/h (40 to 45 mph).

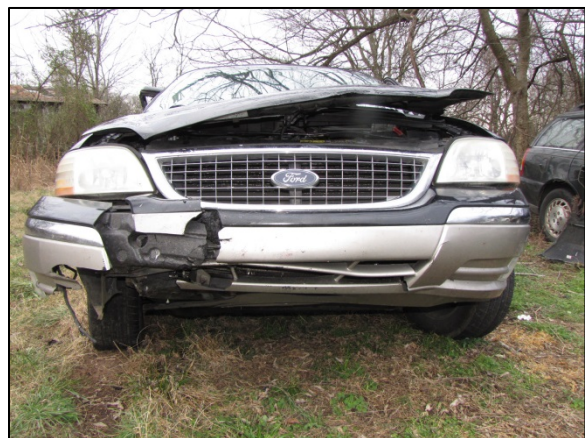
The Event 2 impact damage to the Ford was located at the right and center aspects of the vehicle's front plane (**Figure 19**). The direct contact damage began at the centerline and extended 76 cm (30 in) to the right. The impact force was absorbed and managed by the bumper reinforcement. The fascia and foam absorber were fractured in the damaged region. The residual crush profile measured along the front bumper was: C1 – C3= 0, C4 = 1 cm (0.4 in), C5 = 5 cm (2.1 in), C6 = 1 cm (0.5 in). The CDC assigned to this pattern was 12FZEW1. Using the WinSMASH program, the calculated delta-V of the Ford Windstar for the Event 2 impact with the Ford F150 was 17 km/h (11 mph). Longitudinal and lateral components of the calculated delta-V were -17 km/h (-11 mph) and zero, respectively.

**Figure 19:** Front view of the Ford Windstar depicting the impact damage.

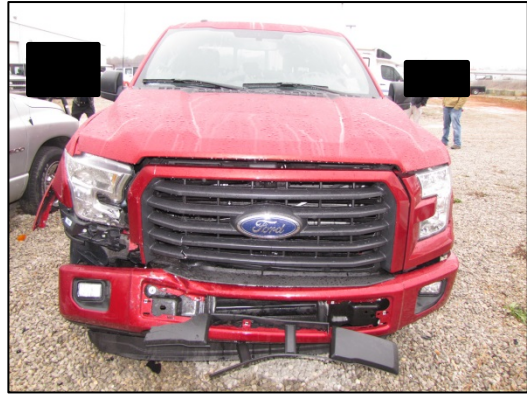
The front plane of the Ford F-150 sustained minor severity damage from its Event 2 impact with the Ford Windstar (**Figure 20**). Direct contact damage began 8 cm (3.1 in) right of center and extended 48 cm (18.9 in) to the right. Induced damage also began 8 cm (3.1 in) right of center, and extended to the front right corner. Damage was limited to the front bumper, grille, right headlamp, and surrounding trim. A residual crush profile documented at bumper level across the end-width of 188 cm (74.0 in) included: C1 – C2 = 0, C3 = 1 cm (0.4 in), C4 = 4 cm (1.6 in), C5 = 5 cm (2.0 in), C6 = 0 cm. The CDC for this damage pattern was 12FZEW1. The delta-V calculated by the damage algorithm of the WinSMASH program was 15 km/h (9 mph), with longitudinal and lateral components of -15 km/h (-9 mph) and zero, respectively.

**Figure 20:** Front view of the 2015 Ford F150 depicting the impact damage.
