U.S. Department  
of Transportation  
**National Highway  
Traffic Safety  
Administration**

DOT HS 812 626

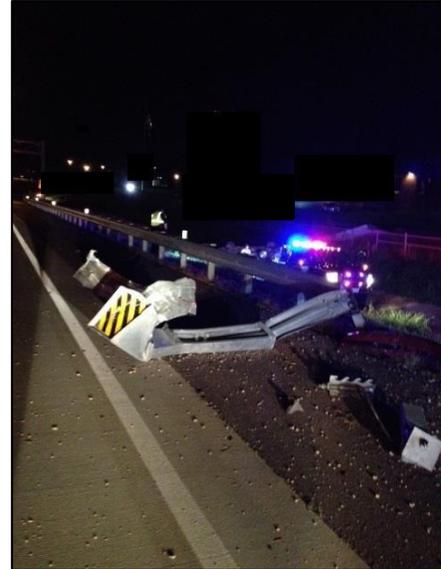
**Figure 1:** South-facing view of the struck SKT guardrail end treatment and crash site. Image supplied by MoDOT.

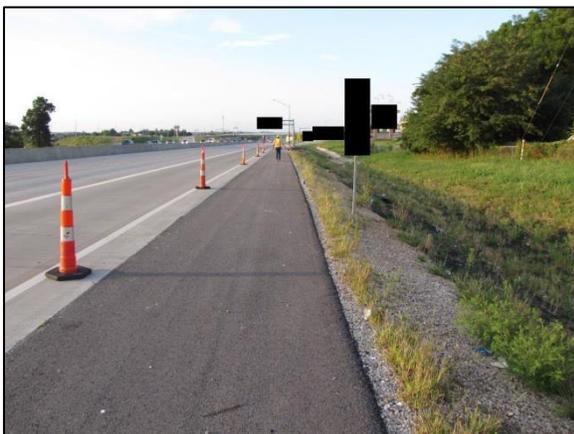
**Figure 2:** South-facing trajectory view at the crash site.

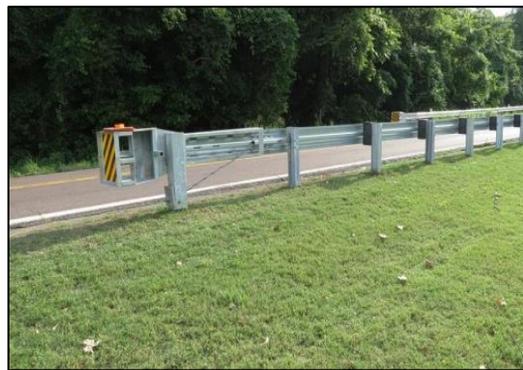
**Figure 8:** Image depicting an exemplar SKT installation.

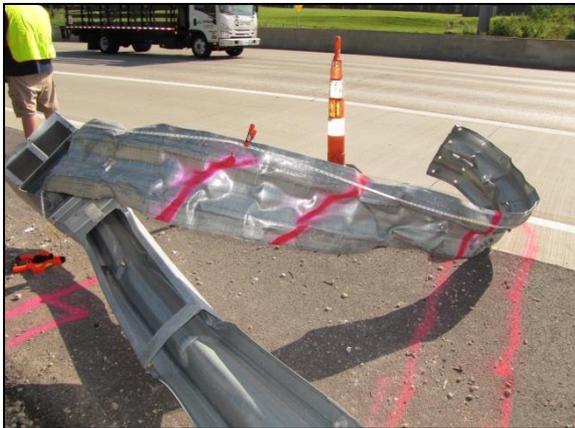
**Figure 9:** Image depicting the struck end terminal and the extruded W-beam.

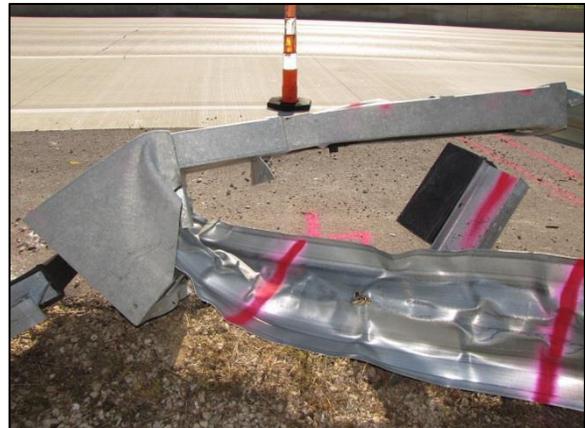
**Figure 10:** Top view of the end terminal depicting the deformation of the impact head.

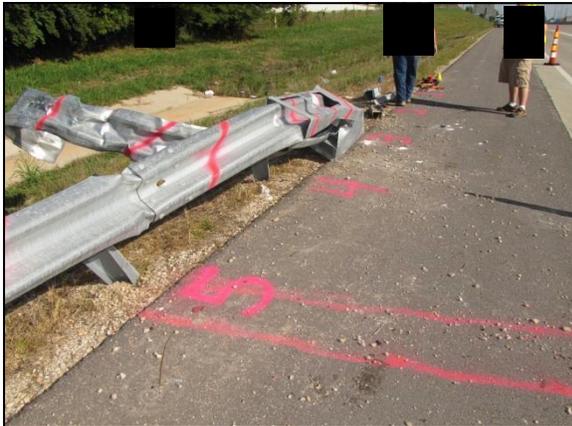
**Figure 11:** North-looking image from Post 5 of the damaged guardrail.

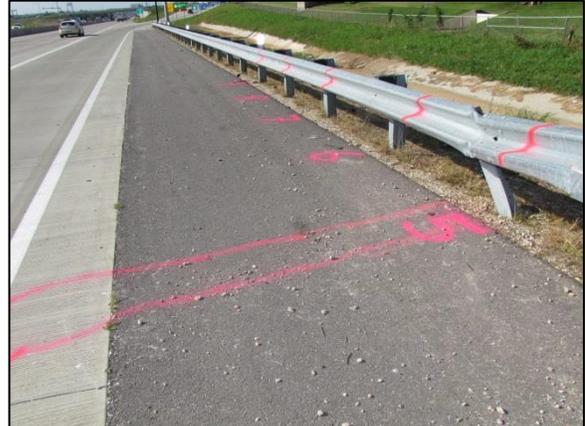
**Figure 12:** South-looking image from Post 5 of the damaged guardrail.

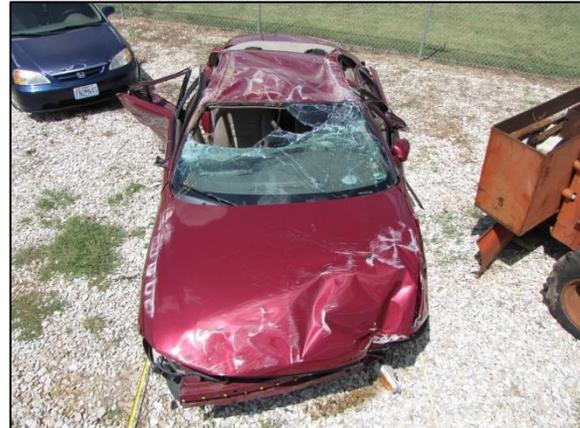
Figure 13: Overhead view of the Buick Century.

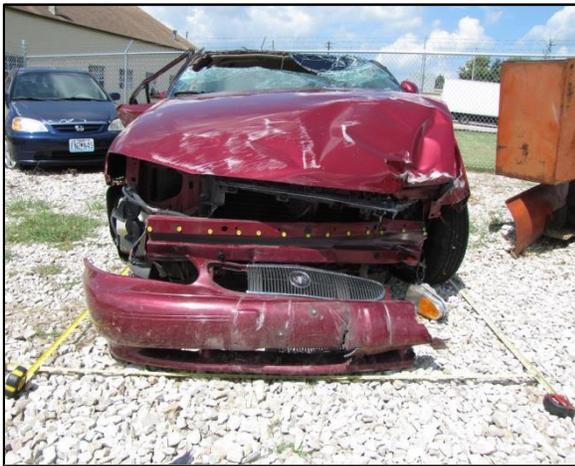
**Figure 14:** Front view depicting the location of the Buick's impact damage.

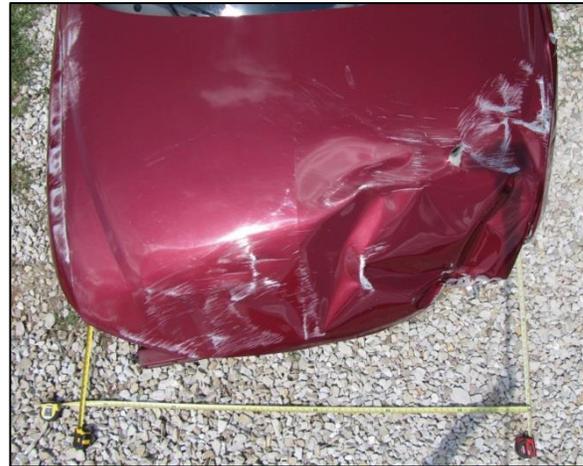
**Figure 15:** Overhead view of the Buick's frontal deformation.

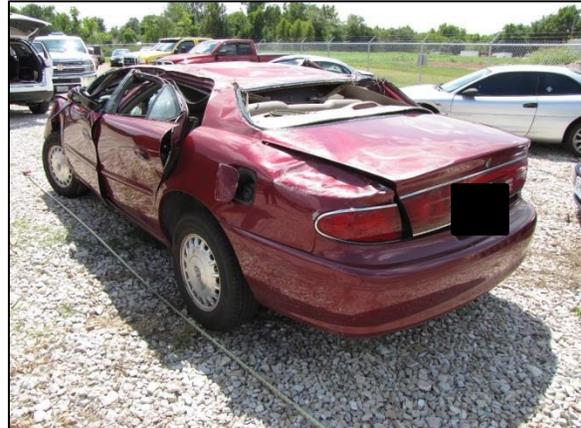
**Figure 16:** Left rear oblique view depicting the Buick's roof deformation.

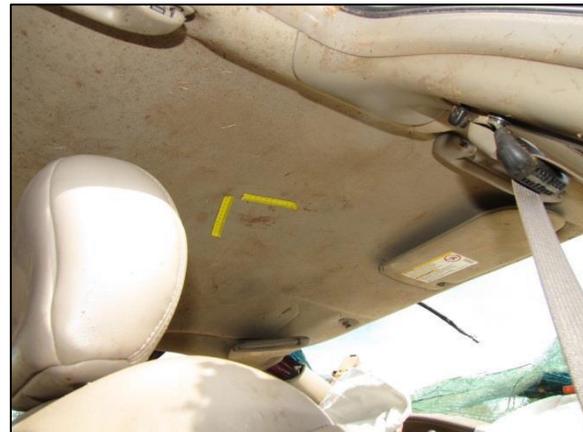
**Figure 17:** Right interior view of the Buick depicting the blood pattern on the headliner.
