Recall Bulletin

PRODUCT SAFETY RECALL

SUBJECT: Harsh Transmission Shift, Engine Stall, Engine May Not Start, MIL or Service Engine Soon Lamp

MODELS: 2005-2008 Pontiac Vibe
Two Wheel Drive Equipped with 1.8L MFI Engine (LV6)

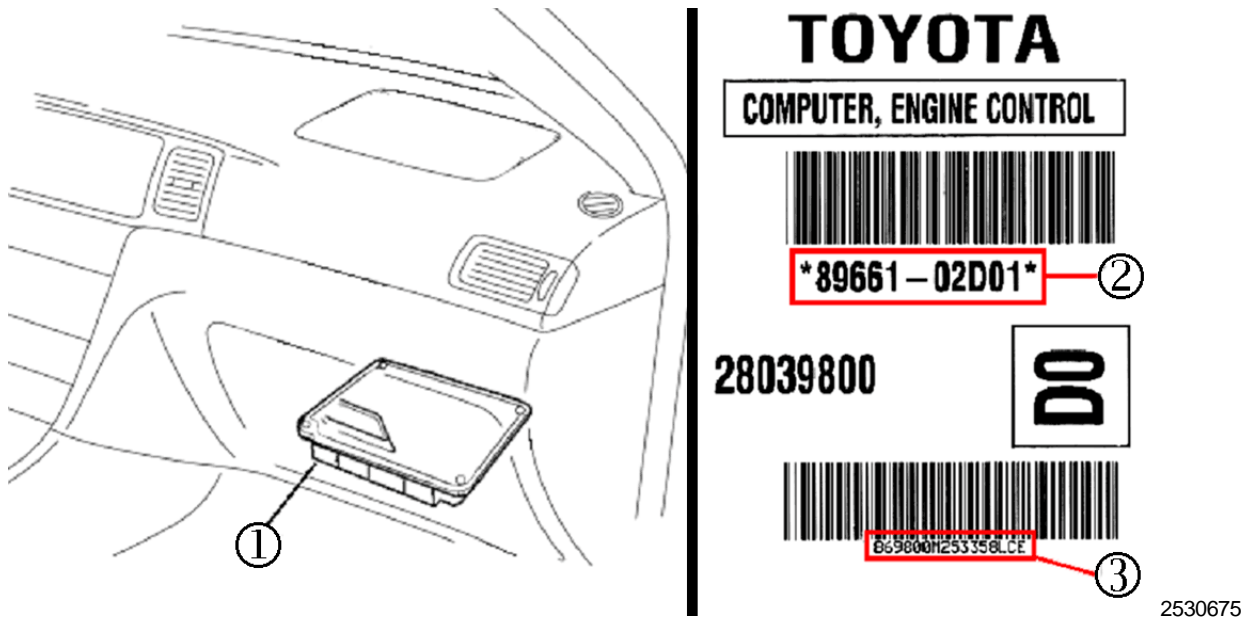
Inspection Procedure

1. Locate the PCM (1) under the glove box compartment.
2. Record the part number (2) and the lot number (3) on the repair order.
3. Confirm the PCM part number to determine the required action using the table below.

Part Number	Action	New Part Number
89661-0112#	Replace the PCM	19205364
89661-0113#	Replace the PCM	19205366
89661-02D1#	Replace the PCM	19205365
89661-02D4#	Replace the PCM	19205364
89661-02D5#	Replace the PCM	19205366
89661-02K12	No Further Action Req'd	N/A
89661-02K22	No Further Action Req'd	N/A
89661-02K30	Replace the PCM	19205364
89661-02K31	Confirm the LOT Number	19205364
89661-02K32	No Further Action Req'd	N/A
89661-02K40	Replace the PCM	19205366
89661-02K41	Confirm the LOT Number	19205366
89661-02K42	No Further Action Req'd	N/A

Part Number	Action	New Part Number
89661-02K50	Replace the PCM	19205365
89661-02K51	Confirm the LOT Number	19205365
89661-02K52	No Further Action Req'd	N/A
89661-02Q91	No Further Action Req'd	N/A
89661-02R01	No Further Action Req'd	N/A
89661-02R10	Confirm the LOT Number	19205371
89661-02R11	No Further Action Req'd	N/A
89661-02R40	Confirm the LOT Number	19205370
89661-02R41	No Further Action Req'd	N/A
89661-02R50	Confirm the LOT Number	19205372
89661-02R51	No Further Action Req'd	N/A
89661-0Z04#	Replace the PCM	19205365

- If the LOT number is 7227 or higher, no further action is required.
- If the LOT number is 7226 or lower, replace the PCM. Refer to *PCM Replacement* in this bulletin.
