**Re: Defect Information Report – Supplemental Report No. 2
10V-468 & 10V-472, 10C-6, MBE900 EPA07 Reprogramming**

**Subject: Safety Recall 10C6
MBE900 EPA07 MCM Reprogramming In School Bus and
Emergency Vehicle Applications**

Subject: **Safety Recall 10C6**
MBE900 EPA07 MCM Reprogramming In School Bus and
Emergency Vehicle Applications

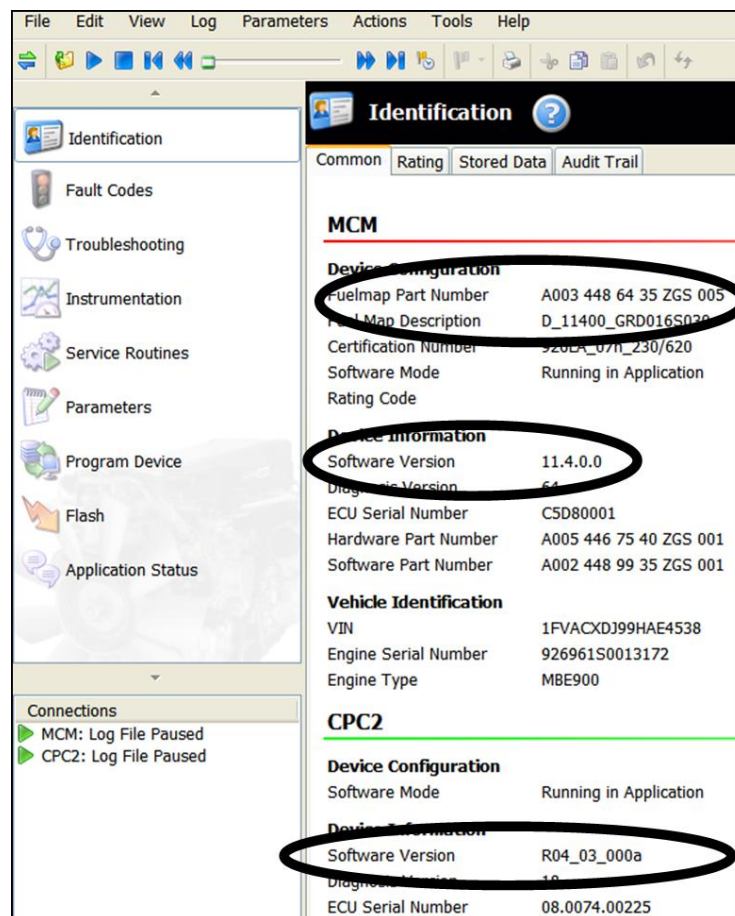
Figure 1 – Software And Fuel Map Version Number

1. Apply the parking brake, chock the wheels, and perform any other applicable safety steps.
2. Using the “Identification” screen in DDRS, check the MCM software level and fuel map version. See Figure 1. In this example, the MCM software level is 11.4.0.0 and the fuel map version is the last three digits of the fuel map part number after the letters ZGS which is 005.

4. Using the “Identification” screen in DDRS, check the CPC software level. See Figure 1. In this example, the CPC software level is r4.03. If the CPC is not at r4.03 software or higher, program it using the “Update Device Software” option. Select “No Charge”, then “Description”, and enter “10C6” in the “Provide Reference” box.

3. If the MCM is not at software 11.4.0.0 with fuel map version 005 or higher, program it to 11.4.0.0 or higher using the “Update Device Software” option. Select “No Charge”, then “Description”, and enter “10C6” in the “Provide Reference” box.
