GROUP Safety Recall Campaign	MODEL Optima (MG) 2006~2008MY
	NUMBER SC 088	DATE March 2011
VOLUNTARY SAFETY RECALL CAMPAIGN		
SUBJECT: OPTIMA (MG) A/T SHIFT CABLE INSPECTION (SC088)

OPTIMA (MG) A/T SHIFT CABLE INSPECTION VOLUNTARY SAFETY RECALL CAMPAIGN (SC088)

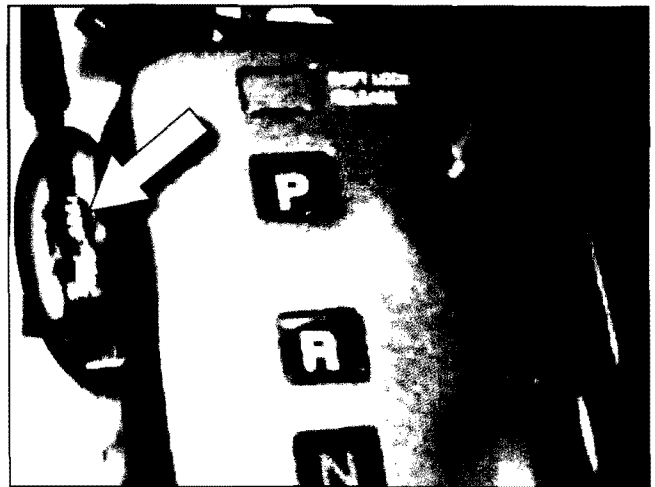
2. Check that the A/T shift cable is installed correctly (arrow). If the cable is found to be installed correctly (saw-edged projections facing up), no further action is required. Reinstall center console cover. If installed incorrectly, proceed with repair procedure beginning at Step 3.
