Safety Recall Circular

Code: 97V3

Subject: 2011 Jetta Sedan (6th Generation)
Converter Box Wiring

March 2011

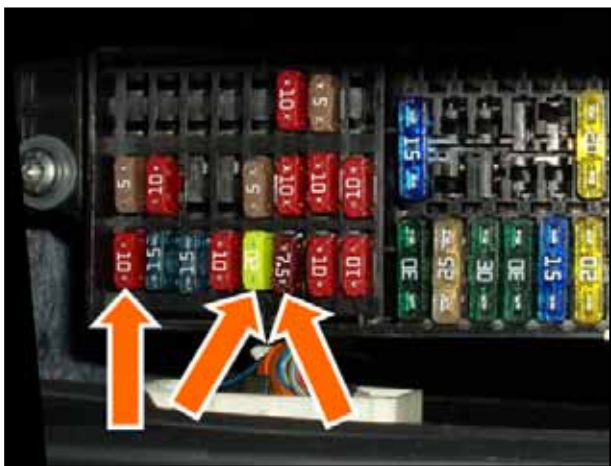
⇐ Check lower left fuse panel for presence of three fuses <arrows>:

- Fuse 10A (red) – position 17
- Fuse 20A (yellow) – position 21
- Fuse 7.5A (brown) – position 22

⇐ If fuses <arrows> are present, **WORK COMPLETE, Continue to Section H**

⇐ If fuses <arrows> are not present, **continue to Section B**

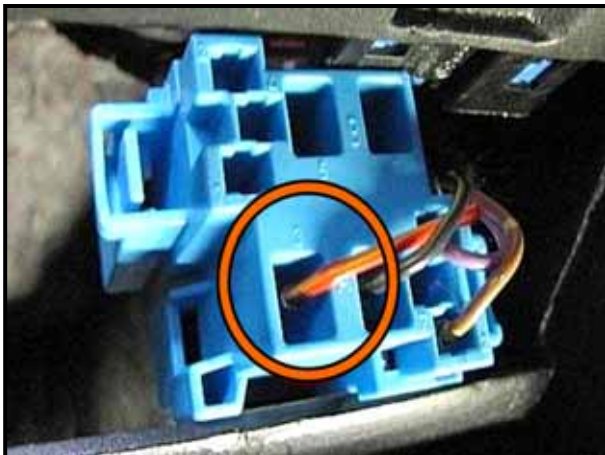
⇐ Pull the red/yellow wire <circle> out of position 3 in the contact housing

- Install the new terminal contact with the designation **(REL. 3.)** from the repair kit (5C0 971 321) into the relay contact housing in the same location used by the wire previously removed

- Engage the secondary locking mechanism of the relay contact housing
