# Safety Recall Trucks

Date	Group.	No.	Page
06.11	SC0350		1(4)

Power Mirror Switch Failure

MRU

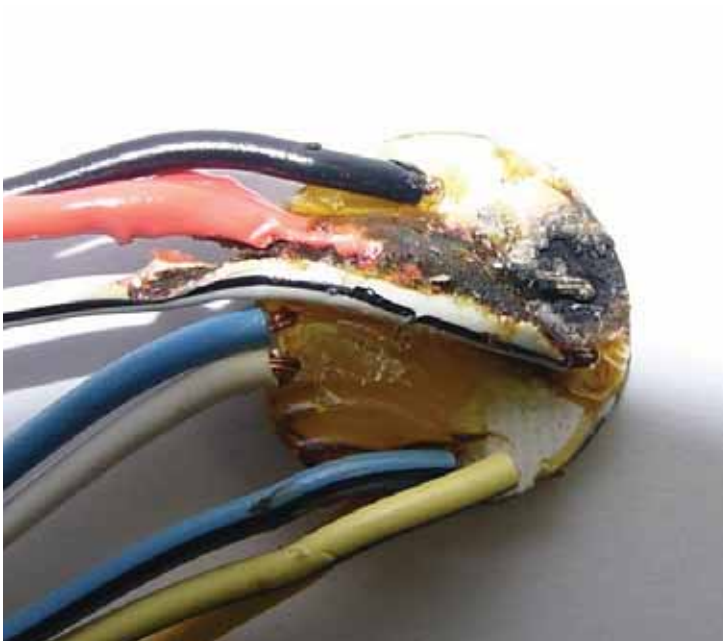
3. Inspect the rear of the mirror switch for signs of overheating. If the switch shows signs of overheating, such as wire insulation melted or discolored, replace the switch with partnumber 25165161.
