**Re: Defect Information Report – Supplemental Report No. 1
11V-330, FL-609, Starter Cable Isolator Bolts
Interim Dealer Bulletin**

August 2011
FL609
NHTSA #11V-330
Transport Canada #11-236
INTERIM RECALL BULLETIN

Subject: Starter Cable Isolator Bolts

Models Affected: Specific Freightliner Cascadia, Century S/T, Columbia, and Coronado vehicles; Sterling A/L-Line vehicles; and Western Star 4900 and 6900 vehicles manufactured January 14, 2008, through June 15, 2011 with a Detroit Diesel DD15 or DD16 engine and a certain rubber isolator.

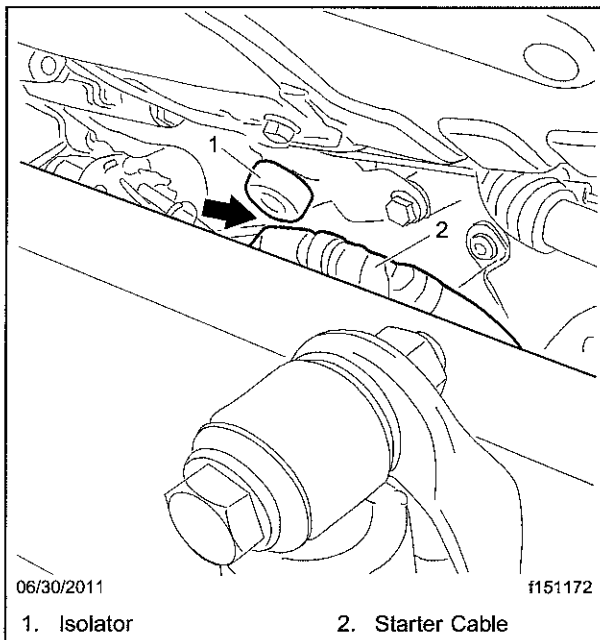
Fig. 1, Correct Isolator Installation

If the bolt is present and there is a minimum of 1/2-inch of clearance between the isolator and the starter cable, no further action is necessary at this time. See Fig. 1.

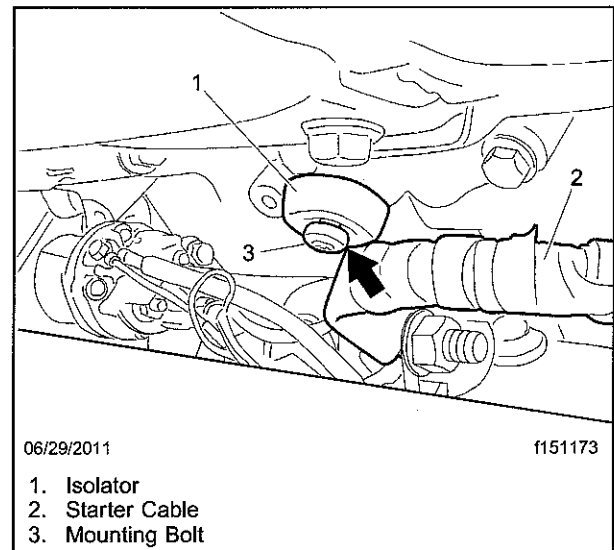
Fig. 2, Bolt Backed Out

On some vehicles equipped with a Detroit Diesel DD15 or DD16 engine, the bolt attaching a rubber isolator to a support bracket may become loose and back out, potentially contacting an un-fused starter cable and creating a short circuit. A short circuit between an un-fused starter cable and chassis ground could result in a vehicle fire.

If the bolt has backed out of the isolator and is protruding past the front surface of the isolator or if the starter cable is within 1/2-in of the isolator, take the vehicle to an authorized Daimler Trucks North America dealer for repair. See Fig. 2.

4. Apply Loctite 272 high temperature thread-locking compound to the capscrew threads, then install the capscrew and the isolator, tightening the capscrew until the rubber isolator begins to compress. The mounting capscrew should not protrude past the front surface of the isolator, and there must be approximately 1/2-inch (13 mm) of clearance between the isolator and the starter cable. See **Fig. 1** and **Fig. 2**.
5. Connect the batteries.
6. Remove the chocks from the tires.
