Recall Bulletin

PRODUCT SAFETY RECALL

SUBJECT: Shift Lever Indicator May Not Display Correct Gear

MODELS: 2008-2010 Chevrolet Malibu
2008-2010 Pontiac G6
2007-2010 Saturn AURA
Equipped with 4-Speed Automatic Transmission (ME7/MN5)

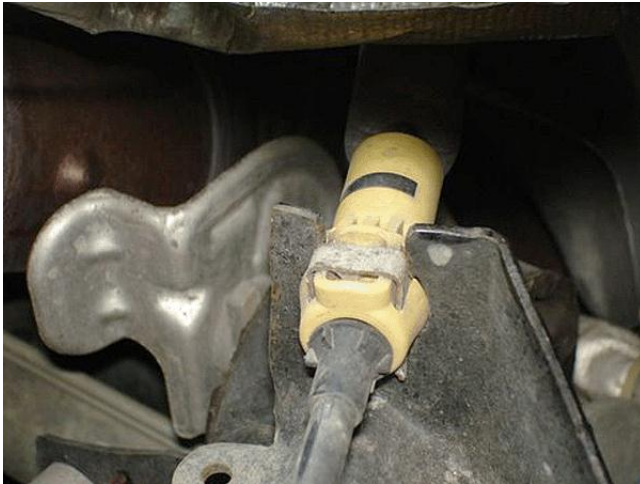
3256032

- If the clam shell cover is installed, no further action is required. Refer to the *Warranty Transaction Information* section of this bulletin. Submit a transaction using labor code V2743.
- If the clam shell cover is NOT installed, determine if the transmission shift cable is a first or second design cable.

Note: Perform the service repair procedure in this bulletin on second design transmission shift cables only. First design transmission shift cables do NOT require a repair. Refer to the illustration to view a first design shift cable. Refer to *Transmission Shift Cable Kit Installation Procedure* in this bulletin to view the second design transmission shift cable.

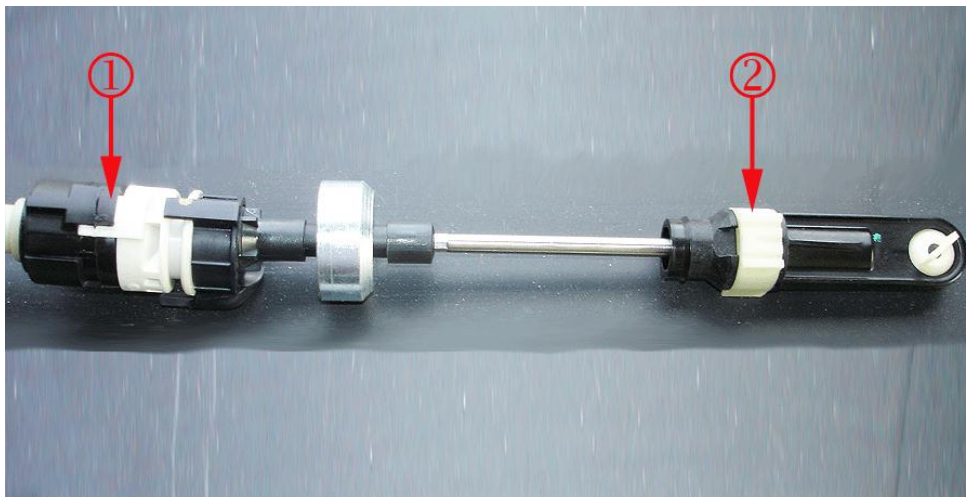
2269489

- (1) Shift Cable Locking Tabs
- (2) Shift Cable Adjuster Locking Clip

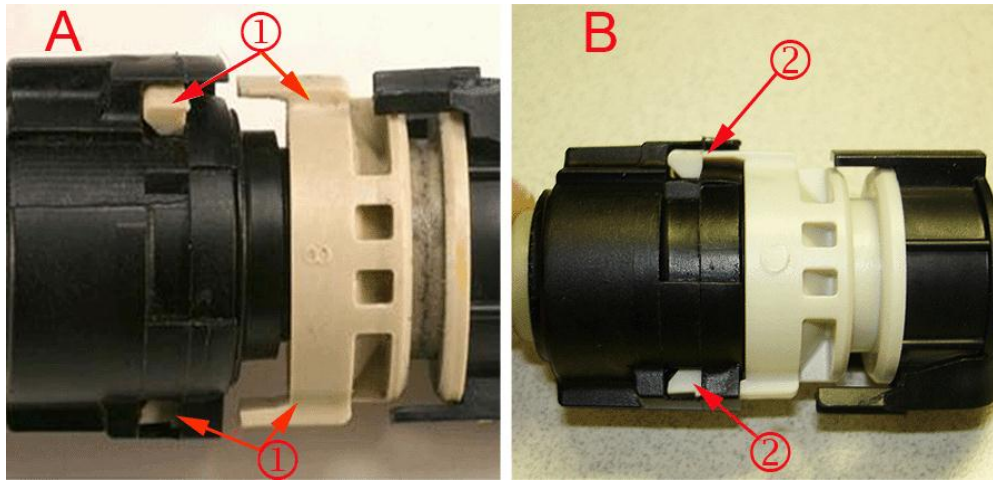
2269486

2. Determine if the transmission shift cable locking tabs are fractured and separated.

- If the transmission shift cable locking tabs (1) are fractured and separated (A), remove the transmission shift cable and replace it with a new one. Refer to *Floor Shift Control Cable Replacement or Range Selector Lever Cable Replacement* in SI. **Also install a transmission shift cable kit with the new shift cable.**
- If the transmission shift cable locking tabs (2) are NOT fractured and separated (B), install the transmission shift cable kit. Proceed to Step 3.

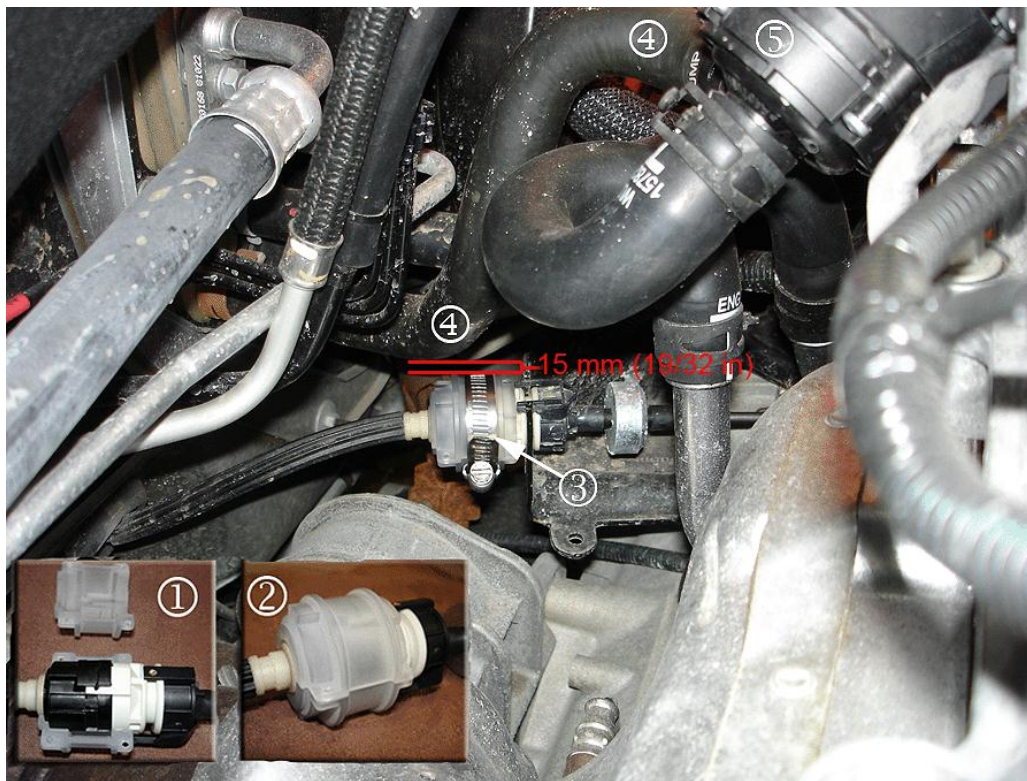
2269484

- (1) Clam Shell in Two Pieces
- (2) Clam Shell Around Shift Cable Locking Tabs
- (3) Clamp on Clam Shell
- (4) Inlet Coolant Hose and
- (5) Heater Cooler Pump.

3. Install the clam shell (1) (2) over the shifter cable locking tabs.
4. Install the service clamp over the clam shell (3). Position the clamp fastener head away from the inlet coolant hose (4). **Tighten the clamp to 4 N·m (35 lb-in).**
5. Ensure that there is 15 mm (19/32 in) of clearance between the inlet coolant hose (4) and the clam shell (3). On hybrid equipped vehicles, it may be necessary to reposition the inlet coolant hose (4) to achieve the required 15 mm (19/32 in) of clearance. **To reposition the inlet coolant hose (4) on hybrid equipped vehicles, locate the heater cooler pump (5) and perform Steps 5.1-5.4.**

Caution: Do not kink or damage the inlet coolant hose (4) when repositioning the hose to obtain the 15 mm (19/32 in) clearance. To avoid damaging the hose clamp, use J-38185 or equivalent hose clamp pliers to loosen the hose clamp.

- 5.1. Using J-38185 or equivalent hose clamp pliers, loosen the inlet coolant hose (4) connected to the heater cooler pump (5). Note the location of the clamp on the inlet coolant hose (4).
 - 5.2. Rotate the inlet coolant hose (4) clockwise until 15 mm (19/32 in) of clearance between the inlet coolant hose (4) and clam shell (3) is achieved.
 - 5.3. Ensure that the inlet coolant hose clamp is secure on the inlet coolant hose (4) in the production location.
 - 5.4. Install the generator control module cover. Refer to *Generator Control Module Cover Replacement* in SI.
6. Close the hood.
