TB No.

1149

and T60 systems

LINAC Support Assembly Roll Pin Replacement

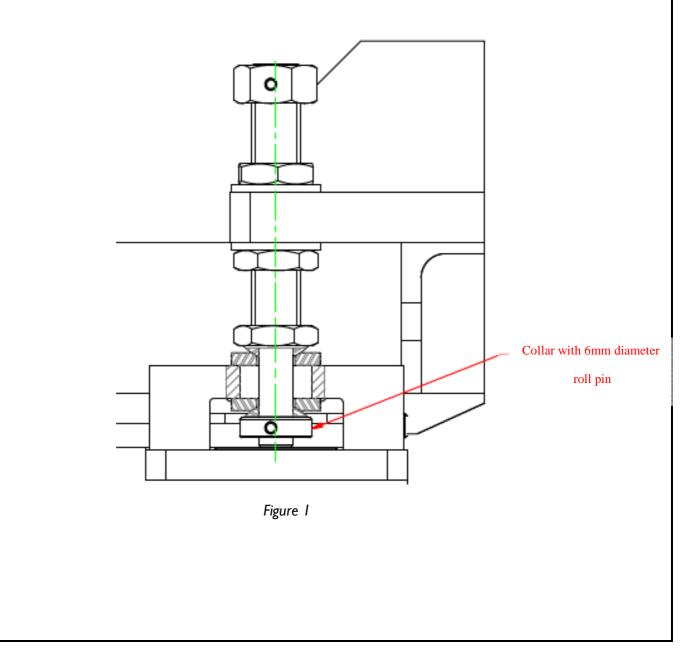
1. The diagram below shows the LINAC table adjuster. The collar at the base of the adjuster has a 6mm roll pin inserted which needs to be replaced.
